**The Old Mill,
Yeolmbridge,
Launceston, Cornwall**

**Level 2-3 Historic
Building Recording**

AB Heritage Project No:10682

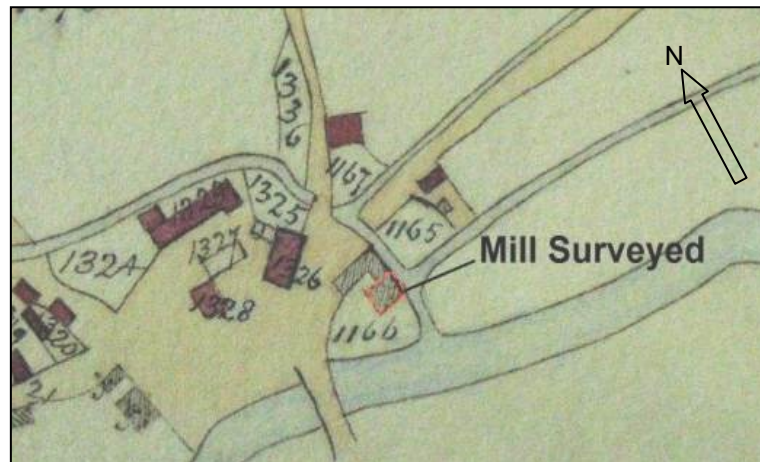
- 4.1.2 The earliest map depicting the mill complex is the Werrington parish Tithe Map of c.1839. A copy of the map was made in 1864 (Plate 2). The 1864 map shows the area exactly as it was depicted on the original c. 1839 version of the map. Comparison between this and the previous map, provide an approximate construction date for the mill and the adjoining former post office building (outside of the application boundary) somewhere between the late 18th and early 19th century, after c. 1761 but prior to c.1839.

- 4.1.3 The mill and former post office buildings form a sub c-shape, single building abutting the mill race to the east. The extension on the western side of the mill is already extant by c.1839. The 1839 tithe apportionment refers to the plot of the proposed development site as a yard, with no mention of the mill operating at the site. The river Ottery is shown running further to the south than at present. Two leats are shown running from the east, western towards the mill. The southern of which enters the mill race adjacent to the eastern side of the mill building. The northern one runs adjacent to the former road and enters the leat leading to the mill race further to the north.

Plate 2: Plan of the Parish of Werrington and St Giles, 1864. Surveyed mill outlined in red (Devon Heritage Centre ref. L1258M/0/E/MAP/7/2).

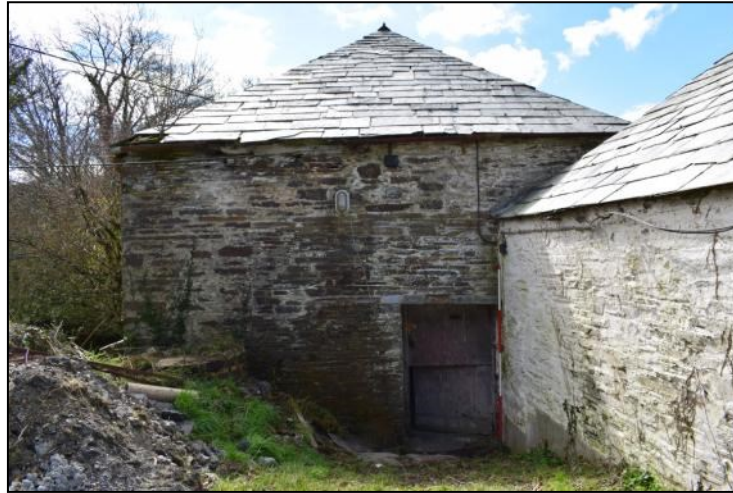
- 5.1.4 The south-west corner of the former post office building abuts and obscured the western part of the northern elevation. A ground floor doorway is located in a former central location within the elevation, now abutting the wall of the former post office building to the west. The timber lintel above the doorway indicates that the width of the doorway has been reduced, with the aperture now only occupying the western side of the original doorway. The western part of the timber lintel is covered by a number of slate tiles c. 0.2m long and 0.1m wide (Photo 1).

Photo 1: Northern elevation of the mill. Scale 2m

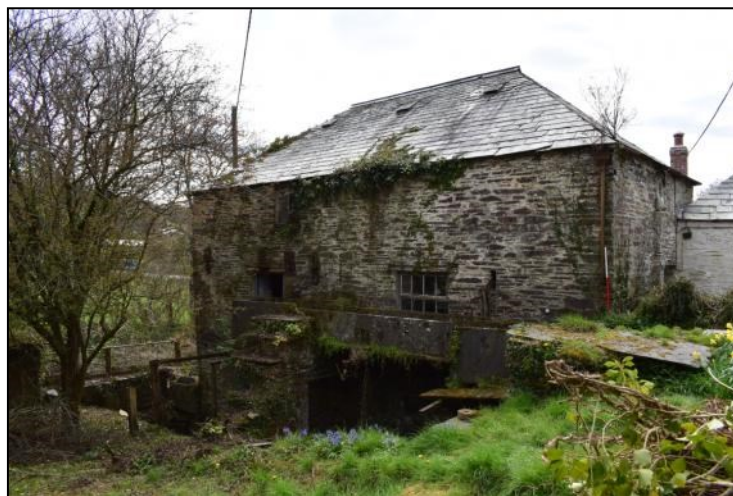
- 5.1.5 The wheel pit is located adjacent to the eastern elevation. The base of the wheel pit is present c. 1m below the adjacent ground level. The side and end walls of the wheel pit are constructed from slate ragstone slabs. Two apertures are present on the eastern elevation to house the axles for two waterwheels.

- 5.1.6 The position of the launder and the sluice gates suggests that the mill probably ended with a pitchback wheel that replaced both of the overshot wheels. Both waterwheel axle apertures are covered with slate slabs, with corresponding holes (Photo 3). A slate slab on the edge of the southern aperture is carved with the letters 'H P'. The remains of an iron waterwheel axle are located within the wheel pit. A single small timber casement window is present at second floor level, towards the southern end of the elevation. Two first floor timber casement windows have timber lintels and slate slab sills. A number of anchor plates are present at the southern end of the eastern elevation (Photo 2).

Photo 2: Eastern elevation of the mill with wheel pit & launder. Scale 1m

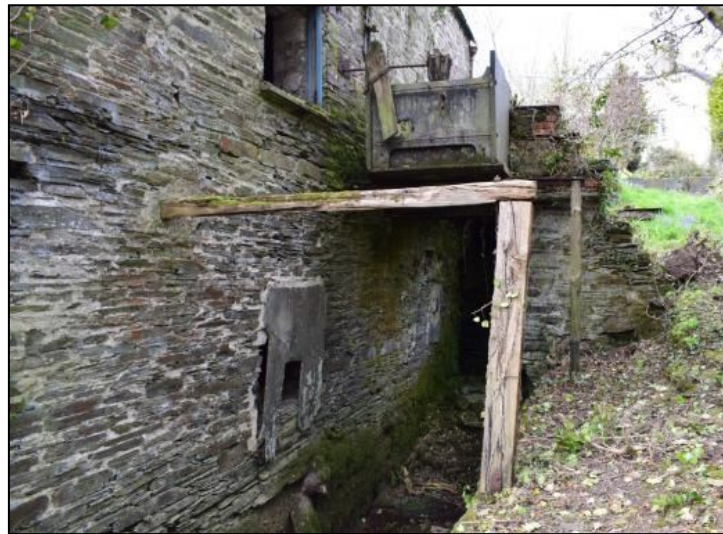
- 5.1.7 The remains of a launder are present adjacent to the eastern elevation, constructed from slate slabs up to c. 1m long and c. 0.5m wide. The southern end of the launder is no longer extant. The base of the launder is supported by a timber and iron frame. The frame is built into the eastern elevation of the mill building and into the adjacent low wall on the eastern side of the wheel pit. A number of iron supporting strops are located across the interior width of the launder (Photo 4). A slate built stack with slate steps has been constructed to provide access to the launder. The upper section of the steps has been repaired with bricks in the recent past (Photo 2 & 3).

Photo 3: The wheel pit, launder and waterwheel apertures, from the south

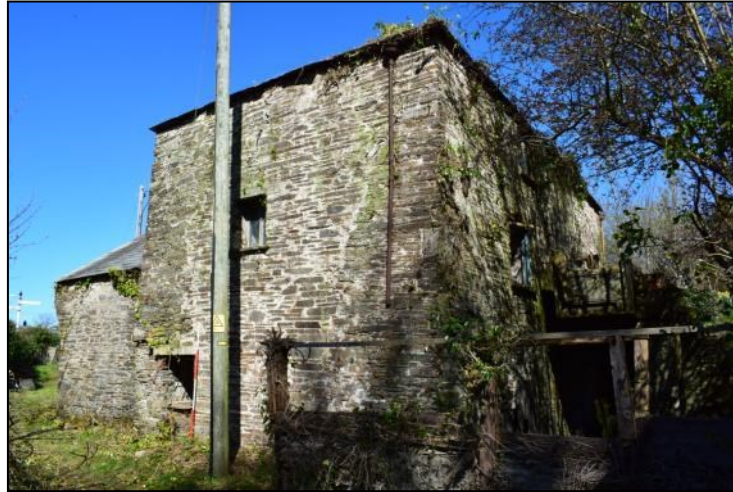
- 5.1.9 A former doorway is present at ground floor level on the southern elevation that has been turned into a window, with a cast concrete lintel and a slate sill. The window frame no longer survives. A small timber casement window has been inserted at the first floor level. This also has a cast concrete lintel and slate sill. The western extension to the mill building abuts the south-west corner on the southern elevation (Photo 5).

Photo 5: Southern elevation, Scale 2m

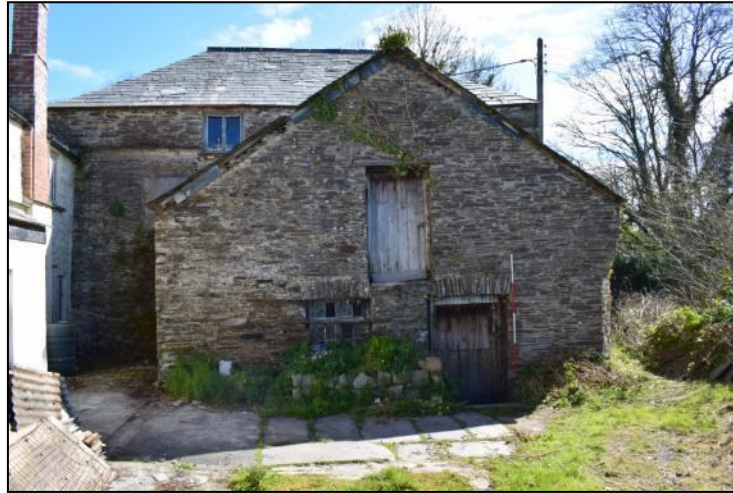
- 5.1.10 An extension to the mill building abuts the western elevation. A small timber casement window is present at second floor level. A small square window is present at ground floor level, although the original frame no longer survives. A former roof line is indicated by a horizontal line of slates protruding from the western elevation at second floor level.
- 5.1.11 A number of large slate slabs are located flat against the western elevation, adjacent to the pitched roof of the extension. The function of these slate slabs is uncertain, but they may have been used to repair the western elevation during the insertion of the extension. The former post office building abuts the north-west corner of the western elevation. Pieces of slate have been placed as barraging along the edge of the western gable roofline (Photo 6).

Photo 6: Western elevation, Scale 2m

5.1.12 The gable western elevation of the extension has a canted lower section at the south-east corner of the building. An off-centre doorway has a vertical slate constructed slightly curved over arch. The adjacent timber casement window has the same type of over arch. A grain door has been inserted later at first floor level and truncates the over arches of the ground floor window and doorway (Photo 6).

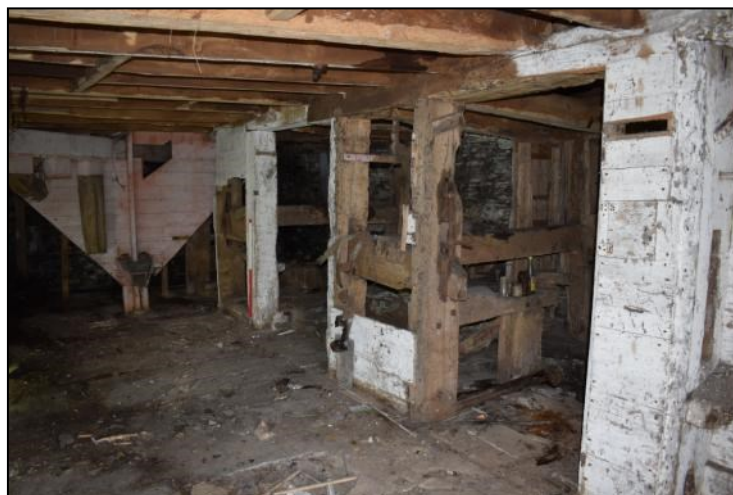
Photo 7: Eastern end of the ground floor with hurst and hopper. Scale 1m

5.1.14 The eastern end of the ground floor contains northern and southern pit wheel pits, enclosed by a boarded hurst, of which some of the boarding remains (Photo 7). The base of the pit

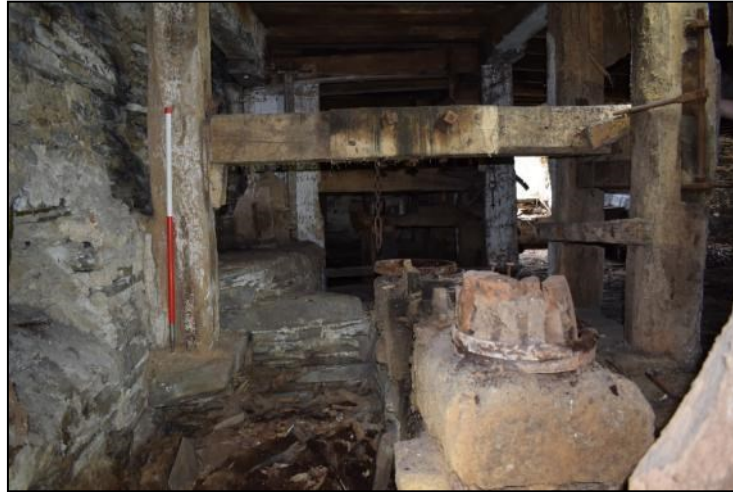
wheel pits was not visible due to the presence of debris and no original elements of the gearing mechanism remains in situ, apart from some of the bearings. The main elements of the timber hurst remain intact, including the bressumer, bridge posts, bridge trees and the stone beams (Photo 7 - 9). The main bridge post timbers are resting on a slate plinth (Photo 8).

Photo 8: View of the interior of the hurst from the north pit wheel pit. Scale 1m

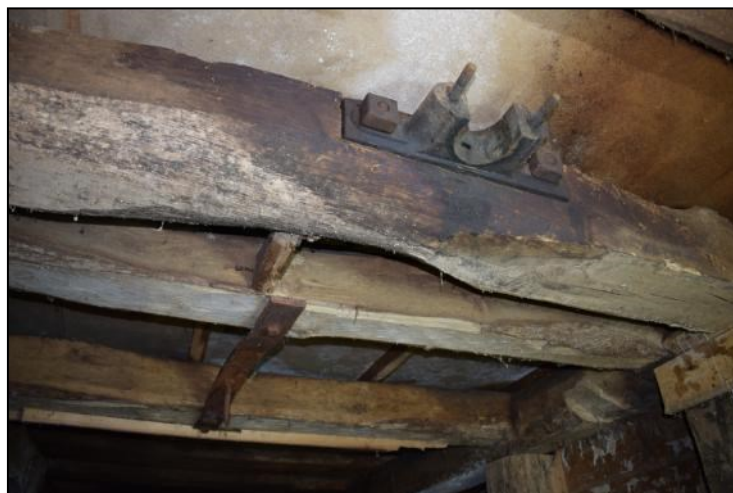
- 5.1.15 Iron bearings are present in the apertures for the waterwheel axles. A number of additional bearings are located along the bridge beams suggesting the position of possible ancillary drives. A position of a horizontal bearing on the timber supporting the pit wheel axle, and a corresponding vertical bearing on the above bridge beam, suggests the millstones above had been operated by a spurwheel type drive with a crown wheel arrangement (Photo 9). A large hopper is located at the northern end of the ground floor (Photo 7). This is a later feature and retains some of the original sack tubes. This hopper was likely fed from the stone floor above.

Photo 9: Stone beams & vertical bearing on bridge beam above northern wheel pit wheel on the ground floor

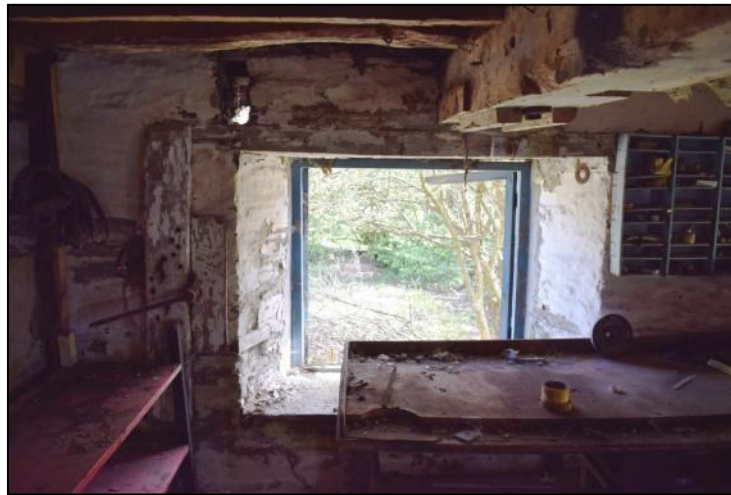
- 5.1.17 There is no evidence for the former use of the floor as a stone floor, although a hopper with sliding grain control door is located against a wall on the ground floor. An iron handle for operating a sluice gate of the launder, is located on the northern side of one of the windows on the eastern elevation (Photo 10). A hole is located above the handle for another missing mechanism. Another iron handle for operating a sluice gate at the northern end of the launder is protruding through a rectangular hole at the northern end of the first floor.

Photo 10: Launder sluice gate mechanism on the first floor

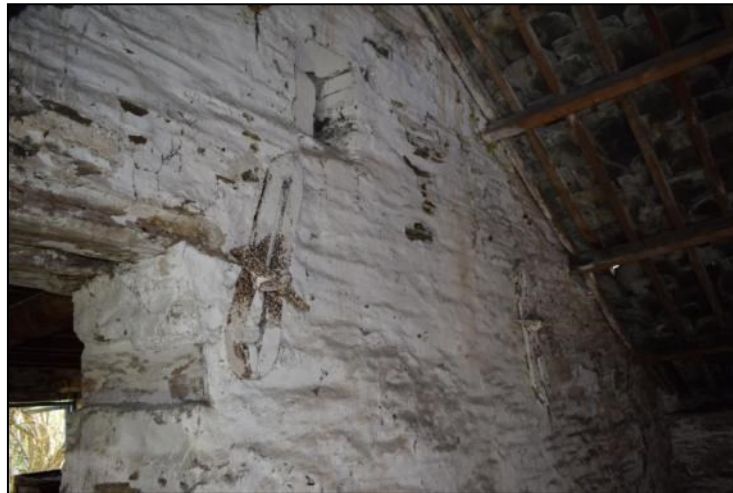
- 5.1.18 A former window with a timber lintel and a slate sill is located on the western wall of the main mill building section. The creation of the doorway through the former exterior wall on the western side of the room is evident from the undulating nature of the southern side of the doorway. The extension part of the first floor is a single open plan room. Two anchor plates are present on the former exterior wall surface, as is a small square opening. The roof has a timber king post structure.

Photo 11: Details of the former west facing exterior wall of the mill at first floor level

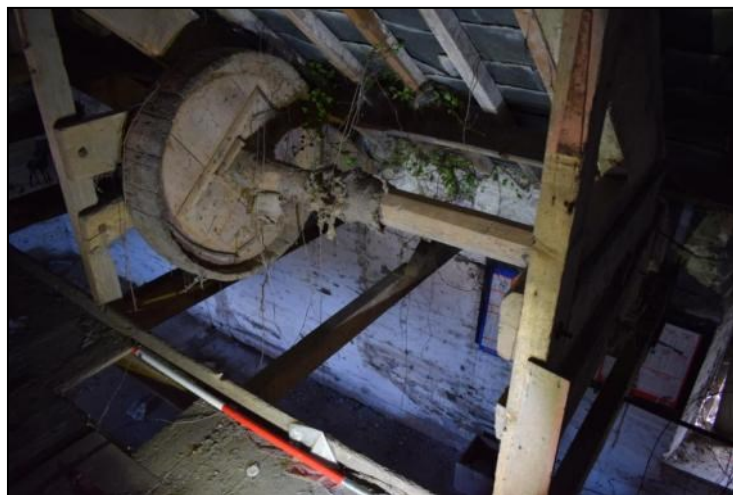
- 5.1.19 The second floor is once again an open plan room, with a small timber partition located at the southern end. The apex of the king post timber roof structure has a four bay ridge plank formation. A timber sack hoist drive wheel and chain drum is located in the loft section of the mill (See Figure 9) (Photo 12). The loft floor retains the sack trap with original doors (Photo 13). A timber and an iron pulley are located in the apex of the roof. A number of iron bearings are situated along the length of the floor suggesting the position of an ancillary drive mechanism, possibly relating to the sack hoist system.

Photo 12: Sack hoist drive wheel & chain drum in the second floor loft. Scale 1m

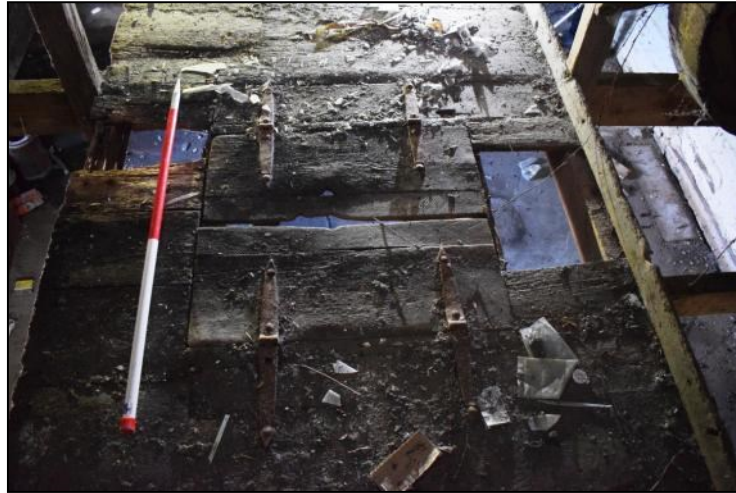
Photo 13: Sack trap with original doors. Scale 1m
