**84b Carlton Hill,  
Westminster, London  
Heritage Statement**

Client: BUILDING LOGISTICS LTD ON  
BEHALF OF MRS FRANCES SILVER

AB Heritage Project No:10925

Date:20/10/2016

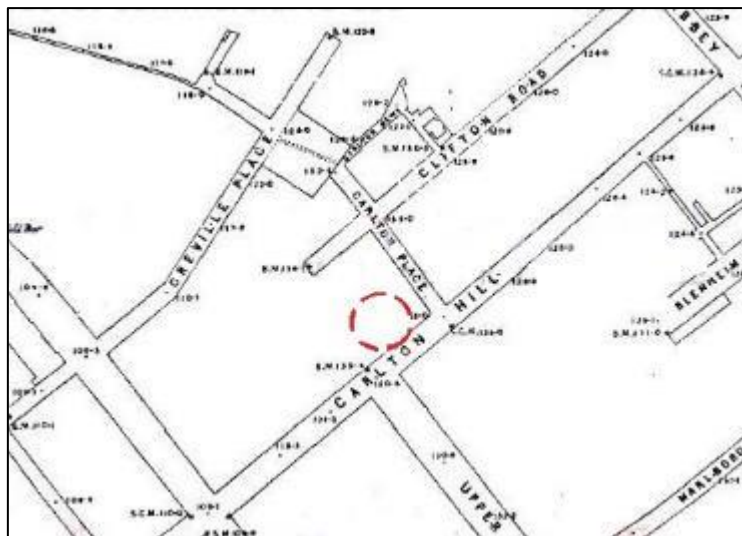
**Plate 2: 1850 OS London Town Plan (© Crown Copyright 2016. Ordnance Survey Licence Number 100050237)**

- 2.2.1 The historic map evidence suggests that 84 Carlton Hill was constructed at the very height of the development of the St John's Wood area, at a time when the land prices were high, making it one of the last of its type to be constructed, during the 1850s. The 1850 OS Town Plan of London (Plate 2) shows that the main streets in the area had been laid out, including Carlton Hill but few buildings are shown to have been constructed in the vicinity by this date.

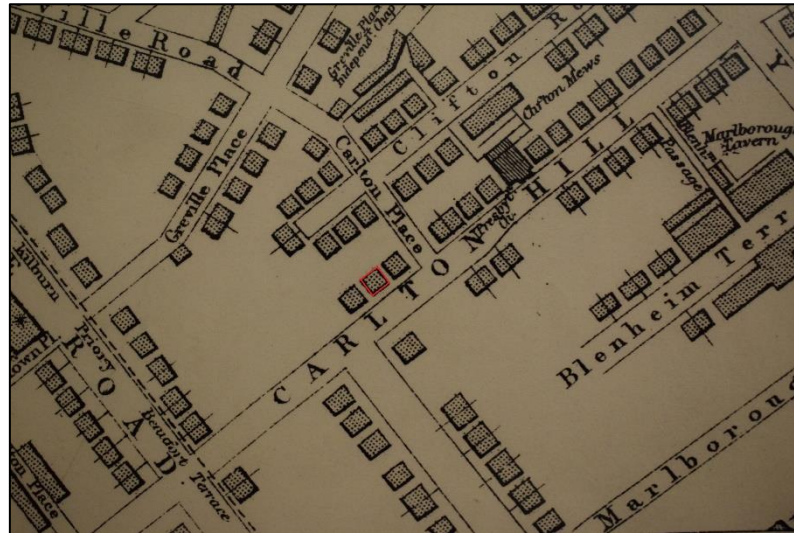
**Plate 3: Weekly Dispatch map, 1862 (London Metropolitan Archives)**

- 2.2.2 84 Carlton Hill is first shown on the Weekly Dispatch map dating to 1862 (Plate 3), although the map is not of a sufficient scale to show the building in a large amount of detail. The map shows that at this date, some plots in the vicinity were yet to be developed.

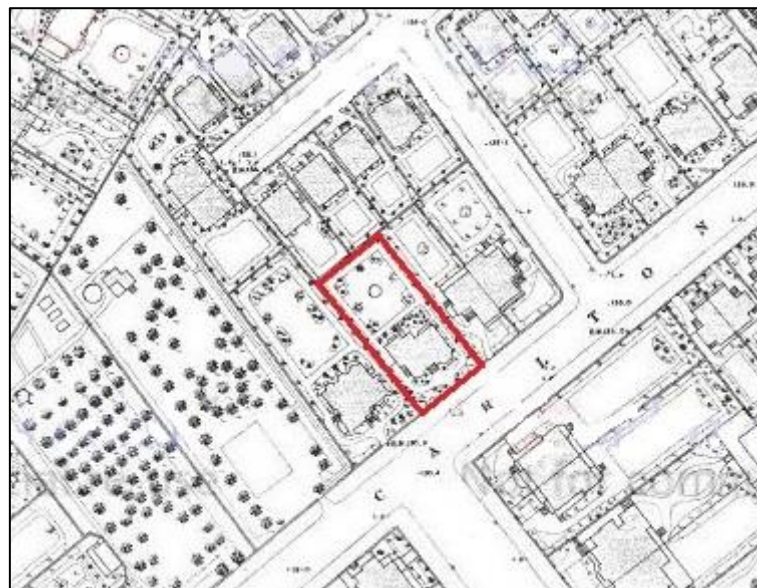
**Plate 4: 1:1,056 OS map, 1872 (© Crown Copyright 2016. Ordnance Survey Licence Number 100050237)**

- 2.2.3 The earliest map that shows 84 Carlton Hill in any detail is the 1:1,056 map dating to 1872 (Plate 4). This map shows the building with two projecting bays on the front elevation and central front steps. A flight of steps appears to be present on the western elevation. An outhouse or store building is located perpendicular to the rear of the building.
- 2.2.4 Structures shown on the rear of both bays of the house and on the front of the right bay are likely to represent projecting bay windows. The main form of the building, apart from the extension on the western elevation, later conservatory and garage additions, is shown much as it was prior to the recent development works. The building is shown within a large plot comprising a front and rear gardens and a large lawn to the rear of the house.

- 4.1.6 The foundations of a three-sided canted bay window were also identified during the redevelopment works. The position of the bay window on the former north elevation of the house is shown on the OS maps (Plate 4 – 6) as part of the original design of the building. It was removed during the early – mid 20<sup>th</sup> century. This has been preserved beneath the new floor level.

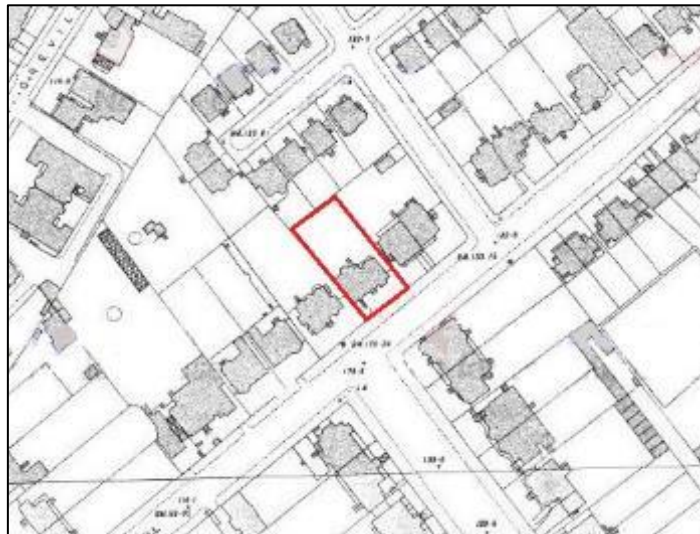
**Plate 5: 1:1,056 OS map, 1938 (© Crown Copyright 2016. Ordnance Survey Licence Number 100050237)**

- 2.2.5 The 1894 and 1916 editions of the OS map show the overall form of the building to remain unchanged since the previous, 1872 edition of the map.
- 2.2.6 Between the 1916 and 1938 (Plate 5) editions of the OS map, a rectangular extension was added to the western elevation of the building, in much the same position as the modern extension that forms 84b. This extension took the western elevation of the building up to the western property boundary. The projecting bay window that is shown on the 1872 map occupying the front elevation of the left bay of the building, has been removed. A structure, possibly for storage is shown perpendicular to the left side of the front elevation.

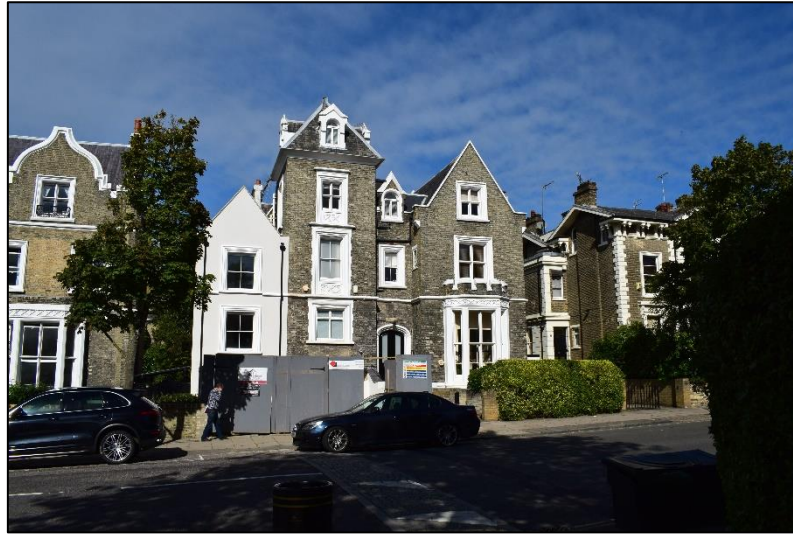
2.3.1 No. 84 is situated on the northern side of a wide, tree lined suburban street that forms Carlton Hill. The property is set back from the pavement and is bounded by a number of low brick walls, metal gates and a large hedge on the southern side, creating a small former front garden area, now an off street parking areas. 84b Carlton Hill, as mentioned above, is a 20<sup>th</sup> century extension located on the western side of 84 Carlton Hill, constructed in the gap between No. 84 and the adjacent villa. (Photo 1).

**Photo 1: 84 Carlton Hill viewed in relation to the adjacent villas**

- 2.3.2 No. 84 is situated within a group of three detached villas of similar Gothic style, comprising a construction of a combination of gault brick and stucco. The villa located on the eastern side, on the corner of Glenville Road, has a more Classical and Italianate style of design than the other two villas (Photo 1).

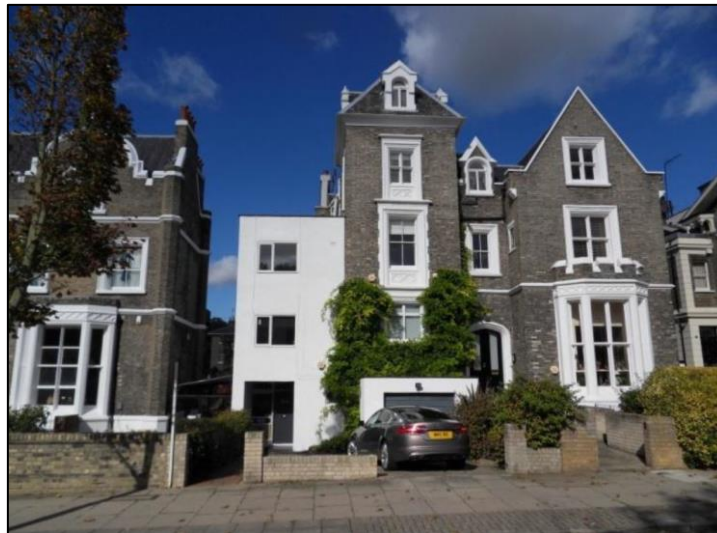
**Photo 5: South elevation prior to the redevelopment (Gemini Building & Design Consultancy)**

- 3.1.1 The detached, irregular three bay property is constructed from Flemish bonded gault bricks with pitched slate roofs. The left bay has a capped slate roof. A carved stone, stucco covered string course is present between the ground and first floor. The majority of the windows have stone carved and stucco covered square architrave surrounds, some of which have mullions and transoms, the others are timber sash or casement windows. The attic windows have arched lights and a two storey bay with crenelated first floor is present at ground floor level on the right bay. A series of stone steps lead up to a central Tudor doorway on the south elevation. Prior to the recent redevelopment, a modern garage was located at ground floor level on the left bay (Photo 5).

- 3.1.2 The left bay was a modern, flat roof extension, constructed during the early 20<sup>th</sup> century and rebuilt or refurbished during the 1950s, as discussed above. The extension had a modern horizontal rectangular window at ground and first floor level. A recessed doorway was present at lower ground floor level (Photo 5).

- 6.3.3 A three-sided, canted, single storey bay window has been reinstated in the location of the unsightly modern garage on the left bay of the southern façade (Photo 5). Overall, the works that have been undertaken to the south façade of the building are considered to have a direct and indirect beneficial impact upon the significance of the building and the surrounding Conservation Area by altering the unsympathetic 1950s extension to fit more with the Gothic style of the original house.

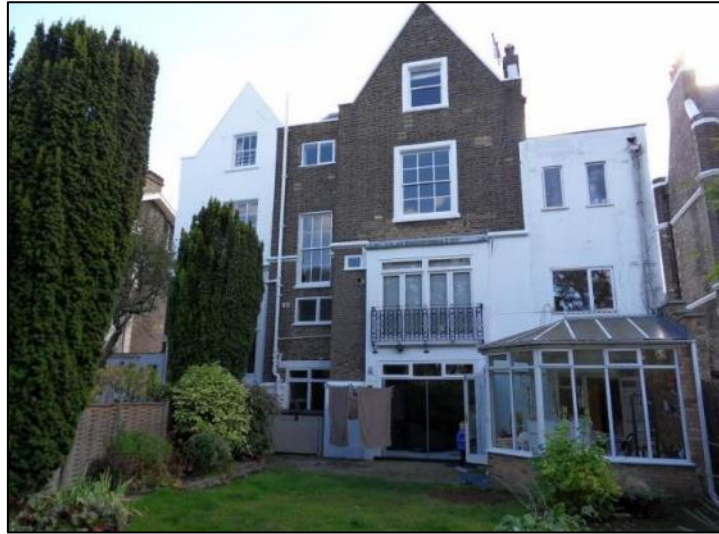
**Photo 6: North elevation prior to the redevelopment (Gemini Building & Design Consultancy)**

- 3.1.3 The north elevation had a small two storey extension on the central bay with first floor timber double French doors with rectangular casement lights. A modern cast iron balcony is present at first floor level. Prior to the redevelopment, a large window had been present at lower ground floor level. A set of modern French doors were present at lower ground floor level on the left bay. A small UPVC conservatory was located on the rear of the modern extension. The extension had a flat roof and two small, vertical, rectangular modern windows at first floor level and a square window at ground floor level (Photo 6).

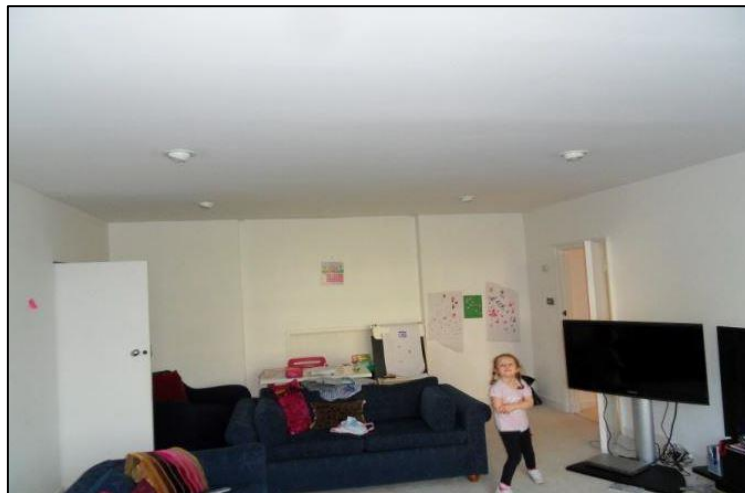
**Photo 7: The living room of 84b, showing limit of architectural details (Gemini Building & Design Consultancy)**

- 3.1.4 The interior layout of the house was altered in the 1950s, during the conversion of the building into three separate dwellings. This involved the stripping out and refurbishment of the majority of the existing interior of the building (Carr. M, 2016, *Pers comm*). Therefore, the living room of 84b that formed a part of the lower ground floor of the original building, contained limited significant historical architectural details, fixtures or fittings prior to the redevelopment (Photo 7).
- 3.1.5 The architectural details that were present consisted of typical small 1950s skirting board (Photo 8), door architrave, plain panel doors and cupboards. A fireplace had been created in a hearth on the former exterior wall of the building (Photo 9).

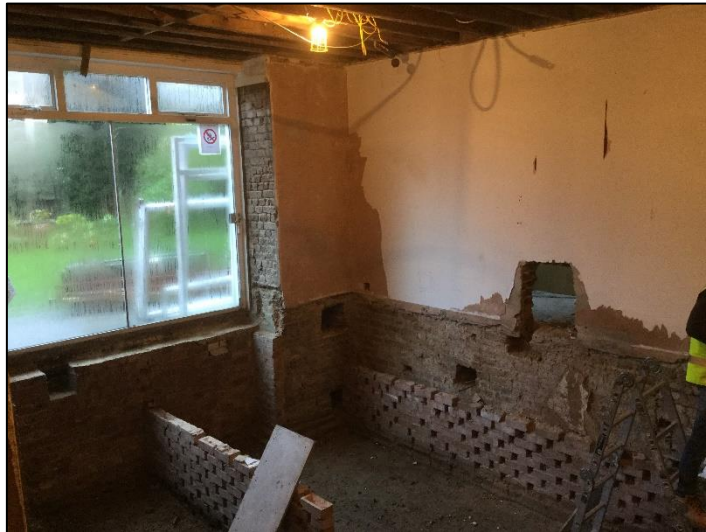
**Photo 10: Raised floor level in the lower ground floor during redevelopment works (Building Logistics Ltd)**

- 4.1.1 During the redevelopment works it was identified that the floor level of the lower ground floor living room of 84b and bedroom 1 had been raised, as the stone floor slabs of the original floor were uncovered c. 1m below (Photo 10).

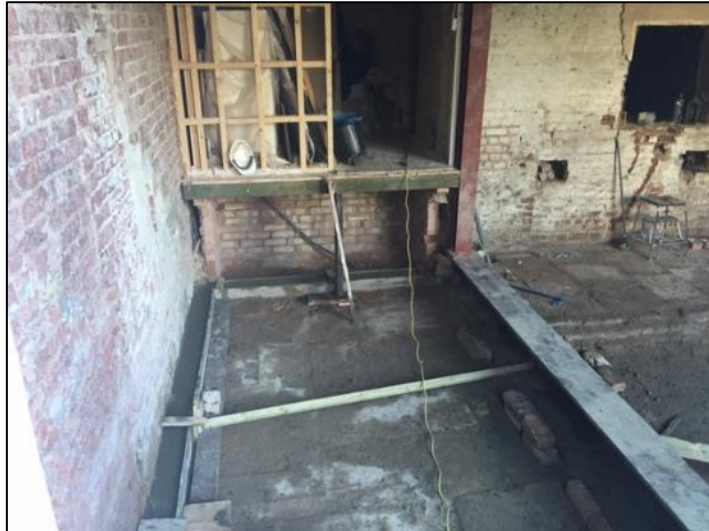
**Photo 11: Stone floor slabs found during redevelopment works (Building Logistics Ltd)**

- 4.1.2 The floor slabs appeared to be square and sub square stone slabs, averaging c. 0.4m long by 0.3m wide (Photo 11). They appear to have been bedding into a mortar foundation that was laid directly onto the earth beneath. The slabs were present beneath the entire area of bedroom 1 and the southern end of the living room area and respected the position of the original internal wall between the living room and bedroom 1 (now removed). It is likely that the slabs originally covered the entire area of the living room and formed the floor of an interior room, possibly a lower ground floor kitchen and scullery or possibly a servant's hall.

- 4.1.3 The floor slabs that were exposed during the redevelopment works have been preserved beneath the new floor of the living room.
- 4.1.4 An opening was identified on the southern wall of the living room. The date of the insertion of this feature and its function of this is uncertain.

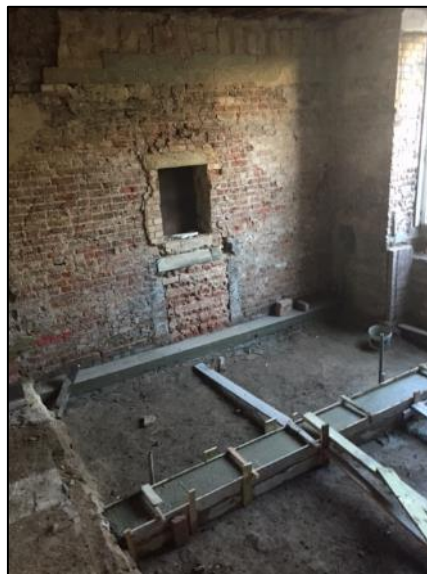
**Photo 12: Blocked chimney (centre) & flue (top left) and raised ceiling height (top) during redevelopment works (Building Logistics Ltd)**

- 4.1.5 A chimney and flue were exposed on the western wall of the living room area (Photo 13). This may have been the position of cooking or heating facilities. There is evidence above the hearth opening that the ceiling height in this area of the building has been raised using concrete blocks and ended bricks (Photo 12).

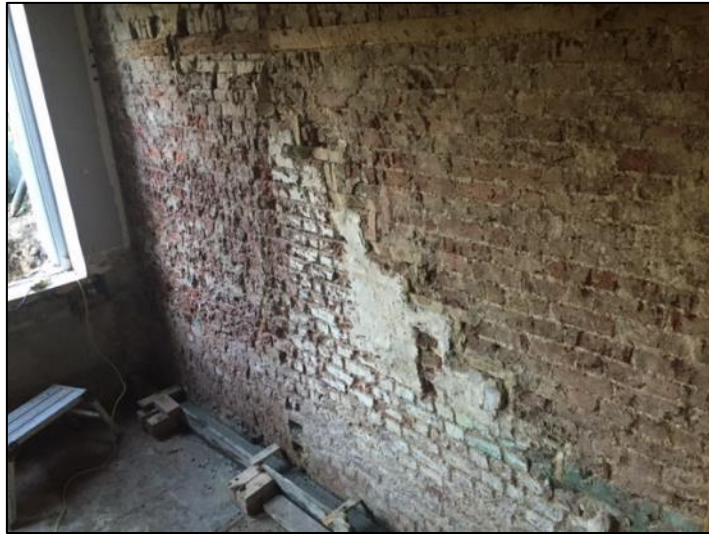
**Photo 13: Scar of former staircase and wall plate during the redevelopment works (Building Logistics Ltd)**

- 4.1.7 The scar of a staircase and wall plate for a possible floor level were identified on the eastern wall of bedroom 1. The adjacent wall appears to have been extended as the brickwork has been knitted into the existing wall (Photo 13).

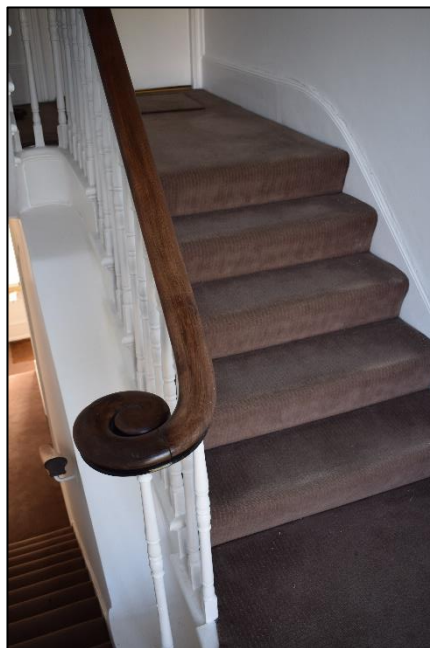
**Photo 14: Elements of the original stairwell survive**

- 5.1.1 During the site visit, some area of the original building that was converted into separate dwellings during the 1950s, was inspected where possible. This included the stairways and the first floor flat within 84a. The site visit identified that the conversion of the building has resulted in a limited survival of the original layout of the building.
- 5.1.2 The ground floor has been raised and within the stairwell, the original ground floor section of the balustrade has been removed, although the upper floor sections survive. This comprises an open string turned balustrade resting upon treads. A spiral rail end survives at first floor level. Additional windows have been inserted into the north elevation, resulting in the truncation of some elements of the original stairwell dado rail.

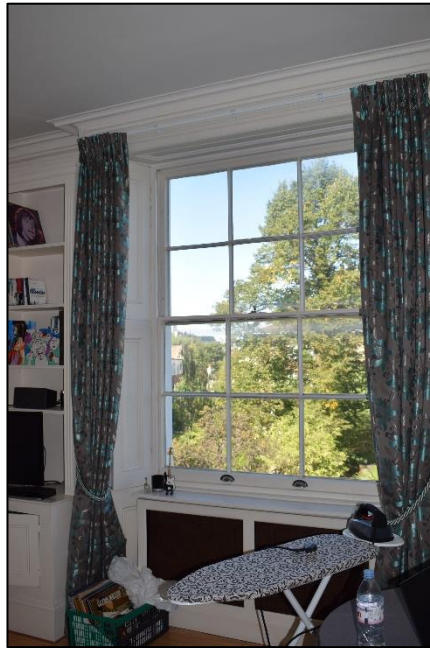
**Photo 15: Panelled window reveal and cornice in first floor flat**

- 5.1.3 The first floor flat revealed that a large degree of partitioning was undertaken during the 1950s refurbishment, in order to create the separate dwellings. This comprised the removal of the chimney breast and alteration to the original doorways. Despite the alteration to the original layout, a number of original features appear to survive. This includes panelled window reveals and shutters, parts of the mid-late Victorian style cornice (Photo 15) and panelled door reveals (Photo 16). It seems likely that some of these original features are no longer in situ, such as the reduced width doorframe (Photo 16), the other side of which was identified in the partition wall. Some elements appear to have been re-used or copied, such as the corncicing (Photo 15), during the 1950s alterations, helping to retain the period feel of the building.

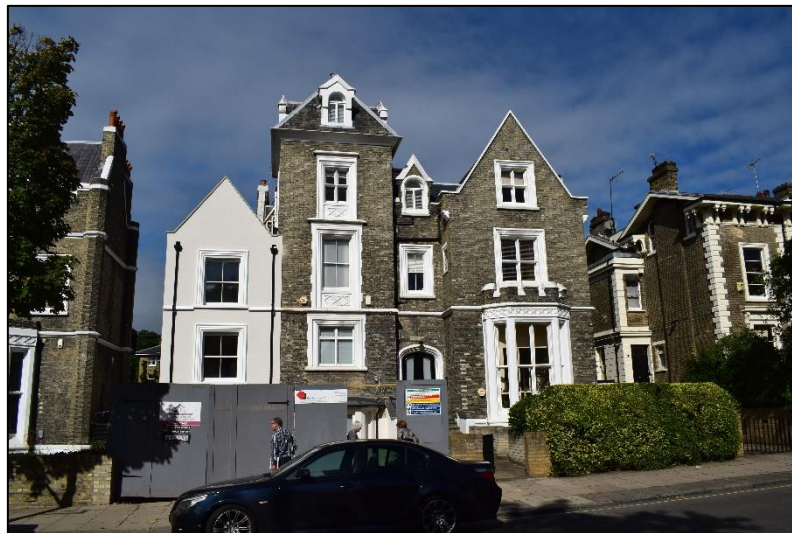
**Photo 17: South elevation following redevelopment works**

- 6.3.2 The treatment of façade of the south elevation of the extension, with the pitched gable roof is considered to be more sympathetic to the Gothic style of the remainder of the pitched roof elements of the façade. The moulded window and door architrave is in keeping with the architrave. Timber sash windows have been installed to match those existing. The moulded string course of the original building has been continued across the façade of the extension. The front door will emulate the curved light design of the existing front door and attic windows. The white rendered façade is thought to be similar in appearance to the stucco on this and other buildings in the vicinity (Photo 17 & Figures 3 & 8).

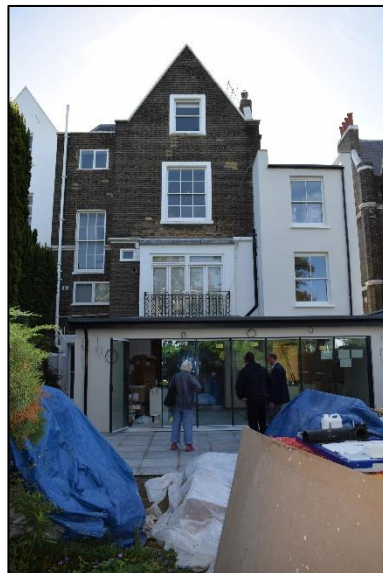
**Photo 18: The north elevation following the redevelopment**

- 6.3.7 The new conservatory which has a large glass door arrangement across the entire north side, is in contrast to the small casement French doors that are present for the window above and with the arrangement of French doors that it has replaced. The conservatory does not appear to respect the period, architectural characteristics or the detailing of the original building (Photo 18) (Westminster City Council, 2004). The nature of the conservatory, therefore, does not appear to preserve or enhance the character of the St John's Wood Conservation Area, in which it is located. As a result, this element of the redevelopment is thought to have a direct and indirect adverse visual impact upon the building and the Conservation Area, although this is not thought to impact upon the significance of these heritage assets.
