**Barn 30m South of Yew
Tree Farmhouse, Yew
Tree Green Road,
Horsmonden, Kent
Heritage Statement**

Heritage Statement

Client	Baker Architectural
Project Number	10944
Prepared:	Kerry Kerr-Peterson
Illustrated:	Peter Bonvoisin
Approved:	Andy Buckley

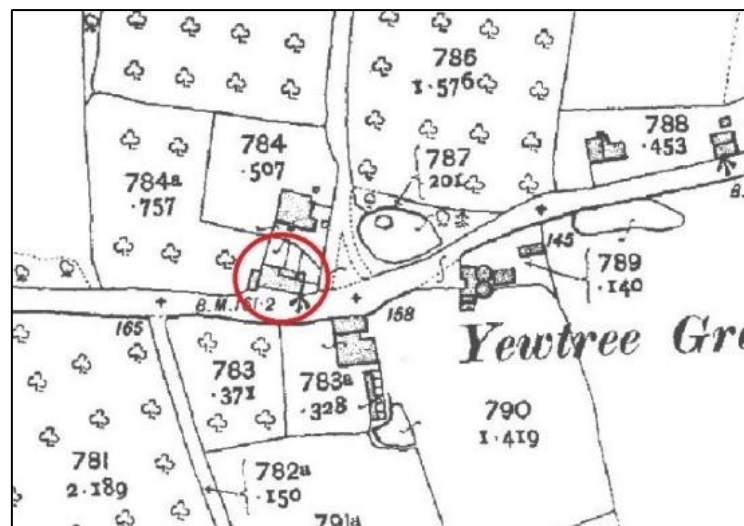
Plate 3: 2nd edition 25'' OS map, 1908

- 3.2.7 The trade directory of 1878 identifies that the farm was under the ownership of Jeffrey George Austin, possibly a relation of the writer Jane Austin, whose family were involved in the regions cloth trade (Hormonden Village Kent, 2016).
- 3.2.8 On the 2nd edition of the 25'' OS map (Plate 3), the northern side of the building is shown to have been extended to the east, bringing it in line with the eastern end of the main part of the building. The eastern end of the northern side of the building is shown to consists of two parts and the adjacent yard has been partitioned to create three yards, corresponding with the position of the different parts of the building. Within the wider landscape, the oast building has extended and developed to have two round kilns. In the yard to the south of the barn, possible hop pickers accommodation buildings have been constructed.

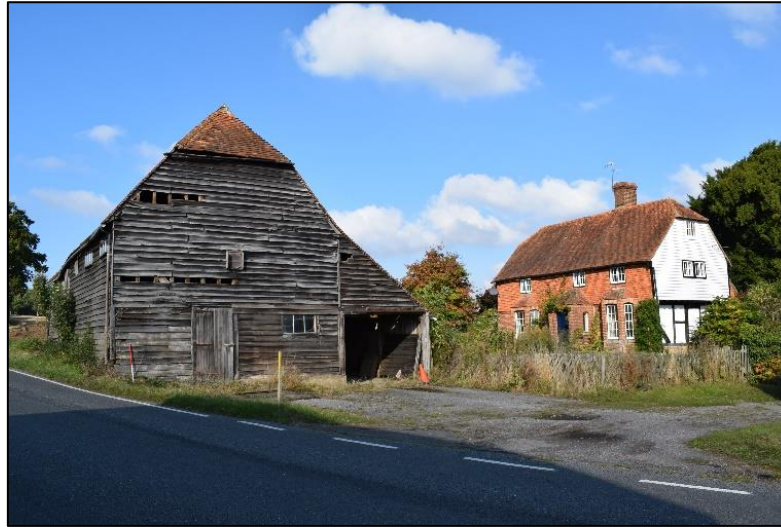
Photo 1: The barn and Yew Tree Farmhouse from the south side of the road

- 3.3.1 The barn is situated 30m to the south of Yew Tree Farmhouse, immediately adjacent to Yew Tree Green Road (Photo 1). The remainder of the buildings that form the farmstead are situated on the south side of Yew Tree Green Road, dispersed along the road to the east (Photo 2). The garden of the farmhouse is located immediately adjacent to the northern side of the barn. A small green is located immediately to the east of barn, with a pond beyond (Photo 1).

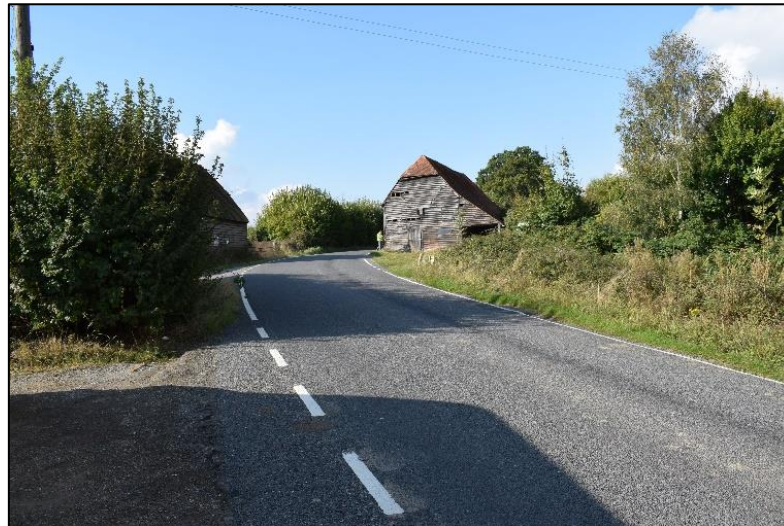
Photo 2: The barn (centre) from the oast to the east

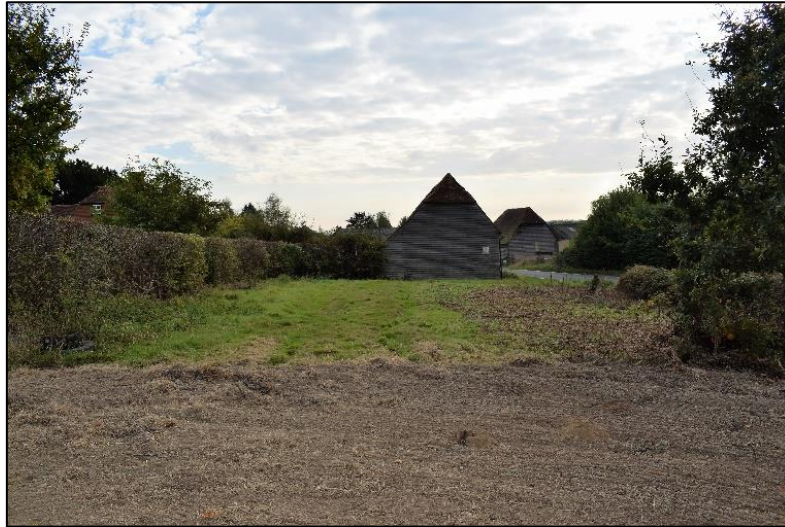
Photo 3: The barn (centre) and farmstead from the west

- 3.3.2 A small piece of, what is now pasture, is located immediately to the west of the barn (Photo 3). A gravel driveway / yard is present on the eastern side of the barn (Photo 1).
- 3.3.3 Beyond the immediate setting, the wider setting is predominantly rural in character, with a small number of residential dwellings, set within large gardens, beyond the farm to the east. A footpath / track is present on the eastern side of the farmhouse and continues off to the north. To the north, beyond the farmhouse, large agricultural fields with mature hedgerows and copses of mature trees spread out to the north, with intermittent farmsteads along with intersecting roads.

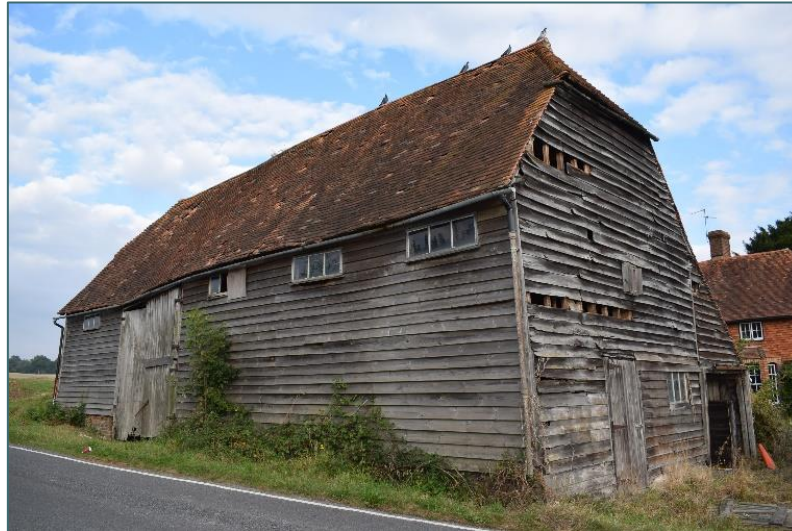
Photo 7: The south and east elevations of the barn (scale 1m)

- 4.1.1 All of the exterior elevations are clad in timber weatherboarding. This is laid horizontally on the majority of the elevation, apart from the north elevation, which is laid vertically. The weatherboarding is particularly degraded on the eastern elevation. All of the exterior weatherboarding has been replaced. The roof is plain ceramic tiles (Photo 7).

- 4.1.3 Four three-light, horizontal, white timber framed windows are present below the eaves on the southern elevation (Photo 7). The weatherboarding overlaps an English bonded plinth of a mixture of handmade and machine manufactured bricks, on a concrete base (Photo 8), suggesting that the plinth of the barn has been renewed during the c. late 19th century or 20th century.
- 4.1.4 A ground floor timber plank door is present on the eastern elevation, along with a timber framed three light, horizontal window. At the catslide end of the eastern elevation, a roller door was installed sometime after the mid-19th century. The roller bar remains in place. A concrete plinth is visible on the eastern elevation (Photo 9).

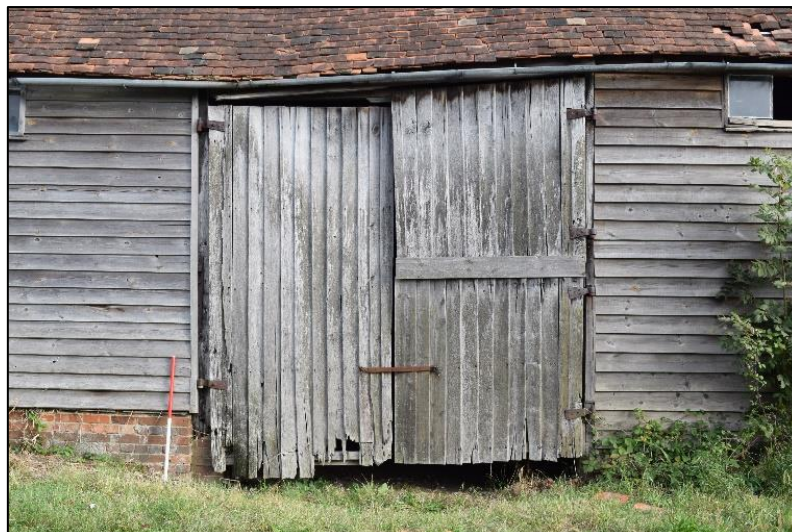
Photo 8: Exterior of the cart doors on the south elevation

- 4.1.2 A full height double cart door is located on the southern elevation. The doors are constructed from vertical timber planks, mounted with iron hinges onto a likely original door jamb on the western side. The eastern door was originally a split door but has been modified to create a single door leaf. The doors have been replaced (Photo 8).

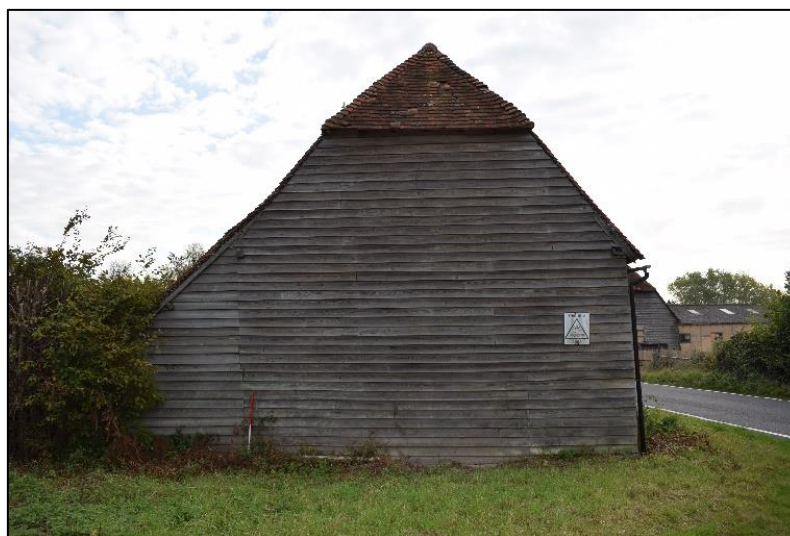
Photo 10: Western elevation of the barn

- 4.1.5 The western elevation is generally featureless. The ends of the wall plates are protruding through the weatherboarding which has been constructed around them. The western elevation of the catslide part of the building has been clad separately (Photo 10).

- 4.1.6 The northern elevation was mostly obscured by vegetation within the garden of the farmhouse at the time of the site visit (Photo 10). It was possible to determine that the weatherboarding has been clad vertically on this elevation.

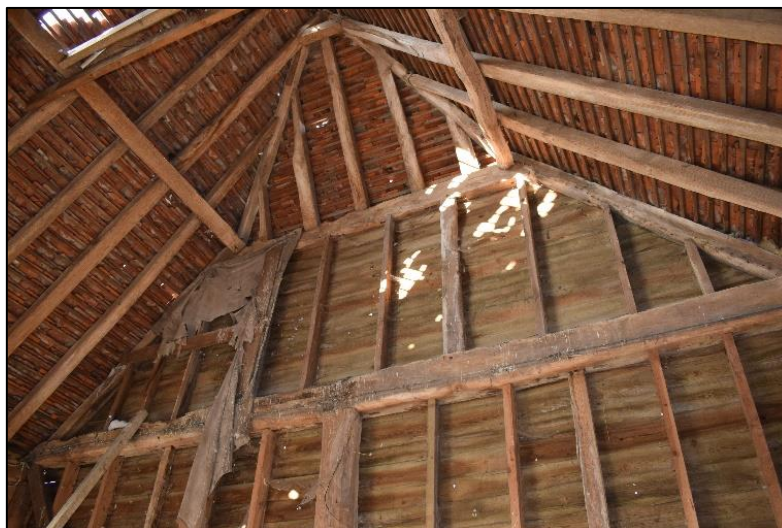
Photo 11: Details of the roof structure at the western end of the barn

- 4.1.7 The barn is of a four bay, post and truss construction with the roof supported with intermediate purlins. The roof trusses of the half hipped roof have queen post arrangements. It is evident that the majority, if not all of the rafters and lathes have been replaced. The majority of the wall studs have also been replaced (Photo 11). A number of the main timbers are axe dressed. A number of slots for former partition studs are visible in the main timbers of the frame and also along the partitions at the eastern end of the barn. A number of new braces have been attached to the existing structure (Photo 14).

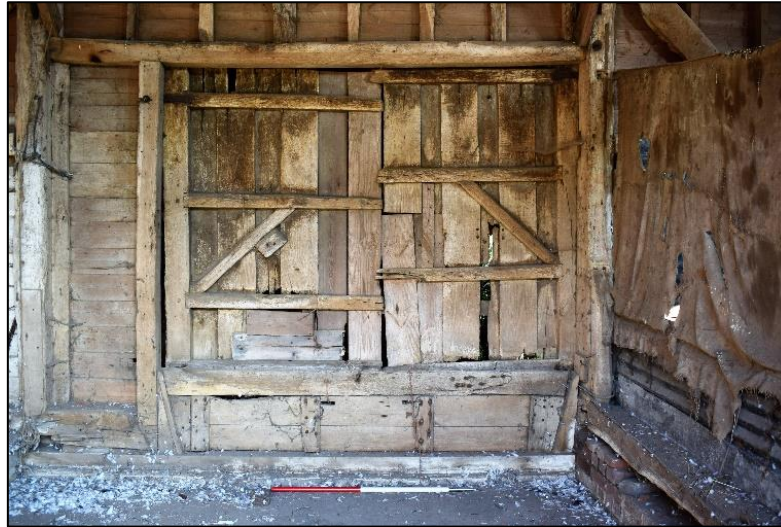
Photo 12: Winnowing door and leap at the north end of the threshing floor

- 4.1.8 The threshing floor is located towards the western end of the barn. The original threshing floor has been covered with concrete. At the northern end of the threshing floor is an original double winnowing door. The ledged and braced door is constructed from wide vertical planks, some of which have been replaced. A leap is present at the base of the door with small hand holes towards the top. Wedge shaped pieces of timber are present at either end of the leap to hold it in place (Photo 12). A burn mark is present on the door frame above the door (Left end of doorframe, Photo 12).

- 5.2.3 Surviving physical elements of the building that contribute to its significance include early doors (the winnowing doors), likely surviving butted boarding within the catslide extension and unusual marks such as burn marks and carpentry marks (*ibid*). The surviving leaper board and wedged stops at the winnowing door is also an unusual and significant survival.

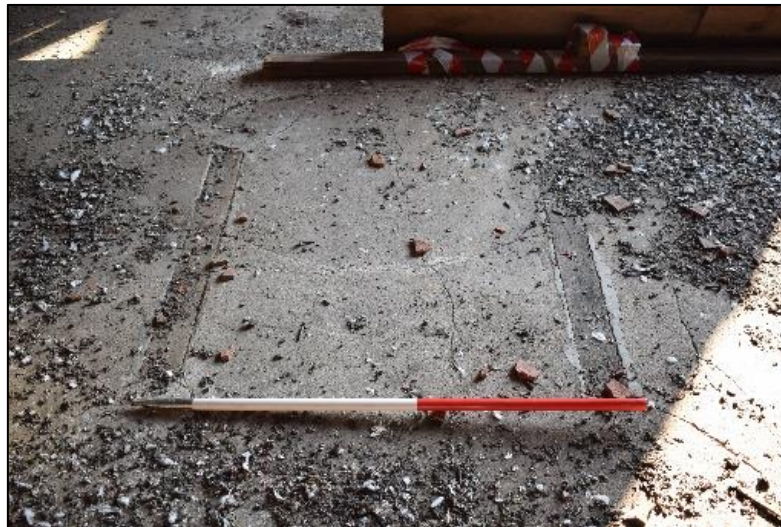
Photo 13: Timber in the floor of the western bay

- 4.1.9 The floor of the bay to the west of the threshing floor is also covered in concrete. Two pieces of timber have been inserted into the concrete (Photo 13). The function of these is uncertain but they may have been related to some sort of storage facility or machinery.

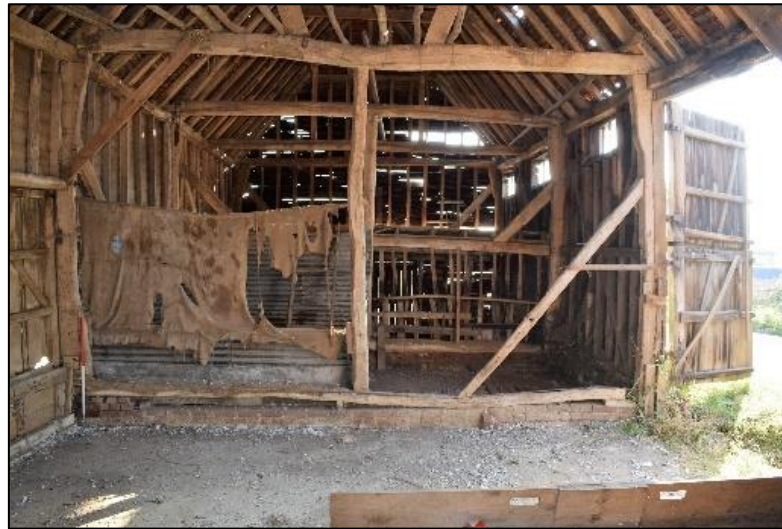
Photo 14: View of the eastern bays of the barn

- 4.1.10 Animal accommodation has been created in the two bays at the eastern end of the barn (Photo 14). This commonly took place across the country during the late 19th century and may be the time when this occurred at Yew Tree Farm. Randomly coursed, handmade brick walls separate the two bays, between the vertical truss posts (Photo 14). The interior of the first bay is clad in corrugated iron sheets at the northern end. A loft is located at the eastern end of the building, over the fourth bay only.

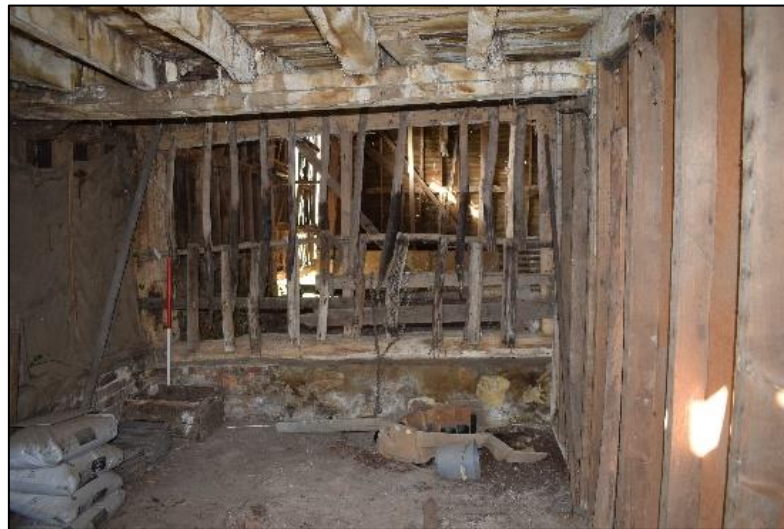
Photo 15: Ragstone foundations at the eastern end of the barn

- 4.1.11 The ground floor of the eastern end of the barn has been separated into two rooms by a modern stud wall. The original rag stone foundations are present along the eastern end of the third bay, although these have been replaced with brick at the southern end (Photo 15). It is likely that this was the original exterior wall of the building, with the fourth bay forming an extension to the building. Split stakes have been used to create a partition wall above the foundations in the eastern end of the barn.

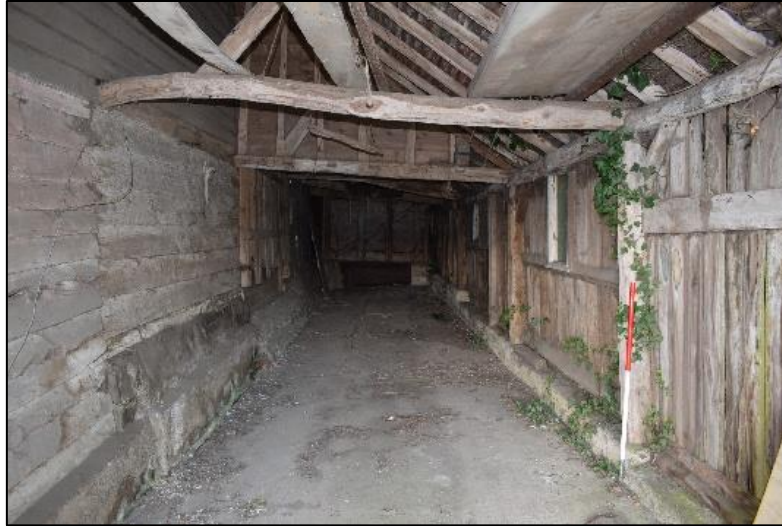
Photo 16: The extension beneath the catslide roof

- 4.1.12 The area beneath the catslide roof on the northern side of the building also has a concrete floor. The foundations are concrete and on the southern side, the concrete is topped with a low, randomly coursed brick wall, partially covered with concrete. An area of earlier, wide, weatherboarding is present on the eastern side of the winnowing door. This earlier weatherboarding appears to represent butted boarding. The position of the survival on a former exterior wall is the likely position for the survival of butted boarding of pre-19th century

date (Historic England, 2014 (c)). The surrounding weatherboarding has been replaced (Photo 16 & 17).

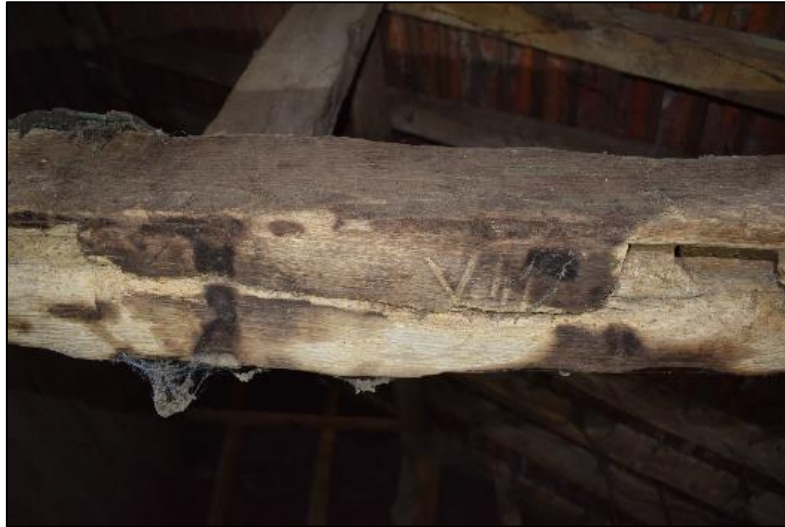
Photo 18: Carpenters mark and burn marks on a timber in the catslide extension

4.1.13 A large timber door is located at the western of the catslide extension, although this does not appear to have been functional but reused as part of the structure. A carpenter's mark is located on one of the tie beams within the catslide extension on the northern side of the barn. This is in the form of Roman numerals for the number eight 'VIII'. This timber also has some burn marks and is likely to be re-used (Photo 18).

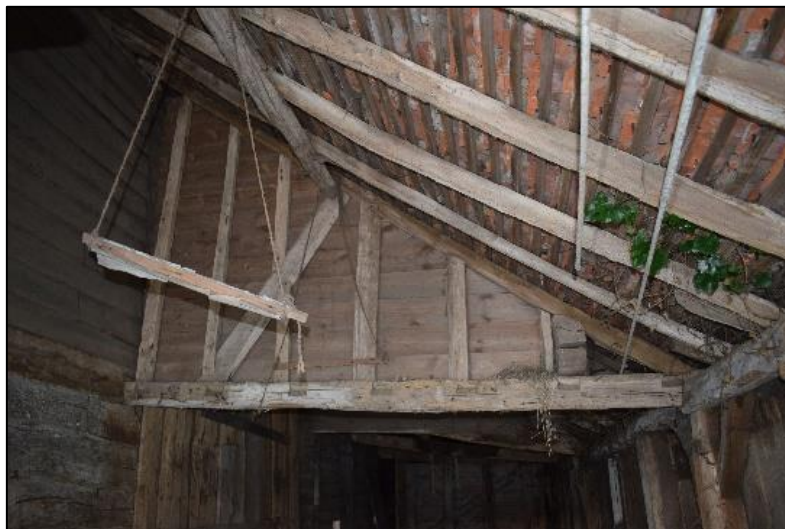
Photo 19: Re-used timber in the catslide extension

4.1.14 A number of other timbers appear to have been re-used. These are focused within the extension at the eastern end of the barn and within the catslide extension on the northern side of the building. This is suggested by the presence of a number of timbers with redundant mortice holes or holes for floor joists within former wall plates or bresssummers (Photo 19).
