**Former Stable Block,  
Brentford, London**

**Level 2 Historic  
Building Recording**

Client: PRIME PLACE

AB Heritage Project No:11036

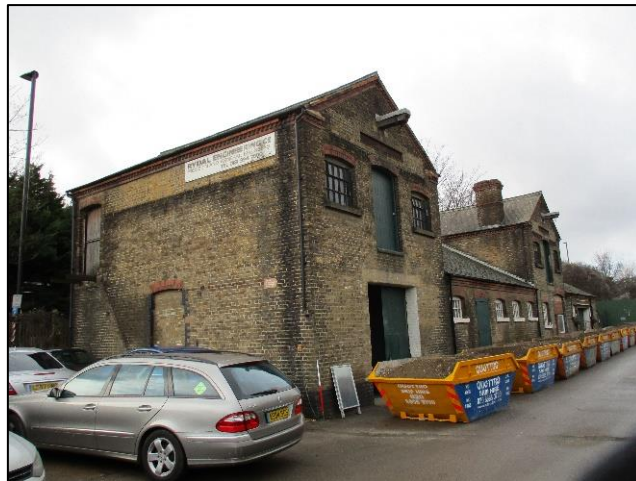
- 4.1.3 The lower courses are of high density, dark coloured, industrial, slag based bricks, as are the quoins around a ground floor doorway on the south-east elevation and a cart door on the north-east elevation. Red bricks have been used to create ornate coggled cornices and arched features such as double segmented window arches (Photo 1).

Photo 1: The former stable block from the south-east

- 4.1.4 The south-eastern elevation (Photo 1) has a central ground floor doorway. This doorway has later been infilled with stock bricks. There is a doorway at first-floor level, with a plank and baton wooden stable door. Two metal beams extend from the wall just below the level of the door, which would have supported an external staircase. A diagonal line marking the location of the staircase is visible. An area of cleaner bricks towards the roofline, indicates that there was once a large sign covering this part of the brickwork.

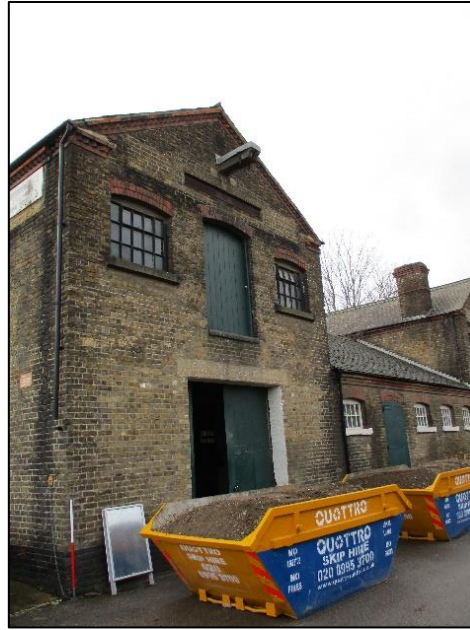
- 4.1.5 The north-eastern elevation is divided into four sections, the south-eastern end (Photo 2) consists of two storeys with a gable-end. At ground floor level is a central double sliding doorway with a concrete lintel. The upper storey has a central plank and baton wooden door with red brick lintel and dark bull-nosed slag based industrial brick sill.

**Photo 2: South-east gable end of the north-east elevation**

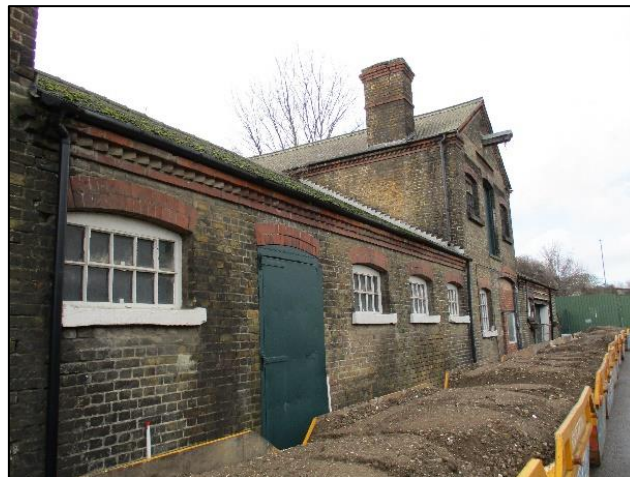
- 4.1.6 The first-floor door is flanked by two 15 light windows with concrete sills and three light openings. Above the door is a projecting horizontal beam, that supports the remains of a pulley system, which would have been used to hoist items for storage on the upper floor. A horizontal metal beam, providing structural support for the lifting system, is embedded in the brick coursing. The location of another sign is suggested by a cleaner are of bricks towards the roofline. The second section is of single storey construction, with four ten light windows and a metal door (Photo 3).

**Photo 3: North-east elevation from the south-east**

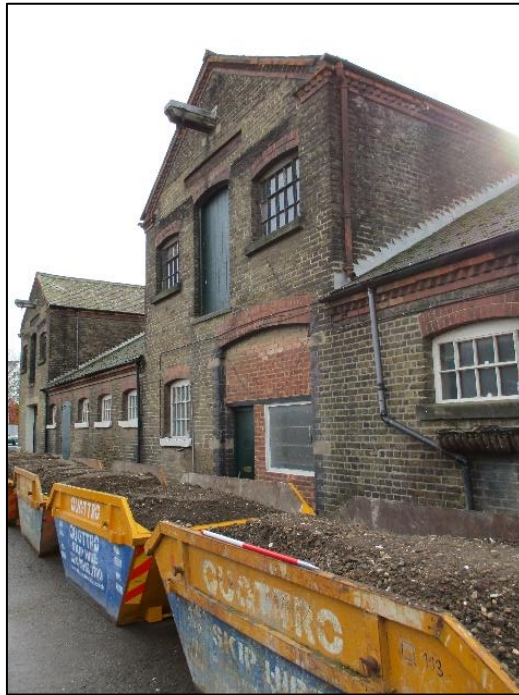
- 4.1.7 The third section is like the south-east end (Photo 4), it is two-storey with gable-end and the upper floor has the same central doorway flanked by windows and remains of a pulley mechanism. The ground floor has a window (as above) and a double doorway. This doorway has been bricked up later with mixed bricks and a smaller door and modern square window inserted. A chimney is present on the south side of the gable, with red brick dressings.

**Photo 4: North-west gable from the north-west**

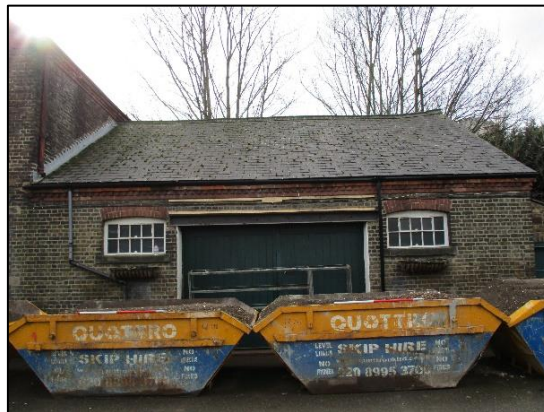
- 4.1.8 The fourth section is single storey construction like the second section. There are two windows (as above) with concrete sills, either side of a double width doorway with a RSJ lintel and sliding doors.

**Photo 5: North-west end from the north-east**

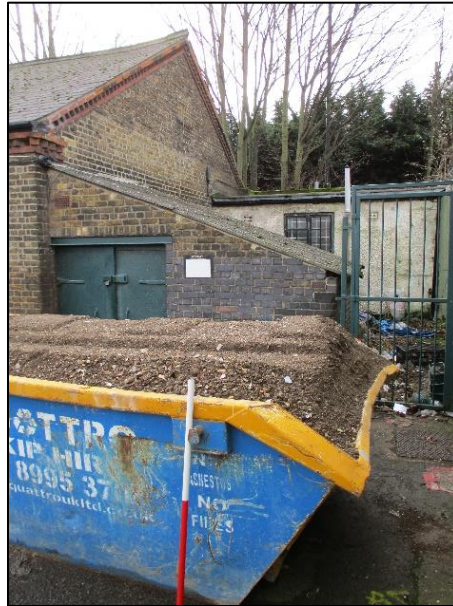
- 4.1.9 On the northern side of the north-western elevation is a lean-to, single storey extension, fabricated from yellow stock bricks and slag based industrial bricks. There is a doorway with exposed RSJ lintel above the door. The roof of the lean-to appears to be made from sheet asbestos. A later, rendered single storey extension is located on the south-west side of the north-west elevation.

**Photo 6: Extensions on the north-west elevation**

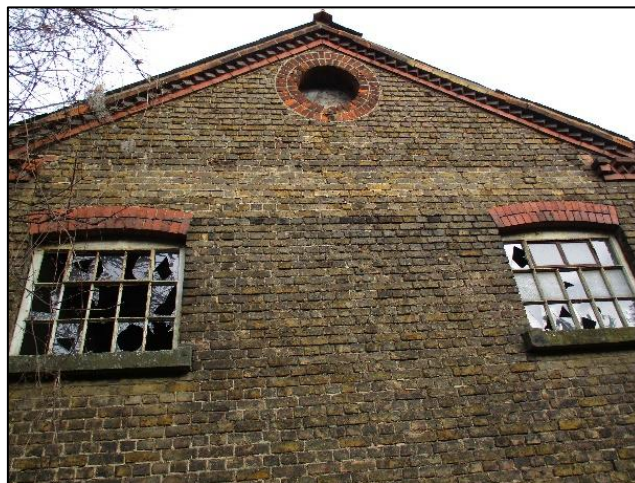
- 4.1.10 The south-west elevation has similar architectural details to the north-west elevation. The south-west facing gable ends have three windows at ground floor level and two at first-floor level. The north-west gable has a round oriel window at the apex of the gable, with red brick dressings (Photo 7).

**Photo 7: Oriel window on the south-west elevation**

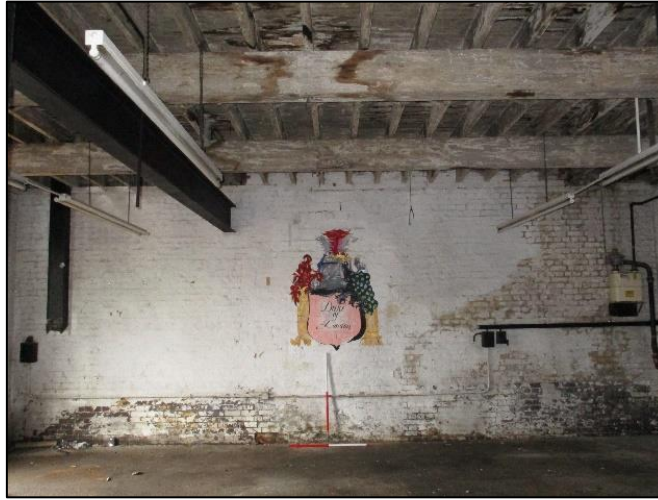
- 4.1.11 The ground floor interior has been stripped of many architectural features. There are no strong surviving indicators of the positions of the former stalls (Photo 8 & 9), apart from the positions of the windows (Photo 3 & 10). Several modern partitions have been created from concrete blockwork within the ground floor interior, mostly in the central bay of the building. The blocked doorways that are evident from the exterior of the building are also visible on the interior. Queen post roof structures are present in the single storey elements of the building,

**Photo 8: Blocked doorway in the south-east end of the building (in location mural) & example of the stripped-out interior**

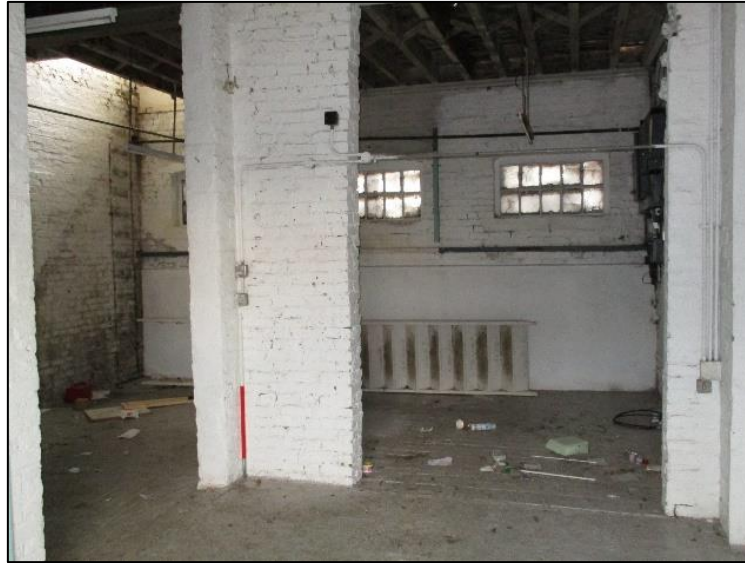
4.1.12 Some areas of brick floors survive but the most of the floors have been covered with concrete.

**Photo 10: Surviving brick floor (rear) & concrete floors (foreground). Position of former staircase (rear left)**

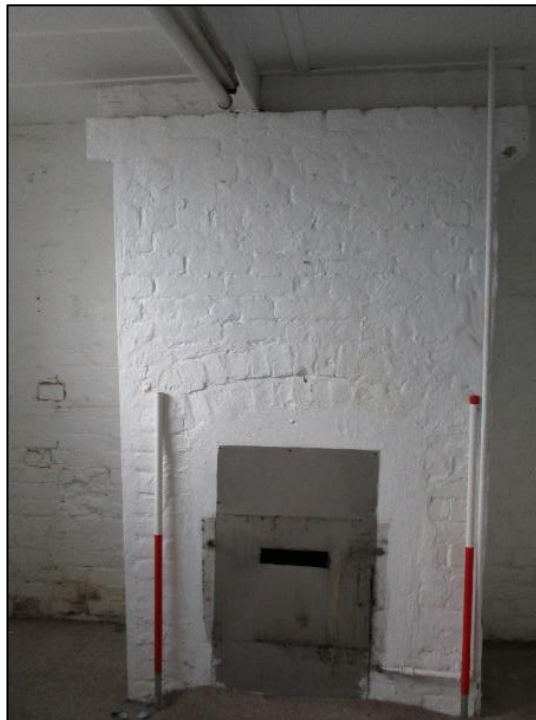
- 4.1.13 The middle bay contains a chimney with fireplace (Photo 11) and formerly some stairs to the first floor (Photo 10). It seems likely that this may have been the location of the horse-keeper's accommodation.

**Photo 11: Chimney & fireplace in ground floor central bay**

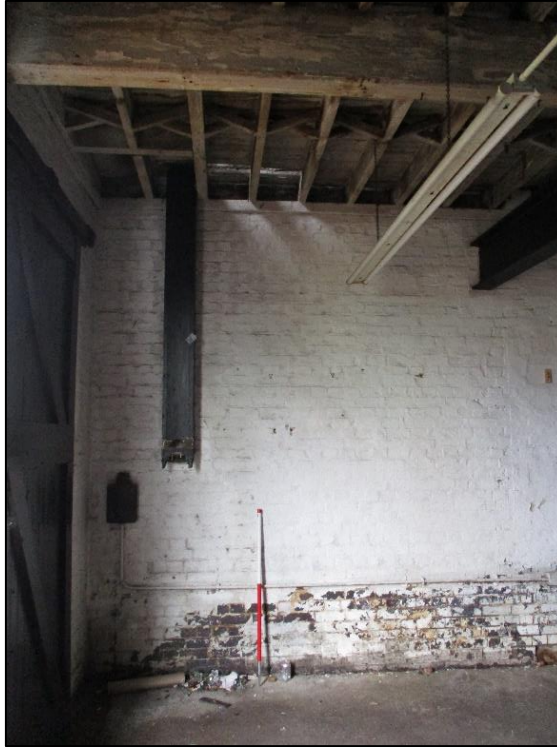
which have metal braces, probably for additional support (Photo 9). The first-floor floorboards have addition bracing between the joists, also for additional support (Photo 12).

- 4.1.14 A metal shoot from the upper floor is in the south-eastern part of the ground floor, likely for the distribution of feed down from first floor level.

**Photo 12: Shoot from first-floor level and additional bracing of the first-floor floor boards**

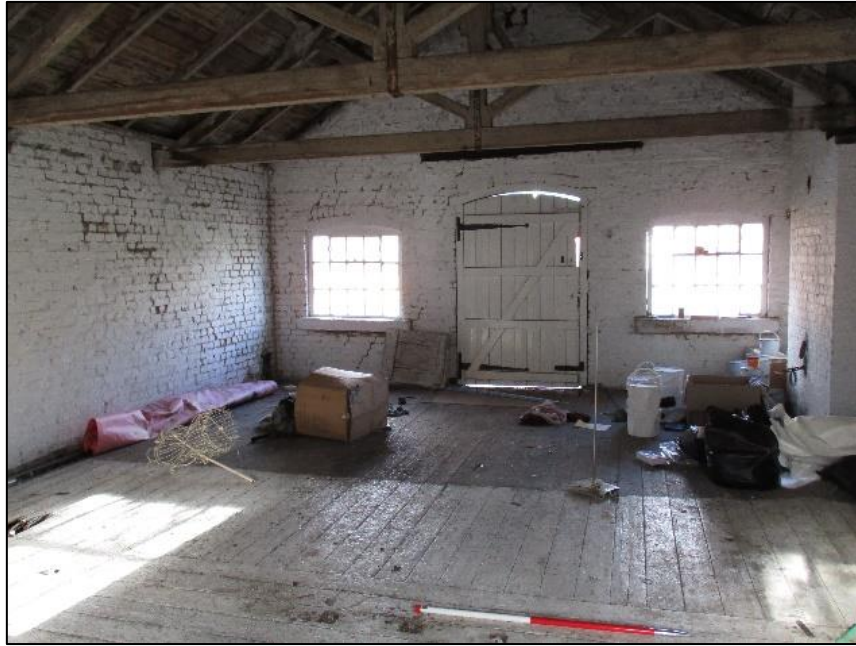
**Photo 14: First floor roof structure and floor boards in the third bay**

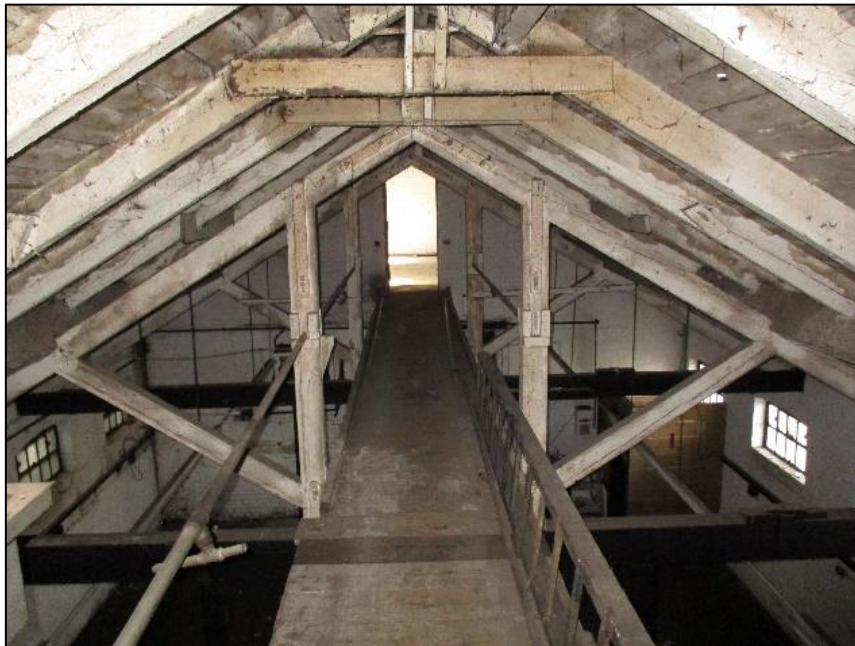
4.1.16 The first-floor walkway is supported by two horizontal beams and would have provided access across the top of the horse stalls. The walkway has been incorporated into the queen post roof structure (Photo 15).

**Photo 15: View along with first-floor walkway, from the south-east**
