**The White House,
Highgate High Street,
Haringey**

Heritage Statement

AB Heritage Project No:60051

Date:20/06/2017

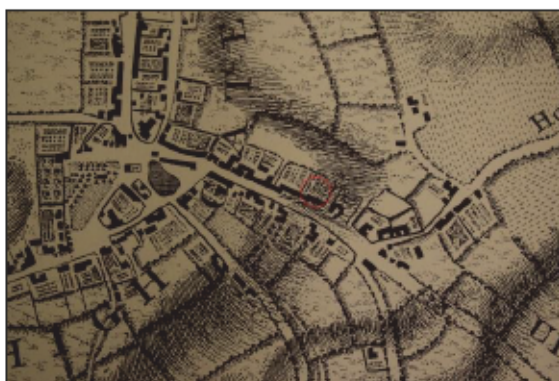
Plate 1: John Rocque's Map 1741 - 45. Approx. location of site outlined in red

- 3.1.4 The map by John Rocque of 1741 – 45 (Plate 1) shows a building occupying the location of The White House with a garden to the rear. The stylised map does not show the site in a large amount of detail but suggests that the extent of the property was limited to a position adjacent to the street frontage.

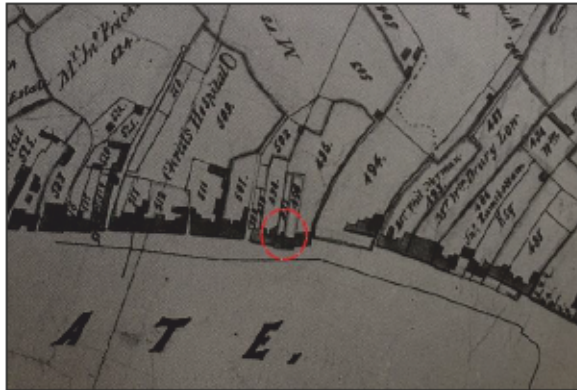
Plate 2: Hornsey Enclosure Map, 1819

- 3.1.6 The Hornsey Enclosure Map of 1819 (Plate 2) and Plan of Highgate of 1842 (Plate 3) are also rather stylised, which makes it difficult to determine precisely which building is The White House. Of those buildings which are likely to be The White House, they are shown simply in plan, occupying the street frontage as on the previous map.

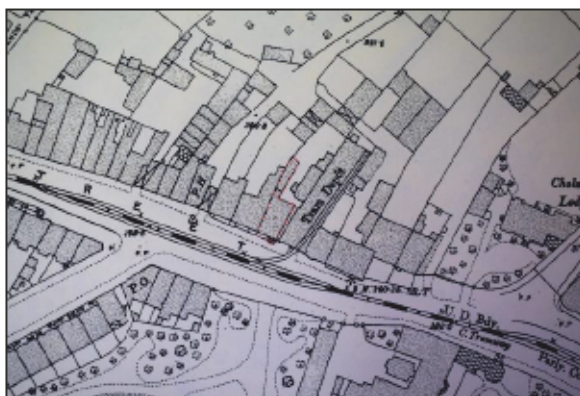
Plate 4: 2nd edition 25" OS Map, 1895

- 3.1.9 The 2nd edition of the 25" OS map (Plate 4), dated 1895, shows the site in more detail. The lightwell and step are depicted at the front of the building. The property to the west no longer encroached onto the western side of The White House, suggesting the adjacent building was partially rebuilt and the rear part of the White House was subsequently extended to the west, between c. 1870 and 1895. The rear extension is shown as a separate building, now in line with the rear elevation of the building. It has been identified that a builder by the name of William Holmes occupied the property in 1885 and he may have been responsible for extending the property.

- 3.1.10 To the east is a tram depot, with several buildings attached to the west side of the depot and likely associated with it, encroaching on the western side of the rear yard of the White House. The yard had been joined with the garden to the north and an outbuilding is located at the northern end. The land around the village remained largely undeveloped at this time.

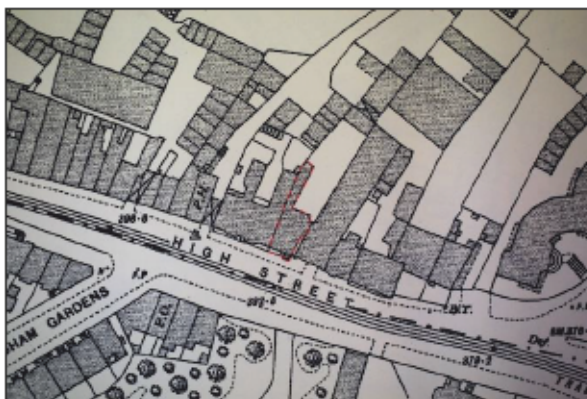
Plate 5: 3rd edition 25" OS Map, 1936

- 3.1.13 The 1950s edition of the 25" OS map (available online) shows the footprint of the building to be the same as the 1936 edition (Plate 5), although the northern end of the extension block is shown as a separate element of the building. The garden has been reduced in length with the boundary now in line with the end of the building.
- 3.1.14 The footprint of the building has remained largely unchanged since the 1930s.
- 3.1.15 A photograph taken during the 1950s or 1960s (Plate 6) reveals that the front ground floor windows retained late 18th or early 19th century exterior moulded pelmets, which have subsequently been removed.

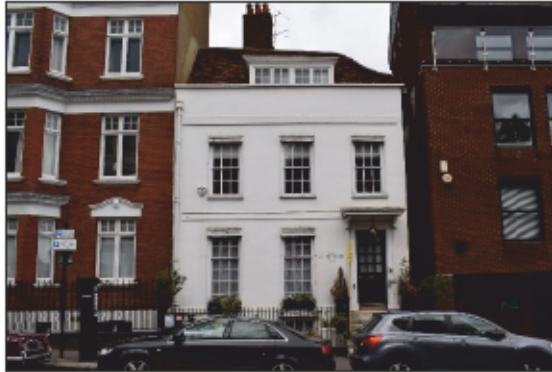
Photo 1: The front elevation from Highgate High Street, looking north

- 3.2.1 The front of the building is painted white render. The roof is steeply pitched, with a single wide dormer behind the parapet. The windows are enclosed timber sashes. A modern half glazed door is present on the front elevation under a late 18th century flat hood with moulded brackets. Wrought iron railings are present on the front steps and around the basement light well. A scar on the adjacent building to the west suggests that the roof has been altered,

following the re-fronting of the adjacent building during the late 19th century (Photo 1). The front elevation appears to have undergone limited alterations, apart from those to the roof.

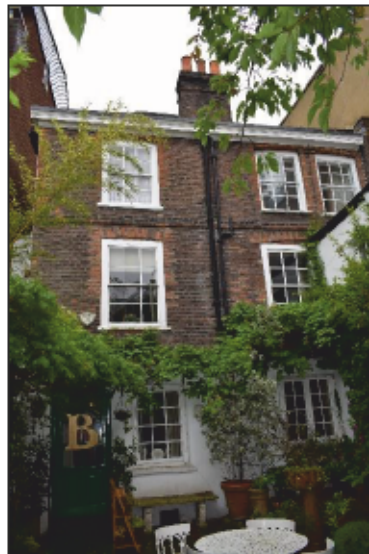
Photo 2: The rear elevation from the garden

- 3.2.2 Most of the original Flemish bonded brickwork is visible on the rear elevation, with curved brick arches over the windows. The brickwork repairs around the windows suggest that the windows have been replaced. The ground and first floor windows are flush with the façade but the second-floor windows are set into the brickwork, suggesting that the upper floor windows have been altered or inserted at a later date. The mid-19th century extension is present on the west side of the elevation (Photo 2).

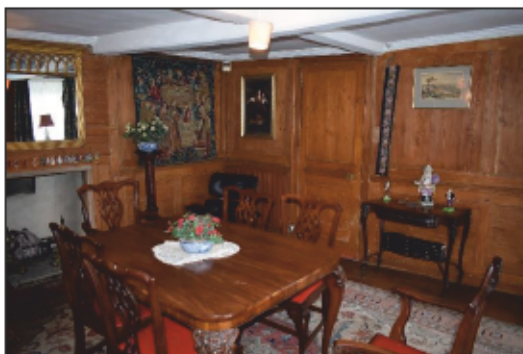
Photo 3: The front ground floor room

- 3.2.3 A covered side entrance is present on the east side of the building, within the former alleyway. The brickwork is exposed on the eastern elevation. A ramp has been inserted up to the doorway of the late 19th – early 20th century extension.
- 3.2.4 The interior layout of the house is based round the staircase rising from the hall at the centre of the house through the core of the building and adjacent to the chimney, thus allowing for large rooms across each frontage with connecting lobbies round the far side of the chimney on each floor. This is similar to other late 17th – early 18th century buildings in the area.
- 3.2.5 The principal ground floor rooms and the hallways are panelled (Photo 3). The panelling appears to have 18th century origins, although most of the dado rail appears to have been

replaced in the hallway and rear room and most of the panelling has been painted. In the front principal room, where the paint has been removed, timber pegs are visible in the panels. Plaster cornices are present throughout.

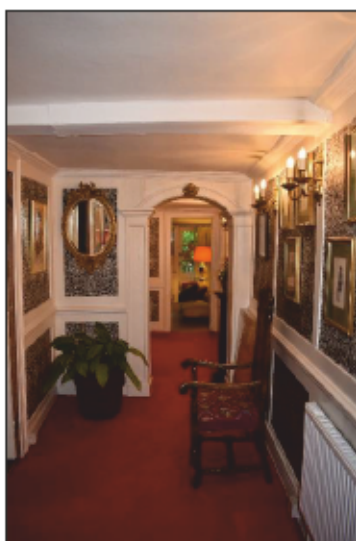
Photo 4: Ground floor hallway looking forwards the rear of the house

- 3.2.6 An original large stone fireplace and hearth is present in the front room. A hatch has been inserted adjacent to the fireplace, from the kitchen. The diagonally set fireplace in the rear room has a timber surround, an early 19th century hob grate and modern tiled hearth. A late 18th – early 19th century built-in corner cabinet is present in the rear room. The doorway in the hallway has been widened and an arched entablature with timber columns has been inserted. The position of the former height of the doorway suggests that the ceiling height may have been lowered.

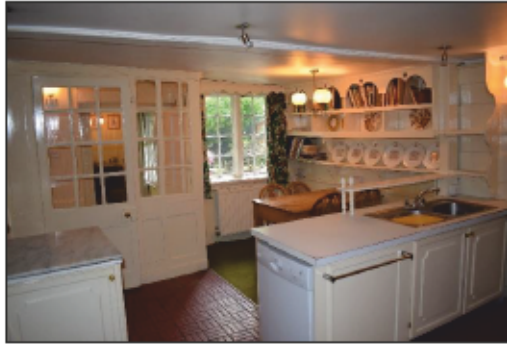
Photo 5: The kitchen looking towards the rear of the house

- 3.2.7 The historic maps suggest that the kitchen was extended to the west during the late 19th century. Therefore, the western elevation, built in cabinets and glazed partition at the northern end are likely to post-date the extension.
- 3.2.8 An aperture is present in the chimney breast, although this has been filled with modern cabinetry, as on the west side of the chimney (Photo 6). Vertical panelling is present on the eastern wall, although this has been partly obscured by modern shelving (Photo 5). The original ground floor rear entrance is present at the rear of the original building and now forms the entrance into the extension. A replacement window is present in an original window

position on the rear elevation. The remains of an interior timber pelmet and fixtures for shutters are present within the window reveal.

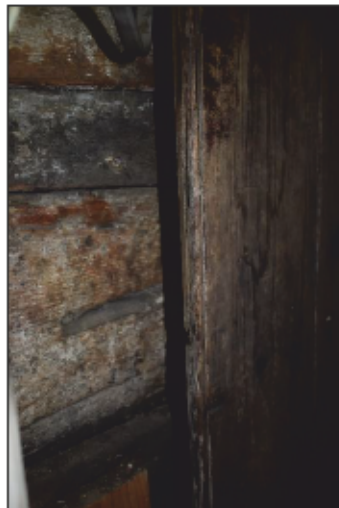
Photo 7: Possible original oak timber panelling behind later panelling in the kitchen

- 3.2.9 A cupboard on the west side of the chimney revealed the original chimney brickwork and several layers of timber wall panelling, culminating in horizontal, probable oak panelling behind the level of the existing partition wall (Photo 7). Whether this extends further along the wall to the north is unknown at this stage.

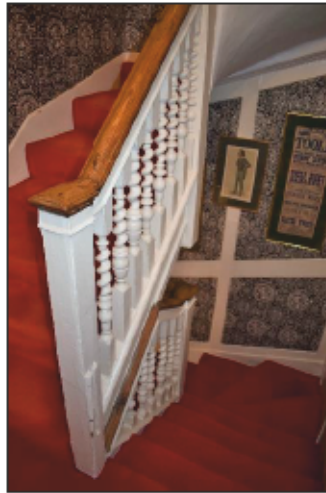
Photo 8: The staircase at first floor level

- 3.2.10 The ground floor of the late 19th century rear extension is devoid of significant architectural features, fixtures or fittings. A ladder has been used to create a staircase to the first-floor at the northern end of the extension.
- 3.2.11 A closed string staircase with twisted balustrade is present between ground and second floor levels. This is a style typical of the late 17th and early 18th centuries (Photo 8).

- 3.2.12 The panelling continues within the stairways (Photo 8) and upper floor hallways, as does the moulded cornice, with some probably original dado rail surviving.

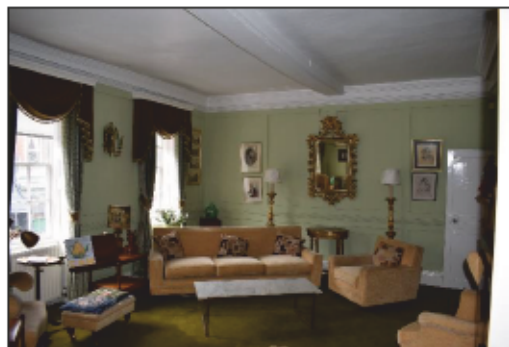
Photo 9: The front first-floor room

- 3.2.13 At first floor level, a door has been inserted during the early 20th century into the first floor of the extension of the eastern side of the building. The principal first floor rooms are panelled with some original doors surviving (Photo 9 & 10). In the front room, the fireplace contains an 18th century basket grate and has a probable 19th century surround. The fireplace in the rear room has an early 19th century register grate and probably another 19th century surround. A lobby is present between the front and rear principal rooms, possibly for service access.

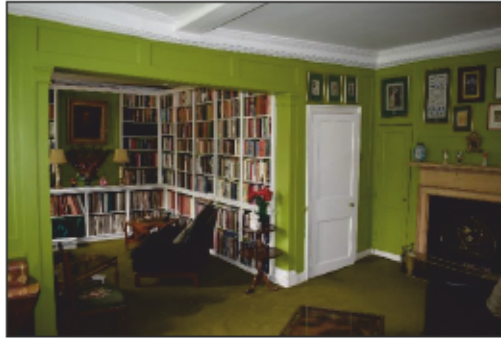
Photo 10: The rear first-floor room

- 3.2.15 The doorway into the formerly separate side room on the first floor has been blocked and an access has been created from the main rear room. This has caused the ceiling to sag in the main rear room (Photo 10). The fireplace in the side room is located behind the shelving but

the condition of this is unknown. The cupboard to the east of the fireplace in the rear room contains remnants of the original plaster.

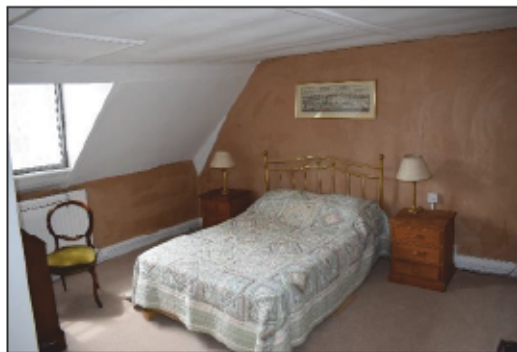
Photo 11: Front second-floor room

- 3.2.16 At second-floor level, the layout of the building appears to have been altered. It is possible that the front room was originally two rooms with a lobby leading from the main landing. Partitions have been inserted to create a bathroom next to the front bedroom. A door has been inserted to connect the two second-floor bedrooms. Both rooms have mid-19th century fireplaces but few other architectural features survive.
- 3.2.17 Some elements of the roof structure are visible at second-floor level, comprising part of a truss in the front room (Photo 11) and part of a cut off tie beam in the rear room. A shower has been inserted into the chimney breast in the rear side room on the second-floor.

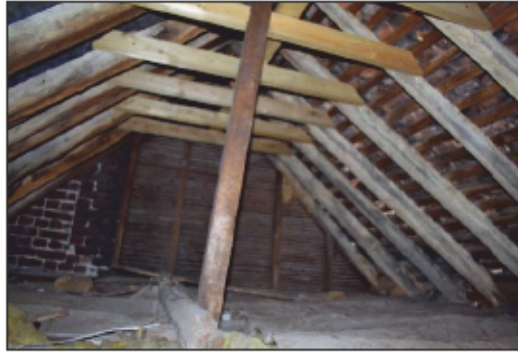
Photo 12: Part of the roof structure

- 3.2.18 The roof structure was viewed where possible from the loft hatches at second-floor level. It is evident that most, if not all, of the roof structure has been replaced, which is suggested from the exterior scar on the adjacent building (Photo 1). However, some earlier timbers remain although they have been superseded by replacement timbers or RSJs (Photo 12).

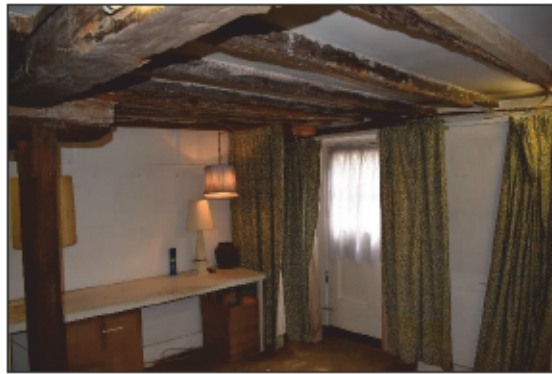
Photo 13: Ground floor timbers visible in the basement

- 3.2.19 The basement covers the area of the principal rooms, apart from the kitchen. Early ground floor supporting cross beams and joists are present, some of which have been repaired. No carpenter's marks could be found on the timbers. The timber floorboards of the ground floor were visible through the floor timbers. A door and window are present on the south elevation, leading to the lightwell at the front of the building.

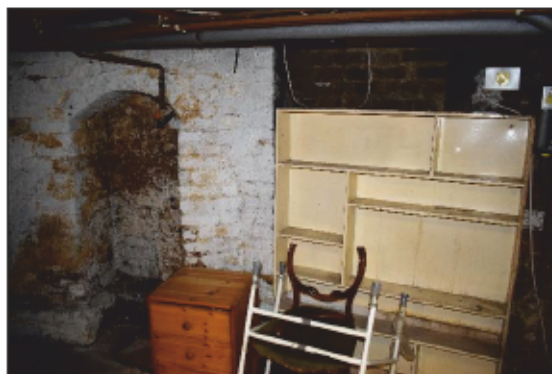
Photo 14: Base of the chimney and blocked doorway (behind the built-in shelves, right) in the rear basement

- 3.2.20 At the rear of the basement, the base of the chimney stack is present along with a blocked doorway on the north elevation. This is thought to have lead out to a rear lightwell, which has been covered by the modern garden patio. Some of the floor joists in the rear part of the basement are discoloured, possibly by fire damage.

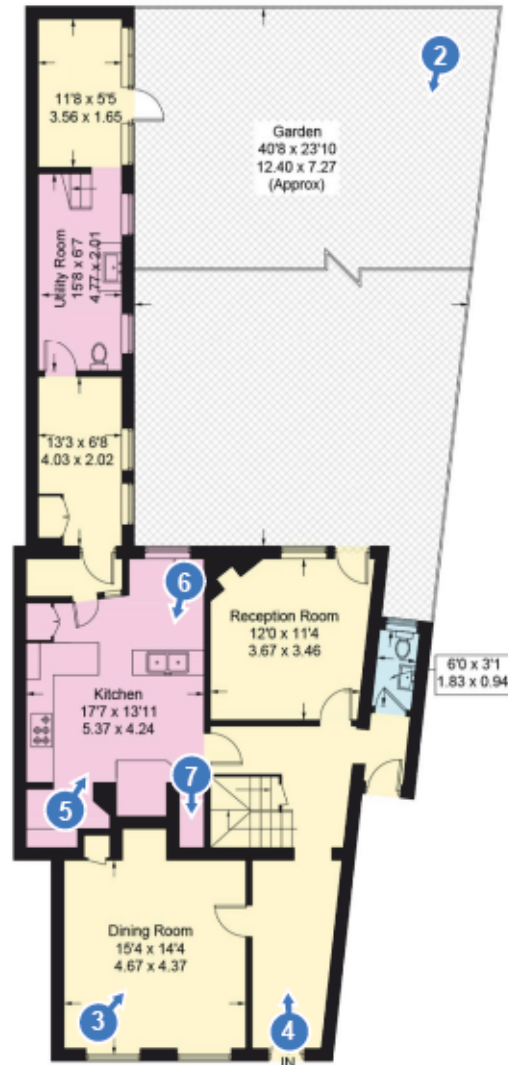
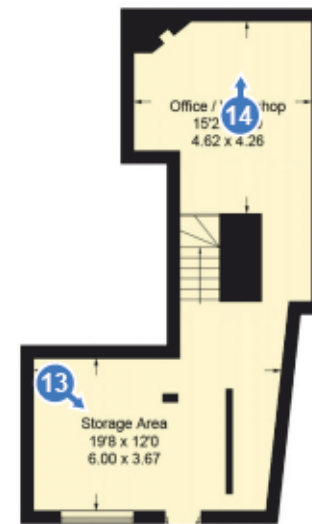
Ground Floor = 1258 sq ft / 116.9 sq m

Basement = 528 sq ft / 49.1 sq m

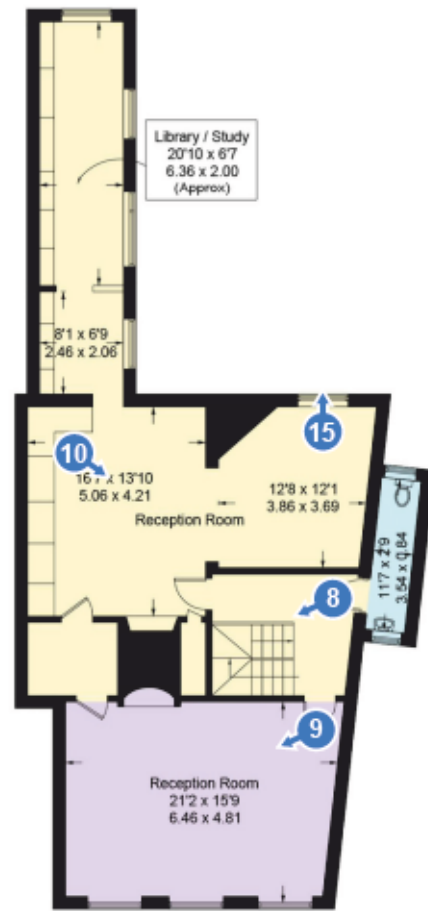
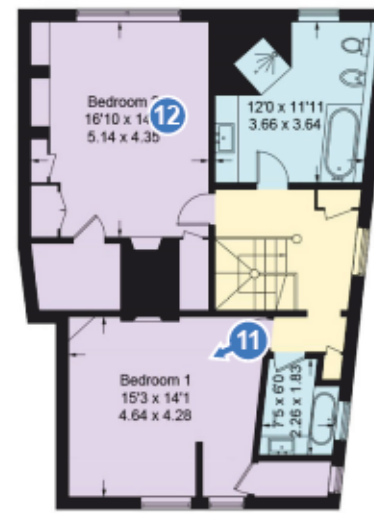
First Floor = 1176 sq ft / 109.3 sq m

Second Floor = 898 sq ft / 83.4 sq m
