**University of West of
England Glenside
Campus Laundry
Redevelopment
Heritage Statement**

University of West of England, Glenside Campus Laundry Redevelopment

Heritage Statement

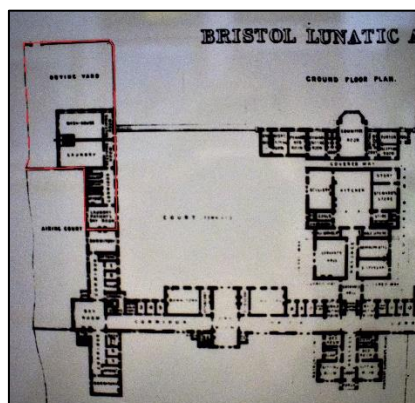
Plate 1: Ground Floor Plan of the Bristol Lunatic Asylum, c. 1857. Original laundry outlined in red (Glenside Hospital Museum)

- 3.2.1 The c. 1857 plans for the earliest phase of the asylum (Plate 1), completed in 1861, illustrate that provisions were made for a laundry on the female side of the building, in the north-west corner of the complex. This comprised a series of single storey rooms referred to on the plans as 'laundry' and 'ware-house', accessed from the adjacent receiving rooms on the eastern side. The receiving rooms were themselves accessed from the adjacent large courtyard. These rooms are shown to have had lantern roofs.
- 3.2.2 To the south was a corridor with a series of small service rooms on the western side and to the south a 'laundry patients [sic] day room', suggesting that patients, who only had one set of clothes at this time, would wait for their laundry in the day room. An enclosed drying yard was

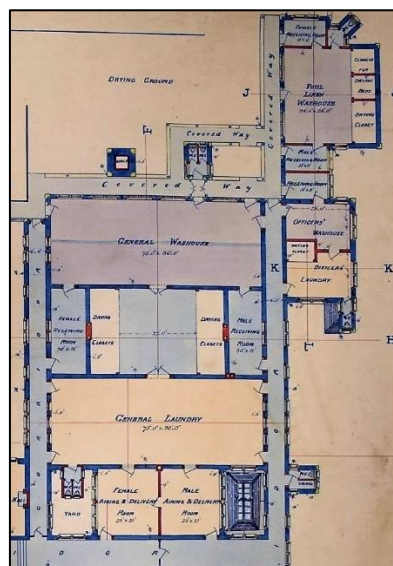
Plate 2: Ground Floor Plan of the new laundry, 1889 (Bristol Record Office ref. Bristol Plans/Arranged/41 [8265])

- 3.2.5 On the northern side, was a series of rooms dedicated for the officers laundry. To the west of this was the foul linen rooms, accessed only via the external covered way and included a drying closet for drying beds.
- 3.2.6 Several WC facilities were included throughout the complex, including in the officers laundry and the foul linen section. A drying ground was located on the western side of the complex.

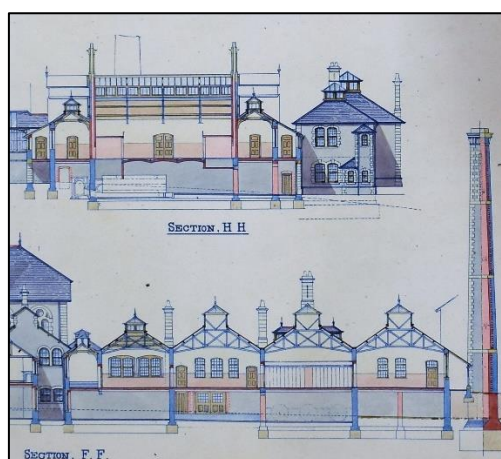
Plate 3: Cross Sections, 1889. East- West Section FF shows (left – right) internal corridor, female airing & delivery room, general laundry, drying closets, general wash house & the chimney. Section HH shows receiving rooms either side of the drying closets (Bristol Record Office ref. Bristol Plans/Arranged/41 [8265])

- 3.2.7 The 1889 elevations and cross sections identify that all the main elements of the laundry, including the principal three rooms, the officers laundry and the foul linen laundry, were all designed with lantern roofs (Plate 3).

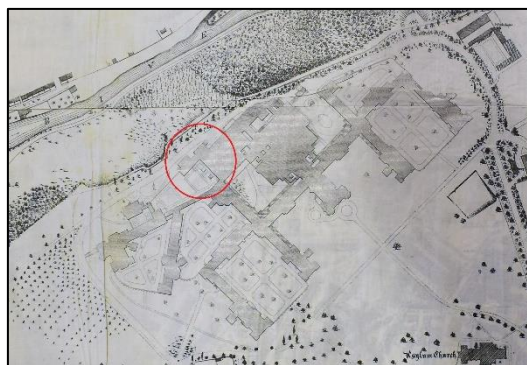
Plate 4: Plan of the Asylum at Fishponds, 1904. Laundry circled in red (Bristol Record Office ref. Bristol Plans/Arranged/70 [08561])

- 3.2.8 The Plan of the City and County Asylum of 1904 (Plate 4), shows the asylum complex following the 1890s extensions. The layout of the laundry is shown to have altered little, if at all from the 1889 plans.

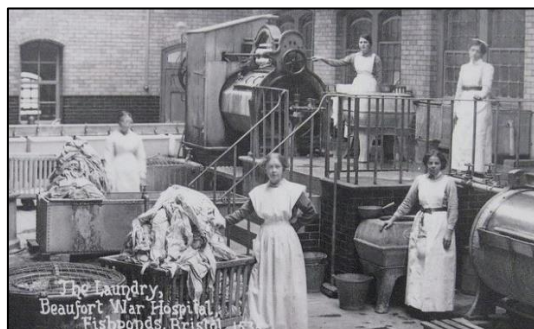
Plate 6: The Laundry during the First World War (Glenside Hospital Museum)

- 3.1.3 In 1891, it was advised that as much of the washing should be done by hand as possible, in a long range of fixed tubs with a supply of hot and cold water (Plate 7). Two large washing machines would be in the centre of the wash house (Plate 6), fitted with wringers, for the rinsing and cleansing of the clothes. The clothes would then pass through several rinsing tanks and from there into a wringing machine, preferably a centrifugal one, that would be located close to the door of the drying closets. The main wash house may also have contained several coppers and a soap boiler.

- 3.2.10 Photographs taken in the general laundry during the First World War (Plate 6 & 7), show the two tone glazed bricks that lined the wall and that some of the original windows remain. A glazed brick dais with railings was located in front of one of the machines, with a line of sinks behind. The floor was covered with large slag stones. It is evident that the doorways have been altered, with the curved overlights filled in. A belt system is shown operating elements of the machinery (Plate 7).

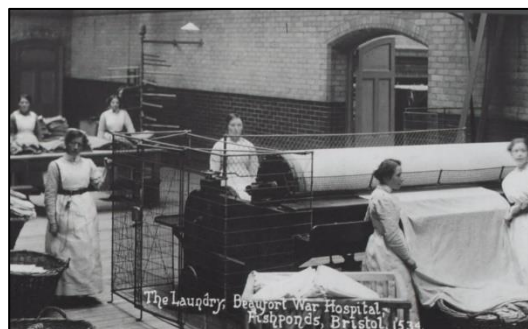
Plate 7: The General Laundry during the First World War (Glenside Hospital Museum)

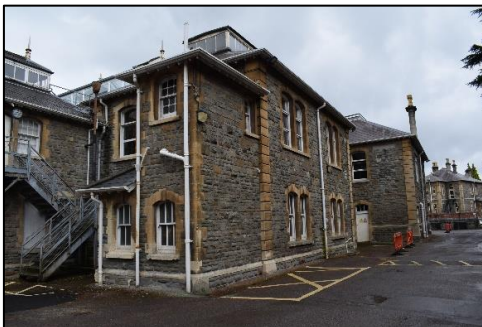
have buff limestone dressings comprising a mixture of plain and staggered quoins and have deep corbelled eaves (Photo 1).

Photo 1: Part of the north elevation of the laundry (former officers dept.), from the north-east

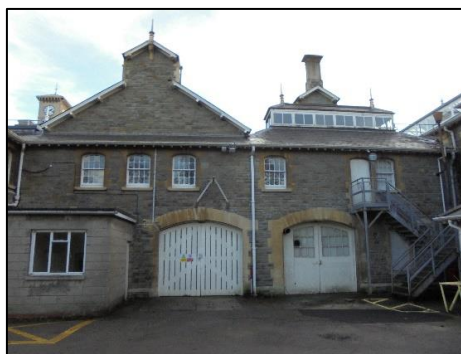
- 3.3.3 The pitched roofs are natural or artificial slate with some original decorative cast iron ridge plates and moulded roof finials surviving (Photo 1). Some of the lantern roofs have timber casement glazing but others have been replaced with metal framed glazing (Photo 2).

Photo 2: The main laundry basement entrance (left) and the boiler room entrance (right), from the north

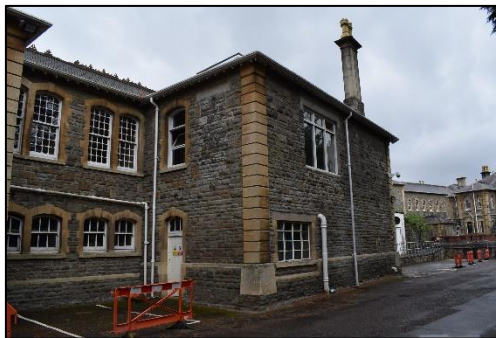
- 3.3.4 On the north elevation, the upper floor windows are largely curved double hung timber sashes, with moulded glazing bars, although some have been replaced. The ground floor windows have plain glazing bars and horns. All the windows have buff limestone detailing including quoins (Photo 1 & 2).
- 3.3.5 The basement boiler room doors have been partly altered with the insertion of several vents (Photo 2). However, the original form of the doors remains largely intact. The main entrance to the basement has been inserted in the place of three former windows.
- 3.3.6 Several fenestration alterations are evident at the north-east end of the north elevation, within the former foul linen department. A first-floor window has been blocked and two windows inserted, including a c. 1950s steel framed example at ground floor level (Photo 3).

Photo 3: Inserted windows in part of the north elevation (former foul linen dept.), from the north-east

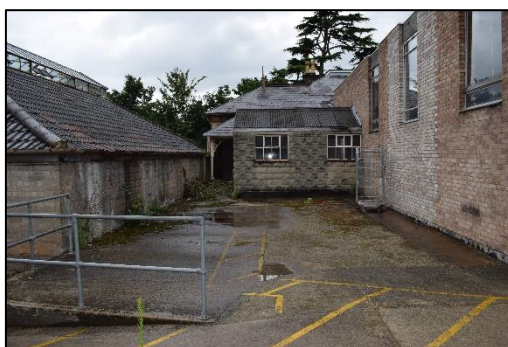
- 3.3.9 The west elevation of the late 20th century extension to the main laundry is brick built with large steel framed high level windows, modern doors and has a flat roof. The small square extension on the west elevation is of textured concrete block construction with concrete lintels and a corrugated roof (Photo 5).

Photo 5: The west elevation of the laundry, extension & rear of the block building, from the south

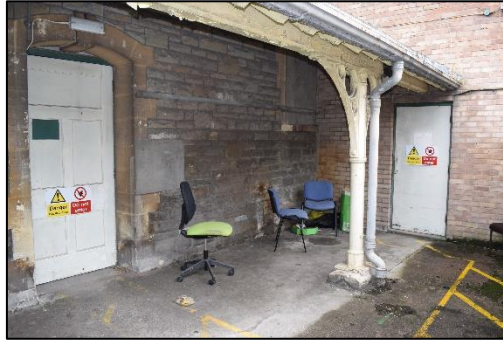
- 3.3.10 On the north side of the small western extension, part of the original pennant stone south facing elevation is present, with the same detailing as the other parts of the original building. One of the few surviving elements of the original veranda over the former covered way survives in this corner, with cast iron columns and brackets and a sloping roof. A blocked window is evident where the western elevation has been inserted (Photo 6).

Photo 6: Surviving veranda in the exterior north-west corner of the laundry

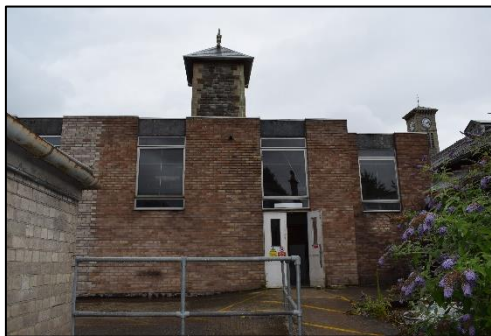
- 3.3.11 On the exterior, the chimney has largely been removed with only a small element remaining extant, which has been capped with a pitched roof with wide eaves. The chimney now forms a very inconspicuous feature of the laundry building (Photo 7).

Photo 7: The remains of the chimney from the exterior, looking east

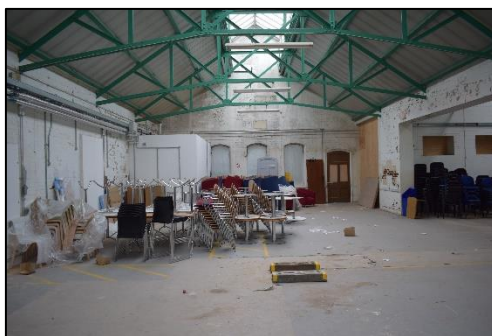
- 3.3.12 At ground floor level, the interior currently comprises three main open bays that are linked via large openings, which have been inserted into the party walls. Metal framed structures span the lantern roofs, which have corrugated sheeting and metal framed lantern glazing. The metal frame trusses appear to be original, with replacement lanterns and roof coverings. These probably dating to one or more of the numerous remodelling events of the 20th century, but closely resemble the original designs for the lantern roof structures (Plate 3 & Photo 8). A pulley and winch system has been installed at the north end of eastern bay, probably at the same time the roofs were replaced during the 20th century. A covered pit or basement access appears to be present beneath the winch system (Photo 8).

Photo 8: Roof structure, blocked windows and original doors in the east bay, looking south

- 3.3.13 The floors have been covered with concrete and a WC has been created in the south-east corner (Photo 8).
- 3.3.14 Although some of the windows and doorways have been blocked on the eastern side, several original windows remain throughout, with a mixture of plain and moulded glazing bars. The doorways have largely been altered, with the replacement of the original frames and the curved overlights have been filled in. However, some original curved frames remain. Despite this, a large number of the original, probably late 19th or early 20th century doors, have been retained within the altered frames (Photo 8 & 9).

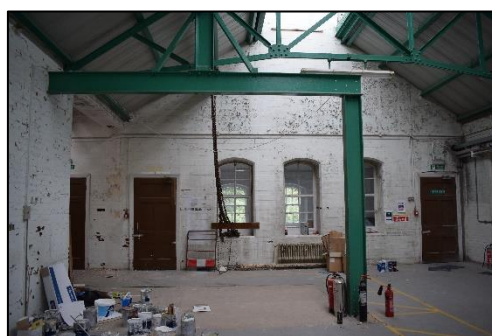
Photo 9: Pulley & winch system and covered pit or basement access in the east bay, looking north

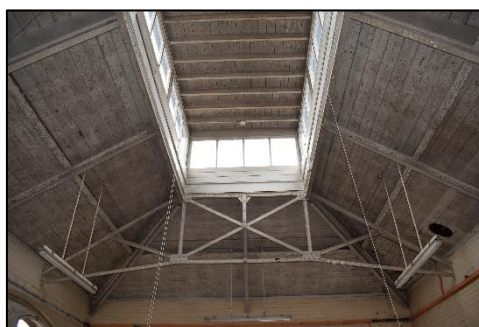
- 3.3.15 On the north side of the building, the original metal roof structure and part of the lantern roof survive in the former foul linen department within one of the northern side rooms, although the lantern had been altered, with the replacement of the pitched roof for a flat roof (Photo 10).

Photo 10: Original metal roof structure in the former officers laundry department, in a northern side room

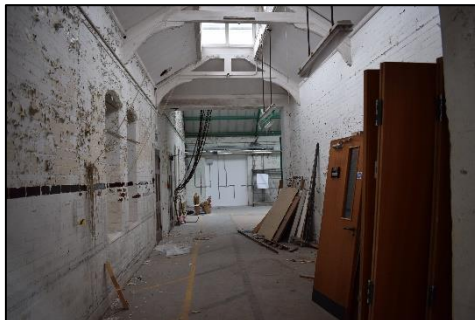
- 3.3.16 The metal roof structure in the former foul linen department, in the adjacent northern side room, is partly visible above a suspended ceiling. The metal roof structure remains intact although the lantern has been removed entirely.
- 3.3.17 The timber trusses of the original lantern roof structure remain within the northern corridor, formerly a receiving room, although the rest of the structure appears to have been altered (Photo 11).

Photo 11: Original timber lantern roof trusses in the north corridor area, looking east

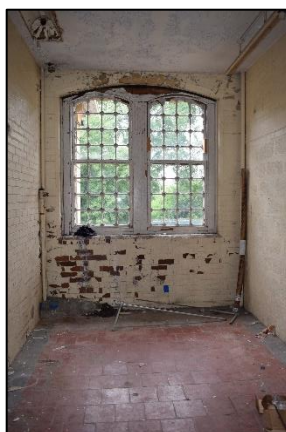
- 3.3.18 Other features that survive include a quarry tile floor in one of the northern side rooms (Photo 12) and an electrical speaker system within the third bay. These round speakers are likely to have been part of a communication or alarm system from the 20th century.

Photo 12: Quarry tile floor and blocked doorway (left) in one of the northern side rooms, looking north

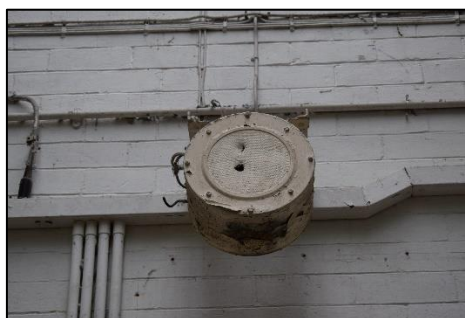
Photo 13: Details of the speaker system within the third bay

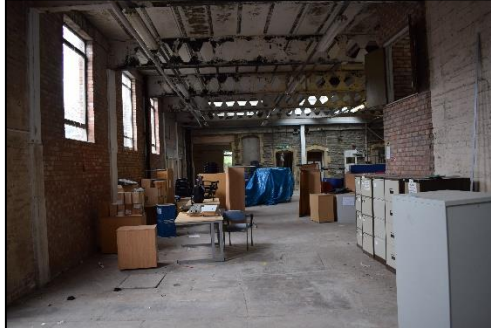
- 3.3.19 The western bay is a late 20th century brick extension. The former exterior elevations of the building remain exposed on the interior. The base of the chimney has been rebuilt in brick and

a WC inserted into the space. There is clear water ingress in areas along the join between the former elevation and the extension (Photo 14). The base of the original chimney has been encapsulated within brick walls for structural reasons, added during the late 20th century (c. 1970s).

Photo 14: Western bay, with the former south elevation in the background and rebuilt chimney base (right), looking north

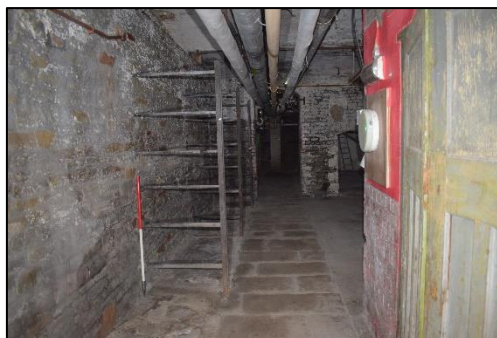
- 3.3.21 At basement level, the laundry layout on the eastern side comprises largely a series of featureless rooms. Several of which have modern partitioning and lead out onto small external courtyards. The pennant stone is exposed throughout the basement, although evidence of glazed brick walls is also present. Most of the rooms have either flag stone or quarry tile floors (Photo 15).

Photo 15: Glazed bricks (background), flagstone floors (centre) and drying horses (left) in the laundry basement

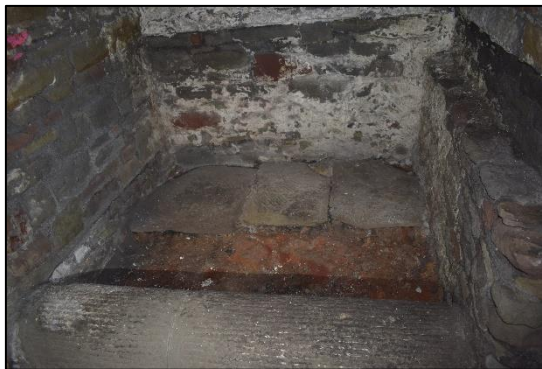
- 3.3.22 However, on the western side, the sequence of rooms is positioned to the west of a main access corridor. These lead into the main boiler house which contains many original features, including attached drying horses (Photo 15), rows of tubs and tanks (Photo 16) and a boiler, which retains the original iron door.

Photo 16: Tub built into the floor of the basement

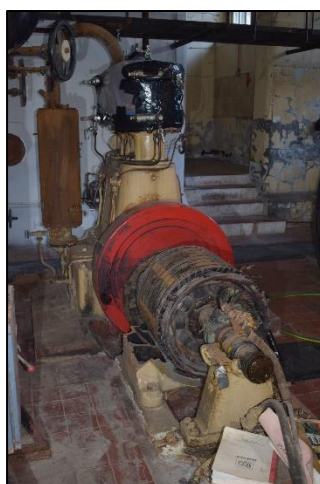
- 3.3.23 At the northern end of the basement, within the former powerhouse, two c. 1960s steam engines are present, which ceased working in 1979 (Photo 17). These are unusual survivals and are mentioned in the Historic England listing description.

Photo 17: One of the c. 1960s steam engines in the basement powerhouse

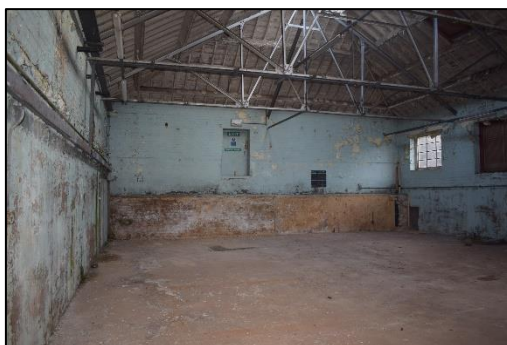
- 3.3.24 At the south-west corner of the basement is the early 20th century block extension. This also has a glazed brick interior that has been painted over. This area is a large, essentially featureless room. There is a suggestion of a former structure at the southern end of the room, perhaps a dais of some sort, which would have given access to a mid - height door on the east elevation. A metal framed structure spans the roof with timber boarding and a central lantern. On the western side is an exterior door.

Photo 18: The interior of the early 20th century block extension, looking south
