**Foxcote Farmhouse,
Foxcote, Nr. Radstock,
Somerset**

**Heritage Statement &
Archaeological Desk
Based Assessment**

AB Heritage Project No:60141

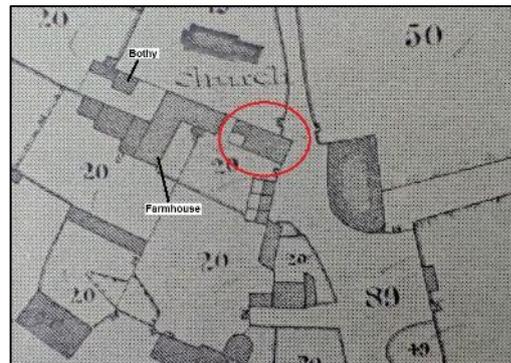
- 4.3.15 The former coach house & stable is shown to have been in existence by the 1839 tithe map (Plate 2). The building had a small extension on the north-west end, with a small yard at the south-west corner. The building is located within a yard on the south-east side of the farmhouse. The western elements of the farmhouse are shown as separate buildings attached to this side of the farmhouse. The 'bothy' was present at the rear of the house, with a T-shaped building attached to its western end.

Plate 2: Close up of Foxcote tithe map, 1839. Former coach house & stable circled in red (SWHT, 2017)

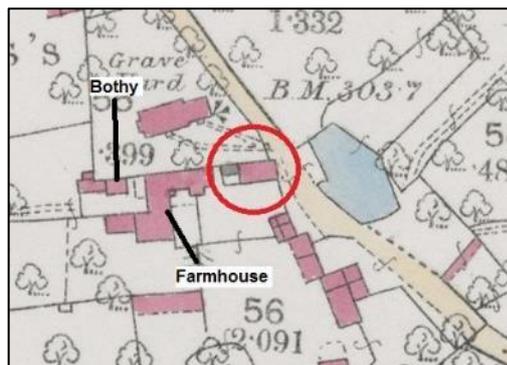
- 4.3.17 The coach house & stable is shown to have changed little, if at all since the 1839 map. The OS map indicated that the extension on the western end of the building was constructed from wood or iron, whereas the remainder of the building was built from stone (Plate 4).

Plate 4: Close up of the 1st edition 25" OS map, c. 1888 (SWHT, 2017 © Crown Copyright 2017. Ordnance Survey Licence Number 100050237)

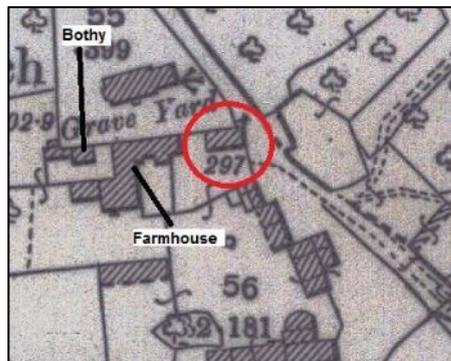
4.3.19 The 2nd edition of the OS map (Plate 6) illustrates that the wood or iron extension on the western side of the coach house & stable, had been removed, as had the small yard on the south-west corner of the building. The removal of several pig houses adjacent to the eastern boundary wall suggests that this wall has been replaced by 1904, along with the southern boundary wall.

Plate 6: Close up of the 2nd edition 25" OS map, c. 1904 (SWHT, 2017 © Crown Copyright 2017. Ordnance Survey Licence Number 100050237)

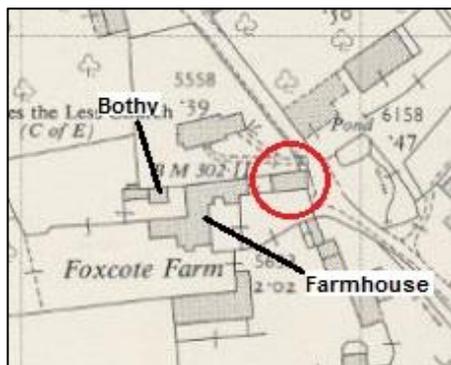
- 4.3.22 The 1940s revision of the OS map shows that the plan of the coach house & stable had changed little, if at all between c. 1904 and c. 1940. A wall had been constructed adjacent to the south-west corner, closing off the area to the west of the building from the adjacent yard.

Plate 8: Close up the 1940s revision of the 25" OS map (SWHT, 2017 © Crown Copyright 2017. Ordnance Survey Licence Number 100050237)

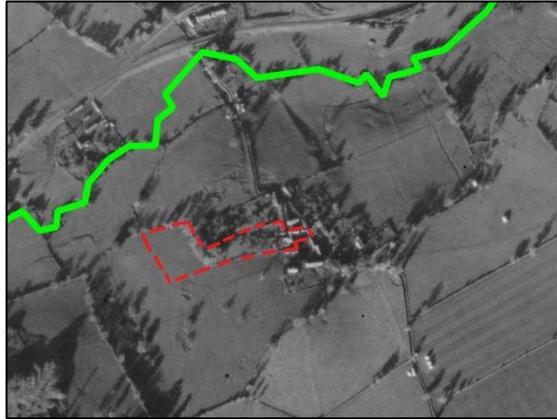
Plate 9: 1940s aerial photograph (SWHT, 2017)

- 4.3.23 An RAF aerial photograph (Plate 9) dating to the 1940s shows the site much as it is shown on the 1940s OS map. The position of the sun has, unfortunately, created shadows across most of the eastern part of the site. However, the western part remains clear although no obvious archaeological or structural features are visible. Boundary walls are visible separating the former plots at the rear of the farmhouse. Evidence of surface quarrying is present to the south-west of the site boundary. In the wider landscape, the earthwork remains of the rest of the former Medieval village [AB 11] located c. 280m to the north of the site are clearly visible on the eastern side of the road and off towards the north-east. The aerial photograph is not of sufficient scale or quality to determine any features of the coach house & stable.

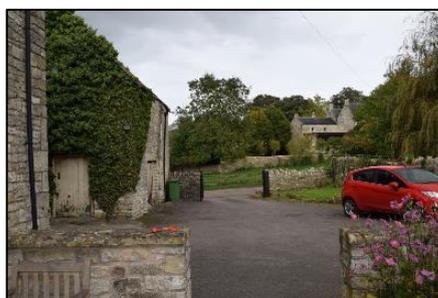
- 4.4.1 The former coach house & stable is situated on the northern side of the farm complex, to the east of the farmhouse (Photo 1). It faces south onto the yard, with the rear of the building facing north onto the adjacent churchyard. A short section of boundary wall adjoins the south-east corner of the building and a short section of the churchyard boundary wall, adjoins the north elevation.

Photo 1: View of the coach house & stable (left) from the farmhouse (Rectory Farm [AB 6] right)

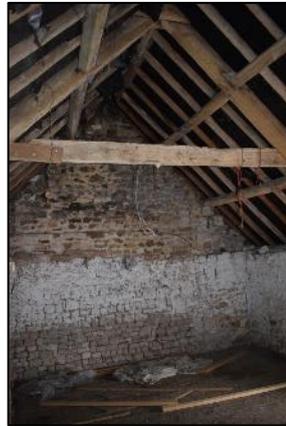
- 4.4.2 The former coach house & stable is constructed from local limestone blocks. The timber roof structure has been replaced, probably during the 19th century, with subsequent repairs (Photo

2). The roof is covered with modern pan tiles (Photo 3). The upper sections of the gable ends of the building appear to have been rebuilt (Photo 2).

Photo 2: Replacement roof structure and rebuilt gable, from the first-floor interior

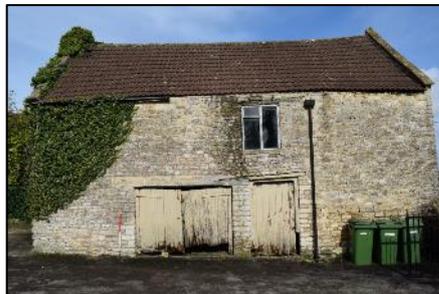
4.4.3 The external south facing elevation currently has a double cart / trap entrance and a single ground floor doorway, both with replacement timber lintels, frames and doors. A single window is present at first-floor level. This has been inserted into a larger aperture, which has been partially blocked around the window. This is likely to be the original hay loft doorway (Photo 3).

Photo 3: Former Coach House & Stable external south facing elevation (scale 1m)

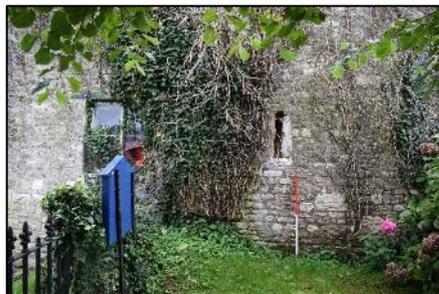
4.4.4 At ground level, the north facing elevation currently has a replacement timber glazed mullion window at the eastern end and 3 x ventilation holes (Photo 4), the latter of which have been blocked. No apertures are present at first-floor level.

Photo 4: Example of the ground floor apertures on the Coach House & Stable external north facing elevation

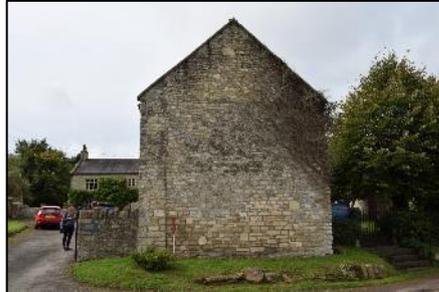
- 4.4.5 The external east facing elevation has a small buttress on the southern side but does not have any apertures (Photo 5). The west facing elevation has a ground floor single doorway and a single small inserted window at first-floor level.

Photo 5: Coach House & Stable east facing external elevation

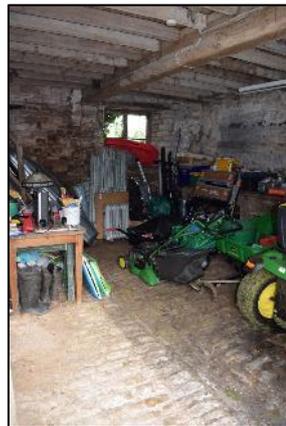
- 4.4.6 The interior layout of the building currently comprises 3 x rooms on the ground floor and an open space, the former hay loft, on the first-floor. The eastern end of the building is the former stable. A timber feeding trough with tethering rings is located along the eastern interior elevation (Photo 7). The floor in the eastern room is cobbled with a central drain (Photo 6).

Photo 6: Cobbled floor in the former Stable, eastern ground floor room

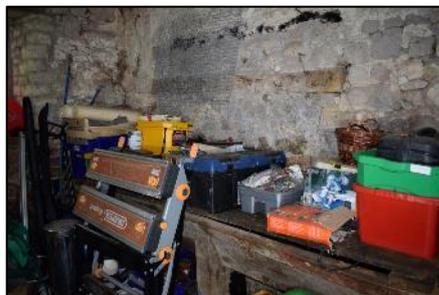
Photo 7: Feeding trough along the interior east elevation of the former Coach House & Stable

- 4.4.7 A timber ladder provides access to the first-floor. Both the floor structure and ladder have been replaced (Photo 6). Timber partitions with horizontal timber cladding separate the three rooms. The original timber lintels appear to survive above the ventilations holes.

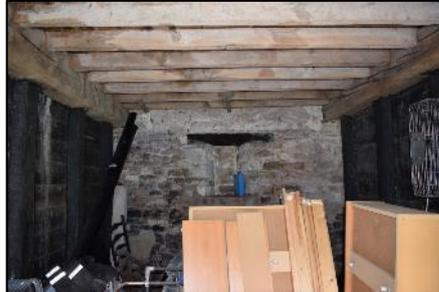
- 4.4.8 The central and western rooms have concrete floors and a blocked ventilations hole on the north elevation. Few other features survive, apart from a small brewing vat in the western room, which has been constructed from modern concrete blocks (Photo 9).

Photo 8: View of the central room with blocked ventilation hole (centre back), replaced ceiling timbers and partition walls in the former Coach House & Stable

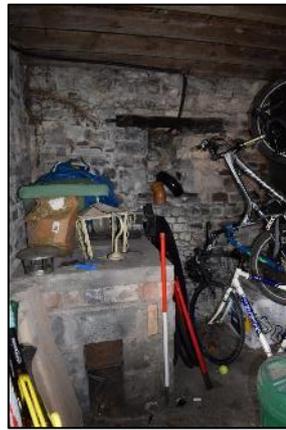
Photo 9: Modern brewing vat (left) and blocked ventilation hole (background) in the western room of the former Coach House & Stable

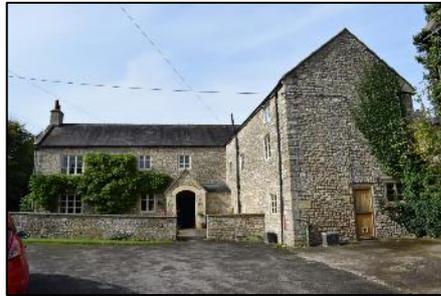
- 4.4.12 The farmhouse is constructed from the same limestone blocks as the coach house & stable and appears to have several phases of construction (Photo 10).

Photo 10: The farmhouse from the east

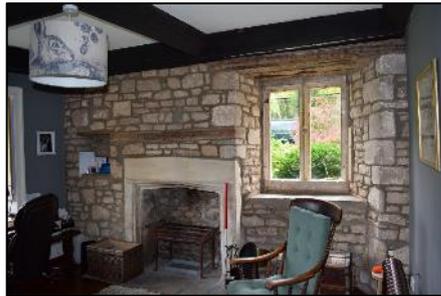
- 4.4.13 To summarise, initial interpretations suggest that the earliest part of the building is the block forming the south-east corner. This may have pre - 16th century origins as an open hall house, which was subsequently extended and altered during the 16th century when a stone fireplace and stone mullion windows were inserted into this part of the house (Photo 11).

Photo 11: Ground floor 16th century fireplace & stone mullion in the Farmhouse

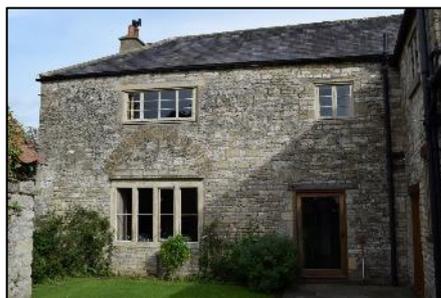
Photo 12: Farmhouse from the west with infilled passage (right)

- 4.4.14 The north-west block may be a broadly contemporary detached kitchen block, which retains a large inglenook fireplace with large timber bressummer, two bread ovens and flagstone floor (Photo 12 & 13).

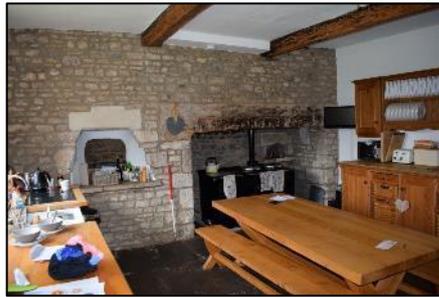
Photo 13: Inglenook fireplace and bread ovens in the Farmhouse kitchen

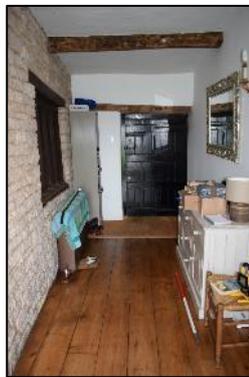
- 4.4.15 A timber mullion window on the interior of what is now the entrance the passage suggests that this was formerly an exterior elevation, which was subsequently infilled, creating a cross passage arrangement (Photo 14).

Photo 14: Infilled passage with former exterior wall inside the Farmhouse (left)

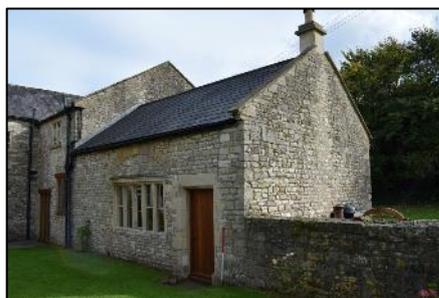
- 4.4.16 The north-eastern block and south-west parts of the house are likely to be additions to the original layout of the house but are pre- early 19th century date. The south-western block has a stone mullion of likely 16th century date. However, the historic mapping suggests that this part of the building may once have been a separate part of the main house. A chimney has been inserted into the west elevation of the south-west block (Photo 15).

Photo 15: Western end of the farmhouse with 16th century stone mullion

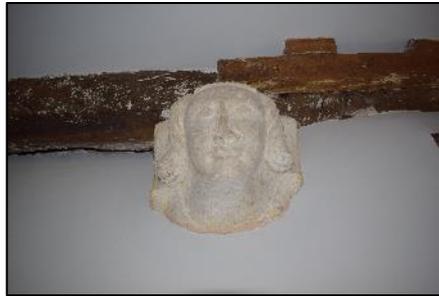
- 4.4.17 An example of the internal features includes an 18th century plank and baton front door (Photo 14), a late 18th century cast iron register grate in one of the bedrooms and a Medieval carved corbel in the shape of a human head with traces of coloured paint, which has been inserted in one of the ground floor rooms (Photo 16). This is likely to have originated from the earlier

church adjacent to the site. The roof structure has been replaced but a large number of earlier structural timbers survive throughout.

Photo 16: Medieval carved corbel from inside the Farmhouse

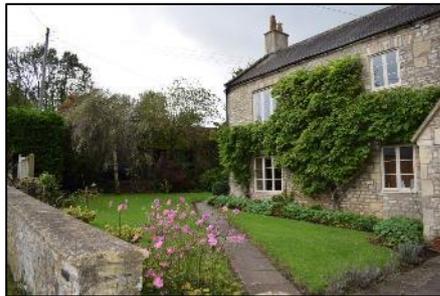
Photo 19: Garden in front of the Farmhouse

- 4.4.20 The immediate setting of the farmhouse to the east comprises the front garden (Photo 19) with a vernacular garden wall which displays evidence of formerly being topped with metal fencing, tarmacked yard and the coach house & stable. The main road through the hamlet and agricultural fields are located beyond to the east. The 17th century Rectory Farmhouse [AB 6] is visible across the road to the south-east (Photo 1, page 25) and the adjacent former barn is prominent beyond the boundary wall to the south (Photo 19). The roofline and parts of the north facing elevation of the 16th century former barn [AB 4] are also visible to the south although most of the elevation is obscured by vegetation (Photo 18).

- 4.4.25 A lawn continues around the south side of the farmhouse. The dense nature of the vegetation along the southern boundary in the area has resulted in limited intervisibility with the adjacent building to the south (Bramble Cottage) (Photo 19).

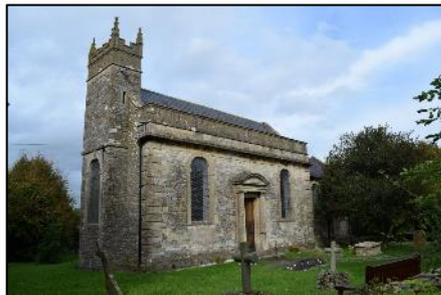
Photo 20: The churchyard & church [AB 3] from the northern site boundary

- 4.4.21 The open and rural character of the setting is further enhanced by the churchyard located immediately to the north of the site, containing the parish church of St James the Less [AB 3] (Photo 20).
- 4.4.22 The wider rural character and the remains of the village of Foxcote form with setting of the church. The rear of the farmhouse, coach house & stable and bothy, form a prominent element of the immediate setting to the south, due to their position on or close to the boundary of the churchyard.

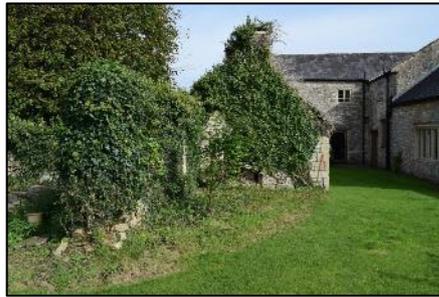
- 4.4.23 The rural setting continues to the west of the farmhouse. A dilapidated 'bothy' and several walls which indicate the location of other former outbuildings, are present at the rear of the farmhouse (Photo 21), with further open fields beyond to the west.

Photo 21: Ivy covered bothy (centre) and walls of former outbuildings, at the rear of the Farmhouse
