**Former General  
Hospital, Newcastle  
Upon Tyne**

**Historic Environment  
Desk Based Assessment**

AB Heritage Project No:60343

## Former General Hospital, Newcastle Upon Tyne Historic Environment Desk Based Assessment

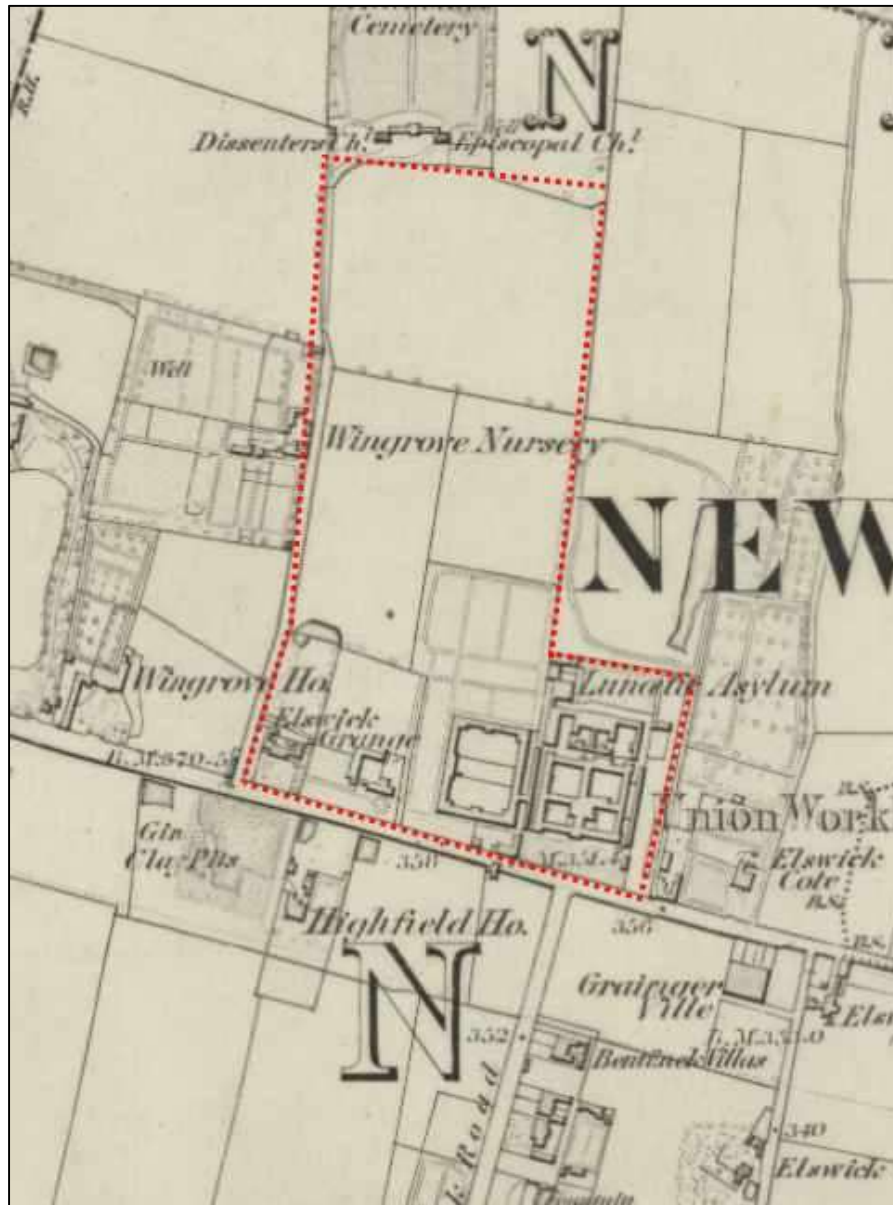
Plate 1. Extract 1<sup>st</sup> Ed. OS 1864. Courtesy of National Library of Scotland

- 4.3.16** In the late 1860s, an Infirmary was constructed in the southern central portion of the site – in the area of what is shown on the Ordnance Survey 1<sup>st</sup> Edition map as containing two buildings, possibly a farmhouse and an L-shaped range of outbuildings (beneath the word Grange on Plate 1). All these additions are shown on the 2nd edition Ordnance Survey map from the 1890s (not shown).

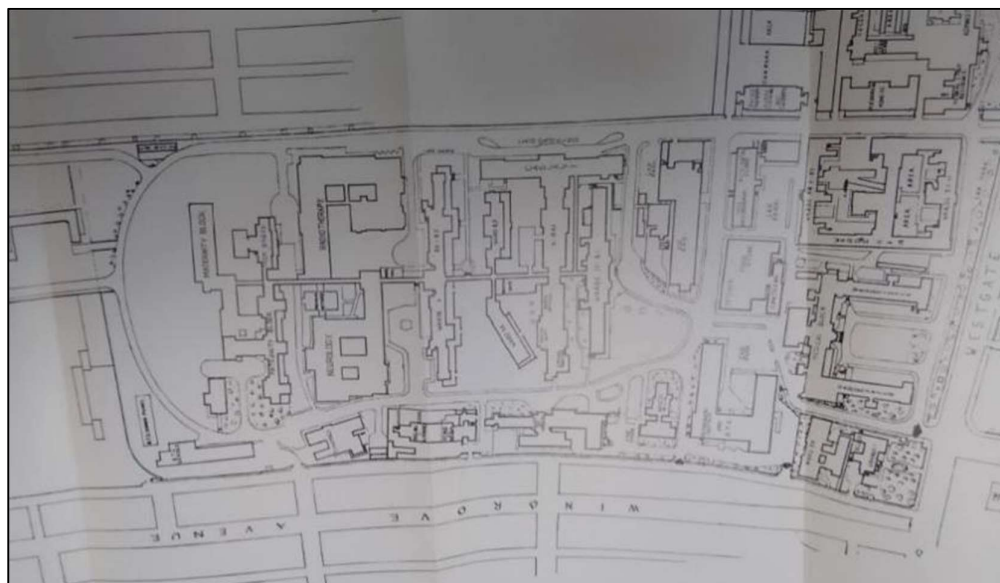
**Plate 3. 1966 Block Plan of General Hospital. Westgate Road to the right**

**4.3.18** By the mid-1960s the hospital site had been further developed, with the site becoming ever busier. By this time several new units had been added including a Casualty unit parallel to the eastern length of the ring road, with an X-Ray unit, Radio Therapy and Neurology Units all added to the services provided (Plate 3).

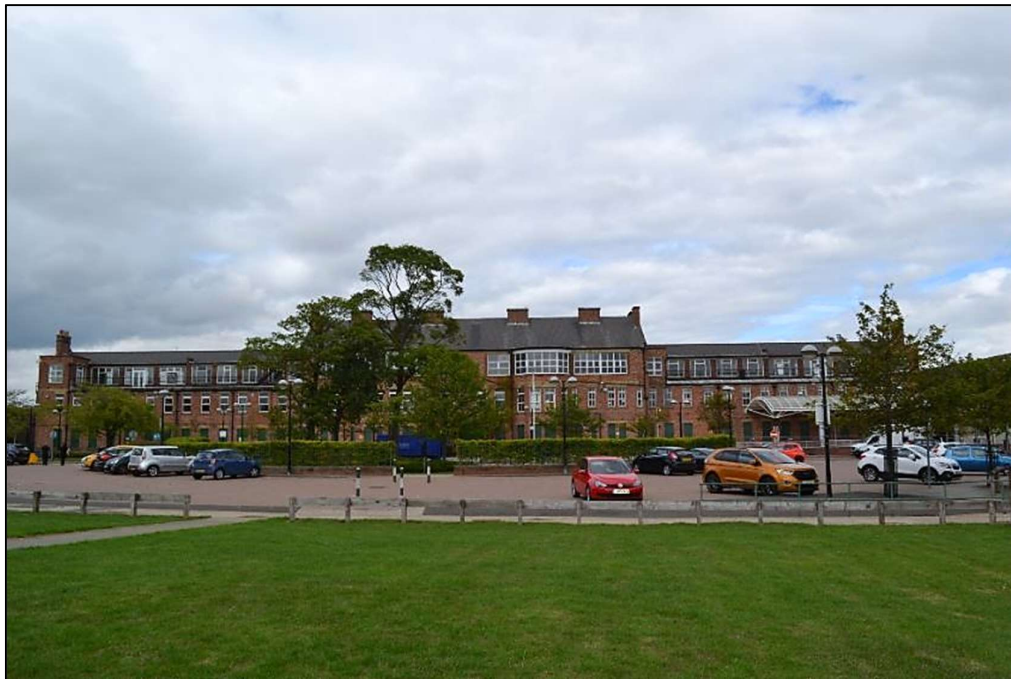
**6.3.1** This building faces south towards Westgate Road, and is currently the first substantial building encountered upon entering the site from the public car parks. This building is generally of three storeys, although the third storey and roof of the west and east wings appear to be later additions (Photo 1).

**Photo 1. Looking north to the New Hospital Building**

**6.3.2** The New Hospital Building is generally of a mottled red brick construction, with stone window sills and lintels and stone door steps. The building comprises a main central section of two bays and a wing to either side.

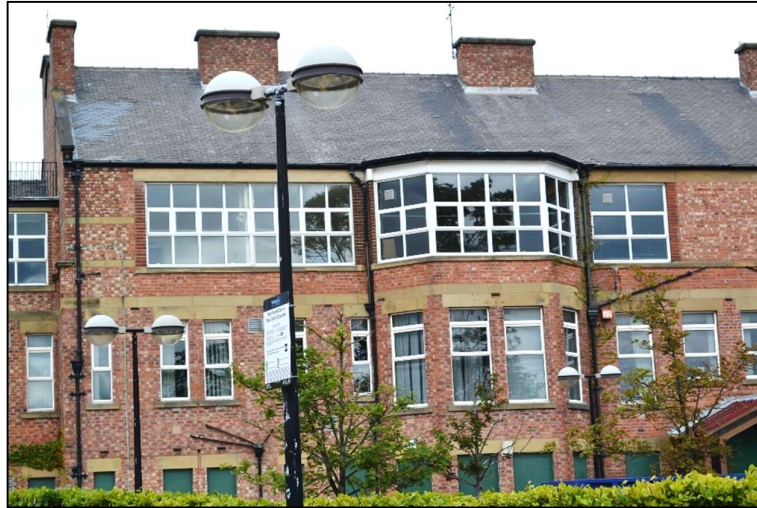
**6.3.3** The central section of the building contains more fenestration than the wings, although the general tripartite style of the windows is approximately similar to all. The central section has a welsh slate roof with four chimney stacks running with the ridge, and at either gable end two smaller chimney stacks perpendicular to the ridge (Photo 2).

**Photo 2. Showing features of central section of New Hospital Building**

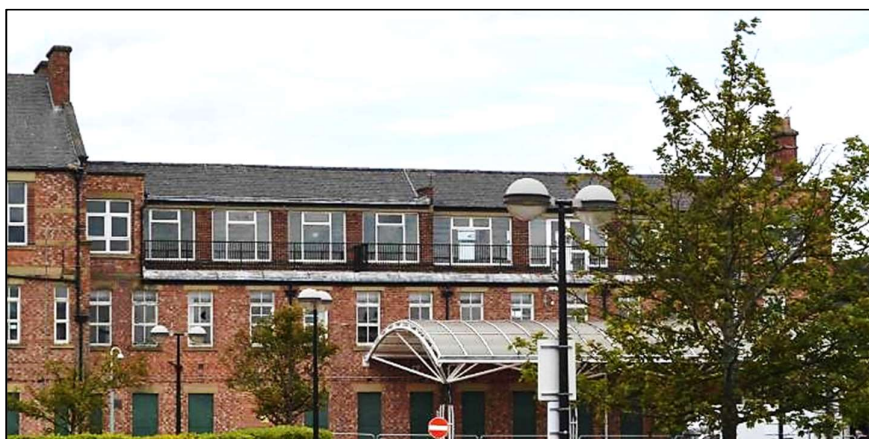
- 6.3.4** Currently all the doorways and windows are boarded on the ground floor.
- 6.3.5** It is likely that the windows present for examination on the first floor are representative of the same on the ground floor i.e. timber framed, tripartite with six glazed panes, with the upper lights as an awning window.
- 6.3.6** The third storeys on the east and west wings are constructed of a darker reddish-brown brick. The wings are nine bays wide with a single, narrow sandstone lintel running over the larger windows.
- 6.3.7** The second floor of the wings is set back behind an iron railing over a sloping leaded roof at first floor. Each of the wings at second floor has a glazed door with side lights (Photo 3 behind the lamppost).

**Photo 3. Looking north showing east wing of New Hospital Building**

- 6.3.8** The east and west wings also show evidence of being extended or altered. Photo 3 shows a change in fenestration and a stub or brick work at gutter level on the roof at the mid-point of the wing. Each wing features a single chimney stack with ceramic pots at each gable end.

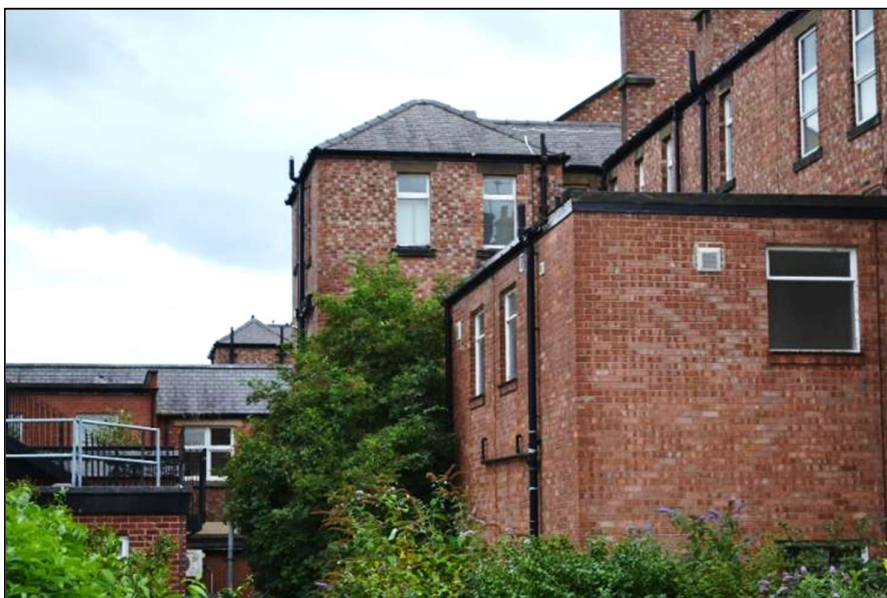
- 6.3.9** The rear of the New Hospital Building is less imposing than the front south elevation. The rear retains the tripartite window styling but maintains the simplest version of it. The rear also shows the utilitarian aspects of the building such as the guttering and downpipes, which are generally better placed on the front south elevation (Photo 4).

**Photo 4. Looking east. Showing rear of New Hospital Building**

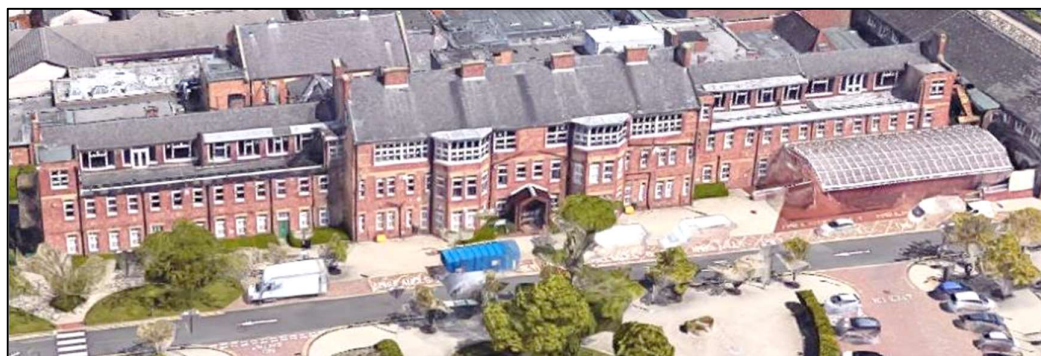
- 6.3.10** The rear of the New Hospital Building has been the focus of extension for presumably functional areas such as washrooms, toilets and rear service stairs – as evidenced by the pipe work and risers shown in Photo 4, as well as the changes in window form.
- 6.3.11** Models 1 & 2 (below) show 3D representations of the front and rear of the New Hospital Building.

**Model 1. Looking NNE. Showing south elevation of New Hospital Building**

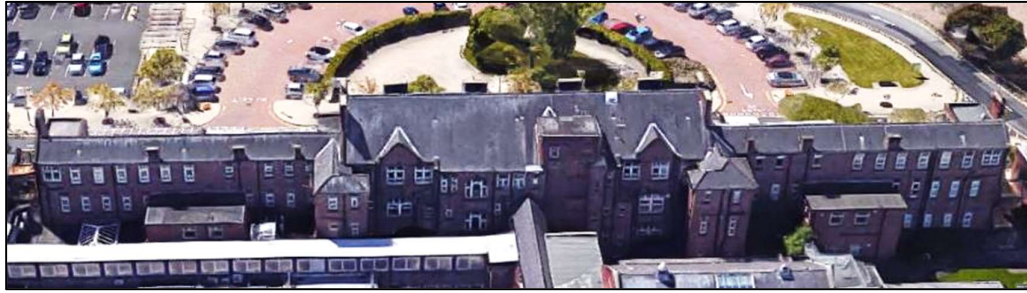
**Model 2. Looking S. Showing rear north elevation of New Hospital Building**

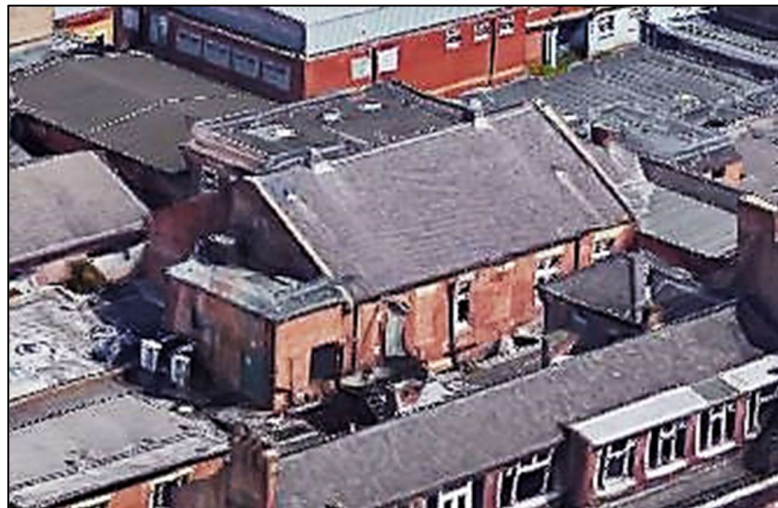
- 6.3.12** The Operating Theatre is located behind the New Hospital building. Access to this building was not available at the time of the site visit, this building is surrounded by several new additions, and locked behind gates to restrict public access.
- 6.3.13** The building is of two storeys and built of the same red brick as the New Hospital Building. The Operating Theatre shares the same design motifs of the stone sills and lintels and Welsh slate roof. A sky light is present on the north facing slope of the roof – this is likely an original feature. Two chimney stacks are present along the ridge of the roof.
- 6.3.14** The Operating Theatre building is notable by its width compared to its length giving a squat appearance to the whole. Models 3 & 4 below show 3D images of the building.

**Model 3. S and W elevations of Operating Theatre**

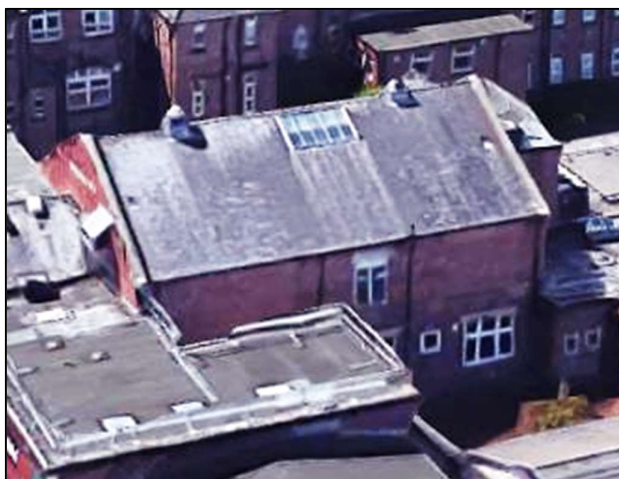
**Model 4. E and N elevations of Operating Theatre**

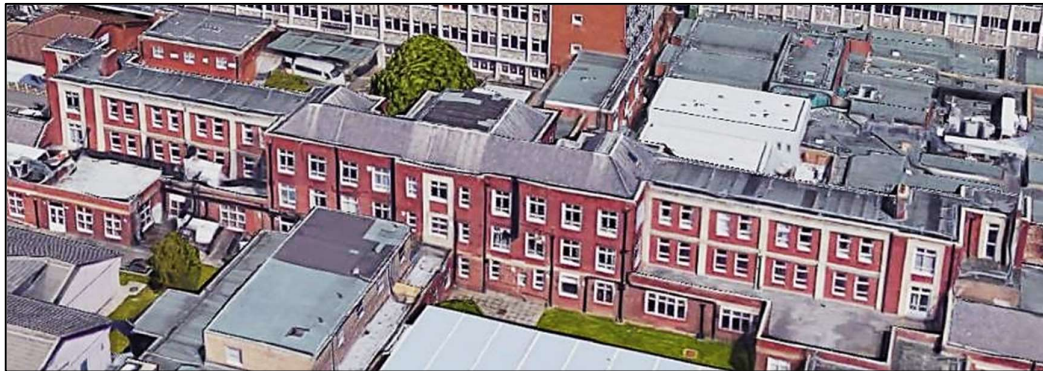
- 6.3.27** The first and second floor of the south elevation of the wings contains square shaped stone detailing, with each square enclosing two window bays. The ends of each wing have stone detailing that is the same as the middle of the central section (Model 5).

**Model 5. Looking NNW showing south elevation of Children's Block**

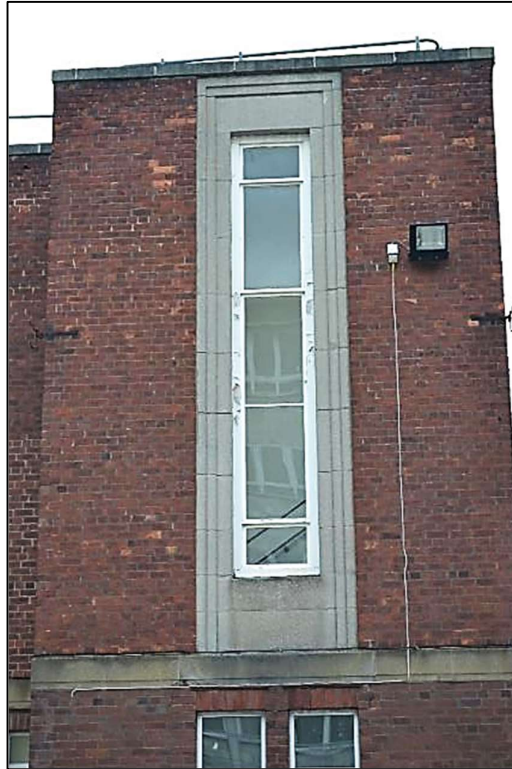
- 6.3.28** Set back from the wings is a distinctive staircase tower (Photo 5 and Model 5).

**Photo 5. Looking S. West staircase tower of west wing**

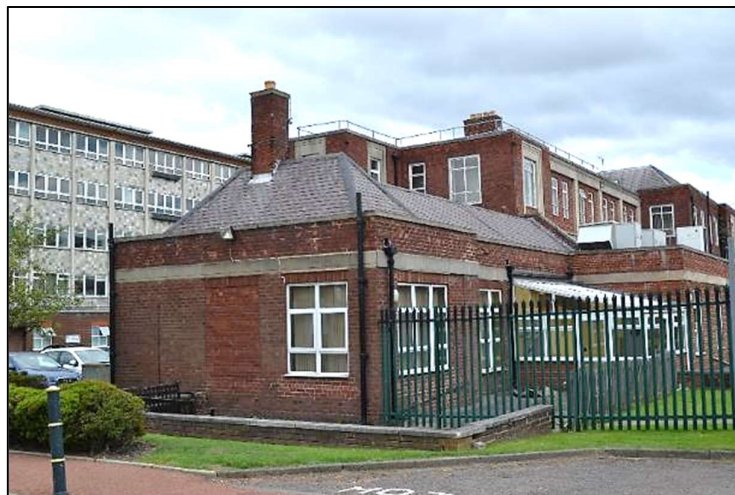
**6.3.29** In front of the wings towards the ends, on the ground floor is a single storey extension which lies in front of the main building. These extensions are marked in hatch design on the 1936 Plan. They are also of red brick with simple stone detailing. The windows are of six light timber framed casements. The front of these extensions is marked by wrought iron railings. The west wing extension has itself been given an extension in the form of a small conservatory (Photo 6).

**Photo 6. Looking E. Showing GF wing extensions to Children's Block**

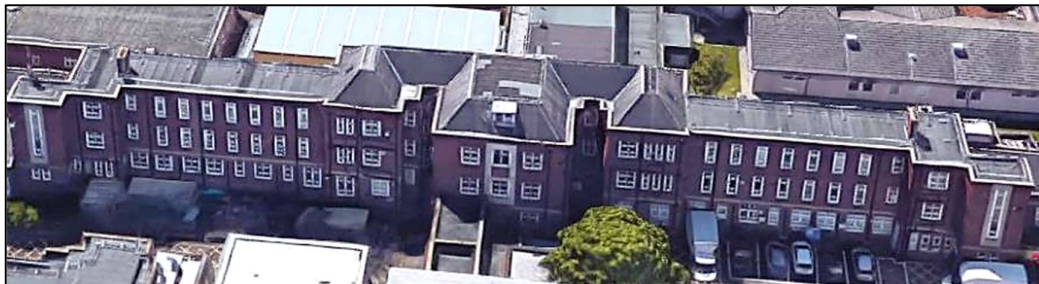
- 6.3.30** The rear (north elevation) of the Children's Block building including the central section and the wings is very similar to the front or south elevation, with the exception of the ground floor wing extensions not being present on the rear north elevation (Model 6).

**Model 6. Looking S. North elevation of Children's Block**

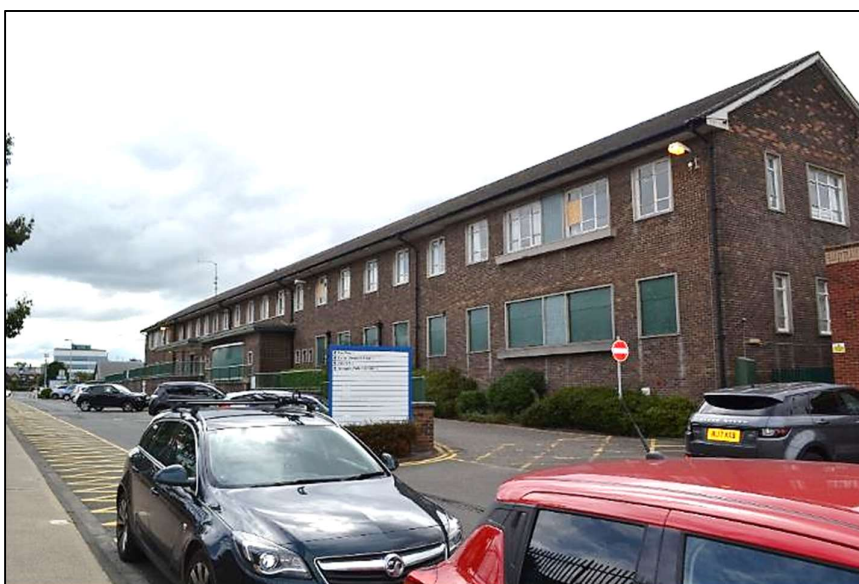
- 6.3.31** The Casualty Department building is shown on the 1966 Block Plan. It is sited to the east end of the New Hospital Building and is orientated N-S along the east stretch of the ring road.
- 6.3.32** The Casualty Department is a long (c. 80m) building of a relatively simple design. The building appears to comprise of three distinctive sections, namely a south and a north section, with a longer central section that was the entrance and pick up and drop off place for ambulances etc.
- 6.3.33** The Casualty Department is constructed of brown bricks and roofed with concrete tiles. There are gables at the south and north.
- 6.3.34** The front elevation faces east and contained the entrance hall and the vehicular drop off spaces. The east elevation is raised above the level of the ring road on a ramp (Photo 7).

**Photo 7. Looking SSW. Showing E elevation of Casualty Department**

- 6.3.35** The east elevation is characterised on the ground floor by a series of rectangular windows (boarded) surrounded by concrete detailing. At the south and north sections, the ground floor windows have a concrete sill, and are separated by green tiles. This pattern of window, sill and tiles is repeated at the first floor (Photo 7).
- 6.3.36** The defining design feature of the Casualty Department is the convex window located to the north of the entrance door.

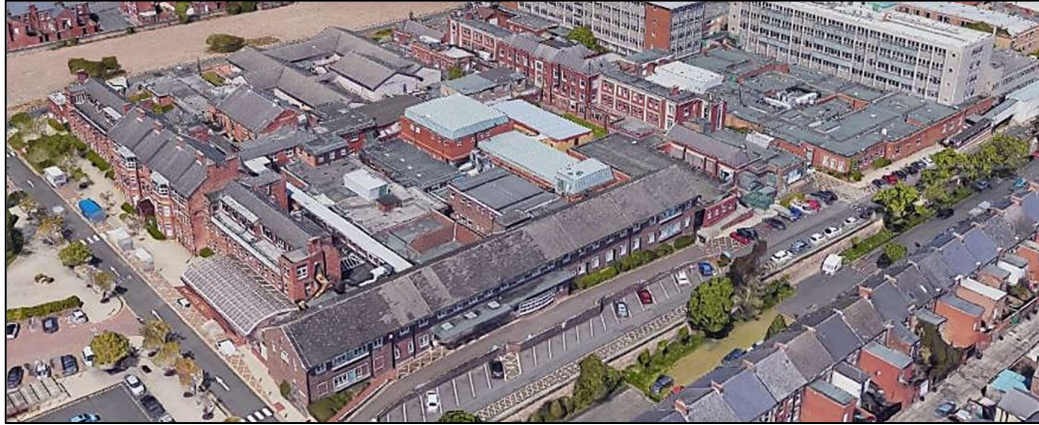
**Model 7. Looking WNW. Showing the New Hospital Building, Operating Theatre, Children's Block & Casualty Dept (within wider site)**
