**Lower Huxham Farm,
East Pennard
Statement of
Significance**

Lower Huxham Farm, East Pennard Statement of Significance

Client Ms. Giaretta
Project Number 60553
Prepared By Alex Farnell & Paul Cooke
Illustrated By Pighill Illustrations
Approved By Andy Buckley

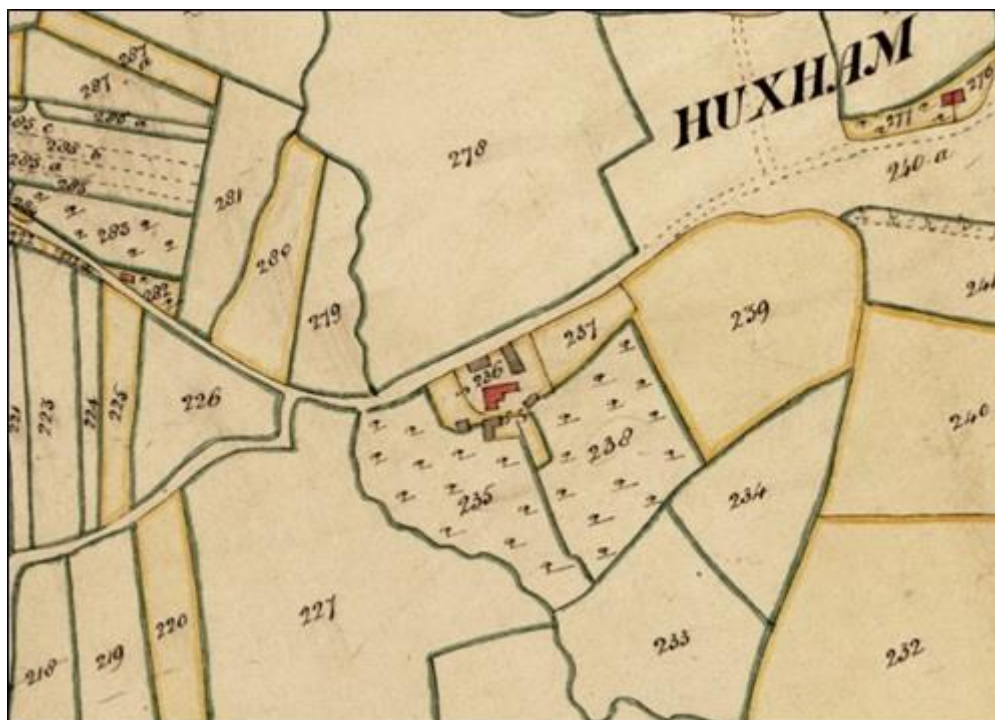
Plate 1: Extract of 1840s East Pennard Tithe Map

- 3.1.2 The 1840s Tithe Map for the area clearly depicts the extended farm house with an 'L' shaped configuration in plan and with three barns to the south, which broadly correspond to Barn C, and parts of Barns E and G. A further two barns are depicted to the north of the farmhouse. Two fields to the south are shown as orchards (Plate 1).

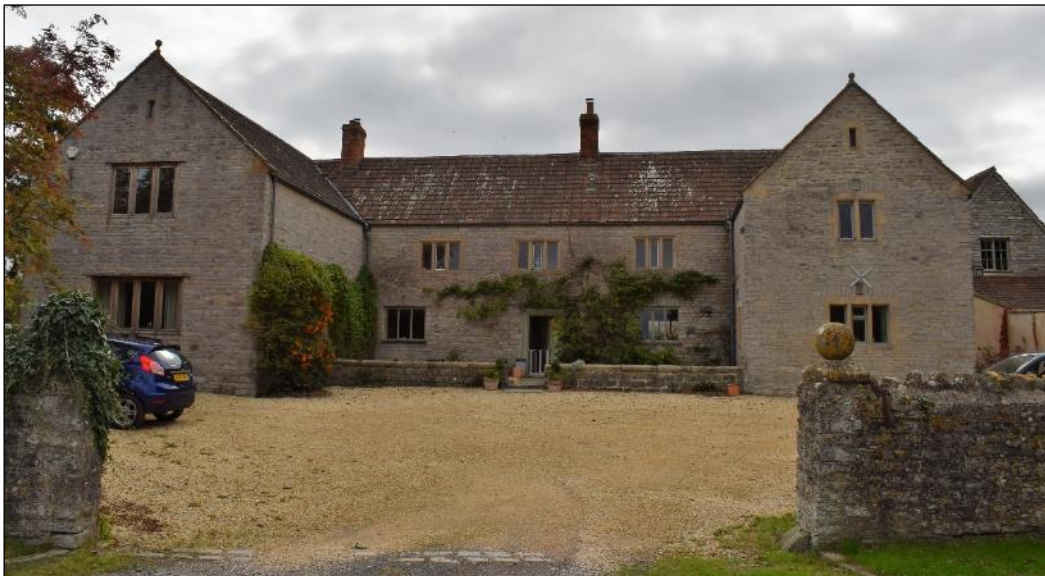
Photo 1: Lower Huxham Farmhouse, north elevation

- 4.2.1 The house is located at the north end of the site, accessed from Huckeymead Lane. It comprises a main east-west aligned original core with later north-south aligned wings at either end (Photo 1).

- 4.2.2 A further series of extensions that lead west from the western wing appear to have incorporated a previously discrete north-south aligned structure, originally situated to the south-west of the house (see Figure 2). This presents a series of differing roof-levels and construction styles and materials, incorporating brick walls and a concrete block garage (visible at the right of Photos 1 & 2).

- 4.2.3 Further additions and alterations to the exterior of the house are visible, such as porches at the east and south elevations, and differing window styles, most of which appear to have been replaced. The addition of further modern windows and doors was noted on the northern, eastern and southern elevations. In the case of the current front door, this appears to have been inserted in the location of a former window. The only window mouldings which might be contemporary with the date of construction were located on the first floor of the original central wing (Photos 1 & 4).

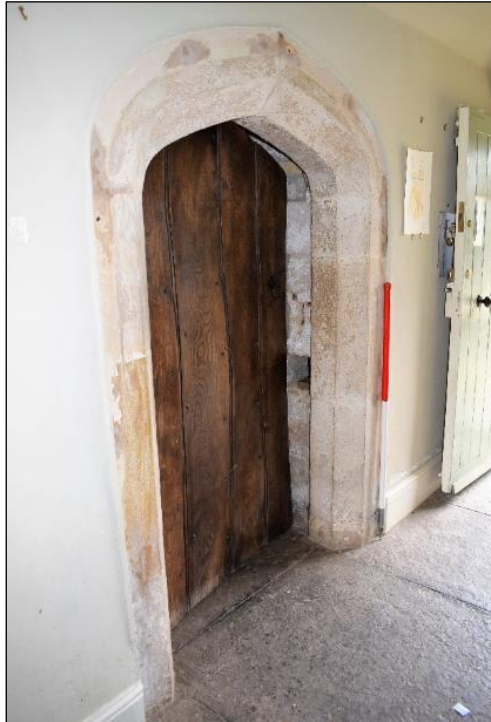
4.2.6 Not all alterations are easily dated, and the layout of the building has clearly been altered numerous times. Many apparent historical features are also of debateable merit, such as the stone doorway from the entrance hall to the kitchen, potentially taken from another site, or the location of a large chamfered beam in the sitting room, which rests in atypical fashion above a window (Photos 5 & 6). Also the historic fireplaces in the kitchen and living room which features a full width timber lintel and evidence of a former curing chamber.

Photo 5: Stone doorframe from entrance hall to kitchen (1m scale)

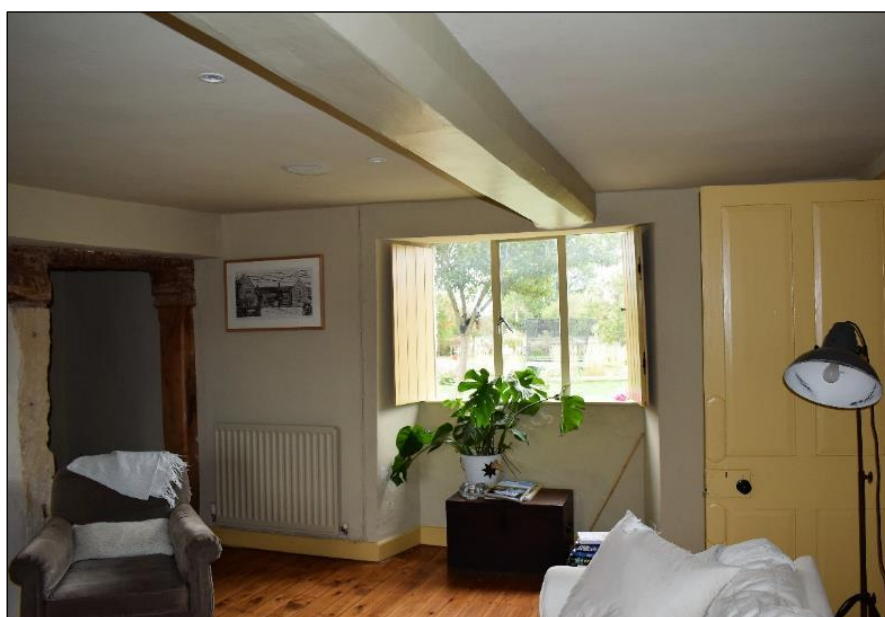
Photo 6: Oddly placed beam in the sitting room

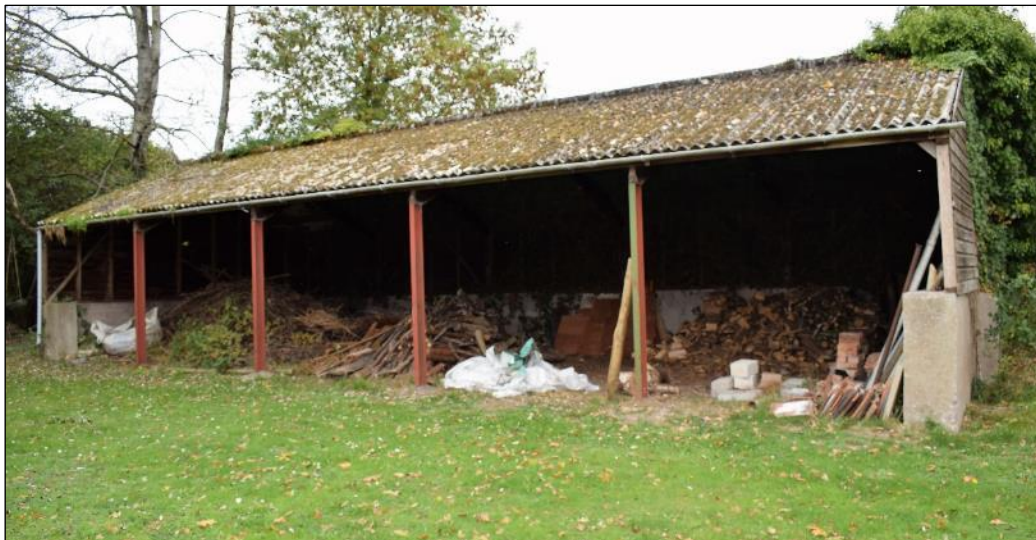
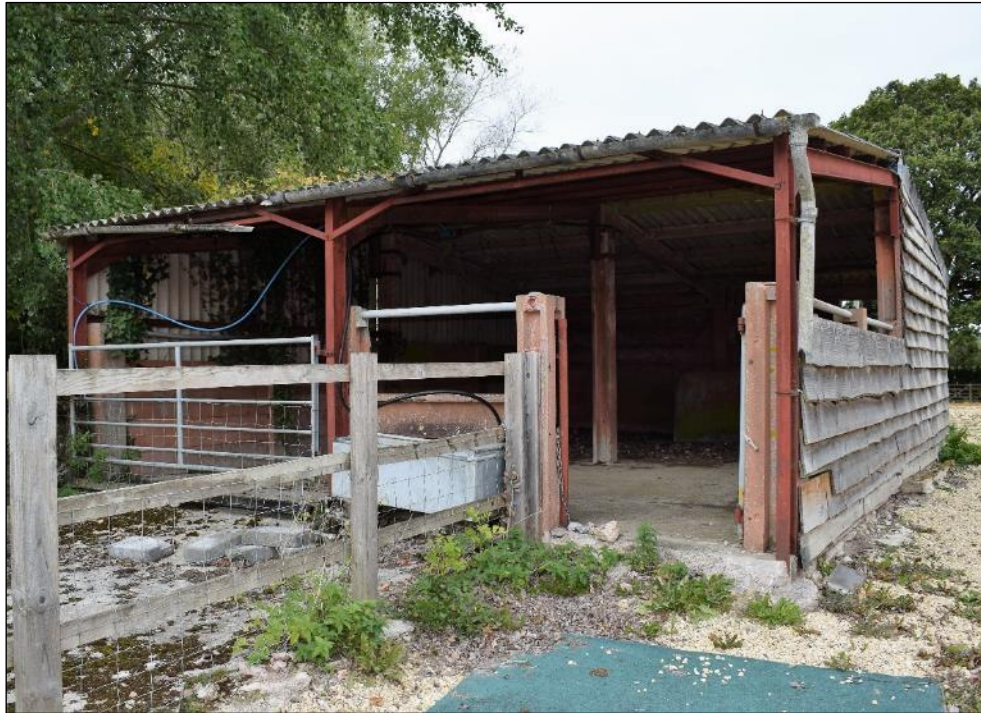
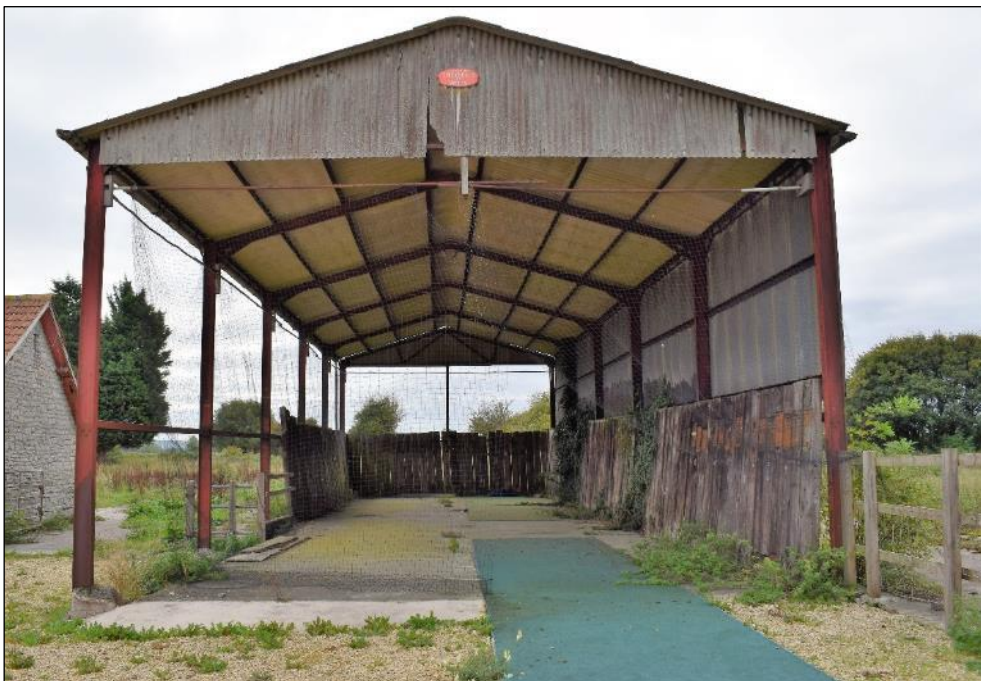
4.3.2 All three buildings are constructed primarily from steel girder frames set on concrete bases. Their sides are constructed either from slatted wooden planks, wooden railway beams, corrugated steel or pre-fabricated reinforced concrete beams, while their roofs are potentially corrugated asbestos sheets (Photos 7 – 9).

4.3.3 They are all in functional condition and are anticipated to be approximately mid-20th in date.

Photo 7: Barn A, view from south-east

Photo 8: Barn D, view from south

Photo 9: Barn F, view from north

7.2.1 Barns B, C, E & G are part of the historic setting of the farmhouse and contribute to its overall significance. However, the modern barns (Barns A, D & F) are not in keeping with the historic character of the farm and their removal is likely to enhance the appreciation of the heritage asset. Barn C is in a very bad state of repair with little probable surviving original fabric. Its removal is not considered to affect the heritage significance of Lower Huxham Farm.

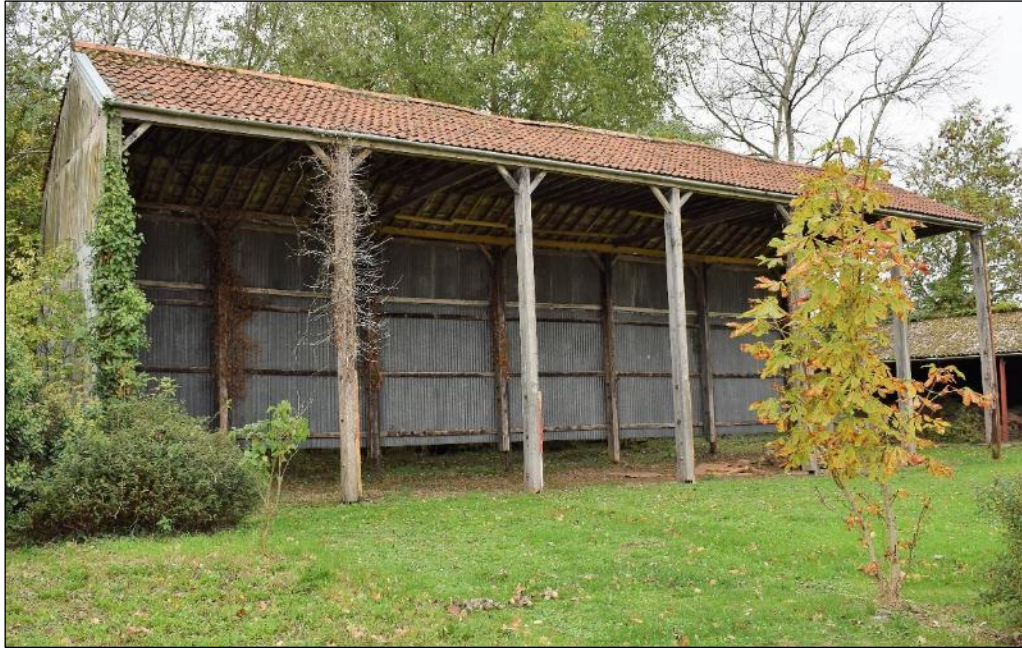
Photo 10: Barn B, view from the east

- 4.4.1 Barn B is located at the western edge of site on a c. north – south alignment, between Barns A and C and is in a poor condition. It appears to be originally of wooden construction, although the upright beams have rotted through at their bases and are now supported by

steel uprights and ad-hoc modern repairs have been made to the roof structure. Steel wire ties hold the building from collapsing east from its western elevation. The roof covering is terracotta ceramic tiles, although it is unclear how much of this is original, as with the corrugated steel sheeting which forms its sides (Photo 10).

- 5.1.4 Barns B and C appear to be in very poor condition with obvious structural issues. Timber framing of Barn B has rotted at ground level and has been repaired by the addition of modern steel uprights. It is also supported by steel wire bracing to the rear. Barn C is in a state of near collapse. The roof tie beams have failed, and the roof structure is pushing the walls apart.

6.2.2 Barn B appears to retain some original timber-framing, though this is in poor repair and supported by modern steel posts, wire bracing and recent timber repairs to the roof structure.

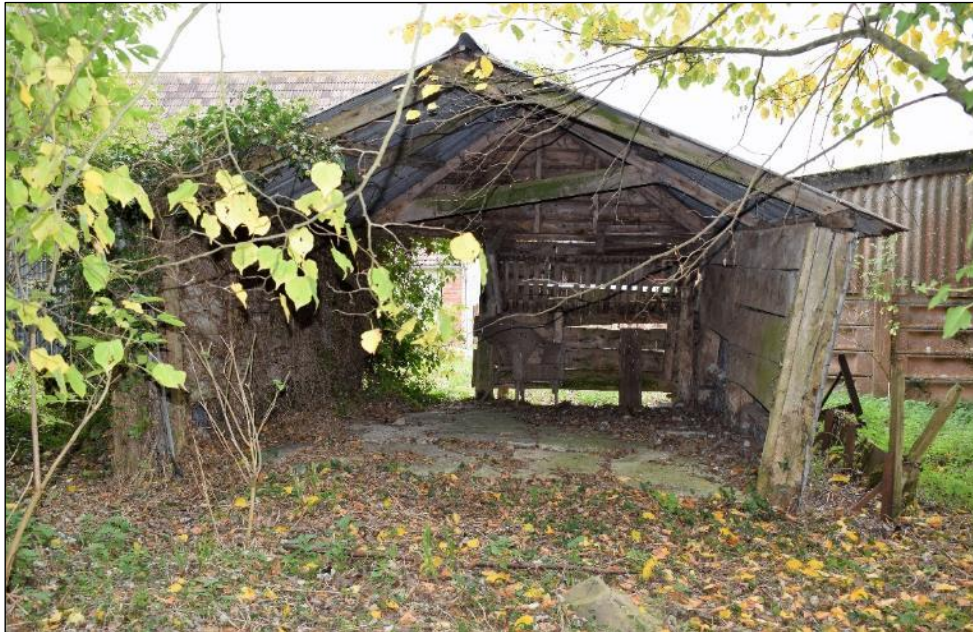
Photo 11: Barn C, view from the west

- 4.5.1 Barn C is located at the western side of the site, between Barns B and D. It is of primarily wooden construction, with some steel probably added along the southern elevation to create a feed trough, with the corrugated sheet iron forming the roof also probably a later addition (Photo 11).
- 4.5.2 This building is atypical compared to the rest of the open barns, as it has a stone floor (seen only in the stone-built buildings). This appears to have some concrete patching / repair. The overall condition of the building is very poor, with the sides clearly pushed outwards by the failing roof structure. It appears on the East Pennard Parish Tithe map (Plate 1) dating it to before c.1840.

6.2.6 Barn C is of some age and certainly predates the 1840s, however it is in an extremely poor state of repair and the only original fabric may be the partial stone flooring.

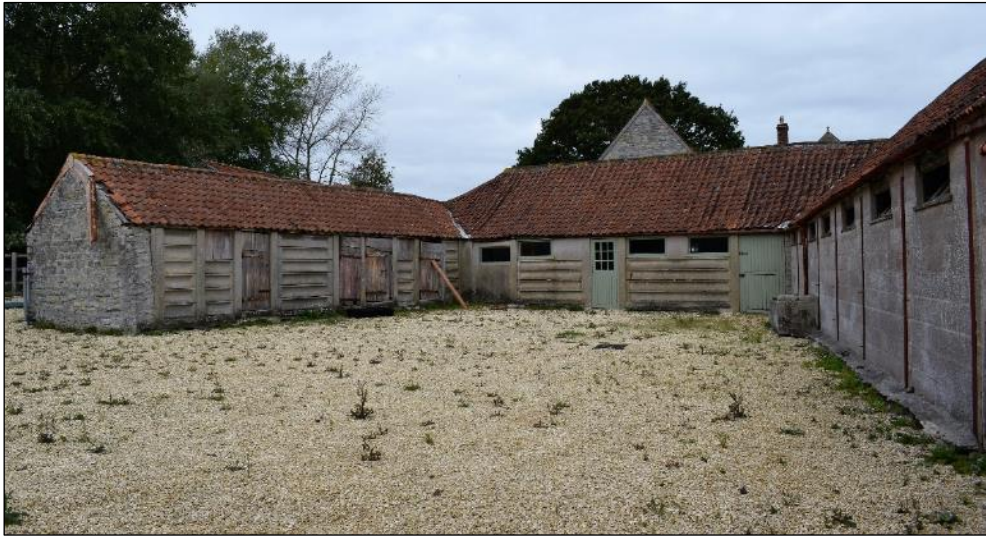
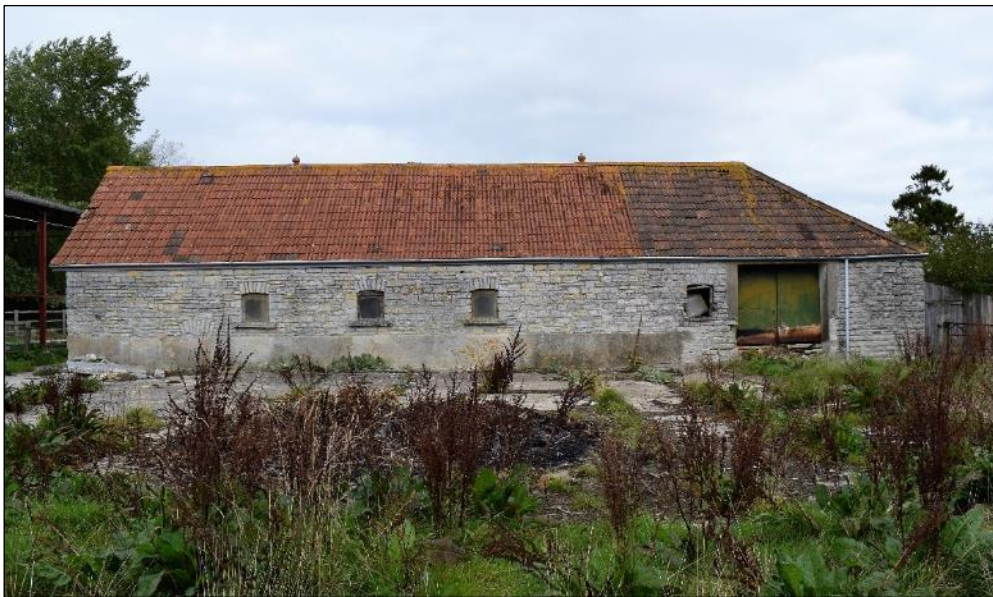
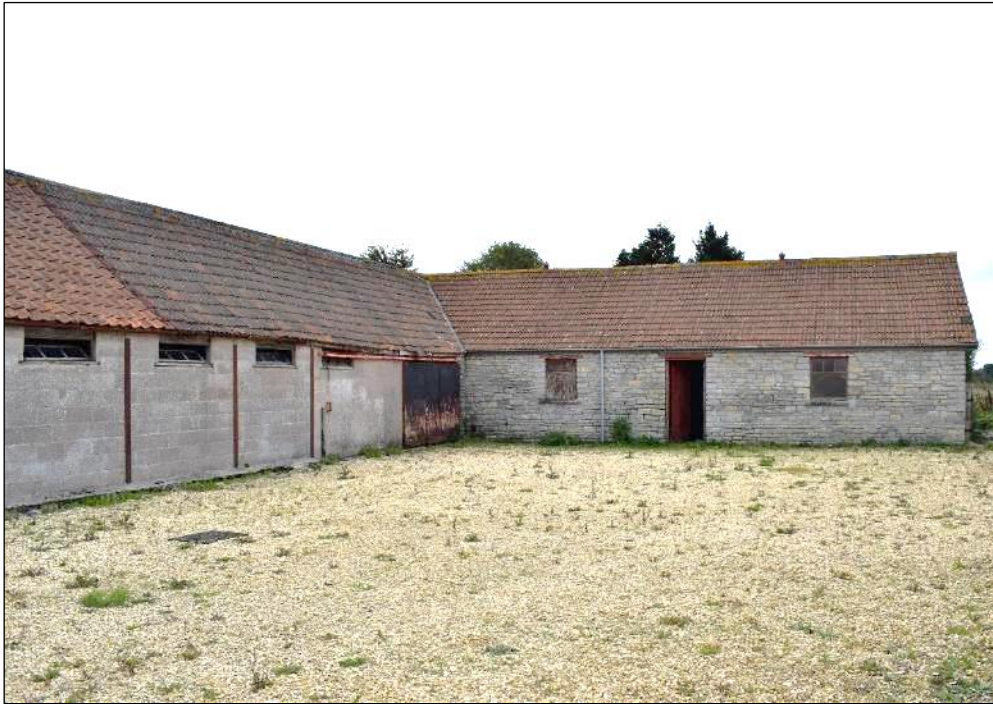
- 4.6.1 Barn E is positioned towards the south of the farm and comprises four interconnected ranges in a roughly 'C'-shaped plan around a central courtyard (Photo 12). Externally it clearly shows different phases of construction or alteration, the development of which is depicted on historic mapping. The west and north ranges appear on the 1840s tithe map with the long east range added in the later 19th century. All three of these ranges are of stone construction and are likely to have been open fronted, with the roof possibly supported by stone pillars, of which there is one potential surviving example.

- 4.6.2 The southern range is an early 20th century addition first shown on the 1921-43 OS map constructed in stone with arched windows in its southern elevation (Photos 13 & 14). The most recent alteration is to the inside wall of each of the north, east and west ranges which are built primarily from concrete blocks and beams and steel pillars of later 20th century date (Photos 12 & 14).

Photo 12: Barn E complex, view from south-west

Photo 13: Barn E complex, view from south

Photo 14: Barn E complex, view from north-west

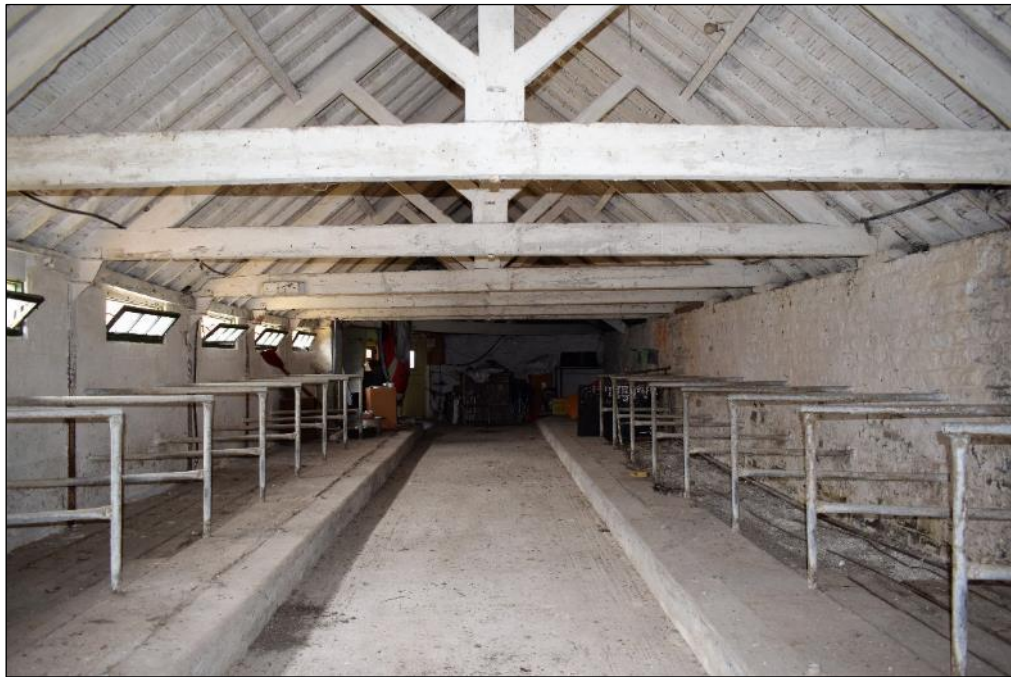
Photo 15: Interior of Barn E, north-south arm, looking north

- 4.6.3 Internally the long north-south aligned eastern range was used as a milking parlour, with metal divisions for stalls and a concrete floor surface. The roof is of wooden lathe construction, with terracotta ceramic tiles, but the impression of the beams and joists was of roof replacement or alteration (Photo 15 – note the wedges under the rafters on the right of the photo).

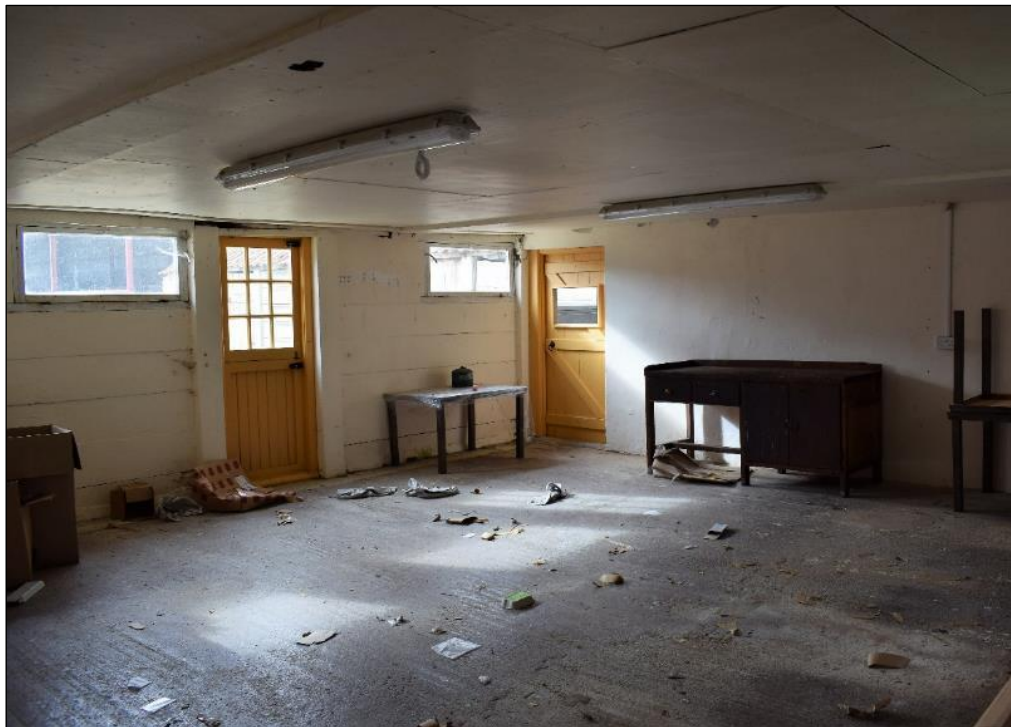
Photo 16: Internal room, northern range of Barn E

- 4.6.4 Modern partitions and some walls and ceilings have been added throughout the north and west ranges to create office rooms and animal stalls respectively (Photo 16).

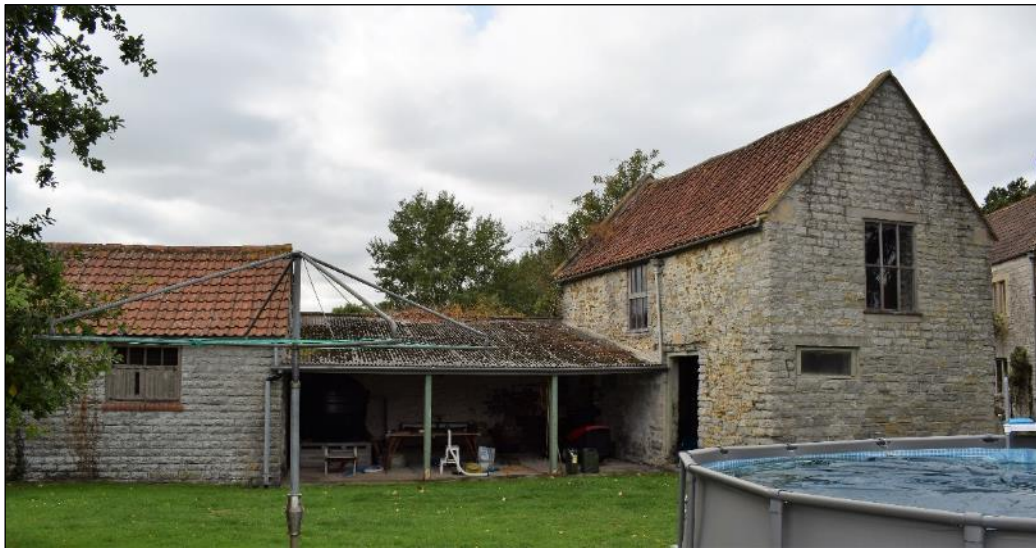
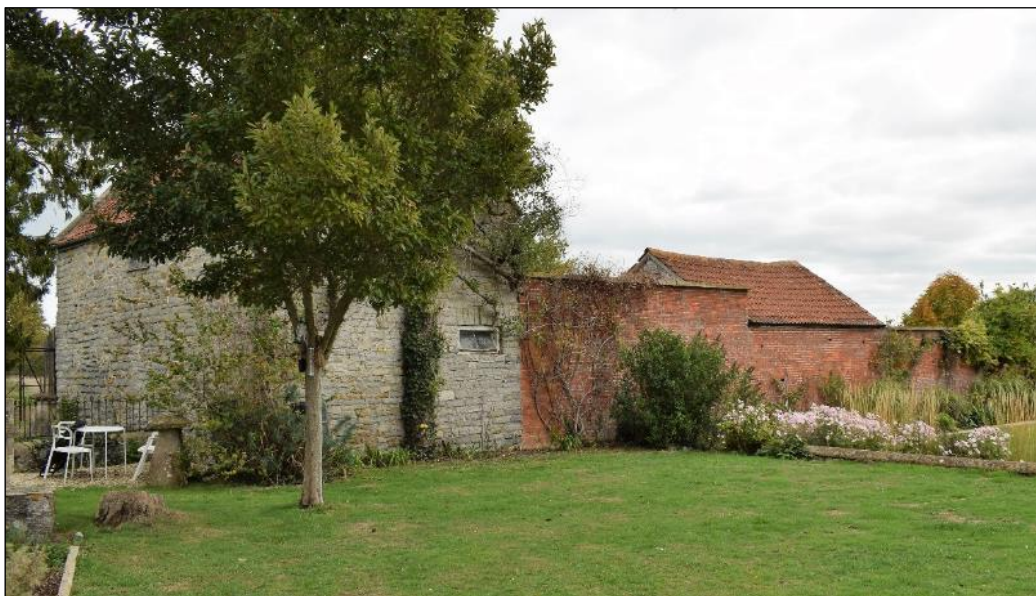
4.7.1 Barn G is located at the eastern edge of site and actually comprises two discrete buildings which have been connected through the addition of a brick garden wall to their west and the provision of a modern roof to create a covered area between the two (Photos 17 & 18).

Photo 17: Barn G, view from the east

Photo 18: Barn G, view from west

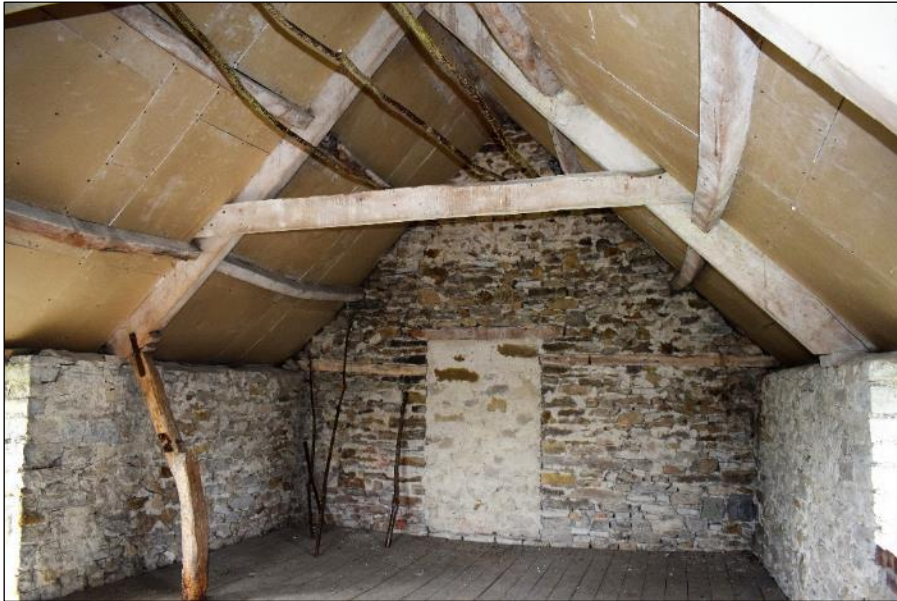
Photo 19: First floor of northern structure, Barn G

4.7.2 The suggestion from the exterior and interior of the northern building of the pair was of an older structure which had undergone extensive repair / alteration, based on:

- Remnants of a limestone rubble wall amongst shale stone replacement (including the whole east elevation);
- Blocked / altered portals;
- The addition of a modern staircase; and
- Probable roof repair / replacement (Photo 19).

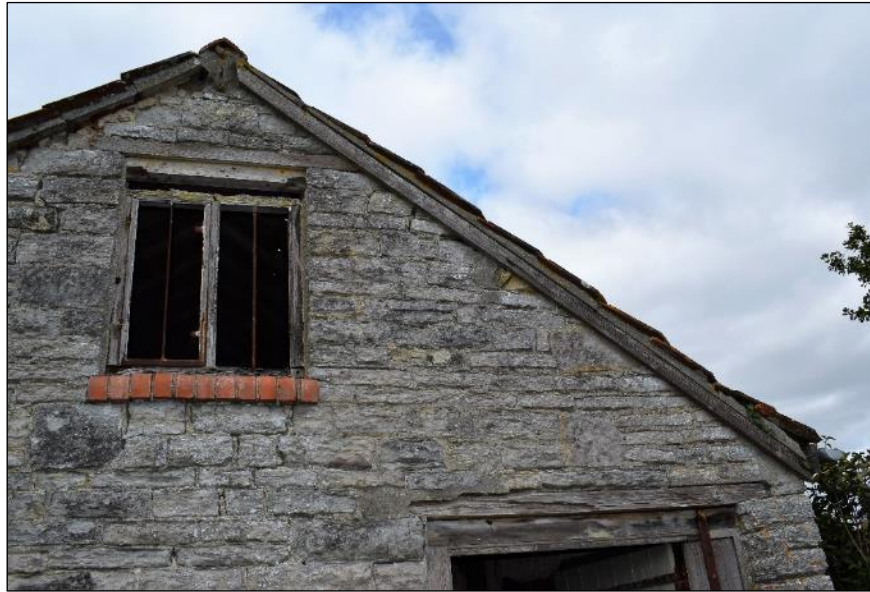
Photo 20: Southern elevation, southern structure of Barn G

- 4.7.3 The southern structure appeared more coherent in its construction, although the use of bricks in the window-sills may suggest the addition / alteration of windows, while the roof appears to have been replaced / repaired.
- 4.7.4 The connecting brick wall between the two structures had some surviving features, including a blocked portal at ground level and an apparent fire-place.
- 4.7.5 Historic mapping suggests that Barn G developed from the northern most structure, present at the latest by the 1840s, extended successively to the south in the later 19th century and in its present form by 1903.
