**57 Beach Road,
South Shields
Heritage Statement**

AB Heritage Project No:60633

57 Beach Road, South Shields Heritage Statement

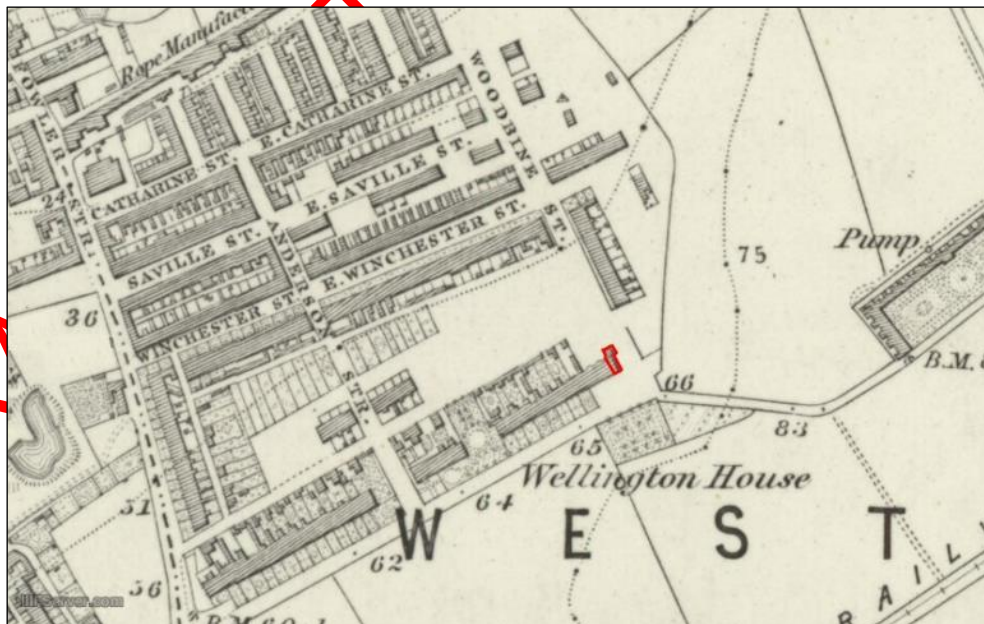
Plate 1: 1862 6" OS map

- 3.1.4 The 1862 6-inch Ordnance Survey (OS) map shows the site outlined in red (Plate 1) with number 57 Beach Road shown in its existing planform as an end terrace house with a rear tenement or extension shown. The ongoing expansion of South Shields can be seen in the unfinished form of Woodbine Street. At this point no road name is indicated to the south of the property and the gardens do not appear to have been formally laid out when the survey was conducted (1855).

- 3.1.5 Mariner's Cottages, located c. 150m to the east of site, can be seen to be part-built at this point, with the southern terrace yet to be added. The site is located beyond the fringe of the industrial activities taking place in South Shields at this time, such as a Rope Manufacturing site located c. 300m to the north-west.

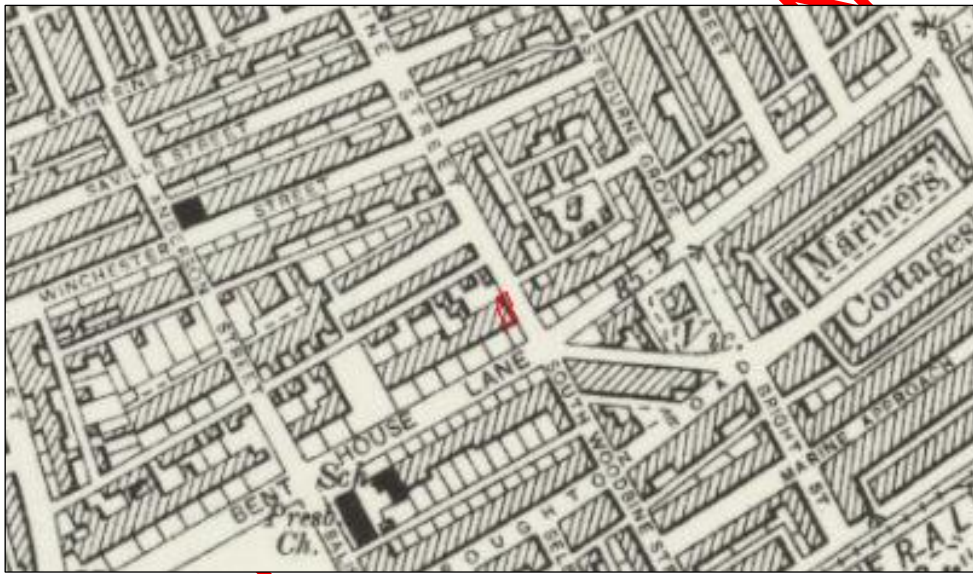
Plate 2: 1898 6" OS map

- 3.1.7 The continued expansion of residential housing in the area surrounding the site is depicted on the 6-inch OS map of 1898 (Plate 2). The street layout is retained from the earlier map (Plate 1) but has been extended with terraced housing increasing in density to the north of the site and spreading south to the railway and east to surround the now completed development of almshouses named as 'Mariners Cottages'.
- 3.1.8 A school and Presbyterian Church are shown approximately 120m to the south-west of the site on the opposite side of Bent House Lane (now Beach Road). A Vicarage is marked c. 80m to the east at the corner of Bright Street and Bent House Lane.

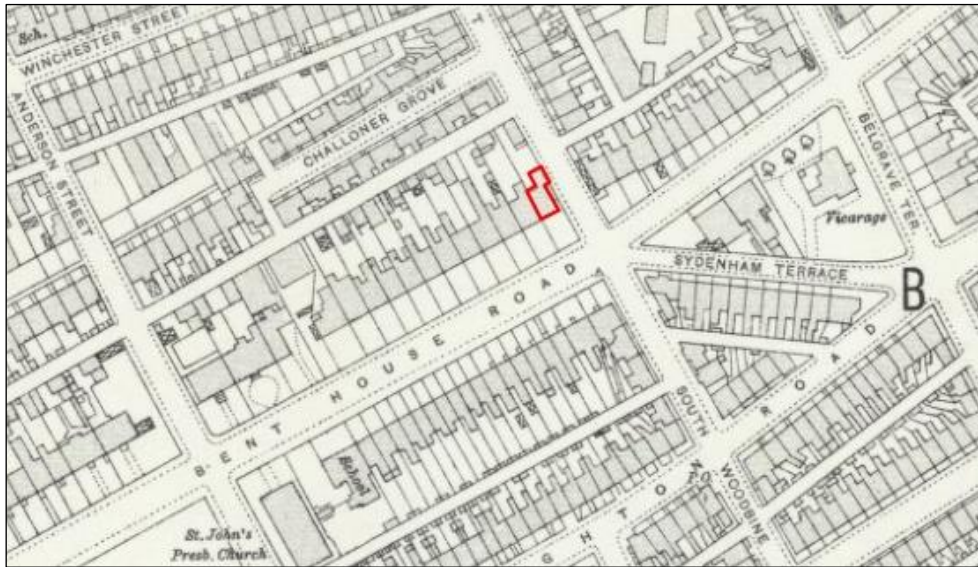
Plate 3: 1915 25" OS map

- 3.1.9 The 25-inch OS Map of 1915 (Plate 3) shows the area in more detail, but little changed. The site itself appears clearly in its current planform. The Vicarage and its grounds are also clearly depicted as are the school and Presbyterian Church, now labelled as St Johns. A plot located c. 90m to the south-west of the site on the north side of Bent House Lane, previously shown as vacant land on the 1898 map, is shown as developed by 1915, containing two separate buildings.

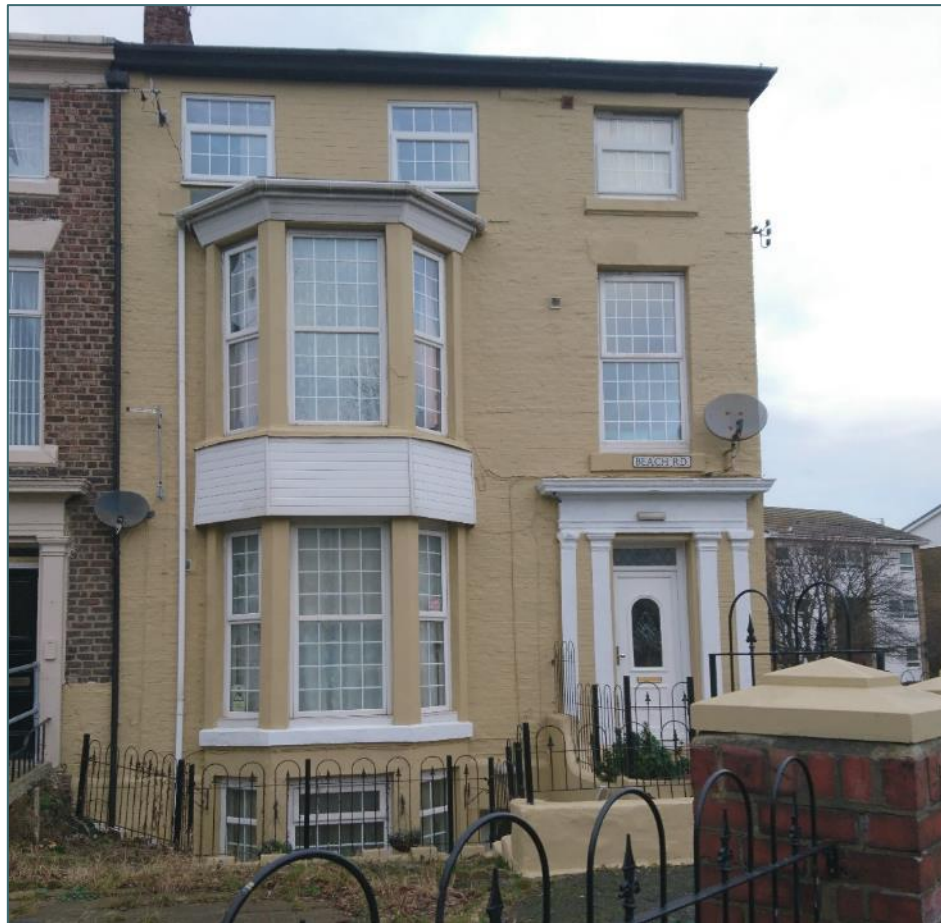
Photo 1 Front (south-east) elevation of 57 Beach Road

3.2.2 The building presents a three-storey elevation facing south-east onto Beach Road (Photo 1). This elevation is notable for the bay windows evident at the ground and first floor as well as the basement level. Above the first floor, the second floor has three casement windows. None of the windows or the front door are original, all having been re-glazed in double glazing and framed within uPVC frames.

3.2.3 The front door retains its original Tuscan doorcase with a flat entablature and flanking double pilasters.

3.2.4 The whole elevation has been painted, thus obscuring the red-brick construction shared with the other houses on the terrace from number 37. This paint has also obscured the stone detailing in the form of the stone lintels and sills as well as the stone eaves cornice.

3.2.5 Overall the building appears in very good condition from the street.

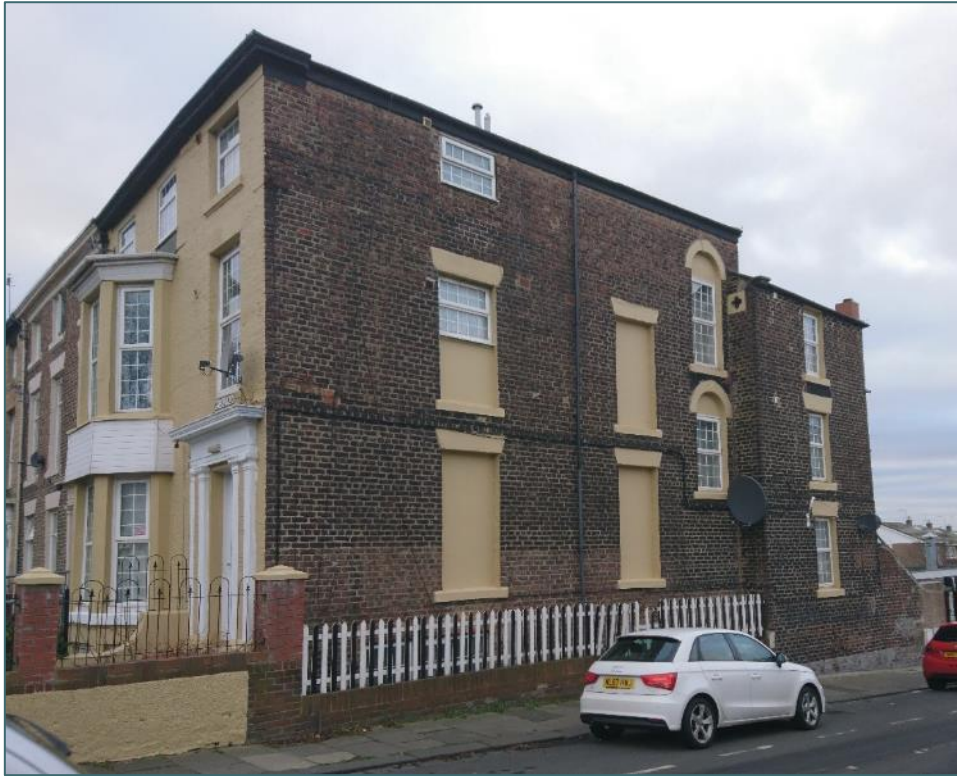
Photo 2. North-east elevation showing added wing towards rear

- 3.2.6 Photo 2 shows the north-east elevation on Woodbine Street. This elevation reveals the red-brick construction and the stone sills and lintels at the windows. The south-east elevation has two large windows at ground level, which have been blocked, and two similar windows at first floor level, one of which is blocked and the other partially blocked. A smaller window is seen at the second floor. Towards the back of the main house are two large round headed windows, these are located at the half floor landing corresponding to the internal staircase.

- 3.2.7 The north-east elevation shows the rear wing addition to the north of the main house (shown to the right of the round headed windows). This is set slightly closer to the kerbside than the main body of the house and is slightly lower at the eaves. A small decorative quatrefoil window is located adjacent to the upper round headed window on the second floor. The wing exhibits three windows in the style of the main house. All of the existing glazing on this elevation has been renewed with double glazing and uPVC.

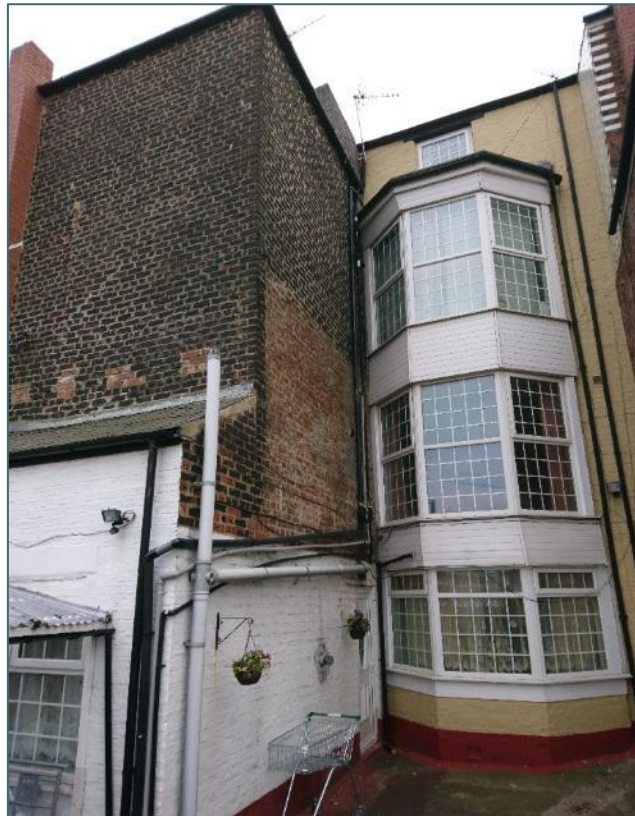
Photo 3. Rear (north-west) elevation

- 3.2.8 Photo 3 shows the rear (north-west) elevation. This elevation presents a very compact, almost cramped façade. The main features are the three bays of the basement, first and second floors with a smaller casement above. The red brick of the main building is again concealed behind a coat of paint and weatherboards on the bays has obscured any stone detailing beneath.
- 3.2.9 The overriding appearance of the rear elevation is the added wing protruding past the bay windows and appearing as an oversized red brick monolith. The wing at the rear has no windows excepting a single window at basement level, and a single uPVC door squeezed uncomfortably next to the basement bay.

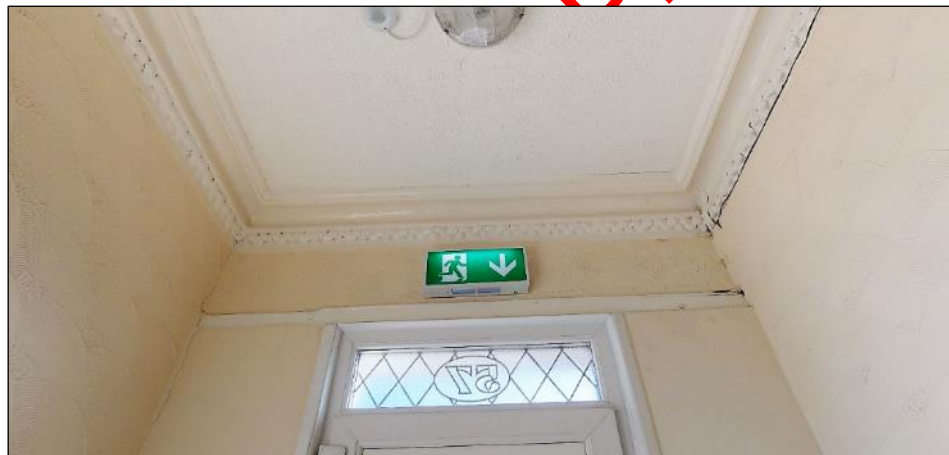
Photo 4: Decorative details above front door

- Original skirting;
- Decorative cornice work with a beaded design around ceiling (Photo 4); and
- Linear feature above front door (Photo 4).

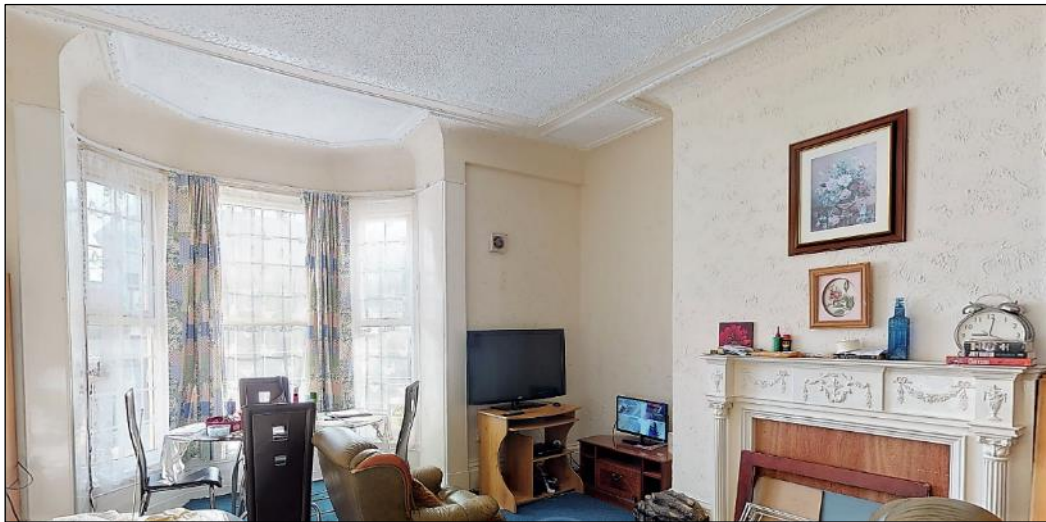
Photo 5: View of historic details in Room 1

- Decorative cornice work around the ceiling including the bay window (Photo 5);
- Architrave panels at bay window (Photo 5);
- Decorated fireplace in original chimney breast (Photo 5);
- Large central ceiling rose (Photo 6); and
- Skirting.

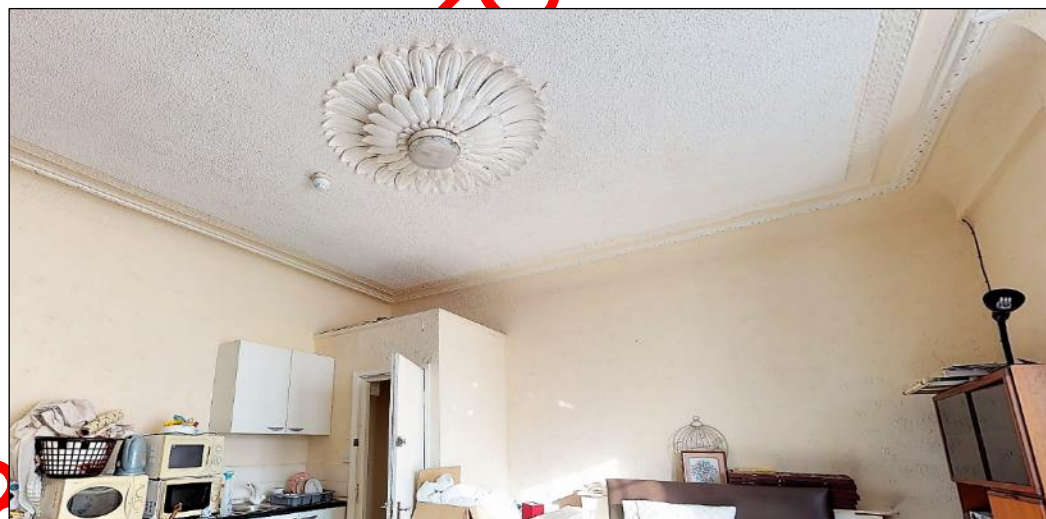
Photo 6: View of decorative features and modern entrance, Room 1

- A pod-built lobby has been added to the bedroom entrance. This comprises two partition walls and a new fire door. The partition walls stop short of reaching ceiling height and as such do not interfere with the decorated cornice work (Photo 6); and
- Kitchen units including sink and draining boards fitted along rear wall of the room (Photo 6).

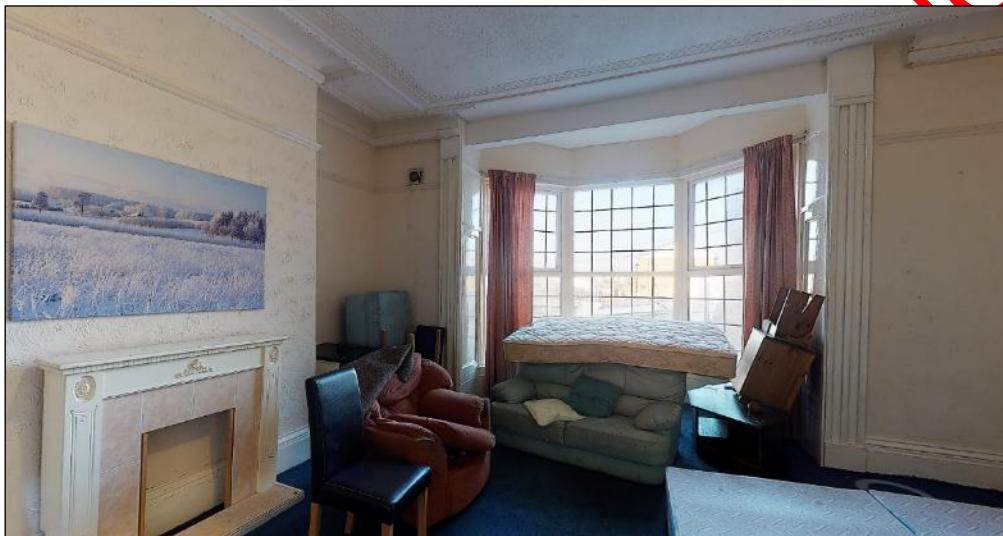
Photo 7: Historic details in Room 2

- Decorative cornice work around the ceiling including the bay window (Photo 7);
- Architrave panels at bay window (Photo 7);
- Dado and picture rails (Photo 7);

- Decorated fireplace in original chimney breast (Photo 7); and
- Skirting.

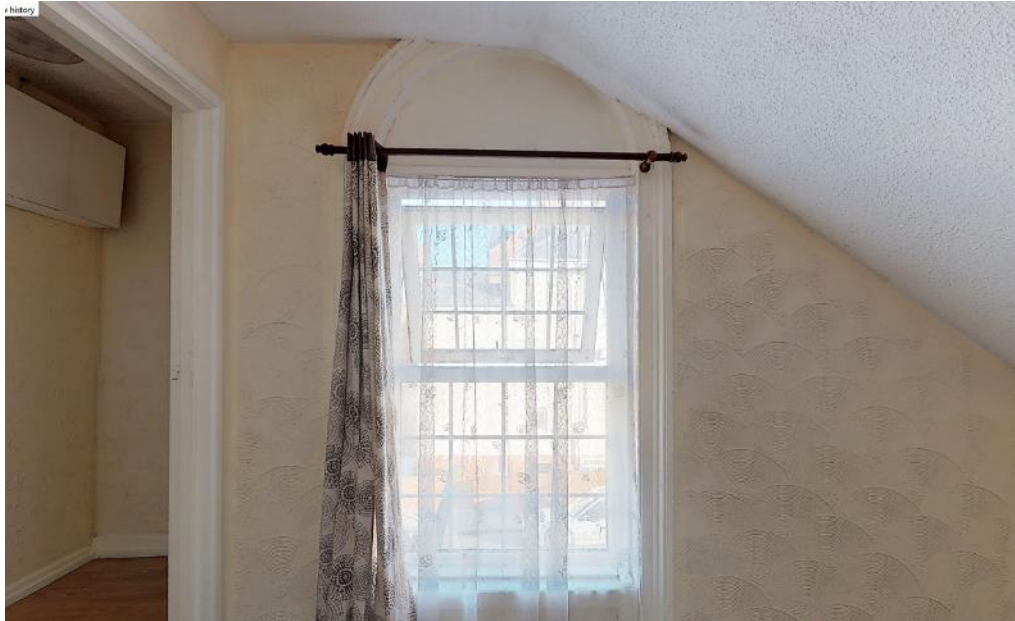
Photo 8: Window at top of first landing

- The partial obscuring of the top of the landing window suggests the staircase has been altered (Photo 9).

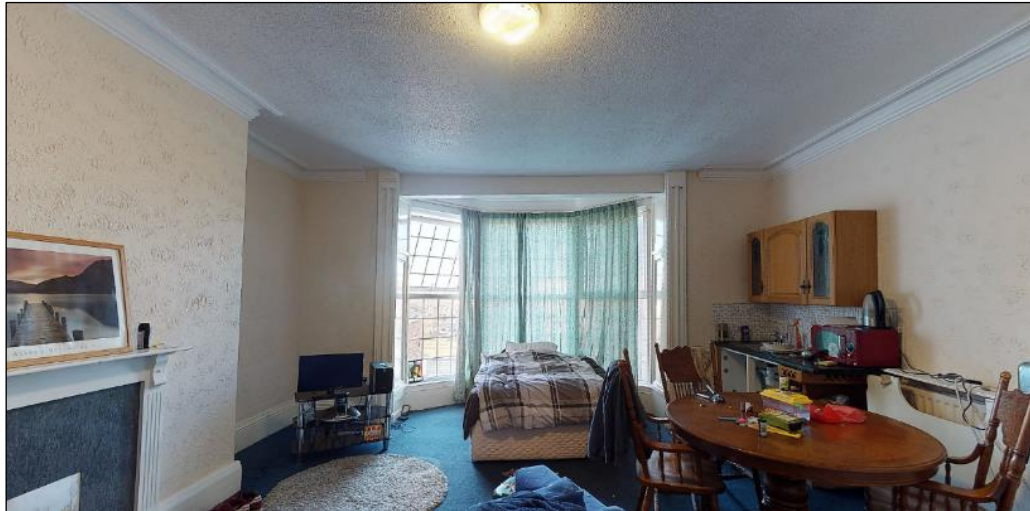
Photo 9: Historic details in Room 5

- An entrance lobby added to the bedroom entrance, also serving Room 6, comprising two ceiling height partition walls and a new fire door. The partition walls interrupt the corncicing; and
- Kitchen units, including sink and draining boards, fitted along one wall of the room.

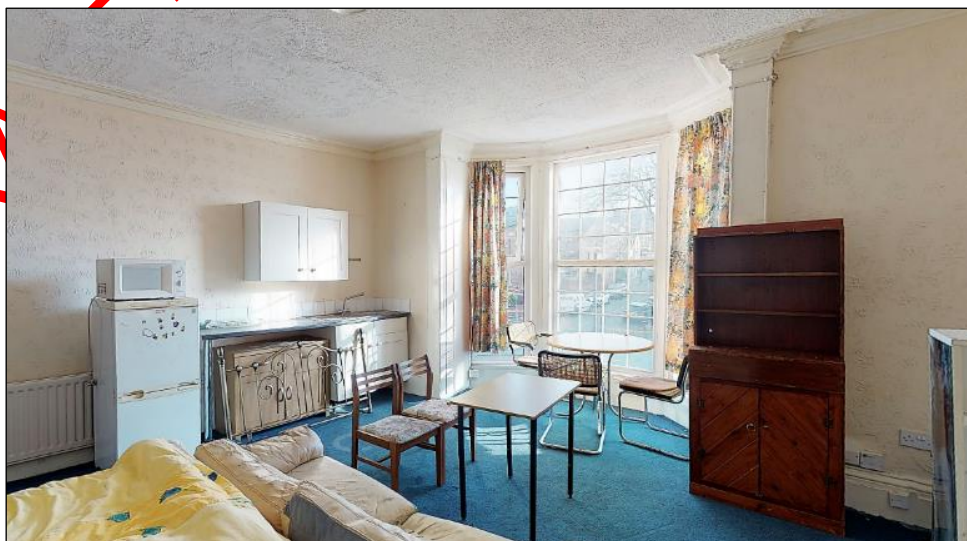
Photo 10: Historic details, Room 6

- Kitchen units, including sink and draining boards, fitted along one wall of the room; and
- The original fireplace has been replaced, possibly early 20th century.

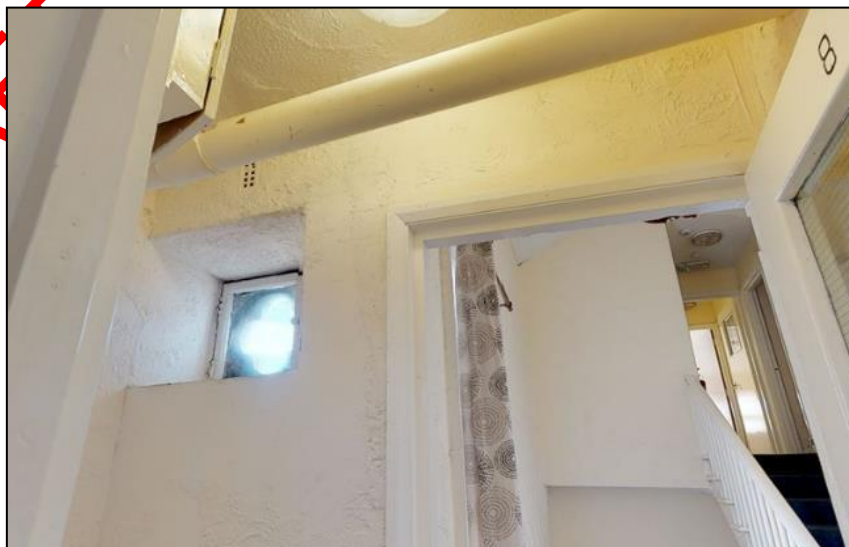
Photo 11: Quatrefoil window, entrance porch to Room 8

- Entrance porch to Room 8;

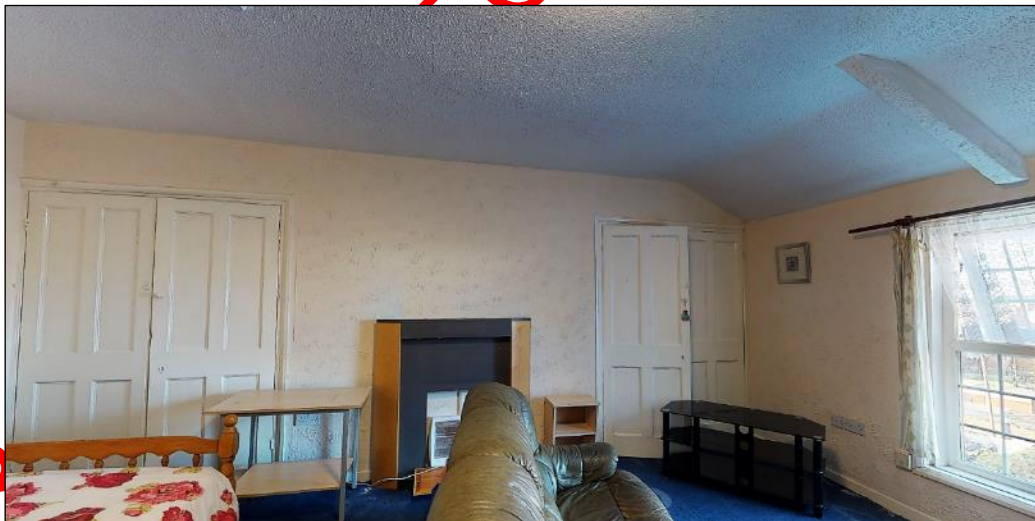
Photo 12: Room 9, wardrobes and exposed beam

- A shared ceiling-height entrance porch shared by both rooms is inserted into Room 9.
- The likely original entrance into Room 10 has been blocked and is now a cupboard.
- Both chimney-breasts have potentially been altered (Photo 12).

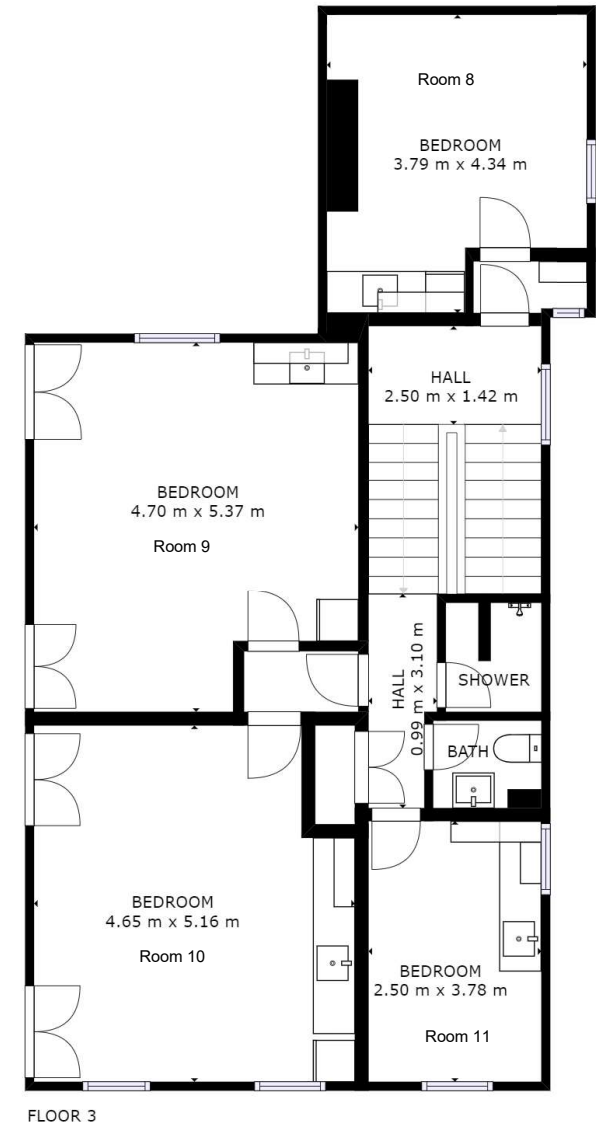
GROSS INTERNAL AREA
 FLOOR 1: 107 m², FLOOR 2: 107 m²
 FLOOR 3: 97 m²
 TOTAL: 310 m²

- 3.2.10 The house at 57 Beach Road is composed of three floors and a separately accessed basement (see Figures 2 & 3). As noted above, the building was converted from the original Victorian Villa to a House of Multiple Occupancy under planning permission granted in 1983 (ST0009/83/LB). This conversion work was carried out with respect for internal historical features and detailing for the most part.
