# **Bank House, 142 Barnston Road Barnston, Heswall**

Level 2 Historic Building Record

Project Code: A0012

Report no. 0010

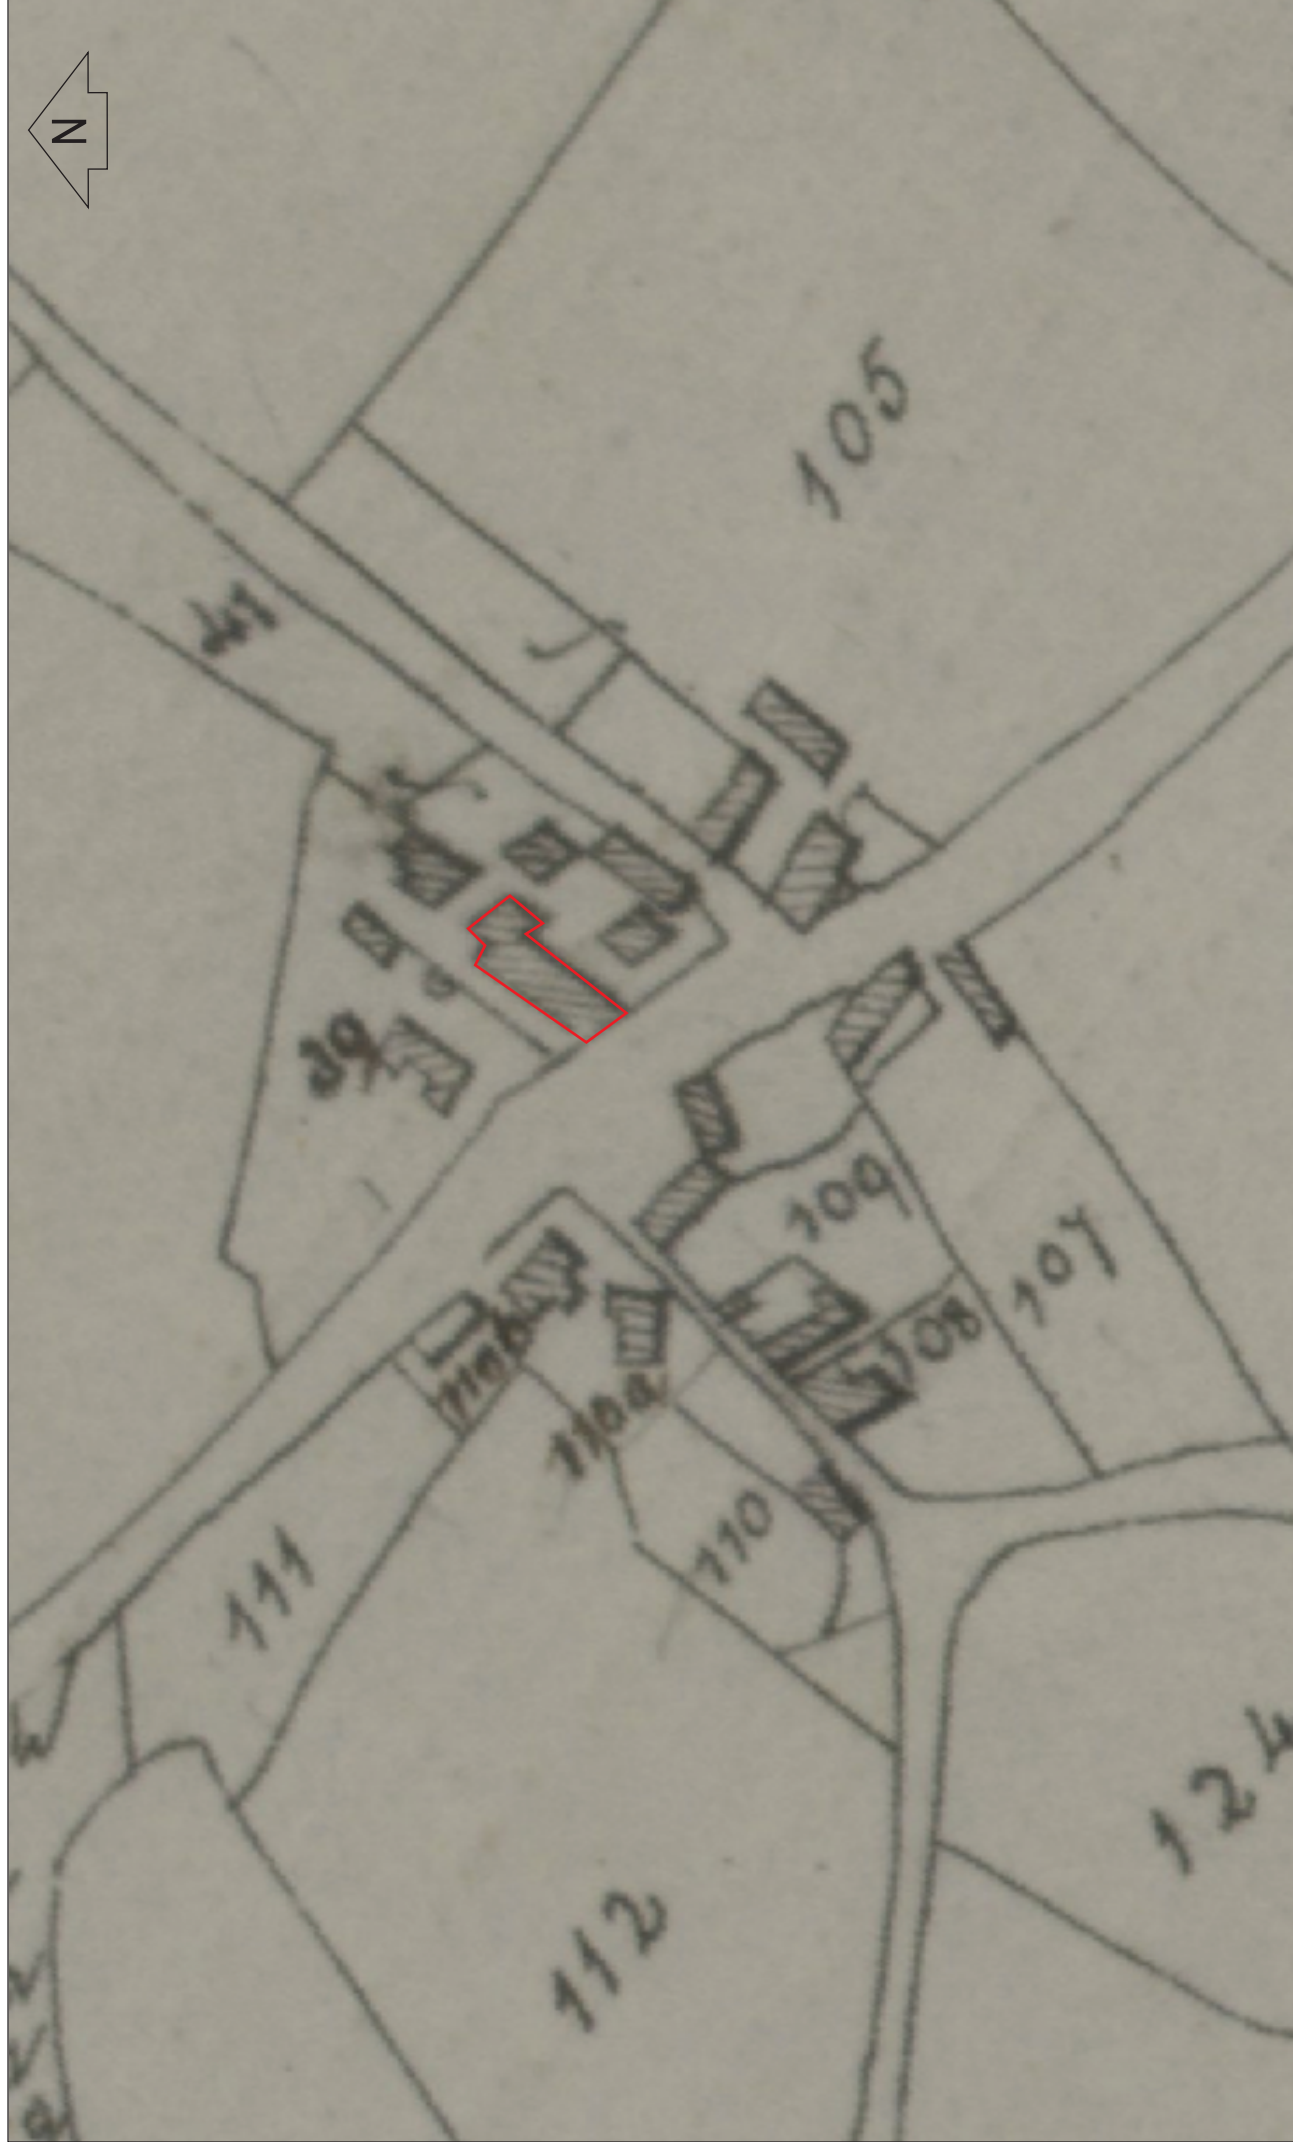
Figure 2: Barnston Parish tithe map of 1849 (site located in red).

The Barnston Parish tithe map of 1849 (figure 2) depicts Bank House much like it exists today, being rectangular in shape and orientated northeast to southwest, with several ancillary buildings associated with the farm surrounding it. The building appears to have an attached structure to the northwest which is offset slightly to the southeast, and is most likely an outbuilding upon which the later extension was constructed.

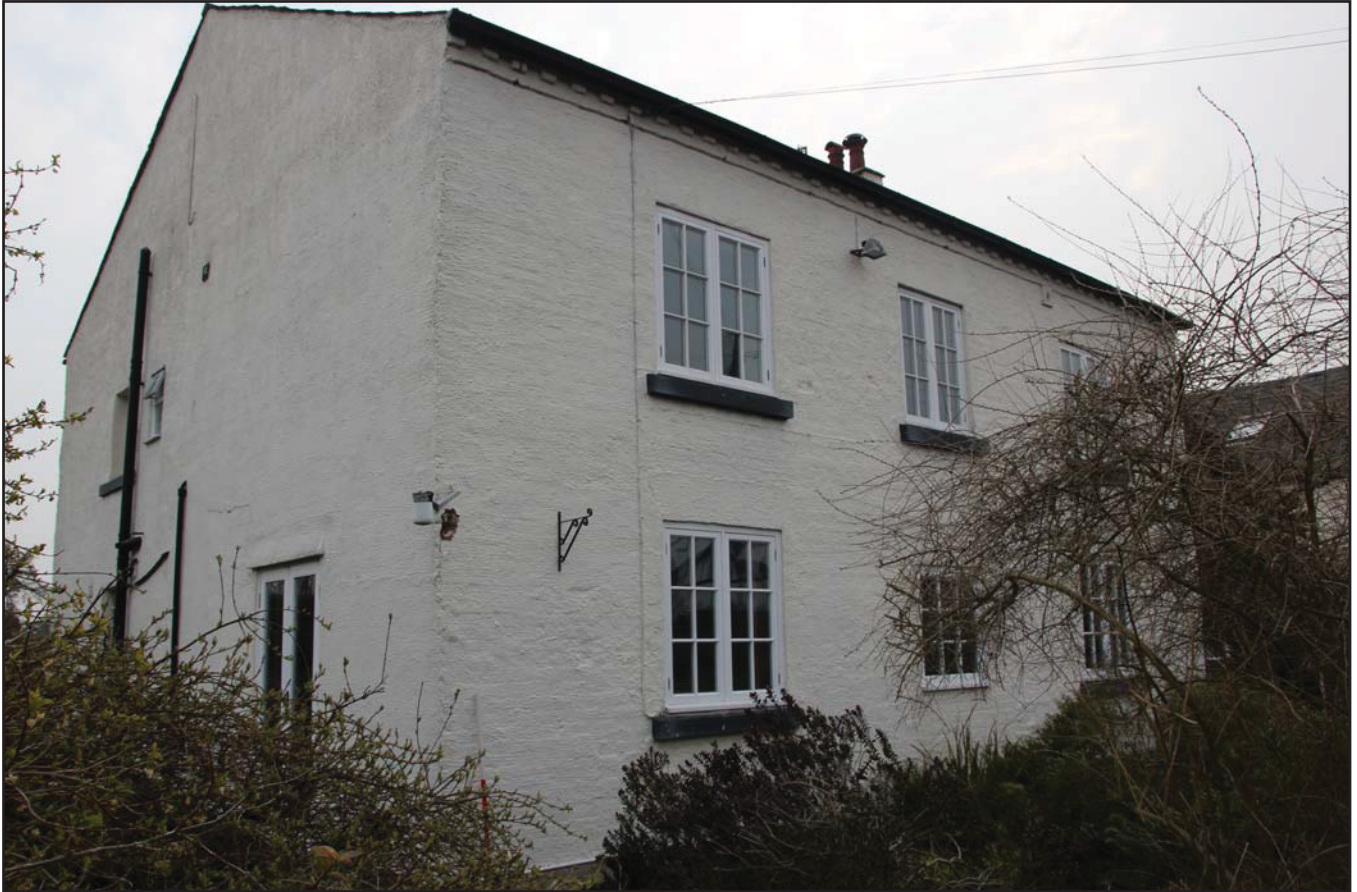
**Plate 01:** Main house showing southwest principal elevation, from the west. Scale 1.0m.

The southwest elevation (plate 1) has a modern black pvc gutter running along the length of the wall and lying above a stone corbel table. The elevation originally had five windows, three to the first floor and two the ground floor. These have been replaced with wooden framed casement windows over stone sills. The doorway and principal entrance into the property was originally located in the centre of the southwest elevation, but has since been blocked and turned into a window, also wooden framed. The walls sit upon skirted foundations of brick and mortar which most likely functioned as a bridge gap to prevent damp within a cellar level.

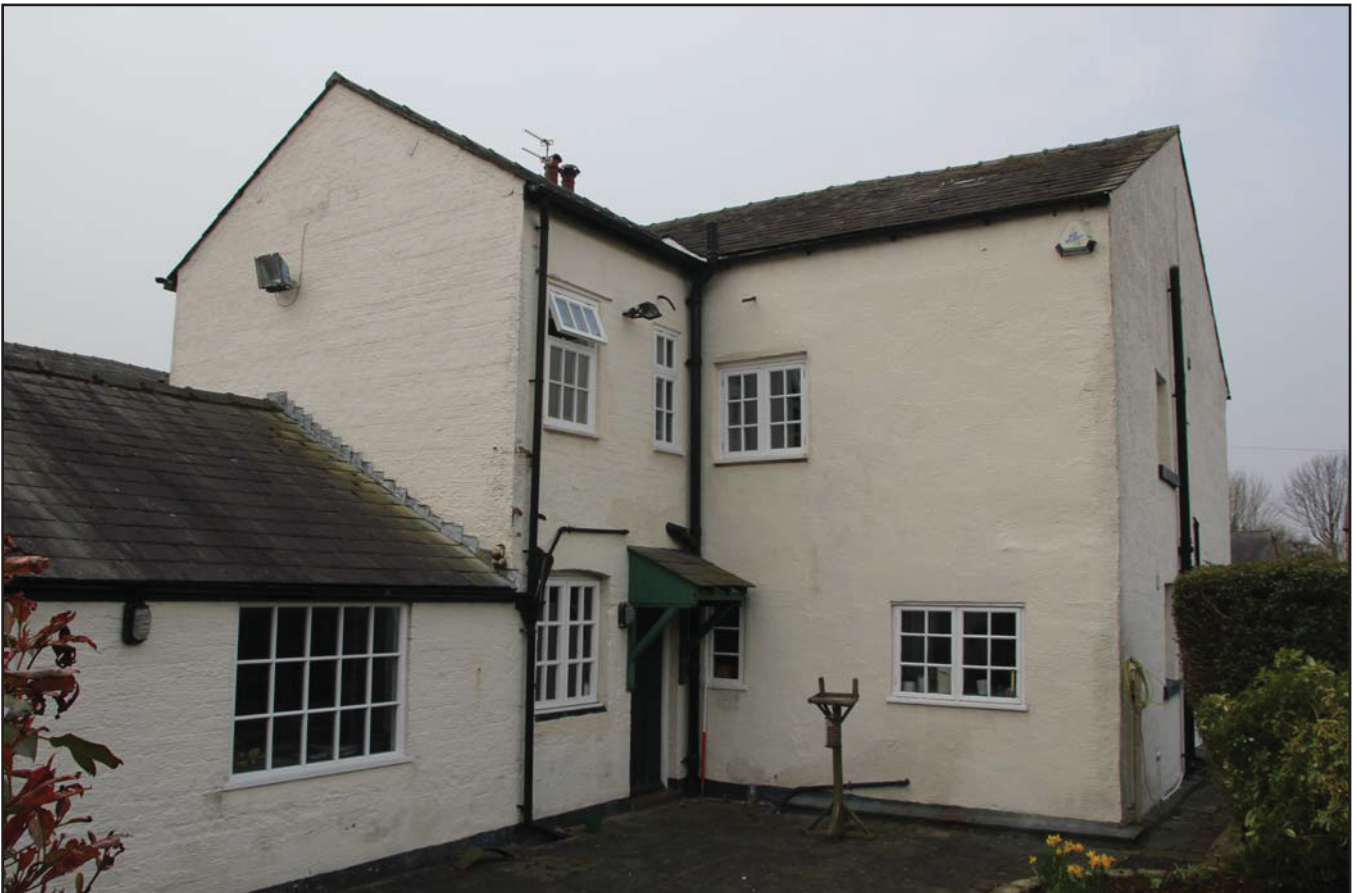
**Plate 02:** Main house northeast elevation showing later extensions, from the north. Scale 1.0m

The north-eastern elevation (plate 2) is half obscured by a later two storey extension (see below). The northwest half of the elevation is however visible and has one first floor 12 pane wooden framed window, as well as a single 3 pane window and double casement, both of which have wooden frames. The skirted cellar footings are visible at ground level continuing 3.5m from the northern corner before presumably heading southwest under the house. The skirted footings are of a different, and seemingly later, construction than those seen towards the southwest of the house, and it is possible that these footings represent an early extension north-eastwards.

The north-western elevation (plate 2) has one 9 pane and one 6 pane wooden framed windows to the first floor, and a double 12 pane window with wooden frame on the ground floor level. A door of wood panel and painted black-brown is located to the southwest of the window. Above this is a green painted wooden porch with slate roof.

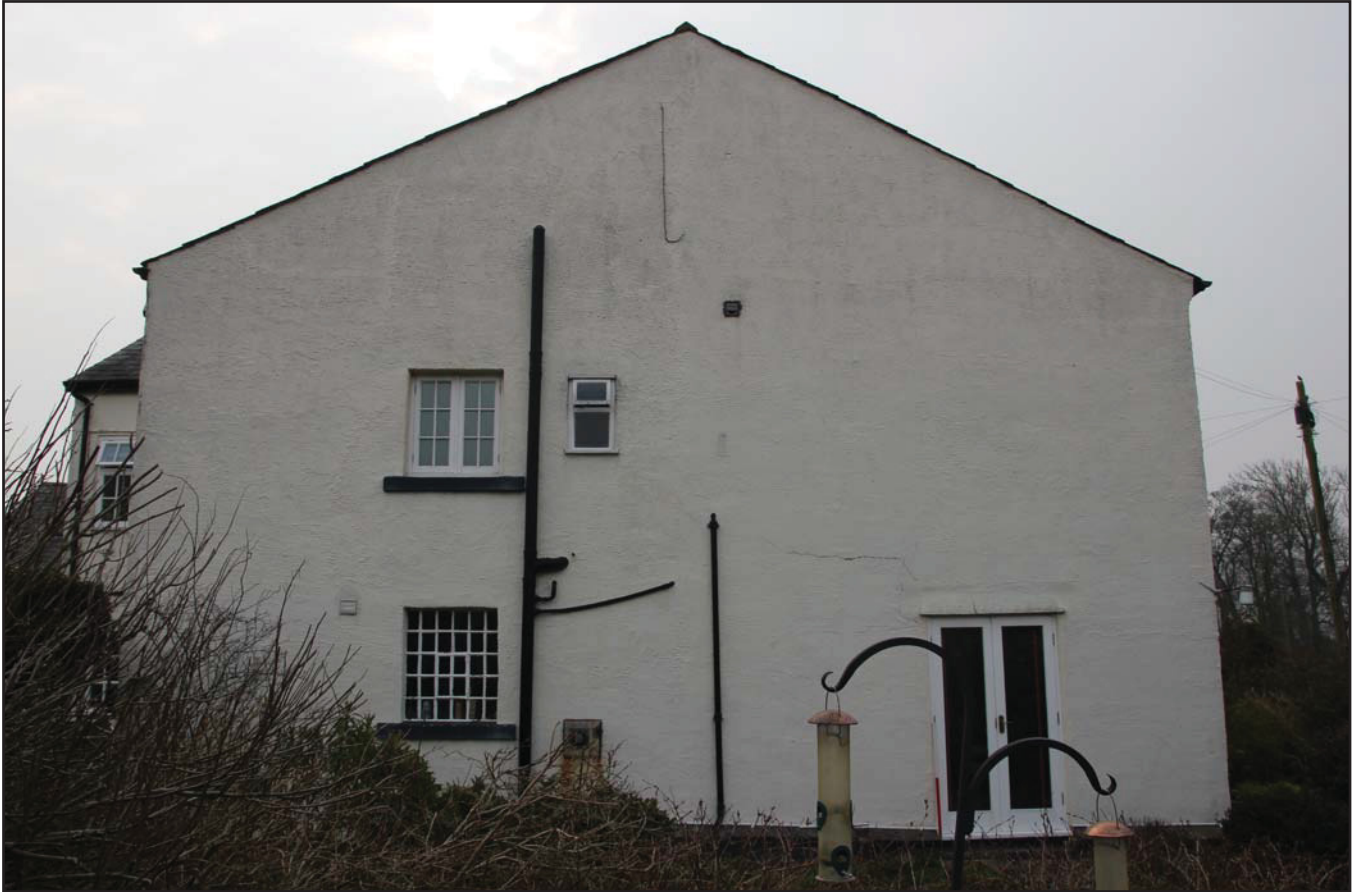
**Plate 03:** Main house northwest elevation, from the northwest. Scale 1.0m.

The northwest elevation (plate 3) has one double wooden framed casement window with a stone sill, as well as a single 2 pane wooden framed window at first floor level. The ground floor has a 30 pane cast-iron framed Coalbrookdale window with black painted stone sill. The window is believed to date to the late 18<sup>th</sup> to early 19<sup>th</sup> century (pers comm. Alison Cearn).

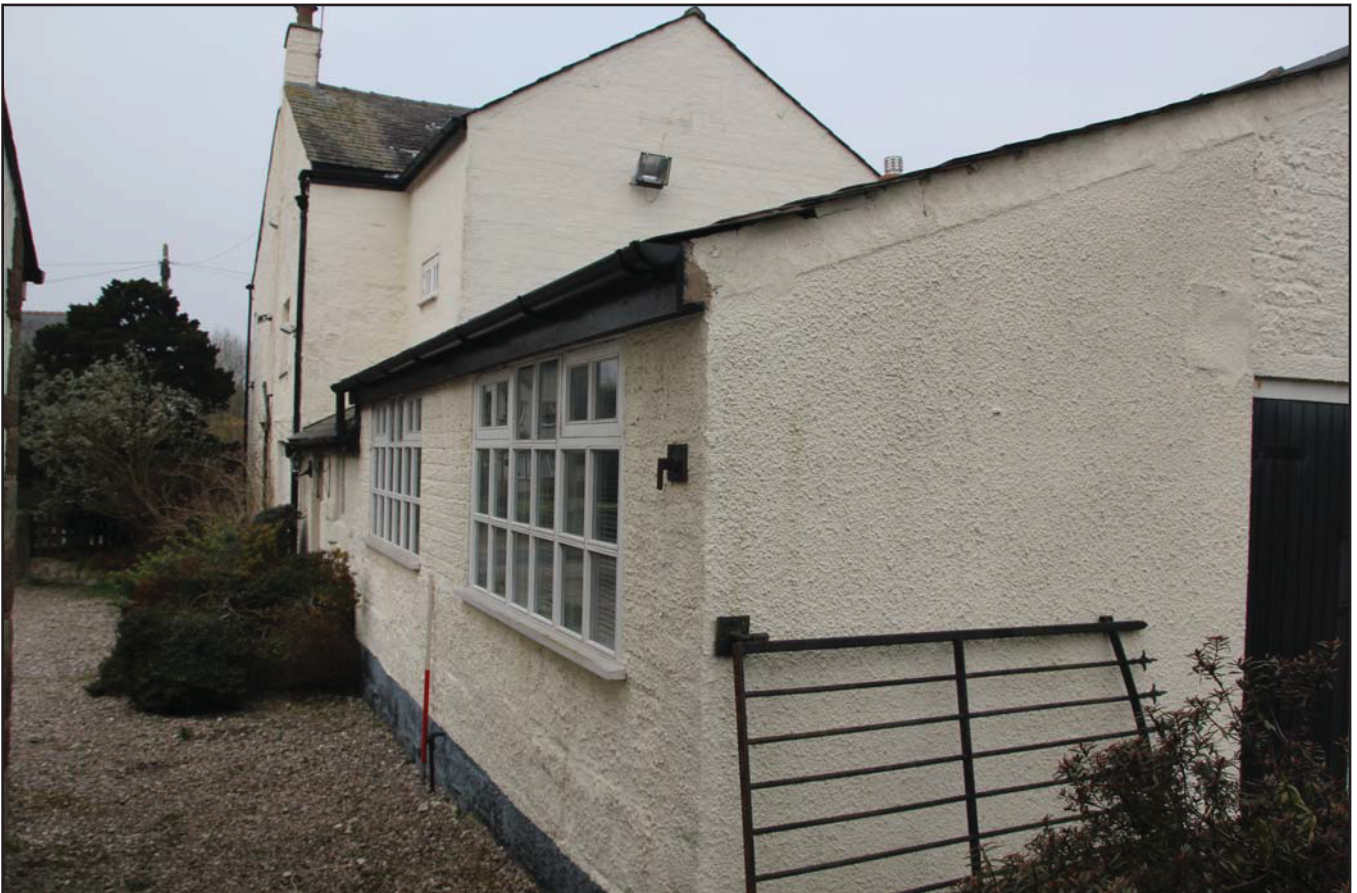
**Plate 04:** Outbuildings extension southeast elevation, from the east. Scale 1.0m

The south-eastern elevation (plate 4) has one 4 pane wooden framed window and two 18 pane wooden framed windows. The wall has lower courses of sandstone to approximately 1.0m in height, above which the walls are brick built.

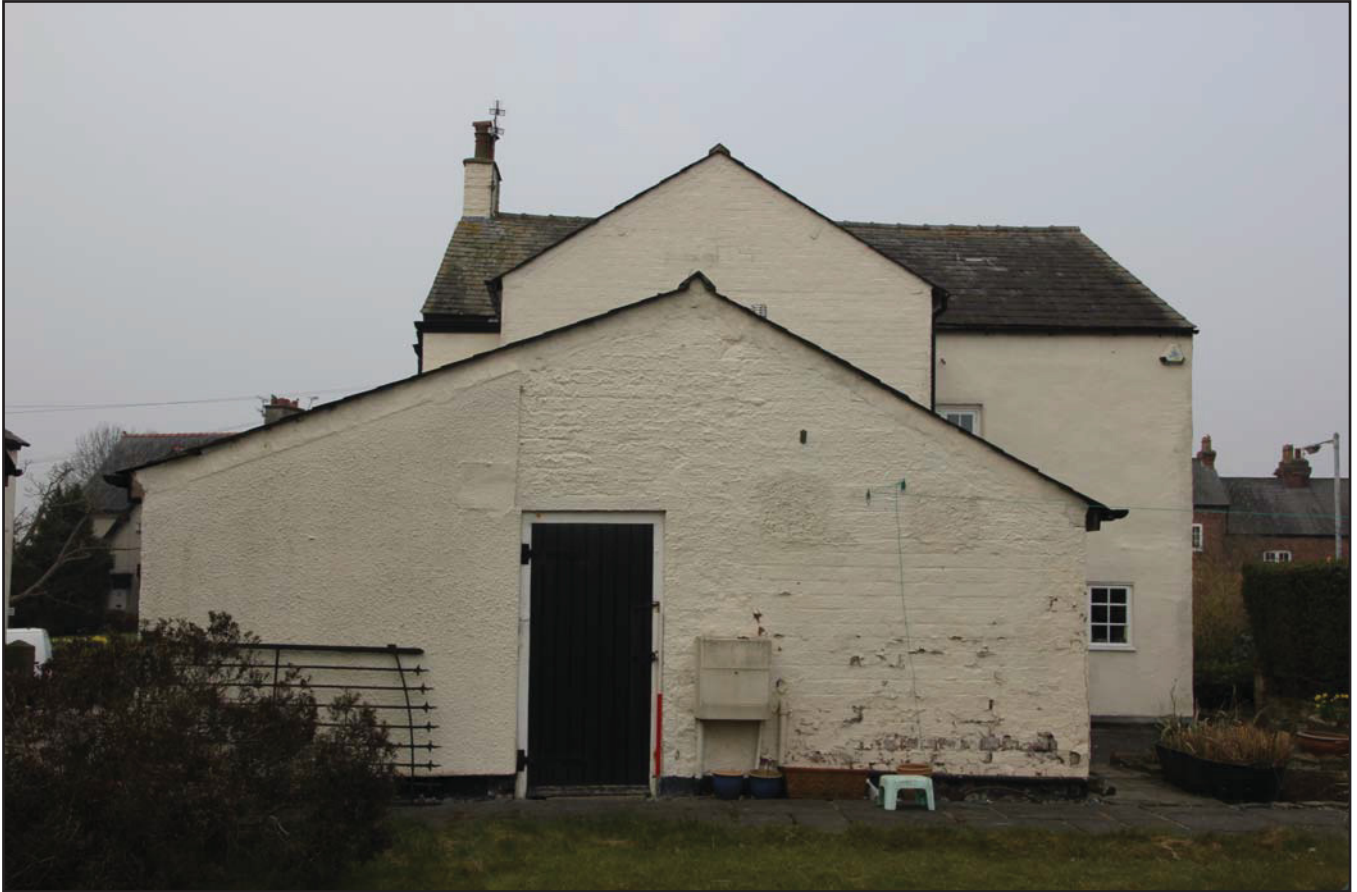
**Plate 05:** Outbuildings extension northeast elevation, from the northeast. Scale 1.0m.

The northeast gable (plates 5 and 6) of the extension is entirely brick built and painted white. A single door is located to the east of the centreline and is of black painted wooden board construction with iron fastenings.

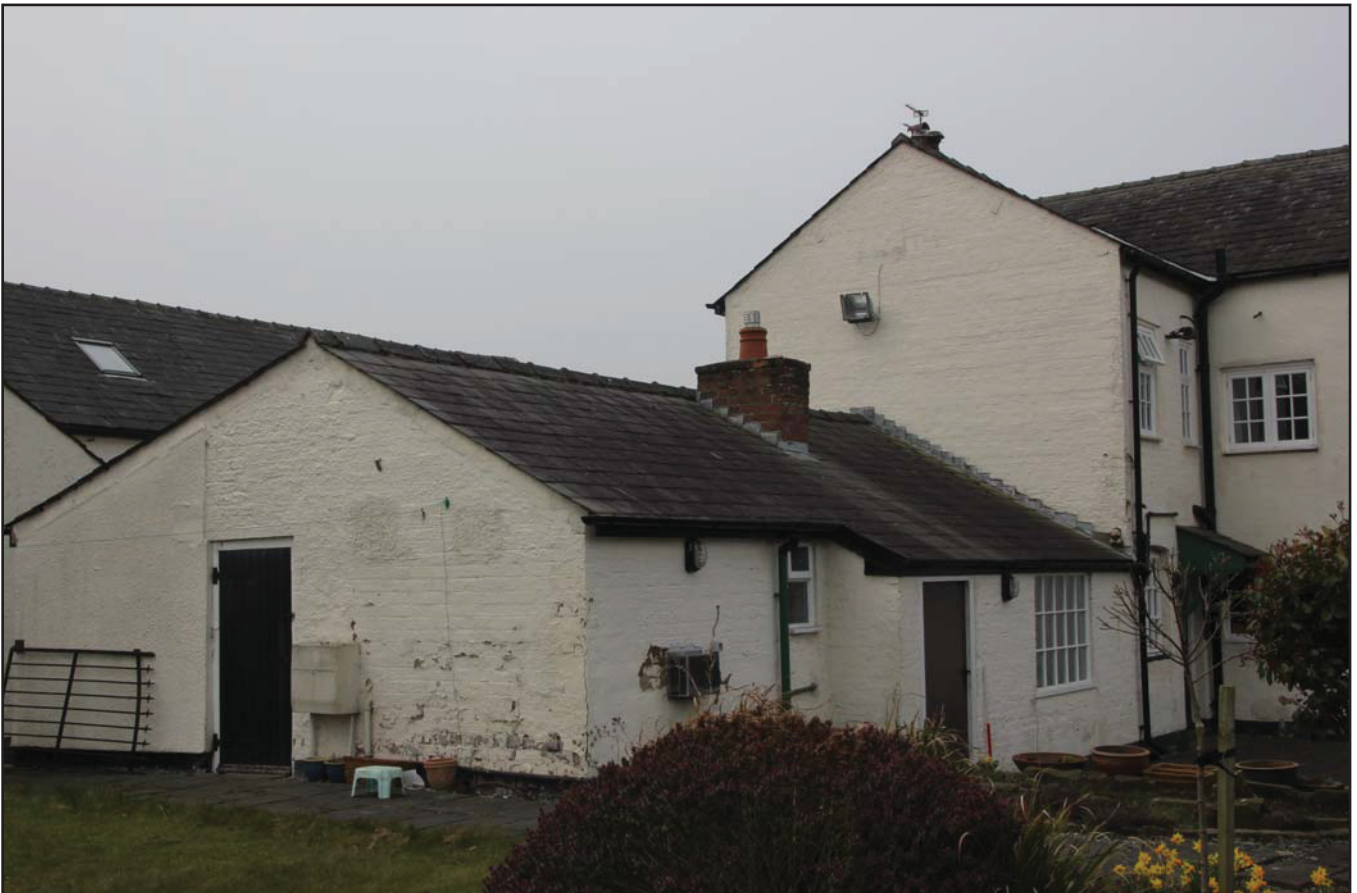
**Plate 06:** Outbuildings extension northeast and northwest elevations, from the north. Scale 1.0m

The north-western elevation (plates 6 and 7) has a short catslide over a brick built wall, also painted white. There is one 15 pane wooden framed window to the south and a doorway to the north of brown painted wooden board. The ground level steps up approximately 0.5m some 8.0m northeast of the main farmhouse building after which there is a single 2 pane wooden framed window.

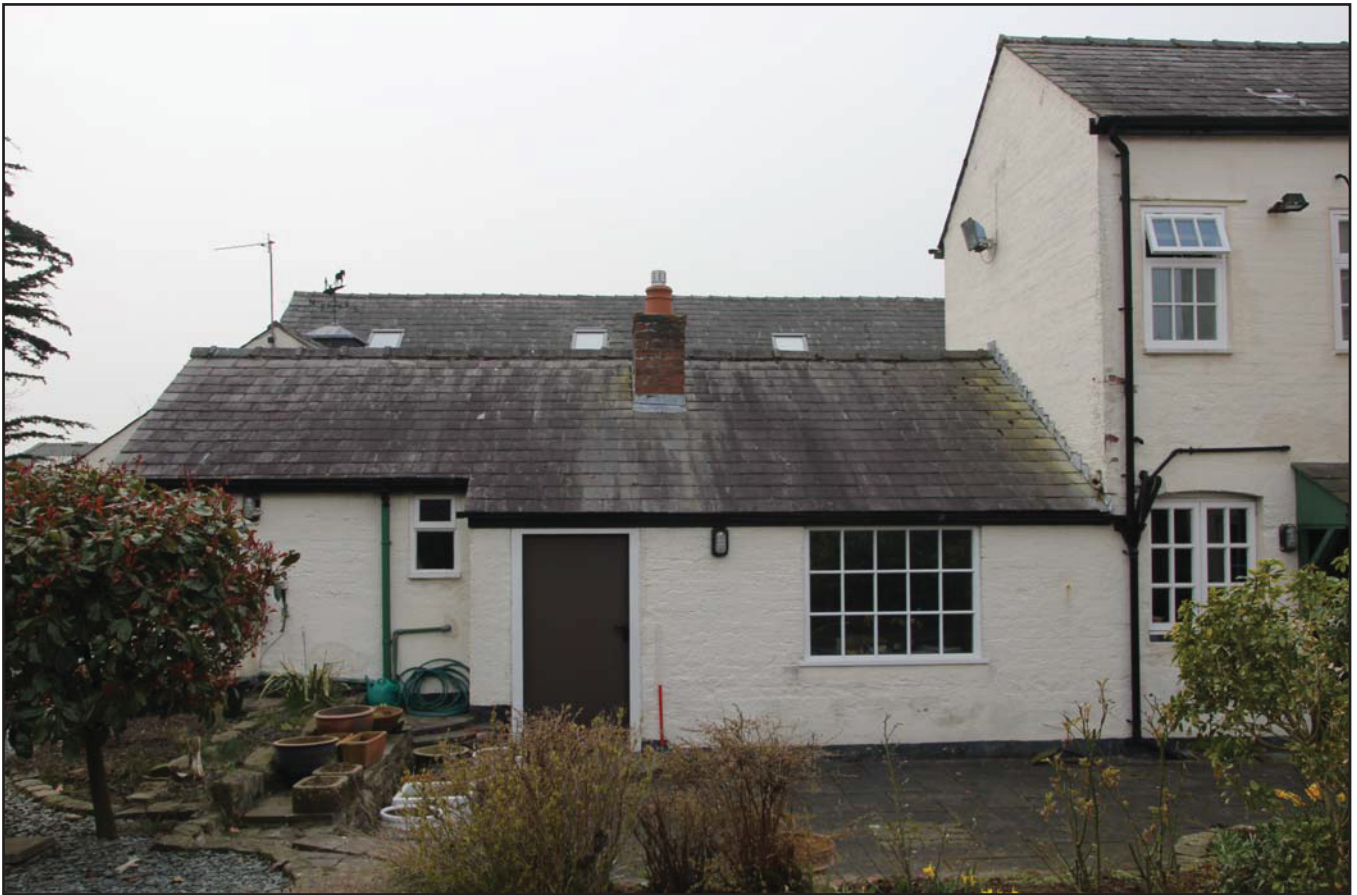
**Plate 07:** Outbuildings extension northwest elevation, from the northwest. Scale 1.0m.

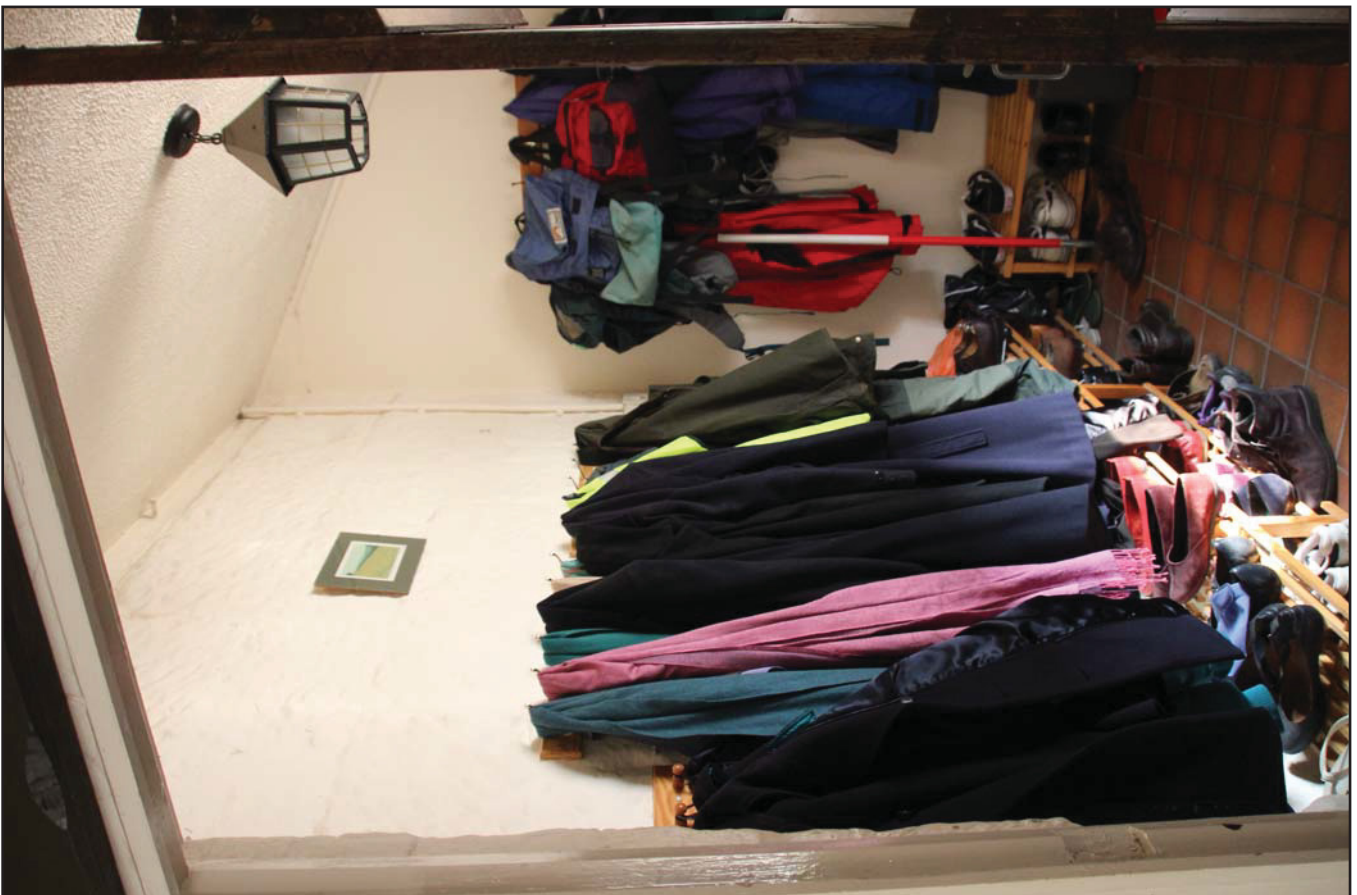
**Plate 08:** Outbuildings extension cloakroom, from the southwest. Scale 1.0m

A rectangular room (plate 8) orientated from northeast to southwest and measuring 2.5m in length by 1.6m in width. Access is gained via a brown painted wooden boarded door in the southwest elevation and there is a 0.3m high step up which corresponds with the roof height change on the exterior of the building. The southeast elevation is constructed from brick which has been painted white and the north east elevation is plastered and painted white. The northwest elevation is partly constructed from sandstone to a height of approximately 1.0m with the upper part of the wall being constructed from brick. The floor is of red ceramic tiles.

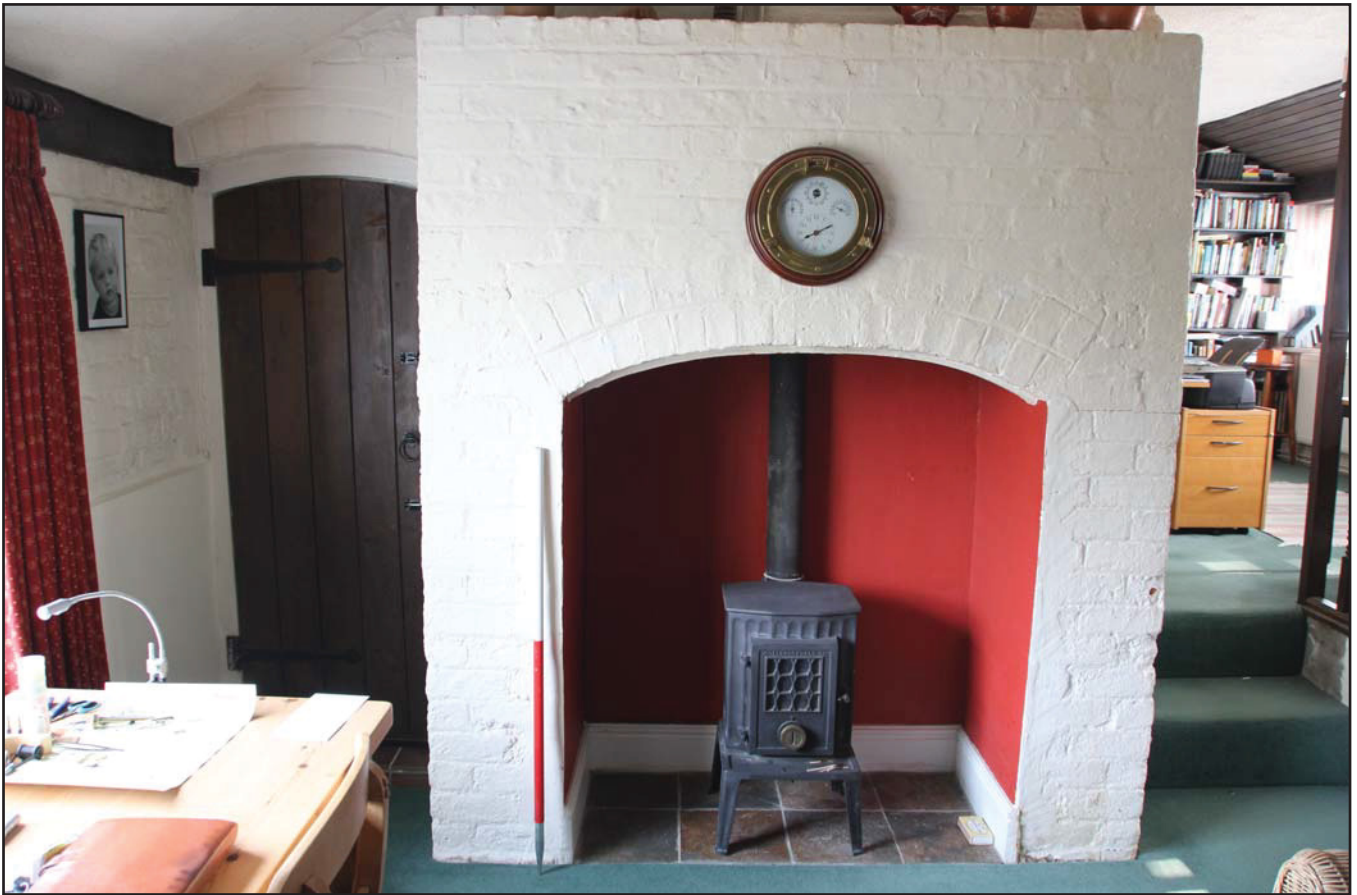
**Plate 09:** Outbuildings extension office 1 showing fireplace, from the southwest. Scale 1.0m.

A square room (plate 9 and 10) measuring 3.5m is located within the southern part of the extension. Access is gained via the south-eastern wall by a brown painted wooden boarded door. The walls are brick built on the south-eastern and north-western sides, although as a sandstone wall was observed in the cloakroom, the south-eastern elevation must be constructed from brick butting up against stone. A dominating fire surround is located at the north-eastern side of the room and is constructed from brick which has been painted white. Radiating vousoirs have been constructed over the fireplace and over a doorway located to the northwest of the fire, which permits access to the toilet hallway.

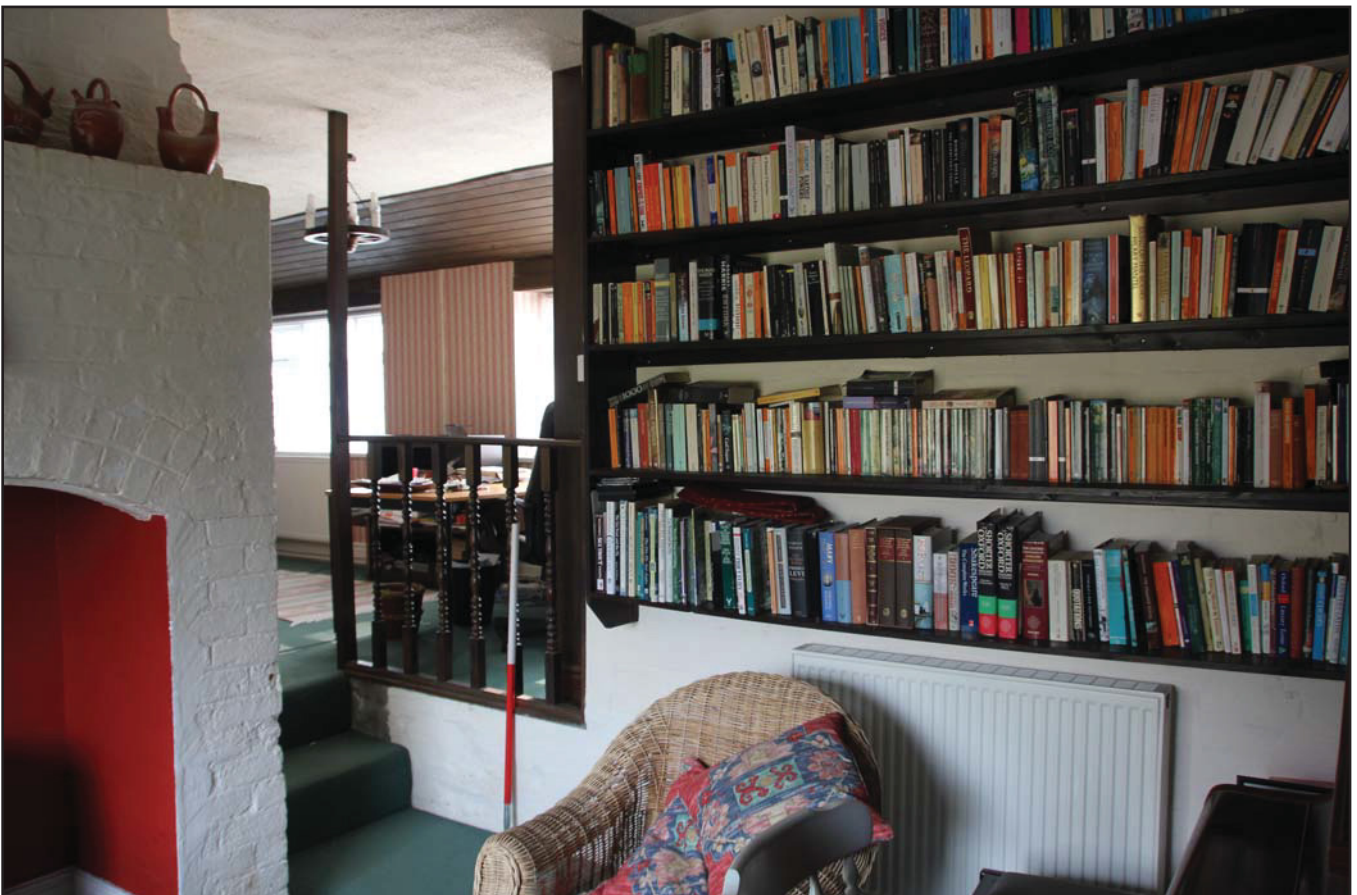
**Plate 10:** Outbuildings extension office 1, from the west. Scale 1.0m

The south-western elevation is of mock post and panel construction and the room has been utilised as an office, with a desk to the northwest, an upright piano against the southwest elevation, and a hanging book case on the southeast elevation. The floor is covered in green carpet throughout.

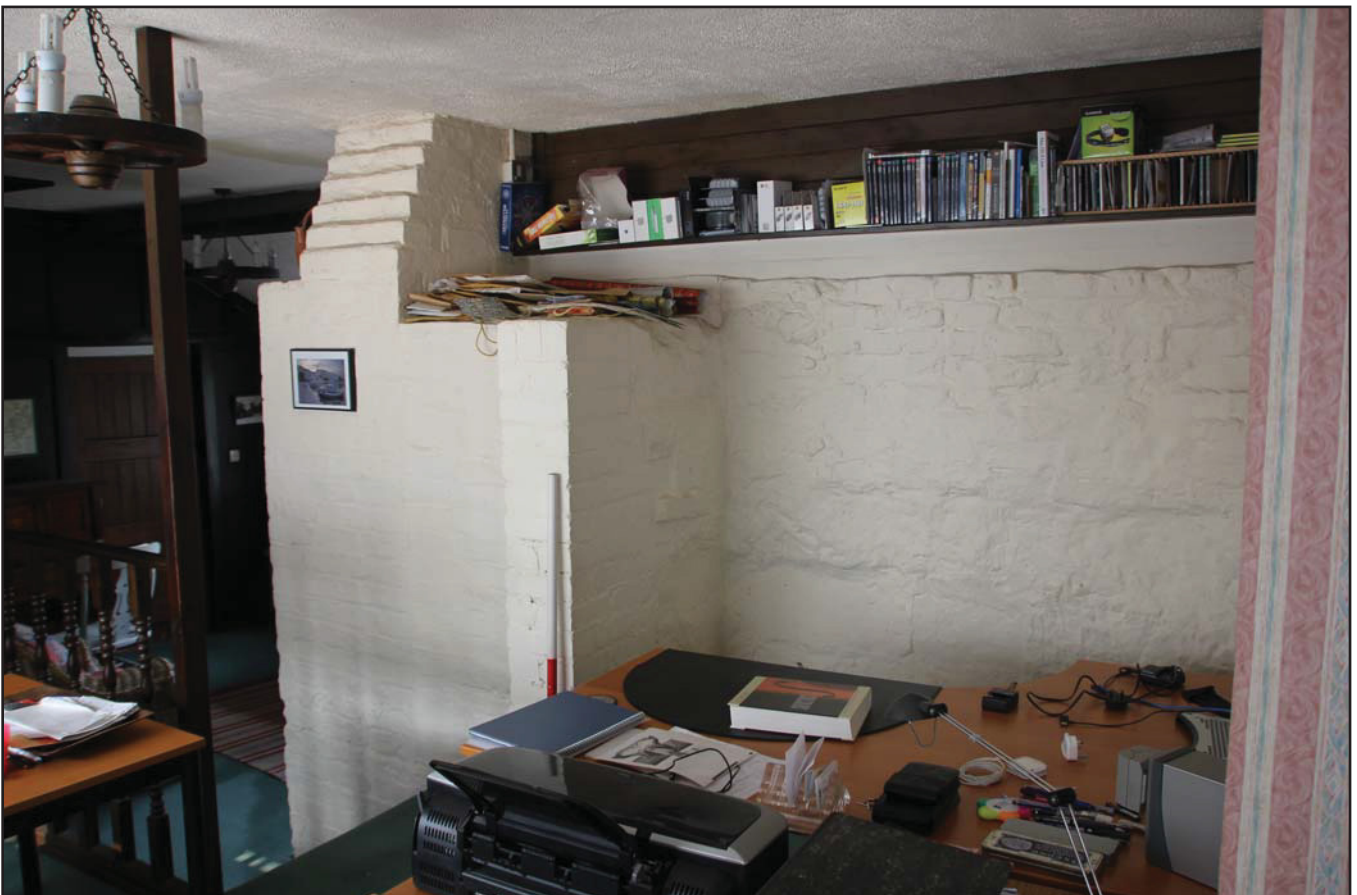
**Plate 12:** Outbuildings extension office 2 showing northwest stall wall, from the west. Scale 1.0m

and is accessed by two steps leading from the first office room. The south-eastern and south-western walls are papered and the floor is covered in green carpet. The north-western elevation is recessed approximately 1.0m and it can be seen that the walls are constructed from sandstone to a height of approximately 1.3m with brick above. The northwest, northeast and southwest walls (plate 12) of the recess are all of sandstone suggesting that it was originally part of an animal stall as depicted on the first edition Ordnance Survey map of 1875 (figure 3).

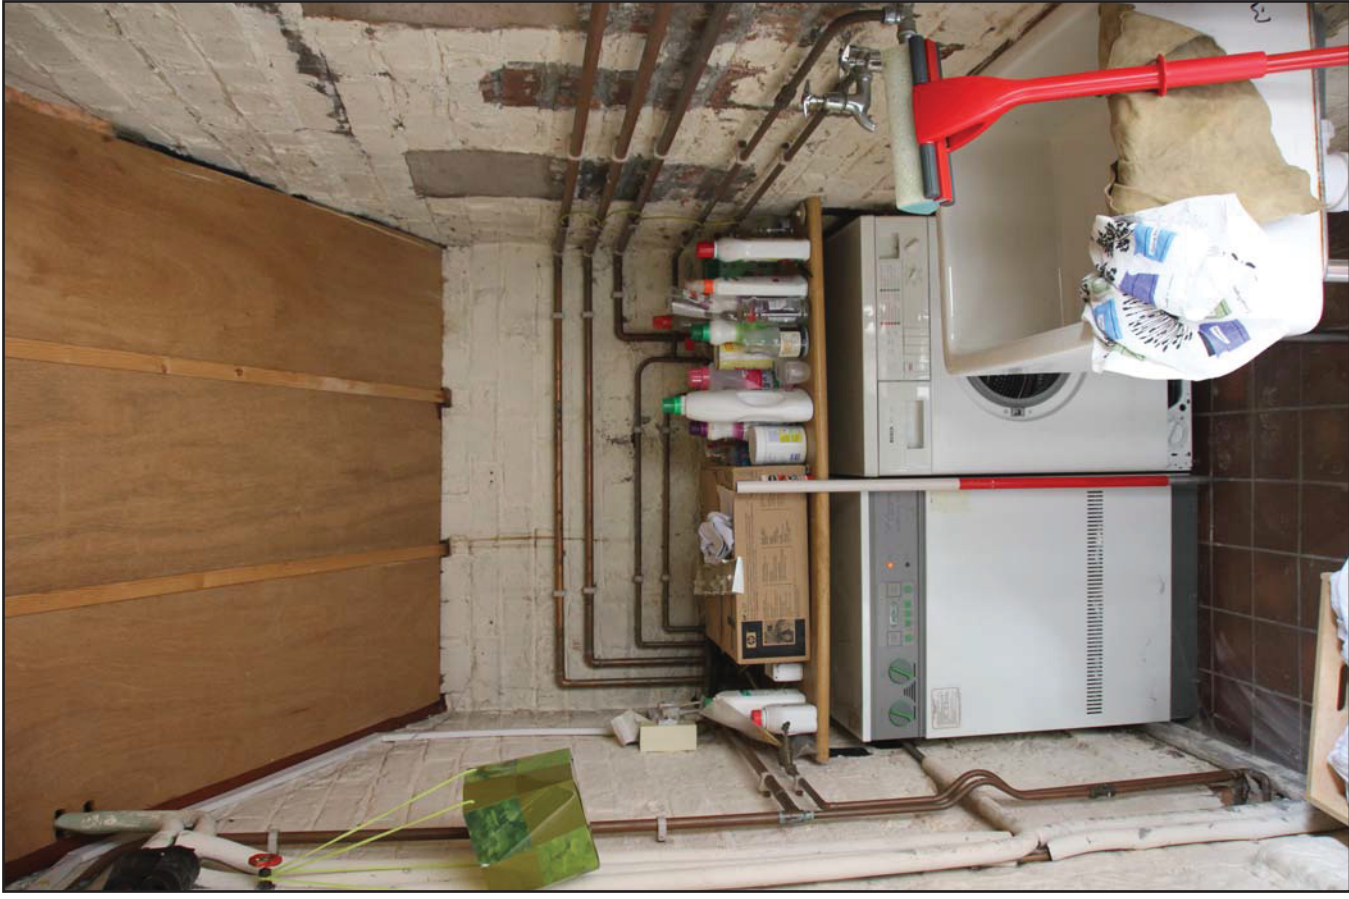
**Plate 13:** Outbuildings extension storage room, from the southeast. Scale 1.0m.

A rectangular storage room (plate 13) is located at the north-eastern end of the outbuildings extension. It is orientated from northwest to southeast and measures 3.2m by 1.3m. The southwest elevation is of sandstone (plate 14) and clearly marks the north-eastern limit of the animal stall identified in office 2 (see above). The other elevations are all of brick construction and painted white. A boiler and washing machine is located against the northwest wall, and a ceramic rectangular sink is against the northeast gable. The floor is of red tiles.

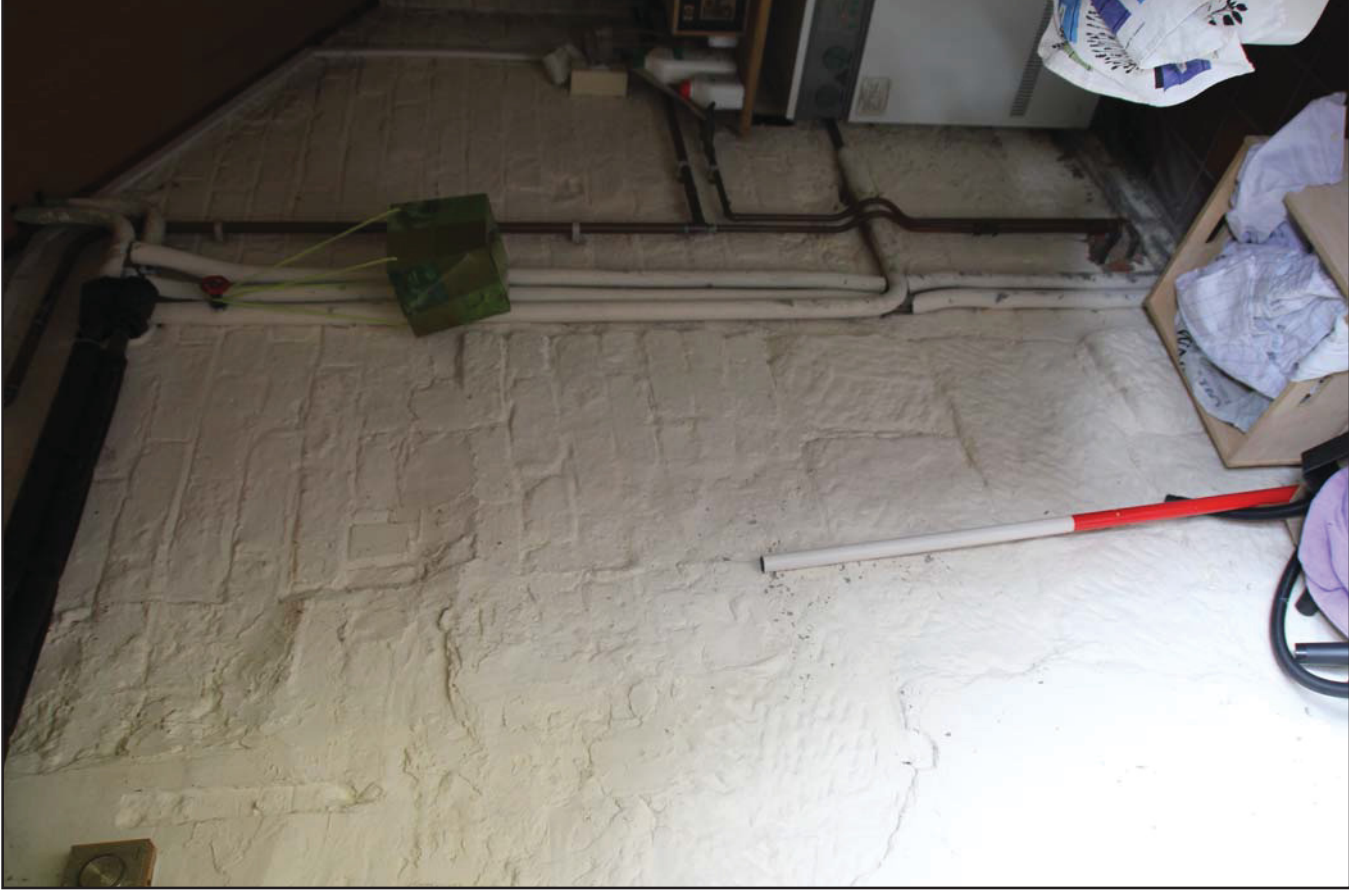
**Plate 14:** Outbuildings extension storage room showing southwest wall construction, from the east. Scale 1.0m

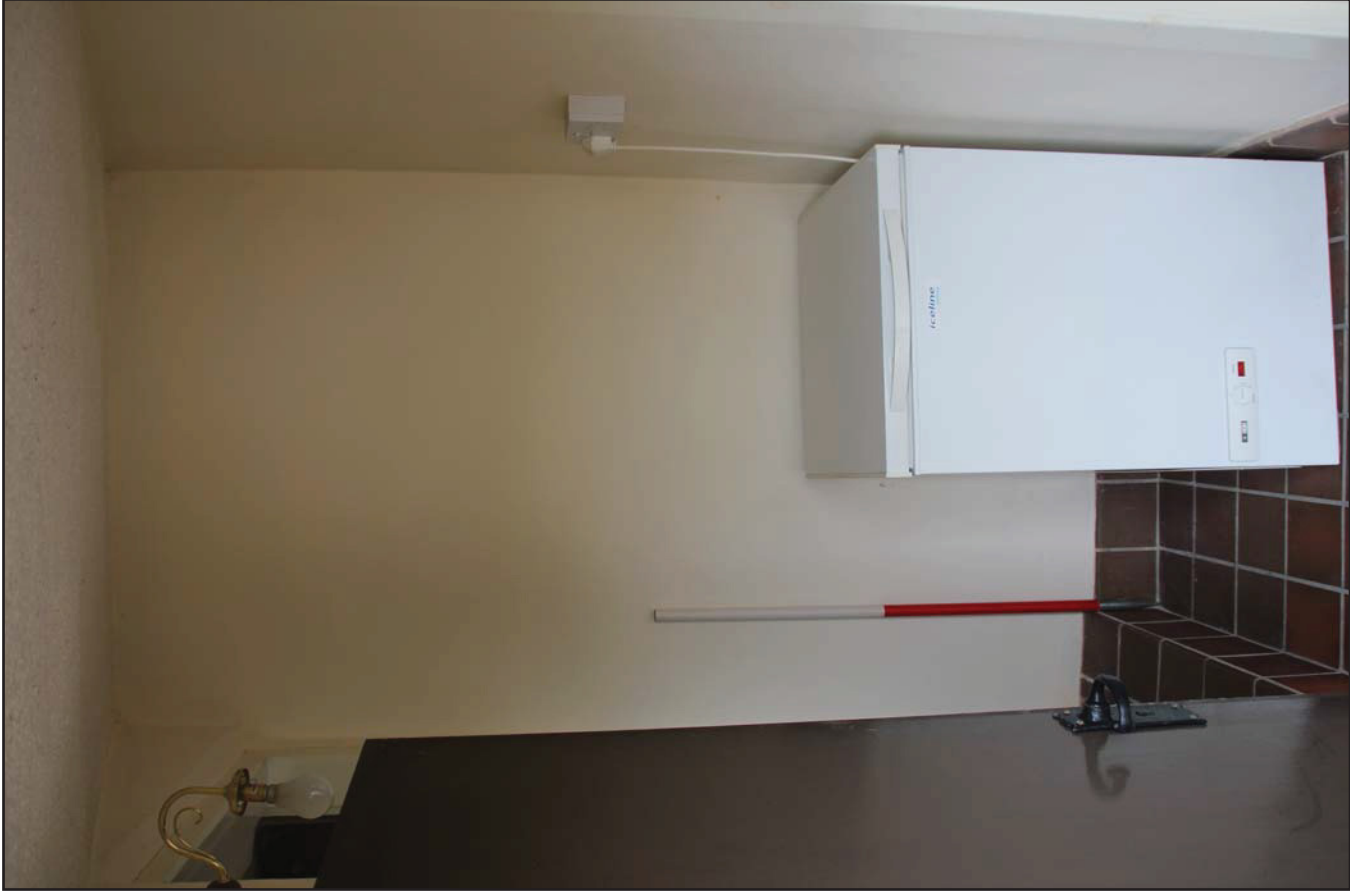
**Plate 15:** Outbuildings extension toilet hallway, from the northwest. Scale 1.0m.

The toilet is accessed via office 1 and consists of a hallway (plate 15) measuring 2.2m by 1.2m and orientated from southeast to northwest, and a water closet (plate 16) measuring 1.2m square. All of the walls are plastered and painted white, with the addition of a dado rail and green paper on the lower part of the northeast water closet wall. There is a step up from the hallway into the water closet which corresponds with the rise in the ground level visible on the external northwest elevation.
