# **Bank House, 142 Barnston Road Barnston, Heswall**

Level 2 Historic Building Record

Project Code: A0012

Report no. 0010

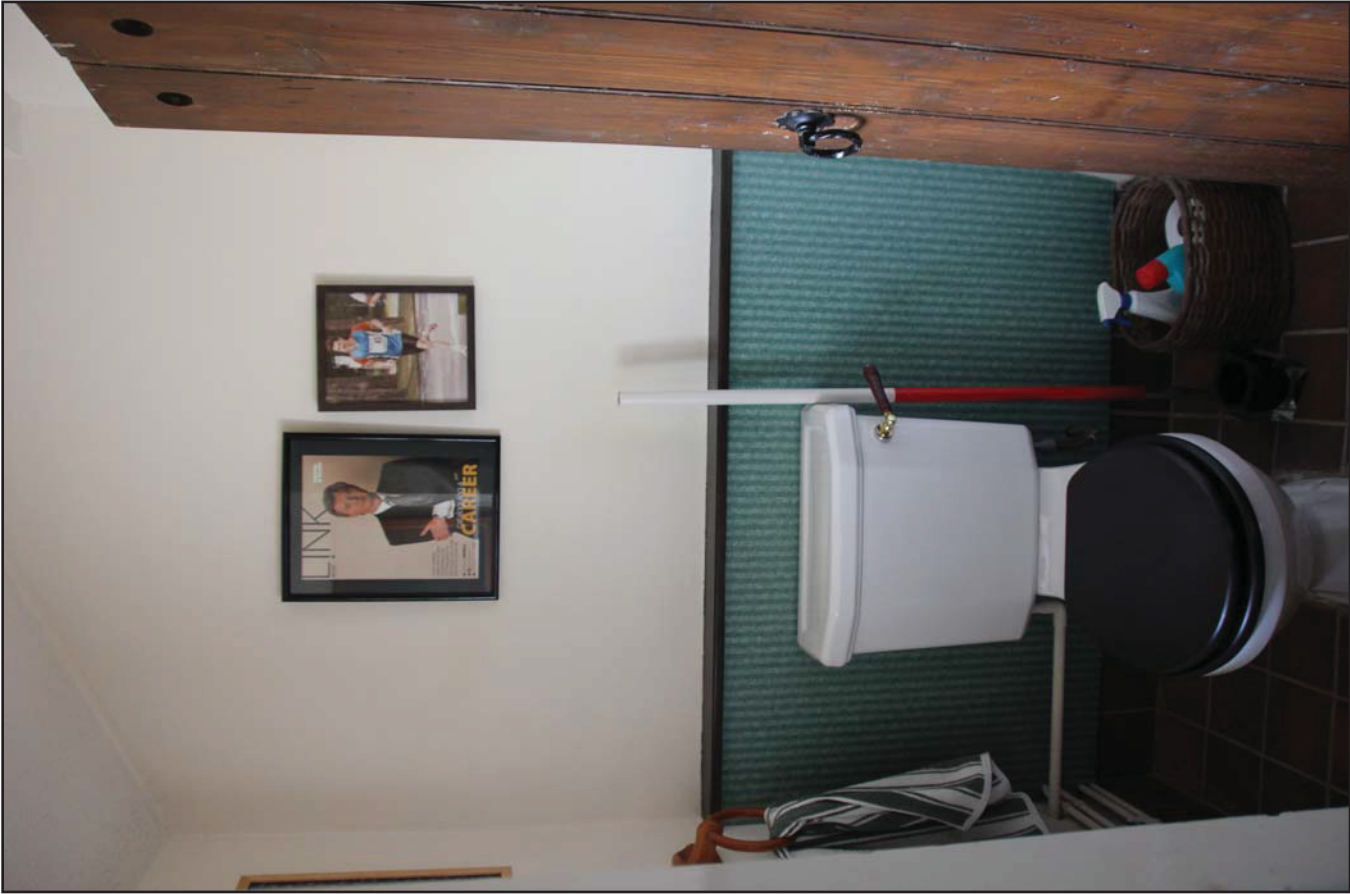
**Plate 16:** Outbuildings extension toilet, from the southwest.  
Scale 1.0m

The toilet is accessed via office 1 and consists of a hallway (plate 15) measuring 2.2m by 1.2m and orientated from southeast to northwest, and a water closet (plate 16) measuring 1.2m square. All of the walls are plastered and painted white, with the addition of a dado rail and green paper on the lower part of the northeast water closet wall. There is a step up from the hallway into the water closet which corresponds with the rise in the ground level visible on the external northwest elevation.
