# Land at Green Lane, Eccles, Greater Manchester. October 2015

Report no. 0069 v1.0

Archaeological Evaluation

Project Code: A0067.1

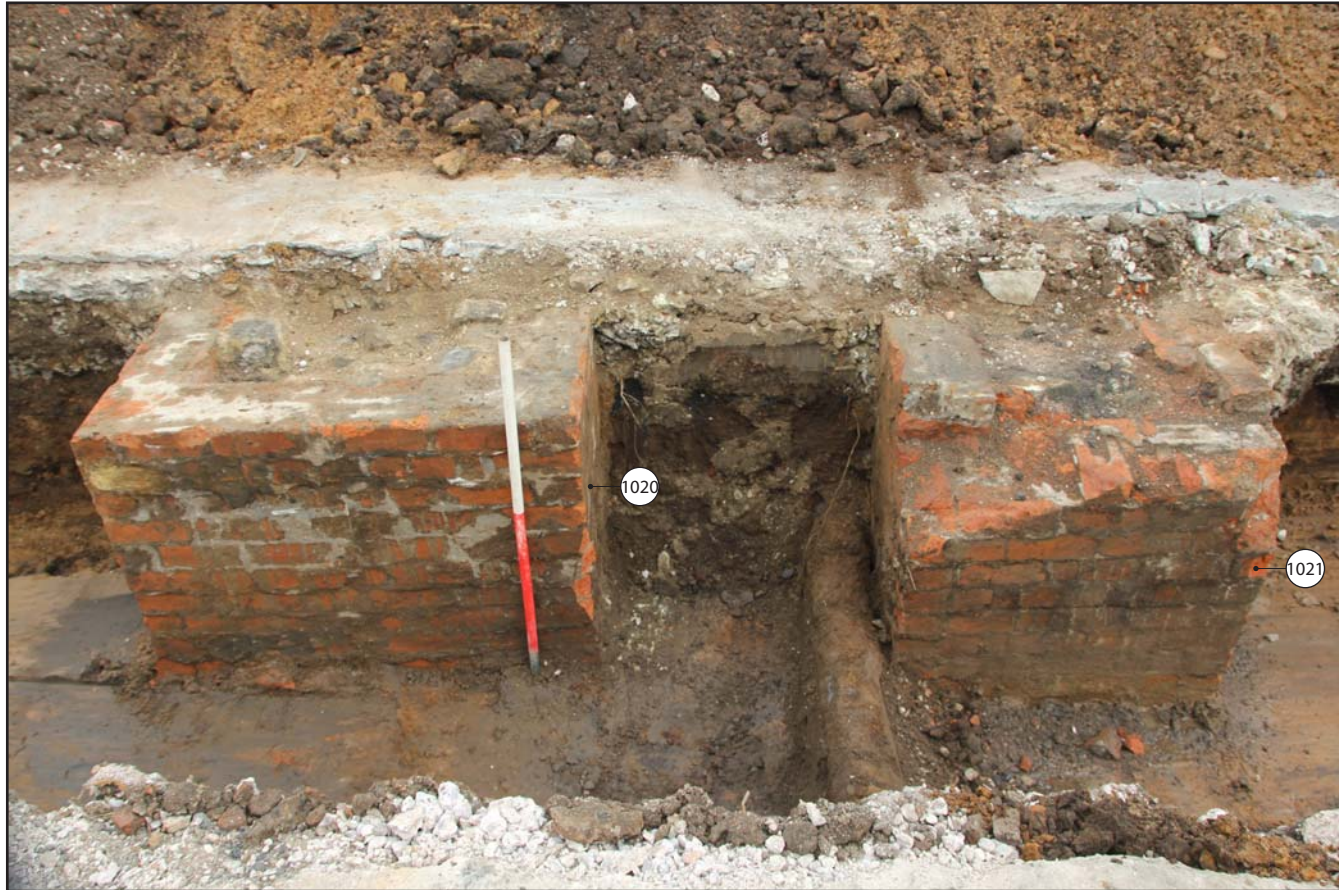
The exception to this destruction was the discovery of the two red-brick structures (1020) and (1021) which appear to be girder bases, possibly for the vertical upright steels that supported the electric crane. However, other than the preservation of these two features the area to the south of the proposed development area appears to have been highly disturbed and the potential for preserved buried remains of the foundry surviving at foundation level appears to be low within this area.

**Plate 04:** Trench 1 showing brick-built girder bases (1020) and (1021), from the west. Scale 1.0m.

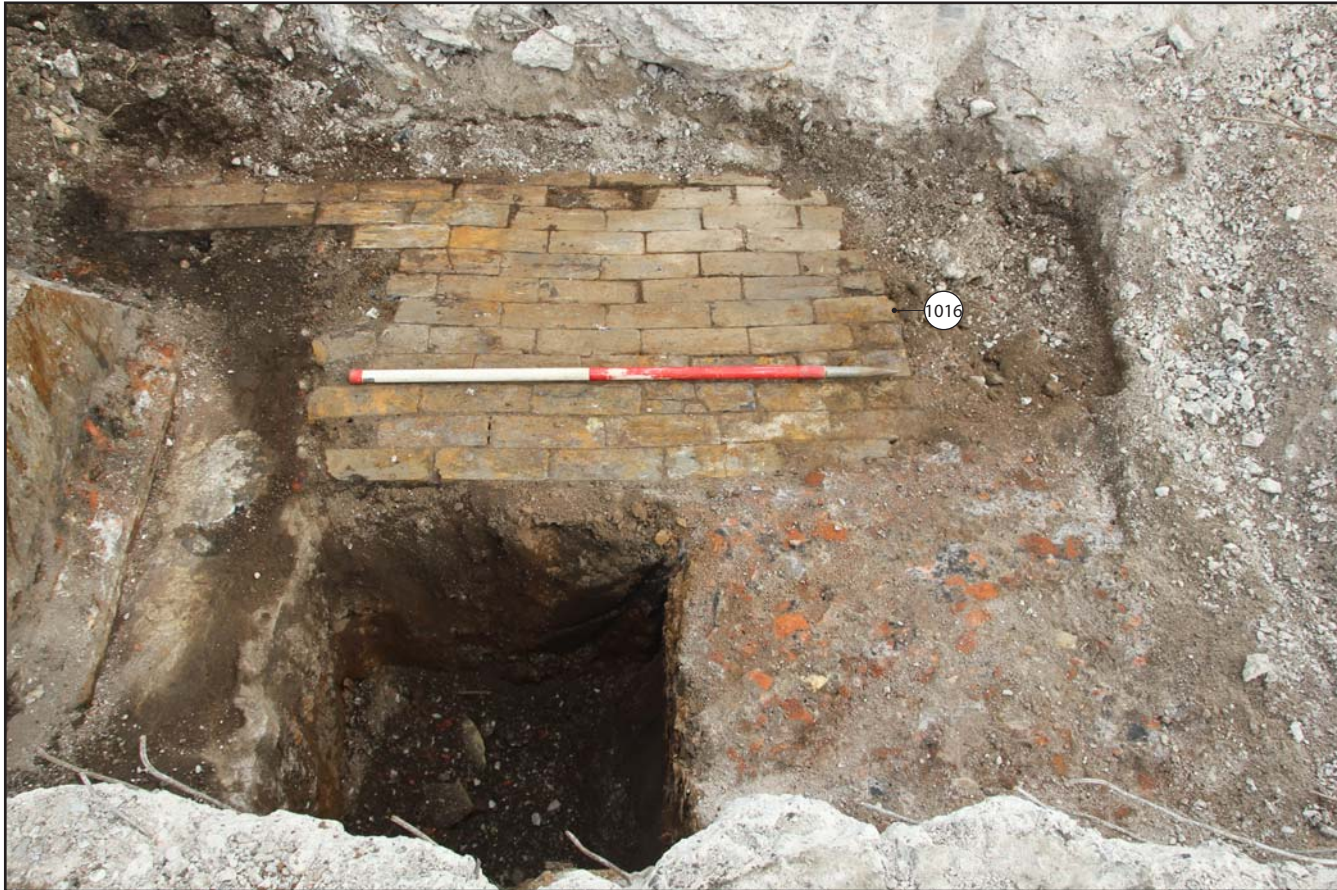
The floor surface (1016) almost certainly represents the working floor of the planing shop, and it is likely that the two concrete bases (1017) and (1019) represent anchor blocks for the planing machines themselves. Moreover, the small section of red-brick wall (1018) found at the southern end of the trench may well relate to one of the two large openings into the southern end of the building as shown on the map of 1913.

**Plate 07:** Trench 2 showing brick floor surface (1016), from the east. Scale 1.0m.

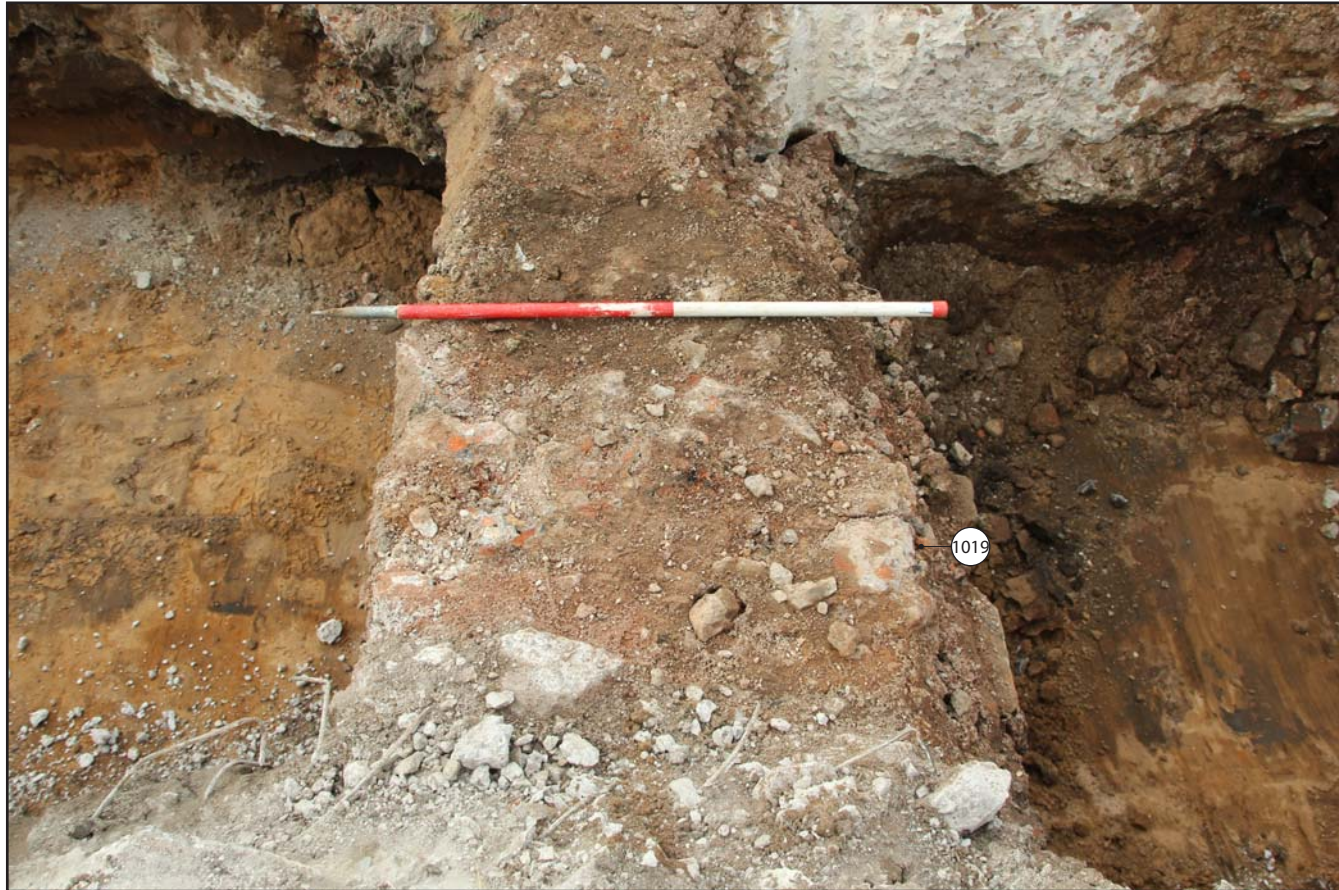
**Plate 08:** Trench 2 showing concrete base (1019), from the east. Scale 1.0m.

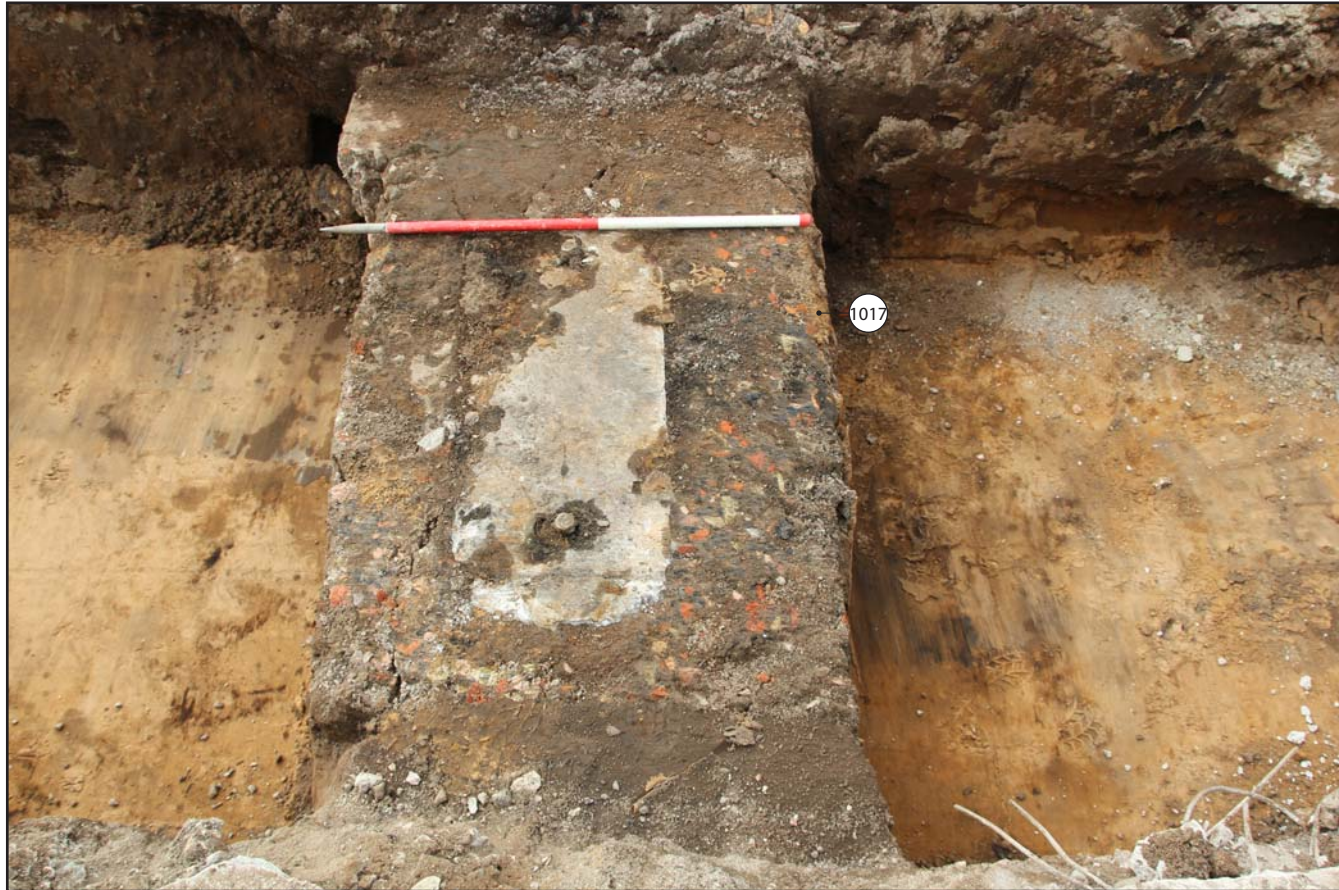
**Plate 09:** Trench 2 showing concrete anchor block (1017), from the east. Scale 1.0m.

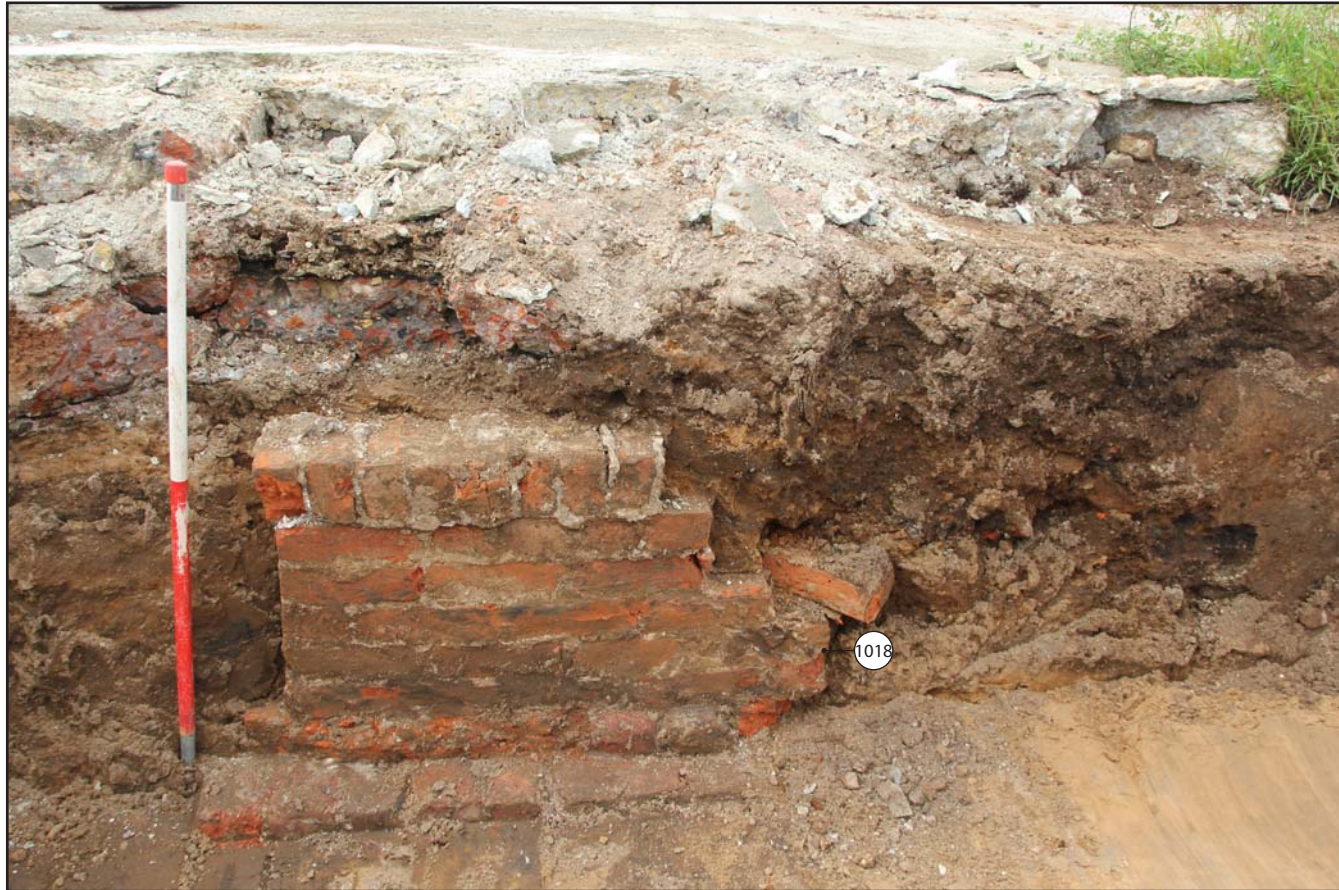
At the southernmost end of the trench and along the western limit of excavation a 1.0m wide unfrogged red-brick wall bonded by mortar was located, which appeared to represent part of a wall or possibly a buttress. This small section of wall was orientated north to south and appeared to sit within a foundation cut into the natural substrata. The red bricks utilised measured 0.22m by 0.11m by 0.07m.

**Plate 10:** Trench 2 showing red-brick wall/buttress (1018), from the east. Scale 1.0m.

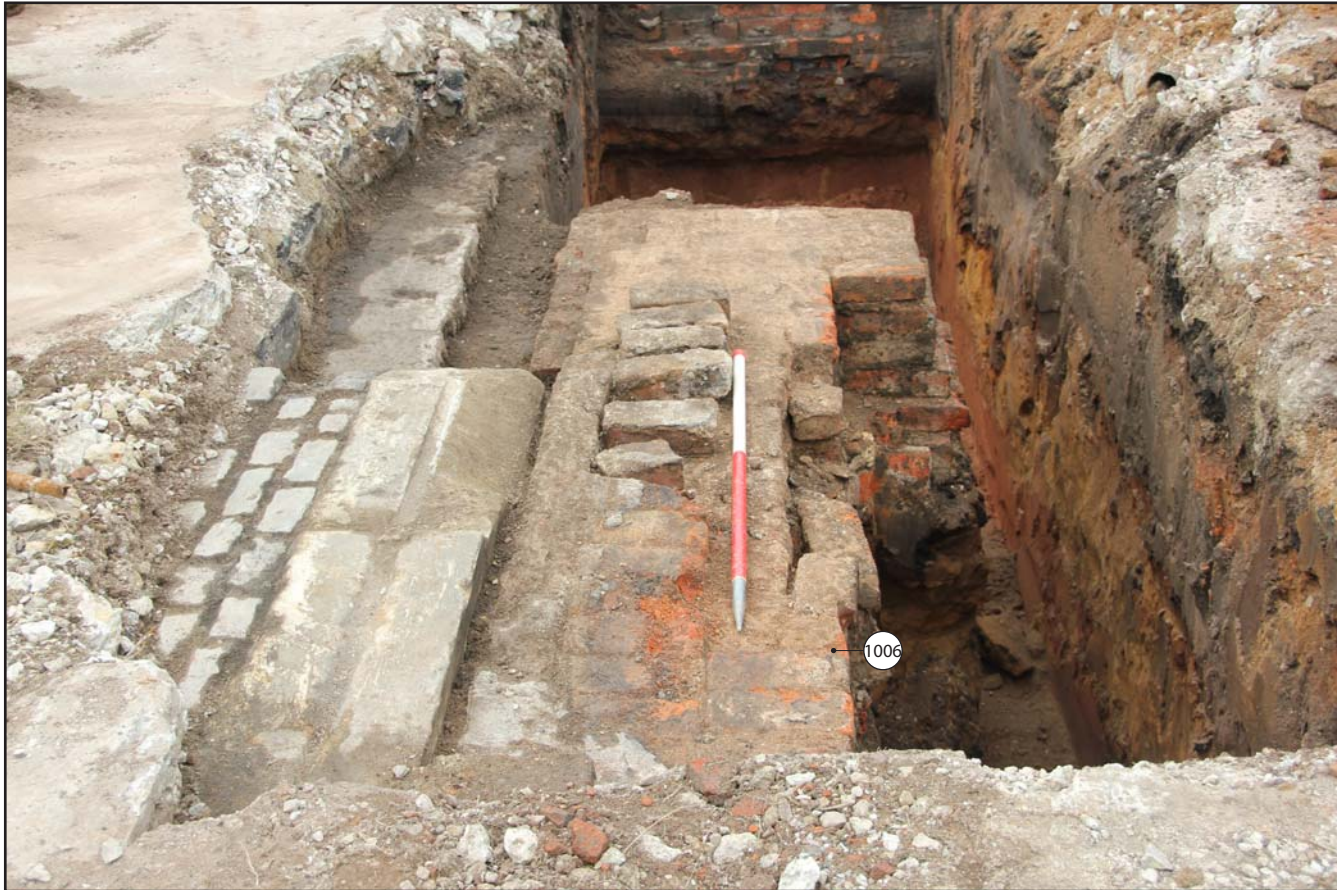
At the western end of the trench a wall (1006) of unfrosted red-brick bonded by mortar and measuring >3.3m in length by >1.2m wide by 1.5m high (7 courses) ran from east to west against the northern limit of excavation. At the northwest corner of the trench this wall butted up against two laid sandstone blocks which appeared to represent an entranceway.

**Plate 13:** Trench 3 showing red-brick wall (1006), from the west. Scale 1.0m.

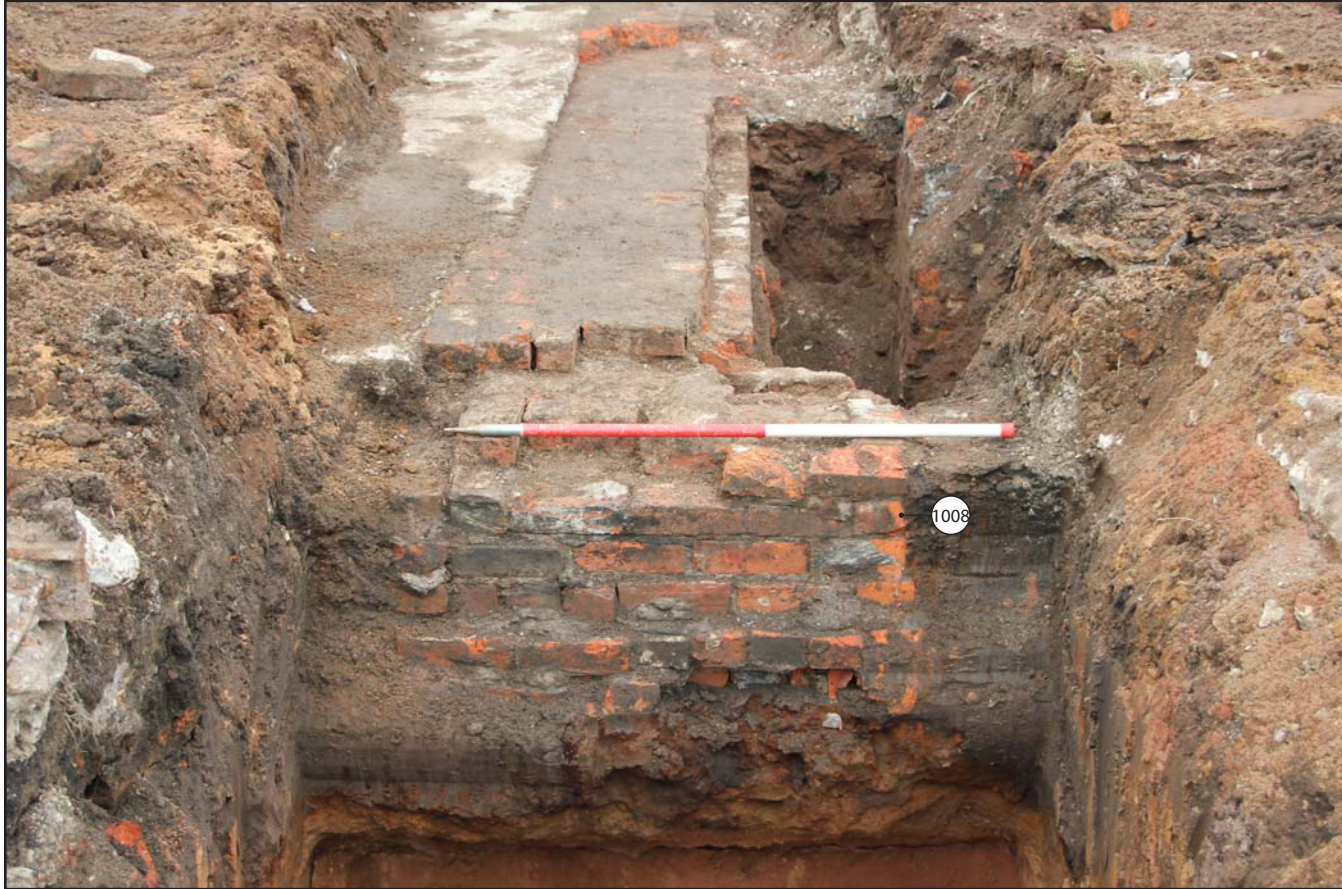
**Plate 15:** Trench 3 showing red-brick wall foundations (1008), from the west. Scale 1.0m.

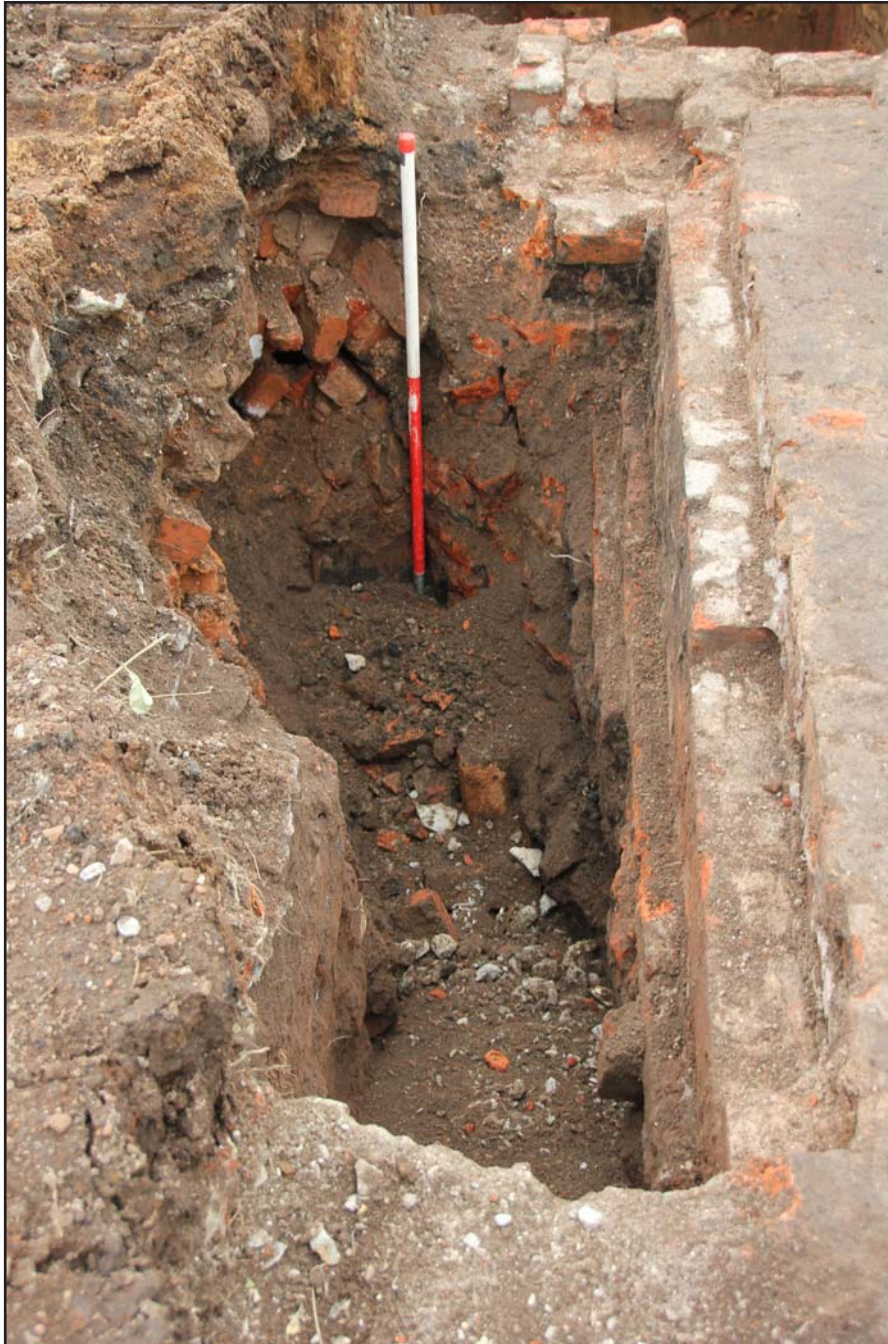
**Plate 16:** Trench 3 showing possible collapsed cellar (1009), from the east. Scale 1.0m.

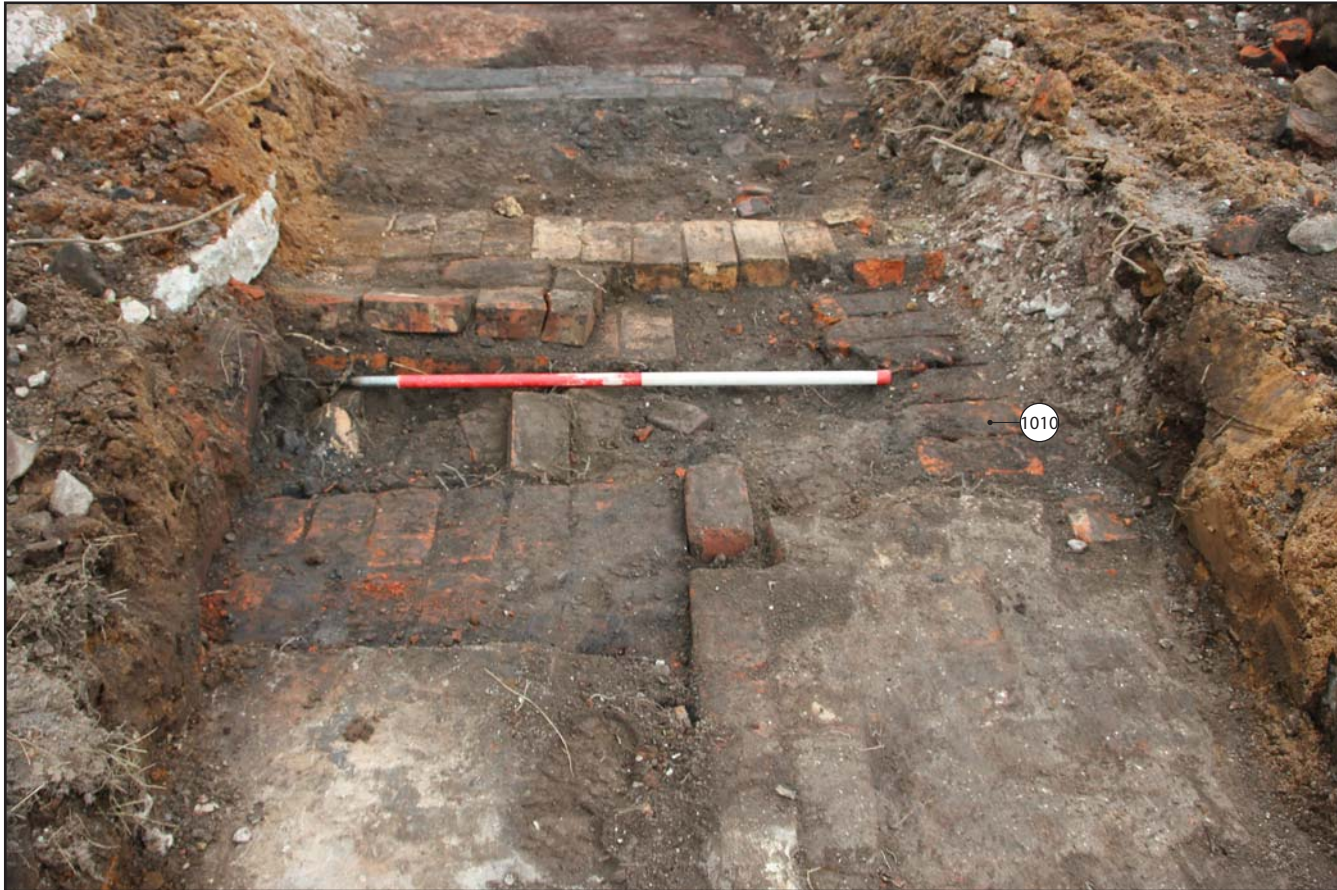
Towards the centre of the trench a feature constructed from unfrosted red-brick bonded by mortar ran from north to south and appeared to be a brick built drain (1010). The feature measured >2.0m in length by 1.8m in width with a central gully measuring 0.55m in width and 0.11m in depth (1 course). As with the red-brick walls, this feature had been constructed from bricks measuring 0.22m in length by 0.11m in width by 0.07m in depth.

**Plate 17:** Trench 3 showing red-brick drain (1010), from the west. Scale 1.0m.

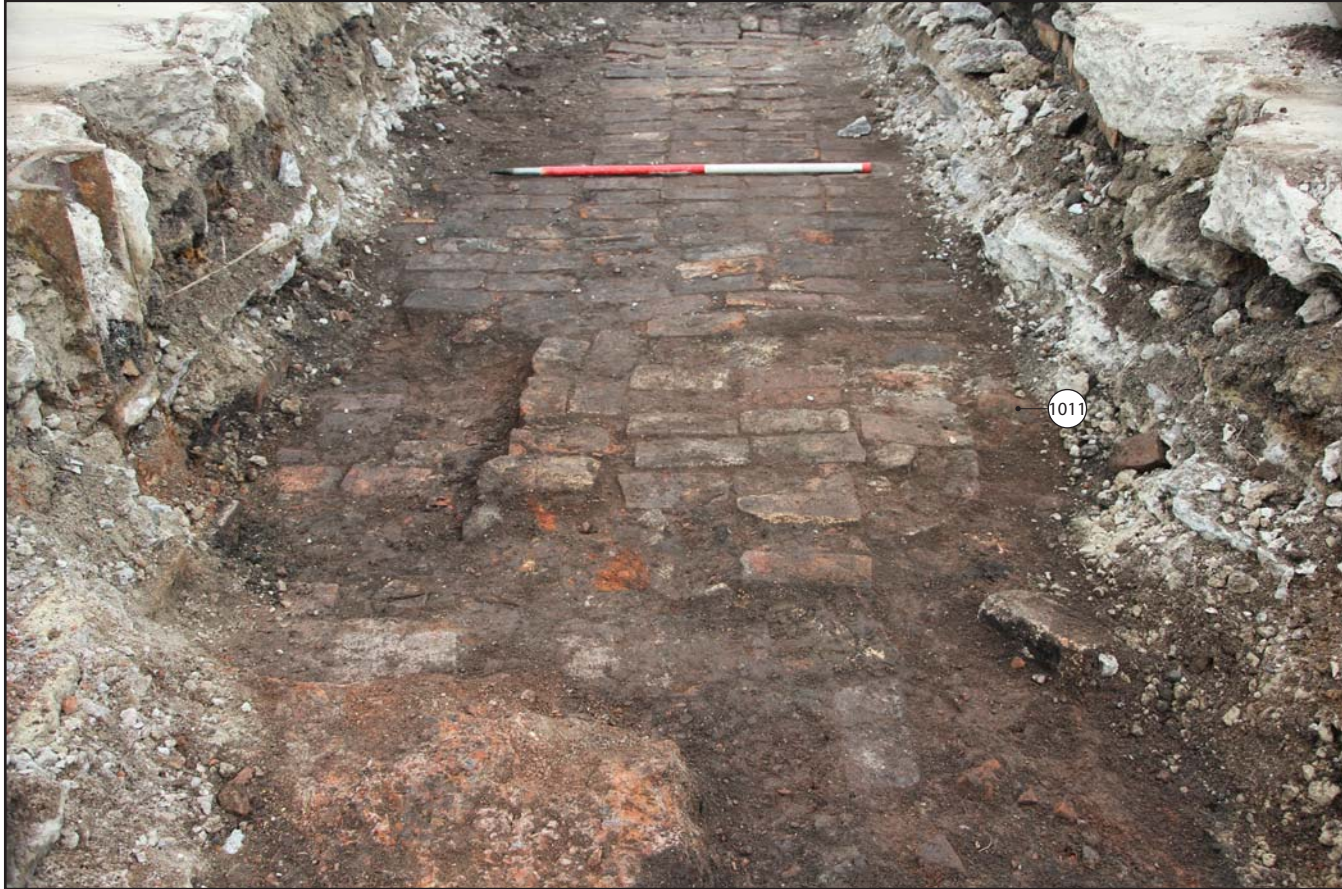
To the immediate east of drain (1010) and butting up against it was a single course laid surface of red bricks (1011) measuring 5.4m in length by >2.0m in width, orientated east to west and continuing into both the northern and southern limits of excavation. The bricks appeared unbounded and for the most part unfrosted, although several frosted bricks had been used to repair the floor.

**Plate 18:** Trench 3 showing red-brick surface (1011), from the west. Scale 1.0m.

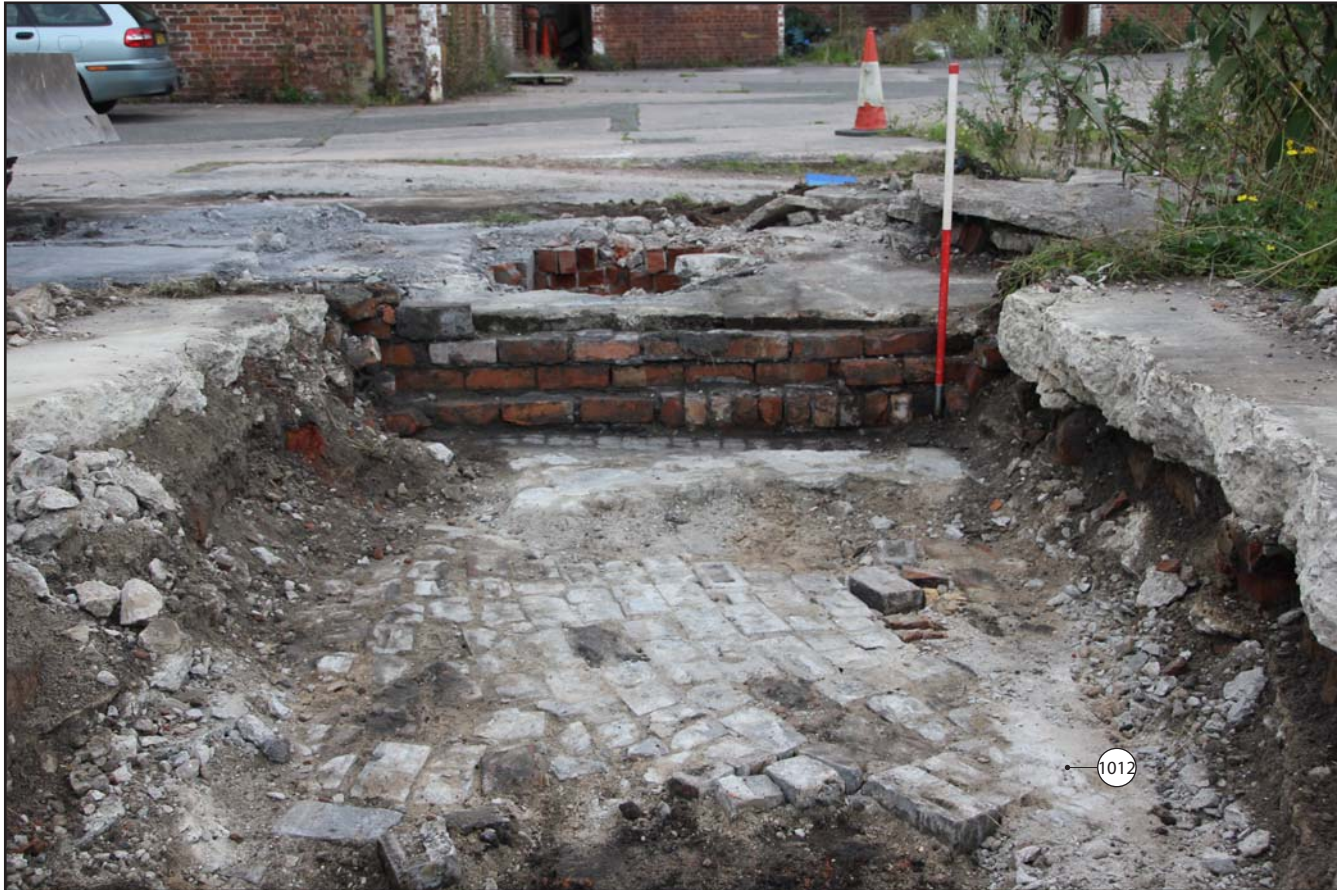
Beyond this and at the eastern end of the trench the laid red-brick surface suddenly terminated and gave way to a 0.5m wide area of demolition which may have been a north-south orientated wall that had been demolished in its entirety. To the immediate east of this was a laid surface of mid/dark grey unfrosted bricks (1012) measuring 2.0m in length by 1.5m in width orientated north to south and which appeared to represent an external floor surface.

**Plate 19:** Trench 3 showing external brick surface (1012), from the west. Scale 1.0m.

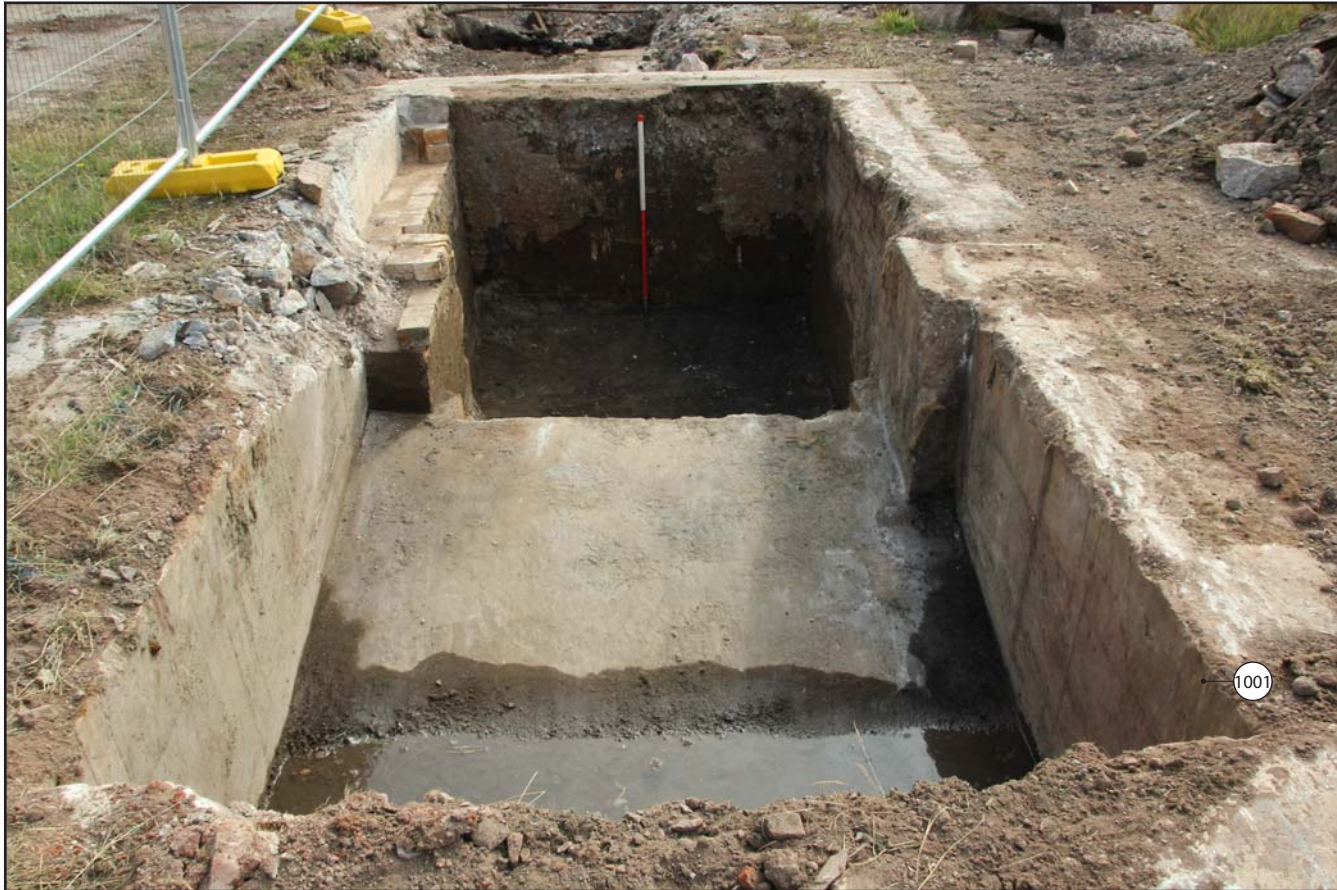
At the northern end of the trench a brick and concrete tank (1001) measuring 4.5m in length by 2.5m in width was located. This had a deeper tank at the southern end and a downward sloping overflow heading north to a drainage hole, most likely representing a quenching tank for the foundry. To the immediate south of this was an area of general demolition which gave on to a laid section of red-brick floor (1002). This measured >2.0m in length by 1.2m in width and continued into the eastern and western limits of excavation. The surface appeared to be only one course thick and utilised unbonded unfrogged red bricks measuring 0.22m in length by 0.11m in width by 0.07m in depth.

The concrete and red-brick tank at the northern end of trench two appears to date to the foundry building rather than any later industrial buildings at the site, and appears to have functioned as a water retaining tank with overflow to the north. This was possibly utilised as a quenching tank to serve the cupolas located to the south.

**Plate 22:** Trench 5 showing concrete and brick tank (1001), from the north. Scale 1.0m.

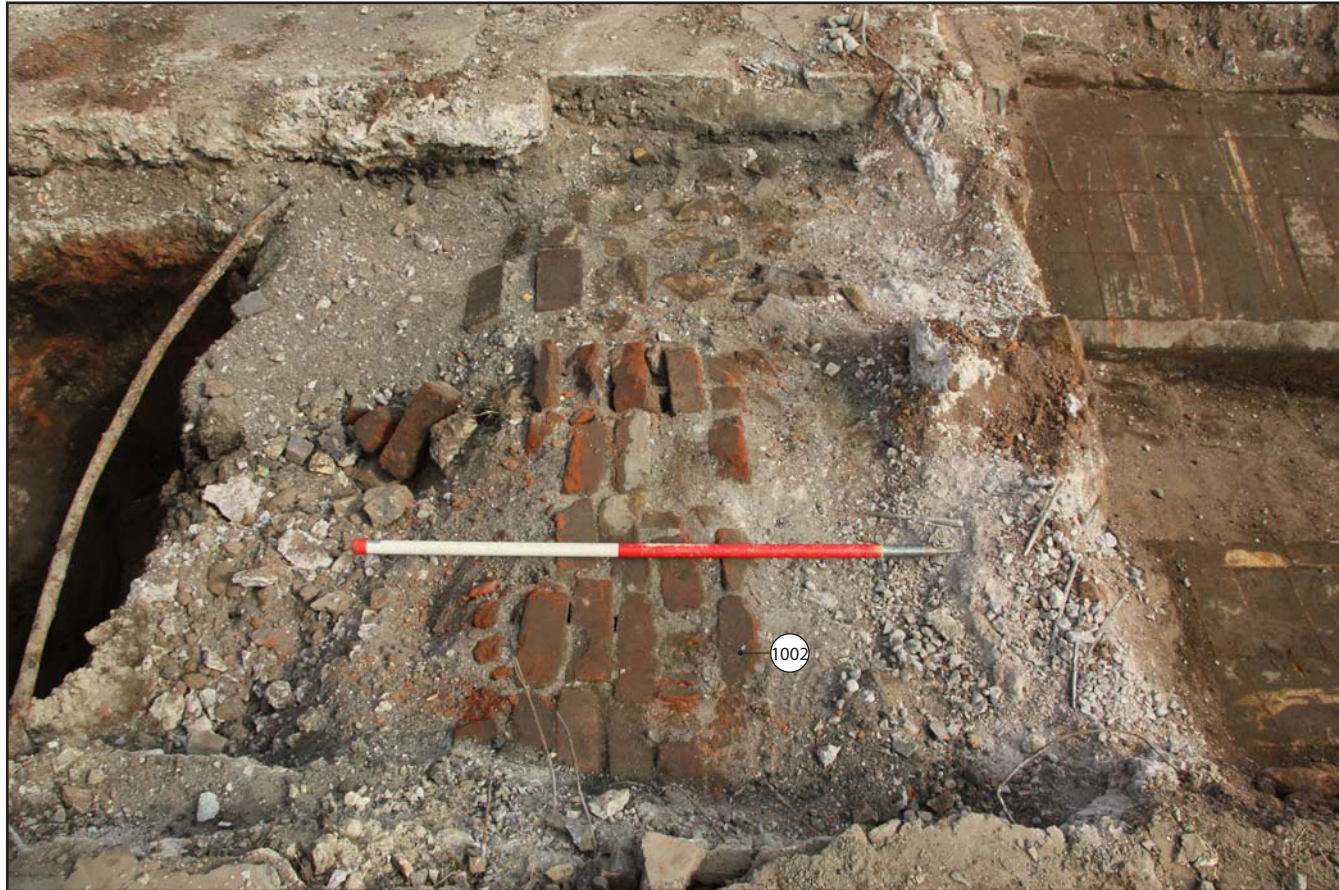
**Plate 23:** Trench 5 showing concrete red-brick surface (1002), from the west. Scale 1.0m.

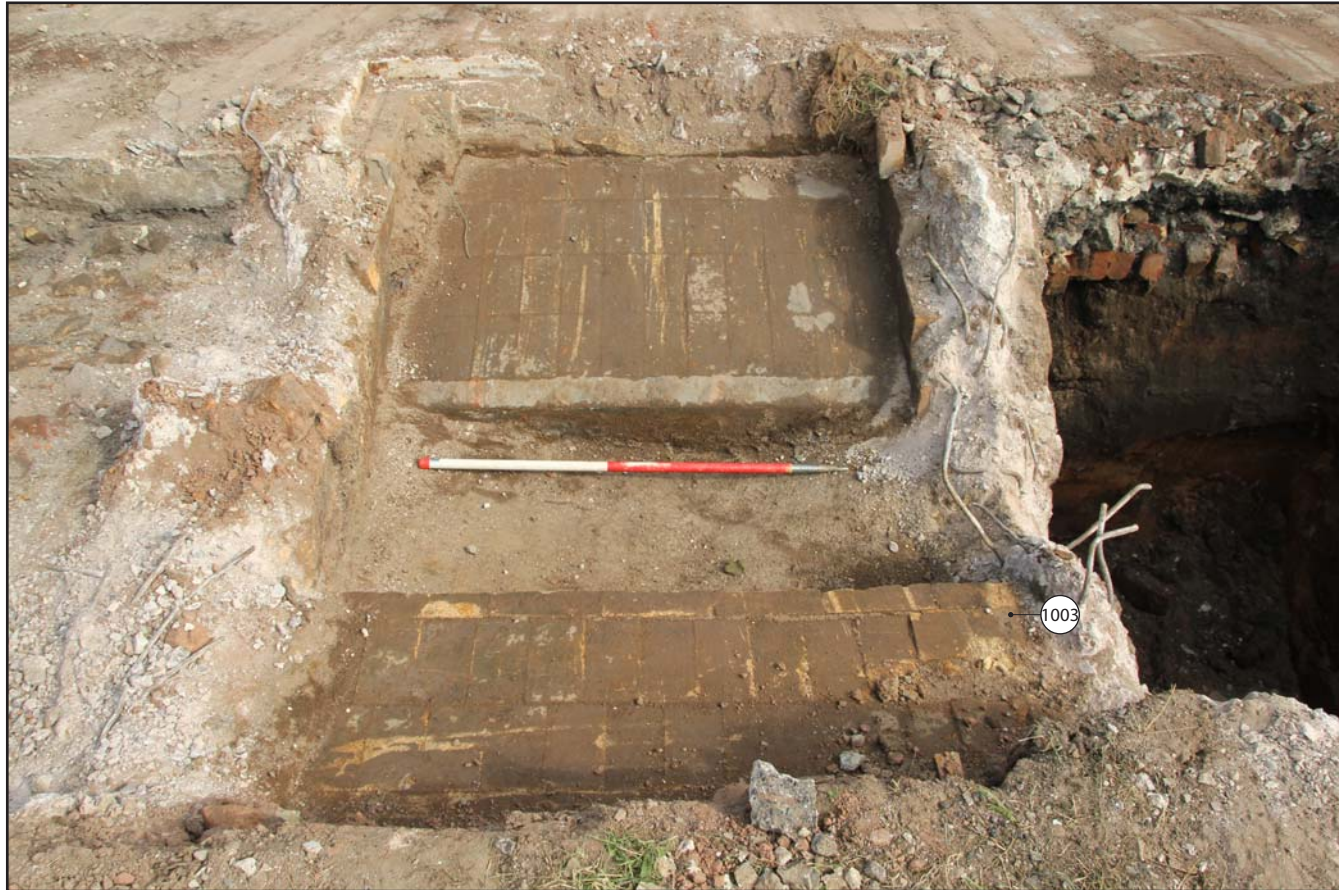
**Plate 24:** Trench 5 showing brick chamber (1003), from the west. Scale 1.0m.

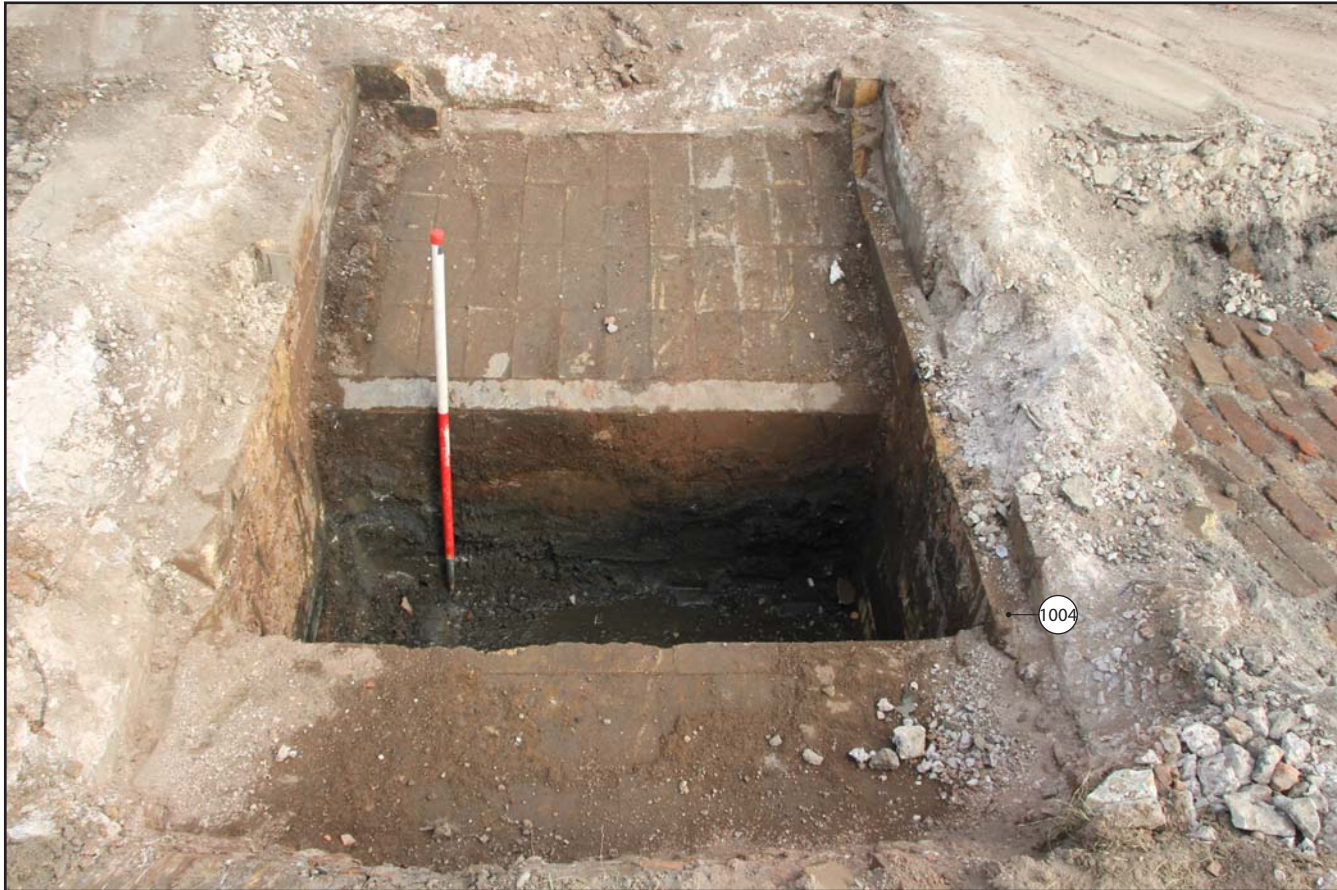
chambers. The presence of an in-situ yellow brick wall to the immediate north of chamber (1004) shows that despite modern disturbance between the two chambers they originally functioned as separate features and were never linked. This part of the foundry housed the six cupolas however no parallels with the chambers have been thus far found linking them to the melting process, and it may be that they were in fact a later addition linked with the Royal Ordinance manufacture.

**Plate 25:** Trench 5 showing brick chamber (1004), from the west. Scale 1.0m.

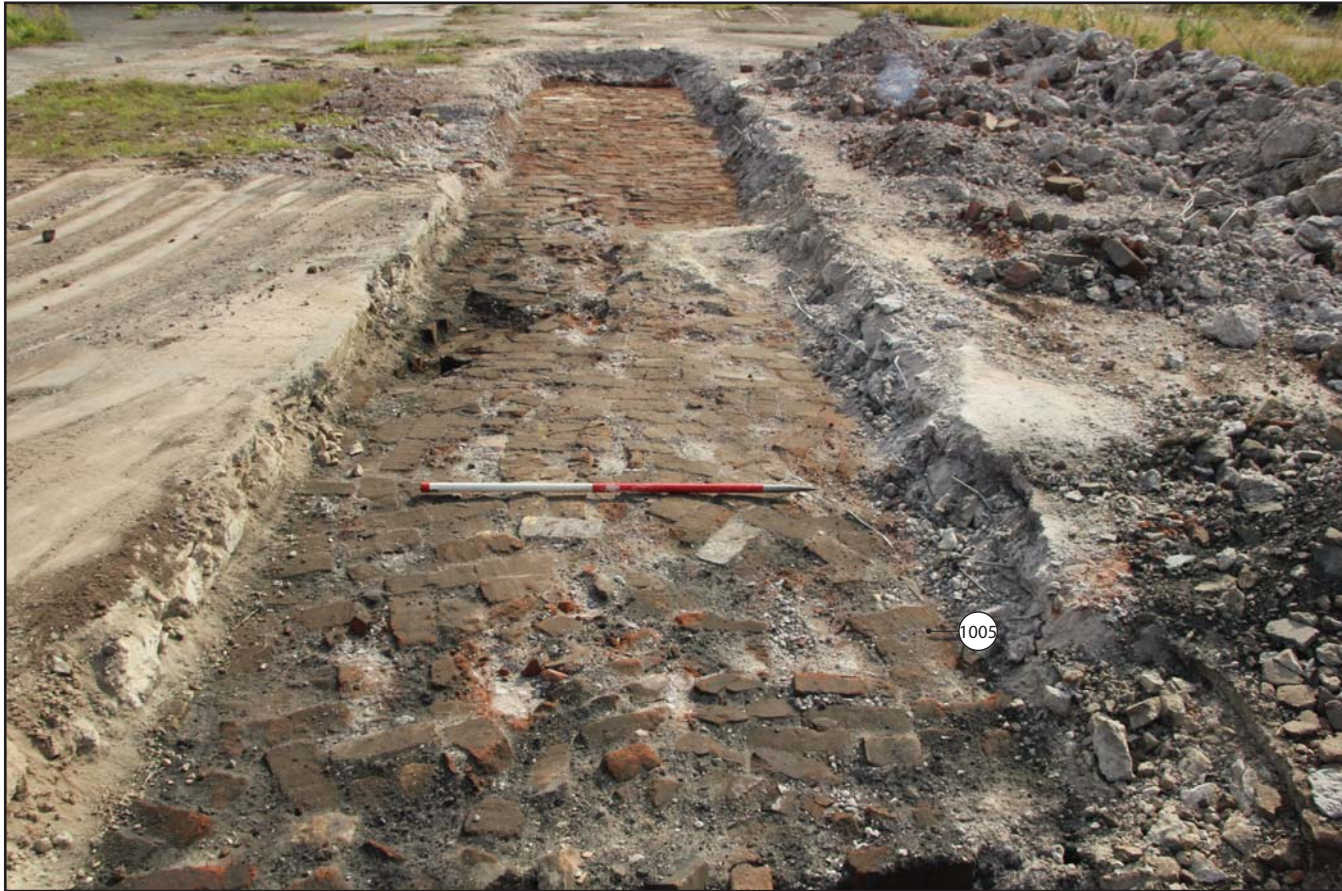
The southern half of the trench was dominated by a well preserved laid surface (1005) of unfrogged red and yellow bricks with occasional frogged brick repairs. This surface measured >13.75m in length by >2.0m in width and appeared to be at least two courses deep in places. The bricks did not appear to be bonded in any way but measured 0.22m in length by 0.11m in width by 0.07m in depth.

**Plate 26:** Trench 5 showing brick surface (1005), from the north. Scale 1.0m.

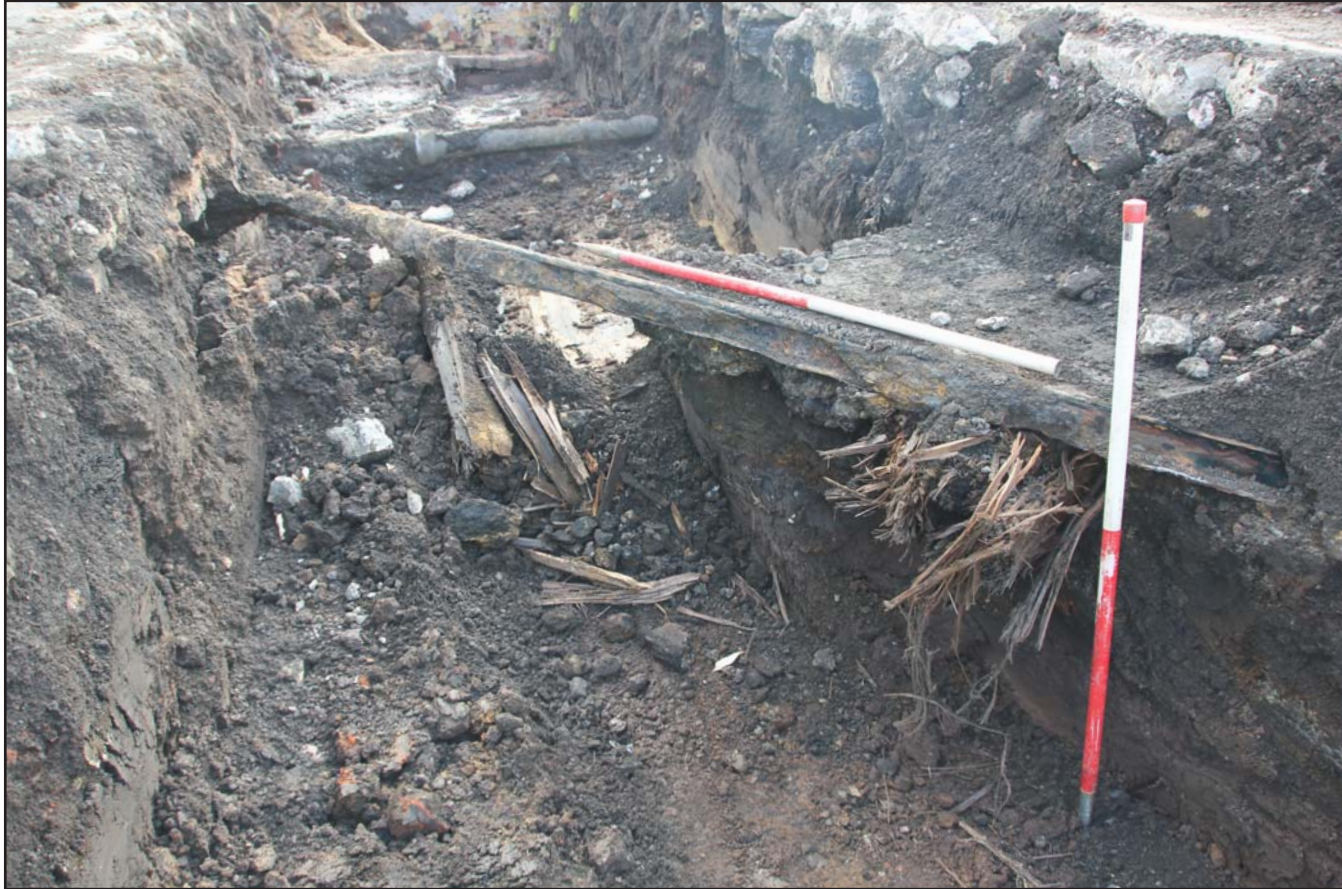
**Plate 30:** Trench 6 showing rail tracks, from the north. Scale 2x1.0m.
