# Land at Green Lane, Eccles, Greater Manchester. October 2015

Report no. 0069 v1.0

Archaeological Evaluation

Project Code: A0067.1

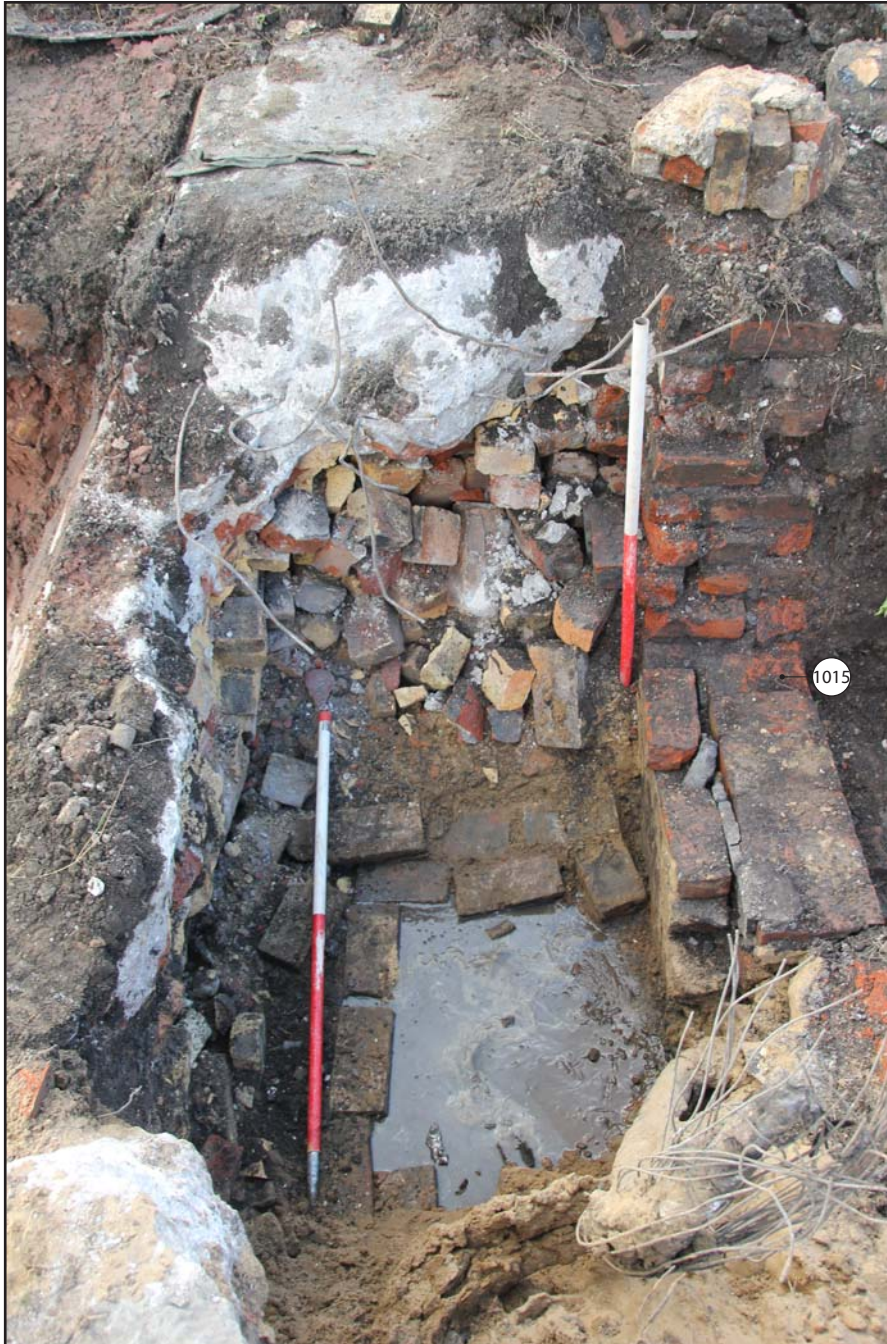
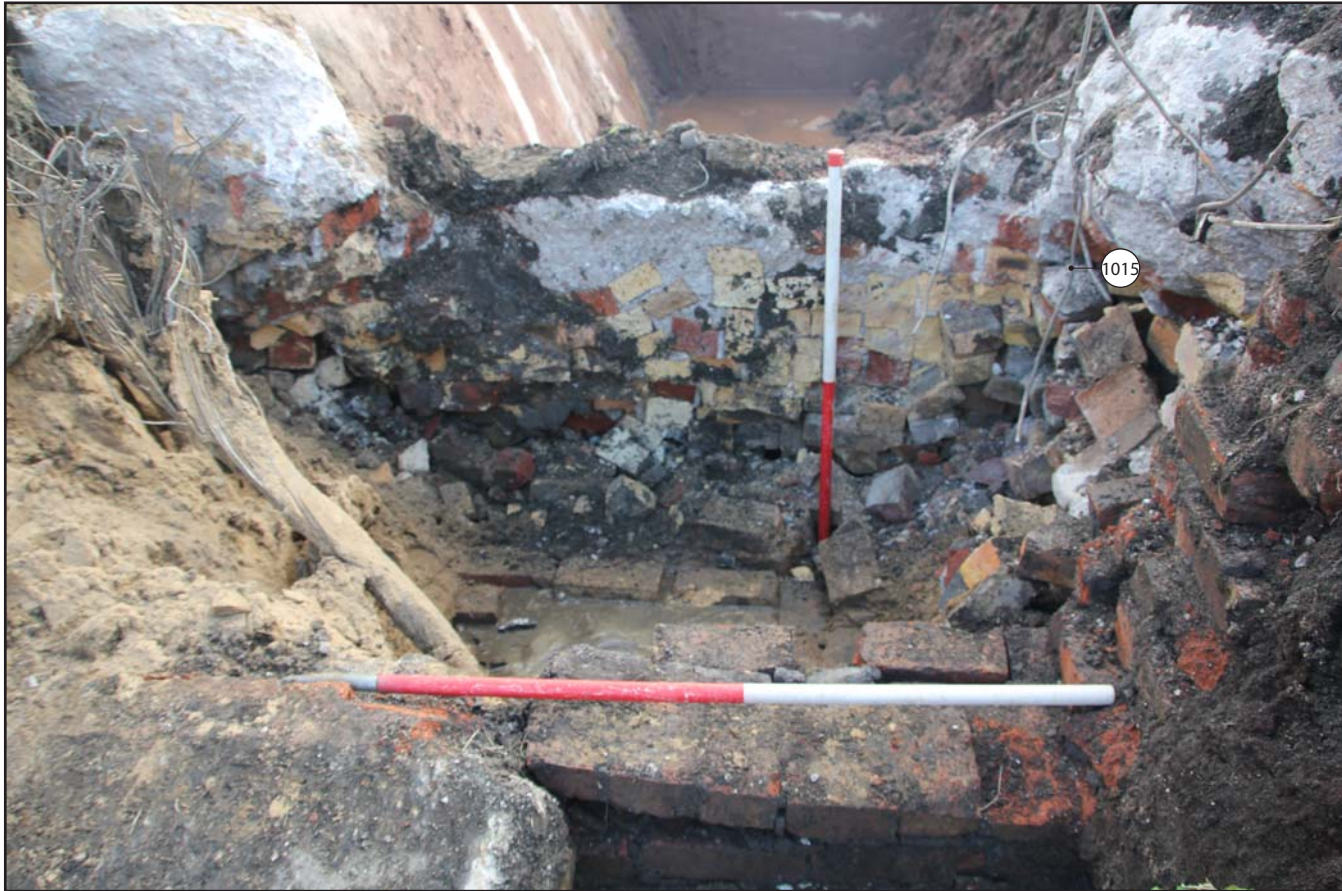
**Plate 31:** Trench 6 showing red-brick wall (1015), from the east. Scale 2x1.0m.

**Plate 32:** Trench 6 showing red-brick wall (1015), from the north. Scale 2x1.0m.

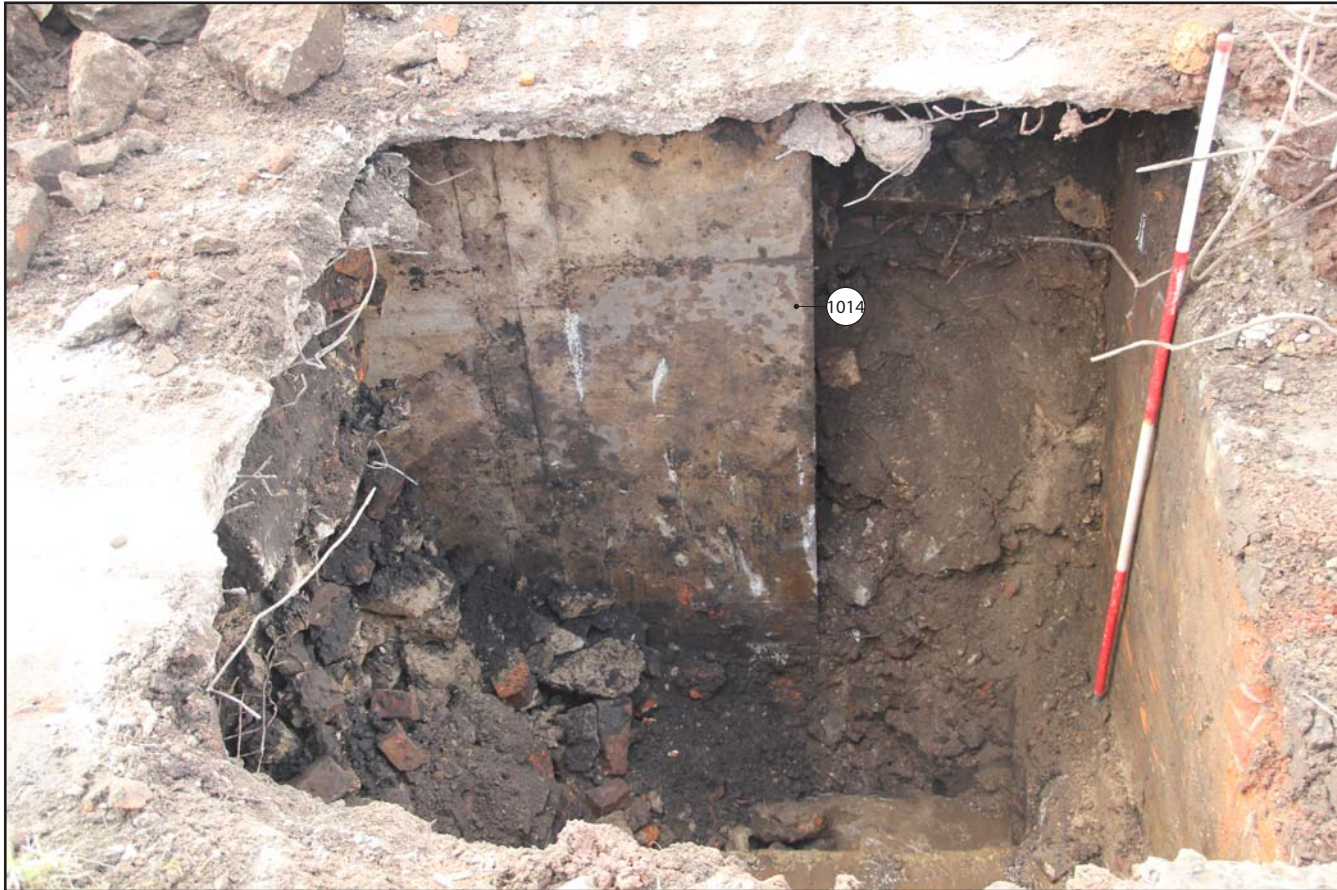
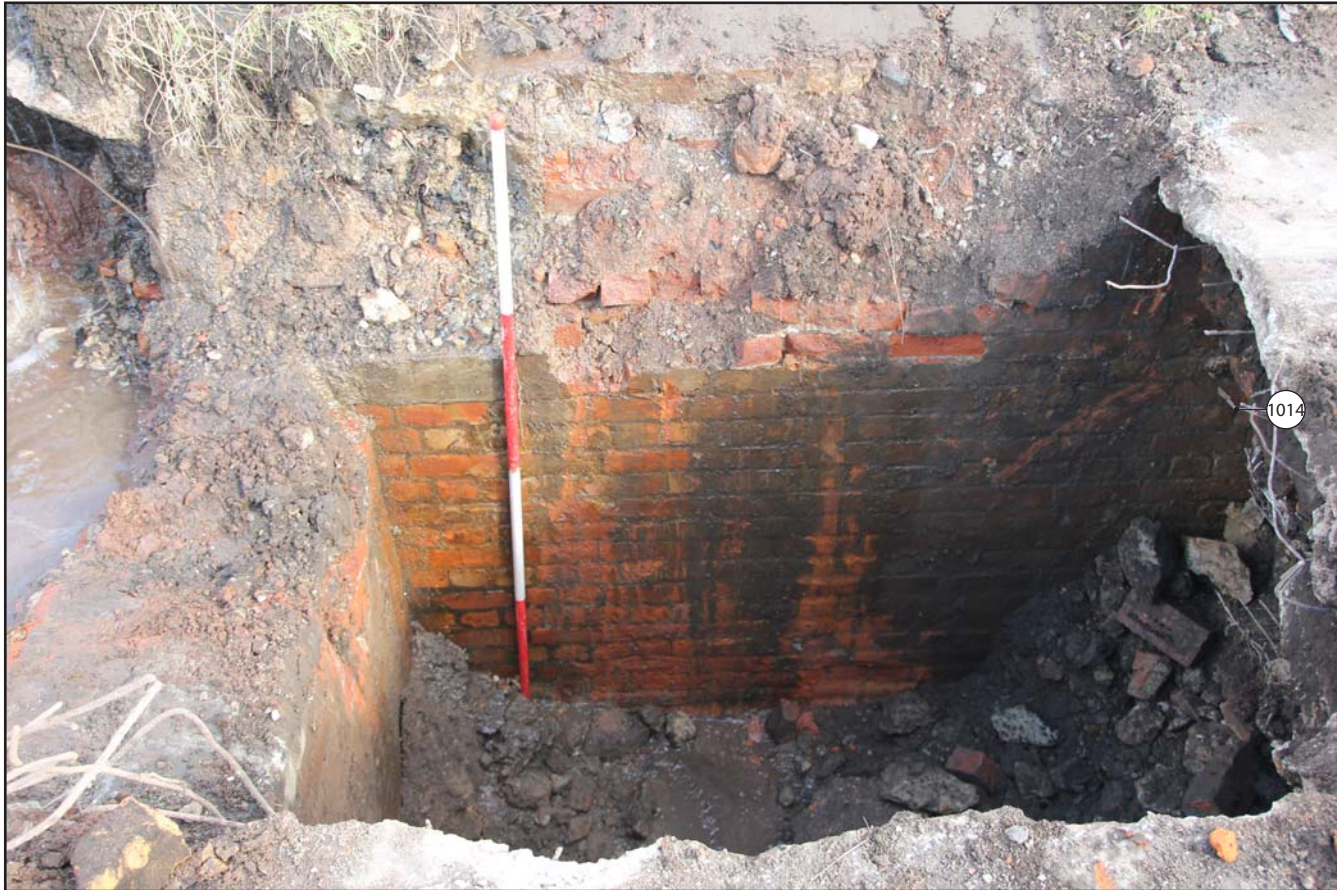
**Plate 33:** Trench 6 showing cellar (1014), from the east. Scale 2.0m.

**Plate 34:** Trench 6 showing cellar (1014), from the west. Scale 2.0m.
