**Grundy's Farm, Clover Road,
Chorley, Lancashire PR7 2NL.
November 2016
V 1.0**

Level 3 Historic Building Record
Project Code: A0100.1
Report no. 0110

Level 3 Historic Building Record

Client: The Casey Group Ltd

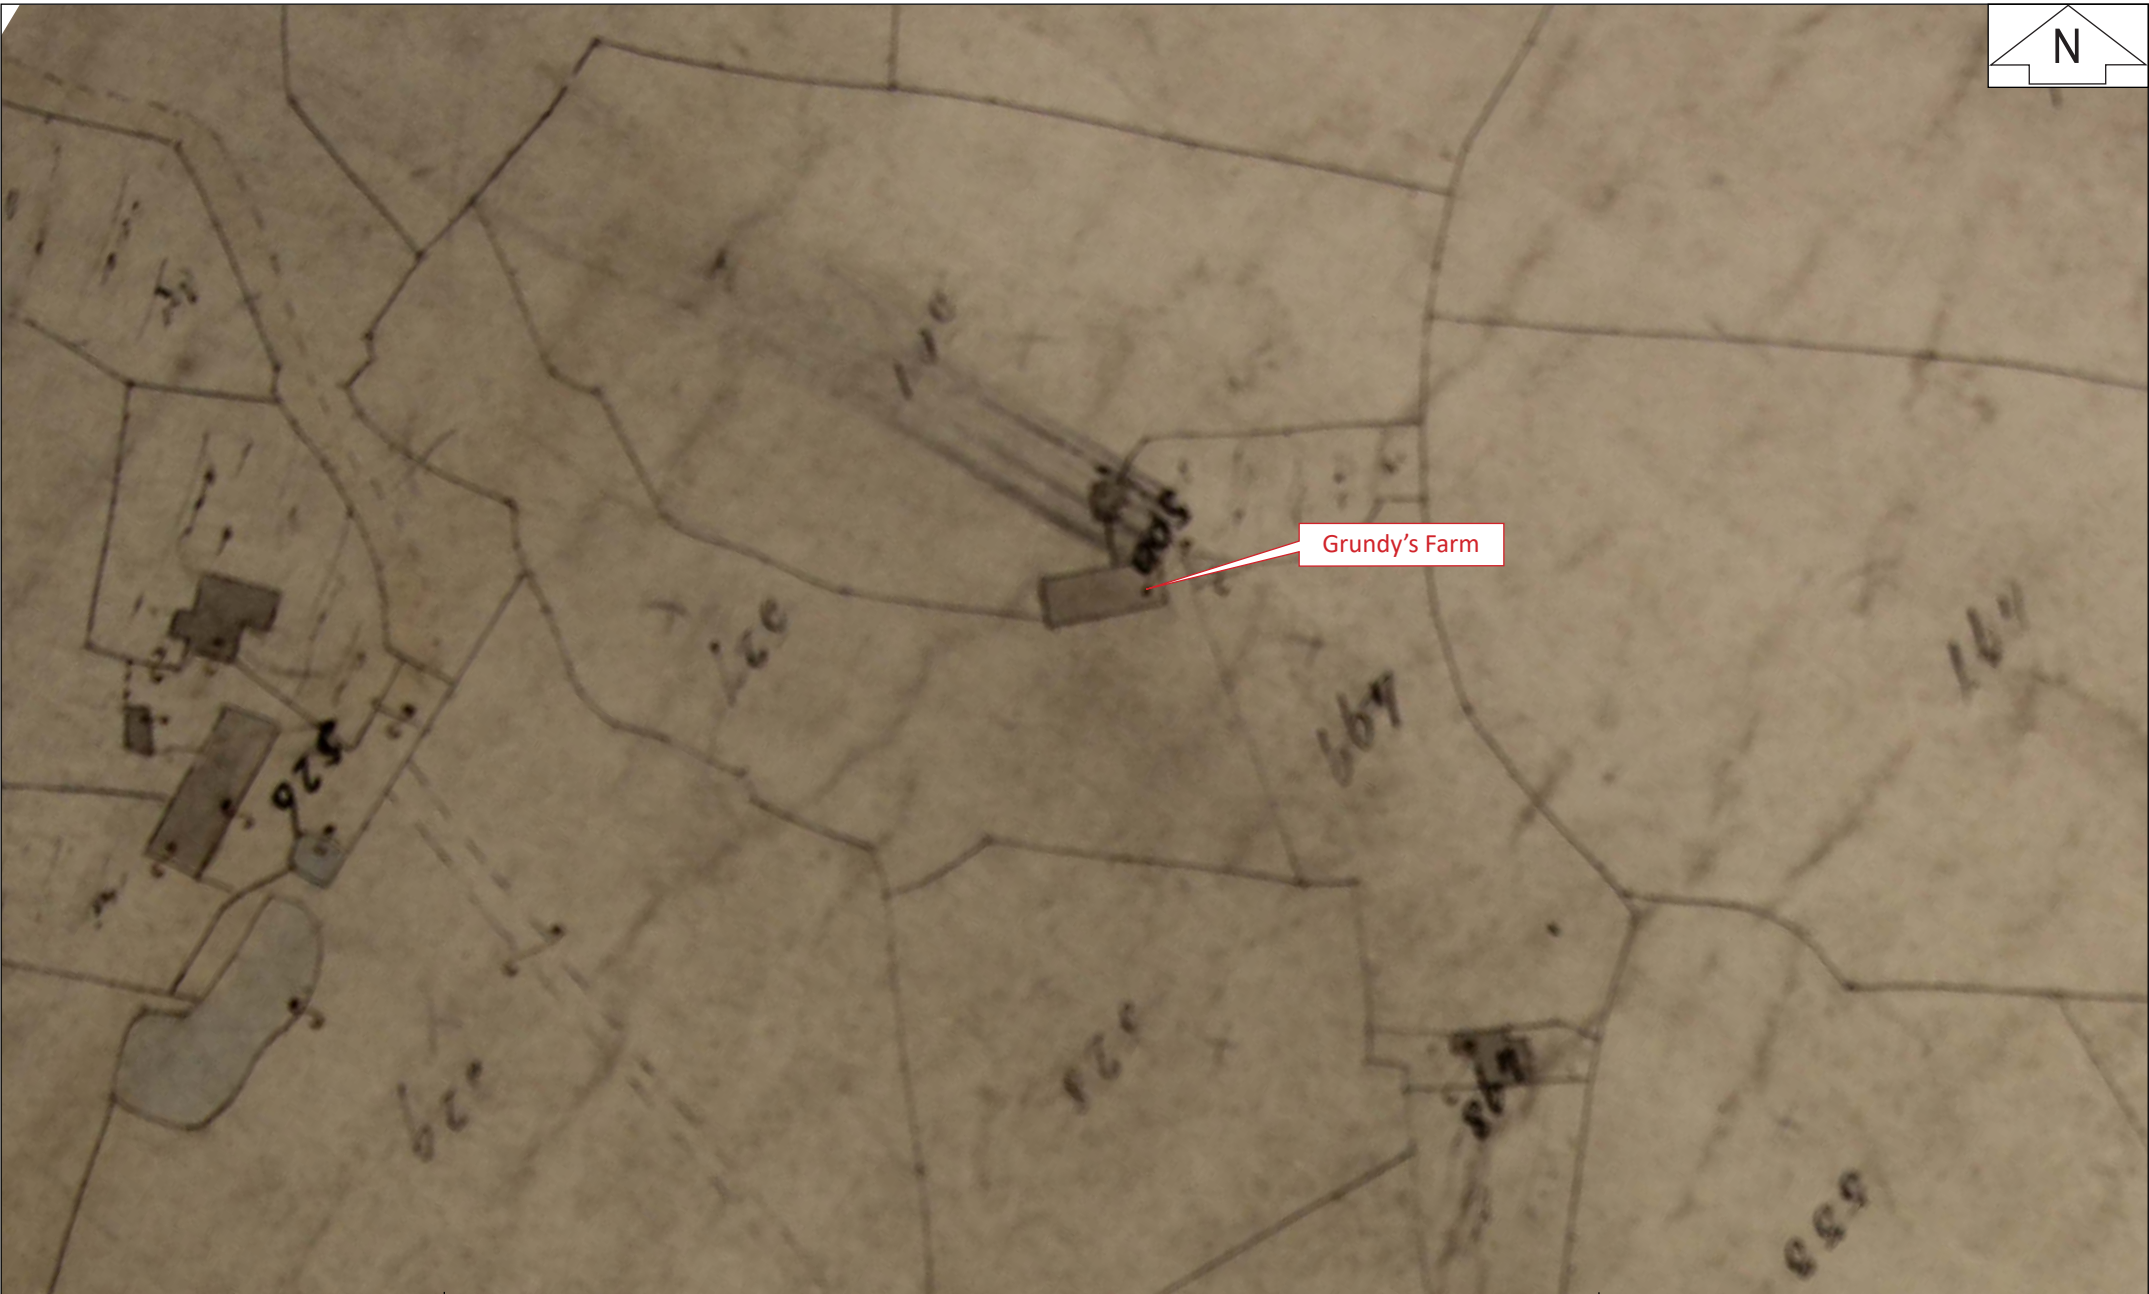
Figure 04: Location of Grundy's Farm on the Chorley Tithe Map of 1839.

The farm is shown on the Chorley tithe map of 1839 (figure 04) where it is again depicted as a rectangular structure orientated east to west. The map also appears to show a small outbuilding located to the north which is no longer in existence. The structure

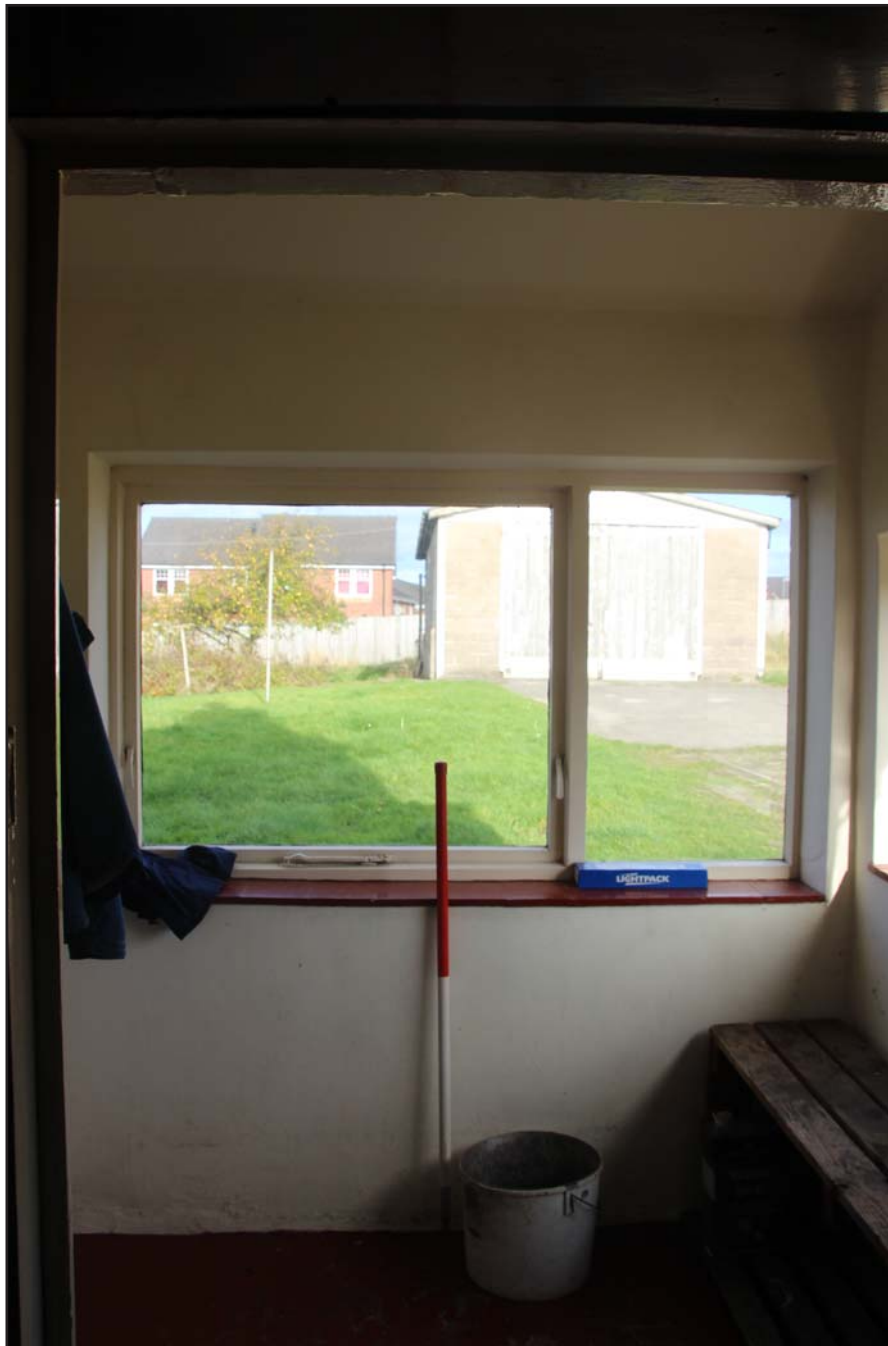
The northern elevation is dominated by a two pane window in white painted wooden frame with red painted tiled sill. The eastern elevation is dominated by a single pane window in white painted wooden frame with red painted tiles sill. A wood plank boot rack is located against the eastern elevation. The southern elevation has a single centralised doorway that permits access to the kitchen diner. The door is of dark stained wood with a single glass pane in the upper half.

The west elevation has a single doorway with dark brown stained wooden plank door to the left end which permits access to the rear of the property. The floor is of red painted concrete.

Plate 12: Northern Porch, from the south. Scale 1.0m.

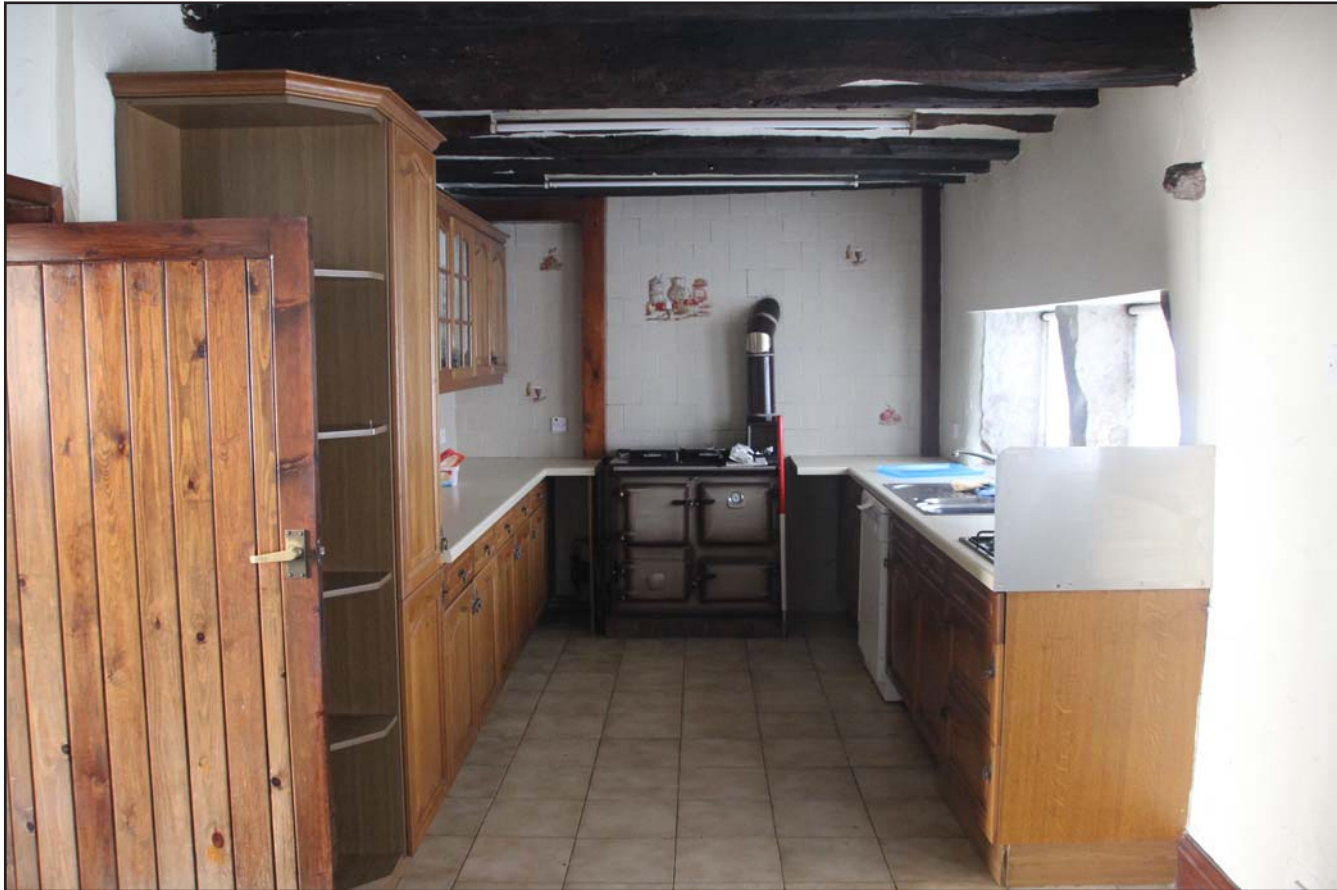
The north, east and south elevations are all plastered and painted white with the western elevation of modern ceramic tile. The eastern elevation has a utility cupboard at the left end with brown stained wooden board door and there is a noticeboard at the right end above a modern white painted radiator.

The southern elevation has a single doorway to the left of centre of dark brown stained wood that permits access to the living room, set within a dark brown stained frame. The right-hand end of the southern elevation is occupied by modern kitchen cupboard units.

The western elevation is featureless apart from a modern aga. There is a dark brown stained skirting board throughout above a floor of green carpet in the diner and yellow-beige tiles in the kitchen.

Plate 14: Kitchen/diner, from the east. Scale 1.0m.

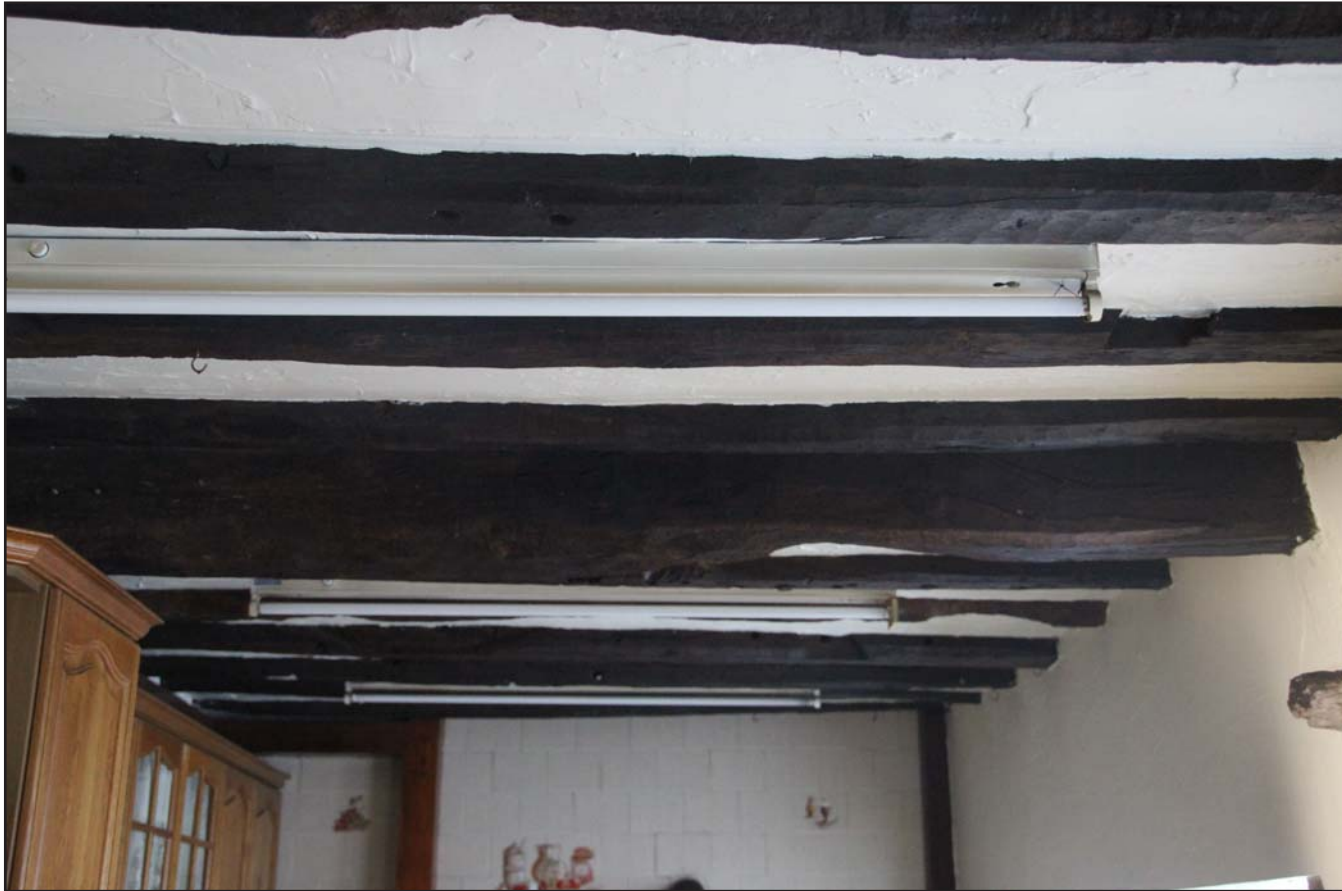
Plate 15: Kitchen/diner roof beam, from the east.

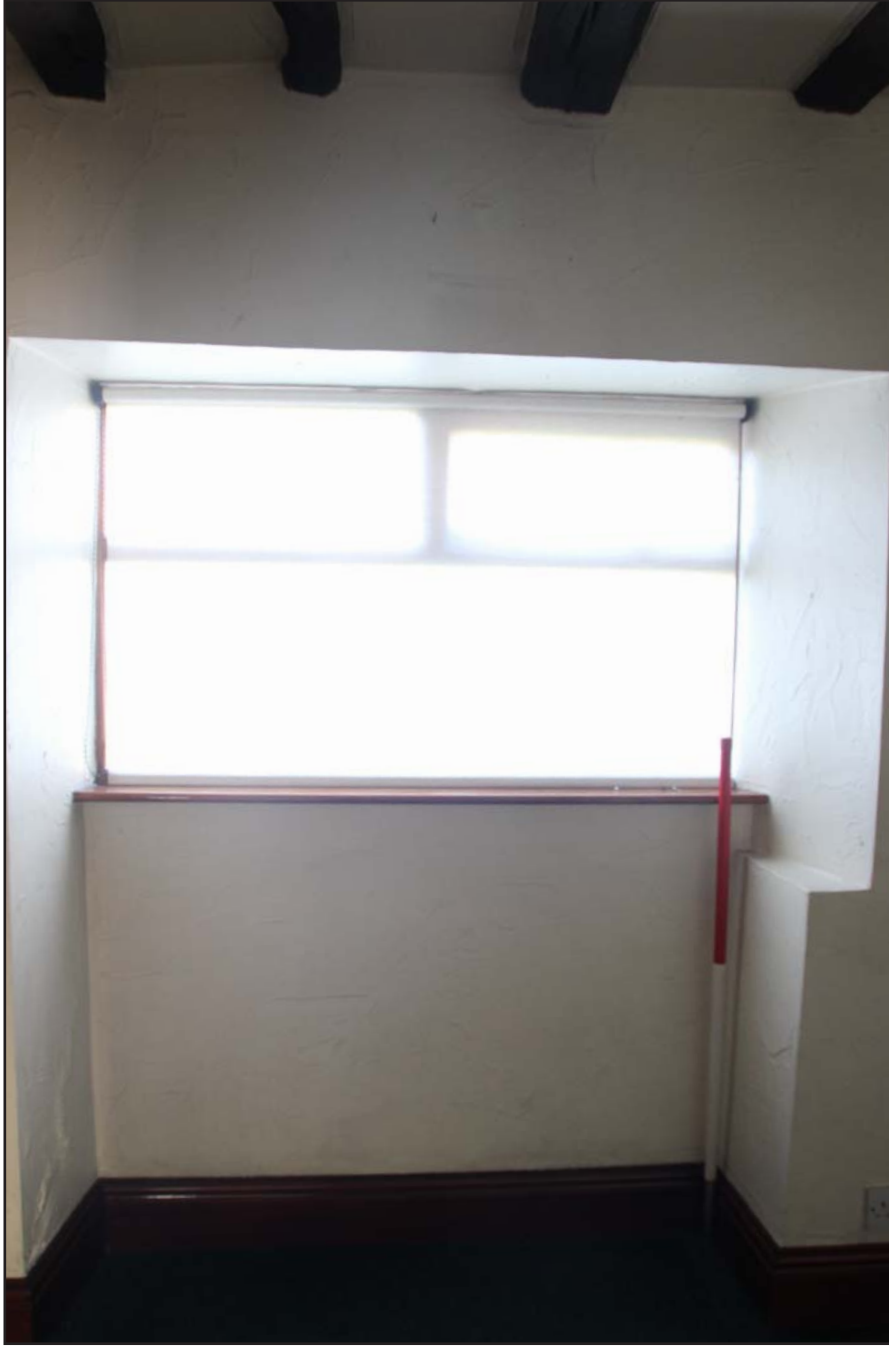
Plate 17: Kitchen/diner blocked door, from the south. Scale 1.0m.

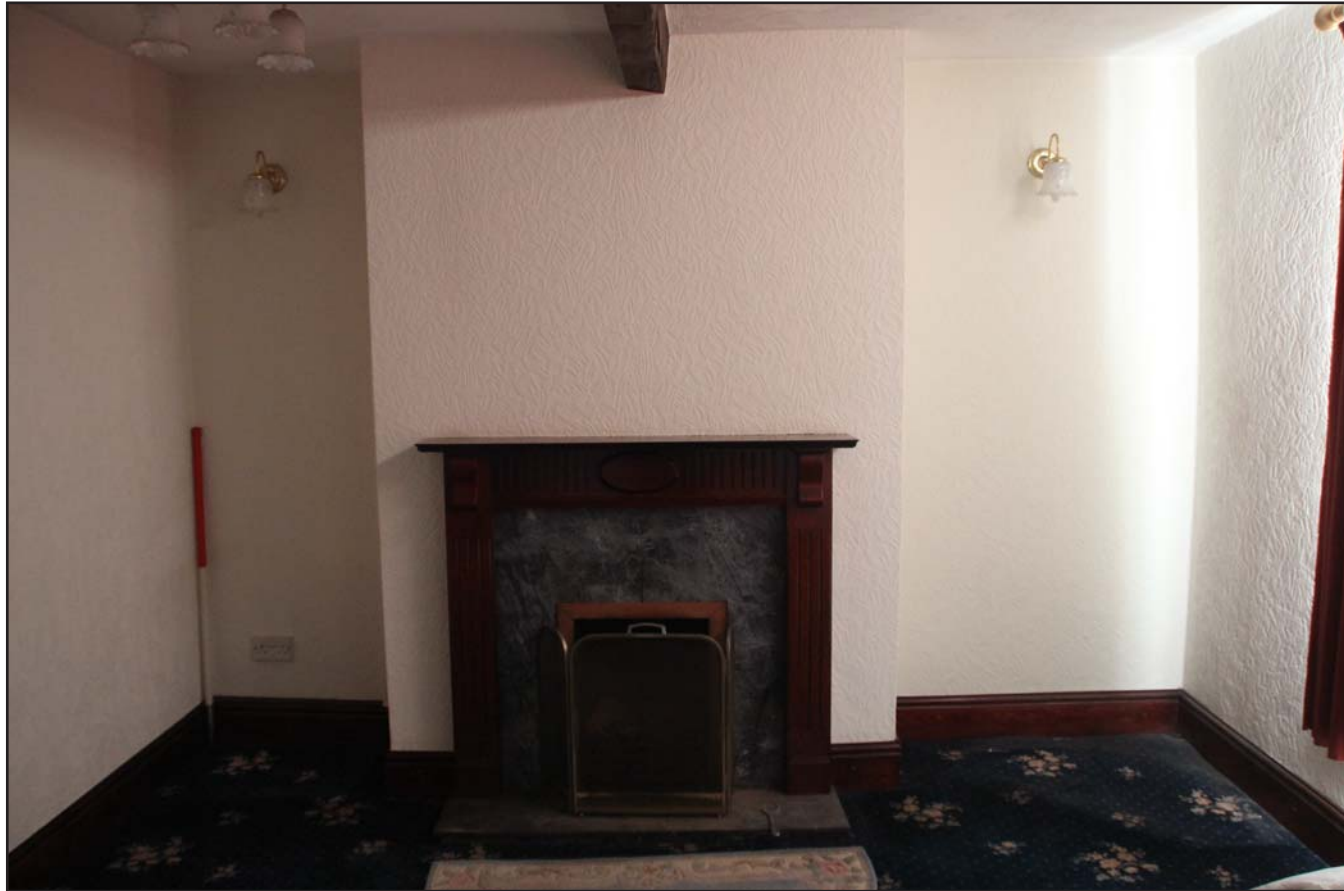
The northern elevation has a single doorway with dark-stained wooden board door to the left of centre, which permits access to the kitchen diner. The eastern elevation has a chimney breast to the left of centre with an open fire with mahogany affect mantelpiece, synthetic blue marble surround, and a grey synthetic marble hearth.

The southern elevation has a window opening to the left of centre with four single glazed window panes in brown stained wooden frames with wooden sill and surrounded by red velvet curtains. The western elevation has a single doorway to the right of centre with dark brown stained wooden door and frame. Mahogany effect skirting board is located throughout the room and the floor is of blue floral patterned carpet.

Plate 18: Living Room, from the west. Scale 1.0m.

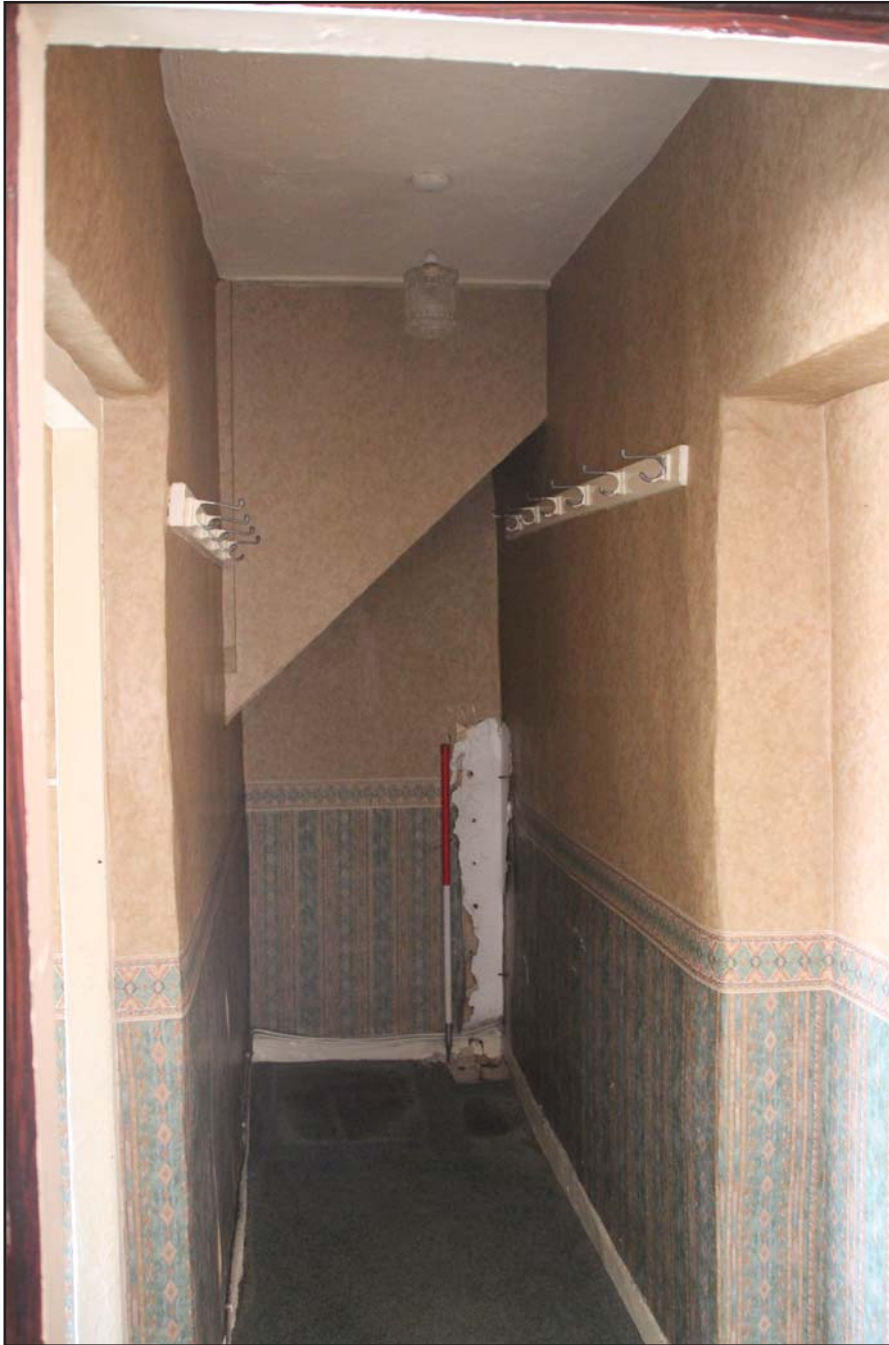
The northern elevation has a coat rack to the left of centre and at the right end has a blocked up doorway that would have led to what is now the kitchen. The eastern elevation is entirely of a single doorway that permits access to the living room via a dark brown stained wooden board door and frame.

Plate 20: Cloak Room, from the east. Scale 1.0m.

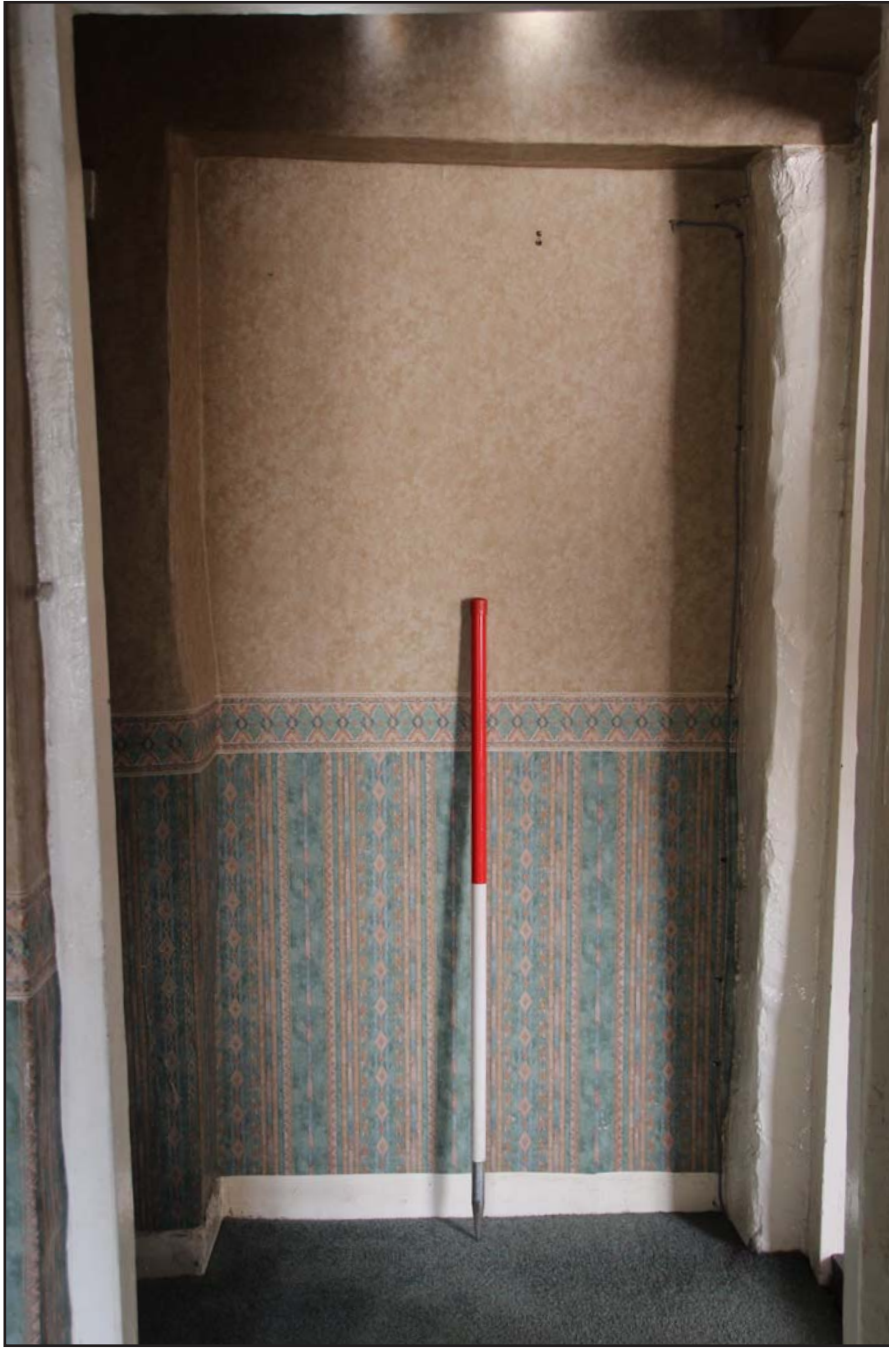
Plate 21: Cloak Room blocked doorway, from the south. Scale 1.0m.

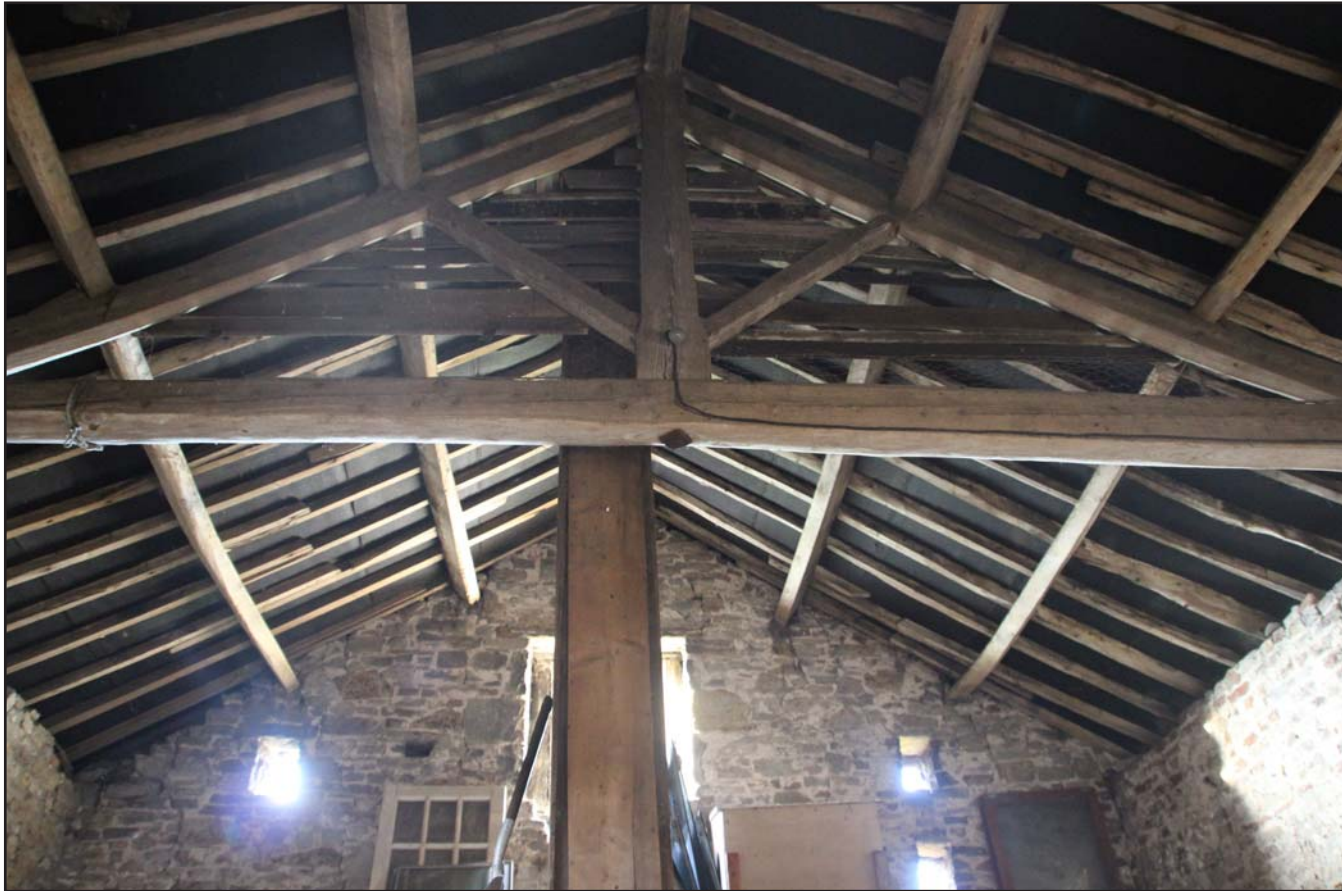
Plate 32: Byre roof showing truss and purlins, from the east.

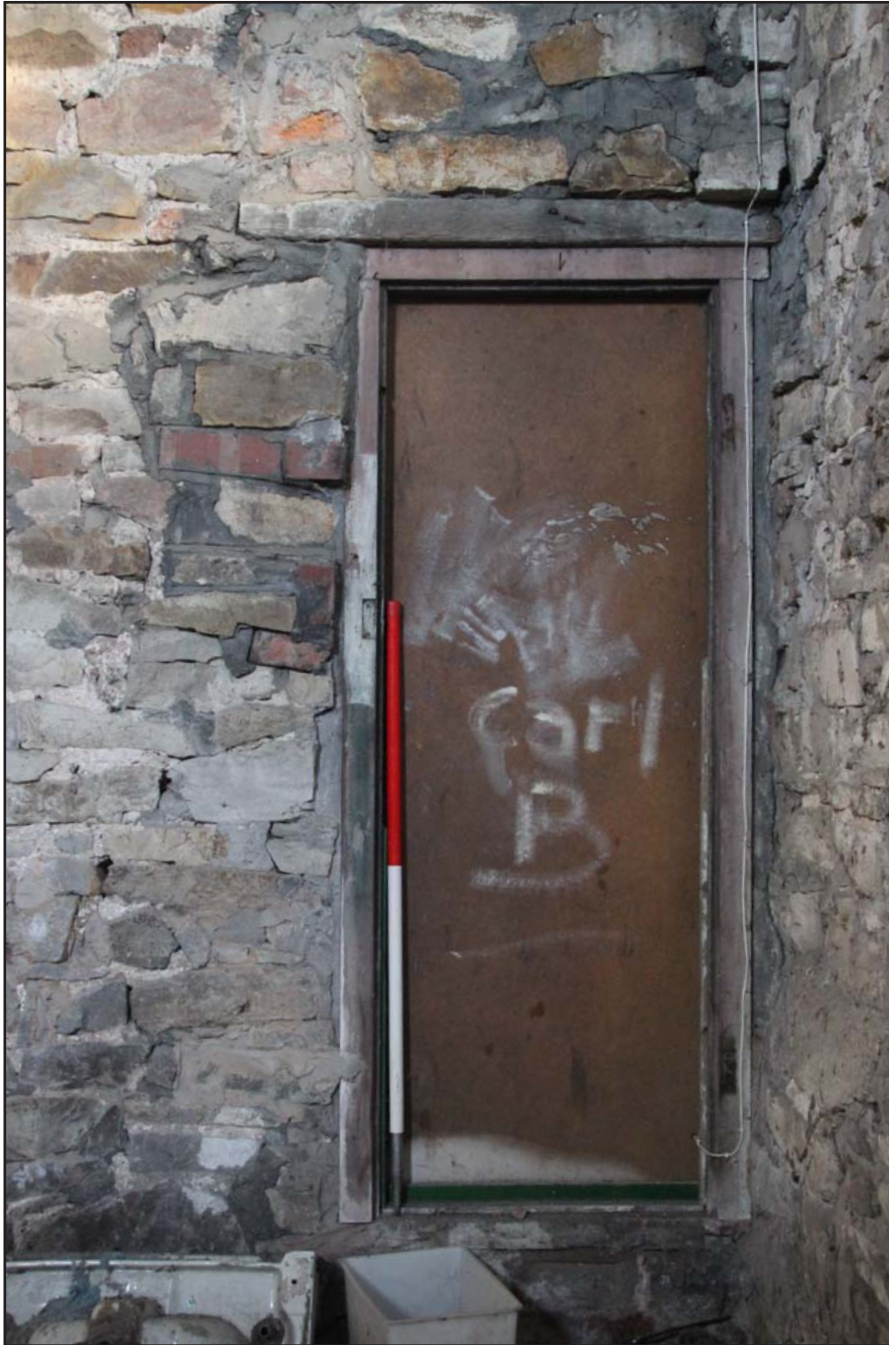
Plate 33: Byre 1 blocked doorway, from the west. Scale 1.0m.

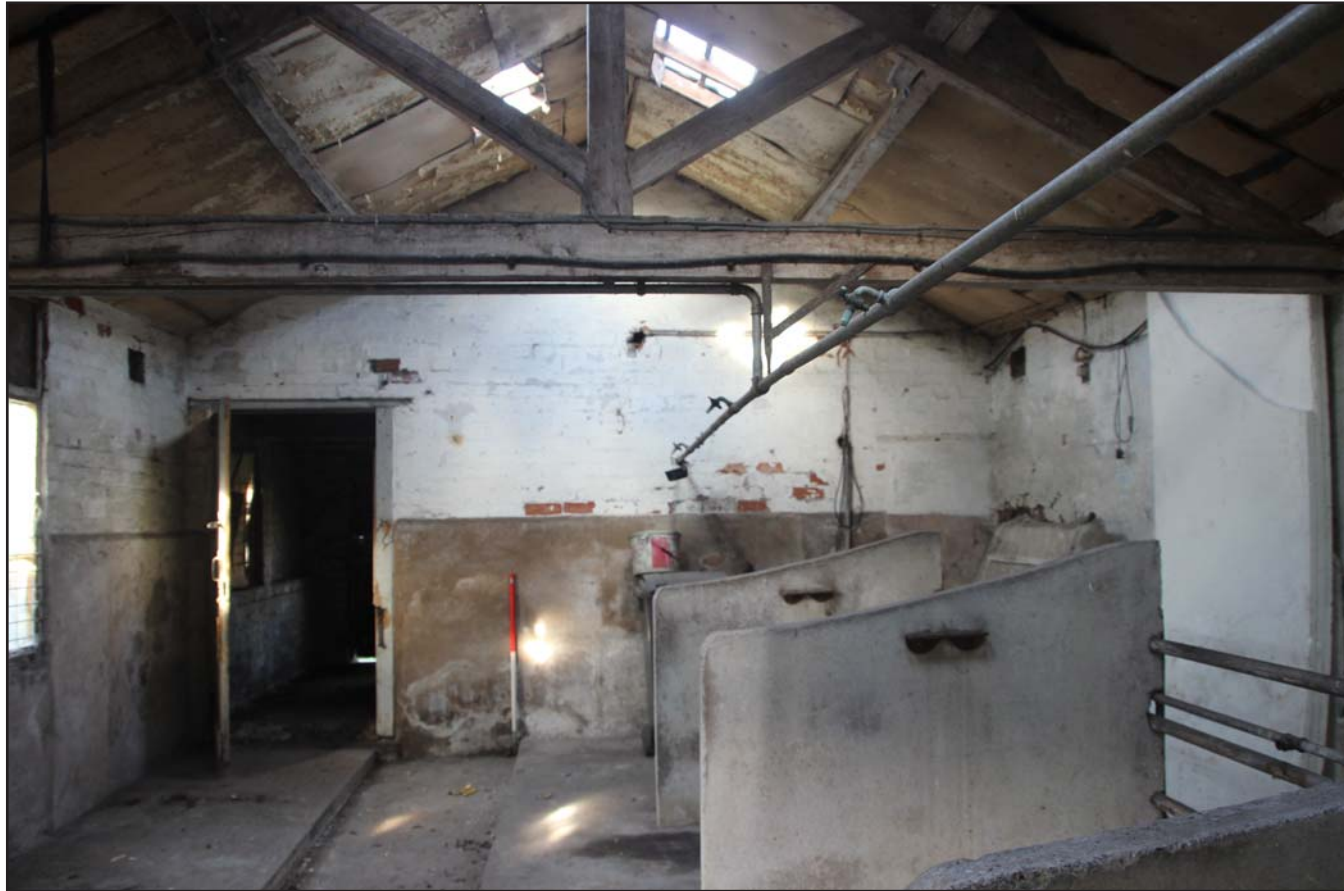
by upright timbers. The walls are all rendered but unpainted. The northern elevation has a single doorway at the left end which permits access into the milking parlour via an unpainted wooden board door and frame. The eastern elevation has three equally spaced window openings, now boarded up. The southern elevation has a single window in wooden frame at the left end and a single doorway with unpainted wooden board door at the right end permitting access to the front of the property. The western elevation has a single centralised window in an unpainted wooden frame with a stone sill.

The floor is of poured concrete and has a north-south gulley running up the western half of the room with three iron milking stalls along the eastern elevation.

Plate 35: Outbuilding milking parlour, from the north. Scale 1.0m.

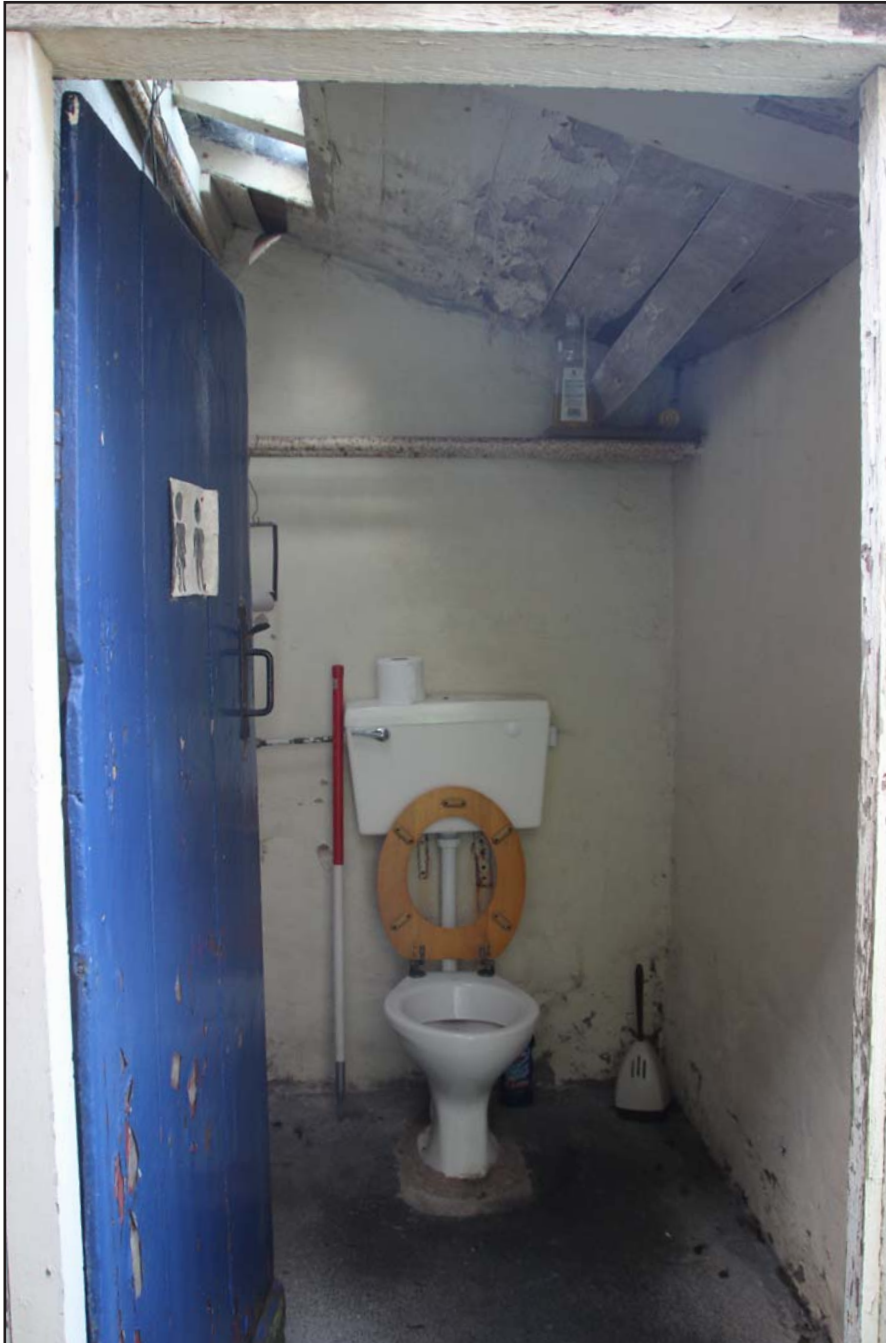
A rectangular room measuring 1.77m in length by 1.22m in width orientated north to south. The ceiling is open to the mono-pitch roof which is of wooden boards and the walls are all plastered and painted magnolia. There is a white ceramic toilet against the northern elevation and a single doorway permitting access to the rear of the building via a blue-painted wooden door in the southern elevation. The floor is of poured concrete.

Plate 37: Outbuilding toilet block, from the south. Scale 1.0m.

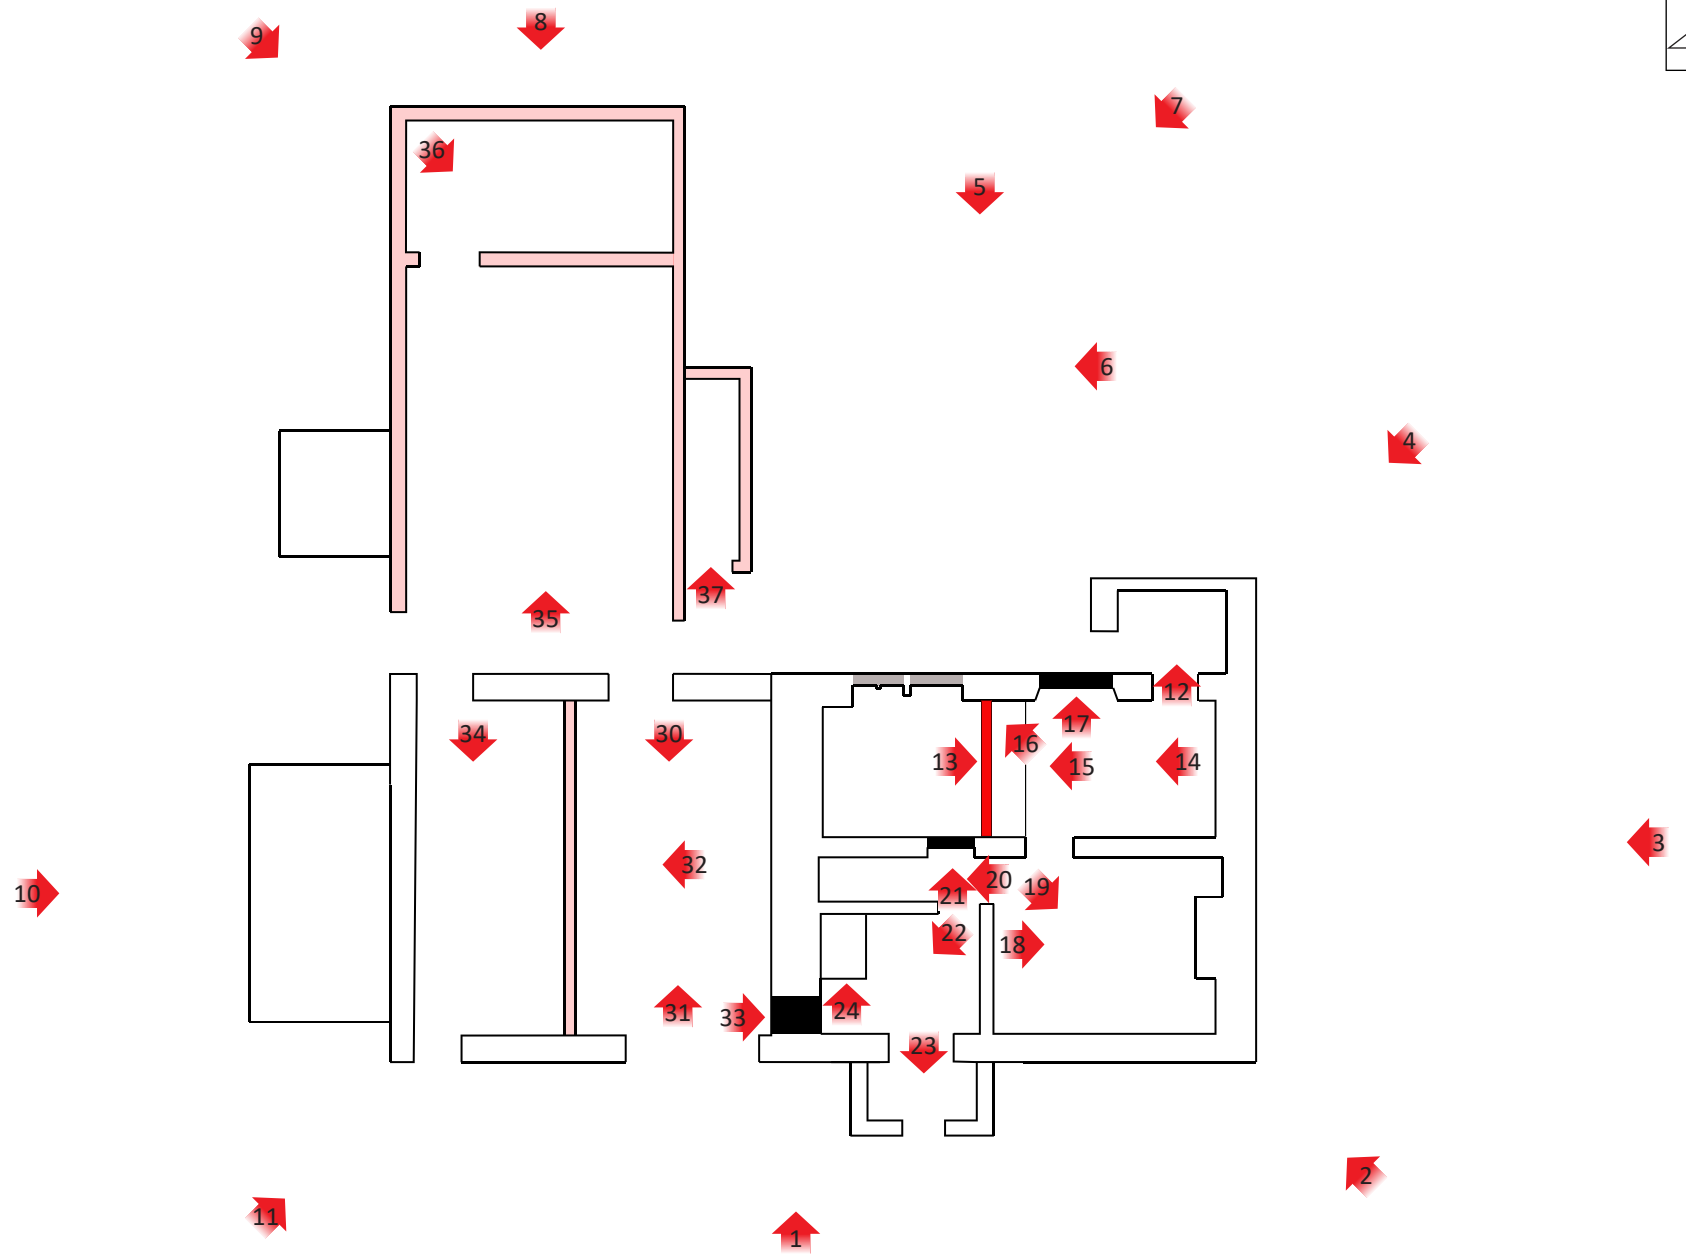
Figure 11: Location and orientation of photographs - Ground floor, Grundy's Farm, Clover Road, Chorley. Scale 1:150 at A4.

The significance, origins and development of the site are discussed with reference to the available historical sources. A photographic record was made using a Canon DSLR 600D camera set to maximum resolution. The location and orientation of photographs are shown on figures 11 and 12.

- Wooden beam
- Blocked Door
- Possible Blocked Door
- Red-Brick Walls
