**Hield House Barn,  
Aston By Budworth, Cheshire,  
CW9 6LP.  
January 2017  
V 1.0**

Level 2 Historic Building Record  
Project Code: A0103.1  
Report no. 0114

Level 2 Historic Building Record

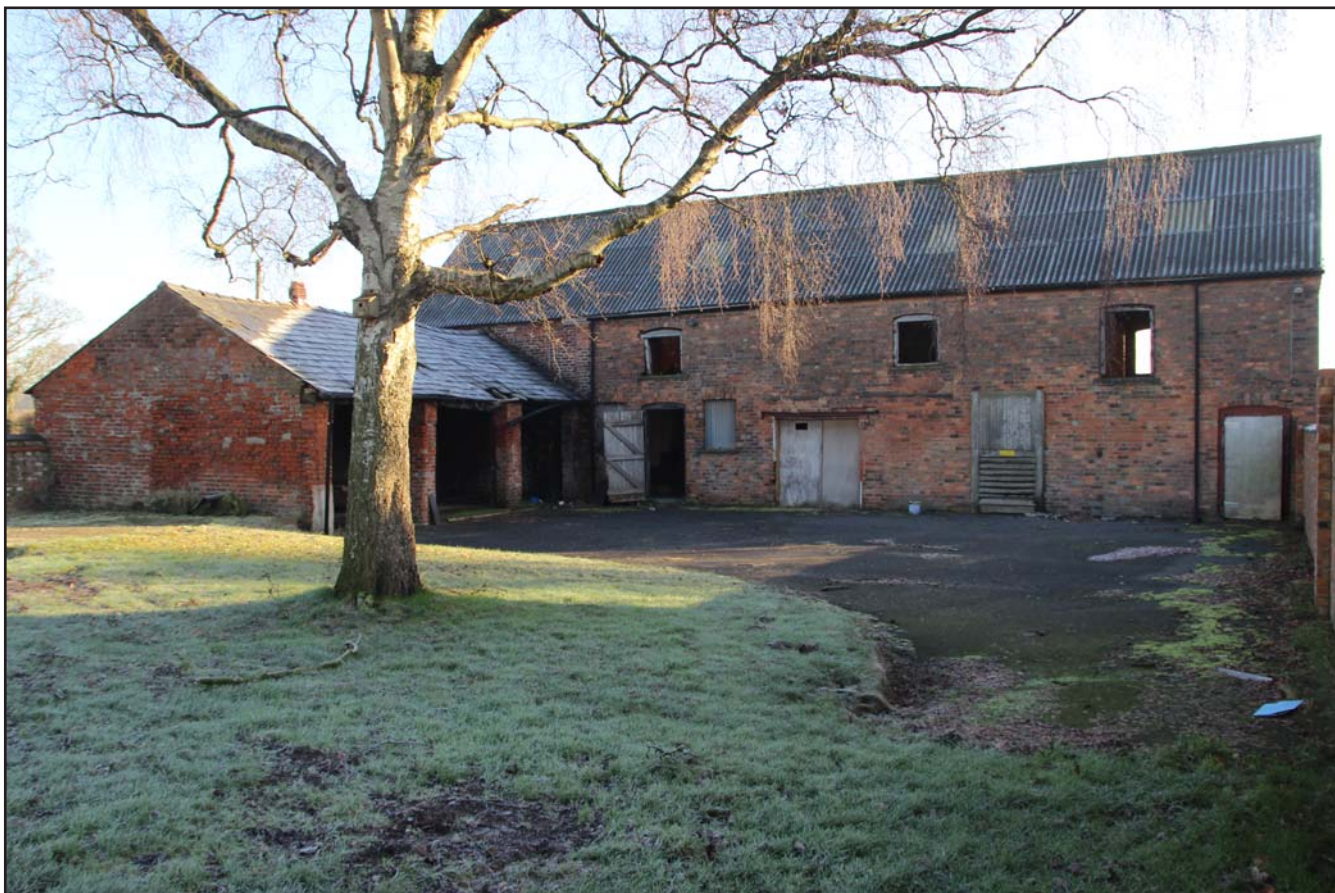
**Plate 01:** West facing external elevation, from the west-southwest. Scale 1.0m.

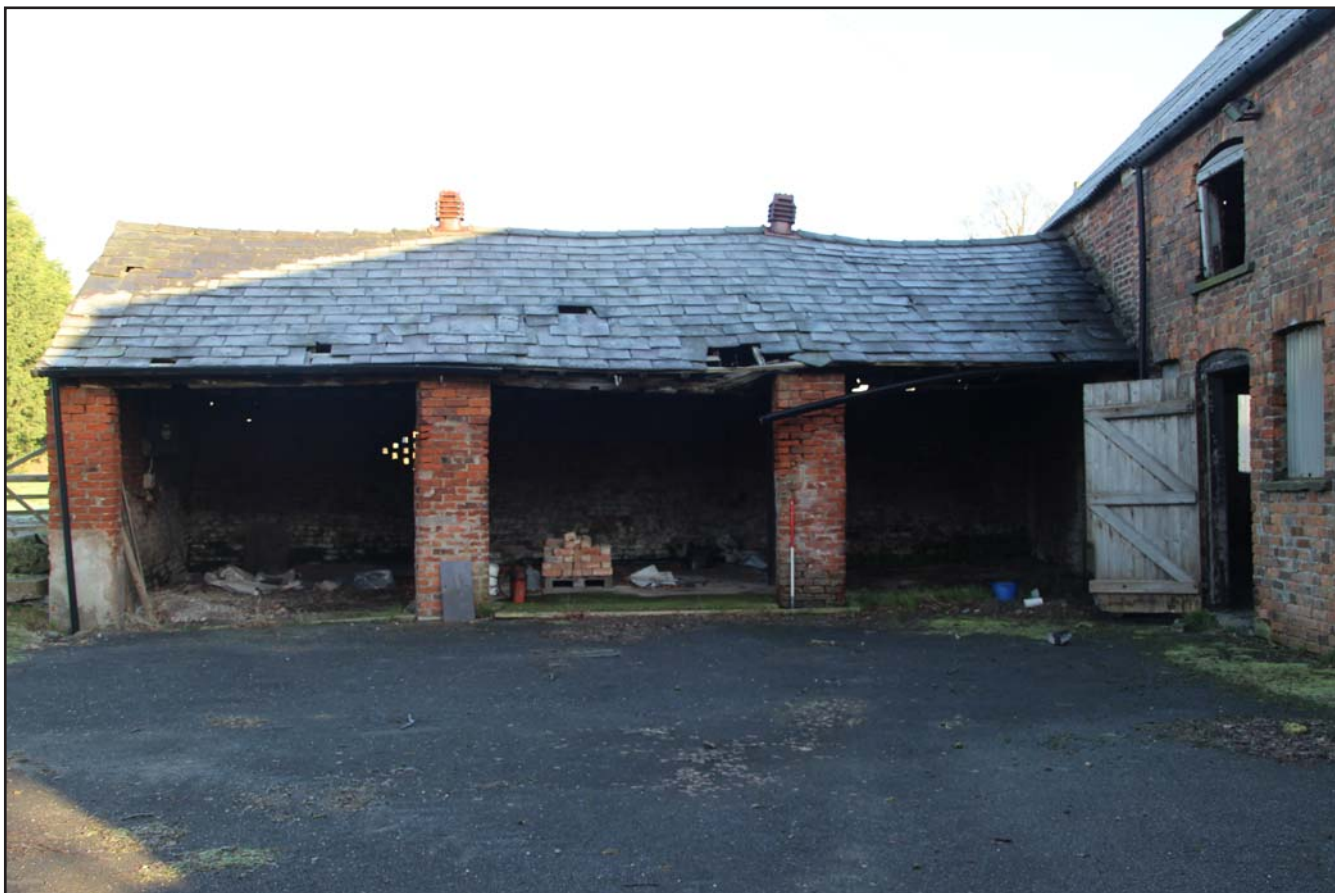
The southern elevation has four pillars of unfrogged red-brick bonded by mortar creating three equally sized entrance bays.

**Plate 02:** South facing external elevation (outbuilding), from the south. Scale 1.0m.

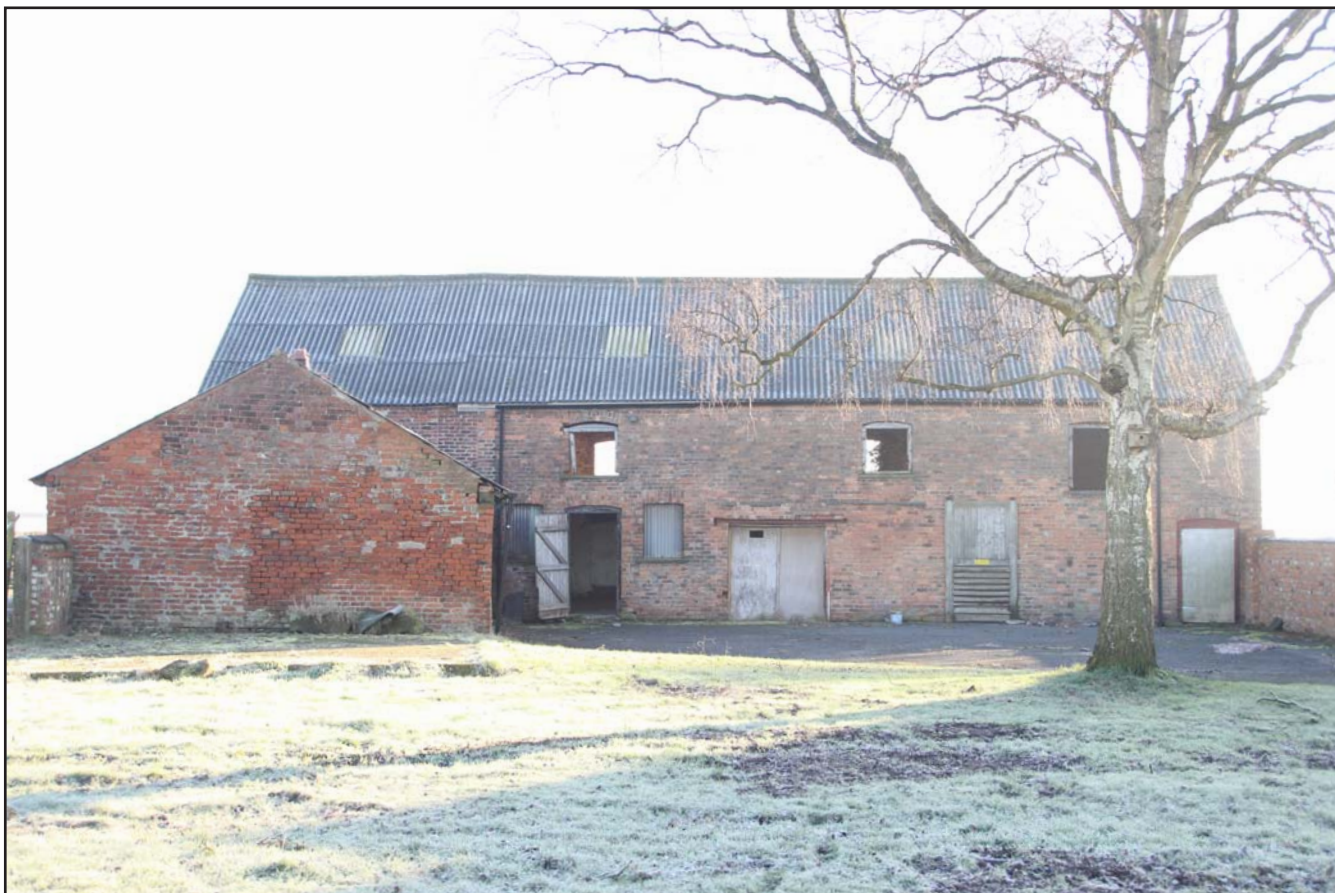
The western elevation has a black PVC gutter directly beneath the roof pitch with two downpipes of the same at either end. There are three window openings at first floor level, all spaced ad-hoc and all with radiating red-brick voussoirs and wooden frames. The central and

left most windows have sandstone sills; the right most window is slightly longer and has a slate sill.

At ground level there are two small window openings at the left end, with radiating red-brick voussoirs and sandstone sills and covered with modern Perspex. Between these two windows a single doorway with wooden board door and black-painted wooden frame is located that permits access into Barn 1.

At the centre of the elevation a double door with iron-rail lintel permits access into Barn 2 but has been boarded-up. Two further single doorways permit access into Barn 2 and are equally spaced to the right of the double door. These both have radiating red-brick voussoirs; the left doorway has been boarded-up with a wooden ventilation door; the right has a red-painted wooden frame and ply-wood board door.

**Plate 03:** West facing external elevation, from the west. Scale 1.0m.

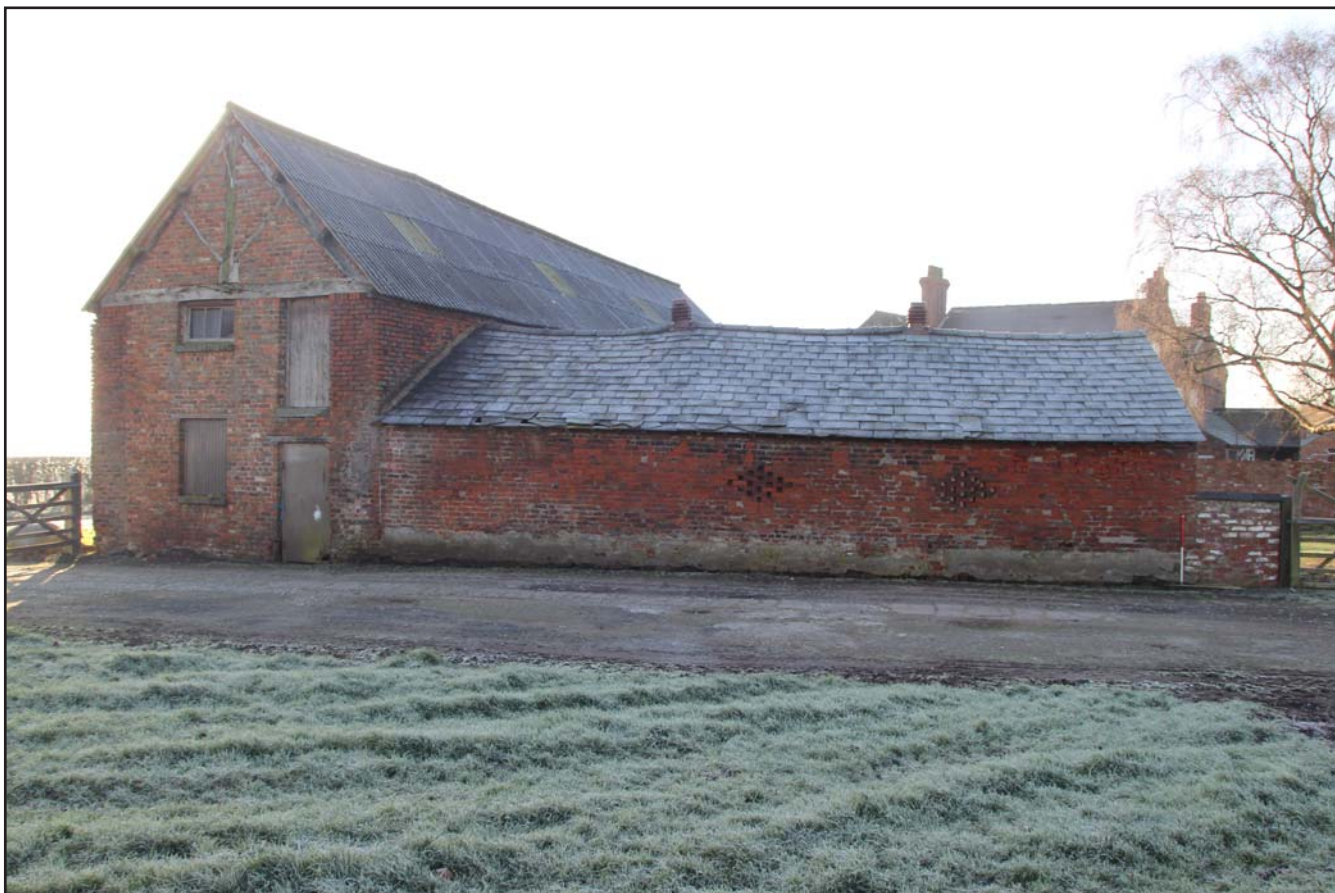
The northern gable elevation has a closed king-post truss visible at first floor level, beneath which is a single wooden board door in wooden frame with sandstone step, also at first floor level. At the left end is a three pane single-glazed window in unpainted wooden frame.

Beneath these and at ground floor level is a single wooden board door with wooden lintel and frame at the right end, and a boarded-up window opening with wooden lintel and brick sill at the left end.

**Plate 04:** North facing external elevation, from the north-northwest. Scale 1.0m.

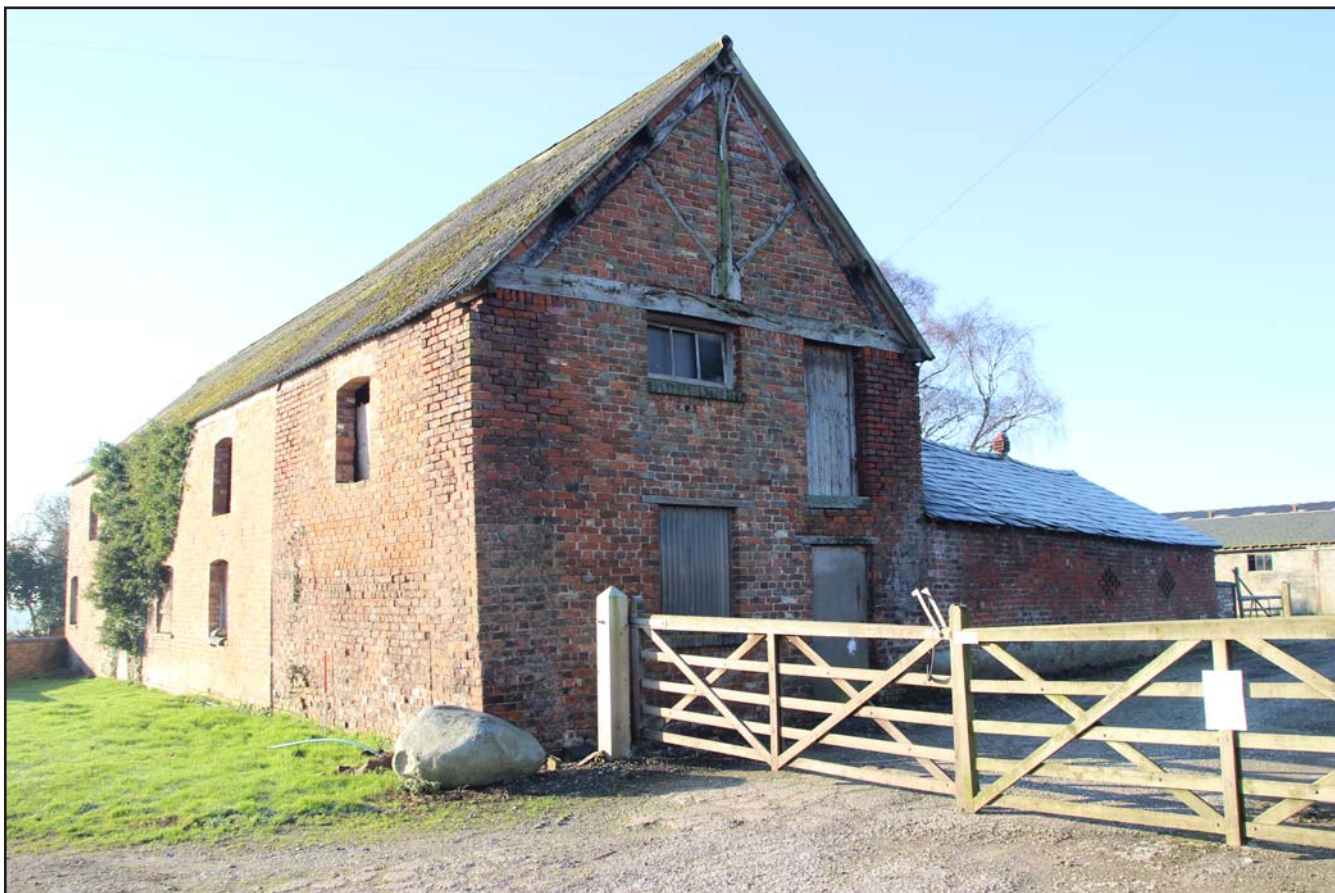
**Plate 05:** North and east facing external elevations, from the northeast. Scale 1.0m.

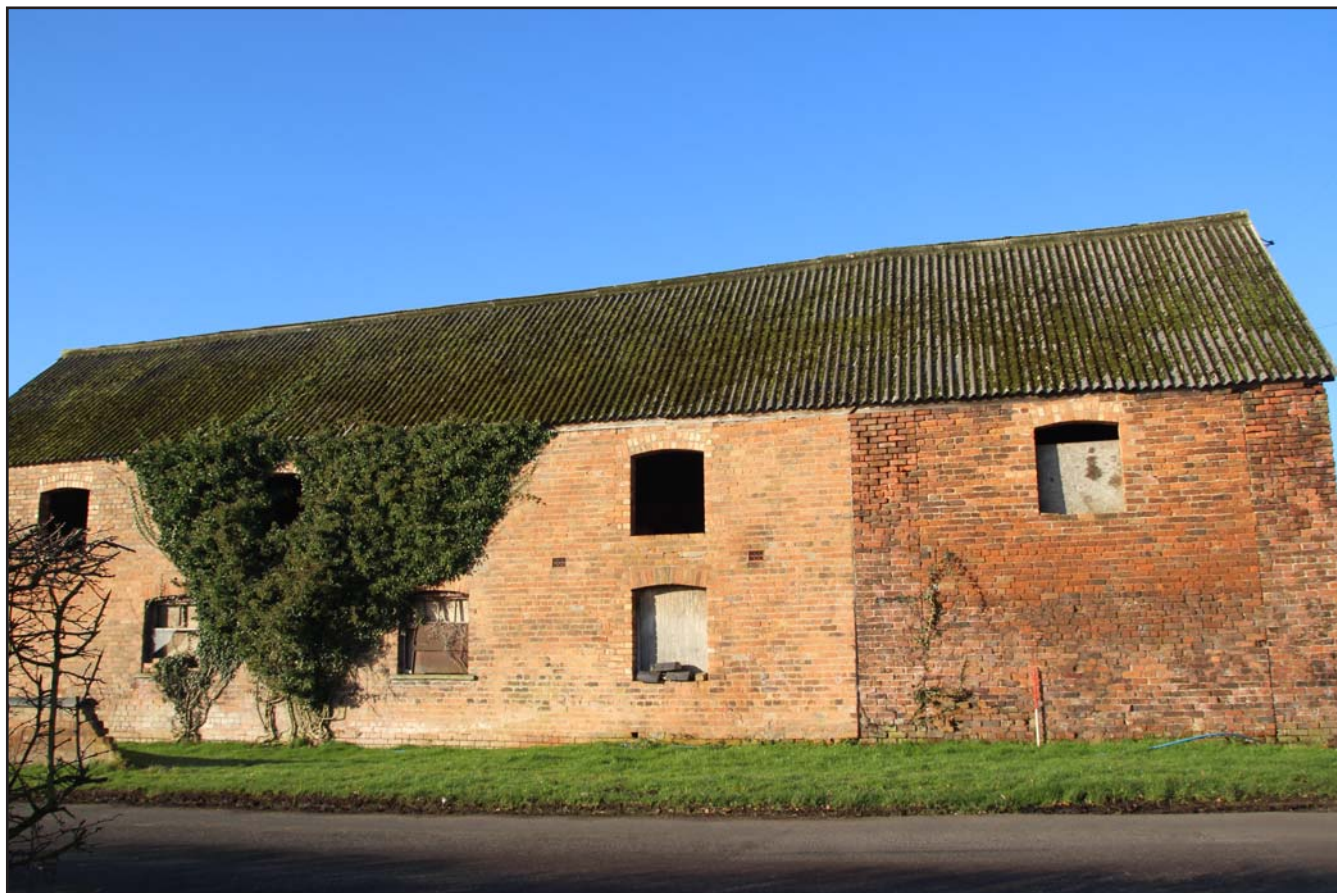
The eastern elevation has four equally spaced window openings at first floor level, all with radiating red-brick voussoirs and without frames and glass. There are a further four window openings at ground floor level, all located within the southern two-thirds of the elevation. The three right hand most windows are equally spaced but the left hand most window is offset to the left. All have radiating red-brick voussoirs and sills, and retain parts of their wooden frames but are without glass.

The northern one-third of the elevation is constructed for the most part of a hand-made unfrogged red-brick, darker in fabric to the rest of the elevation and clearly of an earlier date. At either end of this northern one-third two clear red-brick pillars can be seen within the masonry, suggesting that this part of the barn was originally an open pillared barn which was later bricked-up to form an enclosed building.

**Plate 06:** East facing external elevation, from the east. Scale 1.0m.

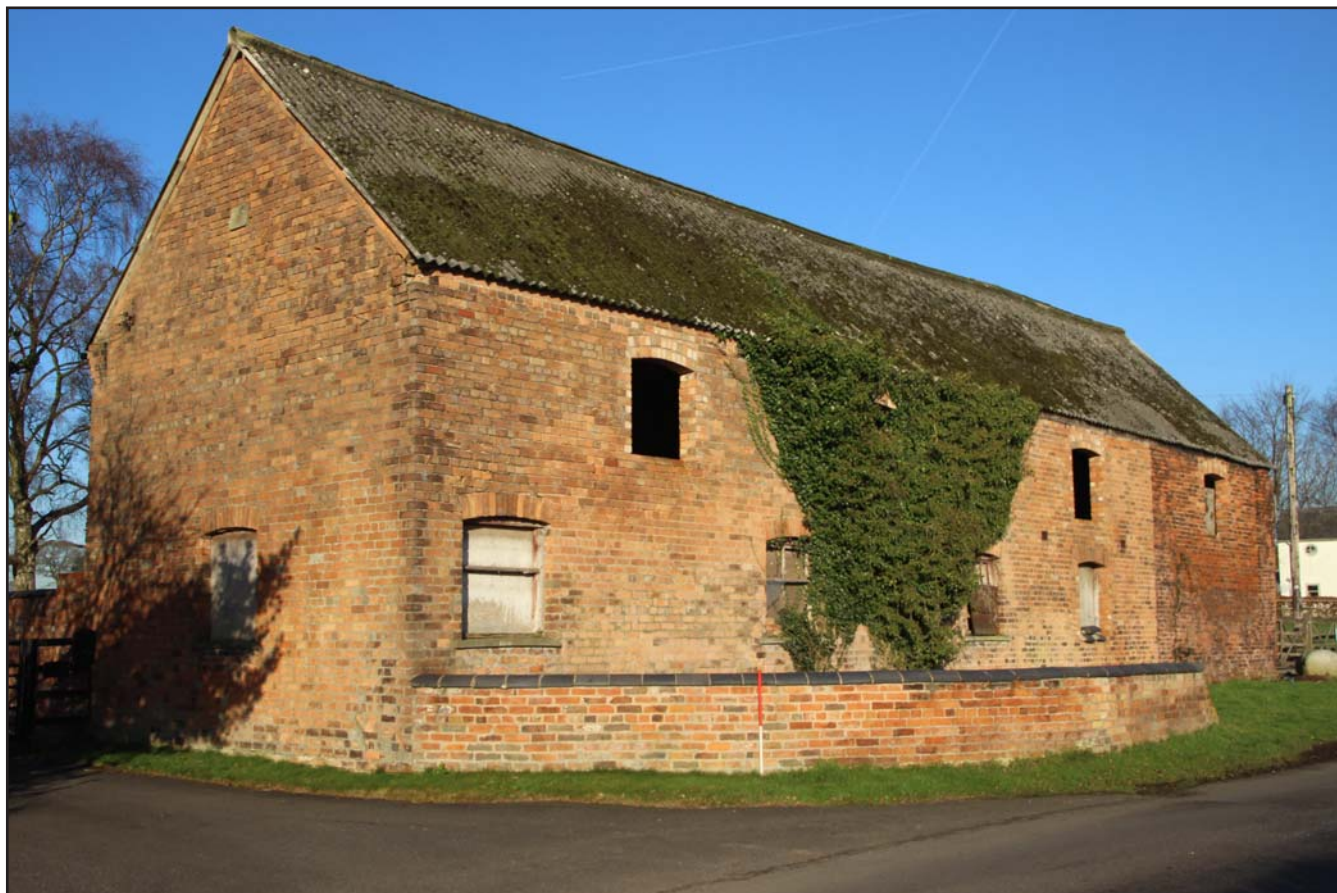
**Plate 07:** East and south facing external elevations, from the southeast. Scale 1.0m.

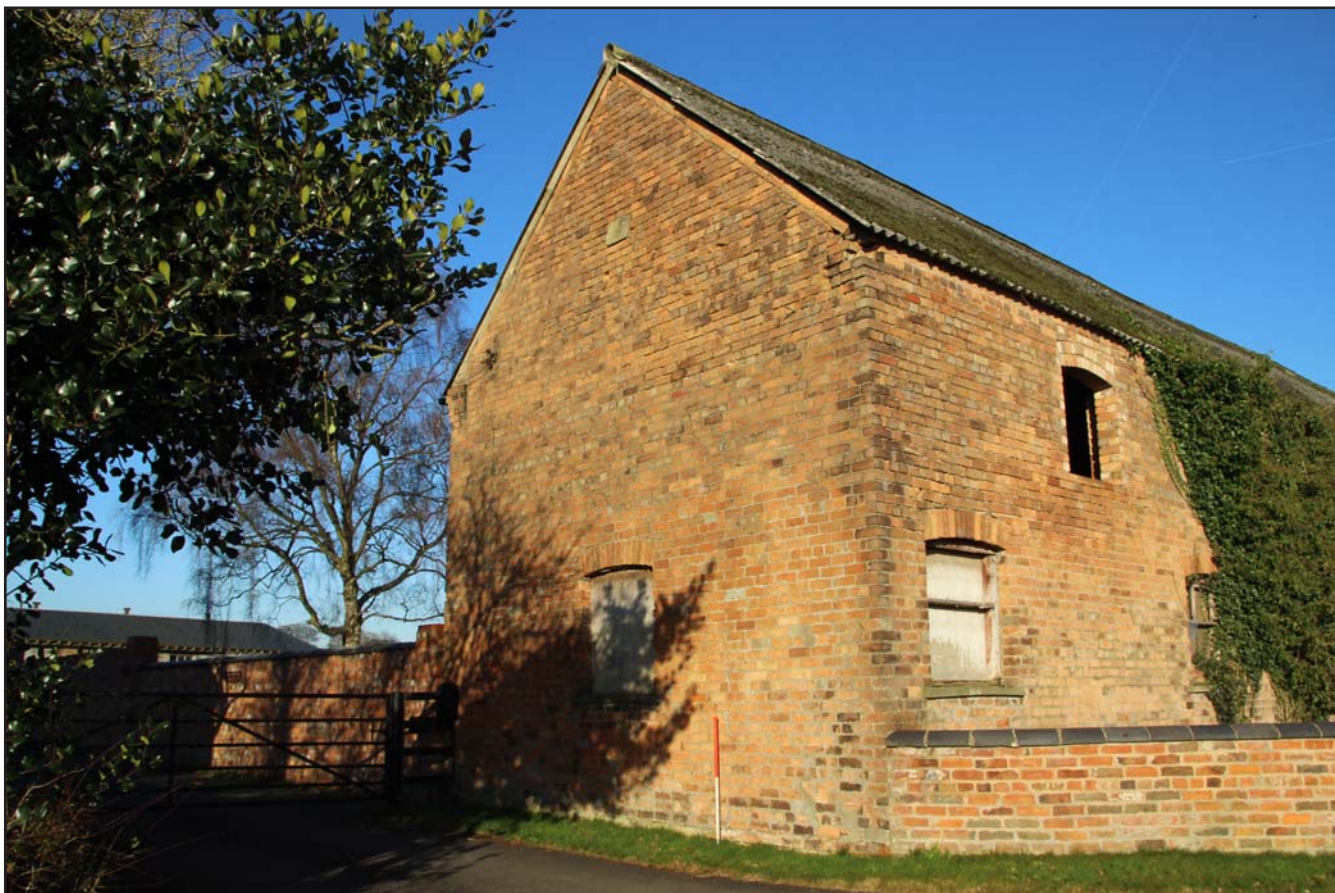
The southern gable elevation has a single projecting sandstone block at first floor level. This lies above a centralised window opening with radiating red-brick voussoirs, sandstone sill, and without frame and glass, at ground level.

**Plate 08:** South facing external elevation, from the south-southeast. Scale 1.0m.

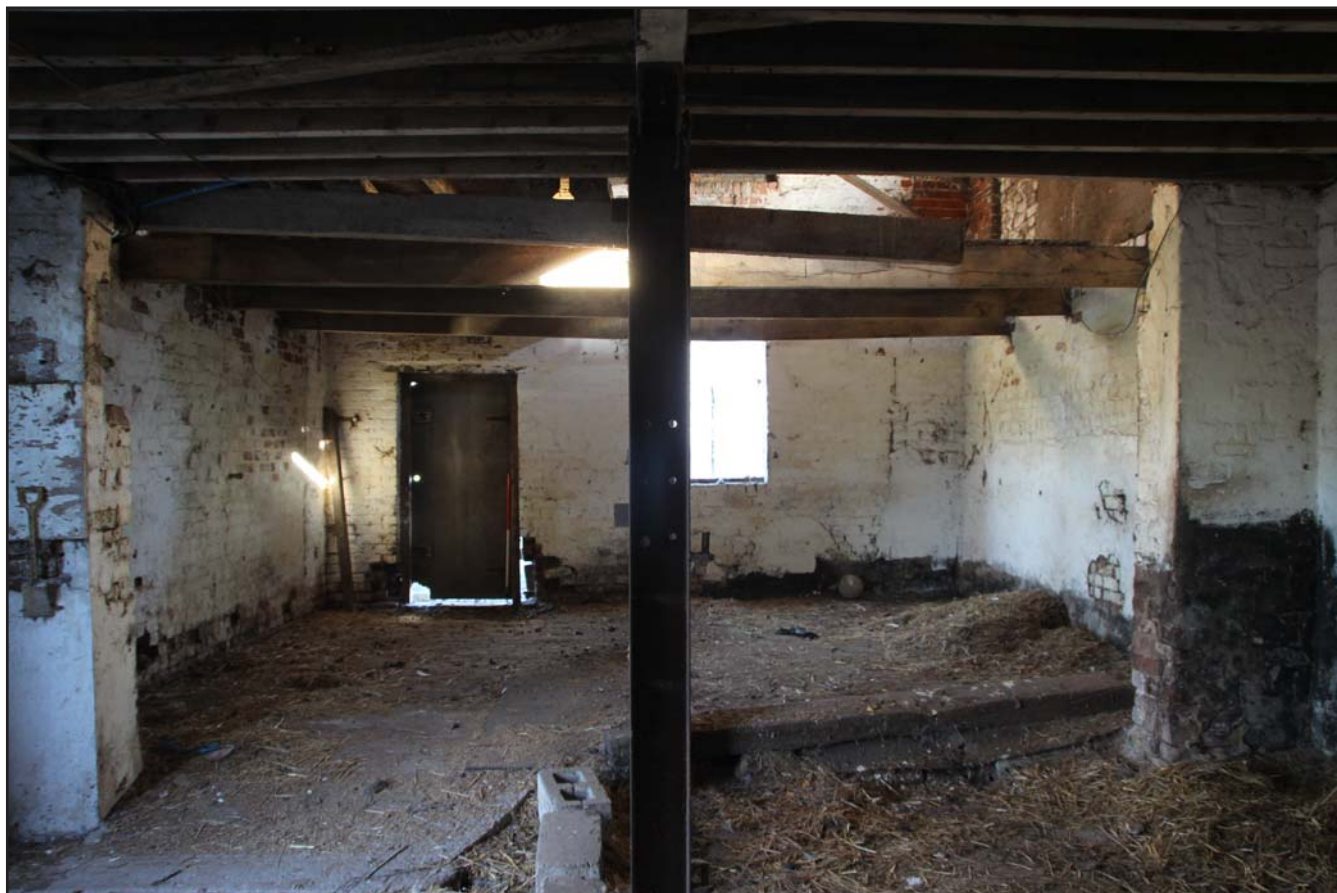
A rectangular room measuring 10.5m in length by 5.6m in width orientated north to south. The northern half of the room has four sawn wooden timber beams running east to west and supporting the floor above. The southern half of the room has a single sawn timber beam running north to south, also supporting the floor above. All of the beams are supported by three upright iron columns.

**Plate 09:** Barn 1, from the south. Scale 1.0m.

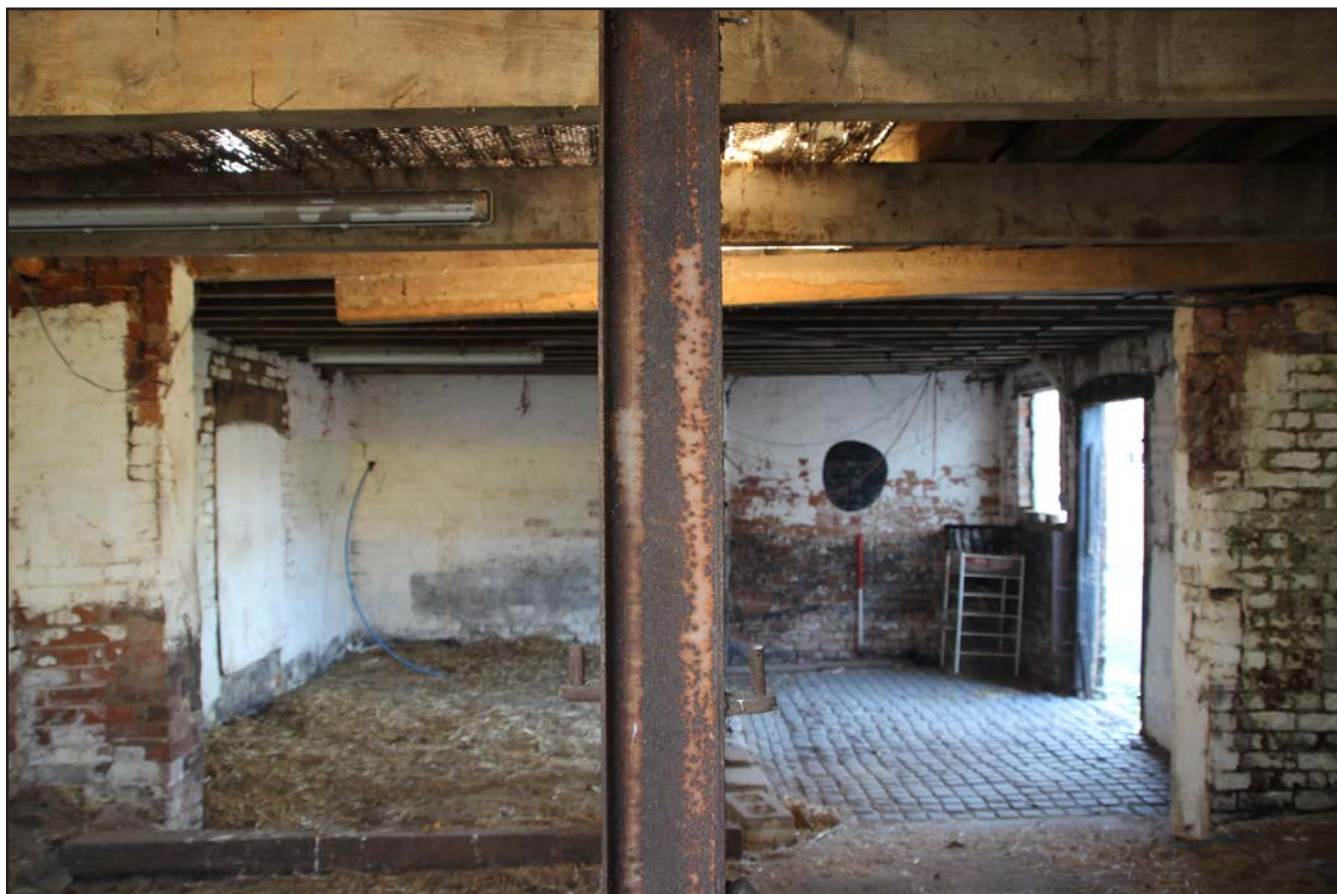
**Plate 10:** Barn 1, from the north. Scale 1.0m.

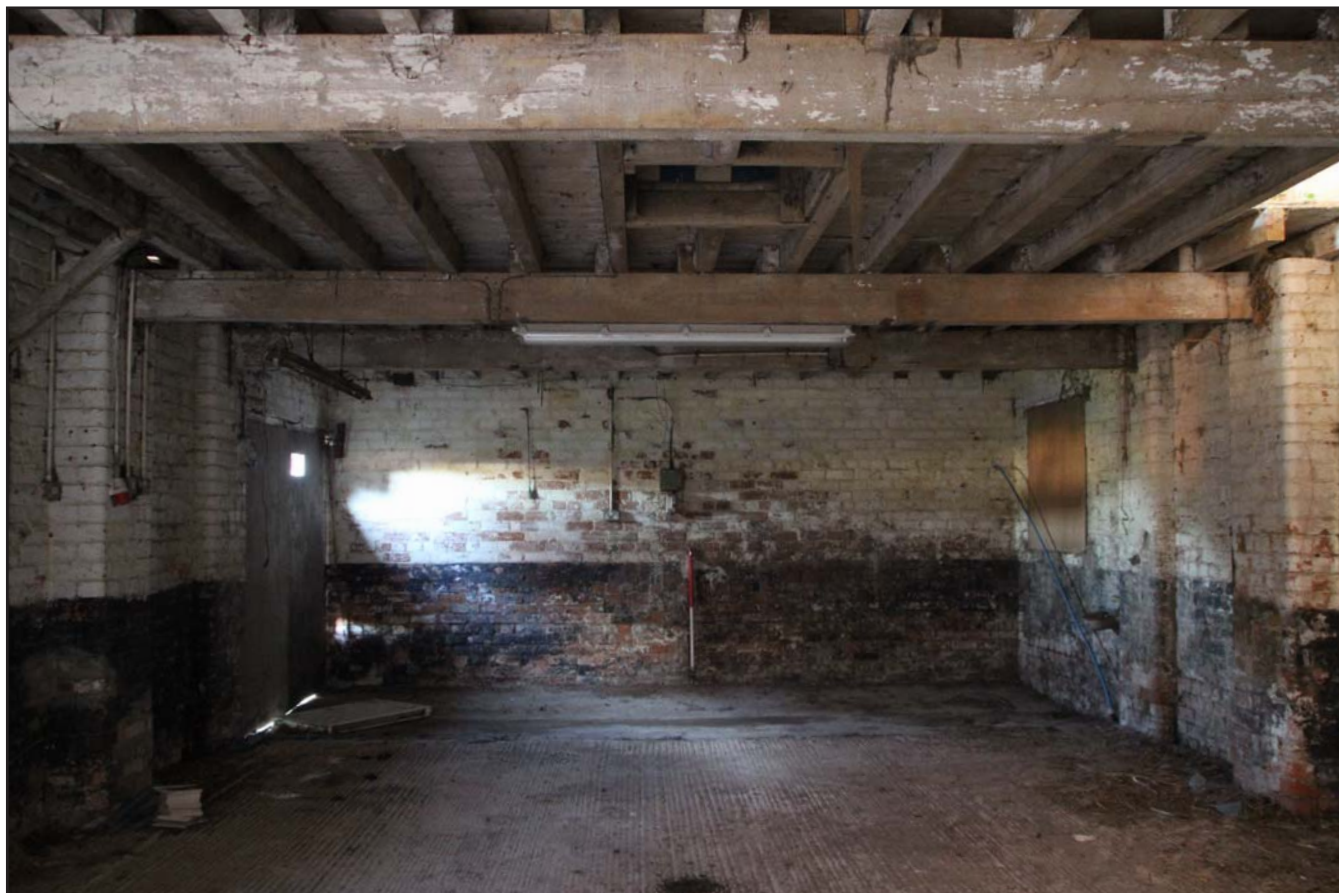
A rectangular room measuring 11.3m in length by 6.0m in width, orientated north to south. There are four sawn wooden beams supporting the floor above and running east to west, all of which are supported on projecting red-brick columns within the east and west elevations. The walls are all of exposed red-brick painted white in the upper half and black beneath.

**Plate 11:** Barn 2, from the south. Scale 1.0m.

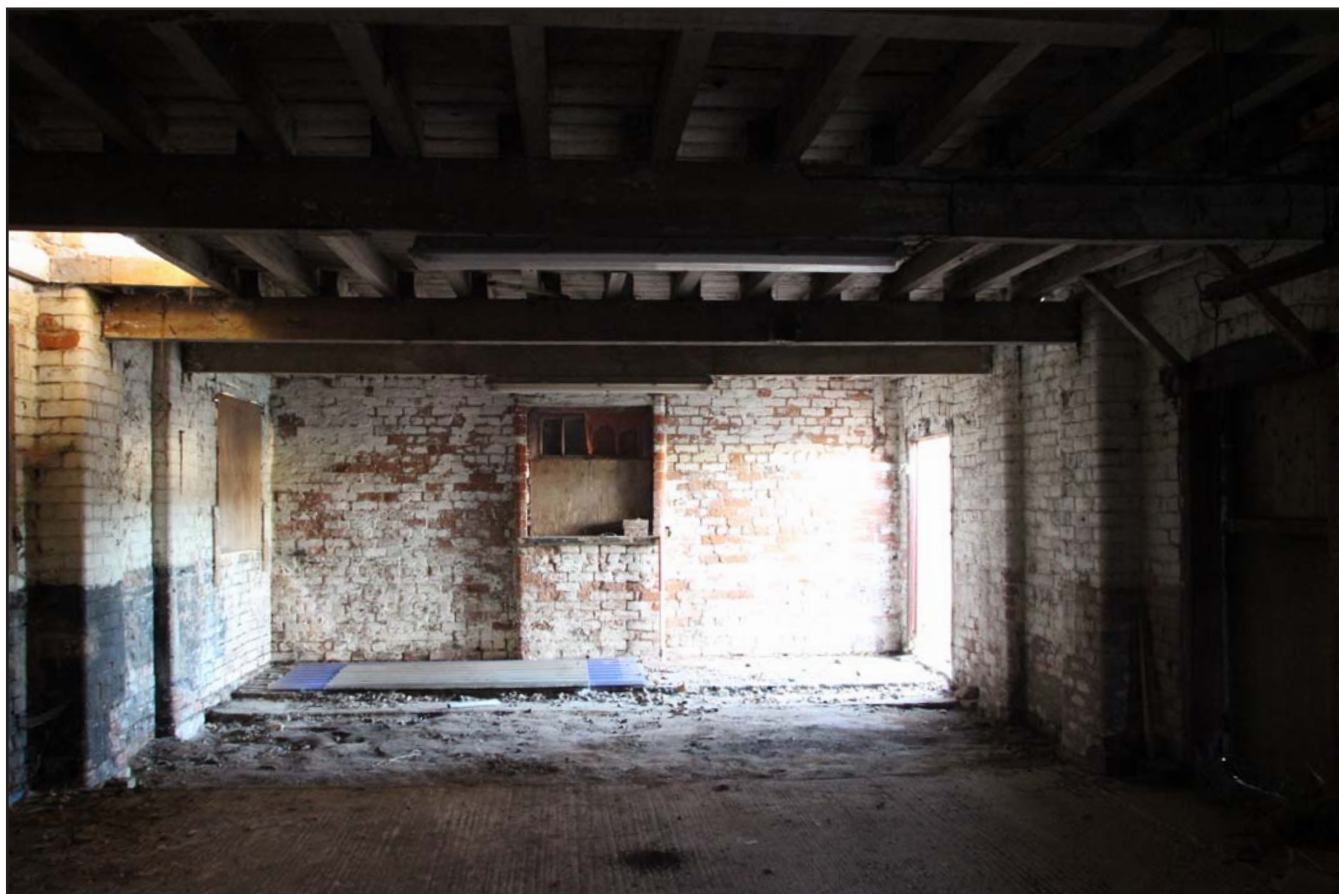
**Plate 12:** Barn 2, from the north. Scale 1.0m.

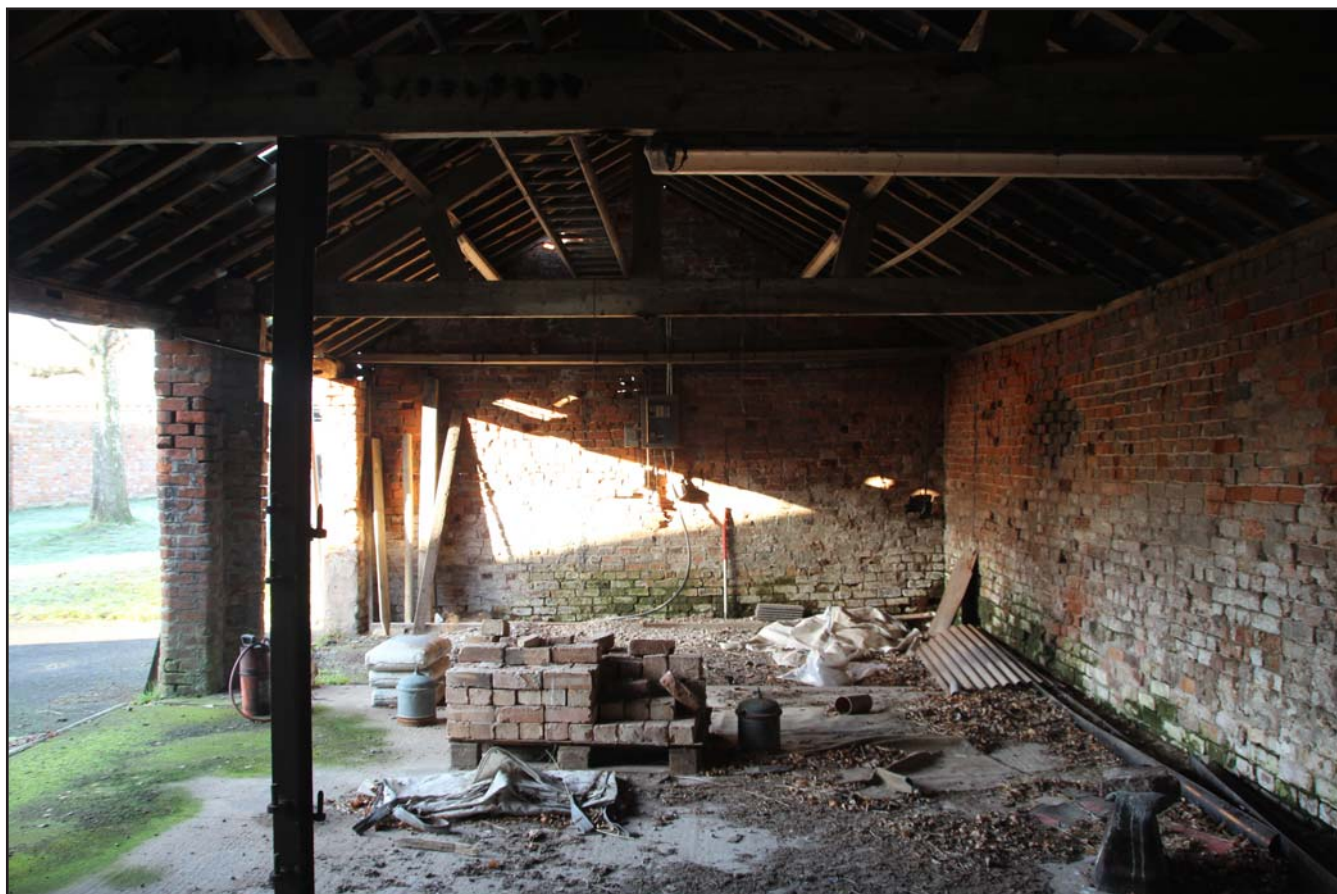
The outbuilding is rectangular in shape and measures 12.0m in length by 5.4m in width, orientated east-northeast to west-southwest. The room is open to the ceiling and has two

equally spaced common trusses of sawn wooden timber supporting two purlins also of sawn timber.

**Plate 13:** Outbuilding, from the east. Scale 1.0m.

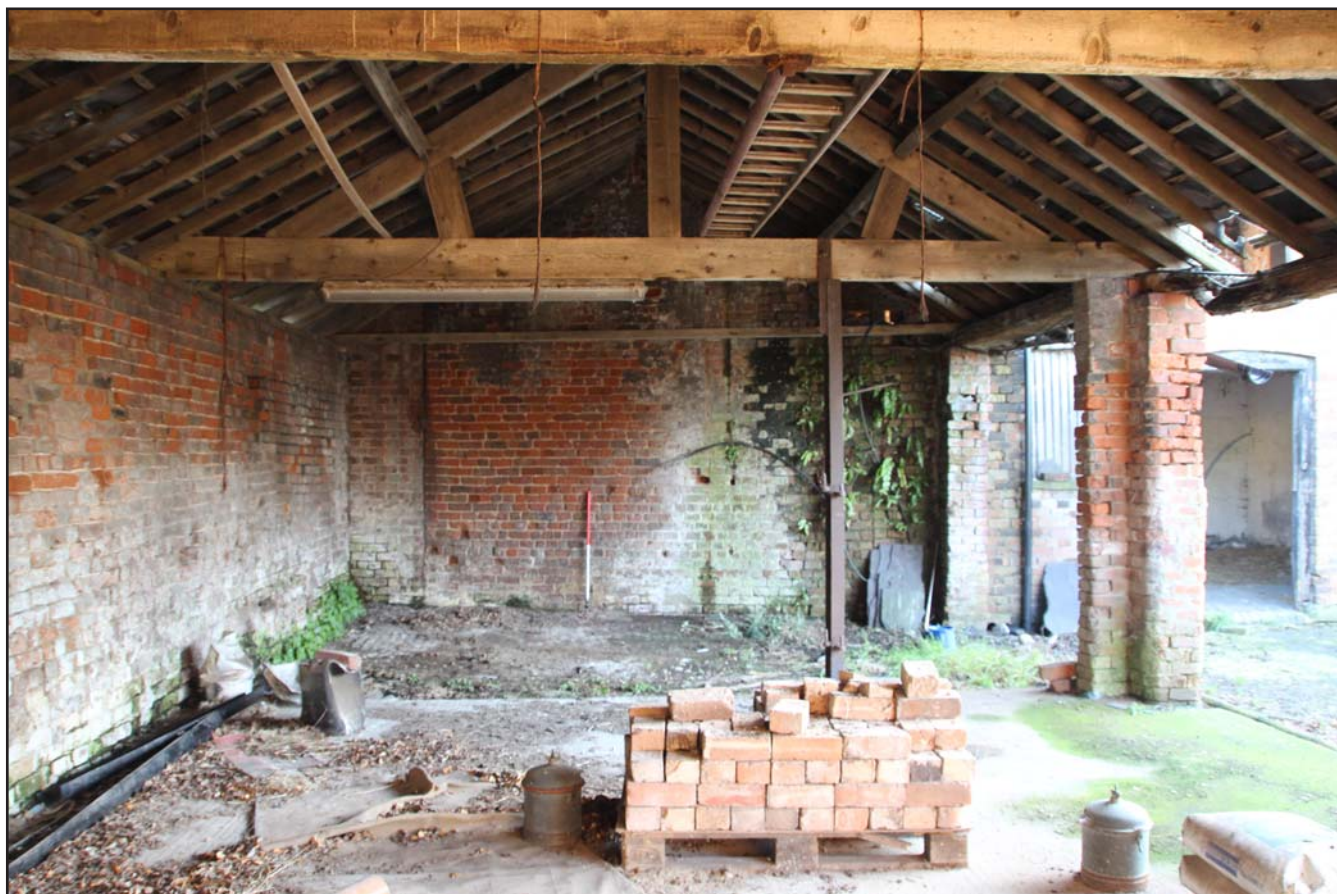
**Plate 14:** Outbuilding, from the west. Scale 1.0m.

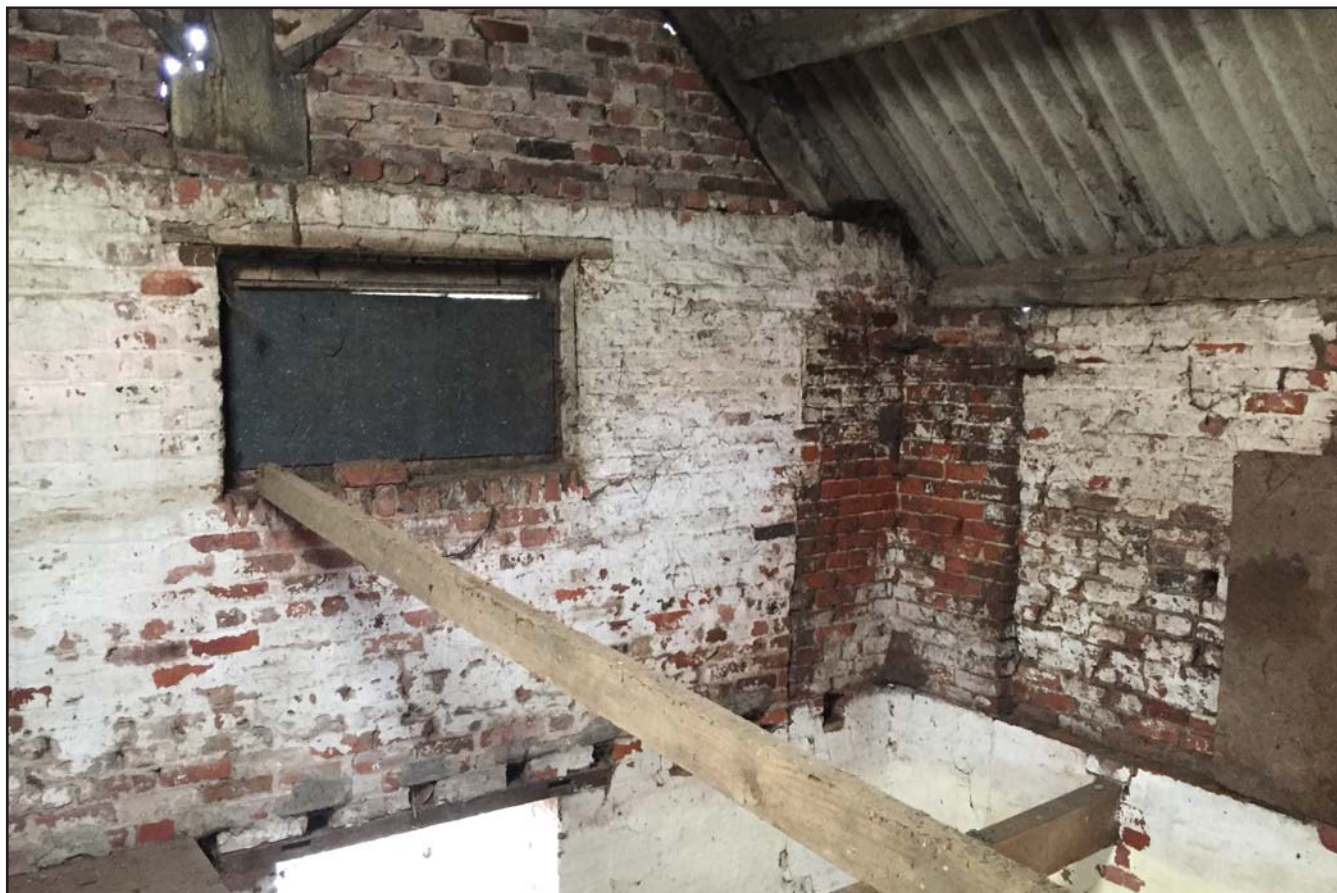
A rectangular room measuring 10.5m in length by 5.6m in width, orientated north to south. The room is open to the roof space and there is a single centralised king-post truss of hand cut timber supported on two red-brick columns with four hand cut purlins running north to south. A second closed king-post truss, also of hand cut timber, is located in the northern gable wall. The walls are all of exposed red-brick with the remnants of white paint.

**Plate 15:** Barn 3, from the southwest.

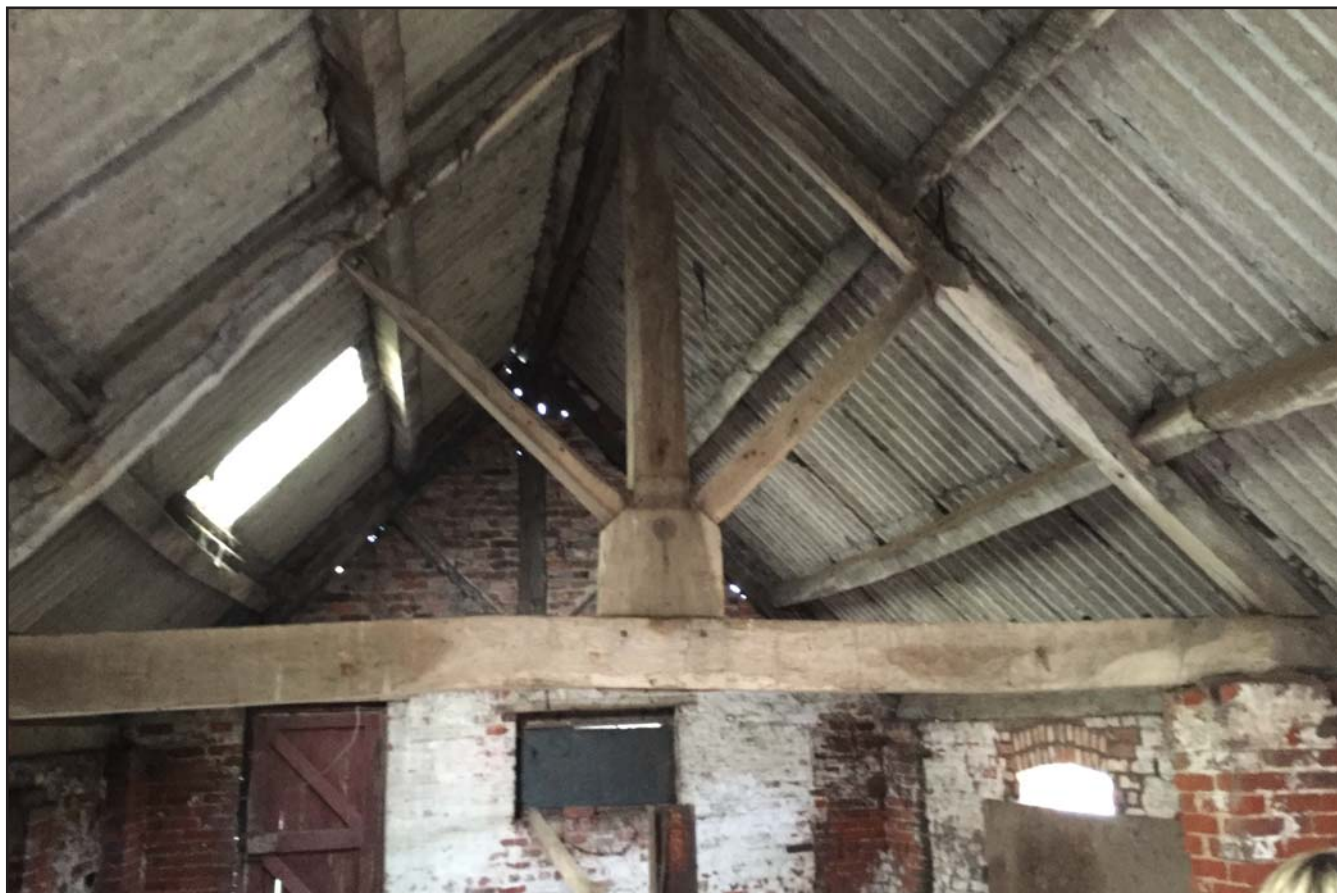
**Plate 16:** Barn 3 showing truss, from the south.

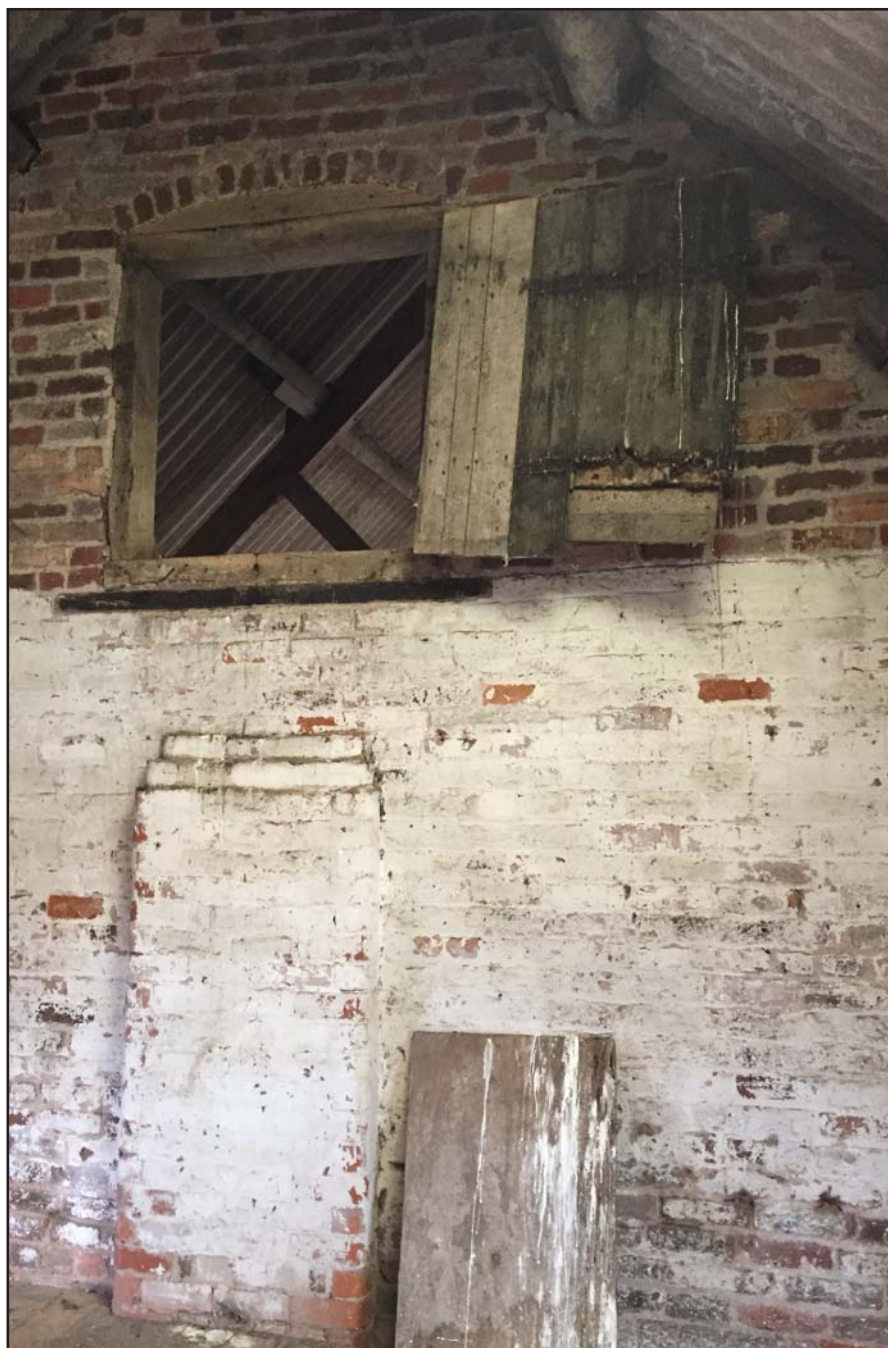
The northern elevation has a single doorway at the left end of dark-brown stained wooden board and wooden frame, to the right of which is a three pane window in wooden frame now boarded-up. These all lie beneath the truss within the gable wall.

Plate 17: Barn 3, from the north.

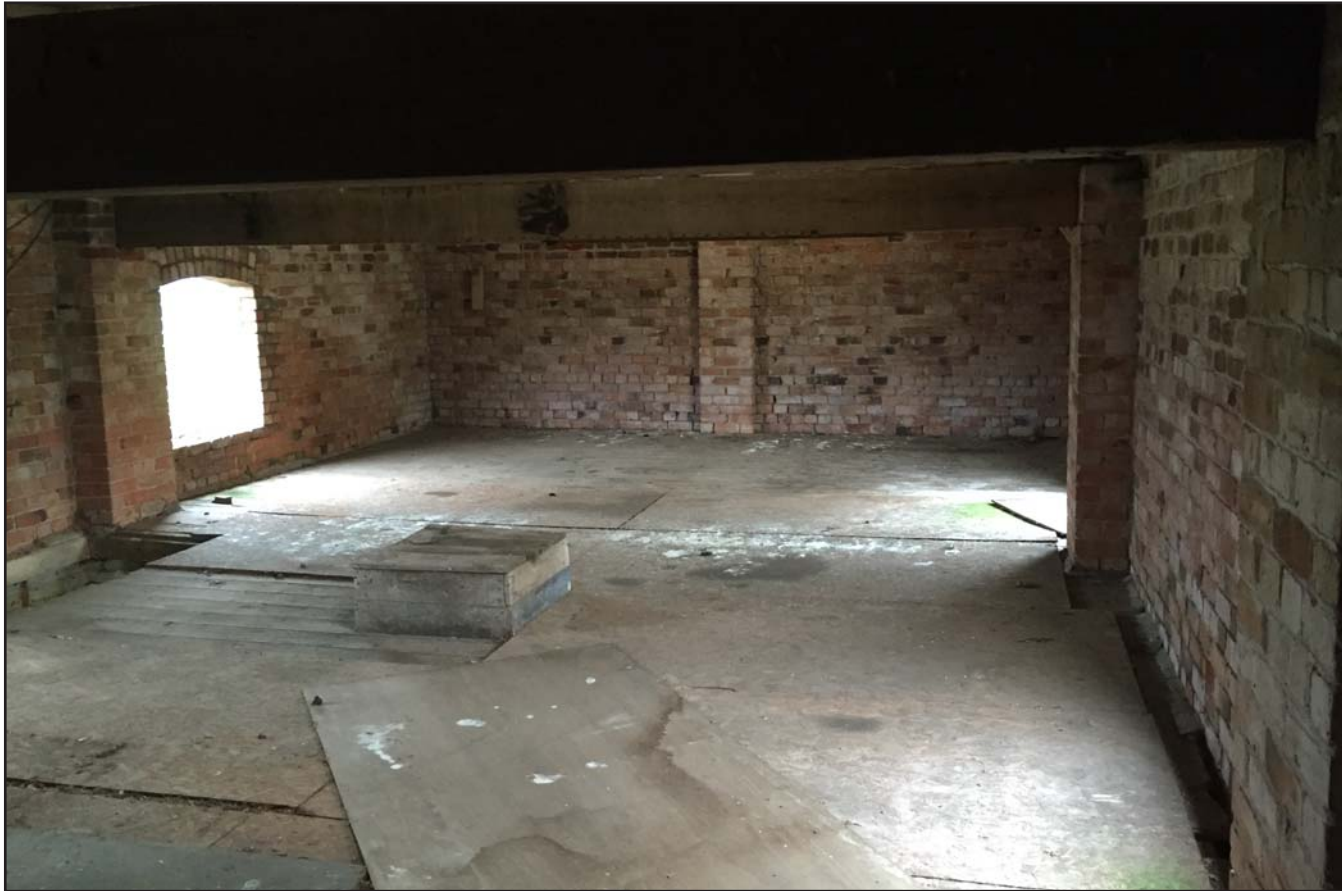
A rectangular room measuring 11.3m in length by 5.9m in width, orientated north to south. The barn is open to the ceiling space and has two equally spaced king-post trusses of sawn timber and supporting four purlins, also of sawn timber and running north to south. The walls are all of exposed red-brick.

**Plate 18:** Barn 4, from the north.
