**Hield House Barn,  
Aston By Budworth, Cheshire,  
CW9 6LP.  
January 2017  
V 1.0**

Level 2 Historic Building Record  
Project Code: A0103.1  
Report no. 0114

Level 2 Historic Building Record

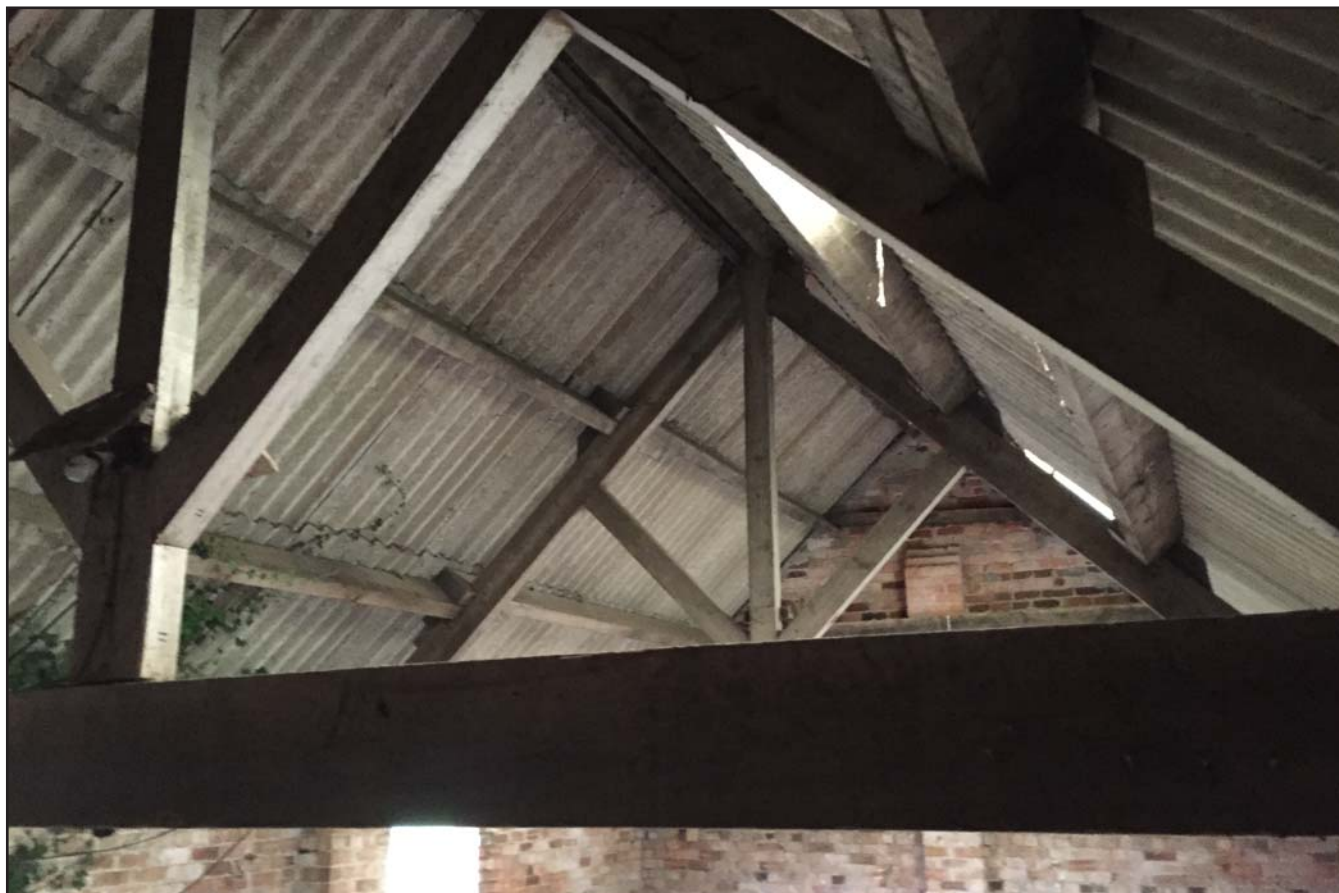
**Plate 19:** Barn 4 showing trusses, from the northwest.
