# St Oswald's Church, Malpas SY14 8PA.

March 2017  
V 1.0

Archaeological Evaluation  
Project Code: A0106.1  
Report no. 0118

Archaeological Evaluation

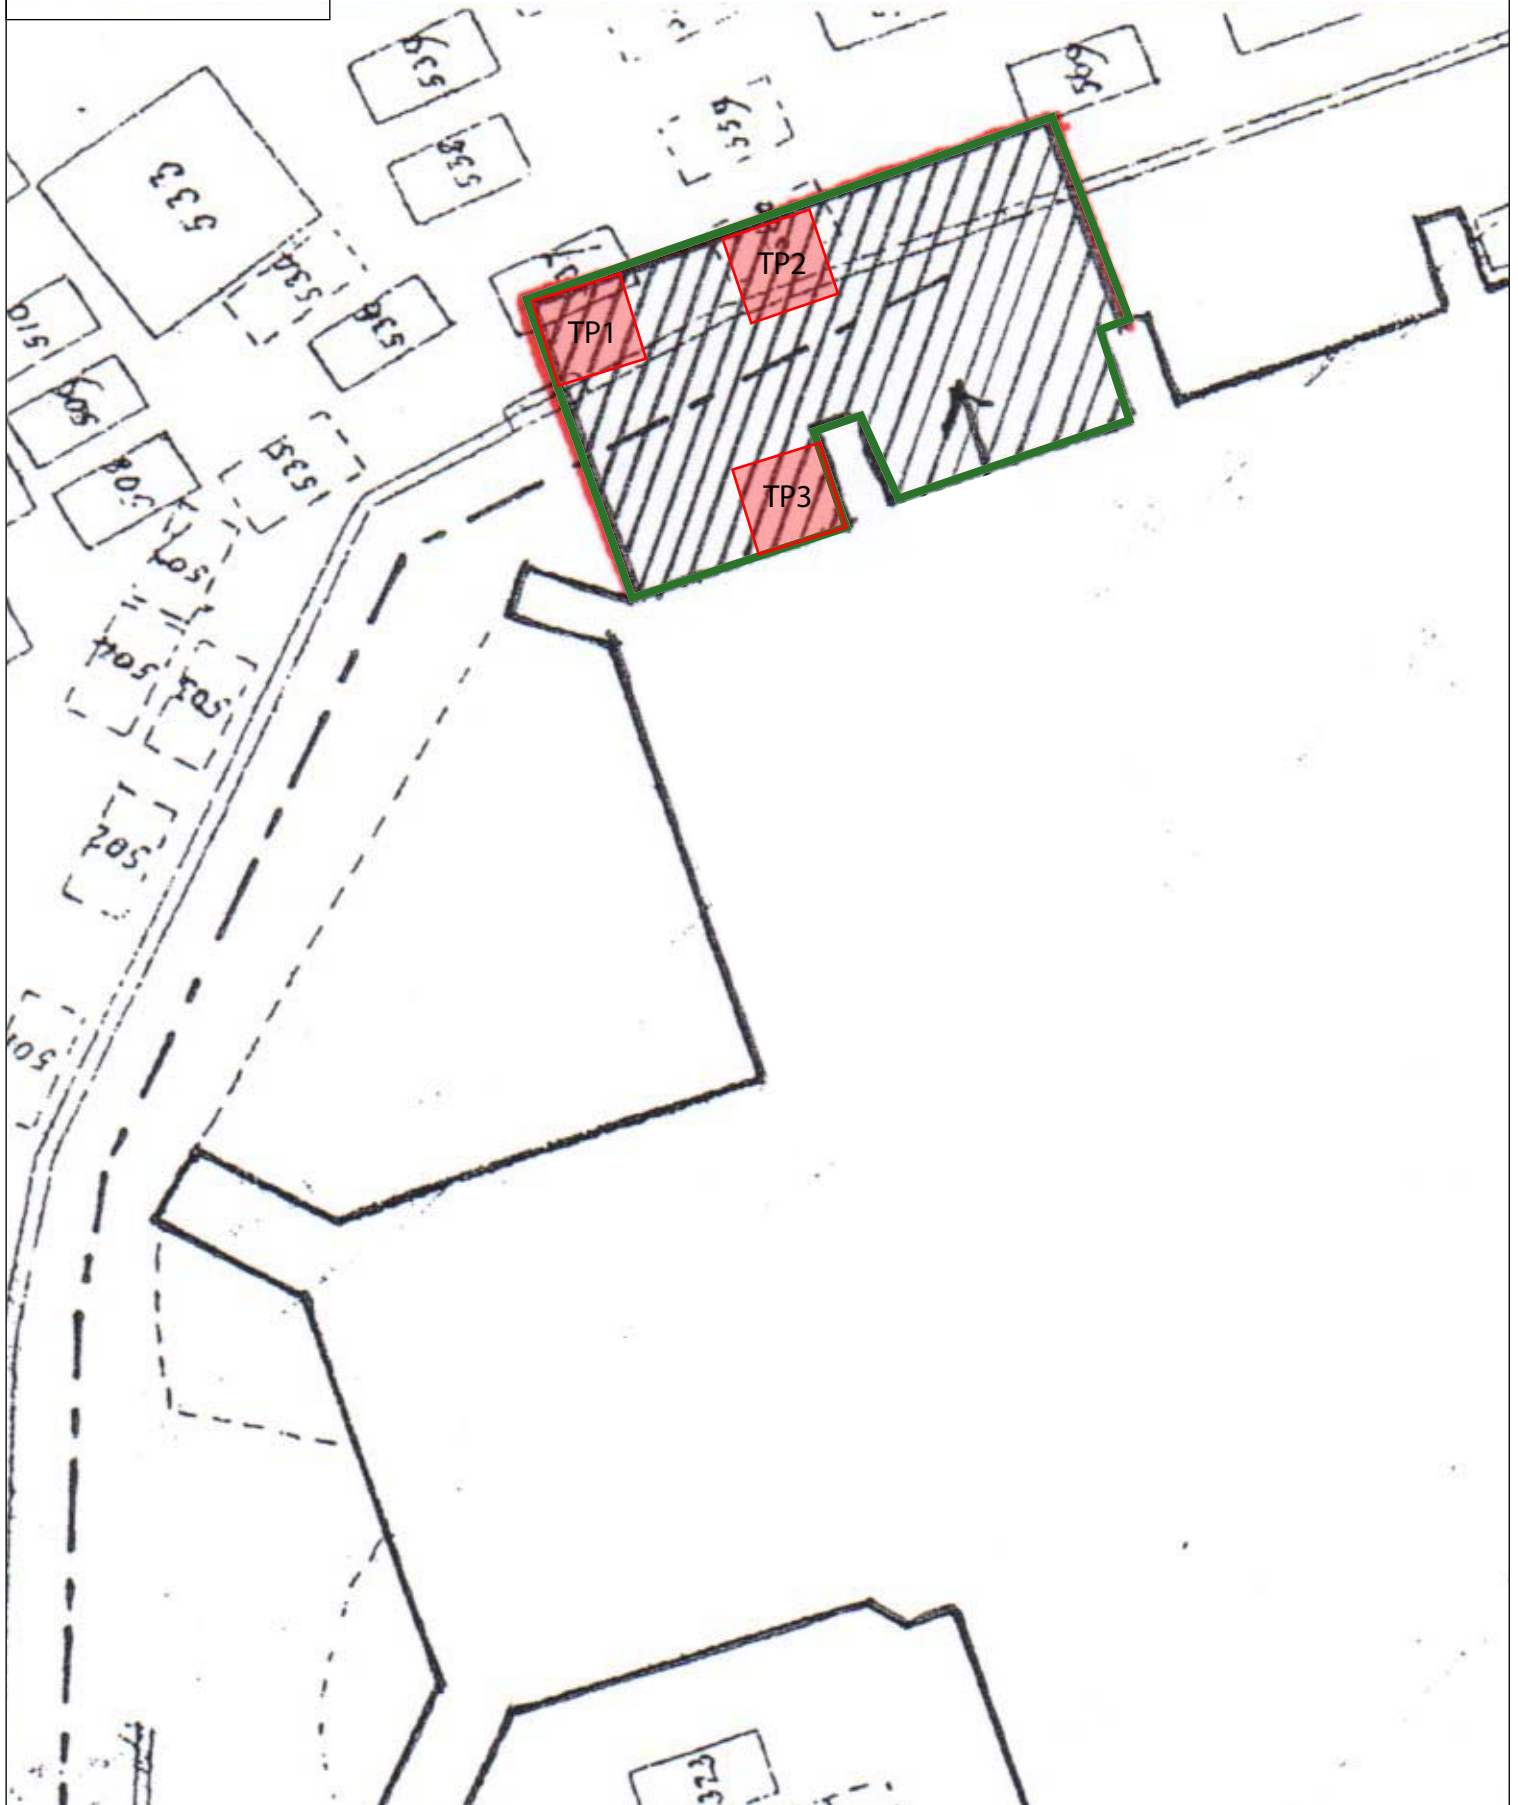
Figure 03: Location of Test Pits 1-3 (TP 1-3) at St Oswald's Church, Malpas overlain on the 1884 Graveyard Plan. Scale 1:100 at A4.

The evaluation test pits were designed to evaluate and characterise the known, or potential, archaeological remains. Each test pit is described and discussed separately. The location of the test pits can be found on figure 3 where they are overlain on the 1884 graveyard plan. The location and orientation of photographs is shown on figure 14.

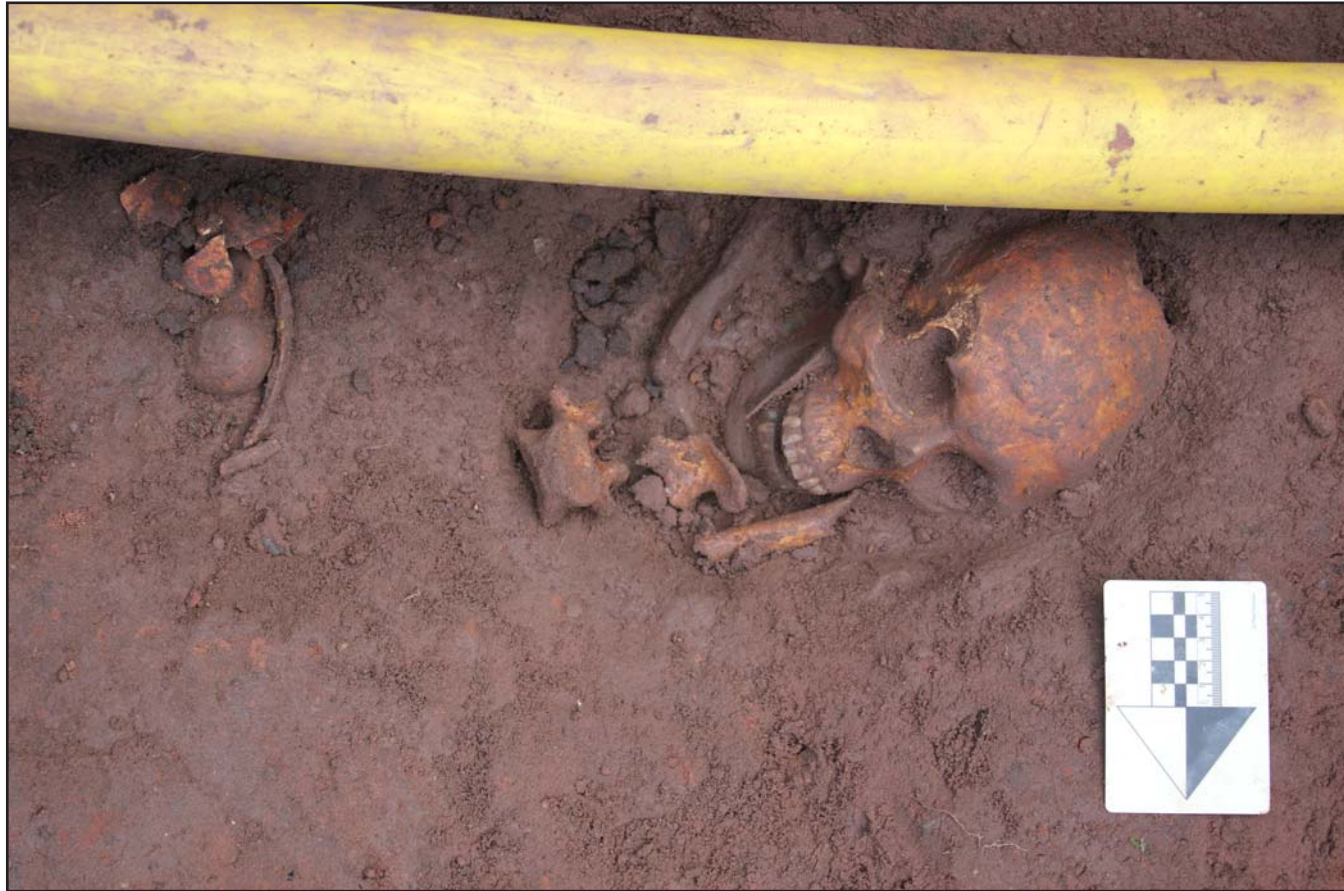
**Plate 05:** Test Pit 1 showing skeleton (01), from the north. Scale 0.05m.

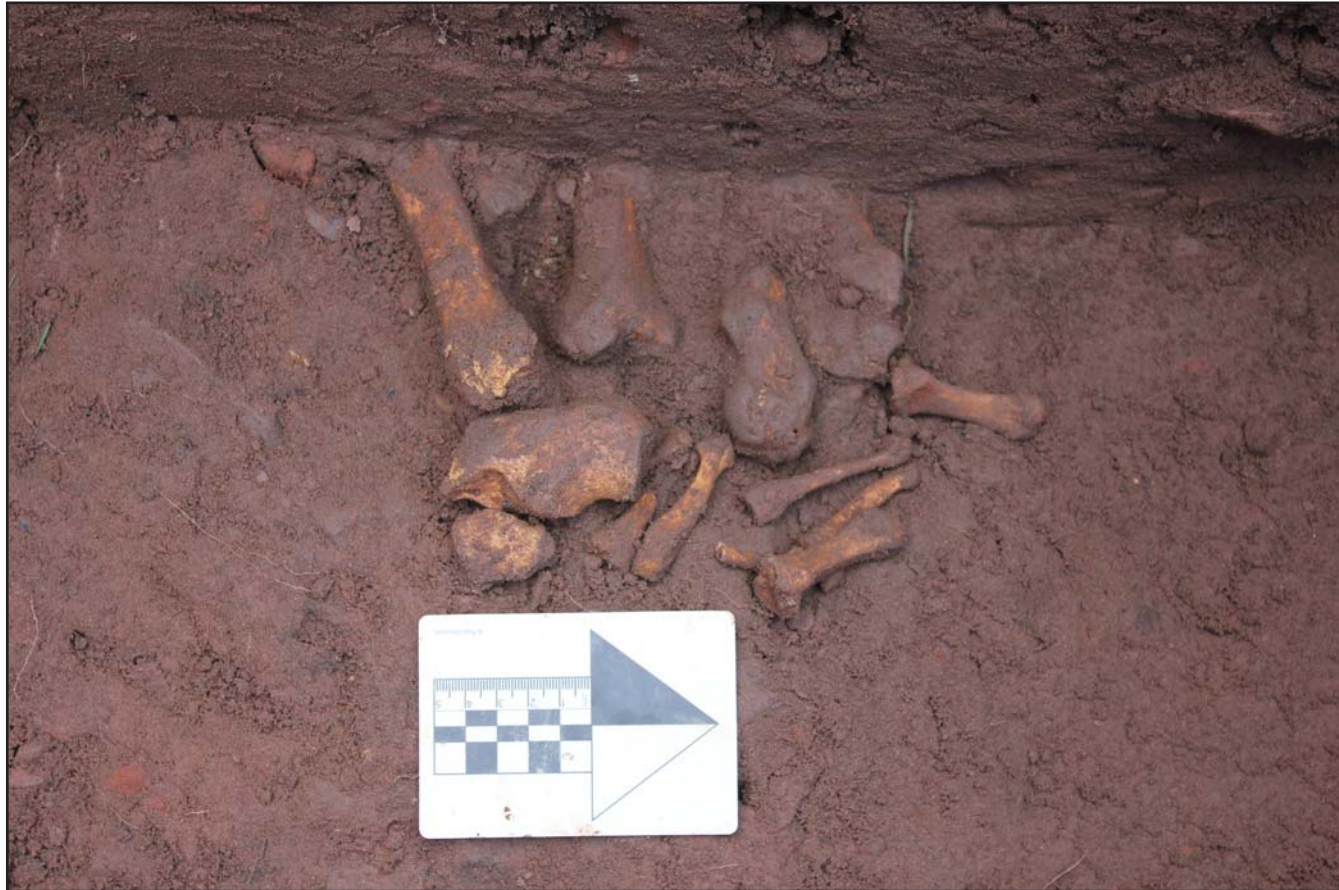
**Plate 06:** Test Pit 1 showing skeleton (02), from the east. Scale 0.05m.

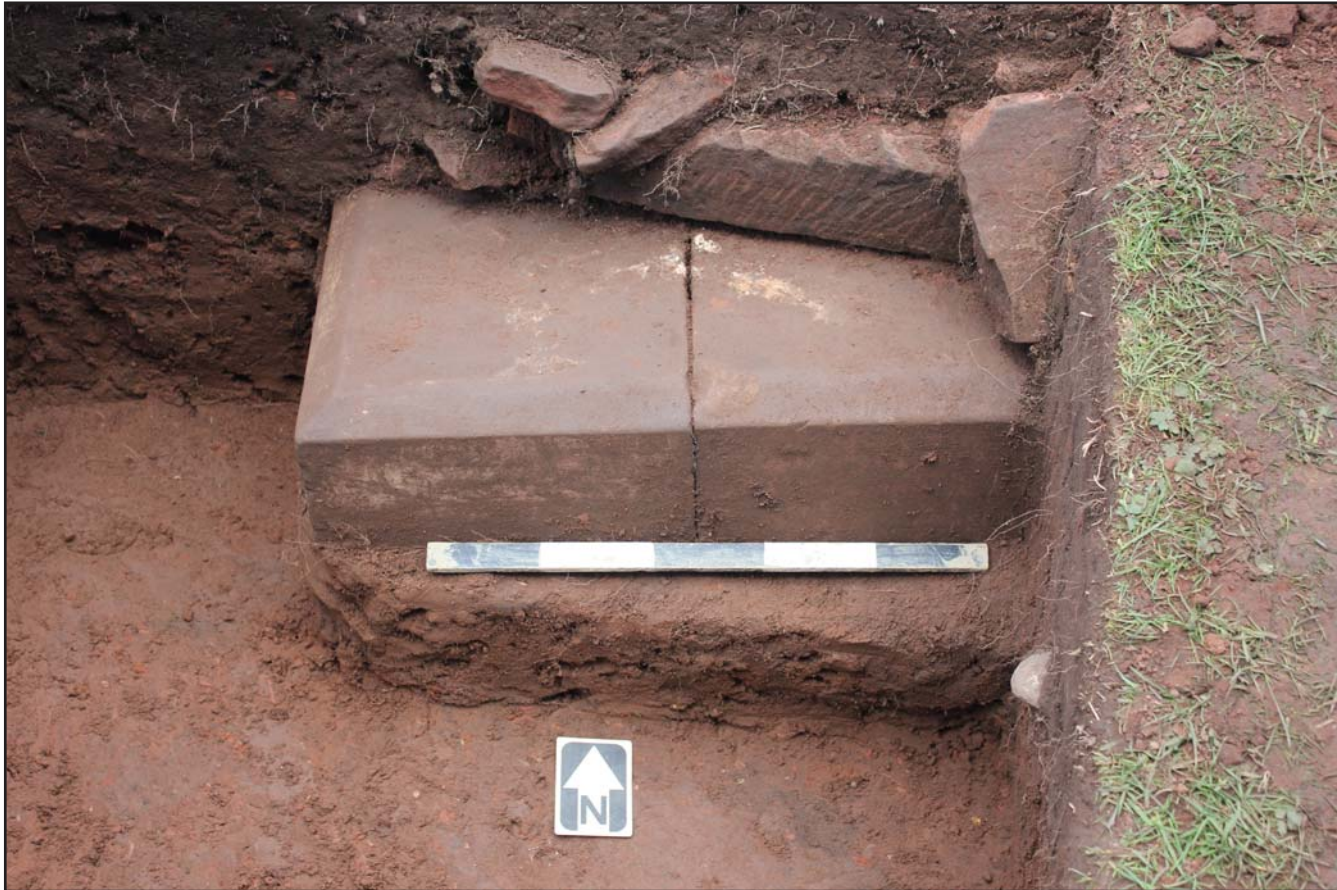
**Plate 07:** Test Pit 1 showing grave marker (1016), from the south. Scale 0.5m.

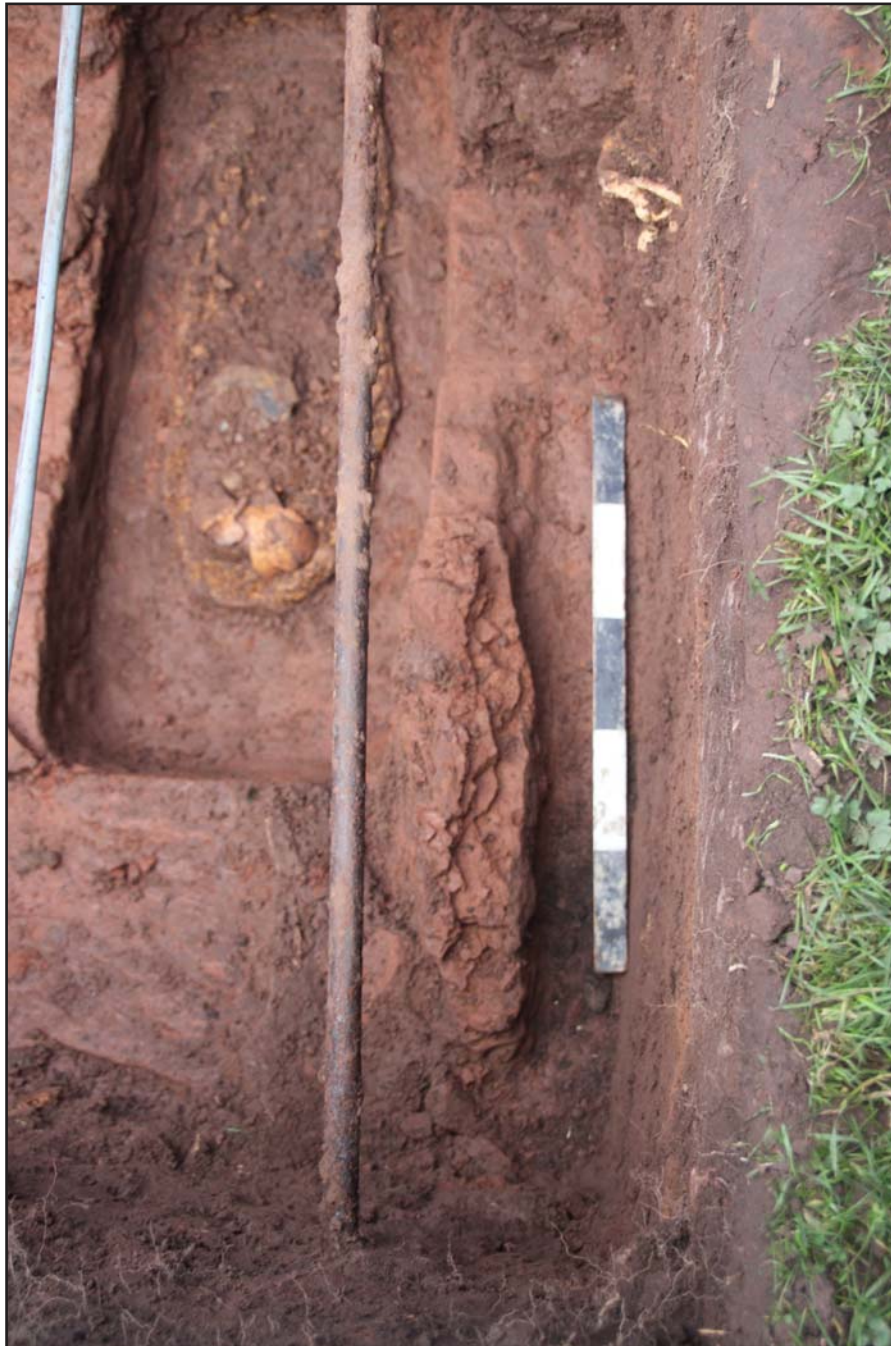
At the southern end of the test pit a sub-rectangular grave [1032] was found cut into the sandstone bedrock (1038). The grave was orientated east to west and measured >0.56m in length by >0.12m in width by >0.07m in depth, and continued into the southern and western limits of excavation. The grave had steep, almost vertical sides with a flat base located at 123.14m OD (0.63m BGL) and was filled with a soft mid red-brown silt-clay (1039) with no trace of any bone fragment inclusions.

**Plate 14:** Test Pit 2 grave cut [1032], from the west. Scale 0.5m.

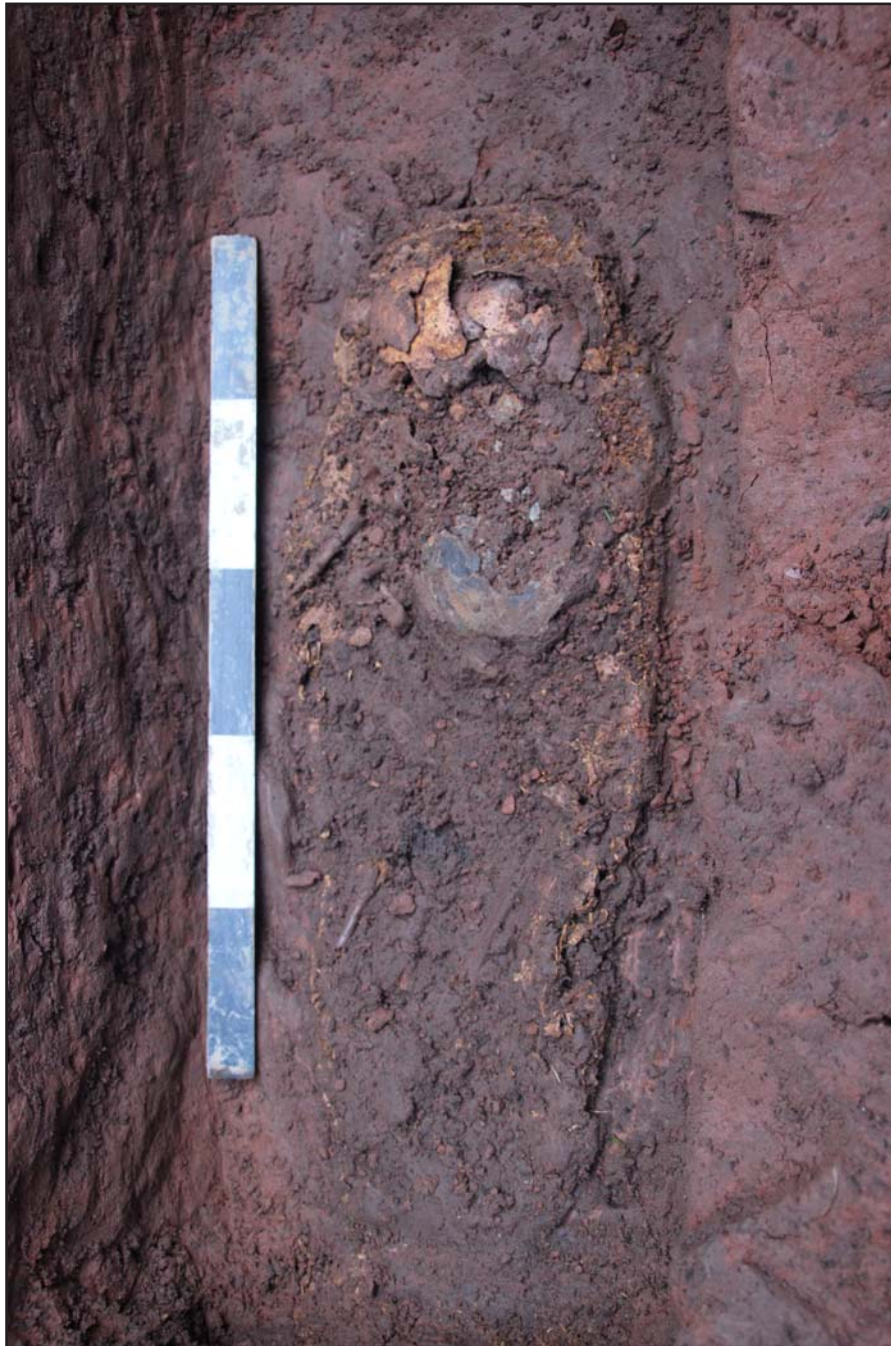
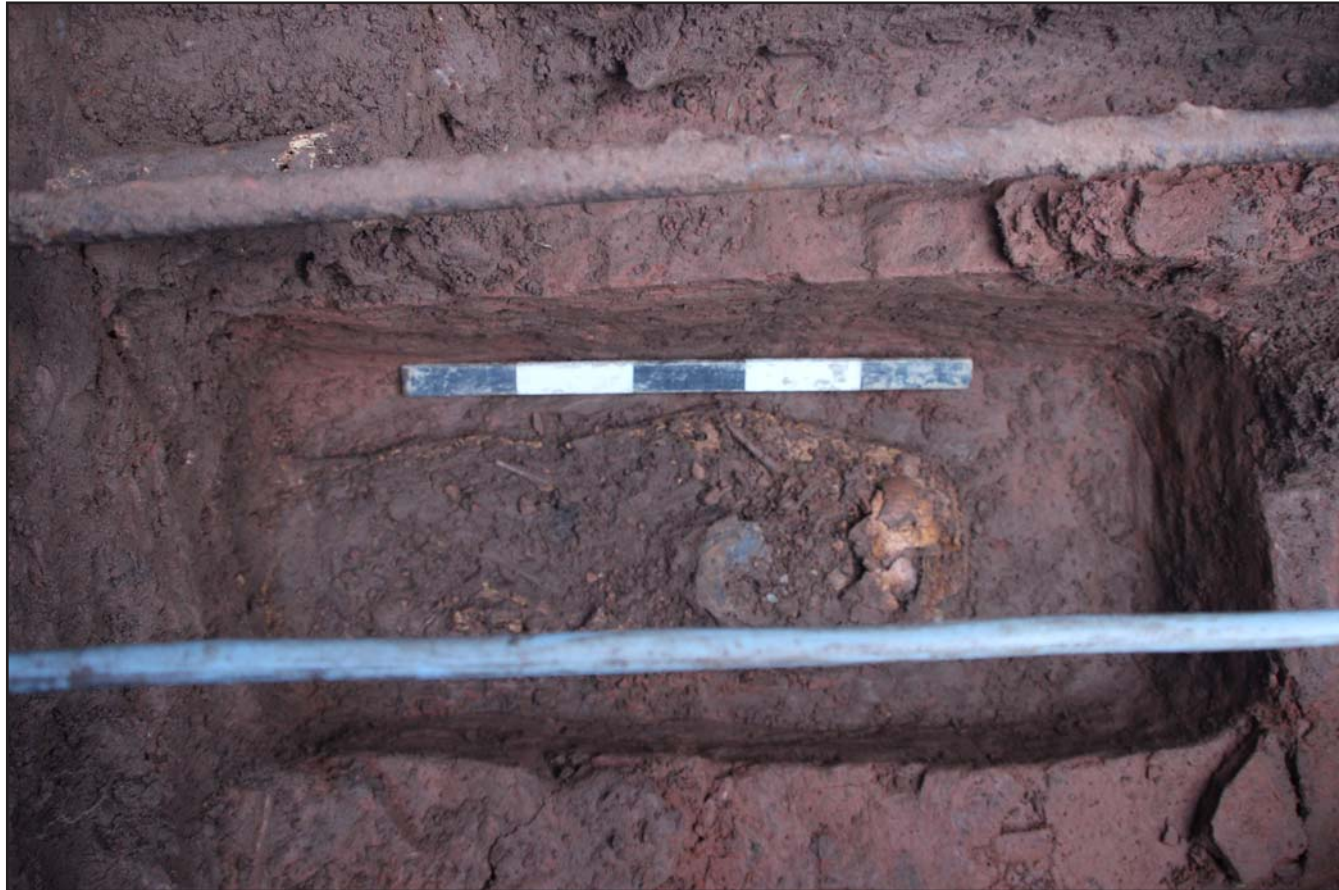
measured 0.58m in length by 0.22m in width, and the remains of a copper alloy plaque was located over the rib cage which was too degraded to carry any inscription.

Burial cuts [1029], [1034] and [1032] were located at only 0.37m BGL, 0.56m BGL, and 0.53m BGL respectively and therefore predate the 19<sup>th</sup> Century anti-grave robbing law. There were no burial artefacts, coffin nails, or shroud pins found although the shallow depth would suggest a possible medieval date. The skeletal remains in both graves [1029] and [1034] had been cut by later infant burial [1025] which despite being only located at 0.77m BGL retained the poorly preserved remains of a wooden coffin and copper alloy plaque suggesting that it dates to the 18<sup>th</sup>-19<sup>th</sup> Century.

**Plate 16:** Test Pit 2 grave cut [1025] showing skeleton (03), coffin (1028) and copper alloy plaque (1027) from the west. Scale 0.5m.

**Plate 17:** Test Pit 2 grave cut [1025] showing skeleton (03), coffin (1028) and copper alloy plaque (1027) from the north. Scale 0.5m.

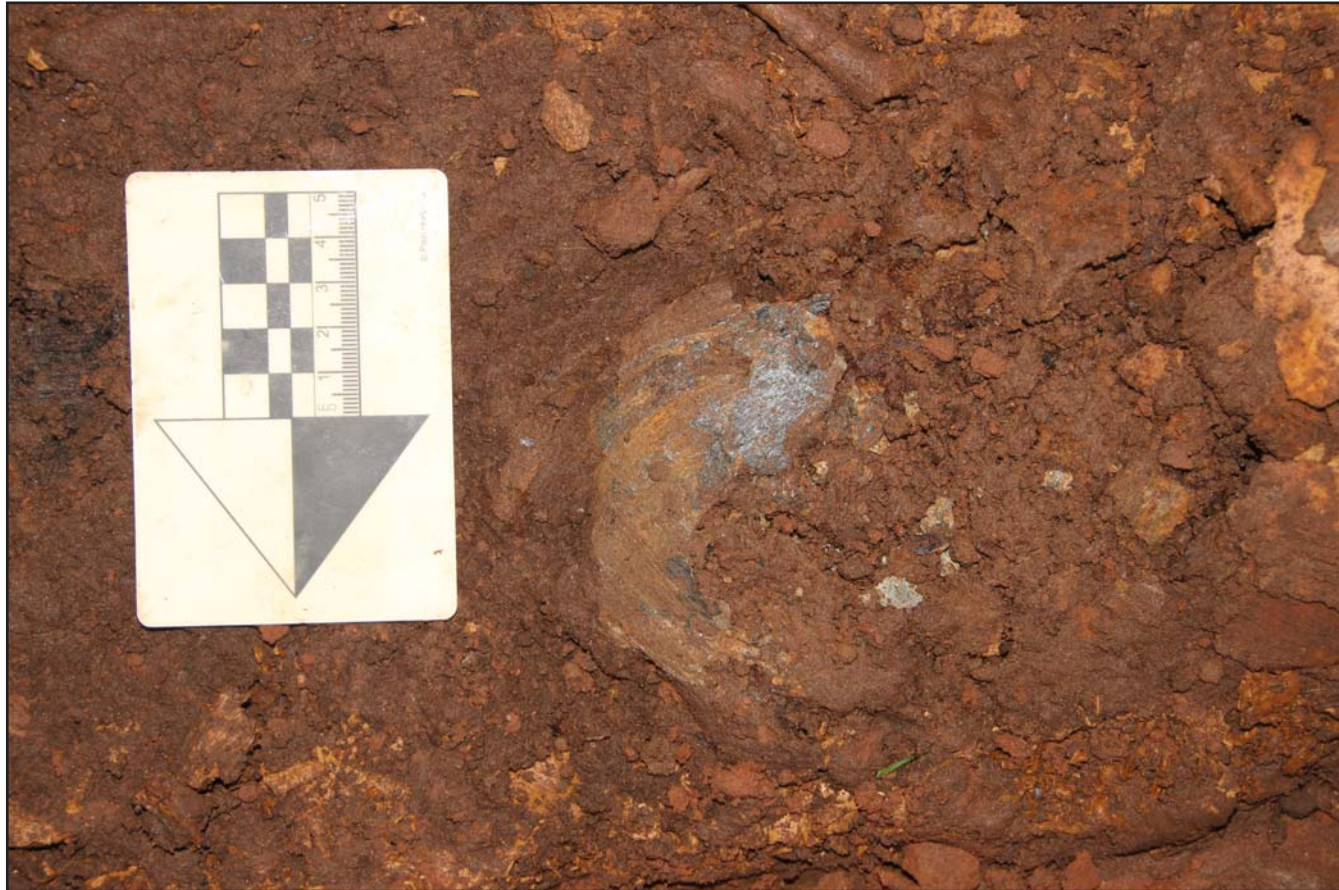
**Plate 19:** Test Pit 2 grave cut [1025] showing copper alloy plaque (1027), from the north. Scale 0.05m.

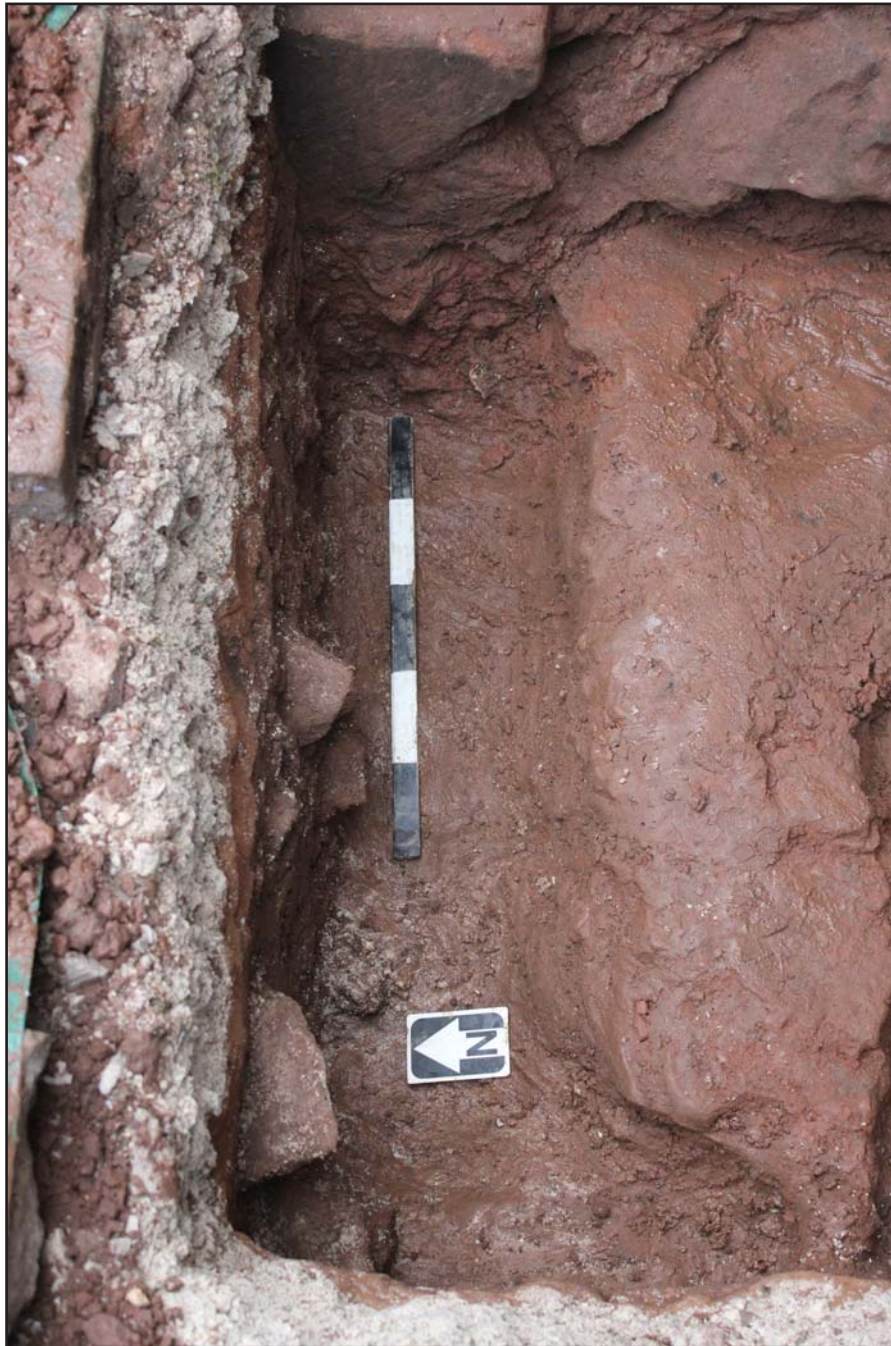
At the northern end of the test pit a sub-rectangular grave [1005] was found cut into the sandstone bedrock (1012). The grave was orientated east to west and measured >1.2m in length by >0.3m in width by 0.23m in depth, and continued into the eastern and western limits of excavation. The grave had steep, almost vertical sides with a slightly concaved base located at 123.21m OD (0.97m BGL) at the eastern end and rising to 123.38m OD (0.8m BGL) at the western end. The grave cut was filled with a moderate/soft mid red-brown silt-clay (1010) which when excavated revealed the poorly preserved remains of an in-situ jaw bone and fibula (skeleton 06), the former lying at 123.42m OD (0.76m BGL). The fibula was located within the eastern limit of excavation and continued beneath the stone rubble foundations (1009) thus predating the church buttress.

**Plate 25:** Test Pit 3 grave cut [1005] showing skeleton (06), from the west. Scale 0.5m.

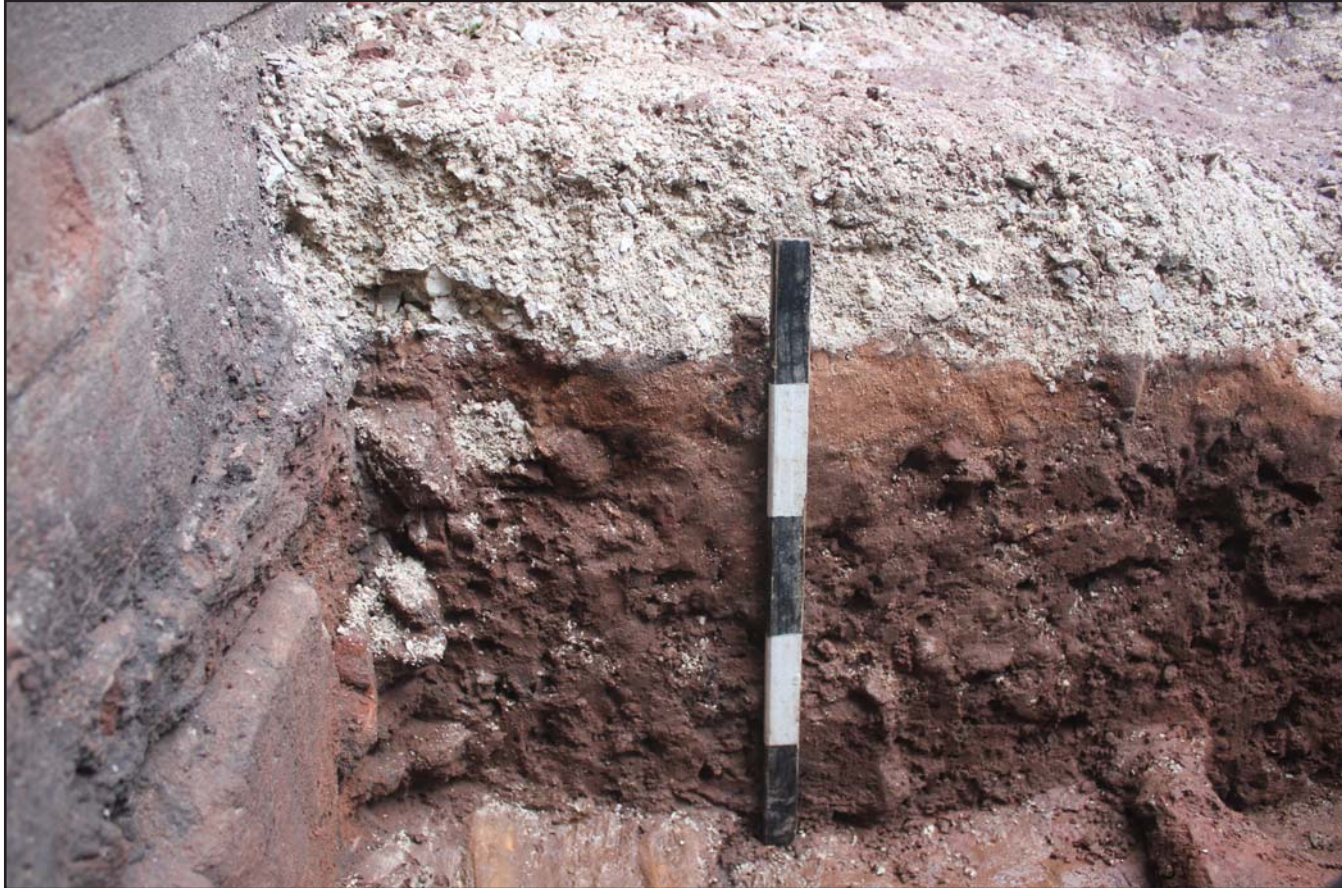
At the southern end of the test pit a second sub-rectangular grave [1006] was found, also cut into the sandstone bedrock (1012). The grave was orientated east to west and measured >1.2m in length by >0.6m in width by 0.05m in depth, and continued into the western limit of excavation. The grave had steep, almost vertical sides with a gently north-south sloping base, and was located at 123.5m OD (0.69m BGL). The grave cut was filled with a soft mid red-brown silt-clay (1011) which when excavated revealed the poorly preserved remains of two in-situ femurs (skeleton 07) that continued into the western limit of excavation. The femurs measured 0.2m apart from their outside edge suggesting that the interred individual was a child, and lay at 123.55m OD (0.64m BGL).

**Plate 27:** Test Pit 3 grave cut [1006] and east facing section, from the east. Scale 0.5m.
