aeon archaeology

October 2017

Report no. 0142 v1.0

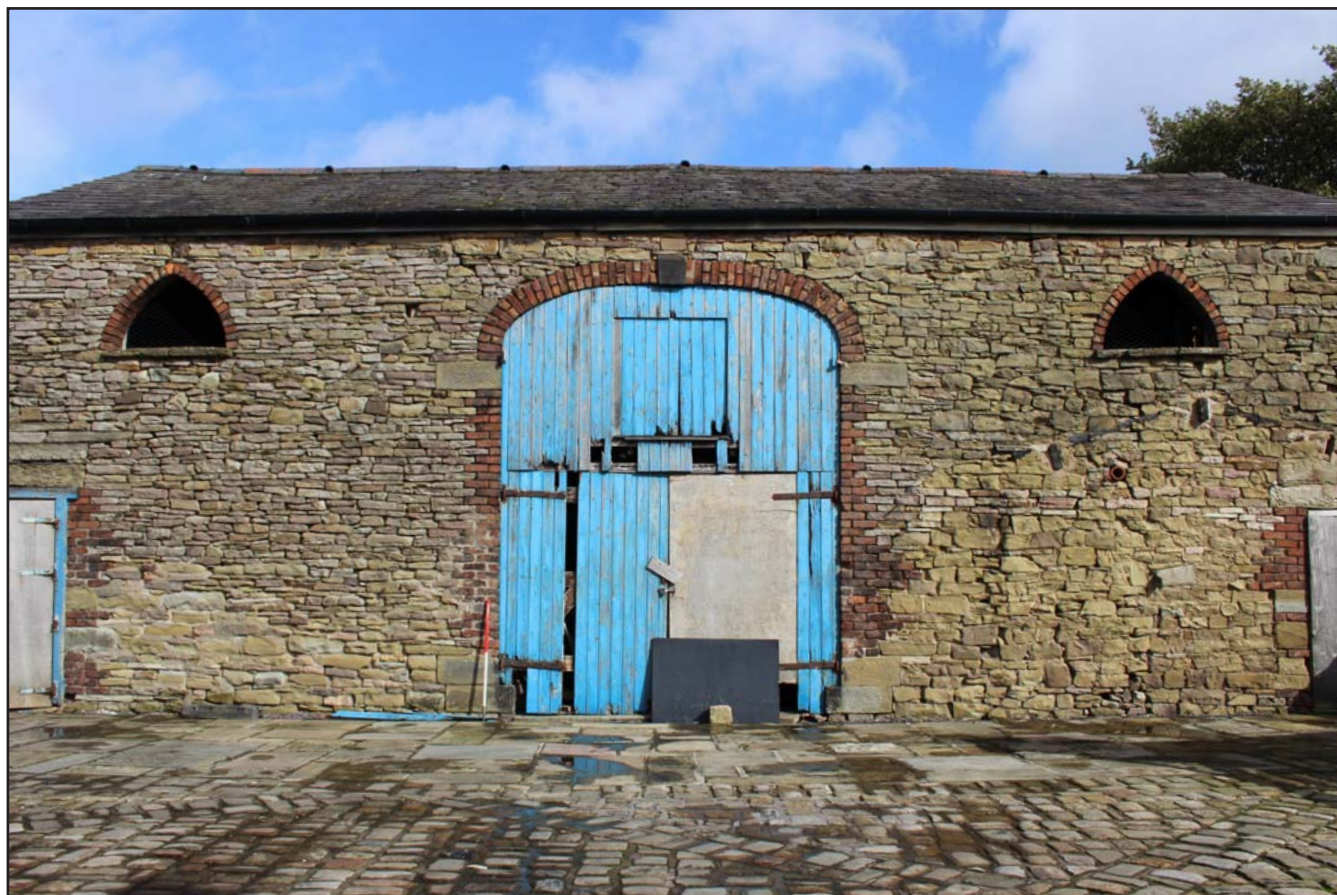
Plate 01: Southwestern elevation - from Southwest - Scale 1m

The south-western elevation is constructed from stone rubble bonded by mortar with dressed stone quoins at either end. There is evidence of numerous brick repairs, particularly around the doorways. On the lower right hand portion of the elevation there appears to be a substantial repair with stone rubble bonded by mortar; the area may once have been a projecting extension from this elevation as roof purlins are still visible in this area of the wall.

Centralised within the elevation and spanning both storeys is a large wooden double, barn door painted blue. This door is bordered in bricks with a basket brick arch supporting the wall above; the arch has a dressed keystone and two dressed stone springers with dressed stone abutments. Flanking the barn door on the first floor are two small stylised lancet windows; constructed from brick with sandstone sills. On the ground floor at the left and right hand limits of the building are two single doorways with stone lintels and wooden doors.

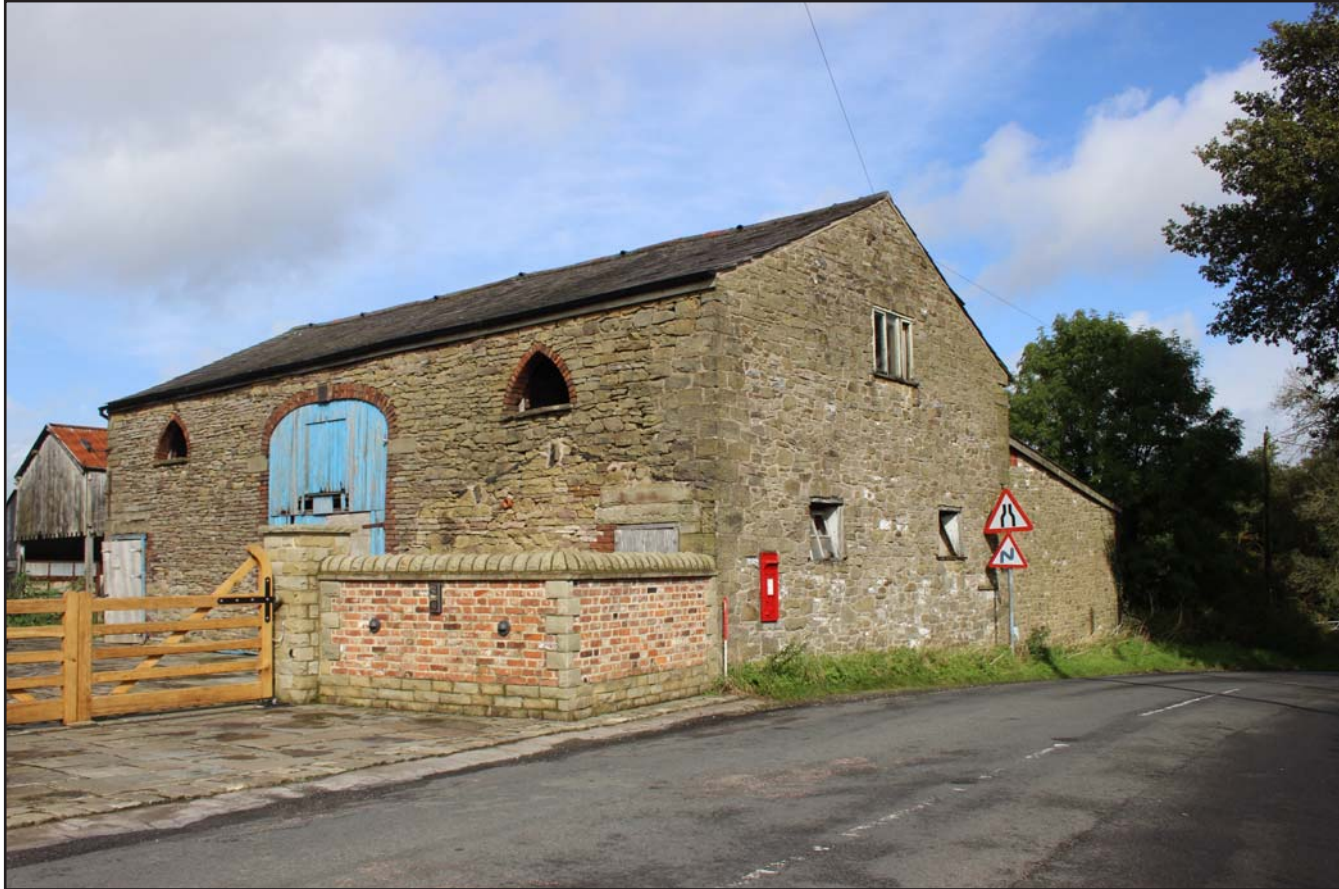
Plate 02: Southwestern and Southeastern elevations (Oblique) - from South - Scale 1m

The south-eastern elevation is constructed from stone rubble bonded by mortar with dressed stone quoins at either end. The elevation displays three wooden framed windows on the ground floor and one on the first floor. The first floor window is rectangular with three panes and is only partially glazed and the ground floor windows are square with timber frames and have been boarded up. On the lower left hand side is a red Elizabeth II postbox set into the rubble stonework. Projecting from the right hand side is a modern extension in stone rubble bonded by mortar; this appears to be a single wall which masks the steel build lean-to behind.

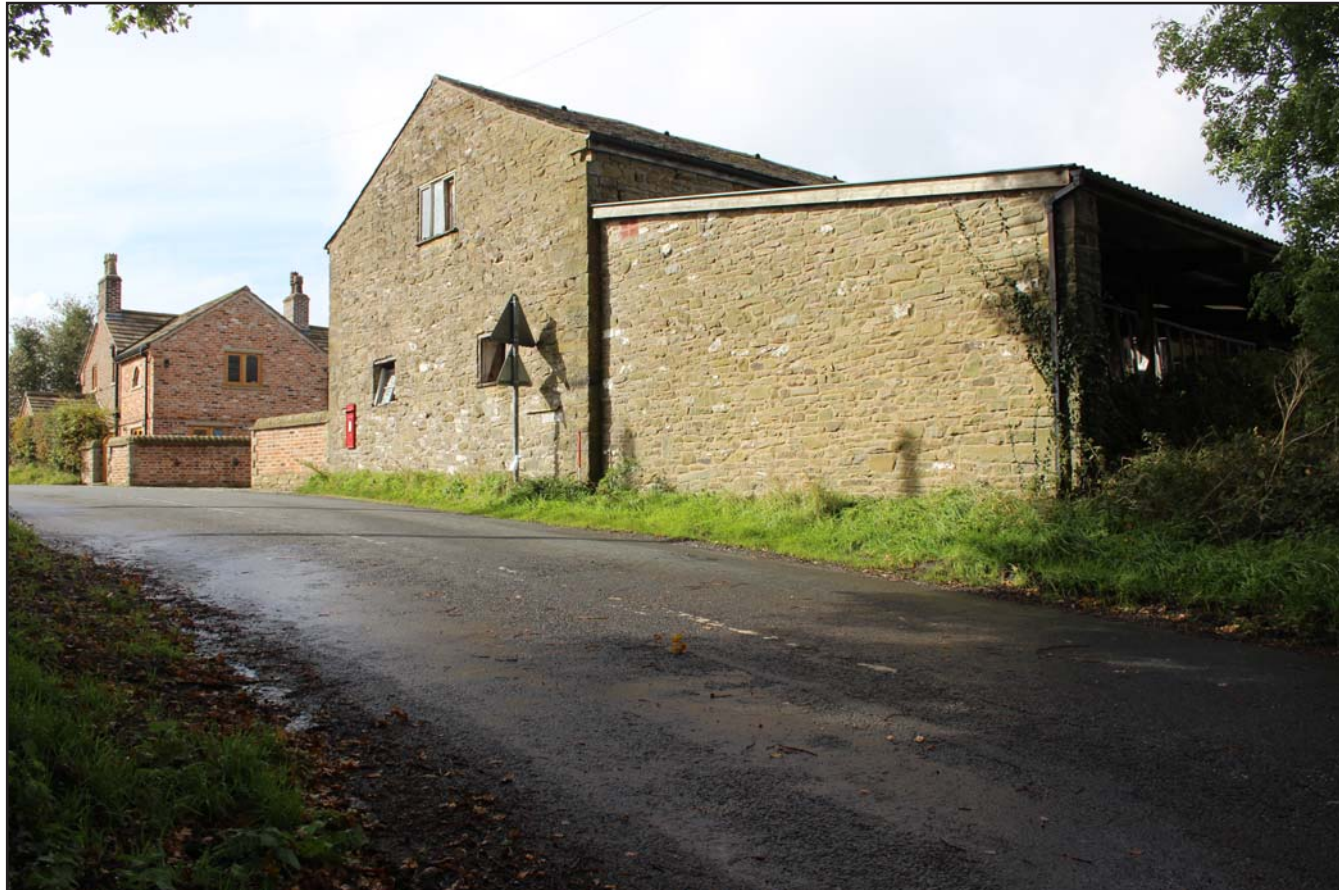
Plate 04: Southeastern and Northeastern elevations (Oblique) - from East - Scale 1m

The north-eastern elevation is constructed from a mixture of stone rubble and red brick bonded by mortar. The elevation is dominated by stone rubble as the main building material with red brick being restricted to around the windows. The lower half of this elevation has been rendered. The elevation has also been obscured by a modern steel build lean-to and the lower half of the elevation was further obscured by stored timbers and building materials.

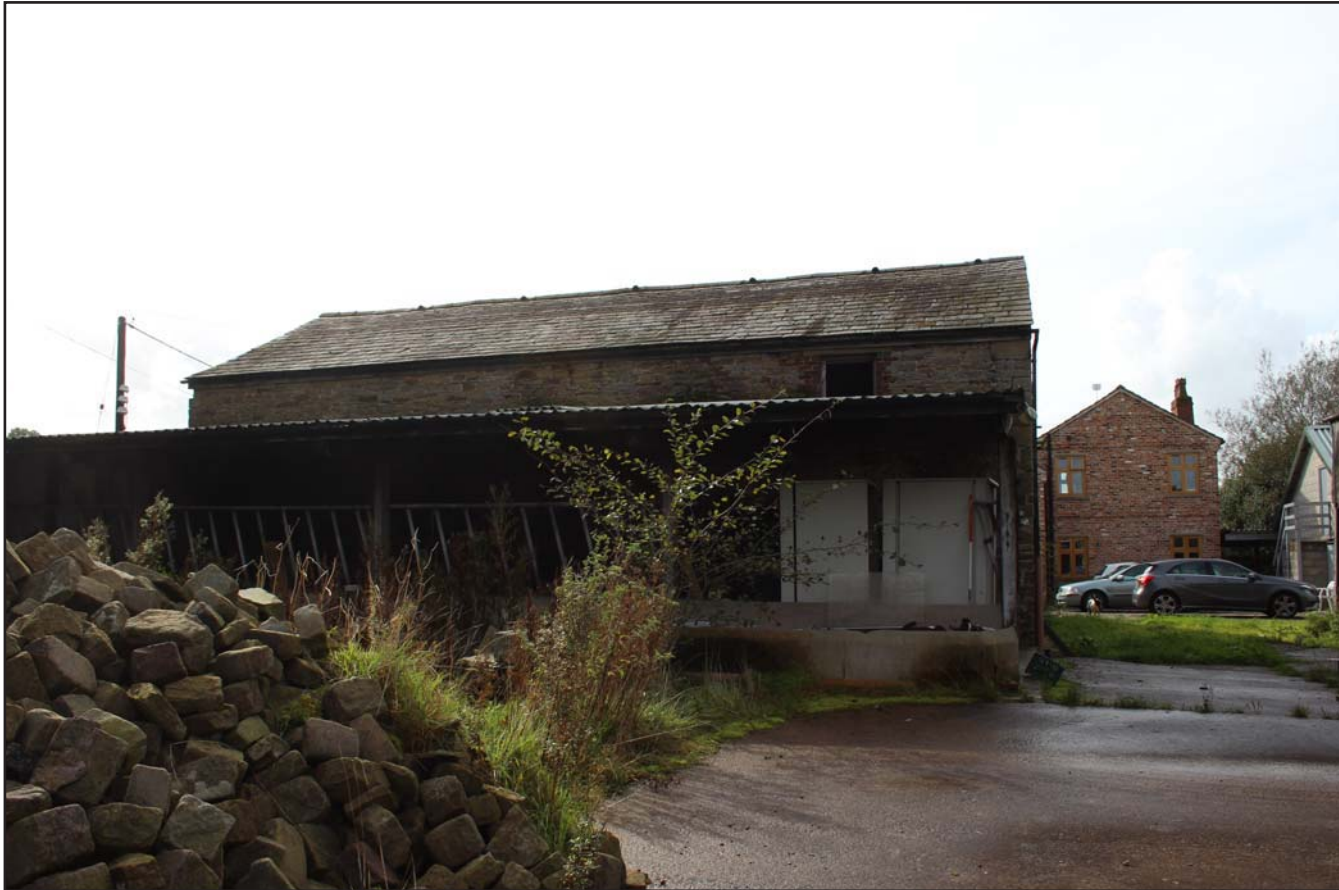
Plate 05: Northeastern elevation - from northeast - Scale 1m

Visible at the right hand side on ground level are two eight pane metal framed rectangular windows and a single doorway; further towards the left-hand end is an eight pane metal framed square window and towards the centre is another eight pane square window. Towards the right of this there is a blocked doorway with an unattached wooden door painted white, with timber lintel and wooden frame also painted white. Above on the first floor towards the right hand side is a single square window with a timber frame; the window has been blocked off with chicken wire.

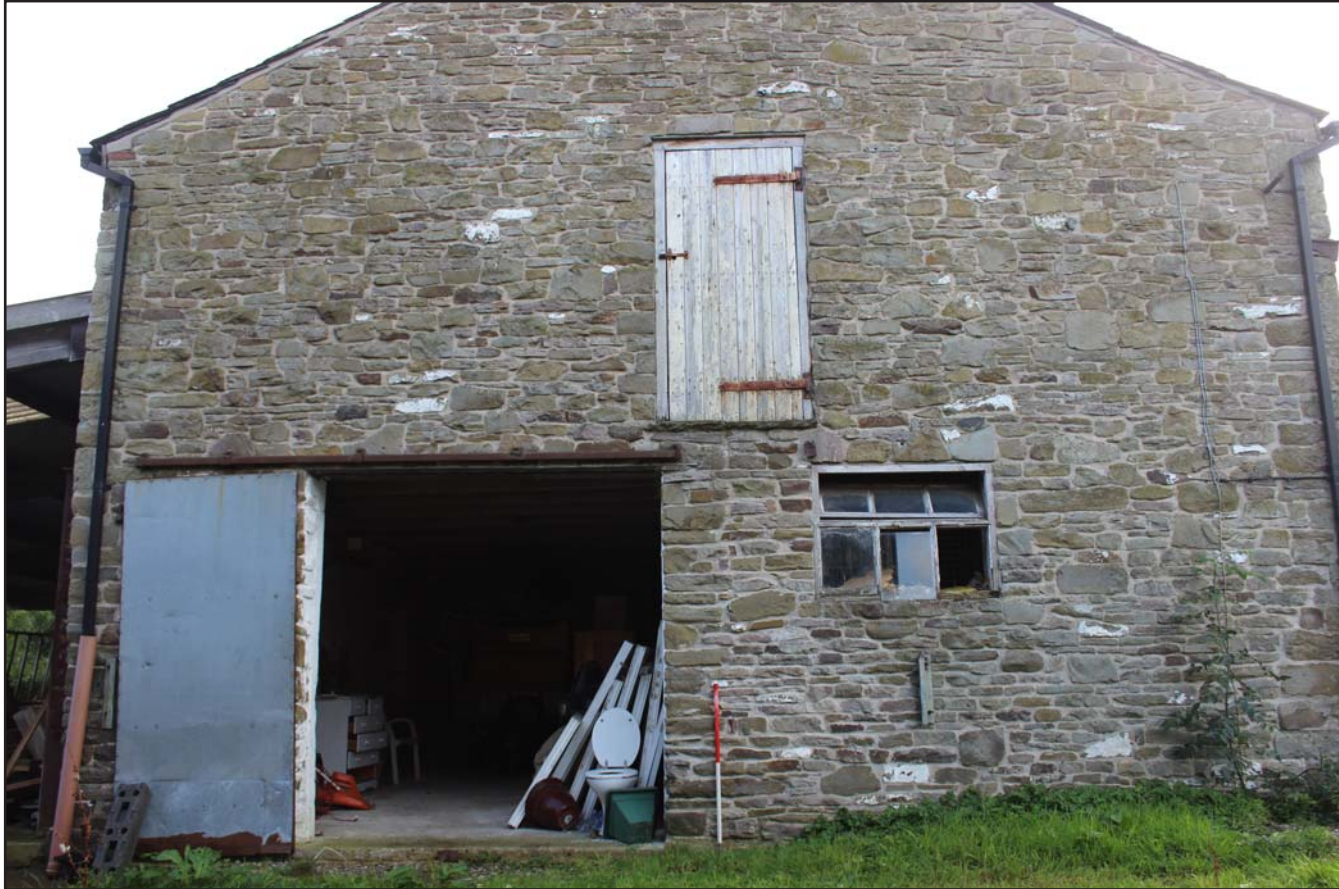
Plate 07: Northwestern elevation - from Northwest - Scale 1m

The north-western exterior is constructed from stone rubble bonded by mortar. The bottom hand left end of the gable is dominated by a double doorway which permits access to the *backstore/byre 2*. This can be closed off via a metal sliding door seated on metal runners. To the immediate right of this doorway (on ground level) is a six pane wooden framed window with wooden glazing bars. Above this window on the first floor is a centralised wooden doorway which permits access to the first floor loft area. Abutting onto the left hand side of this elevation is a modern steel constructed lean to with a corrugated plastic roof.

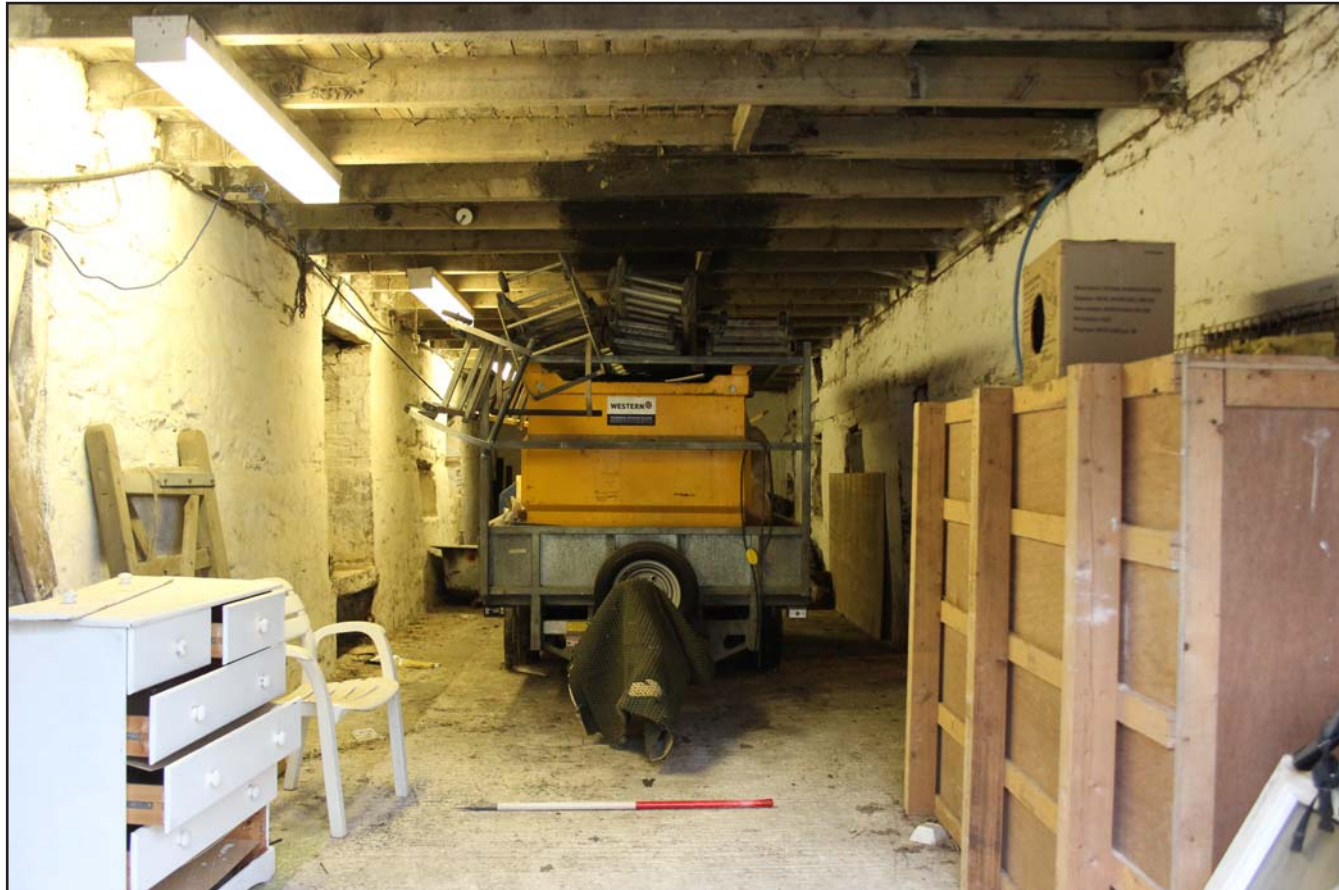
Plate 09: 1. Backstore/Byre - from Northwest - Scale 1m

This is a rectangular room orientated northwest to southeast. The ceiling is composed of 24 sawn timber beams which support the floor above; these beams run northeast to southwest and are set directly upon the walls. The north-western, south-western and north-eastern elevations are of stone rubble bonded by mortar and painted white. The south-eastern elevation is composed of modern breeze block bonded by mortar and also painted white.

The north-western elevation is dominated by a large double doorway to the left of centre. This doorway has a reinforced steel lintel apart from this the elevation is otherwise featureless. The north-eastern elevation has a single doorway at its left end with a timber frame and door painted white. To the immediate left of this there is a timber set horizontally within the wall about halfway up from floor level. Centrally within this elevation there is a large opening which presumably used to be a doorway but has since been turned into a window; with a limestone sill set at knee height and a small recess beneath. The right-hand portion of the elevation has a rectangular recess halfway above floor level with a horizontal timber lintel set above. Immediately to the right of this is a window with a timber frame and horizontal iron bars. Apart from these the elevation is featureless.

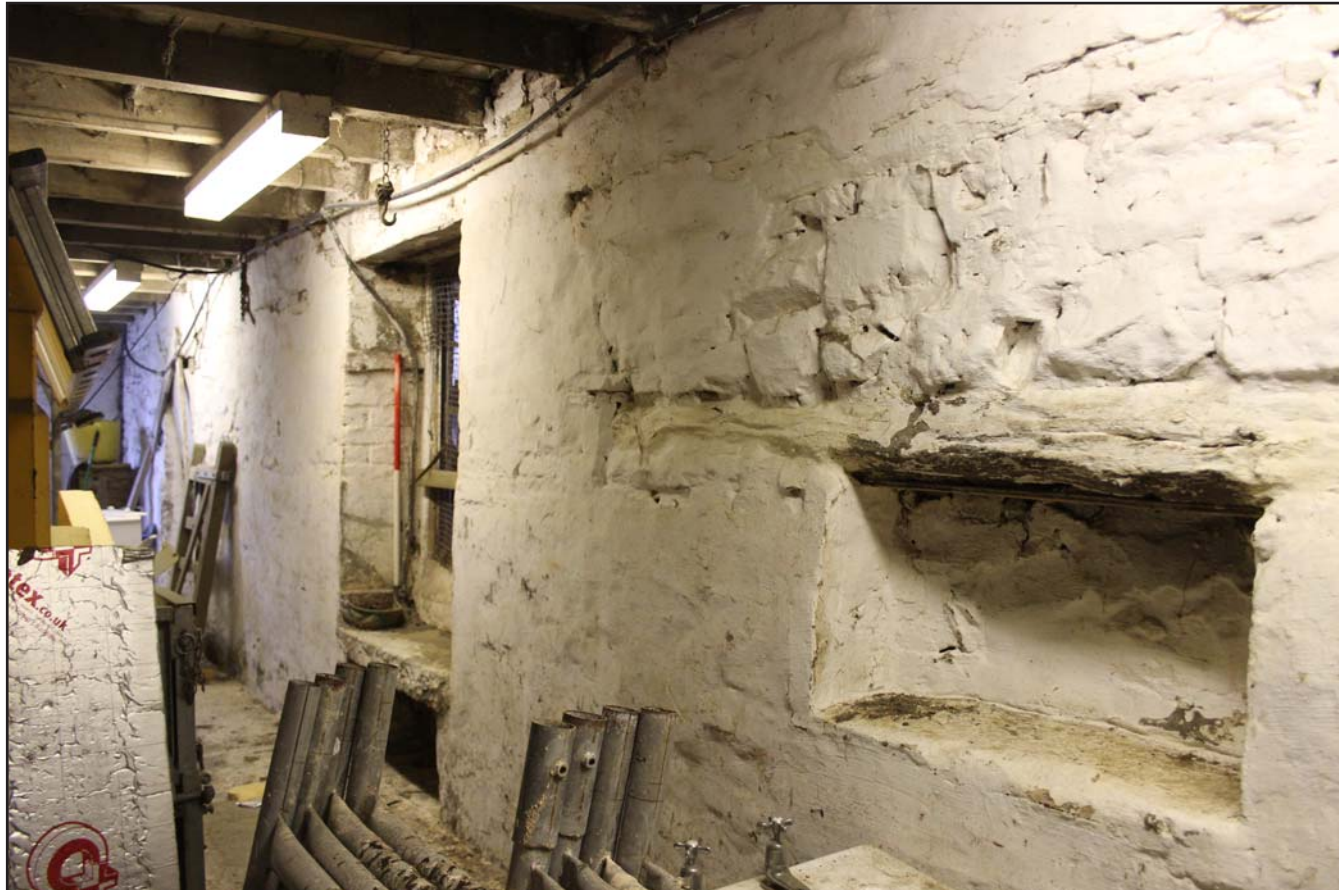
Plate 10: 1. Backstore/Byre - altered window and recess - from South - Scale 1m

The south-eastern elevation has a single window set centrally within the uppermost portion of the wall. This has been boarded up with plywood. Apart from this the elevation is featureless. The south-western elevation appears to have its upper left portion comprised of timber construction. It is difficult to ascertain whether this is structural or superficial boarding on this elevation (*see 3.Barn*). Centrally within the elevation is a single wooden panel doorway with wooden frame, although a metal sheet has been nailed to the door and frame on this elevation; this doorway leads into Barn (3.). To either side of this doorway both left and right are three equally spaced square windows, making six in total. All of the windows have wooden frames, lintels and sills and largely remain open but are loosely boarded up, except the window to the immediate right of the doorway which is completely blocked up with breeze block.

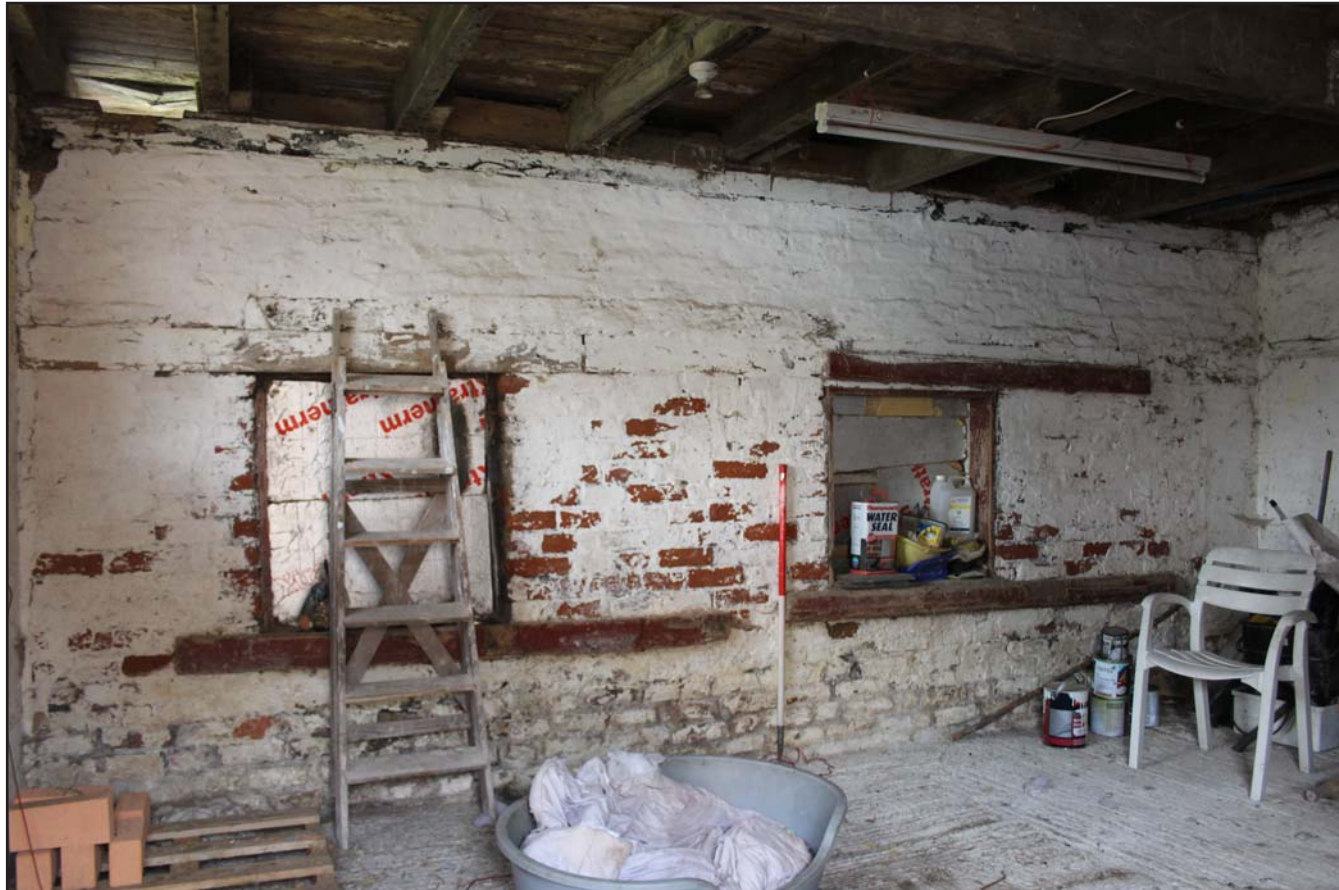
Plate 11: 2. Sidestore/Byre - northeastern elevation- from West - Scale 1m

The north-western elevation has a single window to the right of centre which is timber-framed with six glazed panels. Apart from this the elevation is featureless. The north-eastern elevation has a substantial horizontal timber which runs across the length of the wall about 0.50m below the ceiling. The wall has two equally spaced windows with timber frames, a third is blocked up at the right hand end. At one point they appear to have had timber sliding shutters but these are now absent – although the timber runner below the windows remains. The large timber running across the elevation acts as a lintel for both windows.

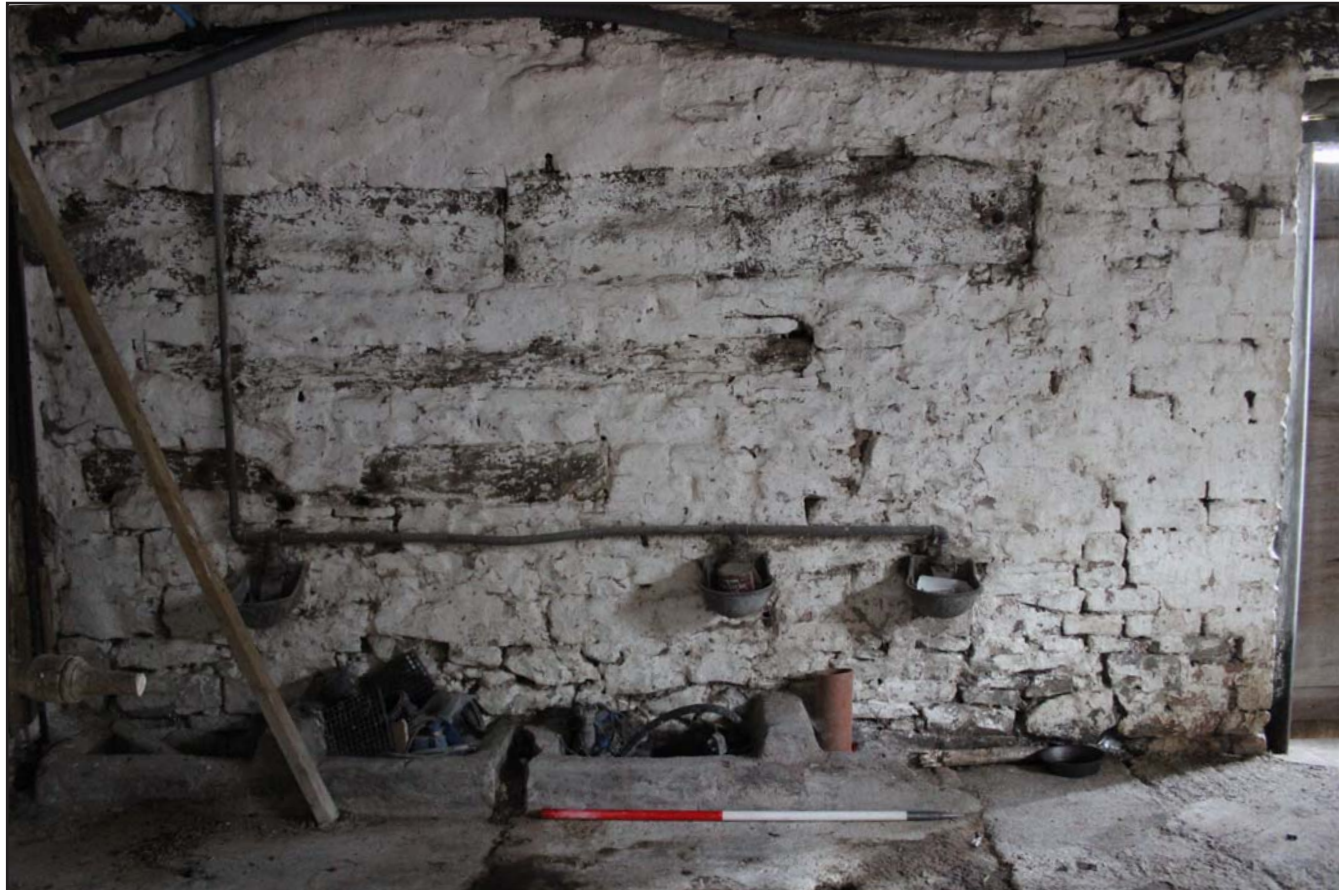
Plate 12: 2. Sidestore/Byre - southwestern elevation- from southwest - Scale 1m

The south-western elevation has a single timber framed doorway at the right end, with a significant hand cut timber lintel above. Within the left and central portions of the wall there are four separate timbers set into the wall at various heights, these could have been part of a framing for livestock pens or they may represent earlier phases of building. At the base of the wall towards the left and centre are two stone troughs with two compartments, this measures 1.37m long by 0.38m wide. Above these floor troughs are different wall mounted troughs; cast iron and pipe fed. The floor is of cast concrete.

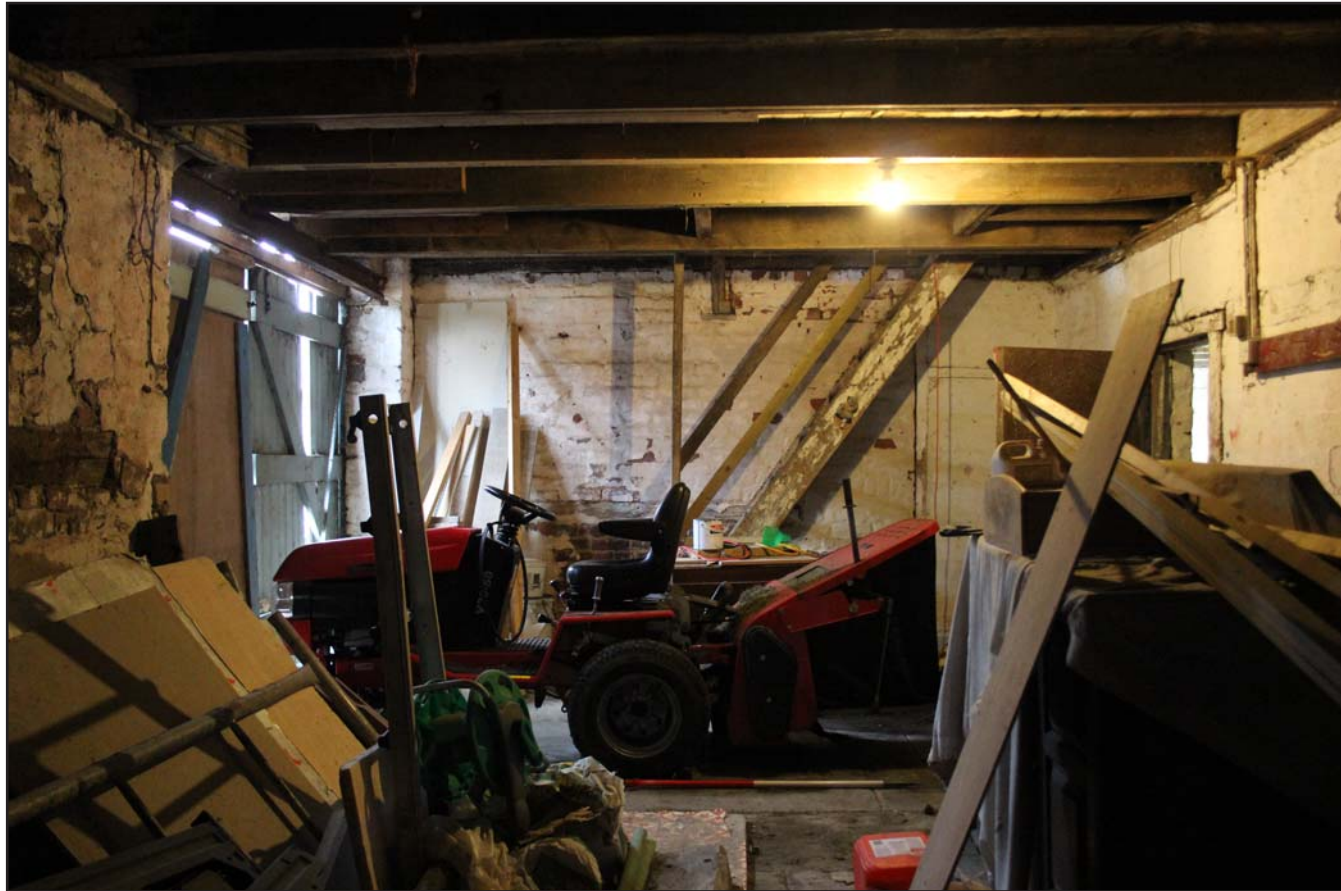
Plate 13: 3. Barn - northwestern elevation- from southeast - Scale 1m

The north-western elevation is of red brick bonded by mortar painted white. Towards the right end of the elevation a doorway with a wooden frame and lintel are also painted white, this doorway has been blocked with modern breeze-block bonded by mortar. Set against this elevation is a timber stairwell permitting access to the first floor via the open hatch.

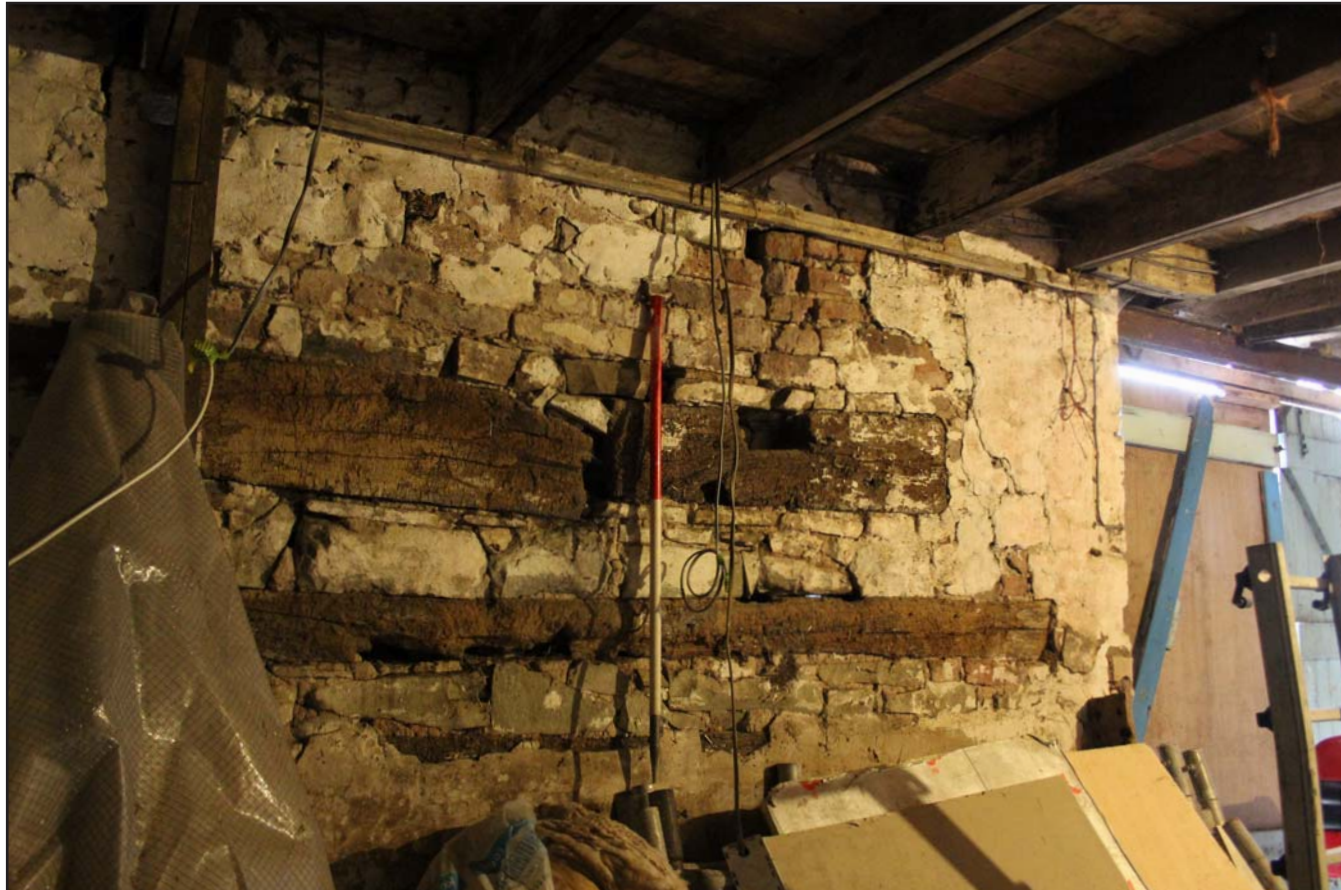
Plate 14: 3. Barn - Southwestern elevation (Showing timbers) - from East - Scale 1m

The south-western elevation is constructed from a mixture of materials; the main wall is constructed from stone rubble bonded by mortar however in the central portion of the wall there appears to have been a significant repair or the blocking up of a large doorway. This is evidenced by two horizontal timber lintels infilled with a mixture of red brick and stone rubble bonded by mortar and partially rendered. The uppermost of these timber lintels measures 3.15m long by 0.27m wide. The lower most of these timber lintels is offset to the right slightly and measures 2.70m long by 0.13m wide. In between these timbers the

stonework differs from the other elevations as it is much narrower and appears to have been used as packing. At the left-hand end is a narrow timber lintel below which there is a single doorway with wooden frame and door painted black. This doorway permits access to the exterior. The right-hand portion of the wall is dominated by a large double doorway with steel lintel and frame and the two doors swinging outward in order to permit access to the exterior. The doors are painted blue. The floor is comprised of stone flags of various sizes. Towards the southeast and there is evidence of cast concrete and extremely large flagstones. The room is currently being used for storage of furniture and timber making detailed photography difficult.

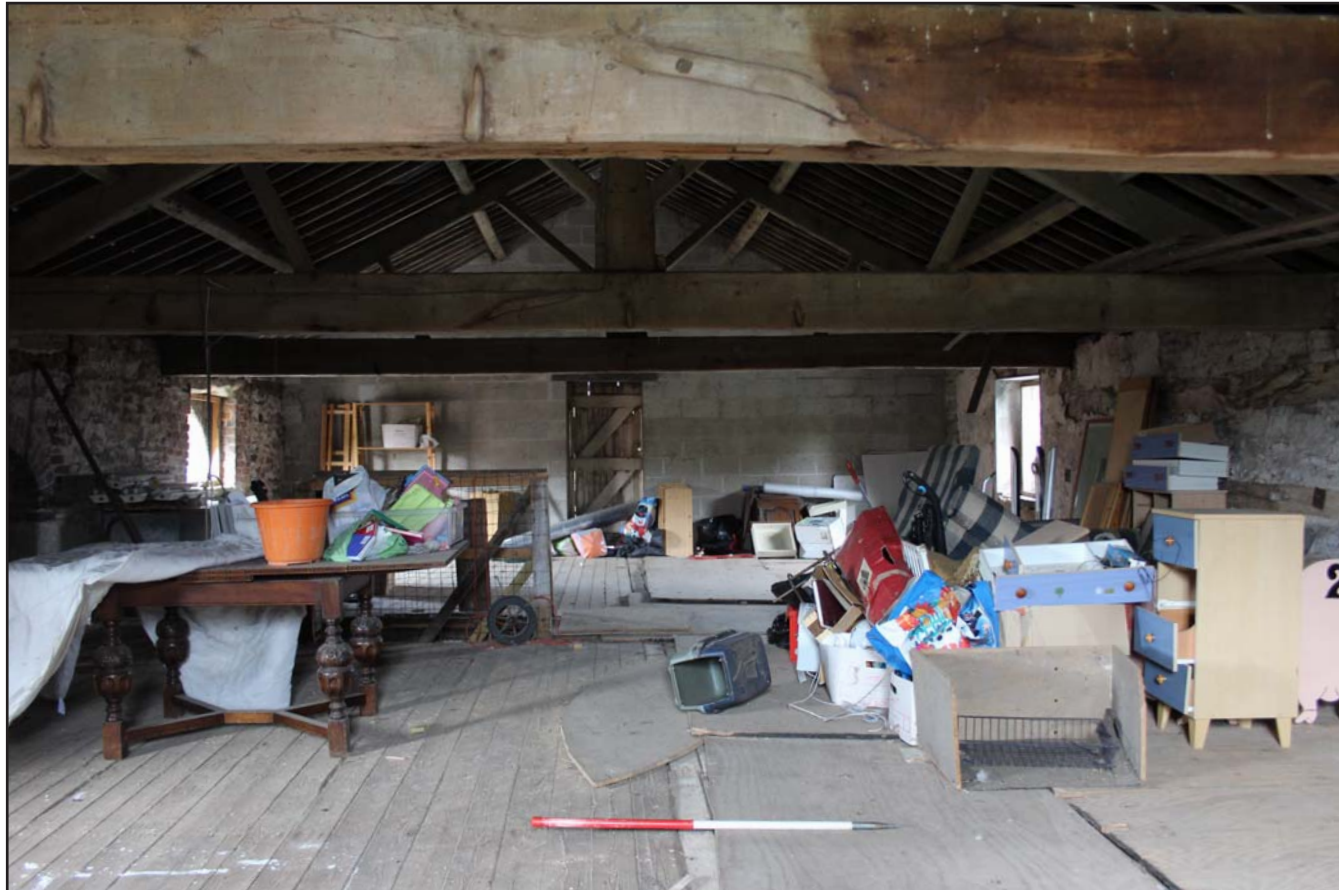
Plate 15: 4. Loft - Northwestern elevation - from Southeast - Scale 1m

The north-western elevation has a centralised single doorway with a wooden lintel and a wooden board and panel door permitting access to the exterior. Apart from this the elevation is featureless. The north-eastern elevation has a single window towards the left end. Surrounding the window there appears to be the remnants of lime and horsehair render but this has severely deteriorated. Within the central portion of the elevation are two horizontal timbers presumably located to receive fittings. Emanating from the timbers on the right hand side are a series of large structural cracks. A course of header bricks caps the wall in-between the trusses. Towards the right end another small horizontal timber is visible.

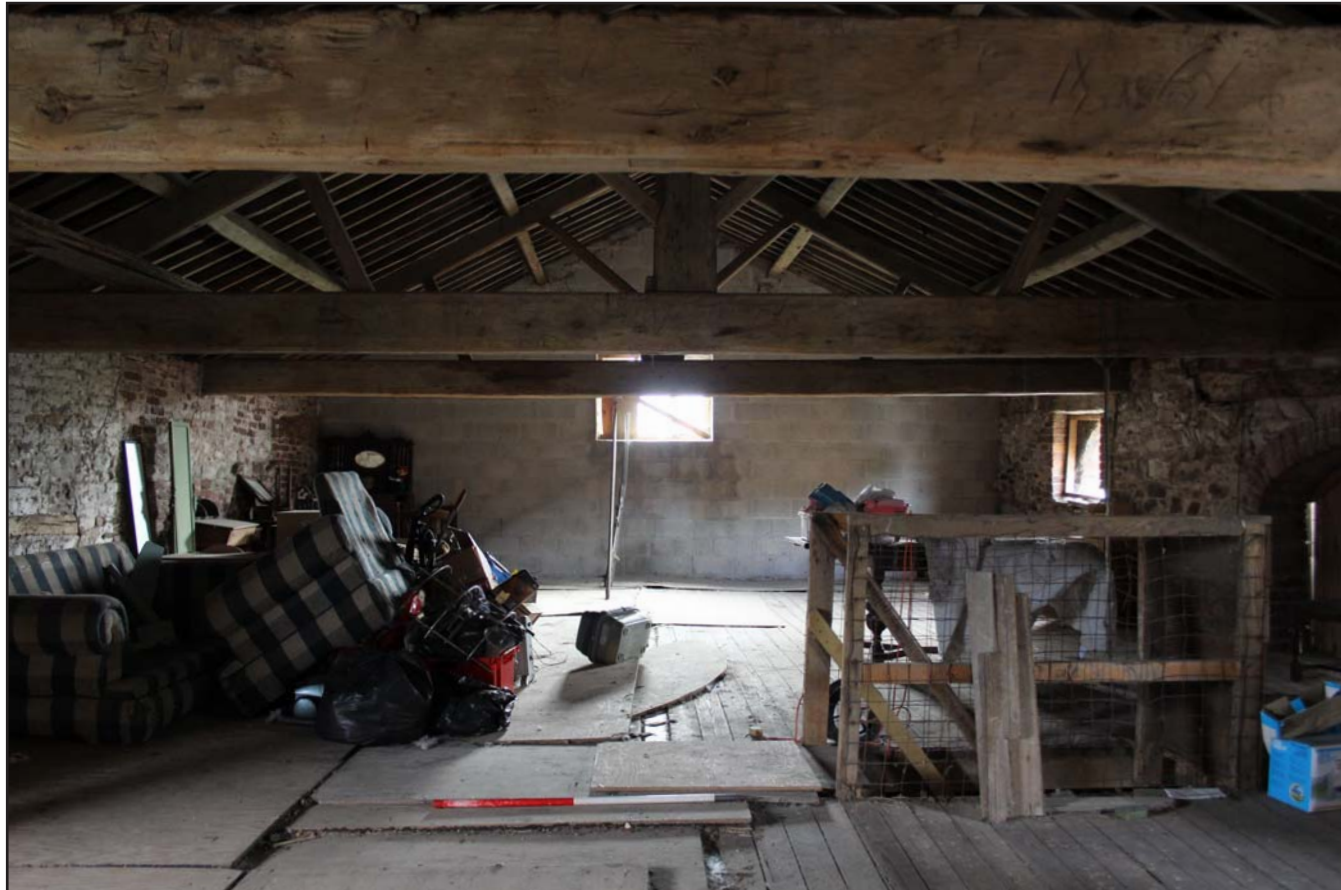
Plate 16: 4. Loft - Southeastern elevation - from Northwest - Scale 1m

The south-eastern elevation is constructed from modern breeze-blocks bonded by mortar. Centralised within the elevation halfway up from the floor level is a small window timber framed and partially glazed. Apart from that the elevation is featureless. Within the south-western elevation in the centre; is the uppermost part of an original large double doorway – the floor bisects this doorway suggesting that it is a later addition. This doorway has a basketed archway constructed from red brick bonded by mortar. Once more emanating from the archway are several structural cracks. A significant wooden lintel appears to have been placed above the archway at a later date. Flanking the archway to the left and right are two identical gothic windows; these are small and have brick-lined arches and wide sandstone sills (0.55m in width). Above these windows are hand-cut wooden lintels.

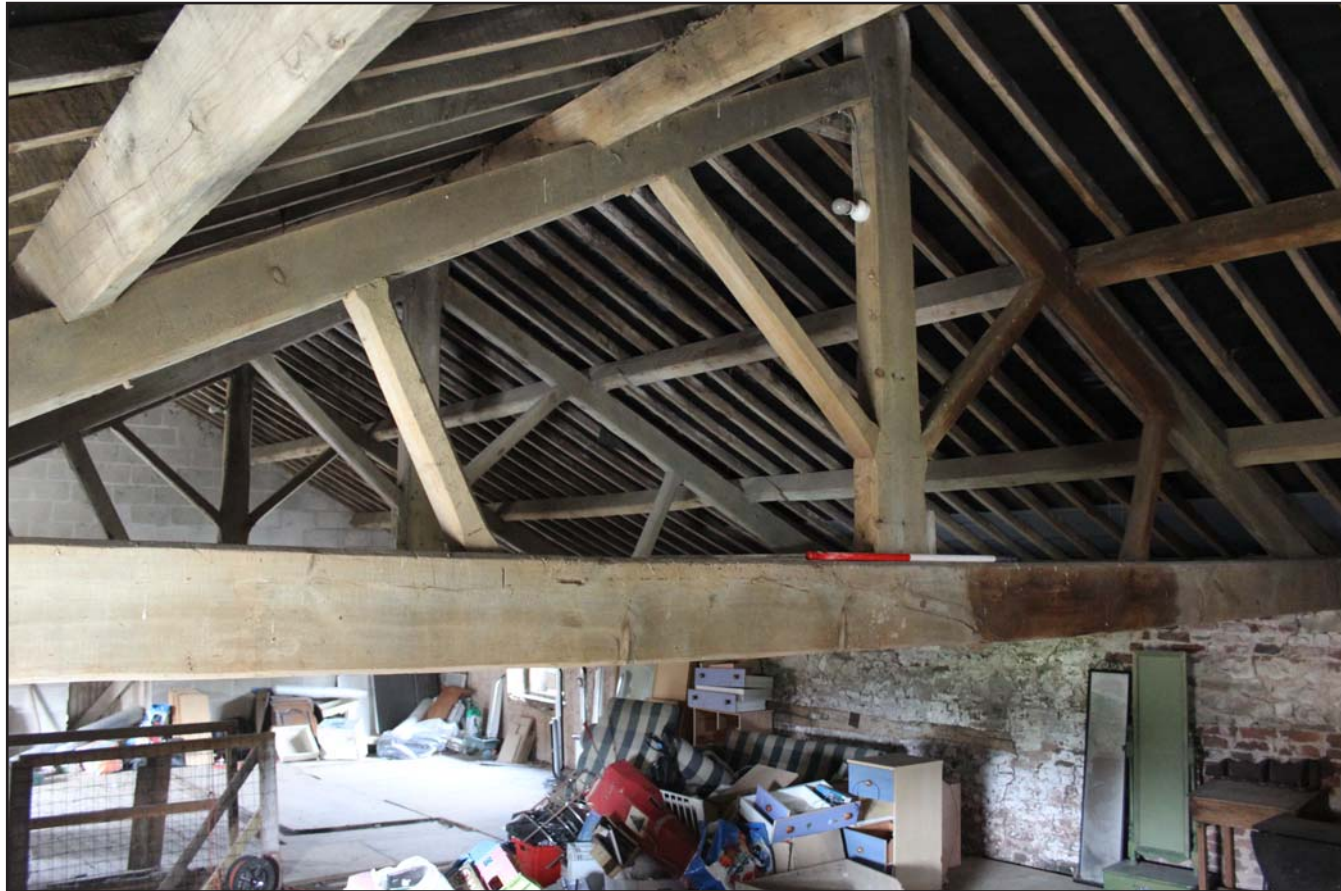
Plate 18: 4. Loft - King post roof truss "A-frame" - from South - Scale 1m

A large rectangular room orientated northwest to southeast. The ceiling comprises of modern building materials. Three king post timber trusses run northeast to southwest across the room. These trusses are directly supported by the south-western and north-eastern elevations. On the south-western elevation the trusses appear to have been recessed and seated up on packing stones. The north-western and south-eastern elevations are constructed from modern breeze-block bonded by mortar. The north-eastern and the south-western elevations are constructed from a mixture of stone rubble and red brick bonded by mortar.
