Historic Building Record Level 2
Project Code: A0147.1
Report no. 0157

Llwyn Y Maen, Oswestry, Shropshire SY10 9DD

Report no. 0157 v2.0

Level 2 Historic Building Record

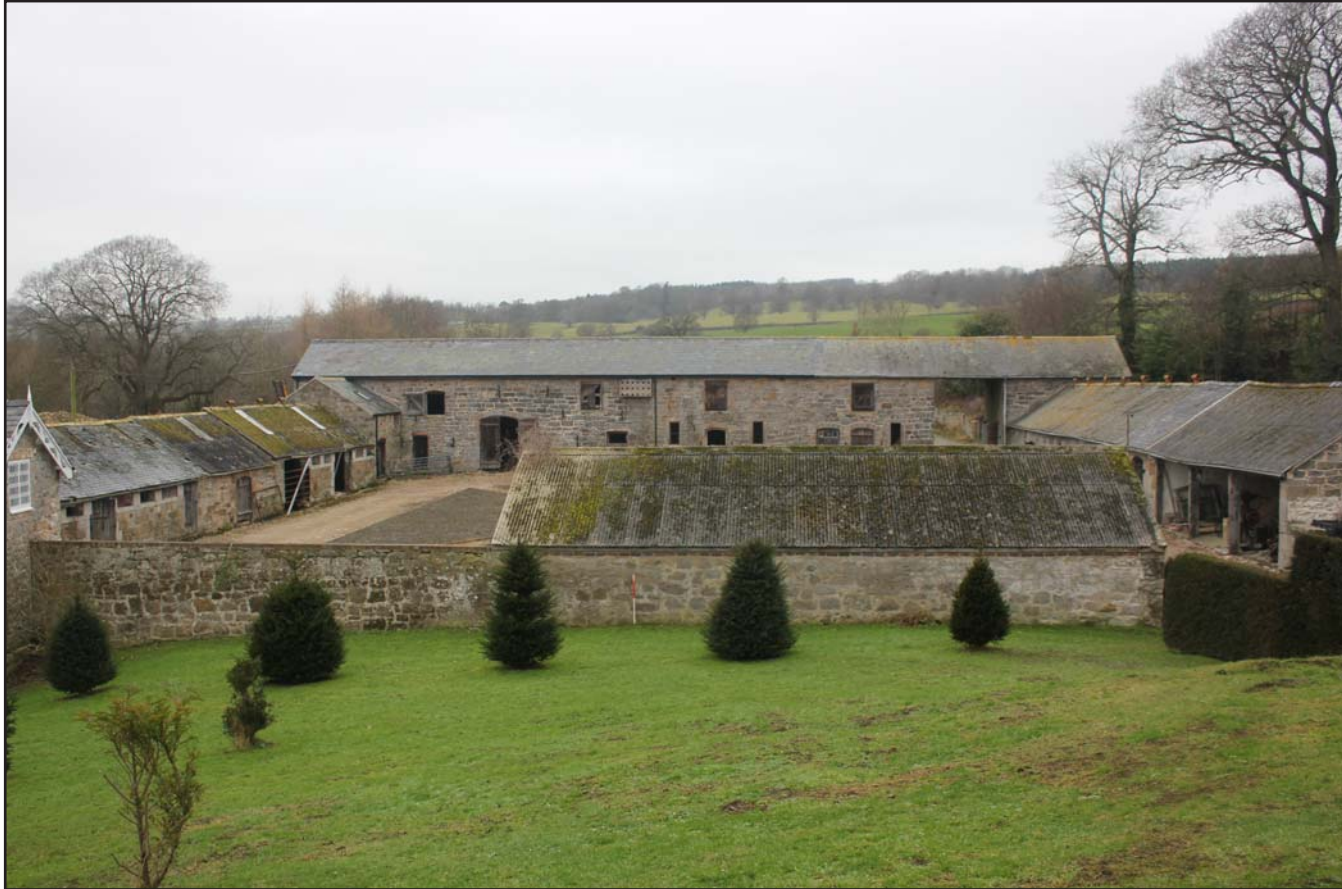
Plate 01: Llyn y Maen, Oswestry, Shropshire. North-eastern range, north-east elevation - From the north-east - scale at 1m

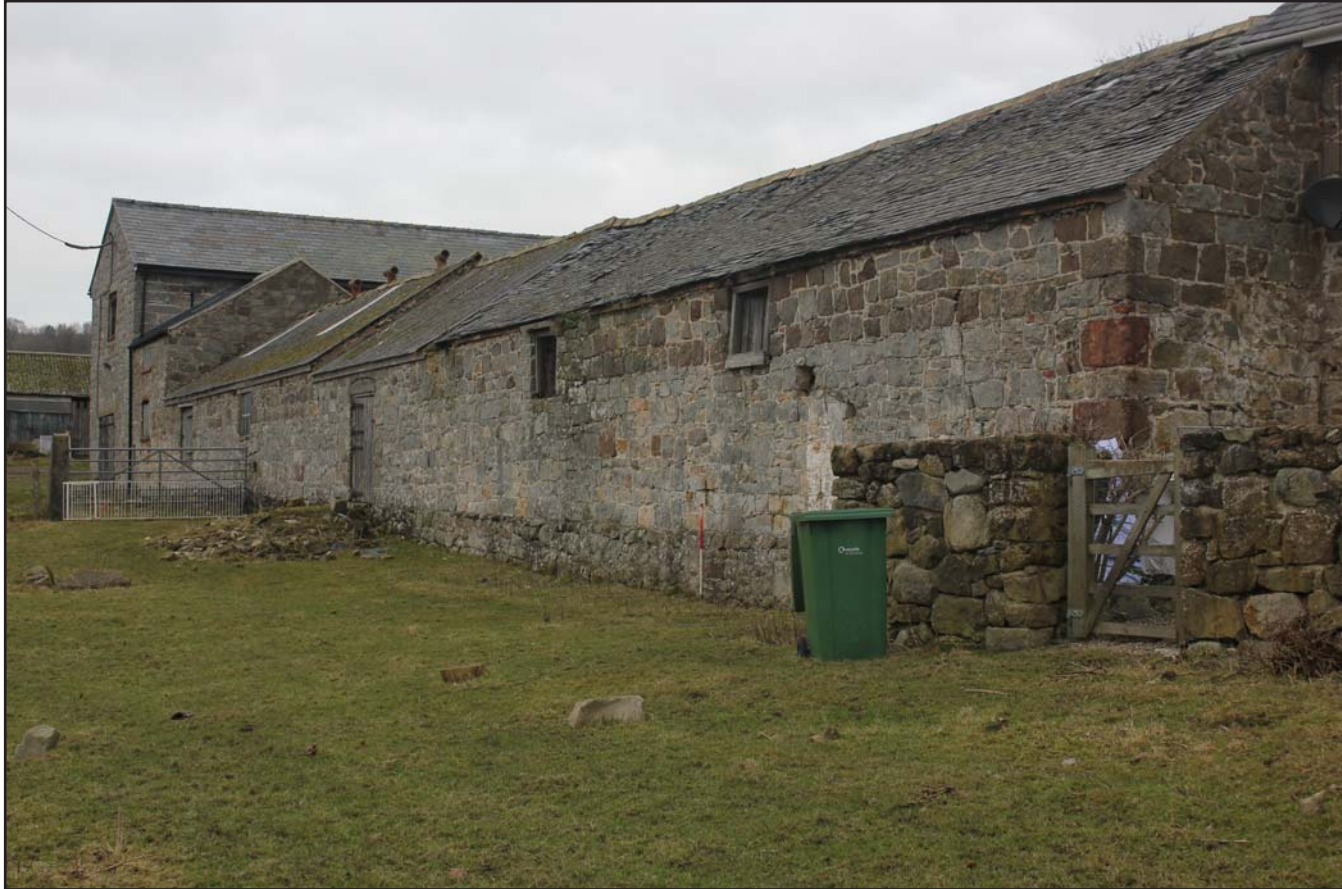
Plate 02: Llwyn y Maen, Oswestry, Shropshire. South-eastern range, south-east elevation - From the east - scale at 1m

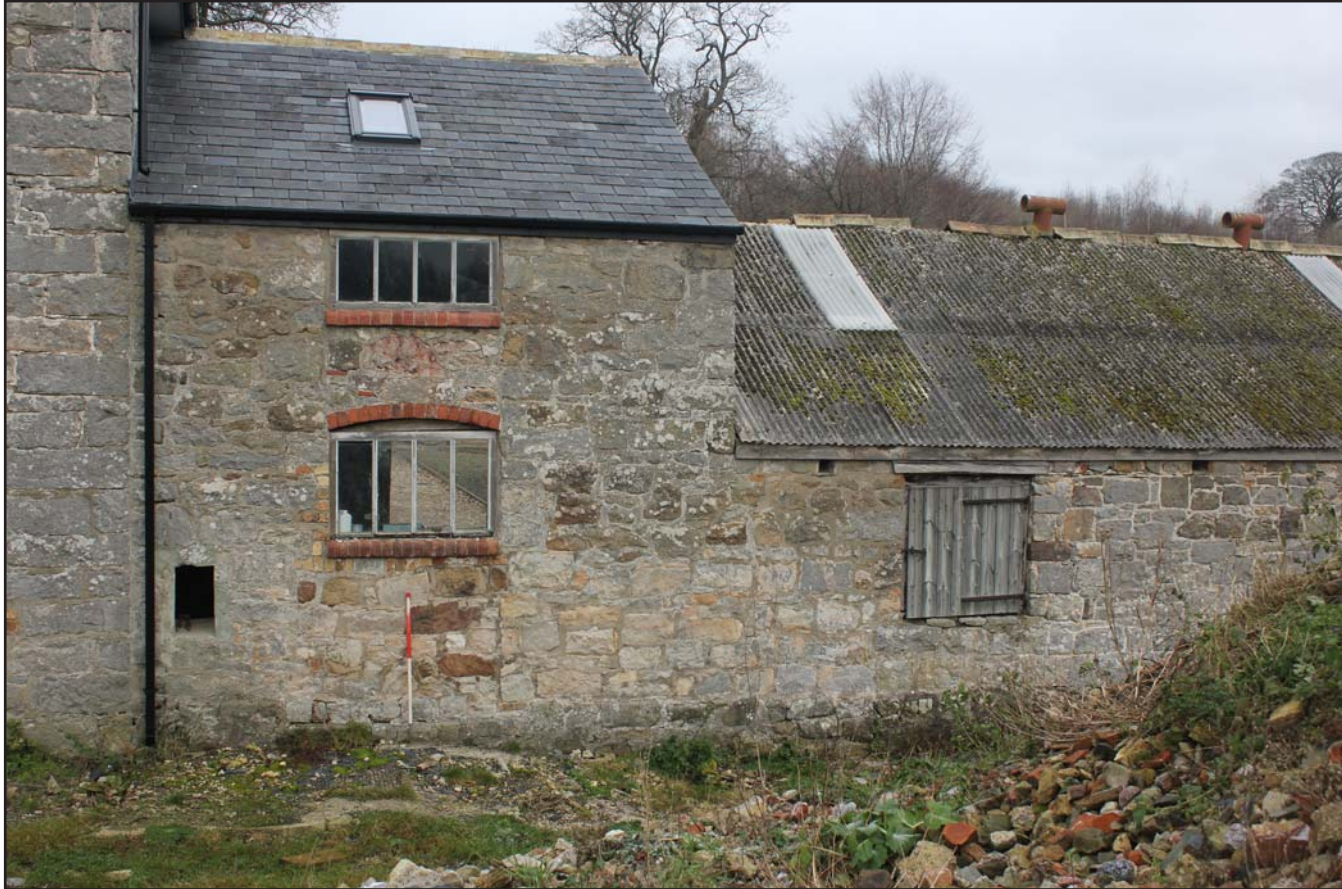
Plate 05: Llwyn y Maen, Oswestry, Shropshire. South-eastern range, south-east elevation (Room 4 - Mill Room) - From the south-east - scale at 1m

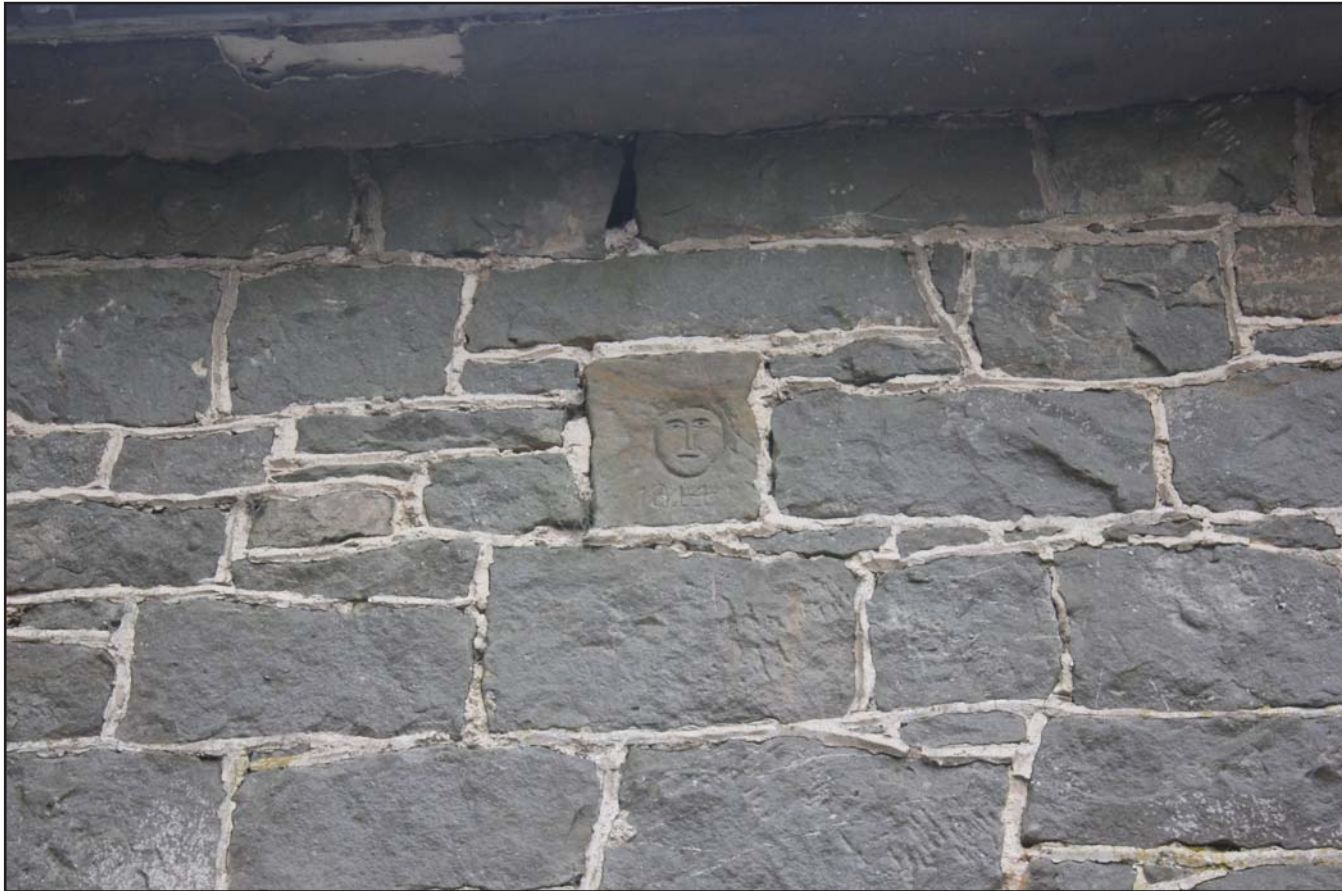
Plate 12B: Llwyn y Maen, Oswestry, Shropshire. South-western range, Stone Mason's portrait and date '1884' at upper left hand end - From the south-west - no scale

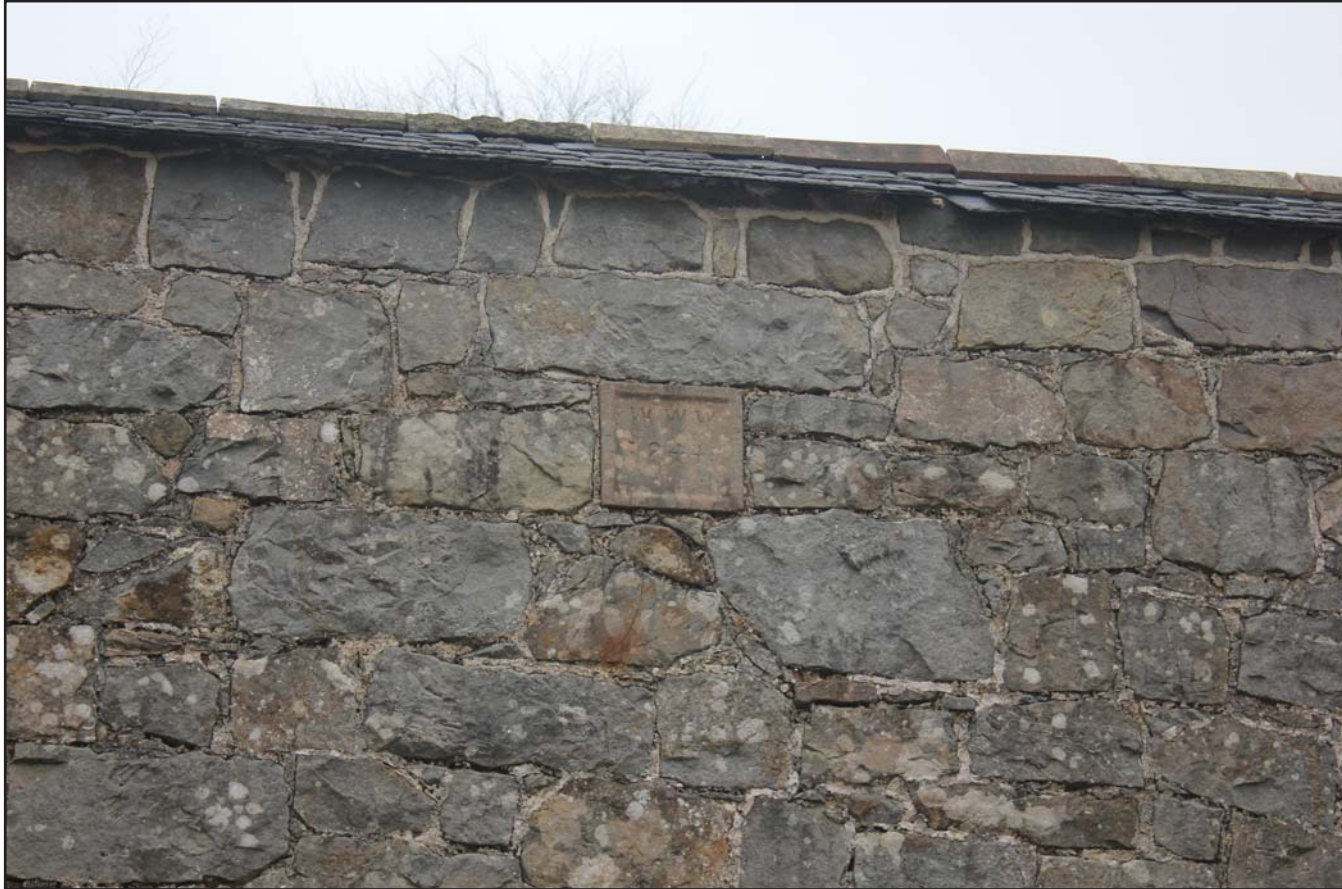
Plate 21B: Llwyn y Maen, Oswestry, Shropshire. Courtyard elevations - south-eastern elevation - Pig sties - Date stone with recoded date - From the east - scale 1.0m

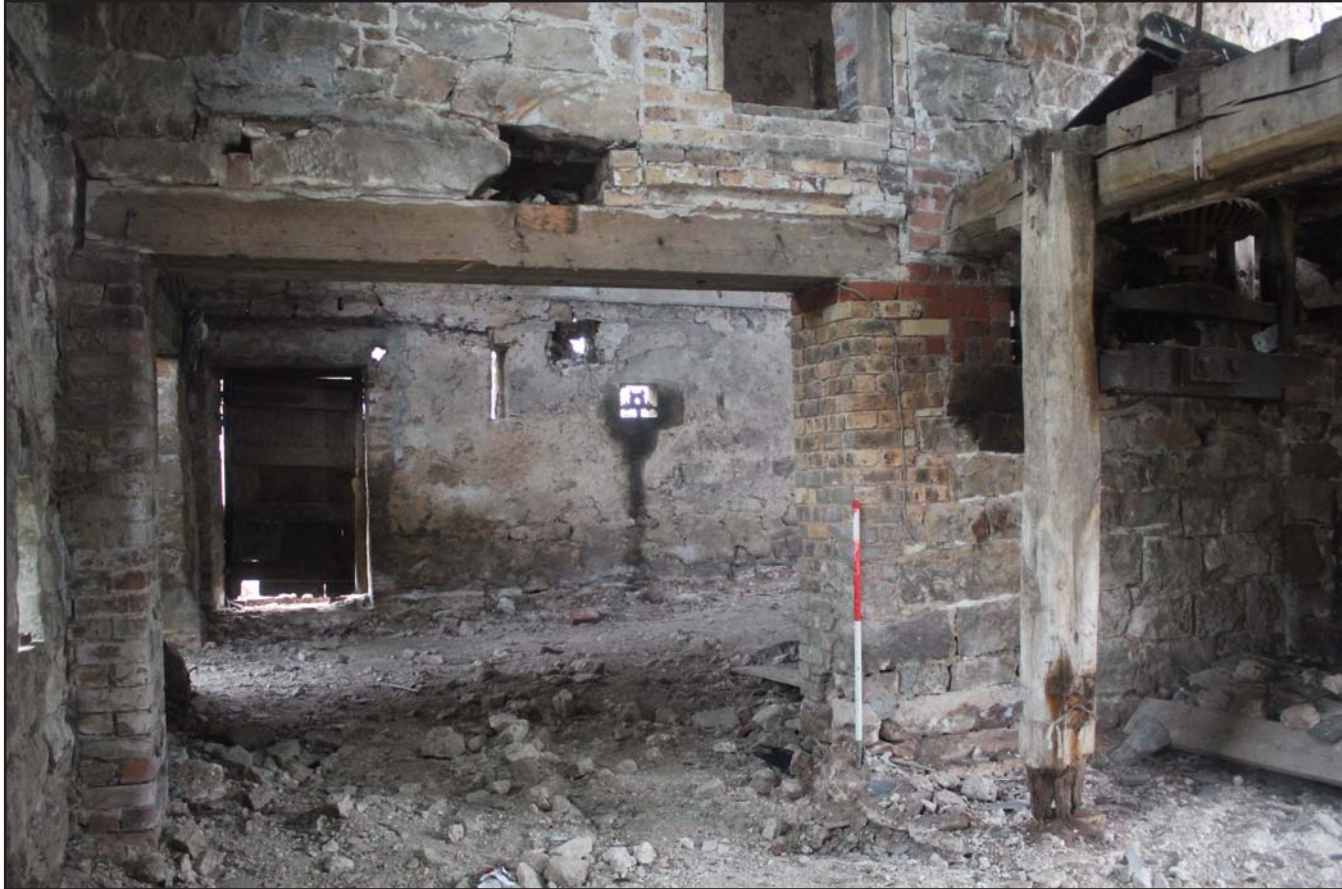
Plate 43: Llwyn y Maen, Oswestry, Shropshire. Room 4 through to Room 5 - From the south - scale 1.0m

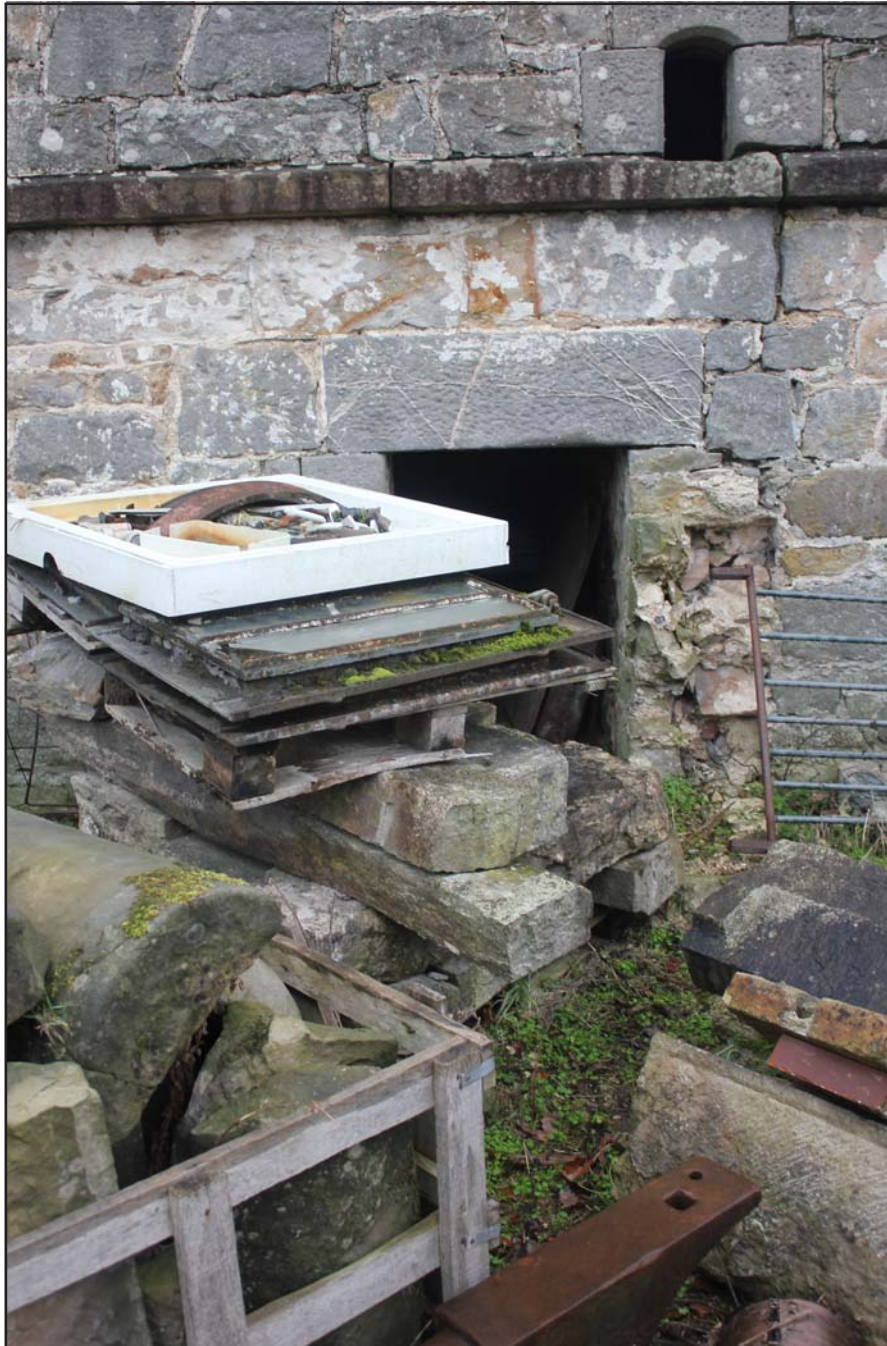
Plate 62: Llwyn y Maen, Oswestry, Shropshire. No access to Pig Sties- From the south-east - scale 1.0m

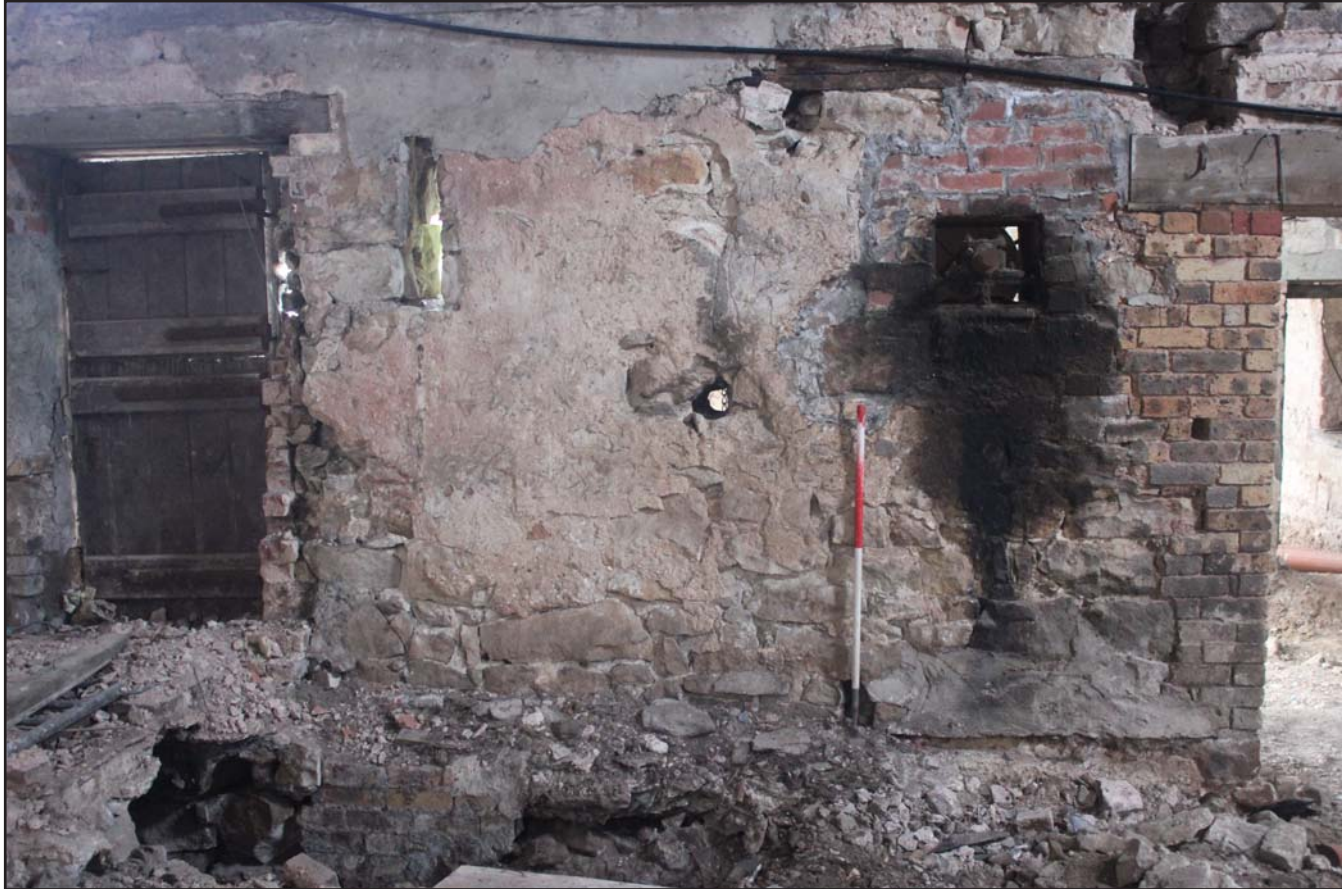
Plate 68: Room 5 - south eastern elevation showing linkage mechanism within wall (Room4 to right) - From the north-west - at 1m scale

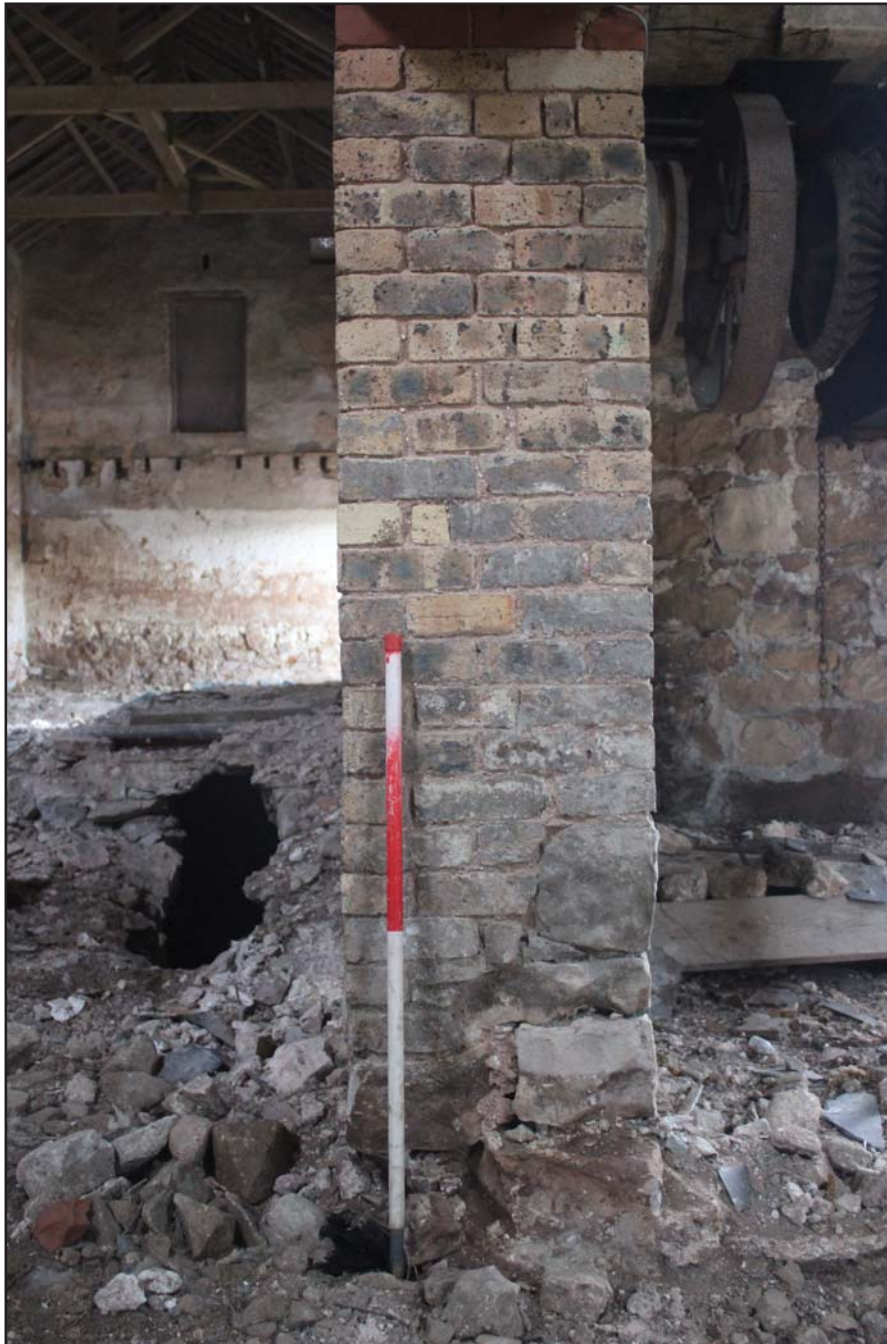
Plate 69: Shot illustrating the distance between the wheel pit (Room 5) and the mill-machinery (Room4) - From the south-west- at 1m scale
