**317, Upton Lane, Widnes,
Cheshire WA8 9AG.**

**January 2018
V 1.0**

Historic Building Record - Level 2
Project Code: A0149.1
Report no. 0153

Historic Building Record - Level 2

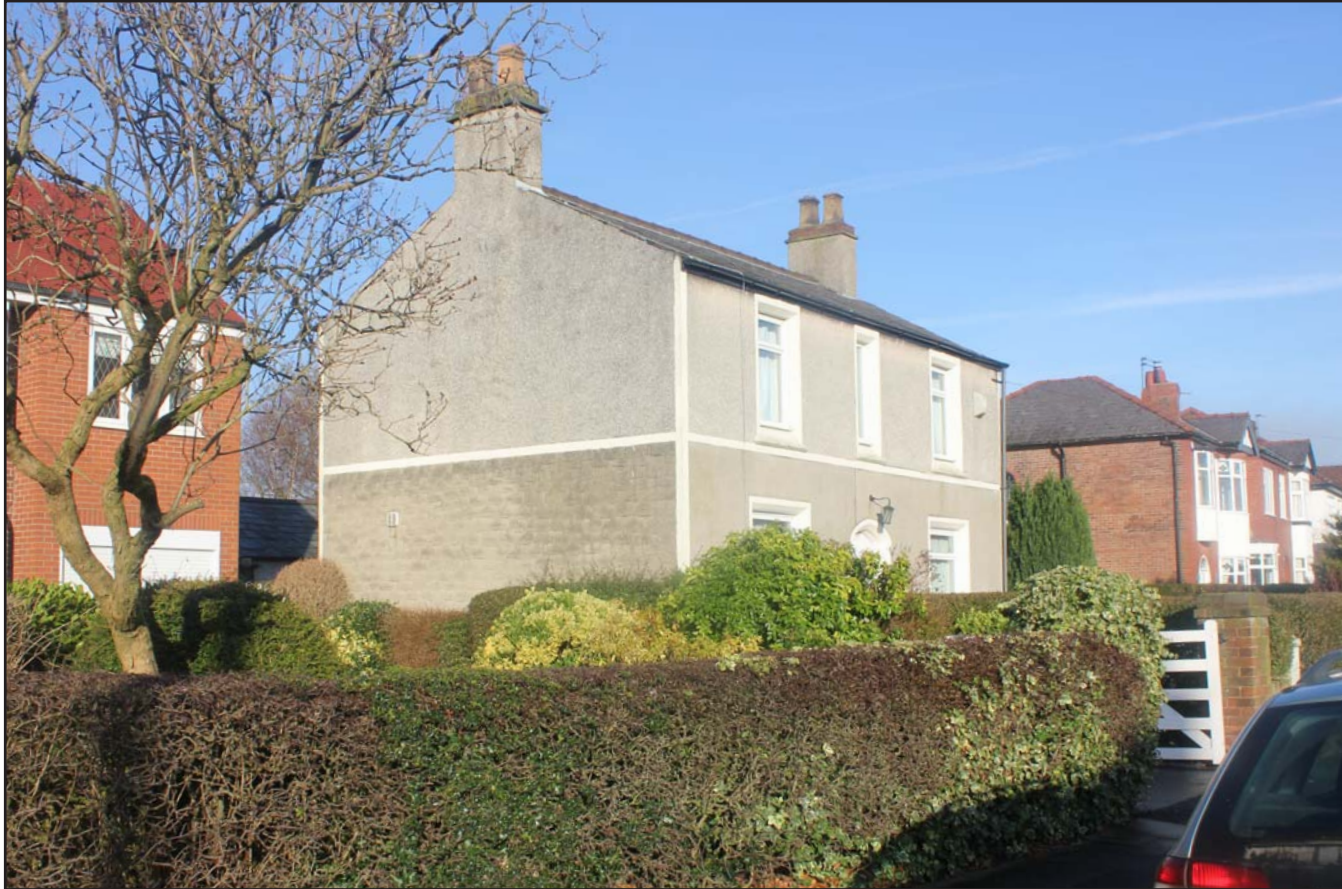
Plate 01: 317, Upton Lane, Widnes external south-western and south-eastern elevations - From the South - scale 1.0m

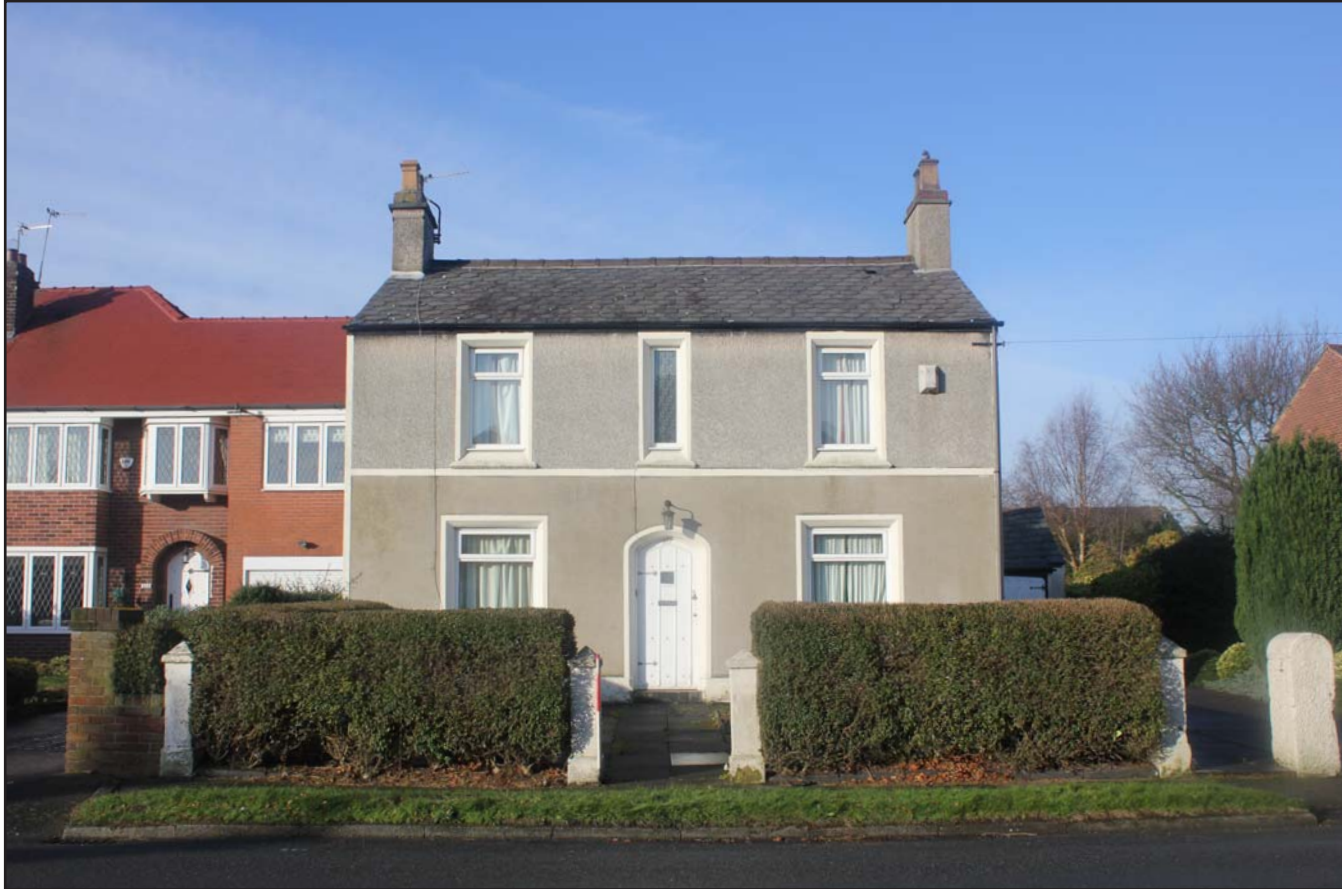
Visible from the exterior of the property are two brick built chimney stacks, which have been rendered with pebble dash. These chimney stacks are situated at either end of the property straddling the gables (at the north-east on the south-west). The roof comprises of slates with ceramic ridge tiles running between the two chimneys with plastic gutters at the eaves. The upper third of the elevation has been rendered with pebble dash (to just below the sill line) below this there is a grey render into which a geometric pattern has been etched; these materials are separated by a line of white-painted render which forms a border. The windows and the doorway are also surrounded by this white-painted render. At the base of the elevation there is a series of cut sandstone blocks which have also been painted white.

On the first floor level are three windows, the central window is a single glass pane horizontal, rectangular shape. This window is flanked by two equally sized and spaced dual pane windows which are also rectangular, but twice the width. All of these windows are constructed of modern plastic PVC. On the ground level the front door is centralised within the elevation; this is made of wood and stylised with cast iron fittings and metal studs, similar to the doors of the outbuilding (discussed below), with the single small square glass pane in the upper portion. Flanking the door either side are two further windows, these windows are equal in size although much larger and apparently square when compared with the windows on the first floor, these windows are also of plastic PVC.

Plate 02: 317, Upton Lane, Widnes external south-eastern elevation - From the southeast - scale 1.0m

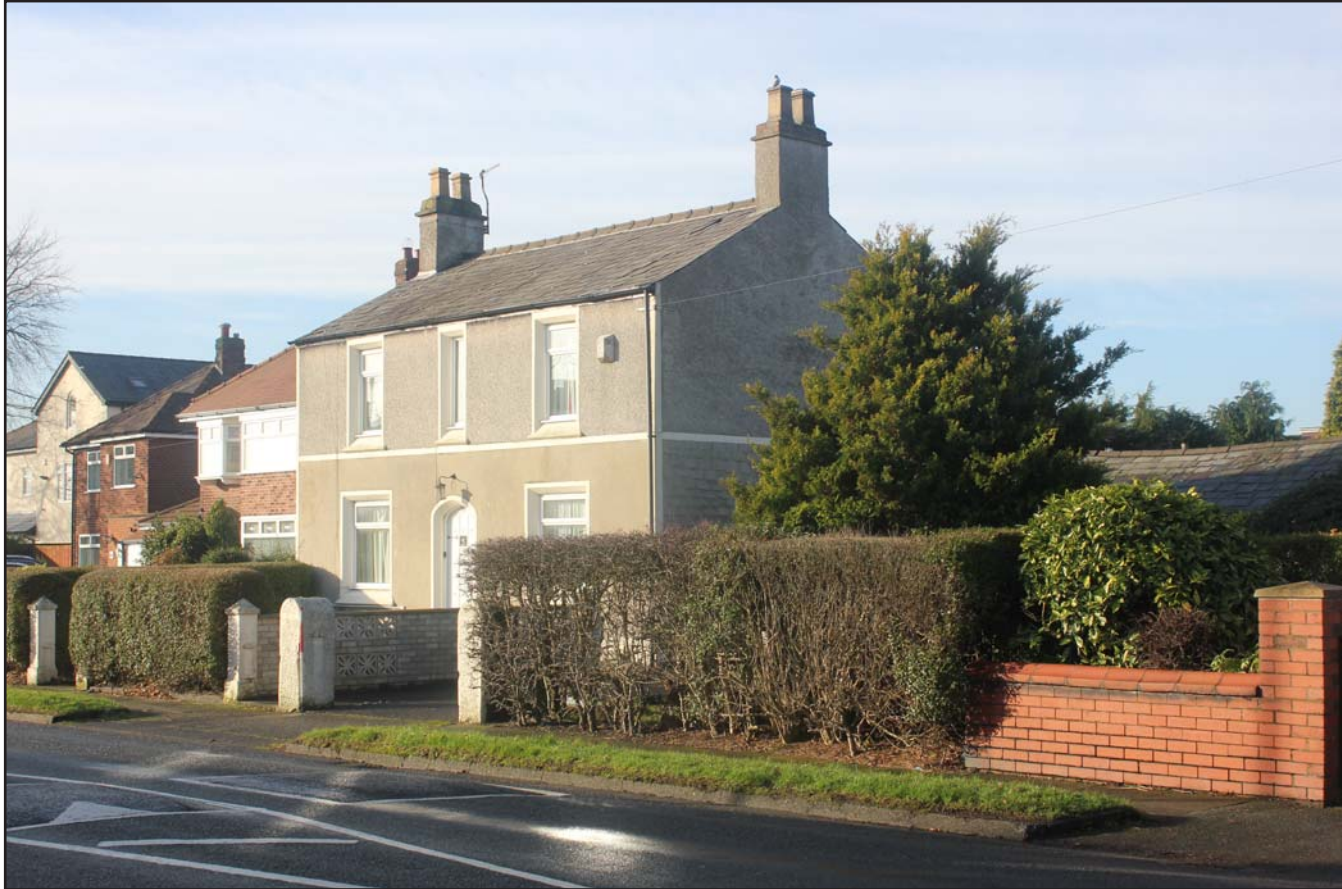
Plate 03: 317, Upton Lane, Widnes external south-eastern and north-eastern elevations - From the east - scale 1.0m

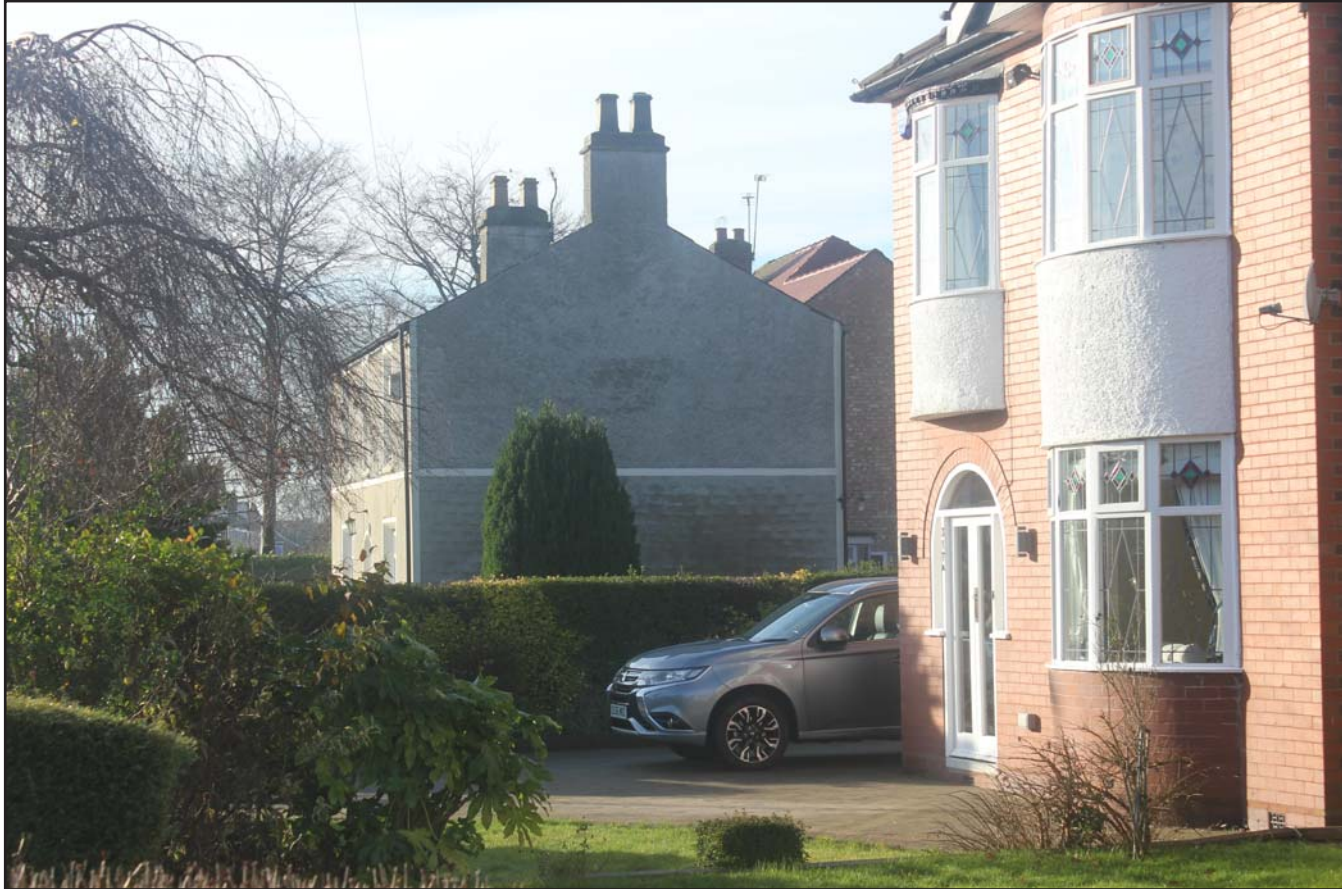
Visible on the northeast elevation is the chimney stack which has been rendered all the way to the top with pebble dash. This pebble dash then extends down the upper third of the property. There is then a white-painted rendered border, which also occurs at the margins of the elevation. Below this border is a large area of render which may have covered up some slates according to the texture of the render. Below this is a thicker white render border with two courses of bonded red-brick visible beneath.

Plate 04: 317, Upton Lane, Widnes external north-eastern elevation - From the northeast - scale 1.0m

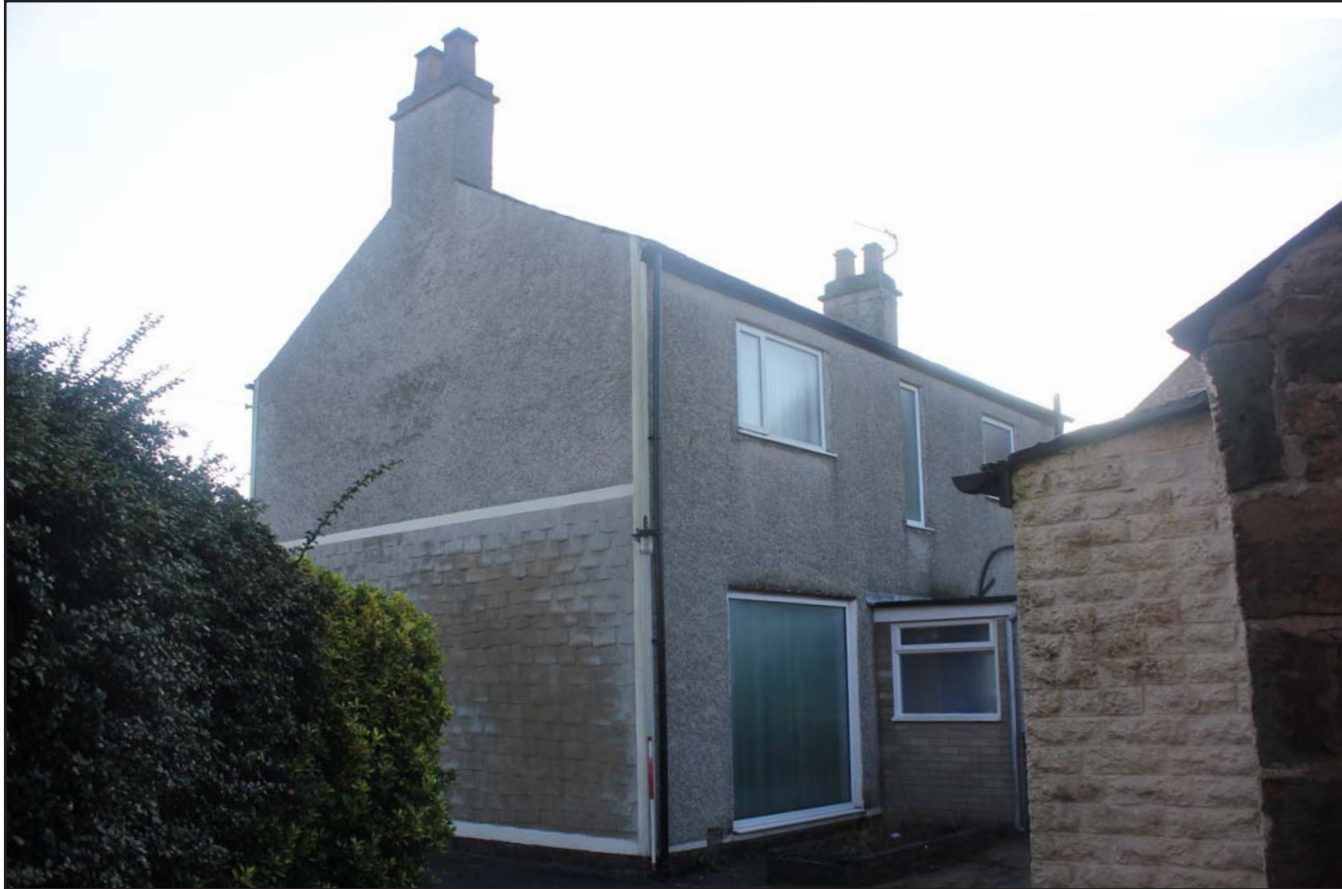
Plate 05: 317, Upton Lane, Widnes external north-eastern and north-western elevations - From the north - scale 1.0m

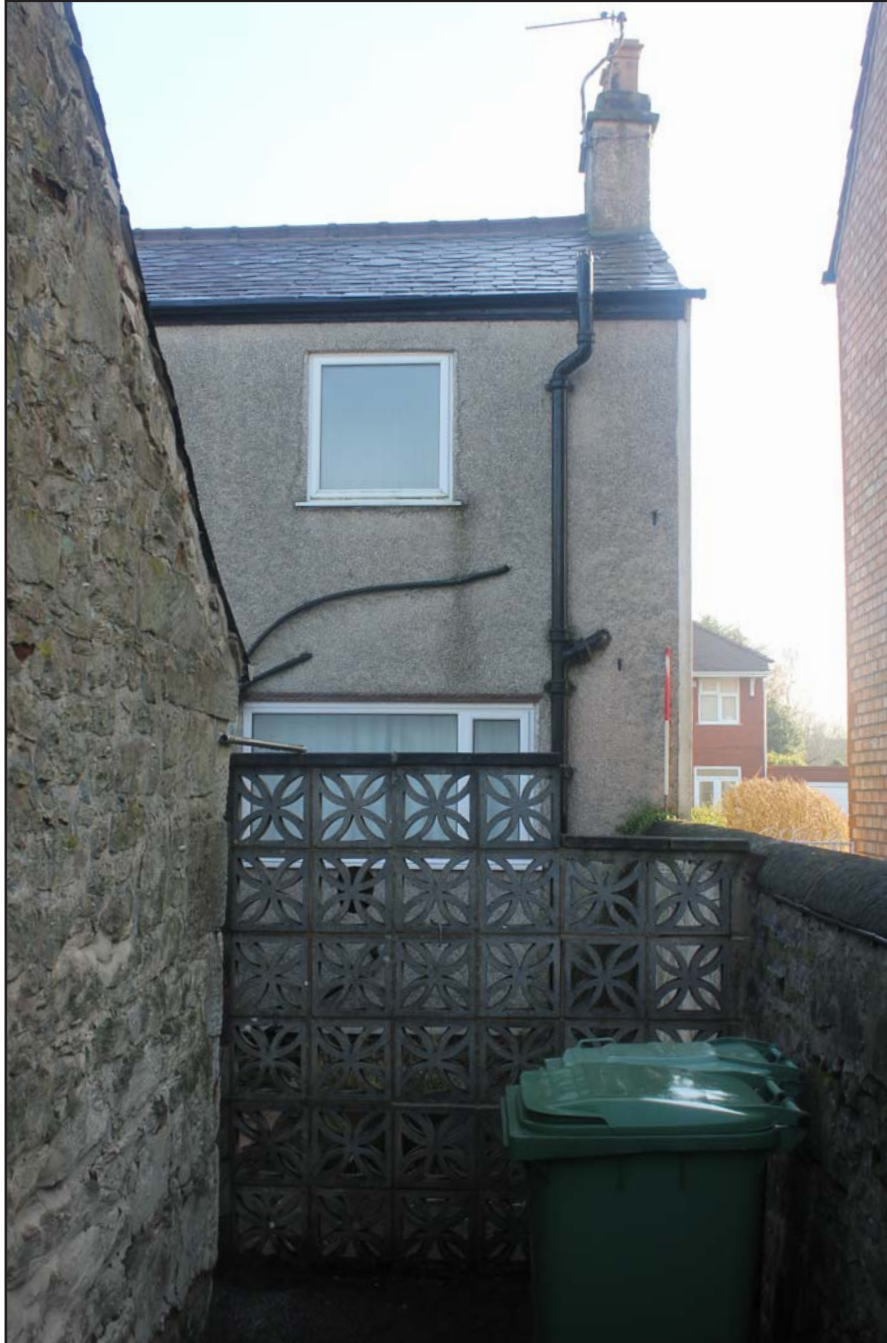
Visible on the side of the property is the same roof configuration as found on the north-east with a slight difference; in that the upper portion of the roof is tiled with hexagonal slates. The entirety of the elevation has been rendered with pebble dash with the same two bonded red-brick courses visible at the base of the elevation. The first floor has three different windows; on the left hand side is a horizontal dual pane window, in the centre is the same vertical rectangular window as seen at the front of property and to the right is a single pane, square, frosted glass window. All window frames are of plastic PVC. On the ground floor a small porch extension is flanked by two windows; on the left hand side is large single pane glass window and on the right hand side is a horizontal square double paned window. These windows are also of modern plastic PVC.

The small porch extension differs from the rest of the building in that it is constructed from tan grey brick which is bonded by mortar. It has a flat pitch roof which is covered with felt. The north eastern and south western elevations of the extension share identical windows; these are horizontal rectangular set within white painted wooden frames, the upper proportion of which are narrow and can be opened via levers. The north western elevation of the extension is dominated by a pair of white PVC sliding doors which have large glass panes set within them.

Plate 06: 317, Upton Lane, Widnes external north-western elevation (partial) - From the northwest- scale 1.0m

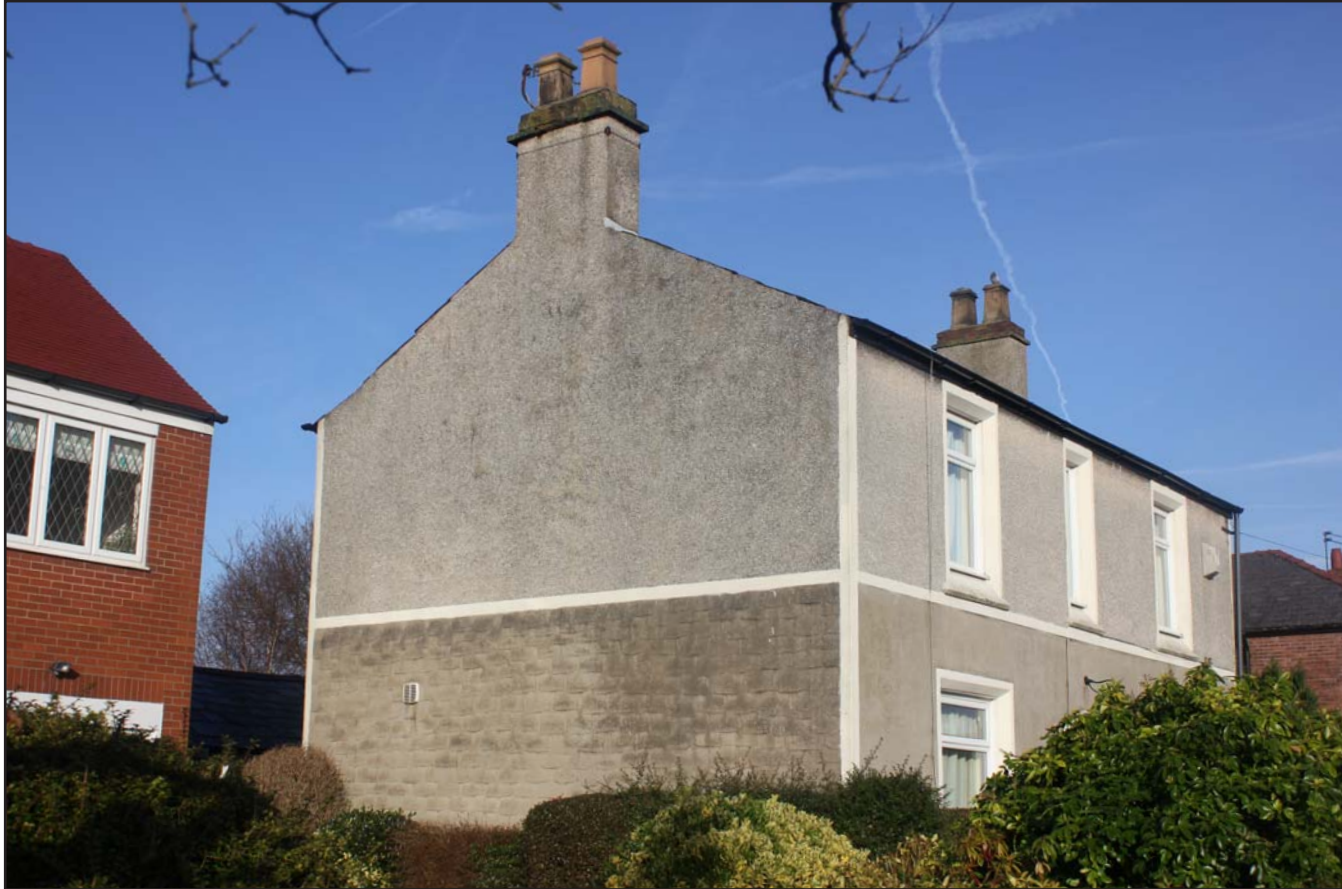
South-west elevation is almost identical in appearance to the northeast elevation. Visible at the top elevation is a chimney stack which has again been rendered all the way to the top with pebble dash. This pebble dash then extends down the upper third of the property. Beneath this there is a white-painted rendered border, which also occurs at the margins of the elevation. Below this border is also pebble dash, however here the wall is obscured by a sandstone wall which had been bonded by mortar.

Plate 07: 317, Upton Lane, Widnes external south-western elevation - From the south west - no scale

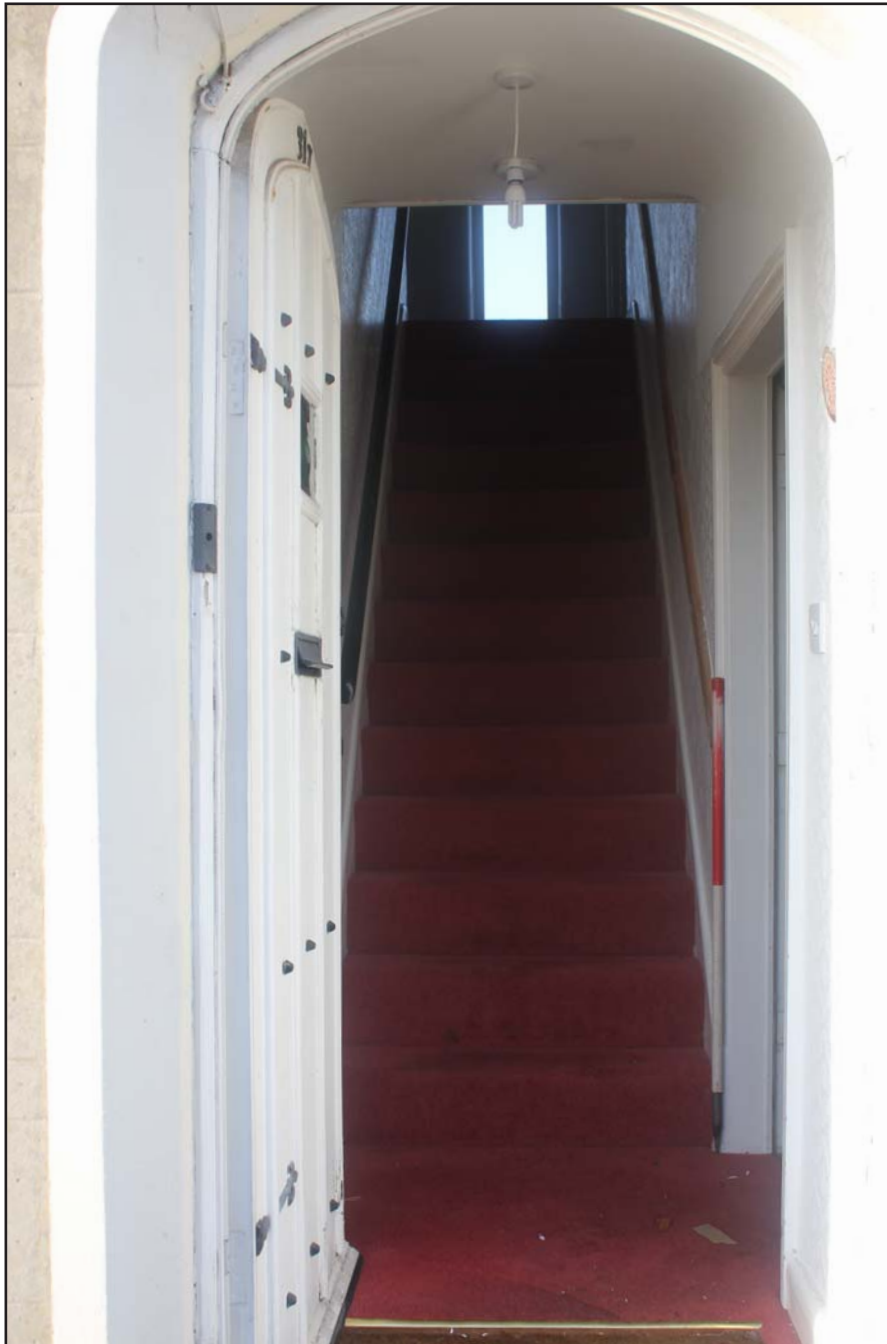
The hallway is small and rectangular, orientated north-east to south-west. Walking in from the front door you are confronted with the stairwell which leads to the first floor. The stairwell's walls are covered with white wallpaper with a wooden banister on the left hand wall. The stairs have been carpeted with a red carpet. This red carpet extends down into the hall area, with a door mat immediately in behind the front door. To the left is a white wooden door which permits access to the kitchen dining area and to the right is another white wooden door which permits access to the living room. All other visible portions of wall and ceiling not on the stairwell are plastered and painted white.

Plate 08: 317, Upton Lane, Widnes - Internal stairwell - From the northeast - scale 1.0m

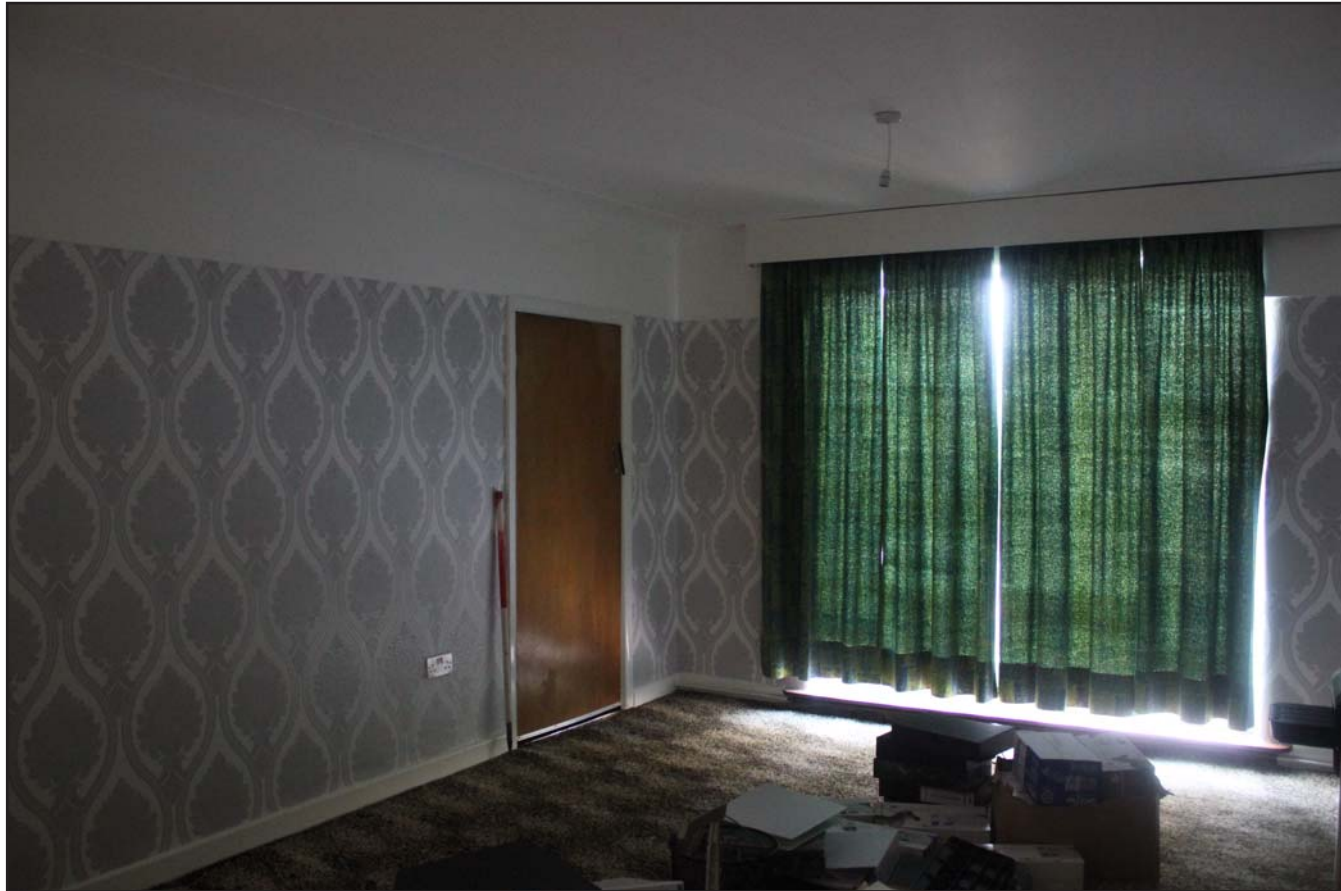
The living room is a rectangular room orientated southeast -northwest. The ceiling is plastered and painted white with two pendant light fittings which are equally spaced. The north-western elevation is dominated by a large glass window which is of plastic PVC and looks out onto the outbuilding. This window has been hung with green curtains and has a wooden window sill. A small portion of the wall is plastered and painted white while the rest has been papered with grey and white paisley pattern wallpaper. A white wooden skirting board runs along the base.

Plate 09: 317, Upton Lane, Widnes - Internal: Living room - From the south east - scale 1.0m

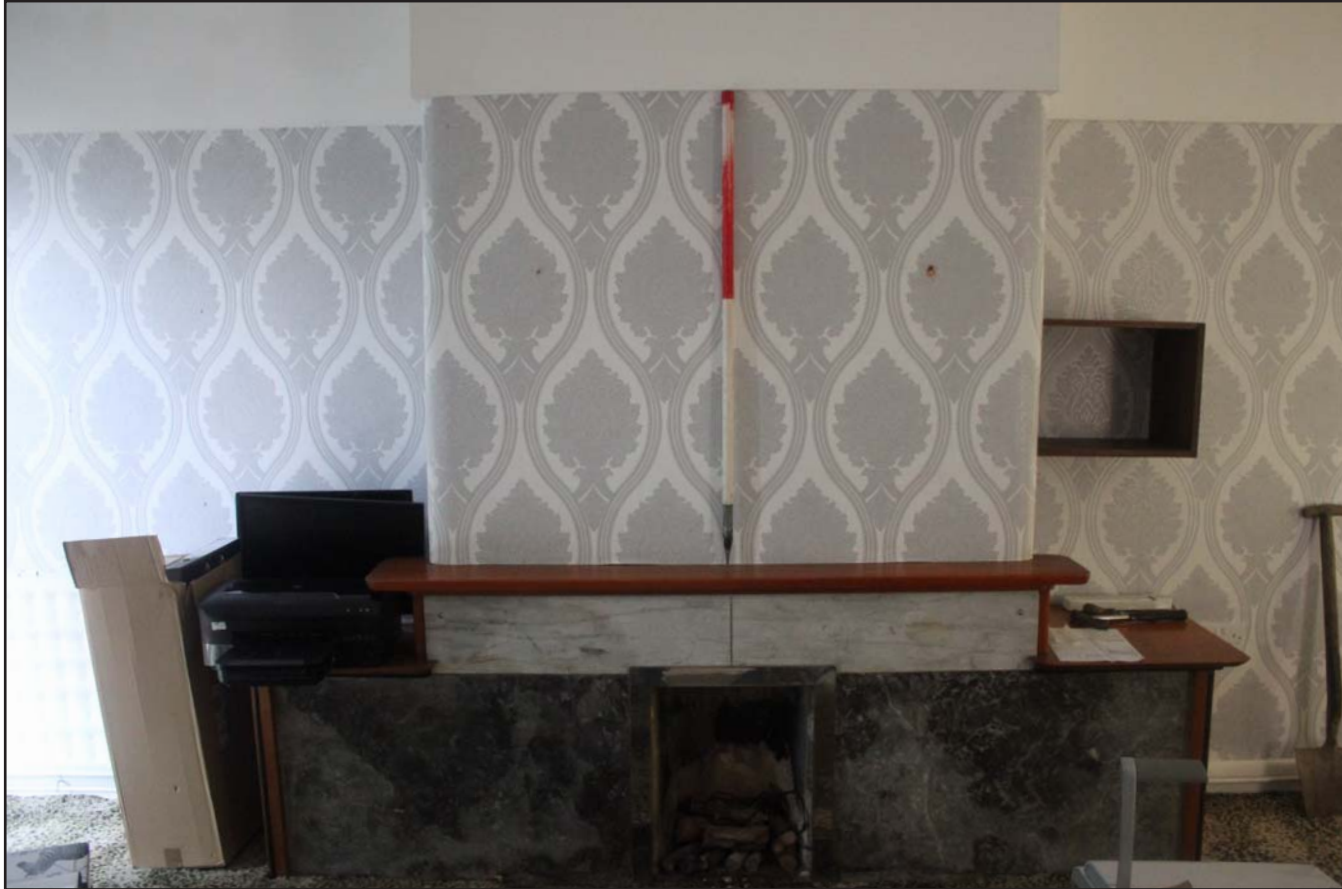
The north-eastern elevation is dominated by a wide chimney breast and surround onto which a fireplace and stylised mantelpiece have been fitted. The fireplace is comprised of a single small electric fire and is surrounded by two types of reproduction marble (grey and white). Either side of the chimney breast is a wooden mantelpiece and wooden shelves. To the left of the fireplace is a large steel white painted radiator. Once more the upper portion of the wall has been plastered and painted white with the rest being papered with white and grey paisley design wallpaper. A white skirting board runs along its base. The floor is of a grey-green brown stippled carpet.

Plate 10: 317, Upton Lane, Widnes - Internal: Living room fireplace - From the northeast - scale 1.0m

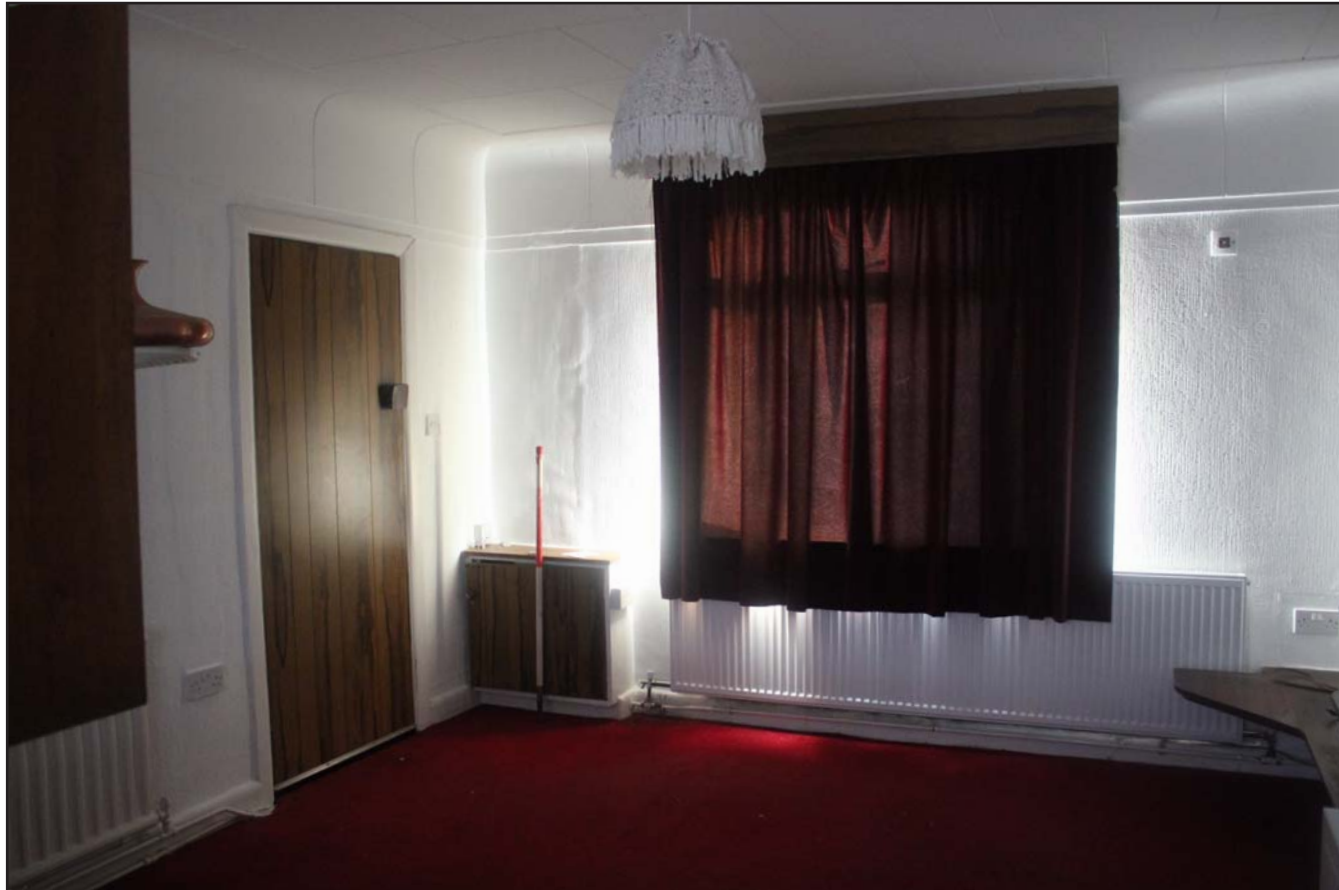
The left hand side of the south western elevation has the same white ceiling tiles which extend down onto the upper portion of the wall. Below the ceiling tiles there is white wallpaper. Visible within the dining room is a blocked up chimney breast, the fireplace of which now houses a wooden drinks cabinet. To the right of the chimney breast the wallpaper continues to the boundary with the kitchen, where kitchen units and an extractor fan dominate the upper portion of the wall. Below these units are the same white and brown floral tiles observed on the north-western elevation and also a large space where the oven was sited.

Plate 11: 317, Upton Lane, Widnes - Internal: Dining Room - From the north - scale 1.0m

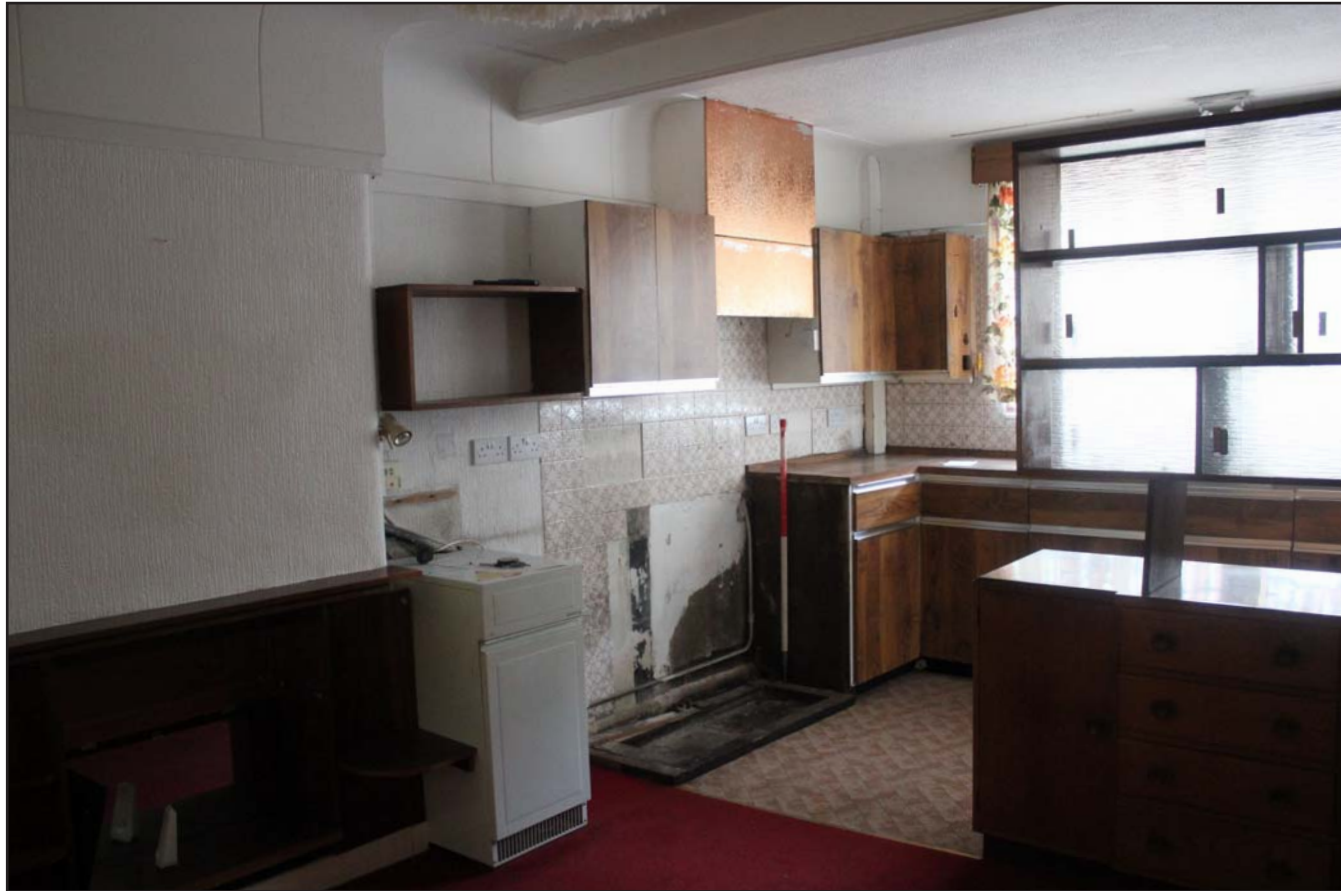
The kitchen dining room is rectangular and orientated northwest to southeast. The ceiling of the kitchen is comprised of artex, this is separated from the dining area by a roof beam which has been boxed in with timber. The ceiling of the dining area is comprised of white roof tiles. The north western elevation is dominated by large double pane window, which is of plastic PVC. The window also has been hung with floral pattern curtains. Below this window runs a series of kitchen units which are comprised of chipboard with a wood pattern finish. The north western elevation is tiled with floral pattern tiles which are white and brown.

Plate 12: 317, Upton Lane, Widnes - Internal: Kitchen - From the south - scale 1.0m

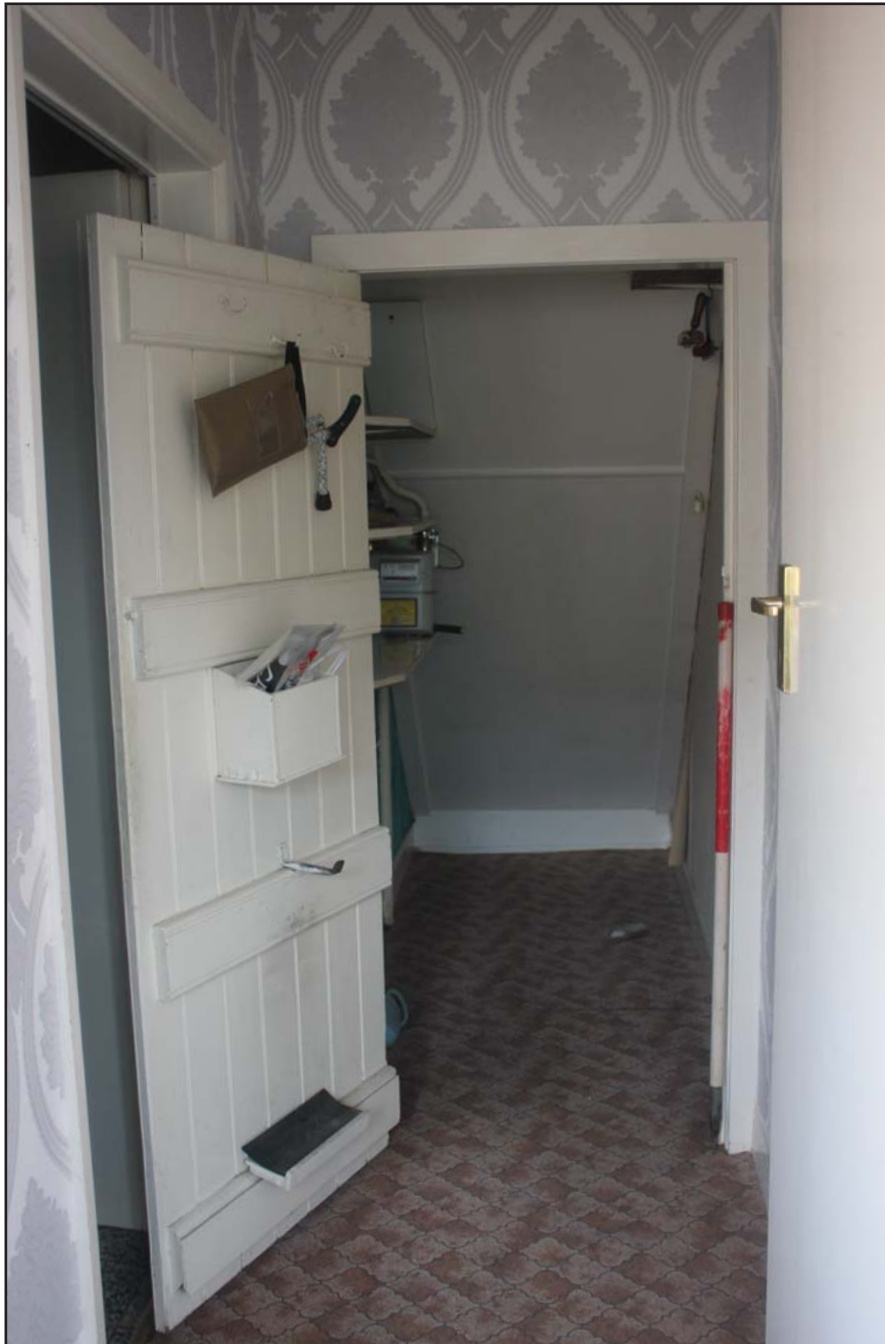
There is a small cupboard underneath the stairs which is housed behind a wooden plank and batten door, which has been painted with cream paint. The left-hand wall is papered with green and blue wallpaper and has shelves attached to it while the right-hand wall has beige wallpaper. The floor is of the same brown linoleum found in the kitchen and the hallway.

Plate 14: 317, Upton Lane, Widnes - Internal: Below stairs store - From the northeast - scale 1.0m

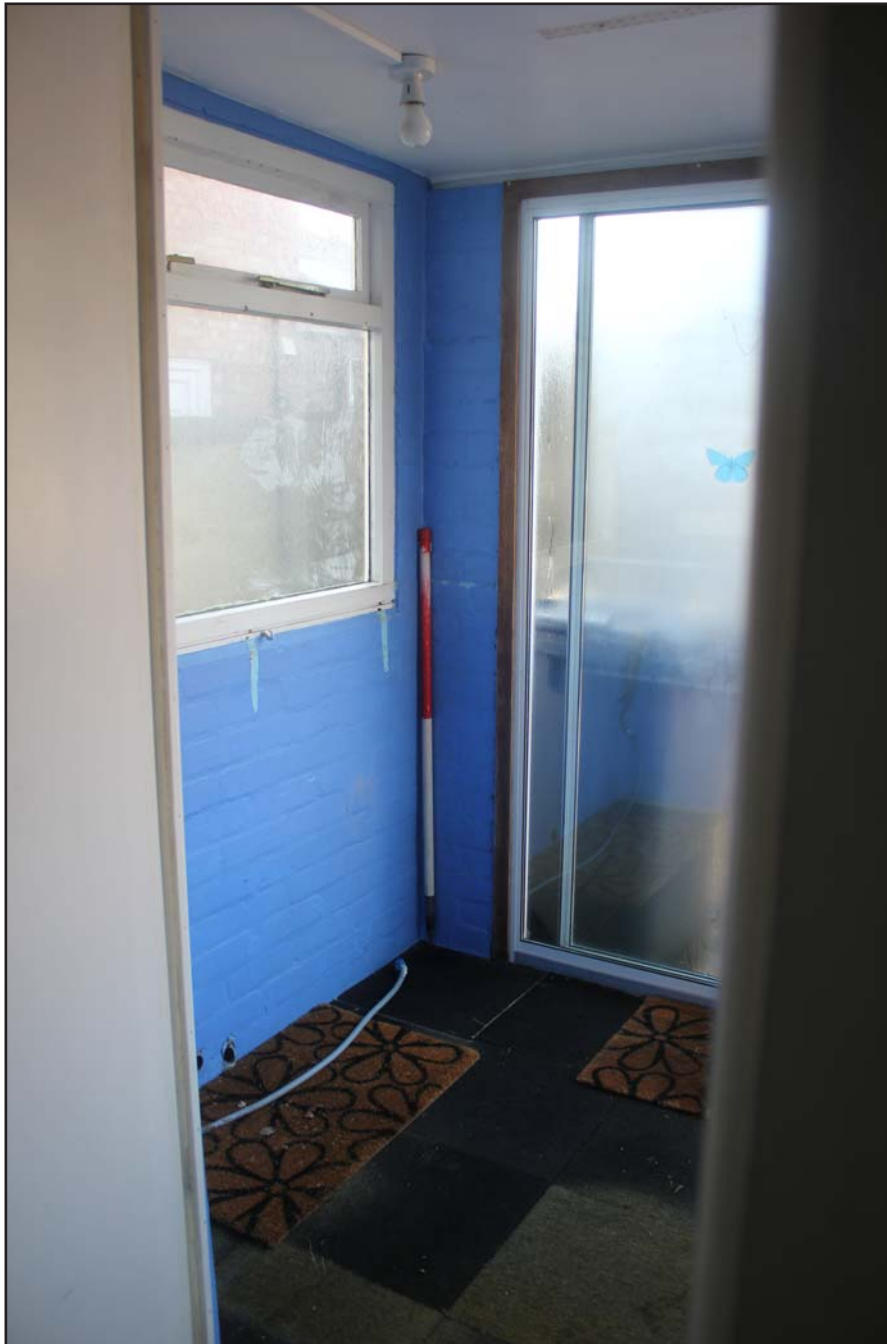
The back porch has a white-painted ceiling. The south-western elevation is of brick construction bonded by mortar and painted blue. This elevation has a wooden window with double pane and narrow opening light at the top. The north-eastern elevation is identical except this wall is painted white. The north-western elevation is dominated by a PVC sliding door which permits access to the exterior. The south-eastern elevation has a white-painted wooden door located in its centre which permits access to the 2nd hallway. This elevation has been plastered and painted blue. The floor is of green and black carpet tiles.

Plate 15: 317, Upton Lane, Widnes - Internal: Back Porch - From the east - scale 1.0m

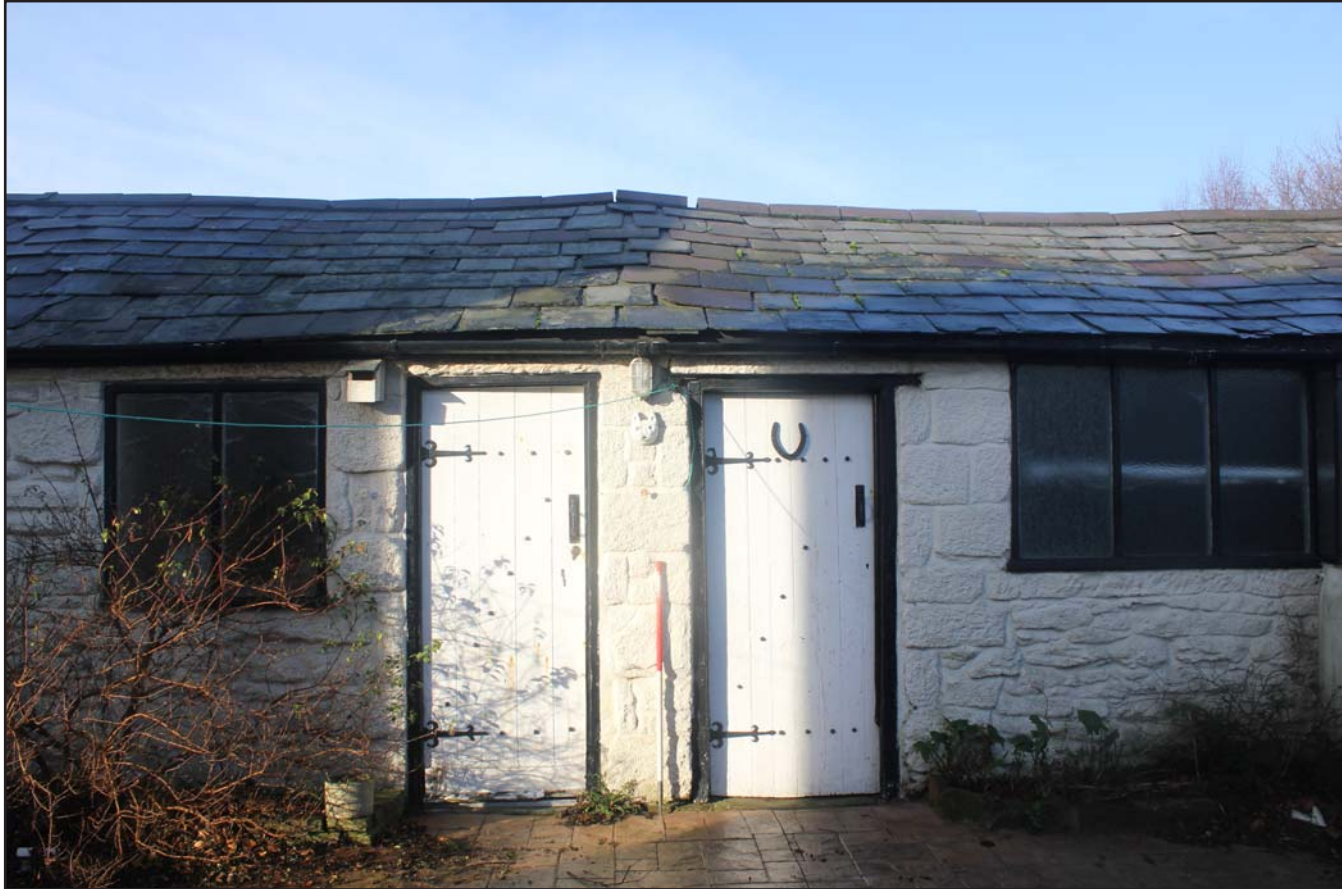
Plate 22: 317, Upton Lane, Widnes - Externals; south-eastern elevation of Outhouse (centre) - From the southeast - scale 1.0m

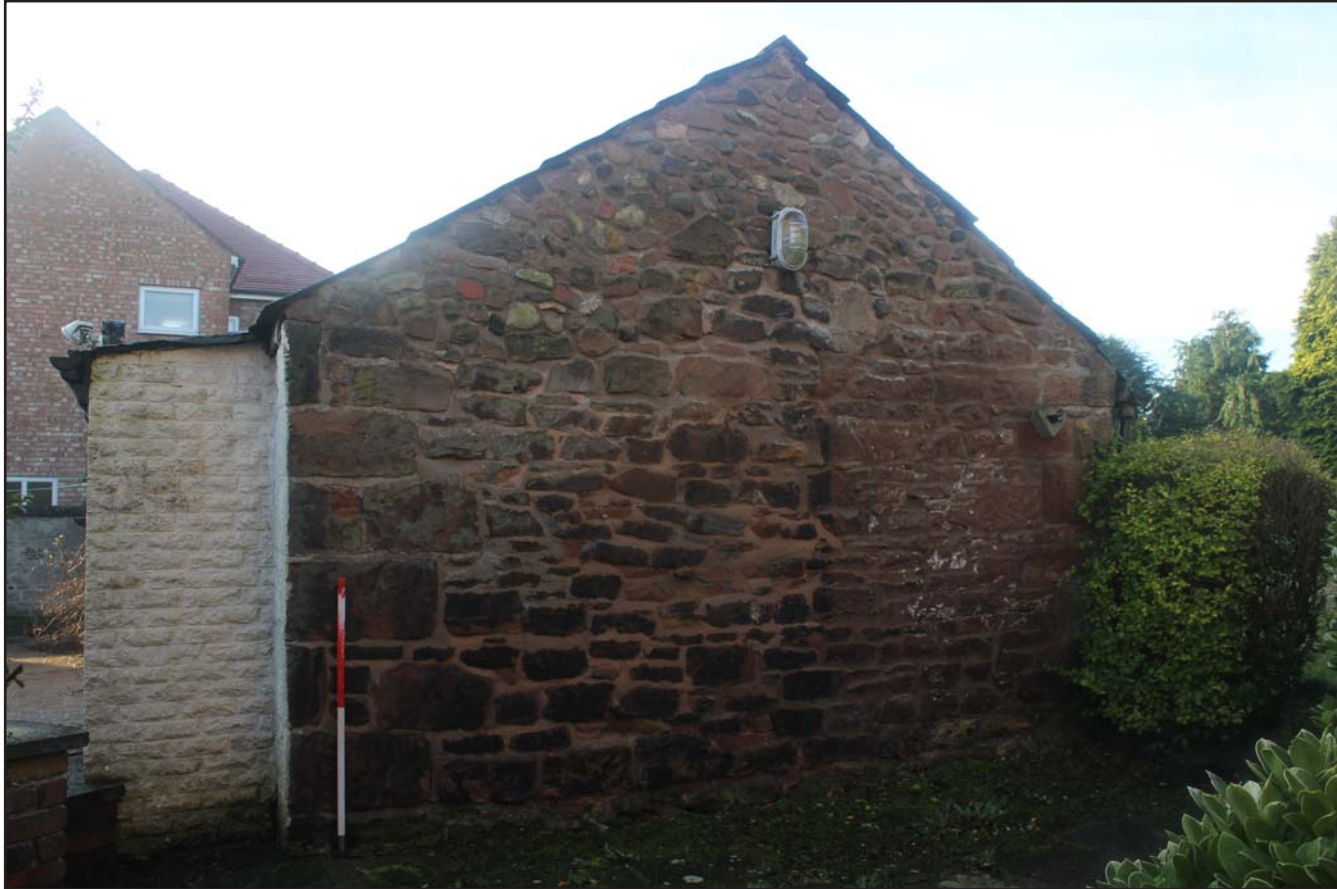
Plate 24: 317, Upton Lane, Widnes - Externals; north-eastern-eastern elevation of Outbuilding - From the northeast - scale 1.0m

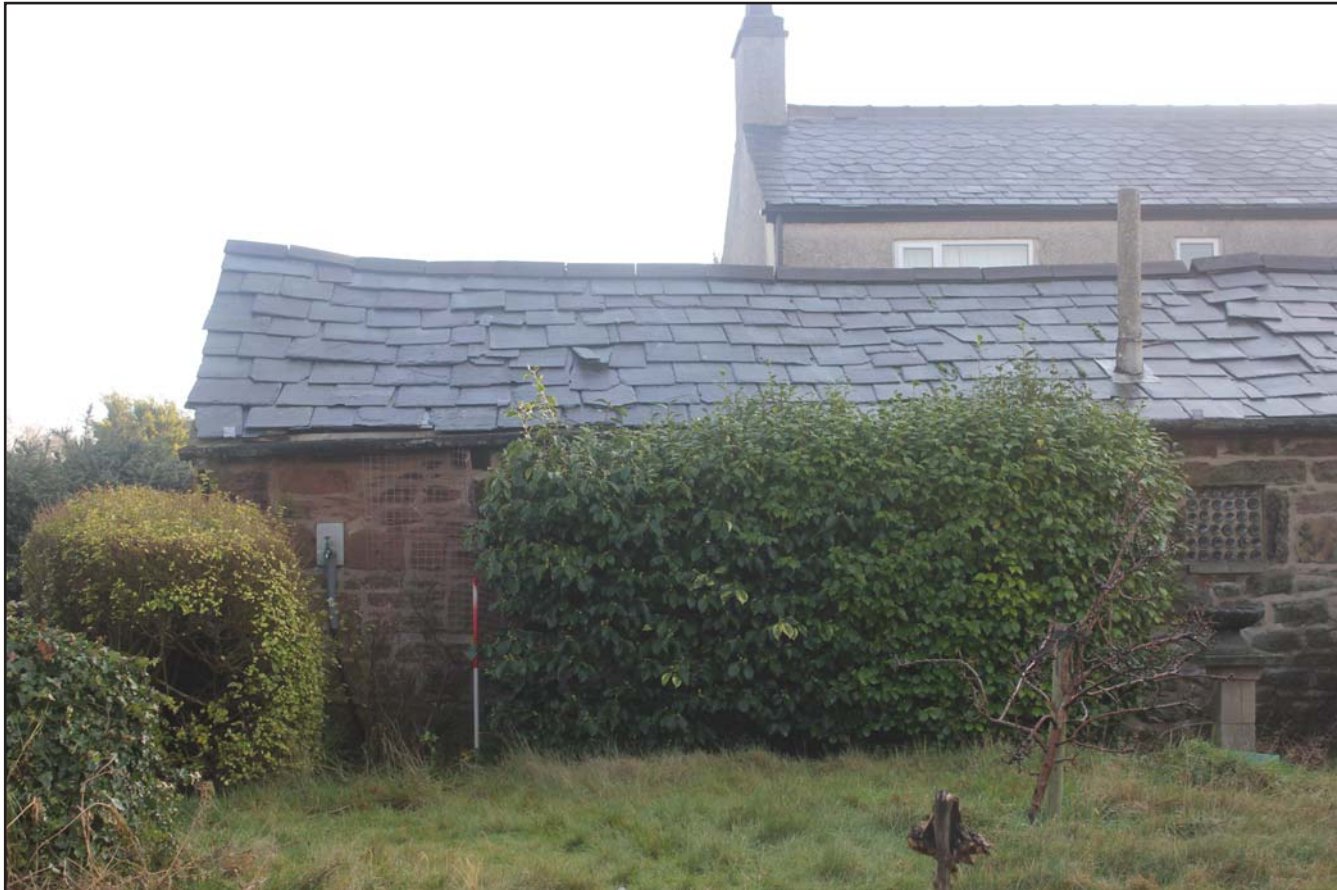
Plate 25: 317, Upton Lane, Widnes - Externals; north-western elevation of Outbuilding - From the northwest - scale 1.0m
