**317, Upton Lane, Widnes,
Cheshire WA8 9AG.**

**January 2018
V 1.0**

Historic Building Record - Level 2
Project Code: A0149.1
Report no. 0153

Historic Building Record - Level 2

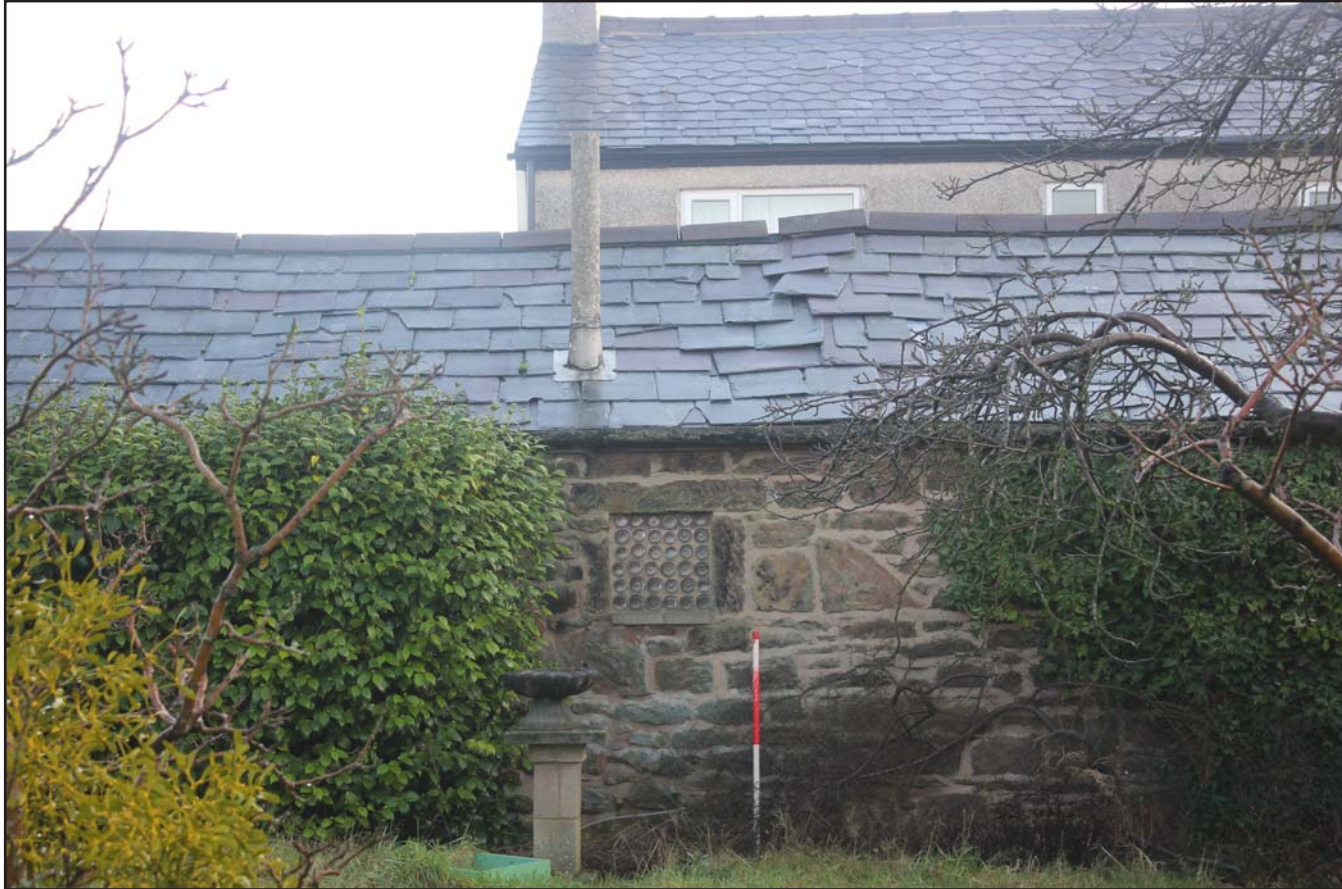
Plate 26: 317, Upton Lane, Widnes - Externals; north-western elevation of Outbuilding (centre) - From the northwest - scale 1.0m

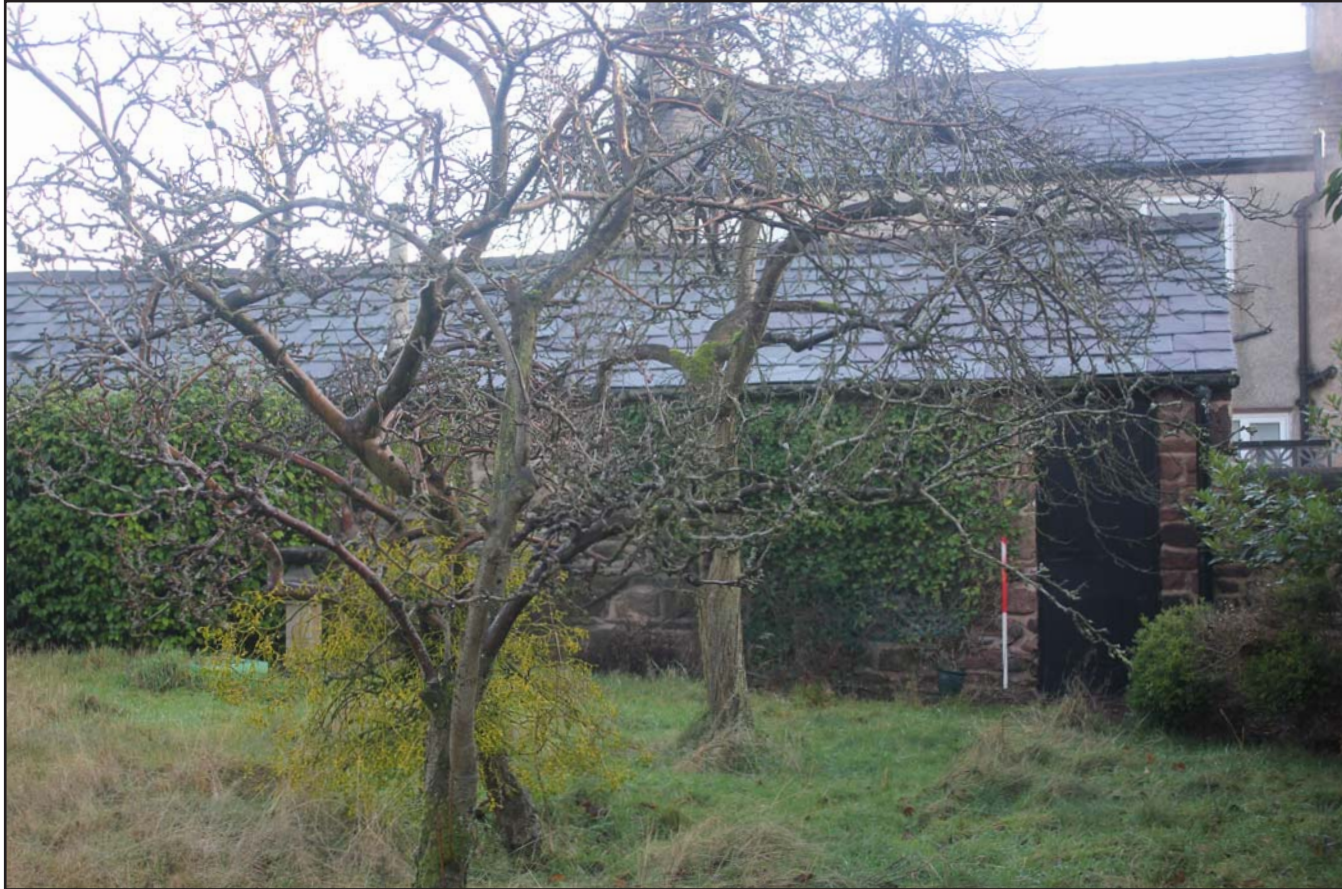
Plate 27: 317, Upton Lane, Widnes - Externals; north-western elevation of Outbuilding (right) - From the northwest - scale 1.0m

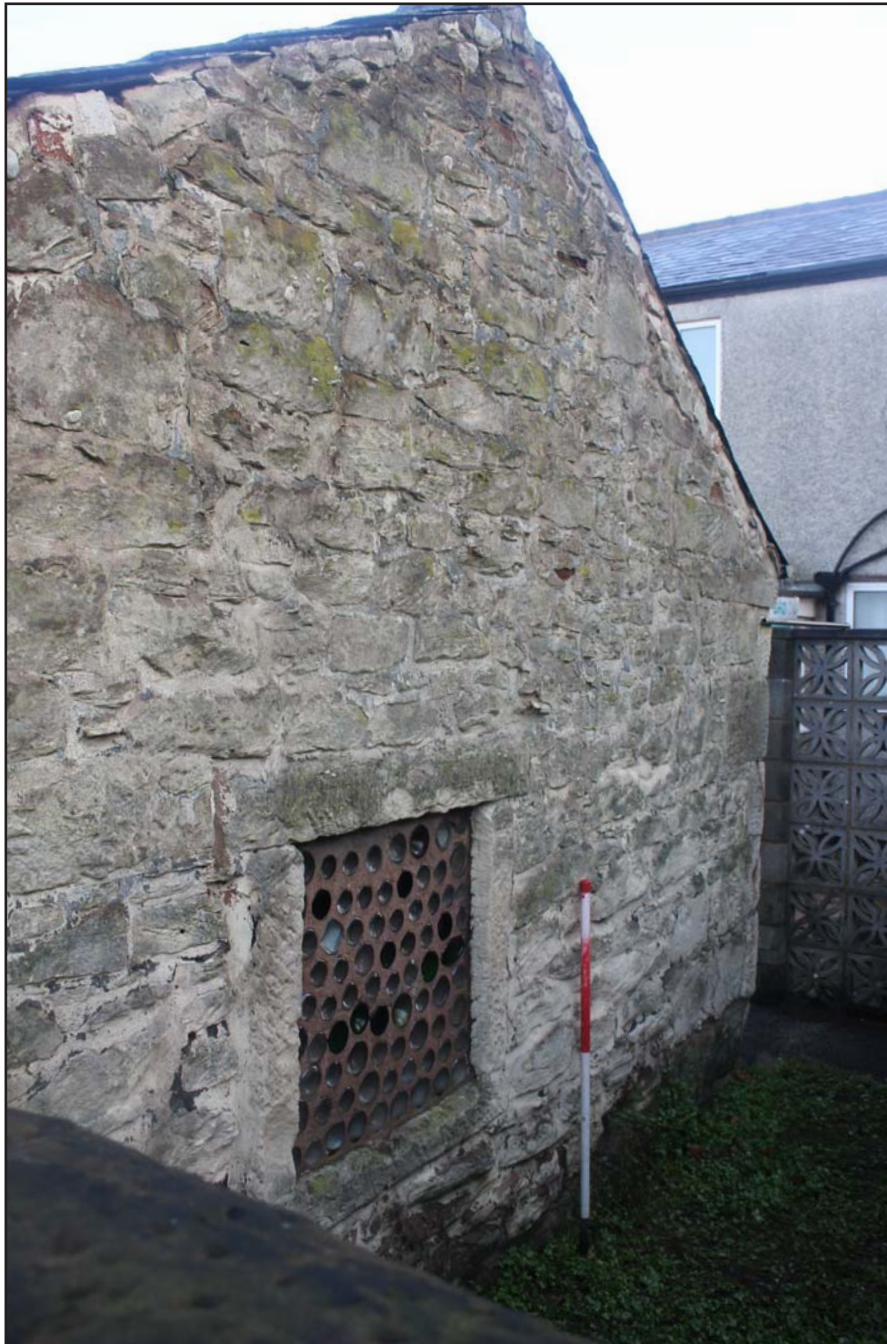
The south-west elevation is constructed from sandstone rubble bonded by a tan brown mortar, once more this elevation is unpainted. There is a single square window aperture visible to the left of centre; this has been filled with a combination of white and clear glass bottle bottoms bonded by cement. This window also seems to have a sill and surround comprised of dressed sandstone.

Plate 28: 317, Upton Lane, Widnes - Externals; north-western and south-western elevations of Outbuilding - From the west - scale 1.0m

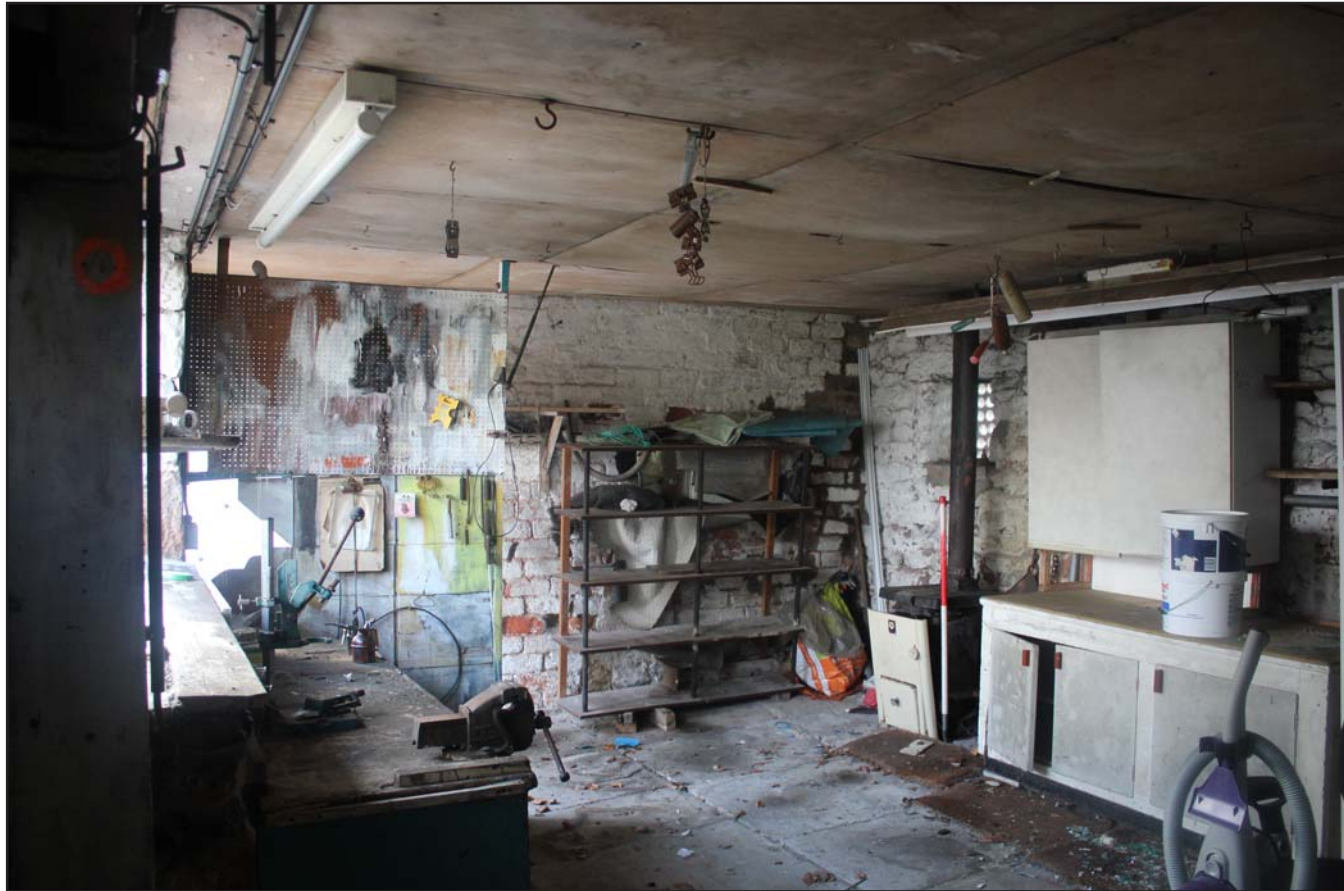
The south-eastern elevation is constructed from sandstone rubble bonded by mortar. Situated to the right of centre is a square window aperture which now contains concrete and glass bottles. This elevation also has a couple of shelves attached as storage. The north-eastern elevation comprises of a wooden plank and batten door painted white.

The north-western elevation is constructed from sandstone rubble bonded by mortar, however visible within the centre of this elevation is an area of brickwork (also bonded by mortar) which suggests the chimney breast may have been added. In the lower portion of the elevation below the chimney breast there is a cavity within the wall created by the brickwork. This cavity leads to the rear of the fireplace in Room 2. The left-hand side of this cavity is supported by a significant brick pillar. This elevation also supports shelving. Visible within the cavity is the end of the flagstone floor within Room 2. Within the confines of Room 3 this changes to a broken stone/rubble floor - there is a possibility that this was once an external area that was subsequently roofed over as an extension to the outbuilding.

Plate 29: 317, Upton Lane, Widnes - Internals; Room 1 - From the east - scale 1.0m

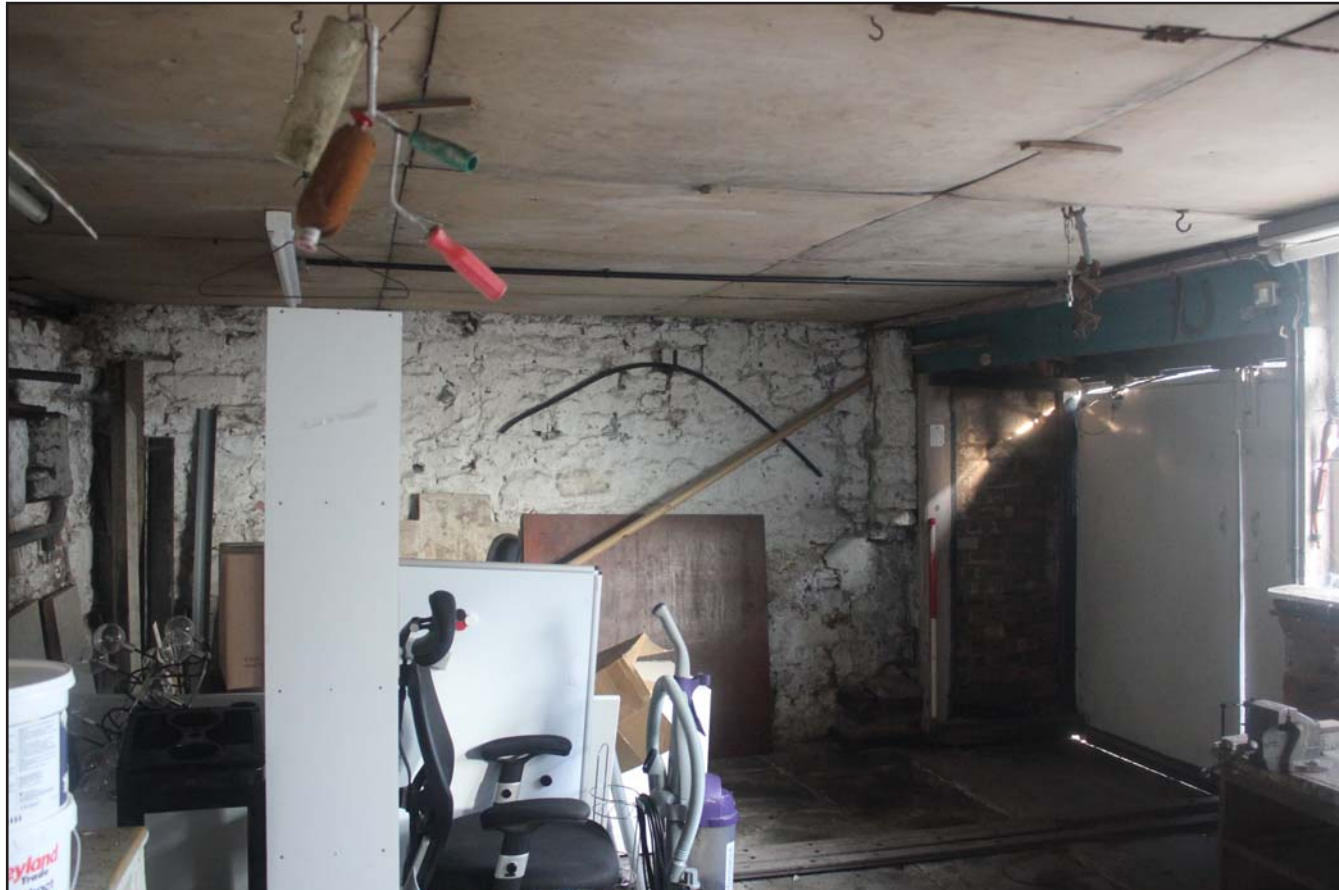
Plate 30: 317, Upton Lane, Widnes - Internals; Room 1 - From the west - scale 1.0m

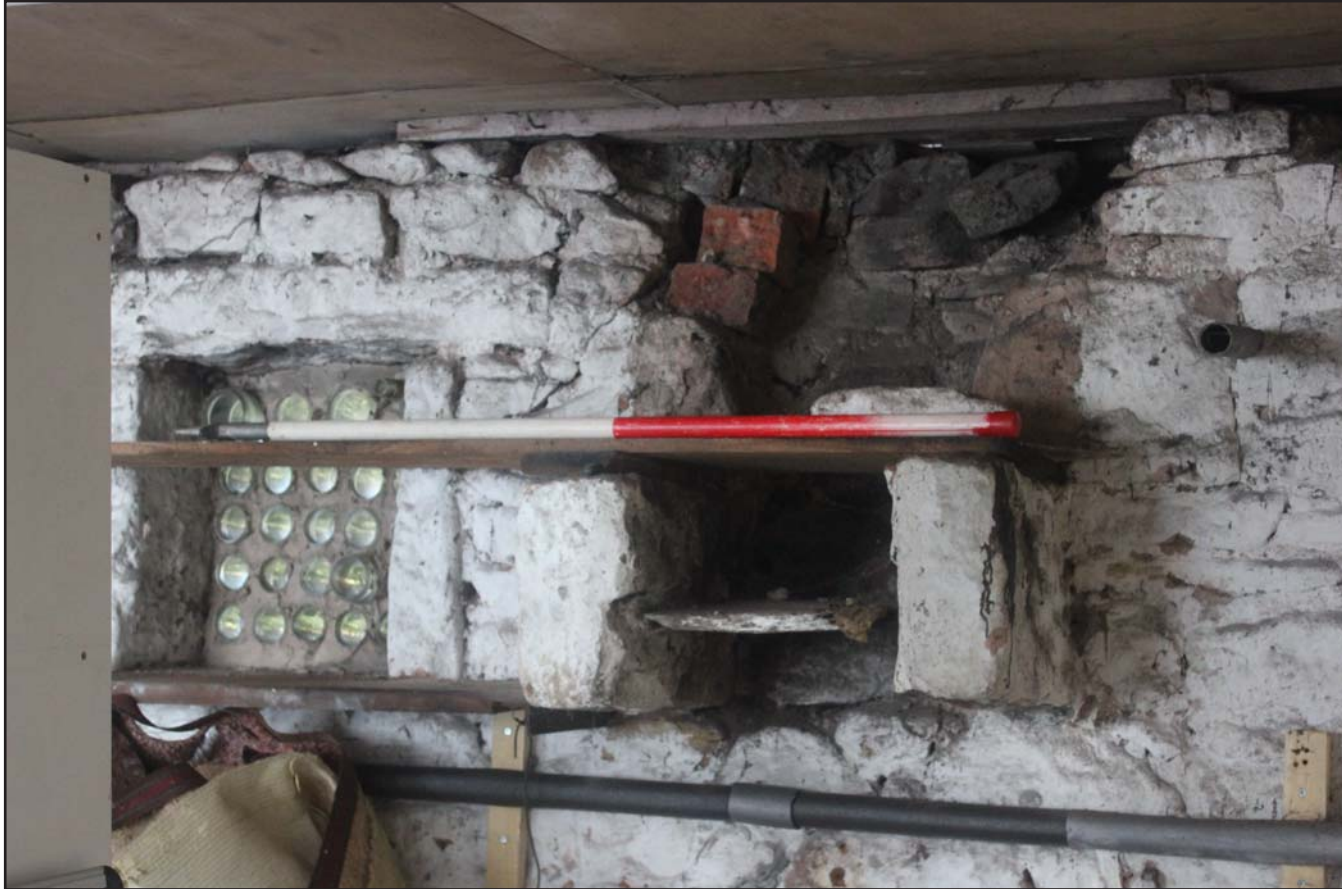
Plate 31: 317, Upton Lane, Widnes - Internals; Room 1 - Flue on north western elevation - scale 1.0m

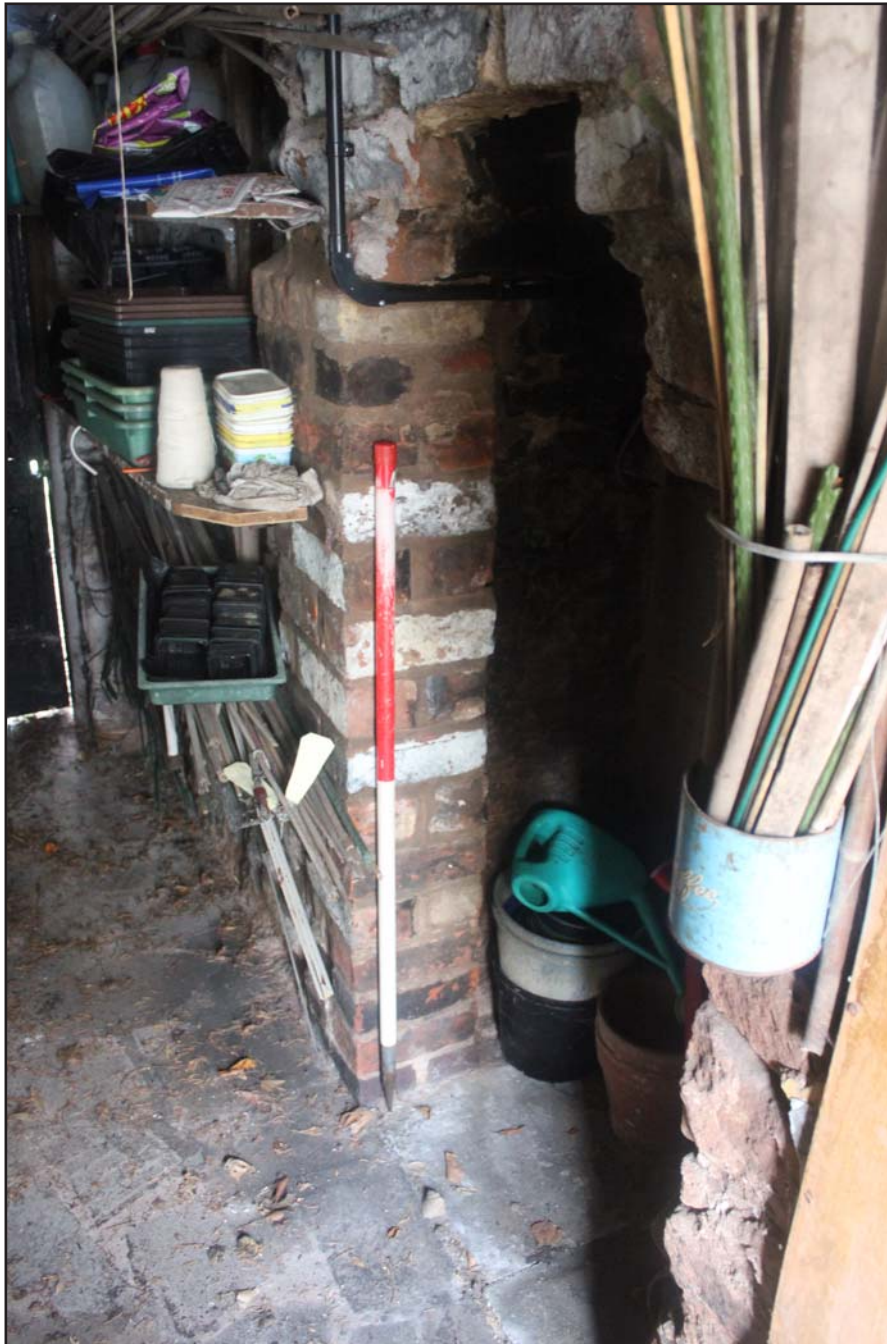
Plate 35: 317, Upton Lane, Widnes - Internals; Room 3 - Fireplace - From the south - scale 1.0m
