# Mill Wood Avenue, Eccleston, St. Helens, Merseyside, WA10 5BE.

Report no. 0221 v3.0

Archaeological Strip, Map & Sample

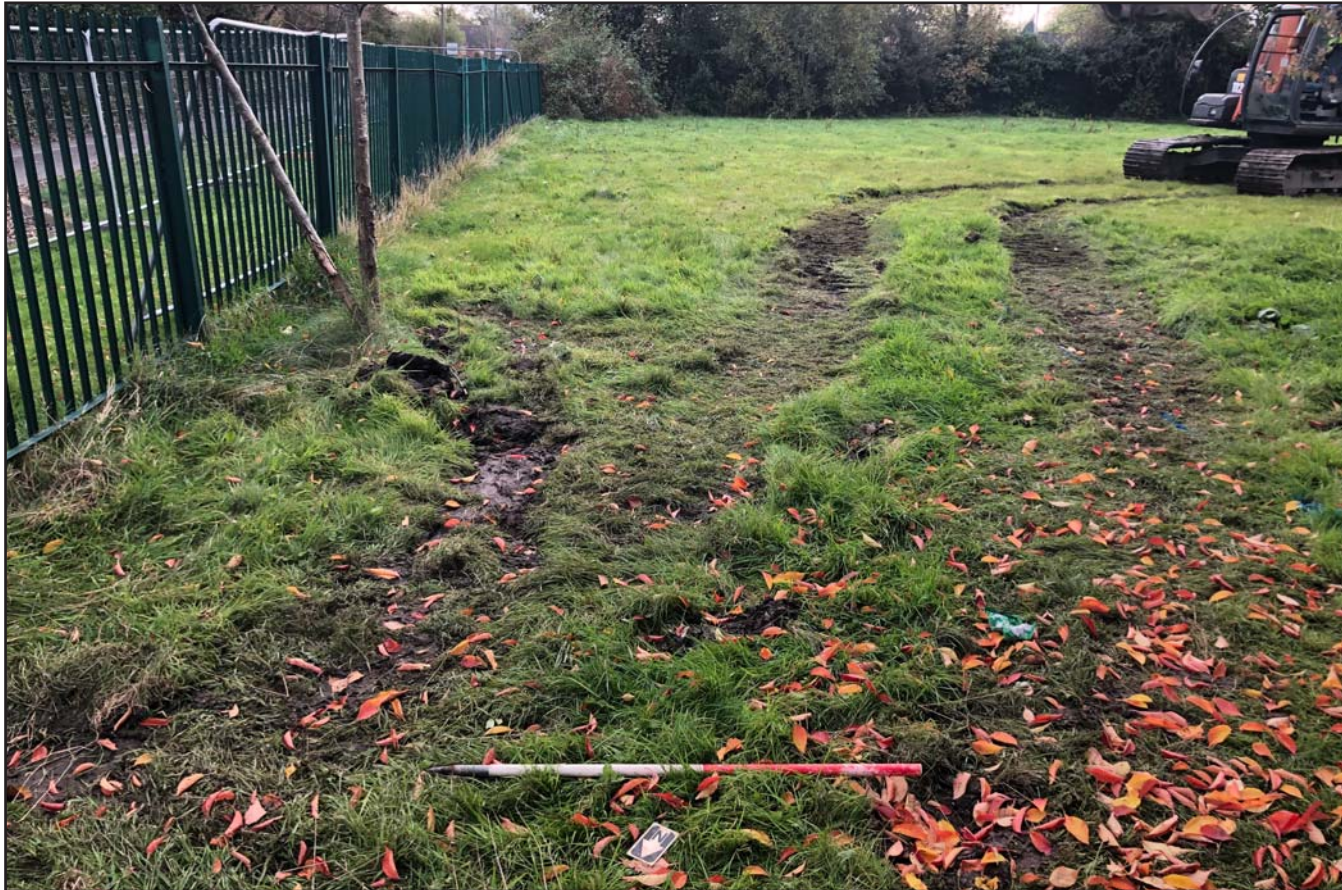
**Plate 01:** Pre excavation shot of trench at Mill Wood Avenue, Eccleston, St. Helens, Merseyside - from the northwest - scale 1m

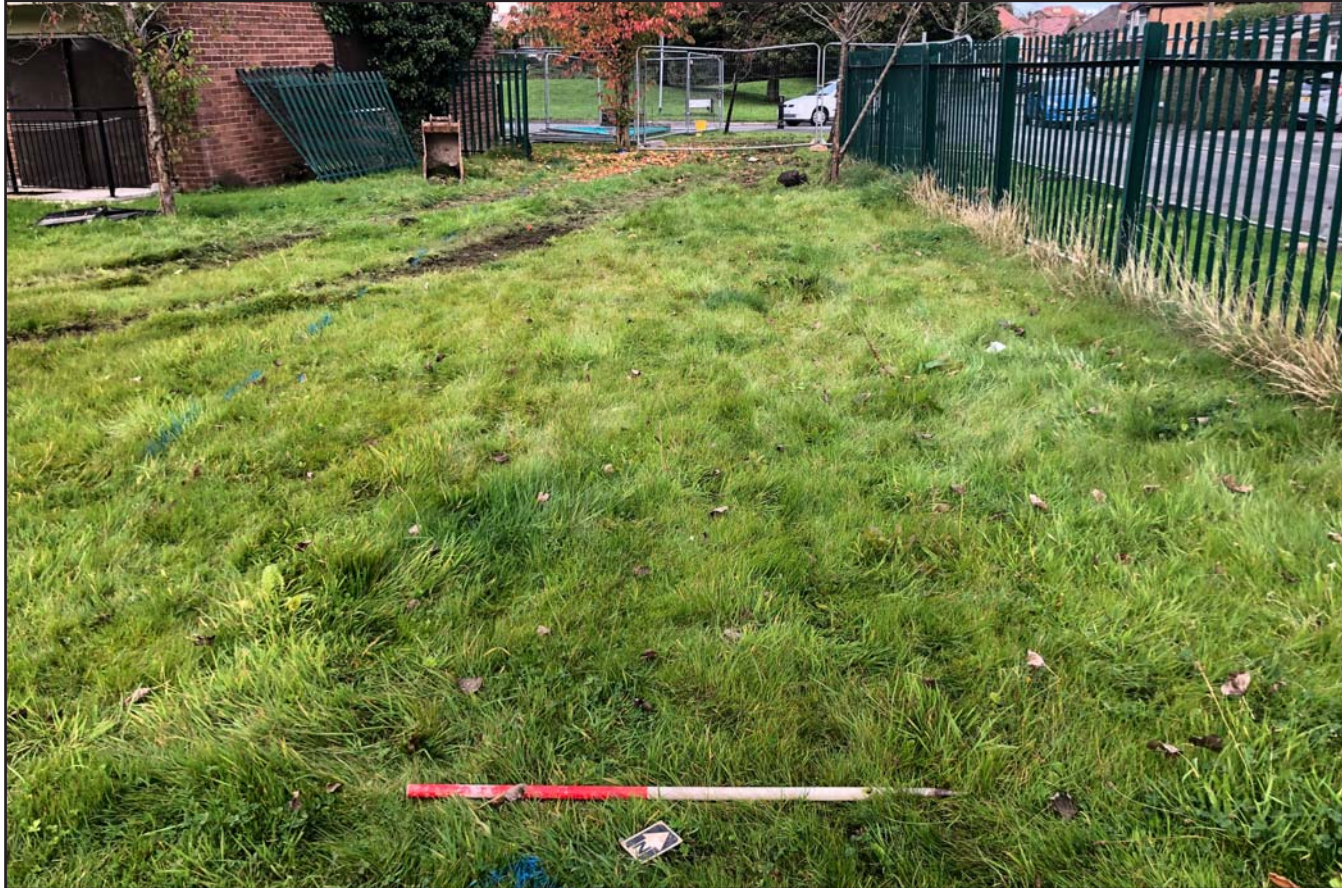
**Plate 02:** Pre excavation shot of trench at Mill Wood Avenue, Eccleston, St. Helens, Merseyside - from the southeast - scale 1m

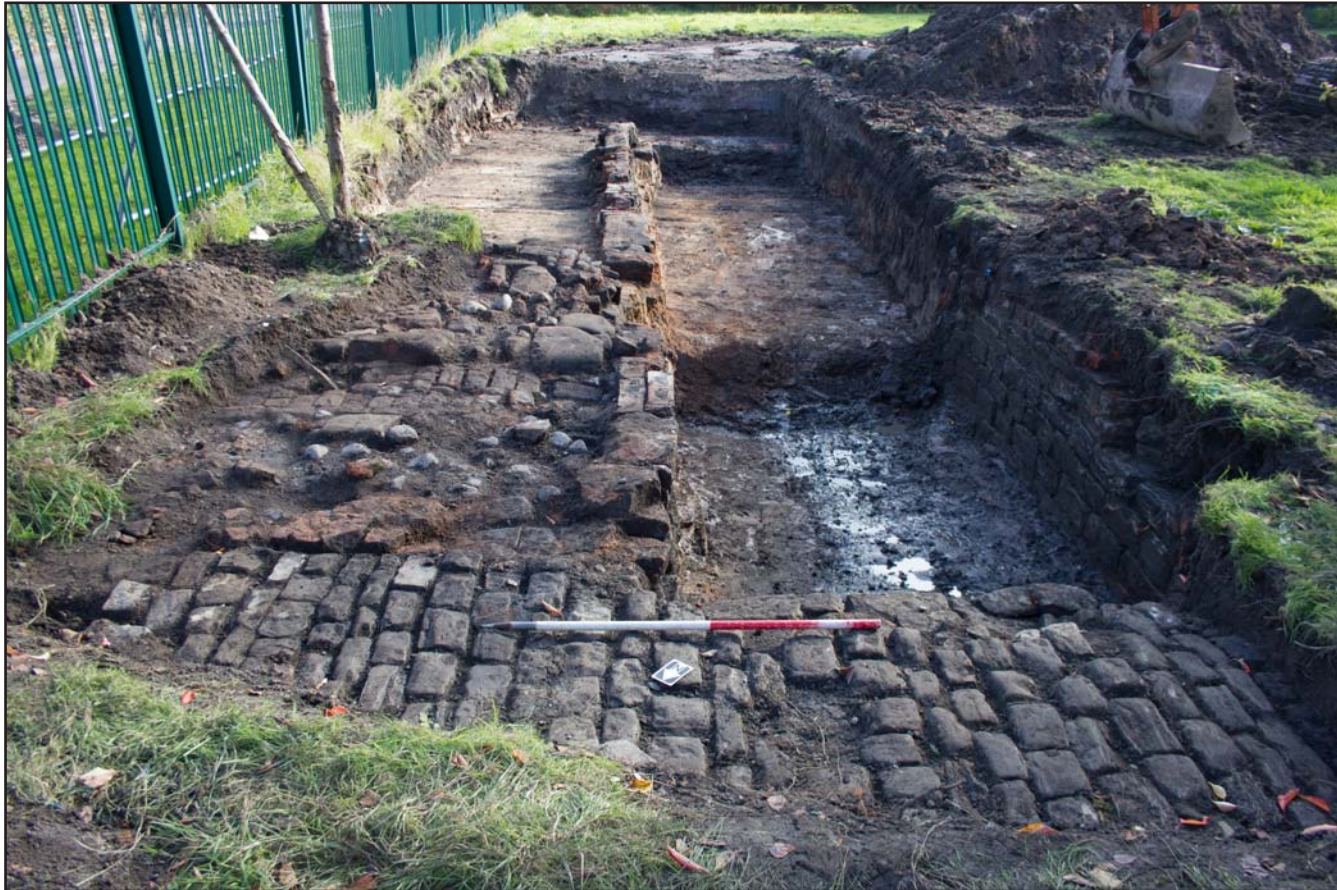
**Plate 03:** Post excavation shot of trench at Mill Wood Avenue, Eccleston, St. Helens, Merseyside - from the northwest - scale 1m

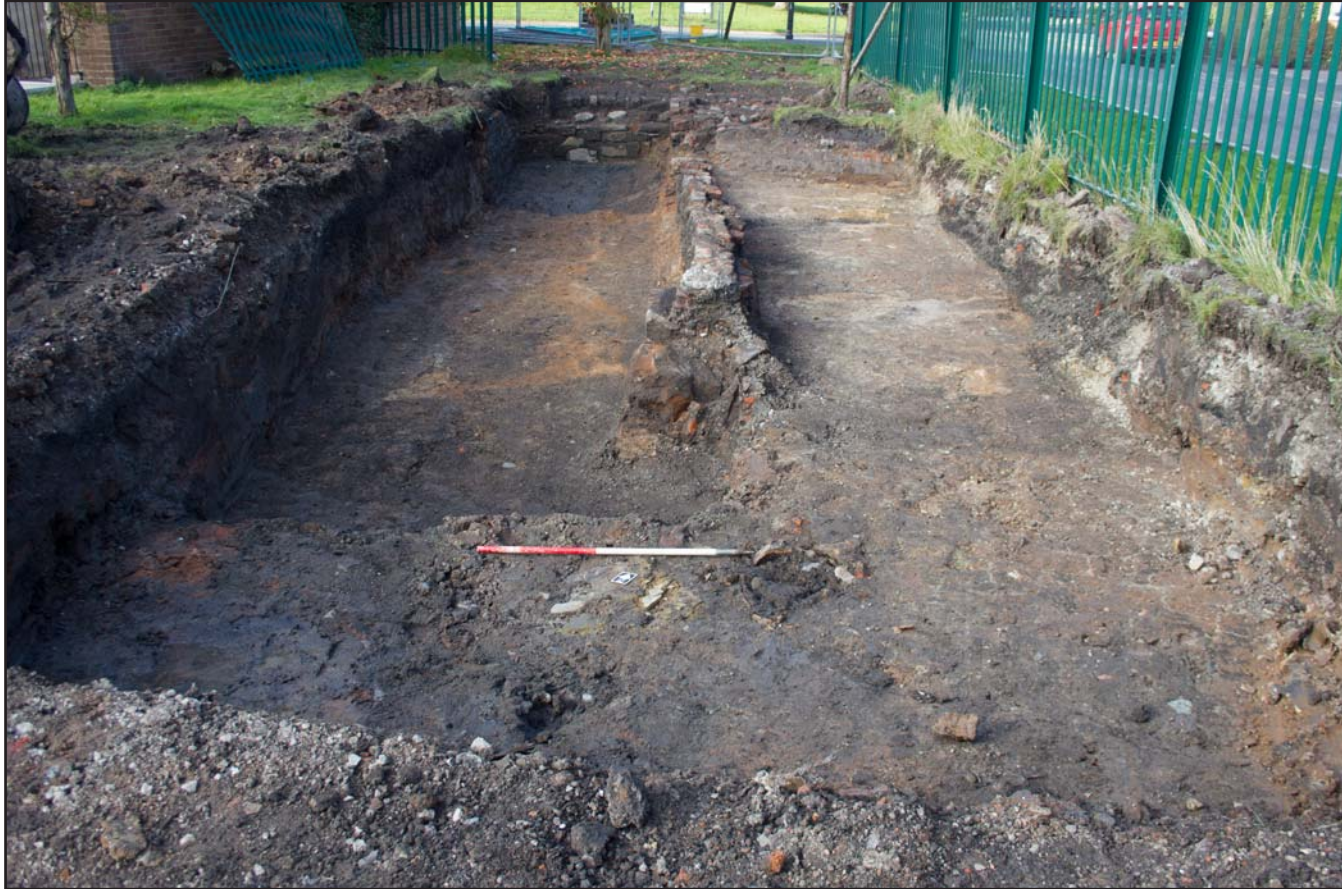
**Plate 04:** Post excavation shot of trench at Mill Wood Avenue, Eccleston, St. Helens, Merseyside - from the southeast - scale 1m

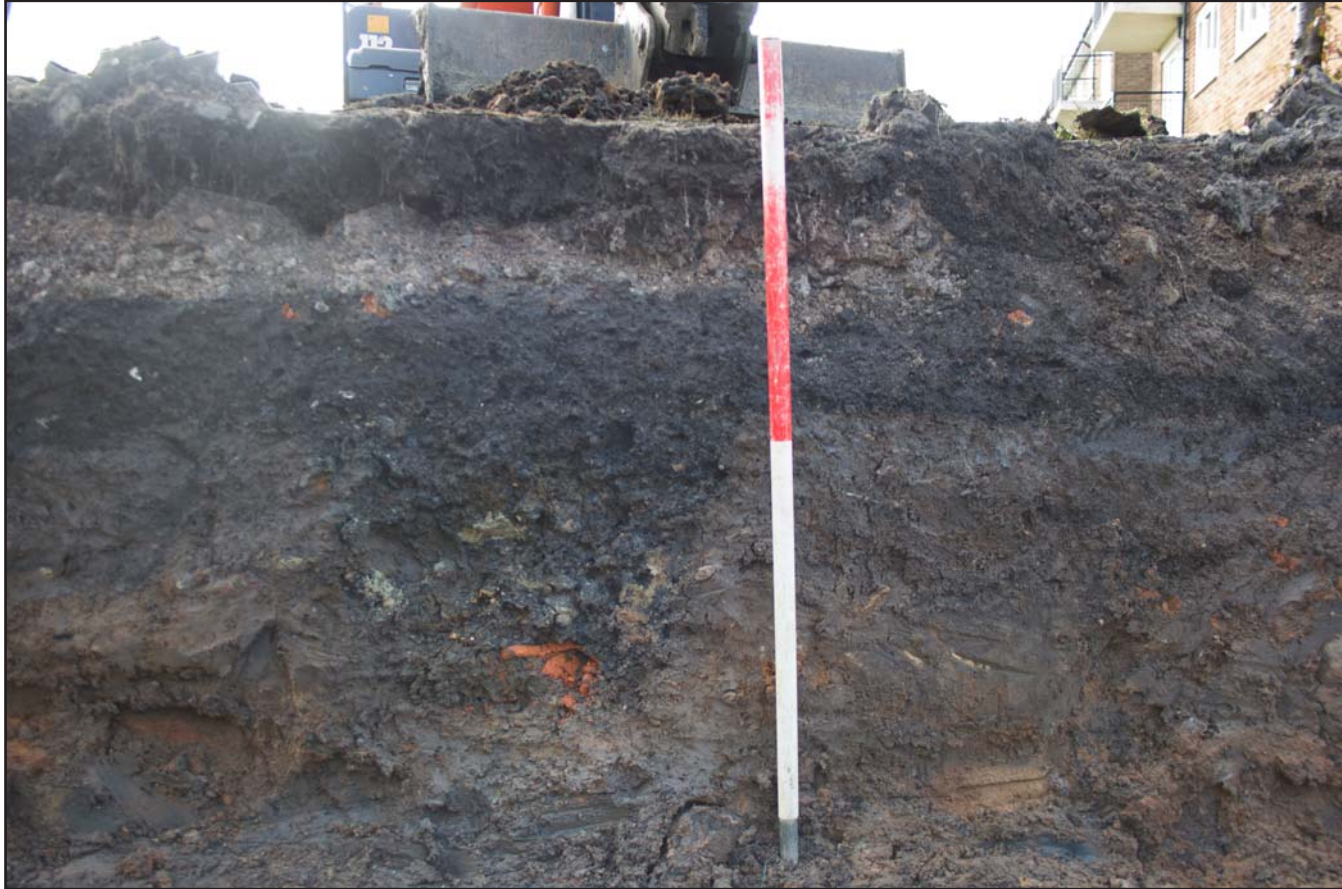
**Plate 05:** Generic section of trench at Mill Wood Avenue, Eccleston, St. Helens, Merseyside - from the northeast - scale 1m

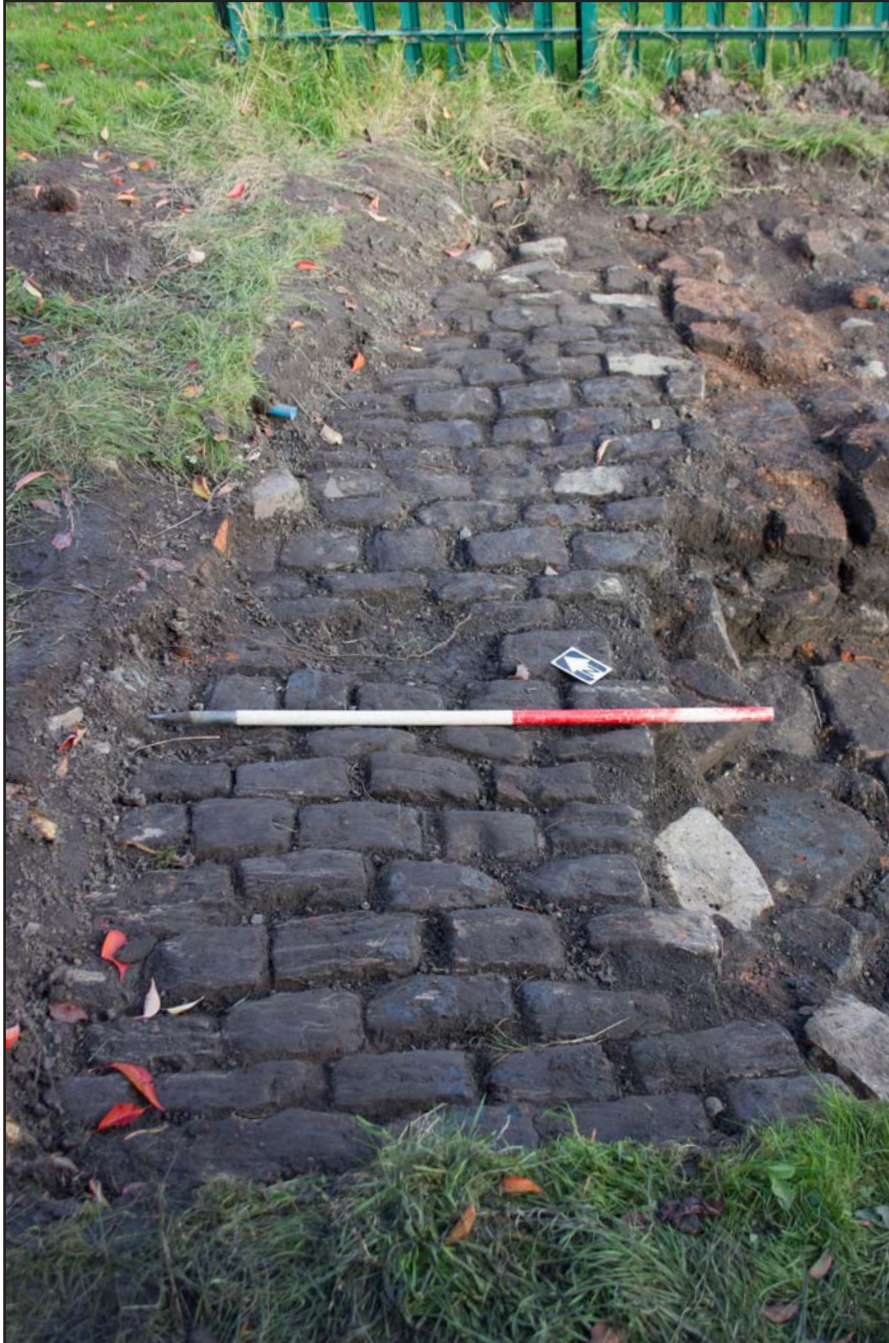
**Plate 06:** Cobbled surface (101) at Mill Wood Avenue, Eccleston, St. Helens, Merseyside - from the southwest - scale 1m

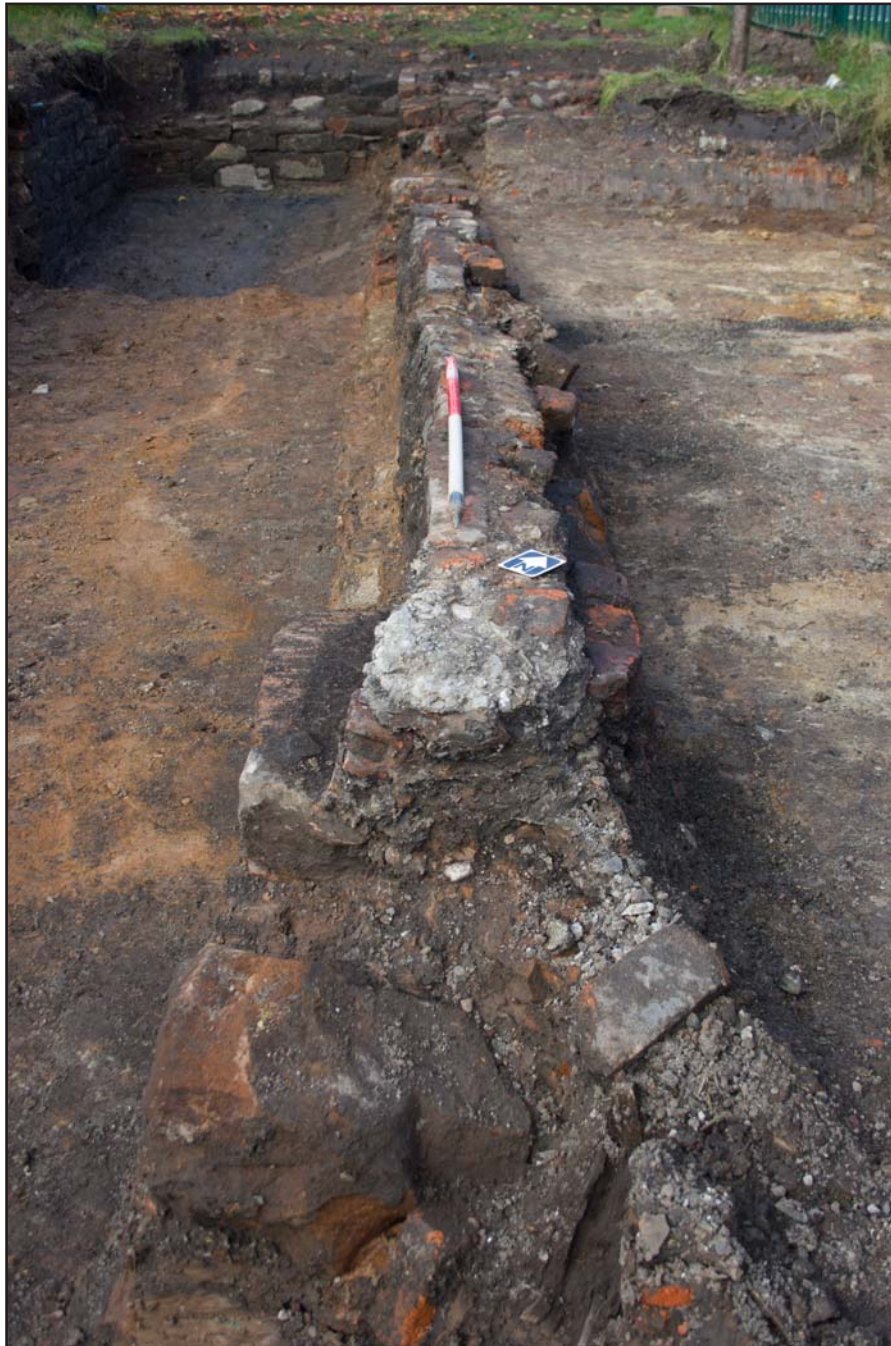
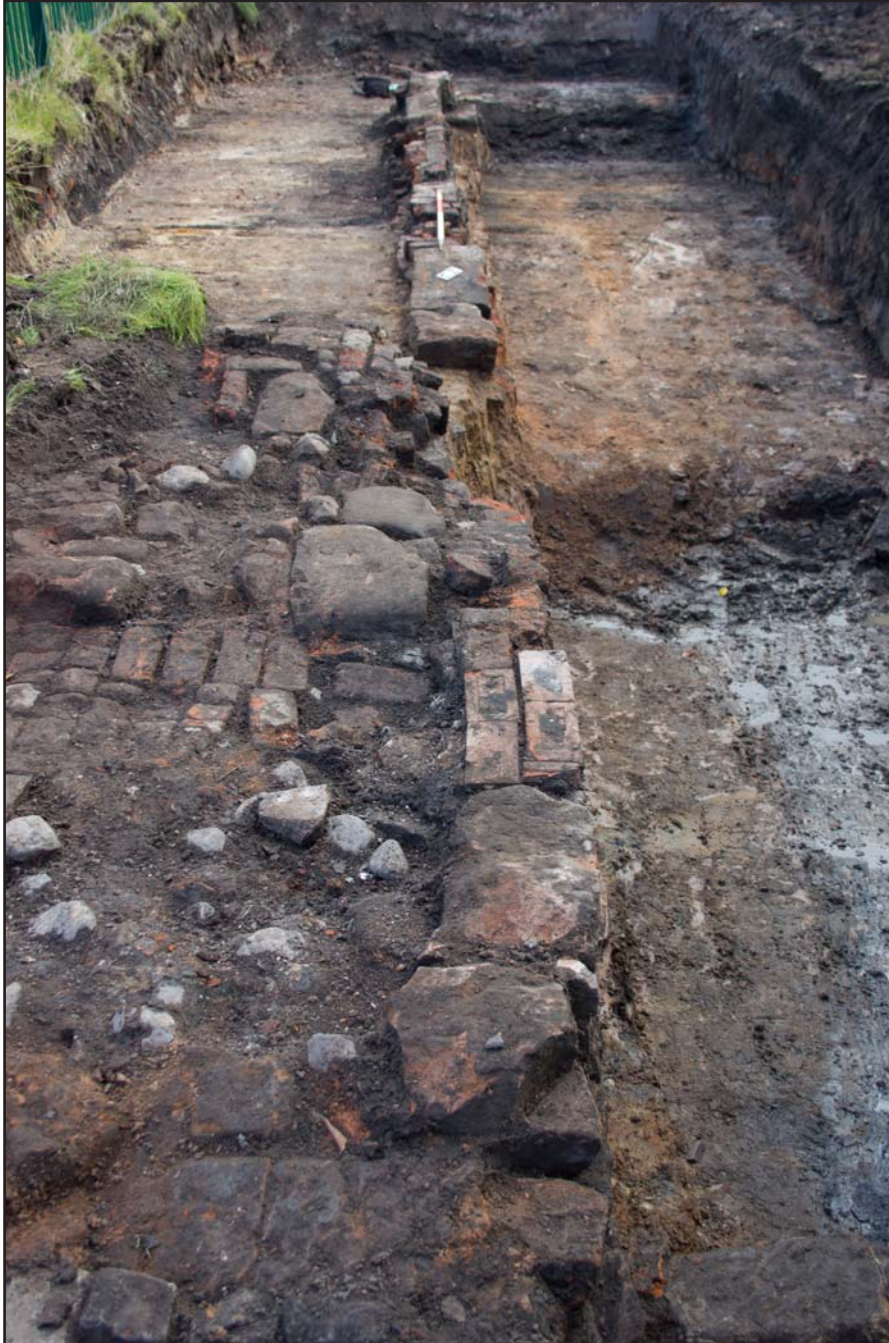
**Plate 07:** Long northwest to southeast wall (102) at Mill Wood Avenue, Eccleston, St. Helens, Merseyside - from the southeast - scale 1m

**Plate 08:** Long northwest to southeast wall (102) at Mill Wood Avenue, Eccleston, St. Helens, Merseyside - from the northwest - scale 1m

The L-shaped sandstone/brick wall (102) was overlain by the topsoil (110) and formed a long linear feature orientated northwest to southeast. It was >10.88m in length before turning on a right angle at its north western end and extending >2.10m northeast into the limit of the excavation. This wall had been entirely truncated by the sewer cut at its southeast end. The wall was 0.65m wide at its maximum width and extended 0.54m in height. This wall appeared to be multi-phase in construction with three courses of dressed sandstone forming the primary foundation phase, a single course of unfrogged red bricks (22cm by 7cm by 6cm) formed the next built phase and an area of later frogged bricks (24cm by 12cm by 7cm) formed the final repair phase, this had been conducted on the wall in isolated areas. Both the bricks and the sandstone blocks were bonded with lime mortar.

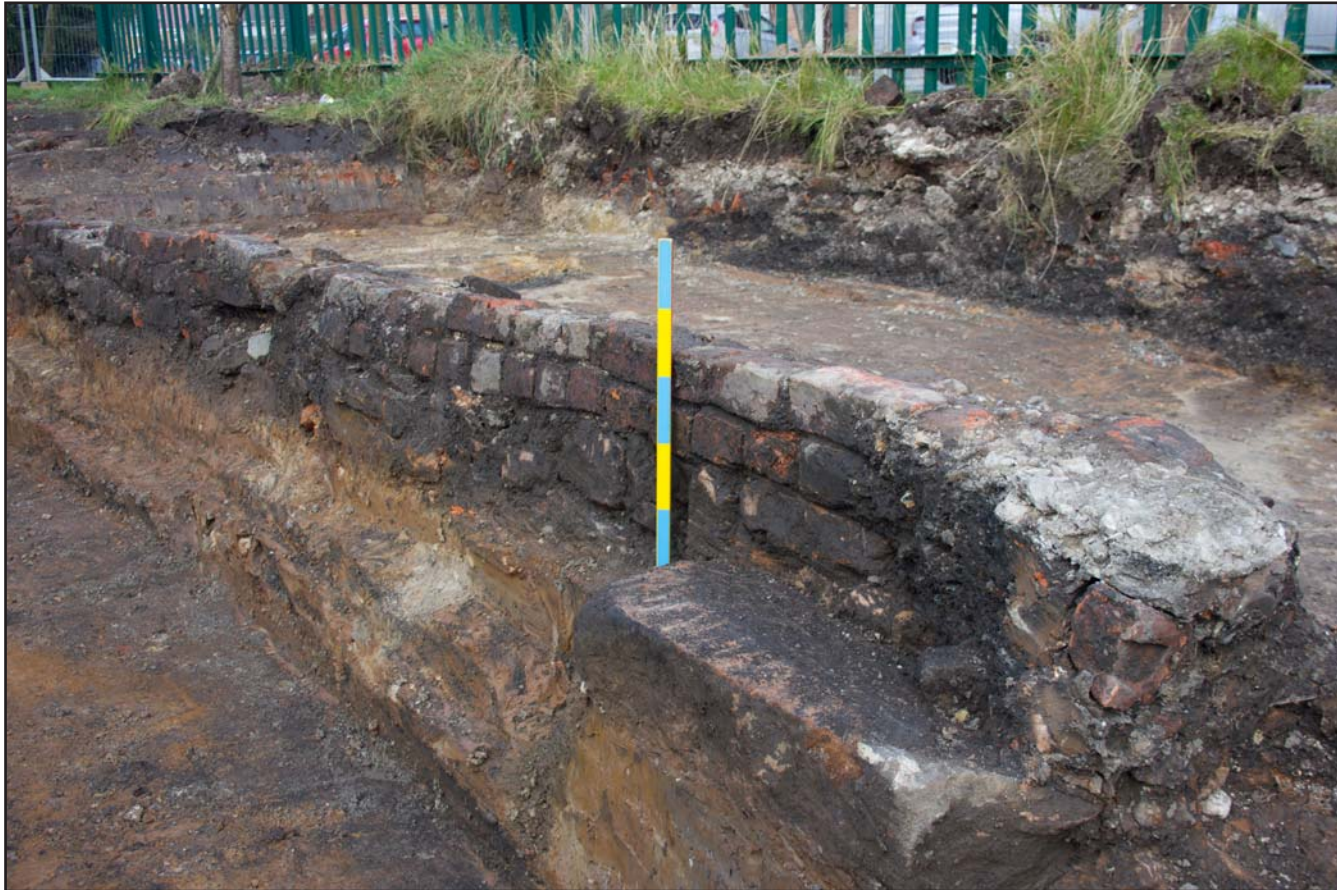
**Plate 09:** Oblique shot of wall (102) at Mill Wood Avenue, Eccleston, St. Helens, Merseyside - from the south - scale 0.50m

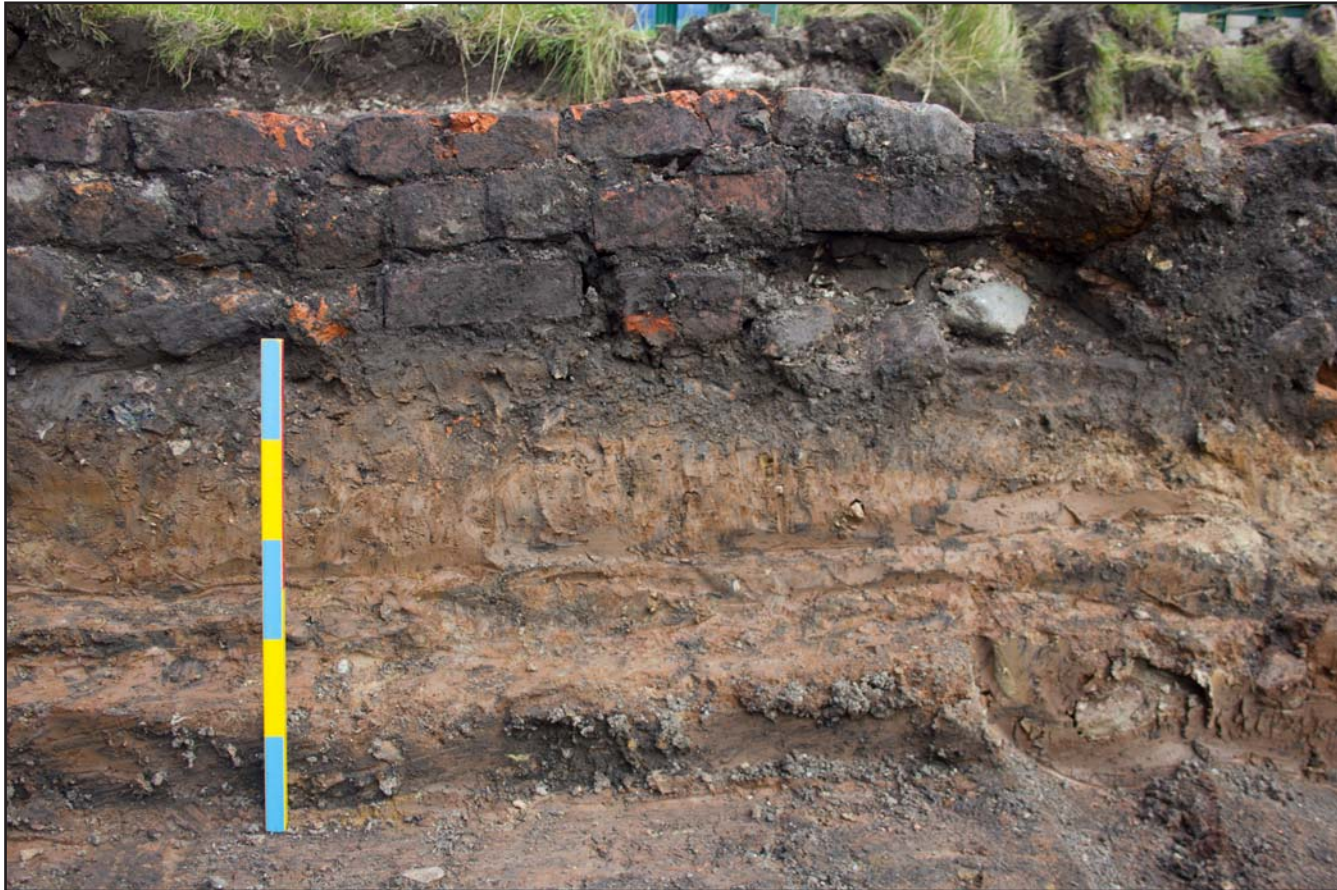
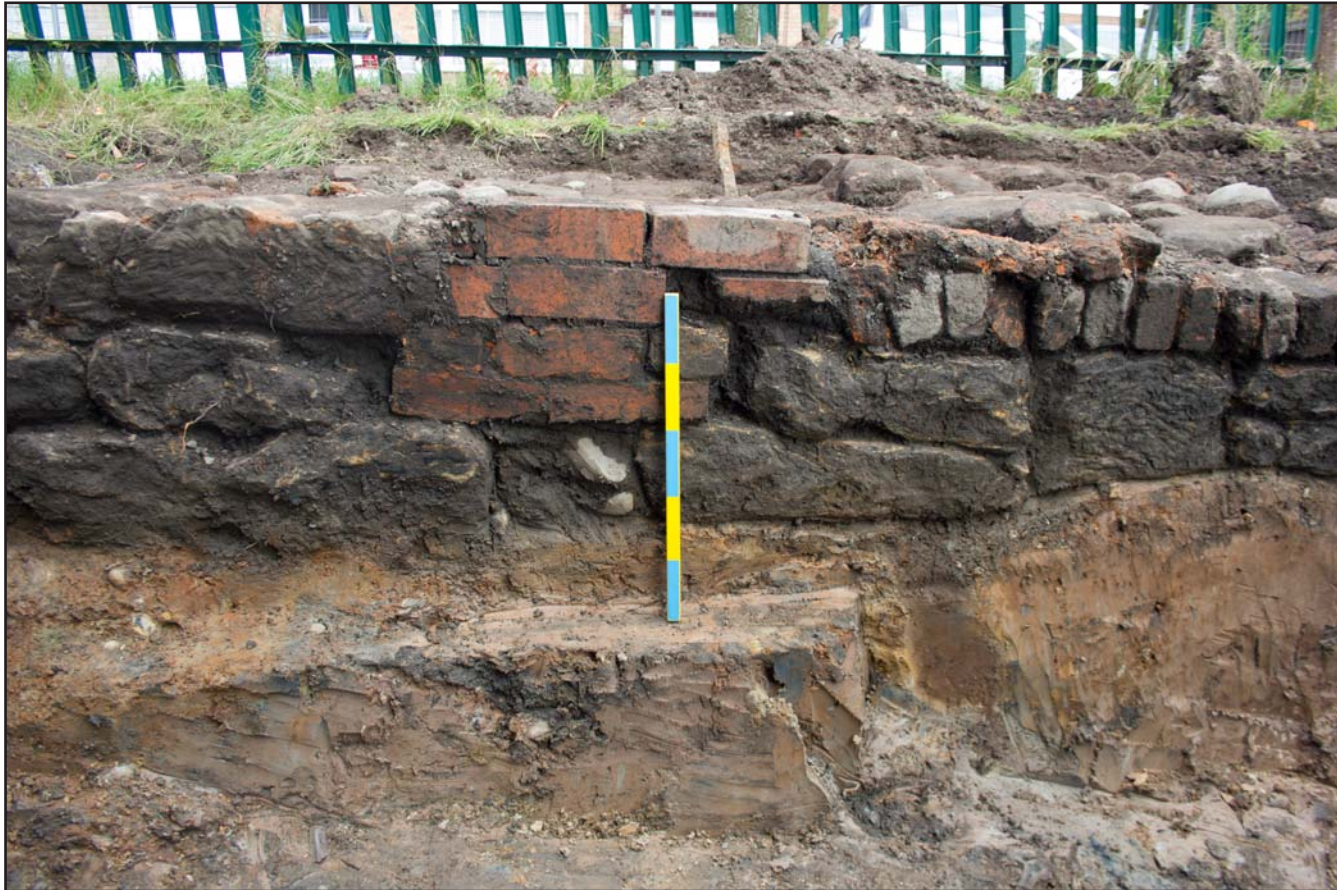
**Plate 10:** Elevation shot of wall (102) at Mill Wood Avenue, Eccleston, St. Helens, Merseyside - from the southwest - scale 0.50m

**Plate 11:** Elevation shot of wall (102) at Mill Wood Avenue, Eccleston, St. Helens, Merseyside - from the southwest - scale 0.50m

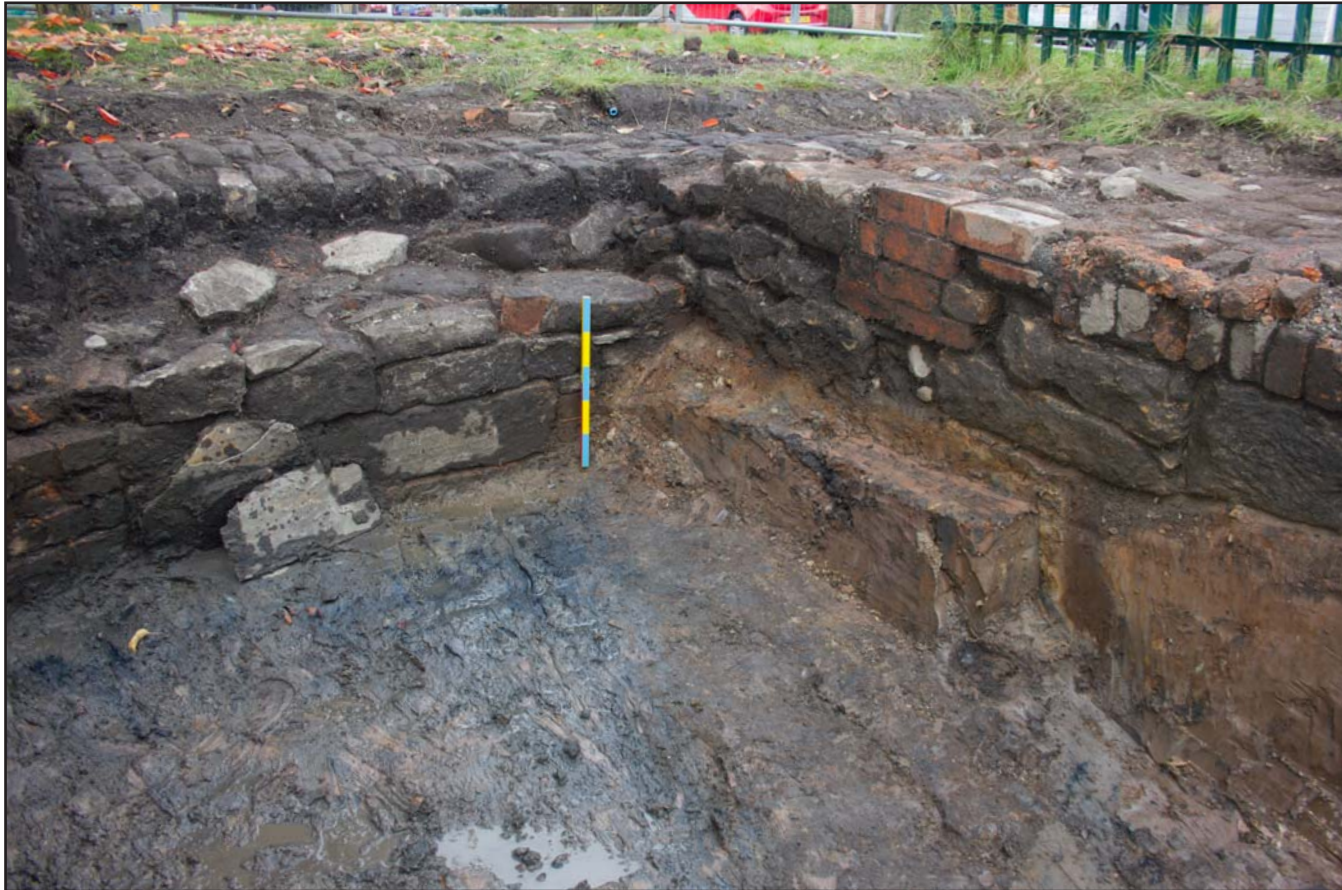
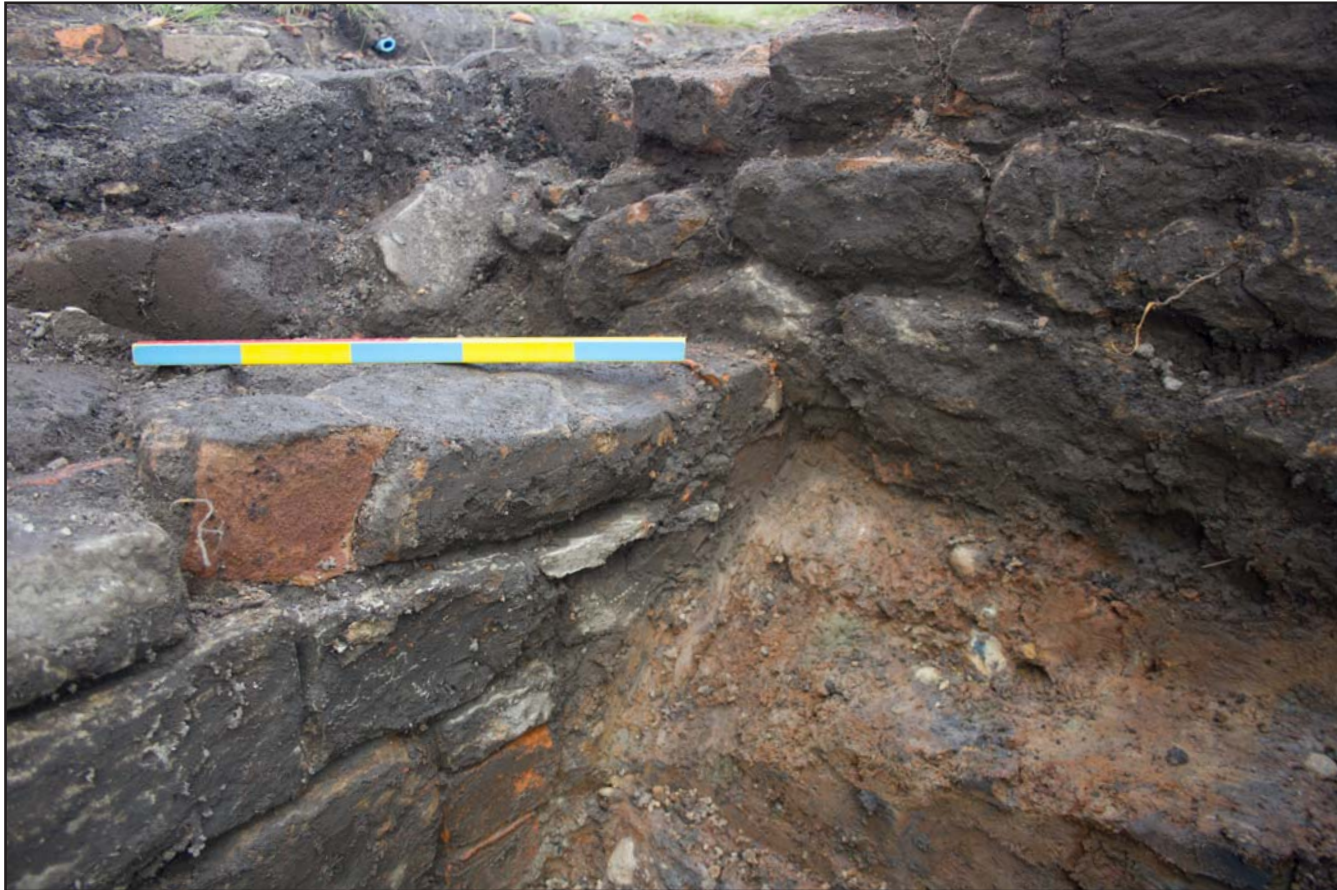
**Plate 12:** Wall (102) and (103) junction at Mill Wood Avenue, Eccleston, St. Helens, Merseyside - from the south - scale 0.50m

**Plate 13:** Focus on relationship between wall (102) and (103) at Mill Wood Avenue, Eccleston, St. Helens, Merseyside - from the south - scale 0.50m

To the southwest of the main elevation (102) at the north western end the sunken tank/cesspit (103) represents a well-constructed structure, it could be a cess-pit possibly dealing with effluent from an outhouse. This theory is supported by the presence of a ceramic drain inlet within the western corner of the tank (orientated northwest to southeast) suggesting that the outhouse was in fact further away to the northwest, possibly represented by one of the other buildings on the 1<sup>st</sup> edition OS map located in that area. The tank appears to have received a degree of design with rounded brick corners, a sandstone cladding and a possible slated floor. It is therefore possible that this was not a cesspit and was used for another agricultural process e.g. as a sheep dip or storage tank or for some unidentified cottage industry.

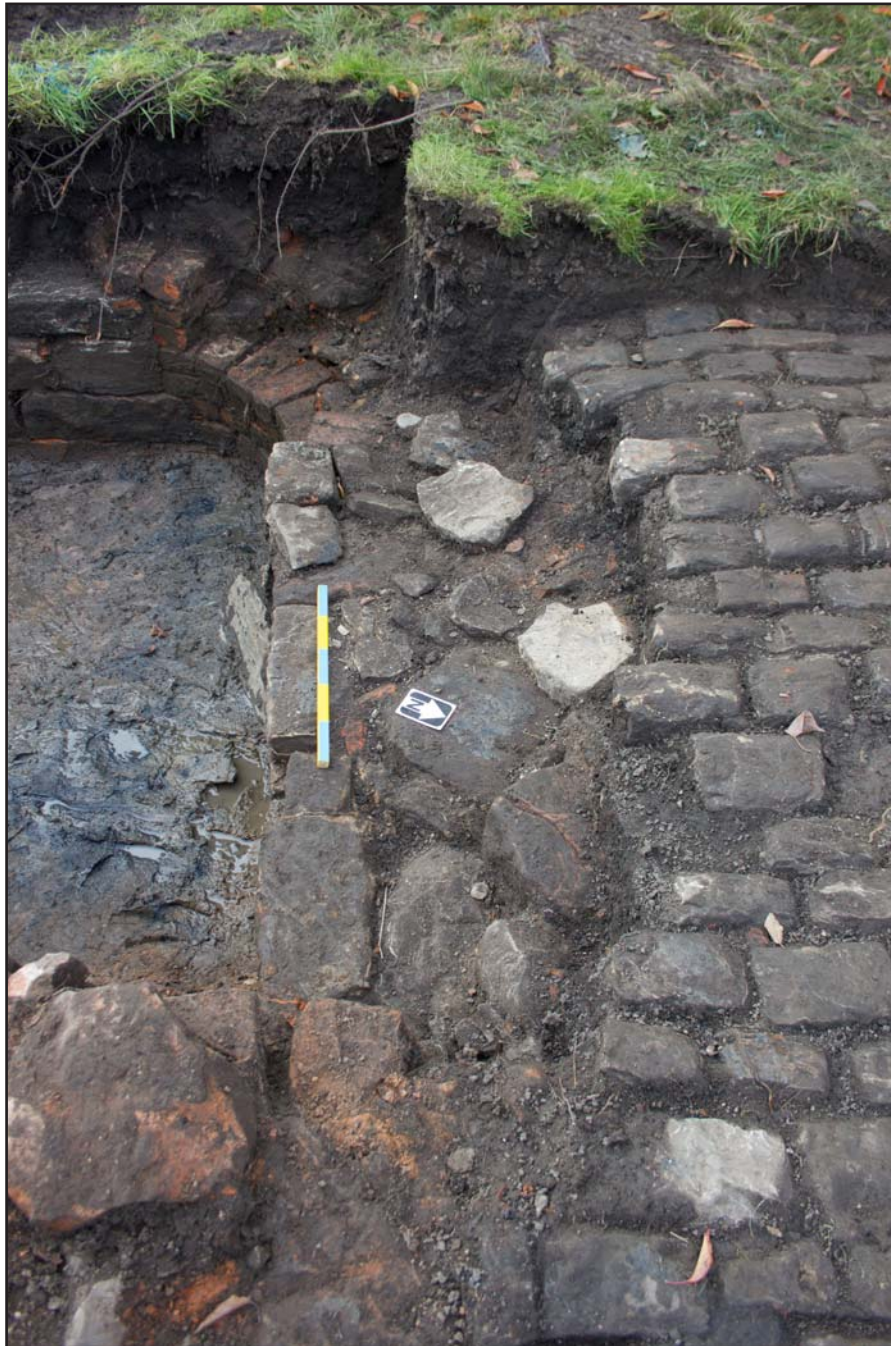
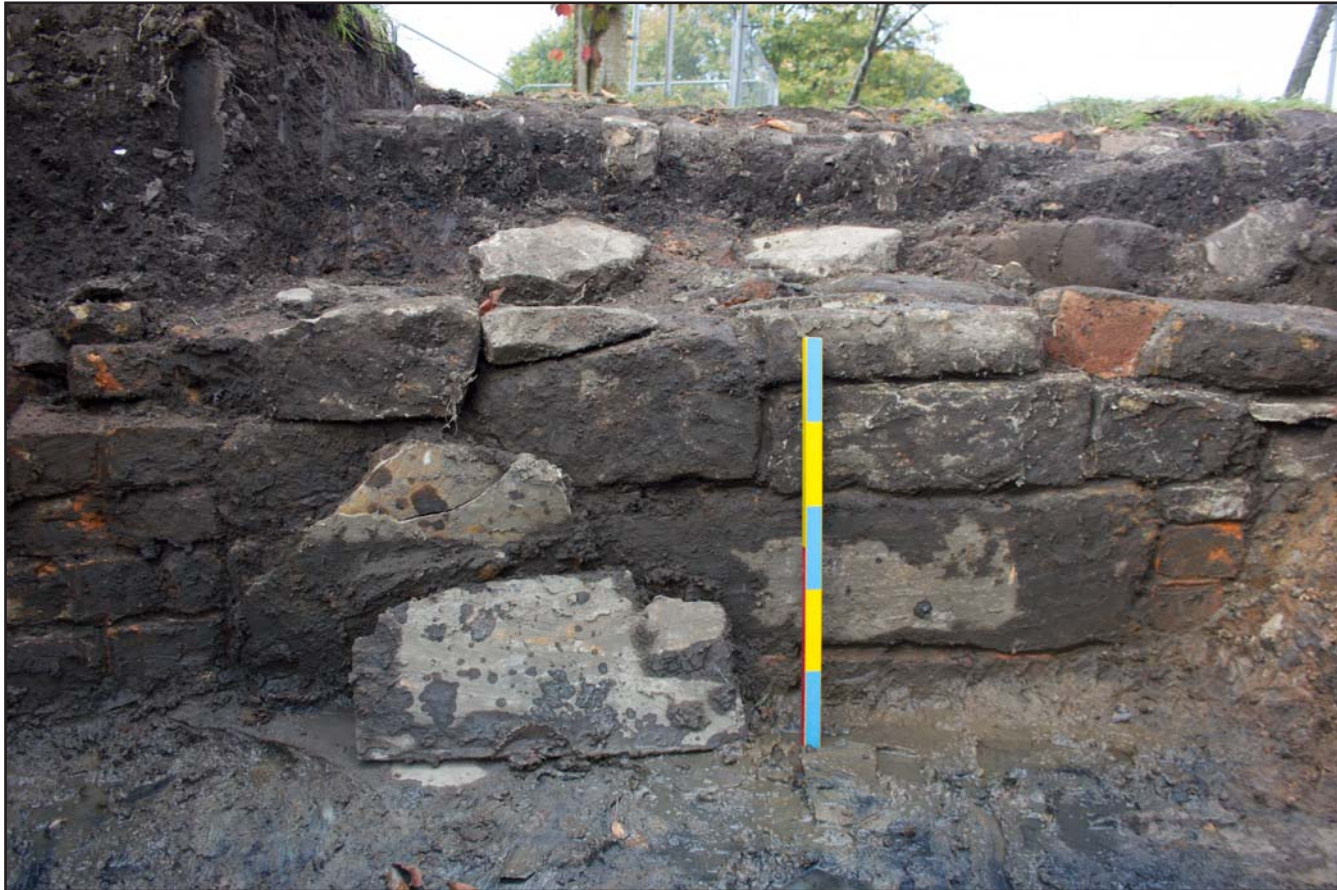
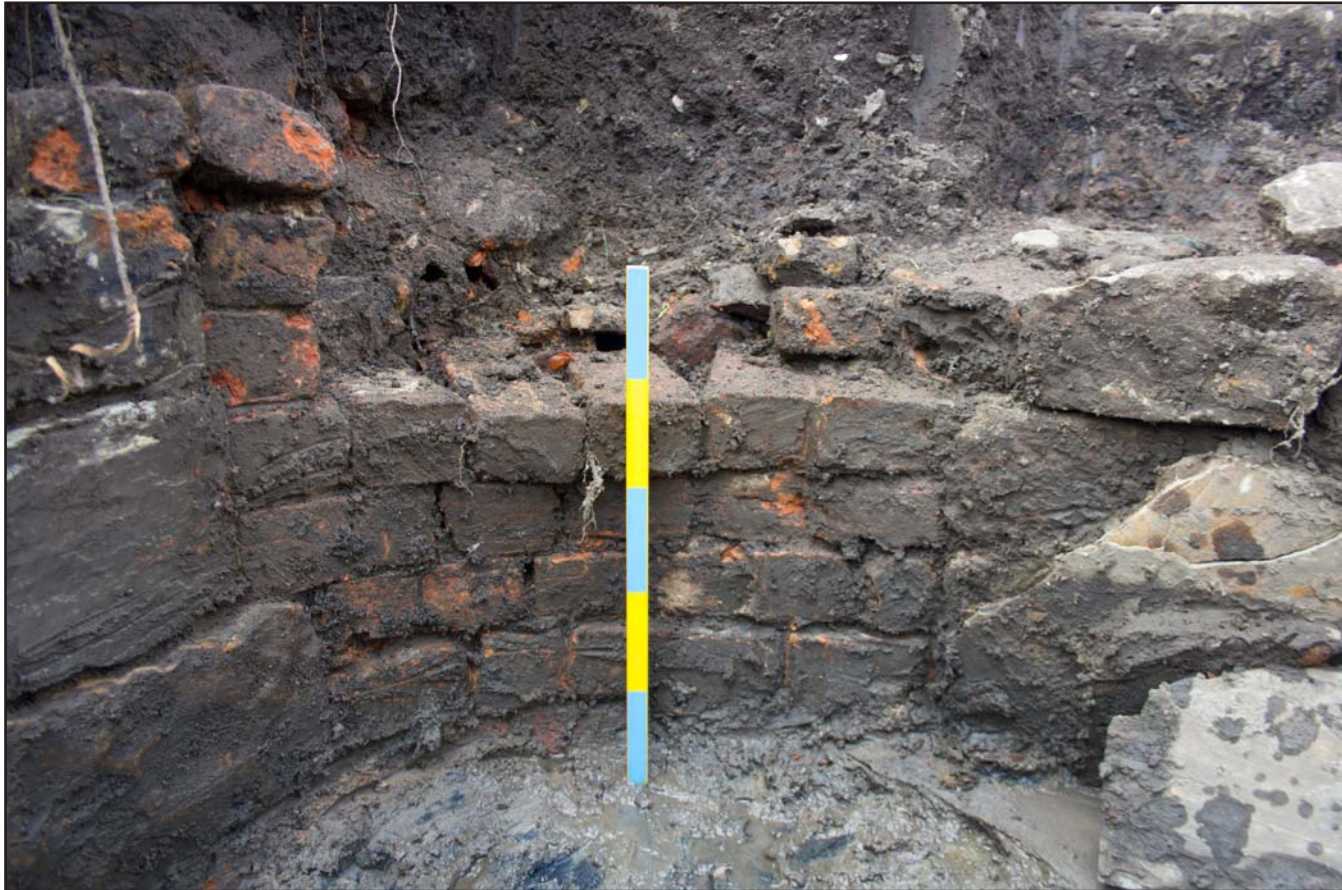
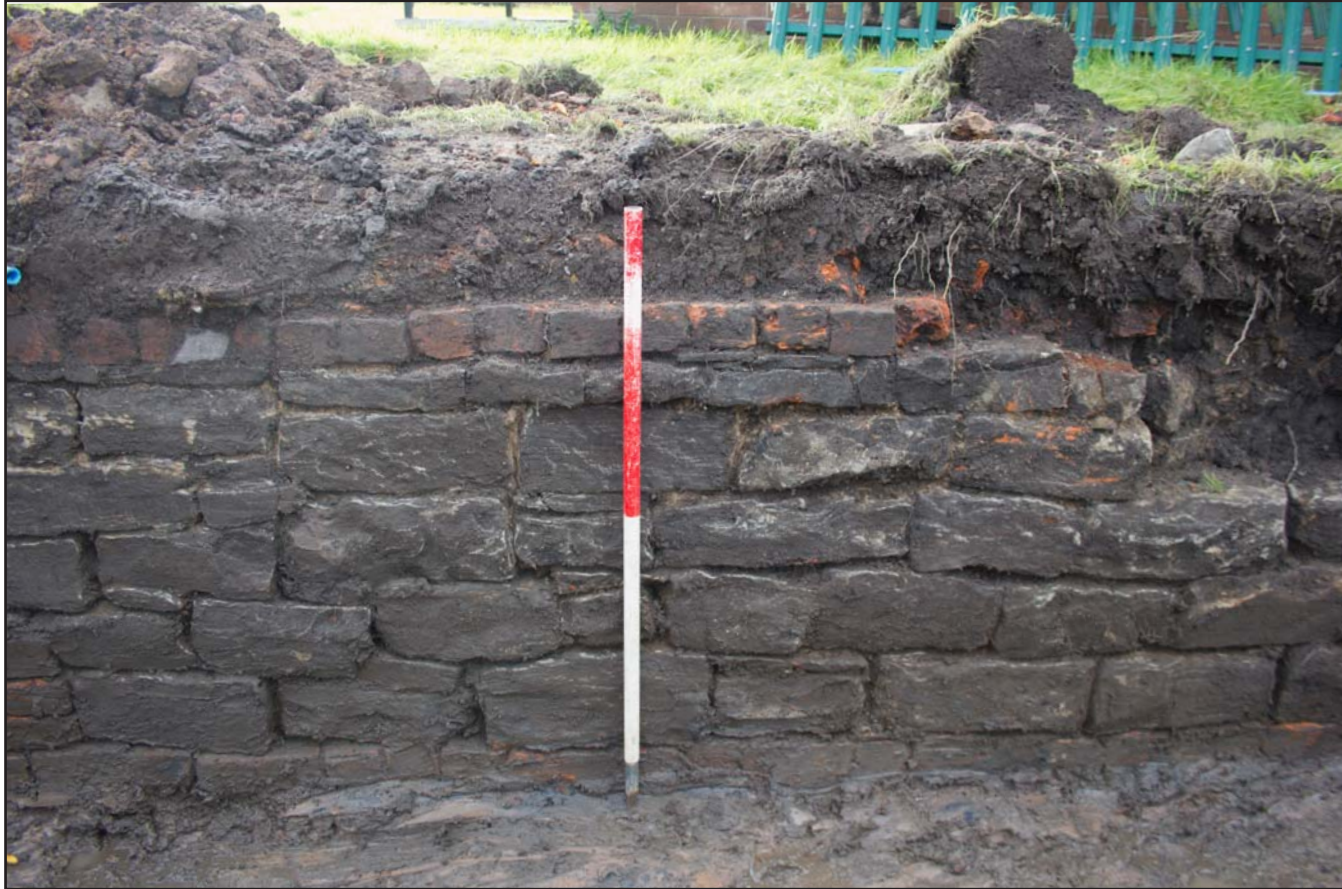
**Plate 14:** North western return of wall (103) at Mill Wood Avenue, Eccleston, St. Helens, Merseyside - from the south - scale 0.50m

**Plate 15:** Elevation shot of wall (103) at Mill Wood Avenue, Eccleston, St. Helens, Merseyside - from the southeast - scale 0.50m

**Plate 16:** Rounded red brick corner of wall (103) at Mill Wood Avenue, Eccleston, St. Helens, Merseyside - from the southeast - scale 0.50m

**Plate 17:** South western return of wall (103) at Mill Wood Avenue, Eccleston, St. Helens, Merseyside - from the northeast- scale 1m

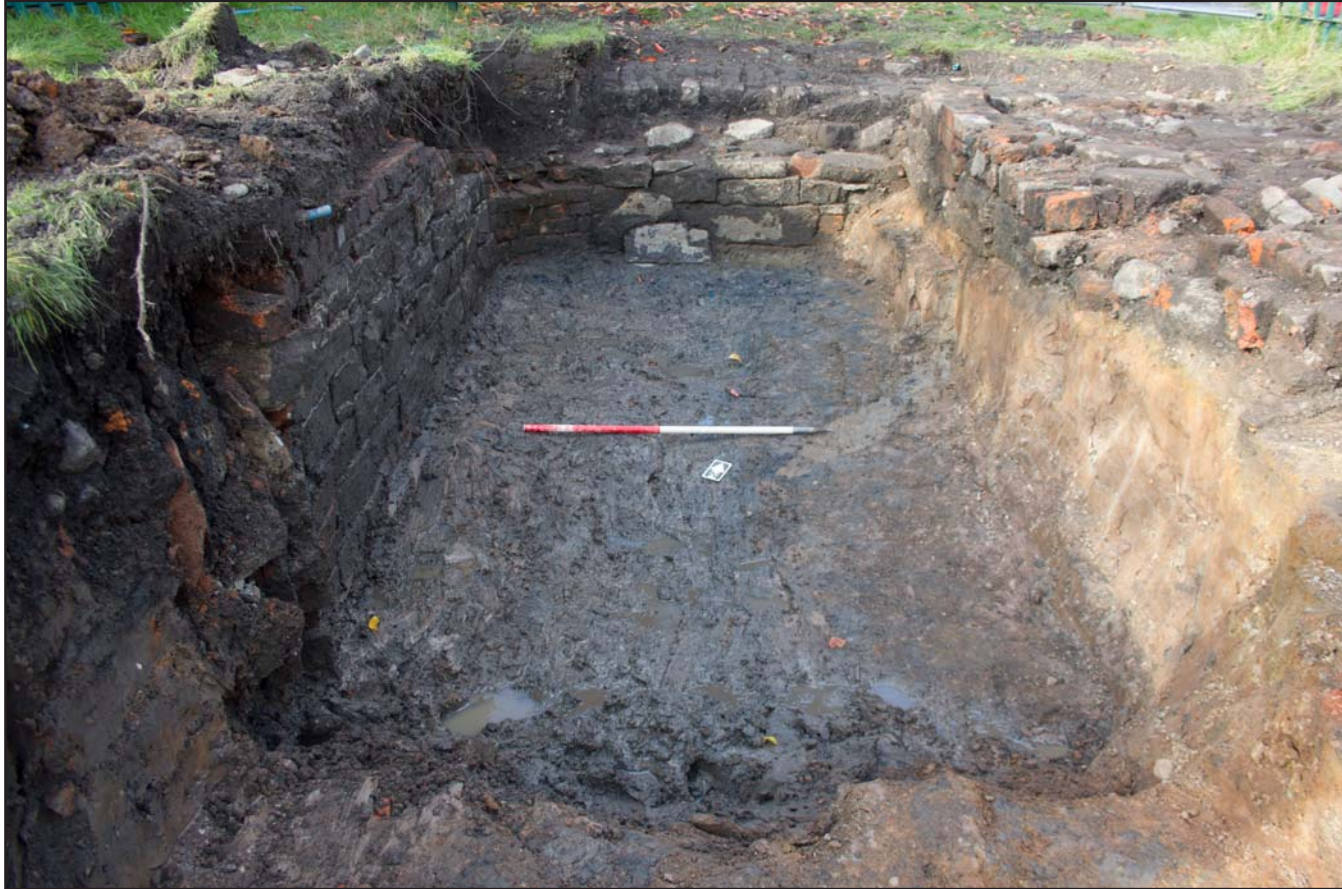
**Plate 18:** Wall (103) forming tank/cess pit at Mill Wood Avenue, Eccleston, St. Helens, Merseyside - from the southeast - scale 1m
