# Mill Wood Avenue, Eccleston, St. Helens, Merseyside, WA10 5BE.

Report no. 0221 v3.0

Archaeological Strip, Map & Sample

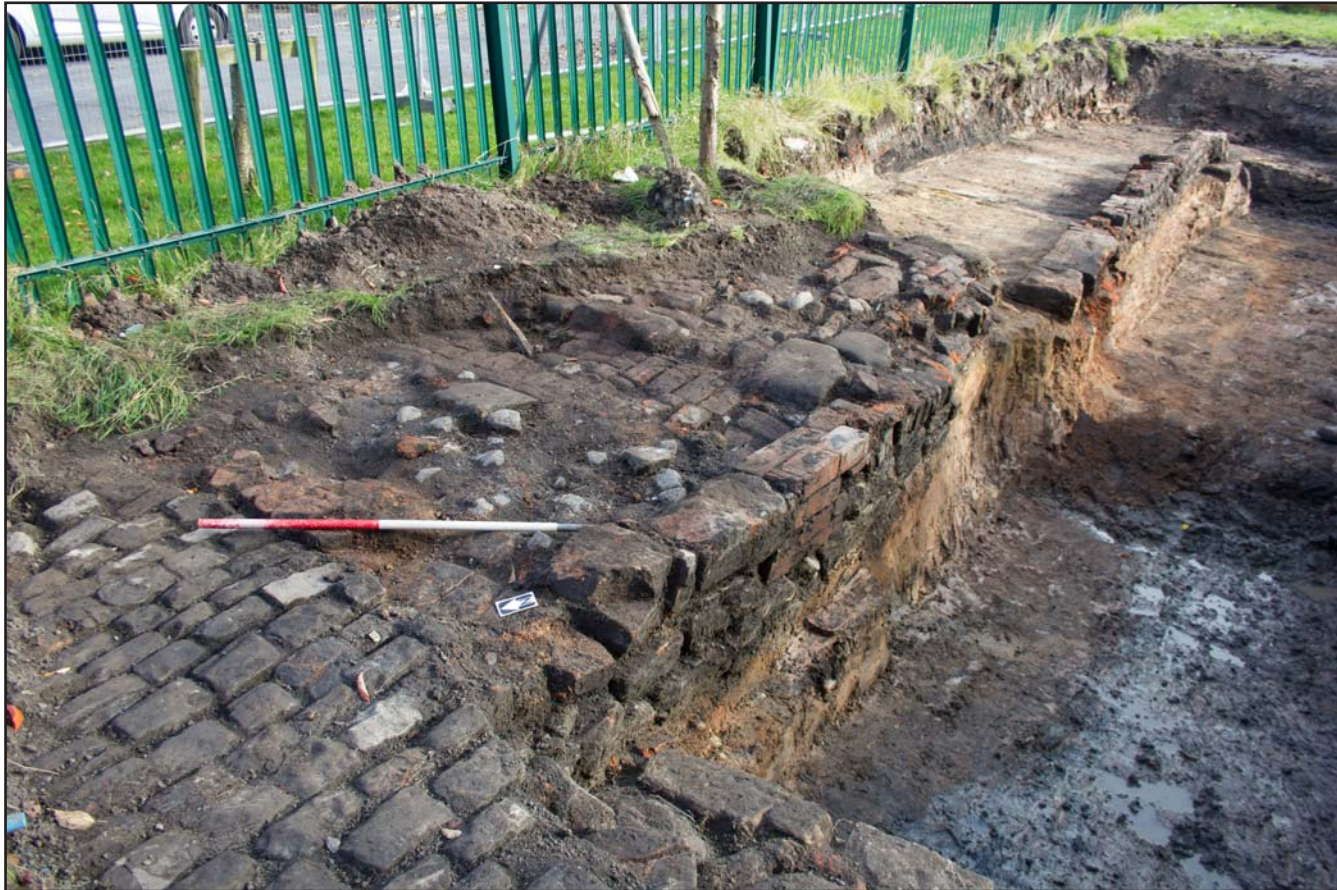
**Plate 19:** Area to the northeast of tank (103) at Mill Wood Avenue, Eccleston, St. Helens, Merseyside - from the west - 1m scale

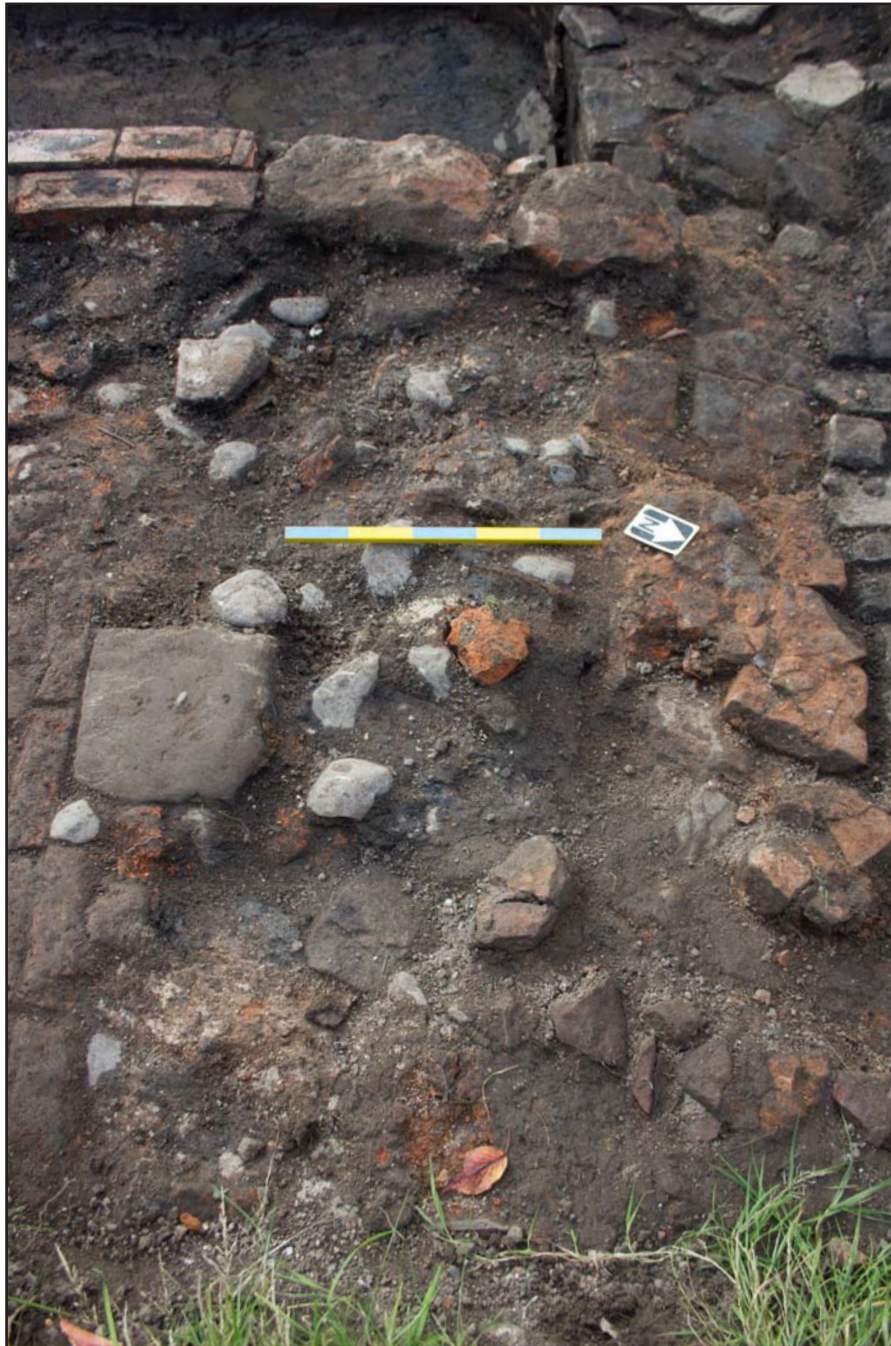
**Plate 20:** Demolition deposit (104) at Mill Wood Avenue, Eccleston, St. Helens, Merseyside - from the northeast - 0.50m scale

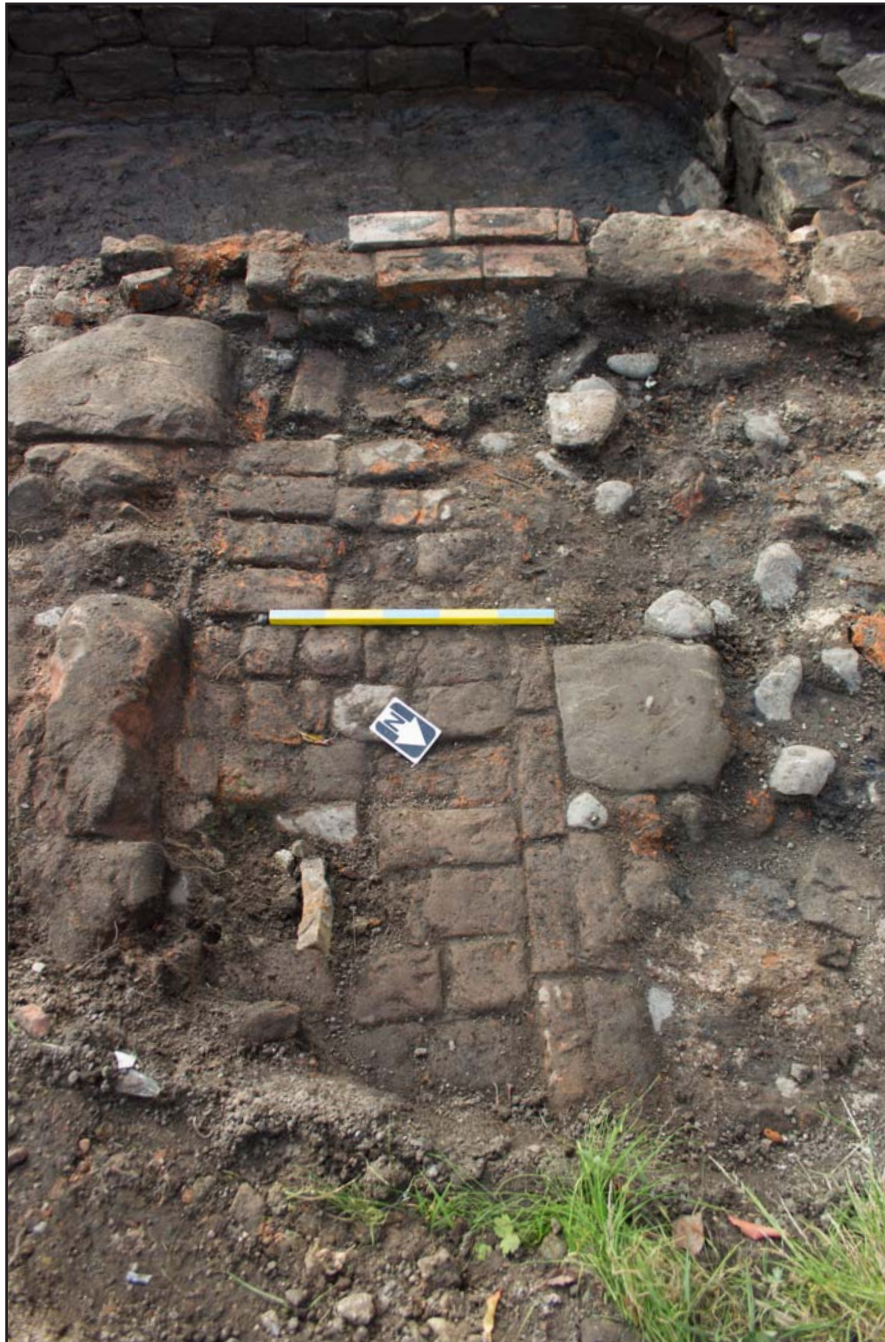
**Plate 21:** Brick surface (105) at Mill Wood Avenue, Eccleston, St. Helens, Merseyside - from the northeast - 0.50m scale

The red brick surface (105) was overlain by the topsoil (110) and consisted of an area of >1.75m long by 0.62m wide: this area was orientated northeast to southwest. The red bricks were handmade and unfrosted (22cm by 7cm by 6cm) and had been laid in a manner which was suggestive of it being located on the margin within a room or as a corridor or pathway. These bricks overlay the demolition layer (104) making them later than the demolition but also abutted the short/broad sandstone wall (106) and were later than that feature. The surface either represents an interior surface within an agricultural building or an external surface between a dwelling and the possible location of an outhouse; which could have once occupied the area where the demolition (104) now resides.

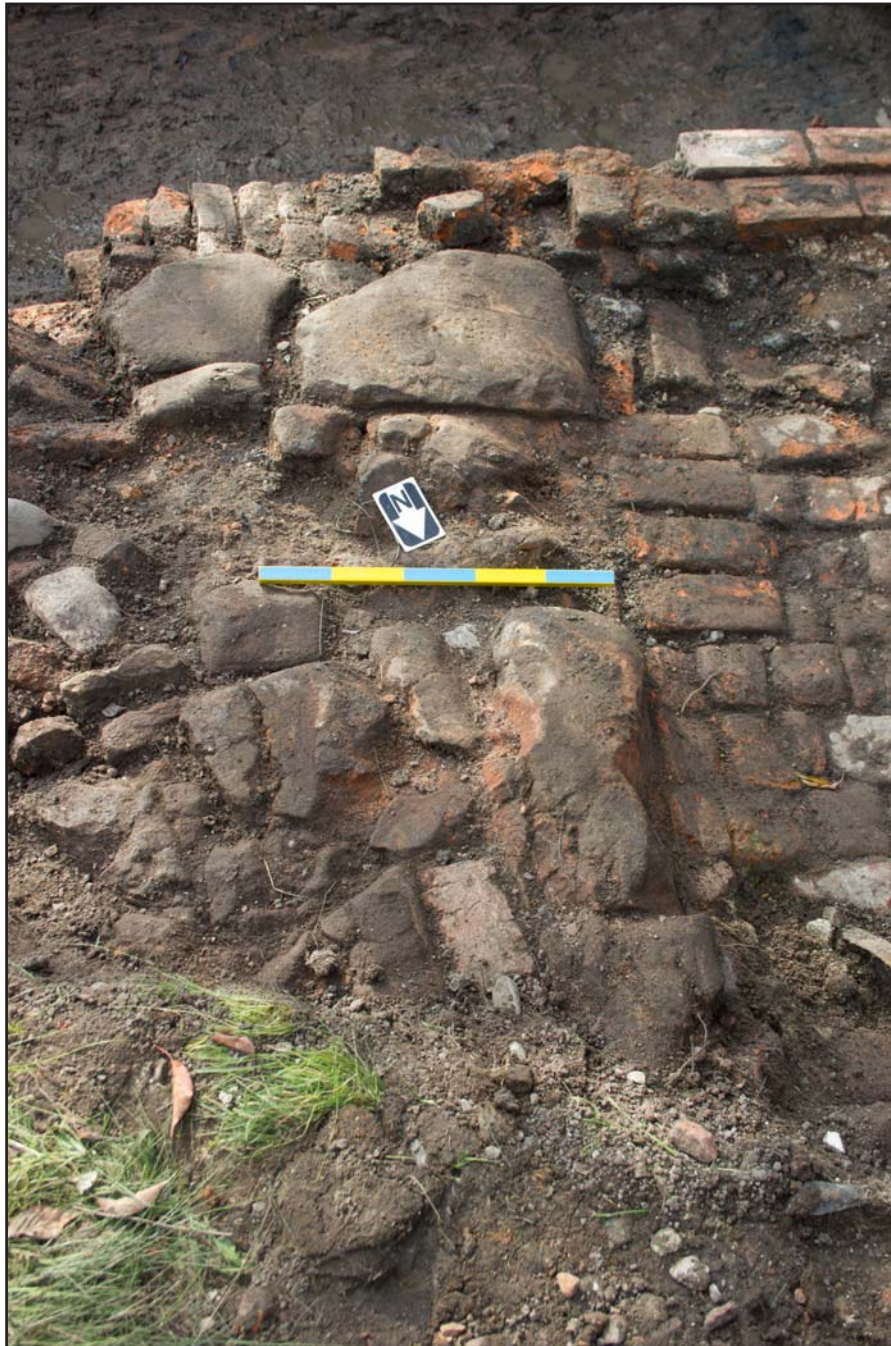
**Plate 22:** Wall (106) at Mill Wood Avenue, Eccleston, St. Helens, Merseyside - from the northeast -  
0.50m scale

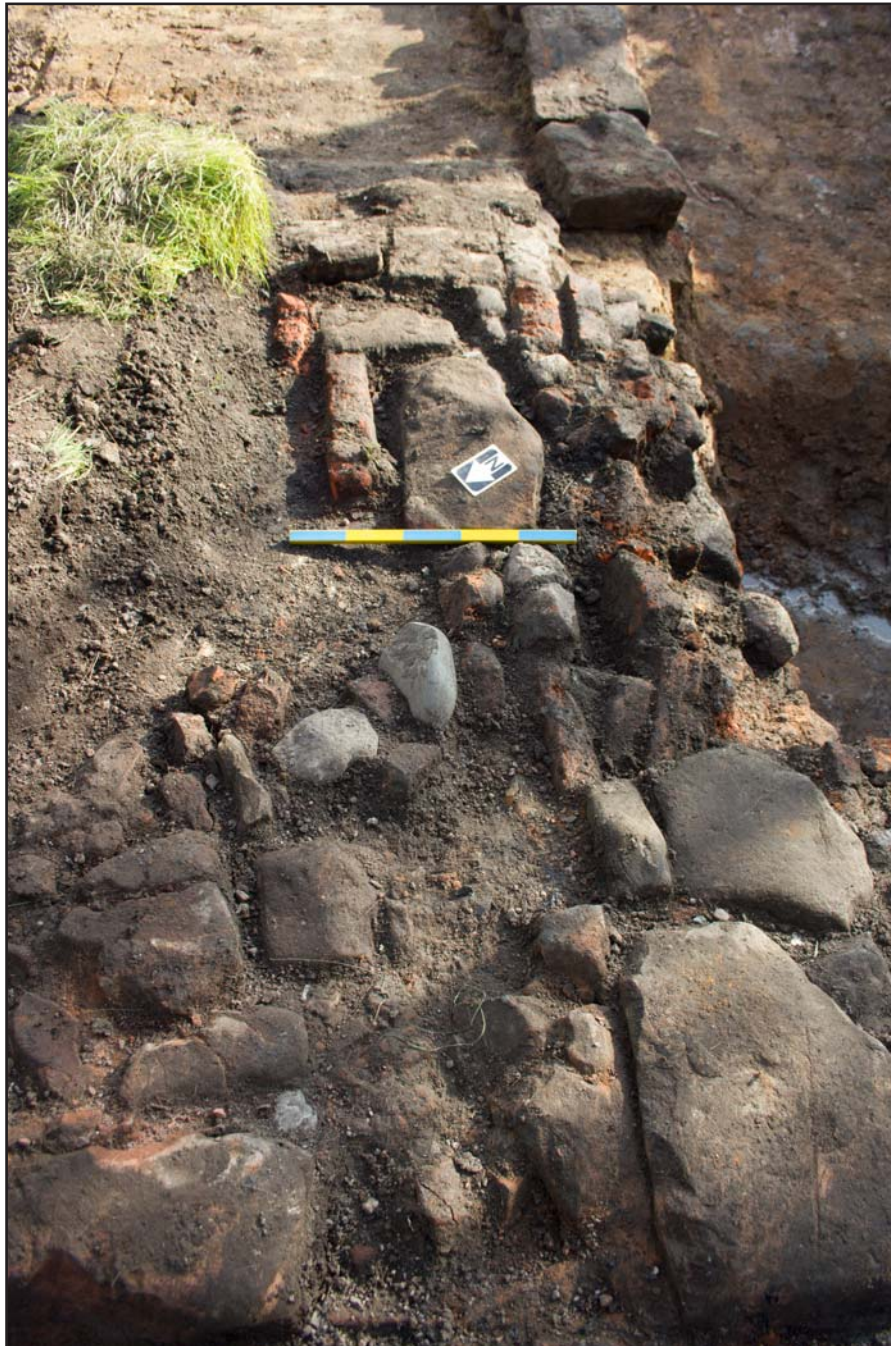
**Plate 23:** In-situ brick and stone (107) at Mill Wood Avenue, Eccleston, St. Helens, Merseyside - from the northwest - 0.50m scale

The in-situ brick and stone (107) was overlain by the topsoil (110) and consisted of an area of >1.75m long by 0.62m wide: this area was orientated northwest to southeast. The feature was an amalgam of materials including dressed sandstone, sub rounded cobbles and red bricks. The red bricks were handmade and unfrosted (22cm by 7cm by 6cm) and had been laid in a manner which was suggestive of a surface or wall. The feature abutted with walls (102) and (106).
