**80, Buxton Road, Congleton,
CW12 2DY.**

Historic Building Record Level 2
Project Code: A0154.1
Report no. 0161

Historic Building Record Level 2

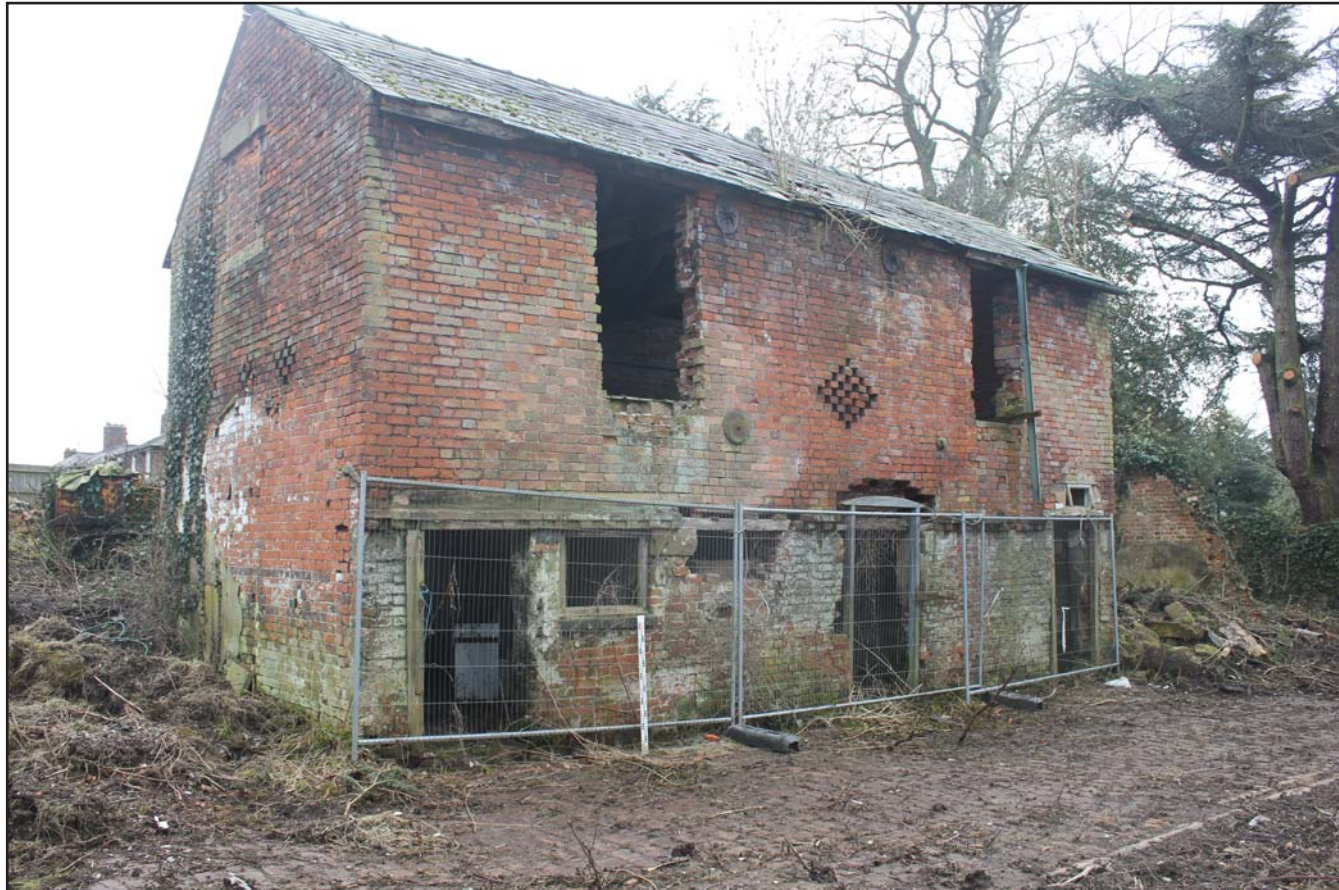
The northern elevation of the northern building is roofed with blue-grey slate and blue-grey ridge tiles and measures approximately 9.90m in length. In the eaves a weatherboard has been fixed to the wall and upon this a plastic gutter was fitted but has since fallen, the elevation is also comprised of red brick bonded by mortar. Access to the interior of the building was prohibited by Herras fencing at the time of the site record as the interior of the building was not safe due to previous fire damage and a roof collapse. Located in the centre of the elevation on the ground floor is a single wooden framed doorway, flanking this doorway at either end of the elevation are two further doorways which are also timber framed. The eastern most doorway has two substantial stone lintels above it which support the brickwork, these appear to have been dressed by a stonemason as the lintel exhibits a squared cornice design. To the immediate right of this doorway there is a small rectangular timber framed window with a brick sill, furthermore to the immediate right of this window there may have been another window at an earlier point in time as there is the evidence of a wooden lintel and an opening in the wall, however no window frame timbers remain. To the right of the central doorway on the western side of the elevation there is another single doorway; which permits access to the interior, located above this doorway is a very small window light.

Located in the centre of the upper story of the building is a decorative embrasure in the shape of a diamond, formed from 16 bricks (on end) and 20 subsequent openings forming ventilation holes. The upper story also has two large vertical window openings; these have no window frames or windowsills. Furthermore located either side of the diamond shaped embrasure are four cast-iron wall ties; two to the left of the embrasure and two to the right, these are situated at the level roughly commensuring with the top and the bottom extent of the upper floor windows.

Plate 01: Little Lowe House, Buglawton, Congleton - External shot Farmhouse - Northern elevation of northern range - From the north - 1m scale

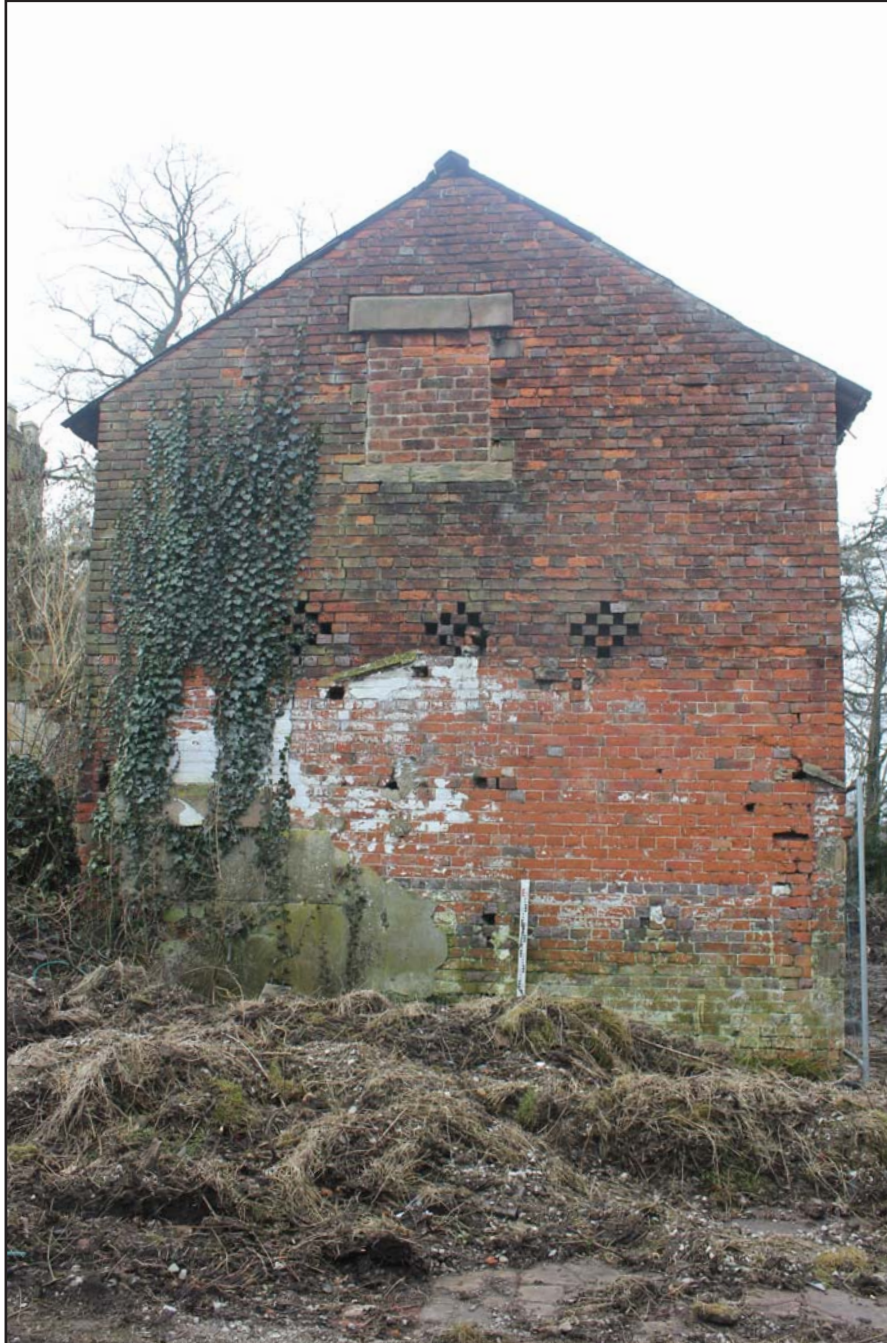
The eastern elevation of the northern range forms the gable end of that structure and measures 5.40m in length. The elevation is comprised of red-brick bonded by mortar with the addition of darker blue bricks near the base of the elevation. Located below the ridge of the roof in the centre of the elevation on the upper floor, there appears to have been a single vertical window with a dressed stone lintel and window sill, however the window has since been bricked up. Located approximately halfway up the elevation are three further diamond-shaped embrasures styled in a similar manner to those in the northern elevation, but these are smaller comprising of only four bricks and 9 subsequent openings forming ventilation holes. Near the base of the

wall there is an attempt at mirroring the diamond design but by the implementation of using blue-bricks to create the same effect. Furthermore the wall looks as if it may have been painted and subsequently rendered in the past; but the render has mostly fallen away and the paint underneath has for the most part flaked away.

Plate 02: Little Lowe House, Buglawton, Congleton - External shot Farmhouse -
Eastern elevation of northern range - From the east - 1m scale

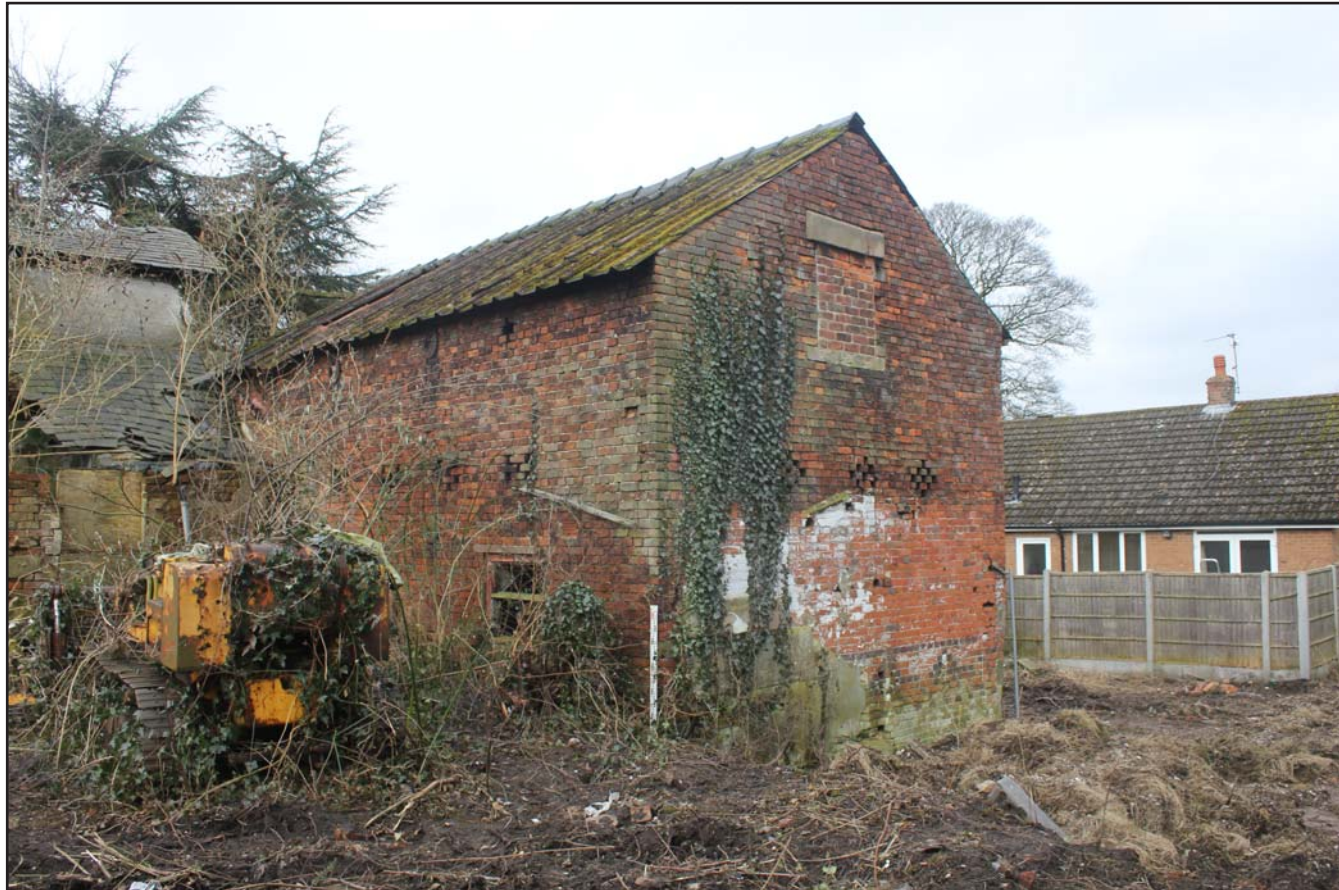
The southern elevation of the northern building measures 6.40m in length. It has been roofed with asbestos sheets (as opposed to slates on the north) but the same grey blue ridge tiles are present. Just below the roofline there are two small ventilation holes and two of the cast iron wall ties are also visible here. Located approximately halfway up the elevation there are a series of embrasures although these are of a different design to the ones found on the northern and eastern elevations; forming a basic cross shape of five openings. Below these on the ground floor are two identical sized square timber framed windows, furthermore the wall ties are also visible to the upper left of these windows. Apart from this the elevation is featureless.

Plate 03: Little Lowe House, Buglawton, Congleton - Oblique shot Farmhouse - Southern & eastern elevations of northern range - From the southeast - 1m scale

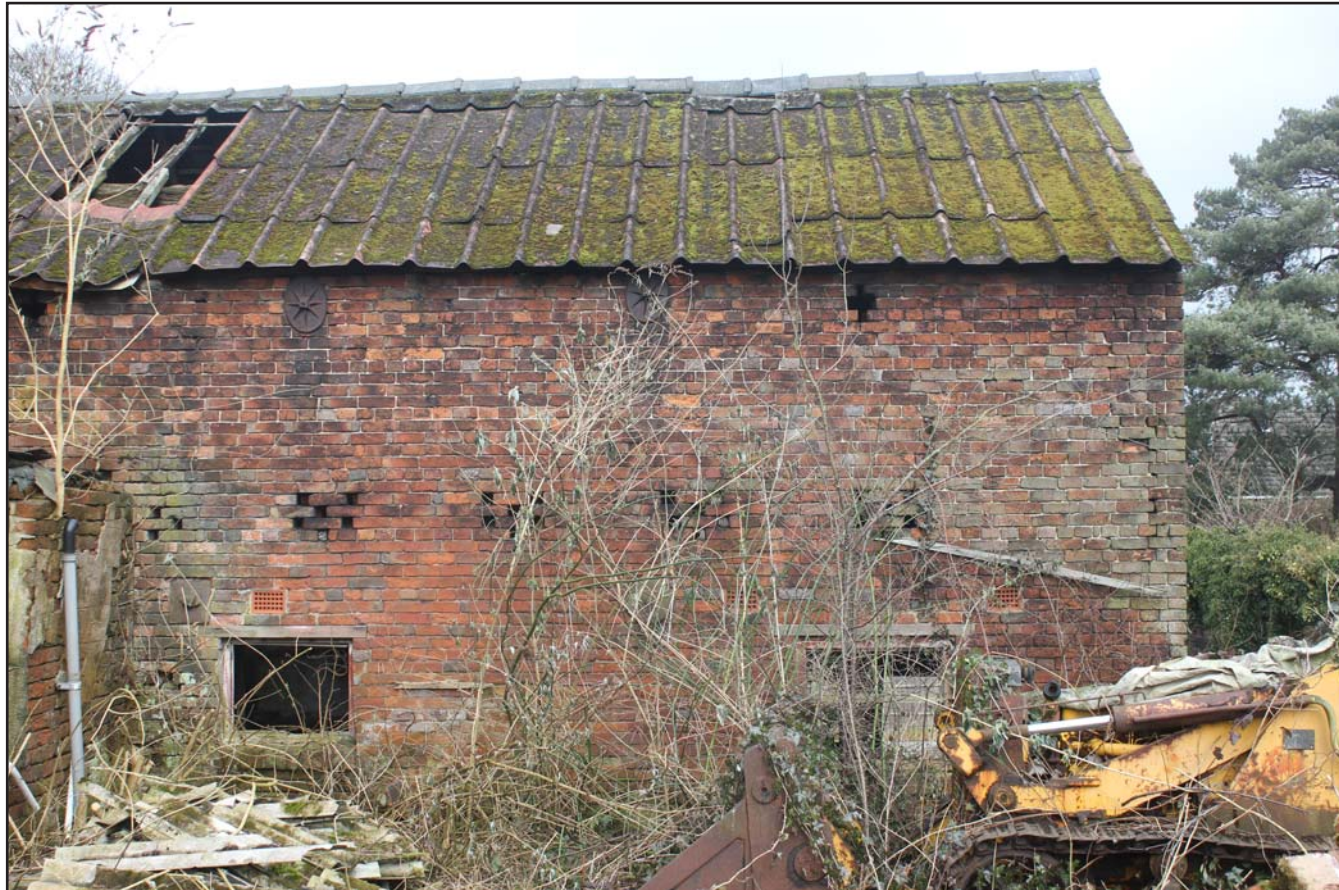
Plate 04: Little Lowe House, Buglawton, Congleton - External shot Farmhouse - Southern elevation of northern range - From the south - no scale

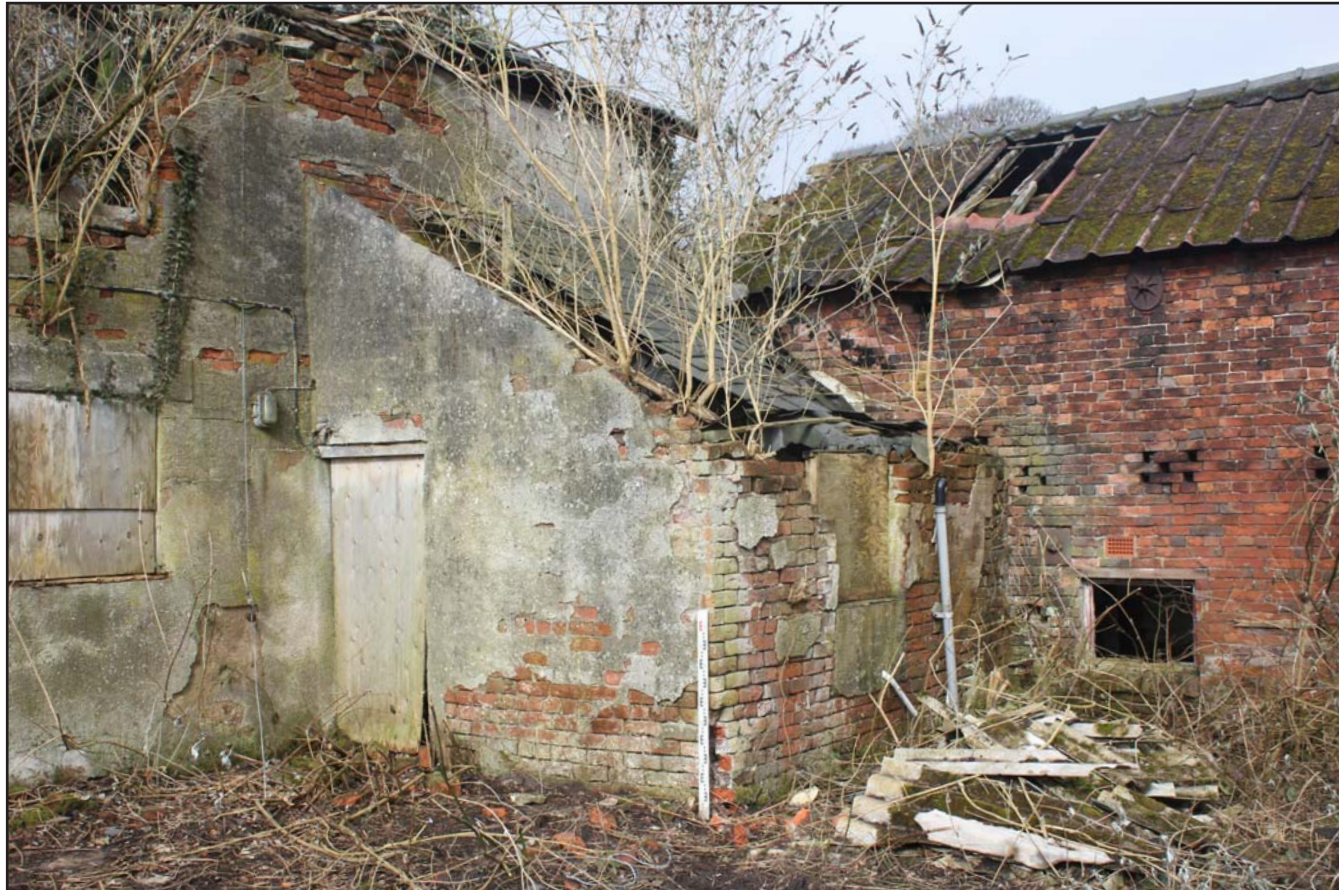
The brick addition is rectangular in plan orientated north to south and is approximately 4m in length by 3m in width. It has a single pitch roof which slopes eastward from the southern range of the farmhouse; this was once roofed with blue grey slates but these have since collapsed inward into the brick addition. The structure is comprised of red-brick bonded by mortar and once appears to have been rendered. On the eastern elevation of the addition there is a single square window opening which is now blocked off with chipboard. On the southern elevation there is a single doorway on the left hand side but this has also been blocked off with chipboard.

Plate 05: Little Lowe House, Buglawton, Congleton - External shot Farmhouse - brick addition situated in cruck of the 'L' - From the southeast - 1m scale

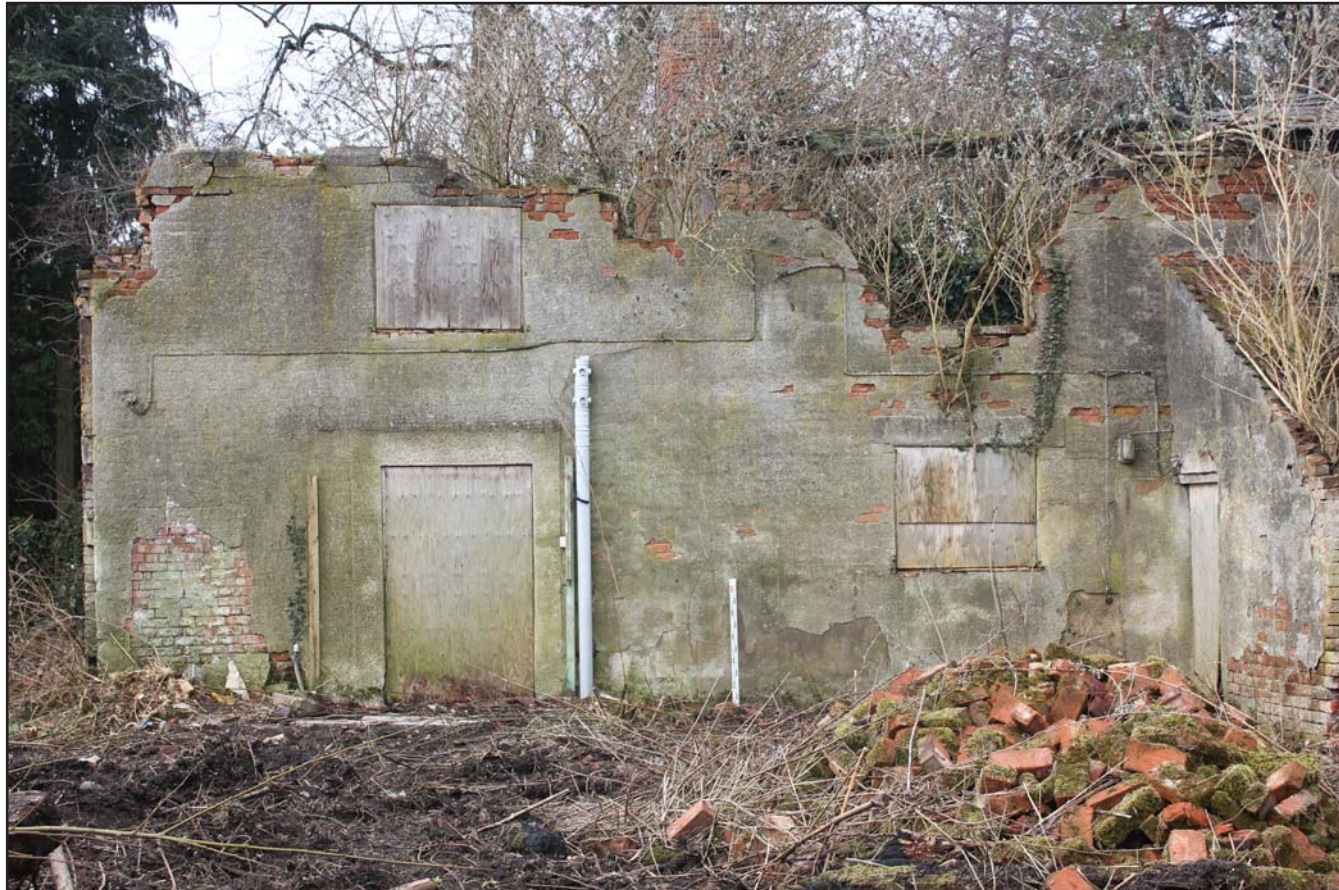
The southern building is in very poor state of repair due to having mostly collapsed during a storm in 2015 and this is evident when viewing the eastern elevation. The roof has predominantly collapsed into the structure, with only a very small amount of blue slate and timber work visible at the northern end. A single chimney stack still stands (in a reasonably good state of repair) and is visible in the centre of the remaining elevation; this has been constructed from red-brick bonded by mortar. The entirety of the southern portion of the southern range has entirely collapsed (at the time of this survey) and the remnants appeared to have been stockpiled over its original footprint (the remaining standing elevation was approximately 13.30m in length). The eastern elevation is constructed of red-brick bonded by mortar but this is still predominantly covered with a coarse render. On the upper floor there appears to have been two rectangular wooden windows; the southern most of which is still visible where the northern window opening has collapsed into the structure. On the ground floor there is another identical rectangular window directly below where the northern upper floor window was and below the southern side upper floor window there is a doorway; all of these openings have been blocked off with chipboard. Apart from this the elevation is featureless.

Plate 06: Little Lowe House, Buglawton, Congleton - External shot Farmhouse - Eastern elevation of southern range - From the east - 1m scale

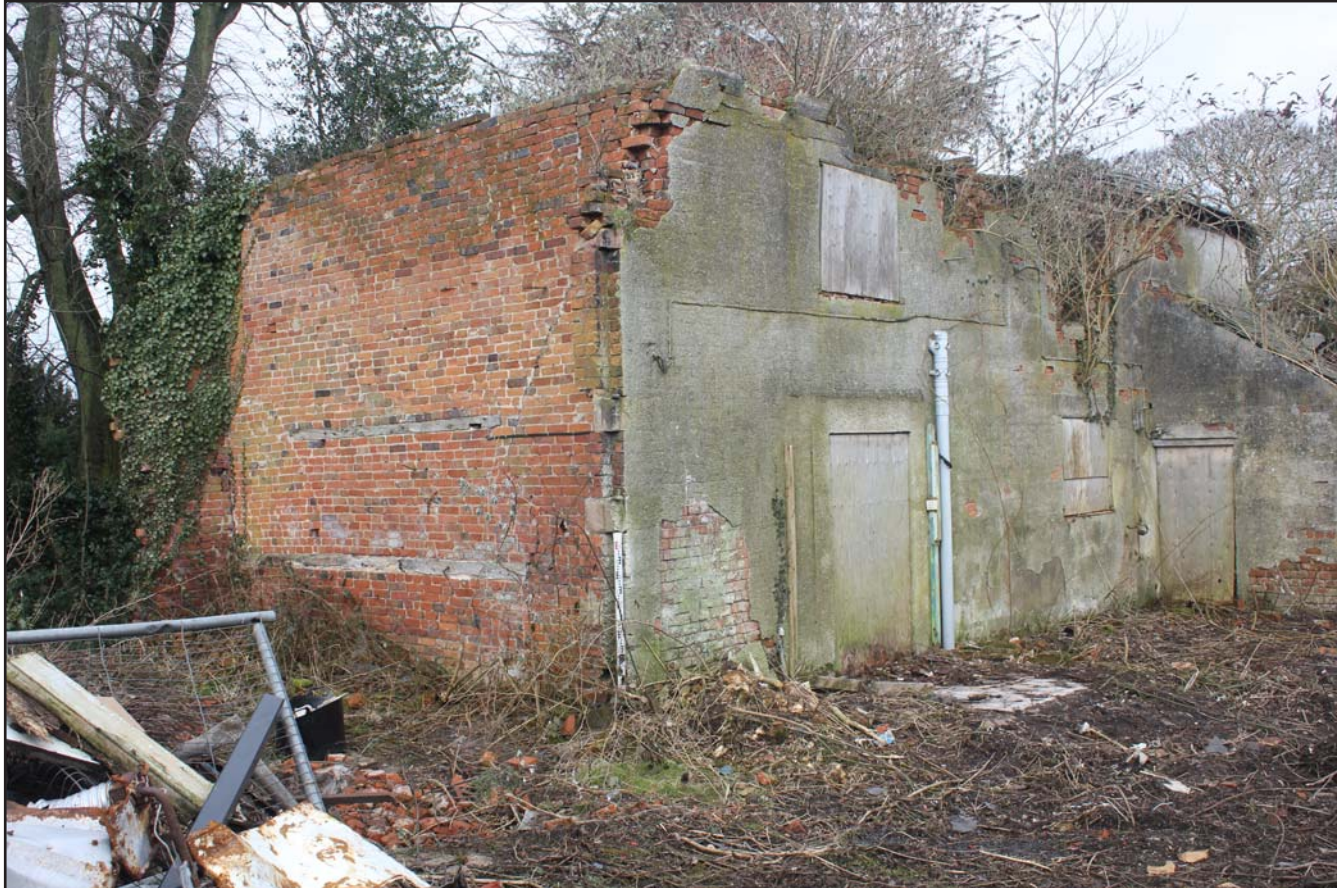
Plate 07: Little Lowe House, Buglawton, Congleton - Oblique shot Farmhouse - Eastern and Southern elevations of southern range - From the southeast - 1m scale

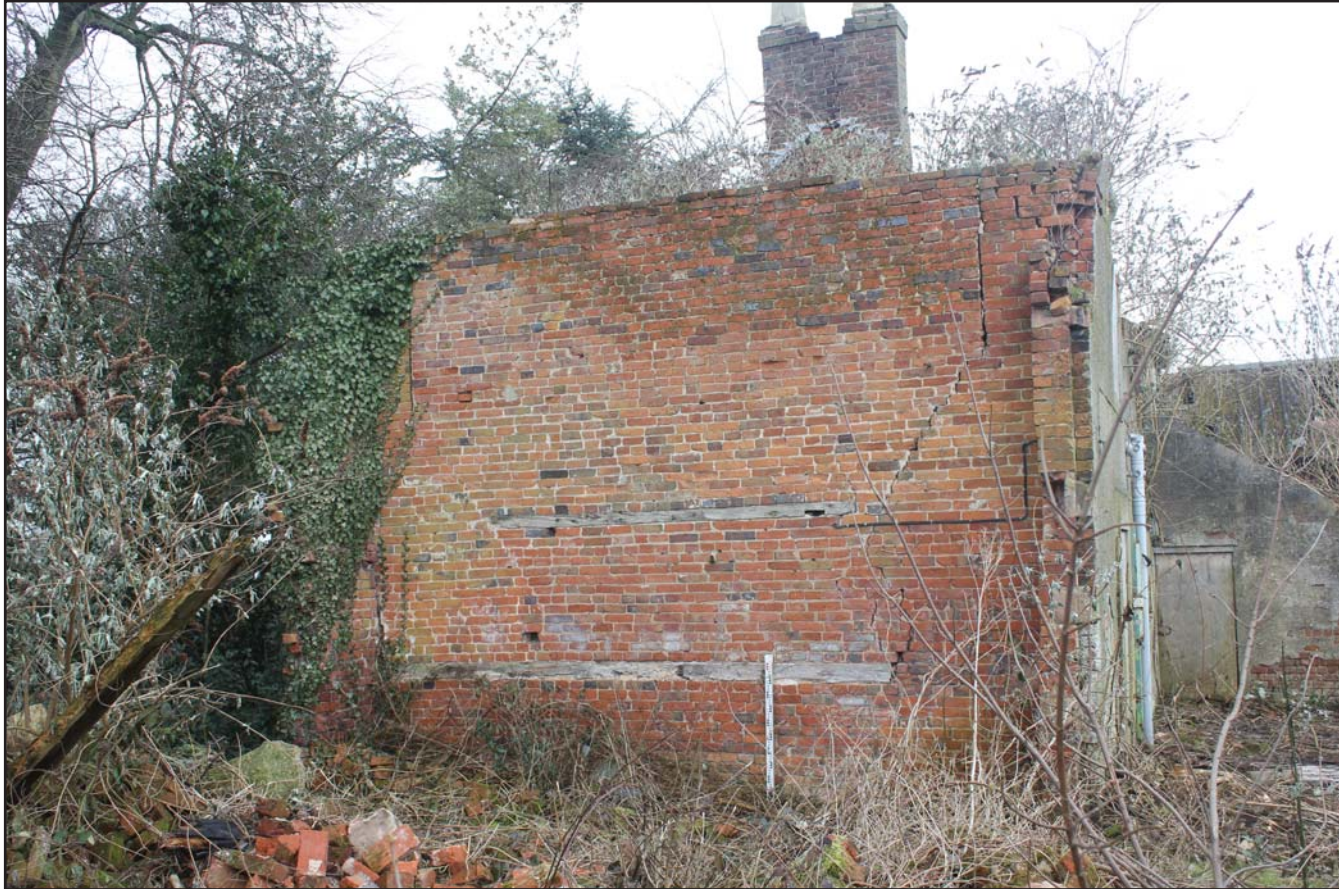
Following the collapse of the southern portion of the building the remaining up-standing elevation measures approximately 6.6m in length. To either side of the interior elevation the original exterior wall is still visible in collapsed spurs which project to the south, these appear to have been constructed from a double course of red-bricks bonded by mortar. The interior wall itself is also comprised of red-brick bonded by mortar. Located both in the centre of the elevation and near the base of the elevation are two horizontal timbers which have metal fittings attached; these may have once been incorporated into the design of the wall in order

to tether animals or hang gates from. Visible on the right hand side of the elevation is a large crack which runs from the top of the elevation to almost the base. Apart from this the elevation is featureless.

Plate 08: Little Lowe House, Buglawton, Congleton - External (internal wall) shot Farmhouse - Southern elevation of southern range - From the south - 1m scale

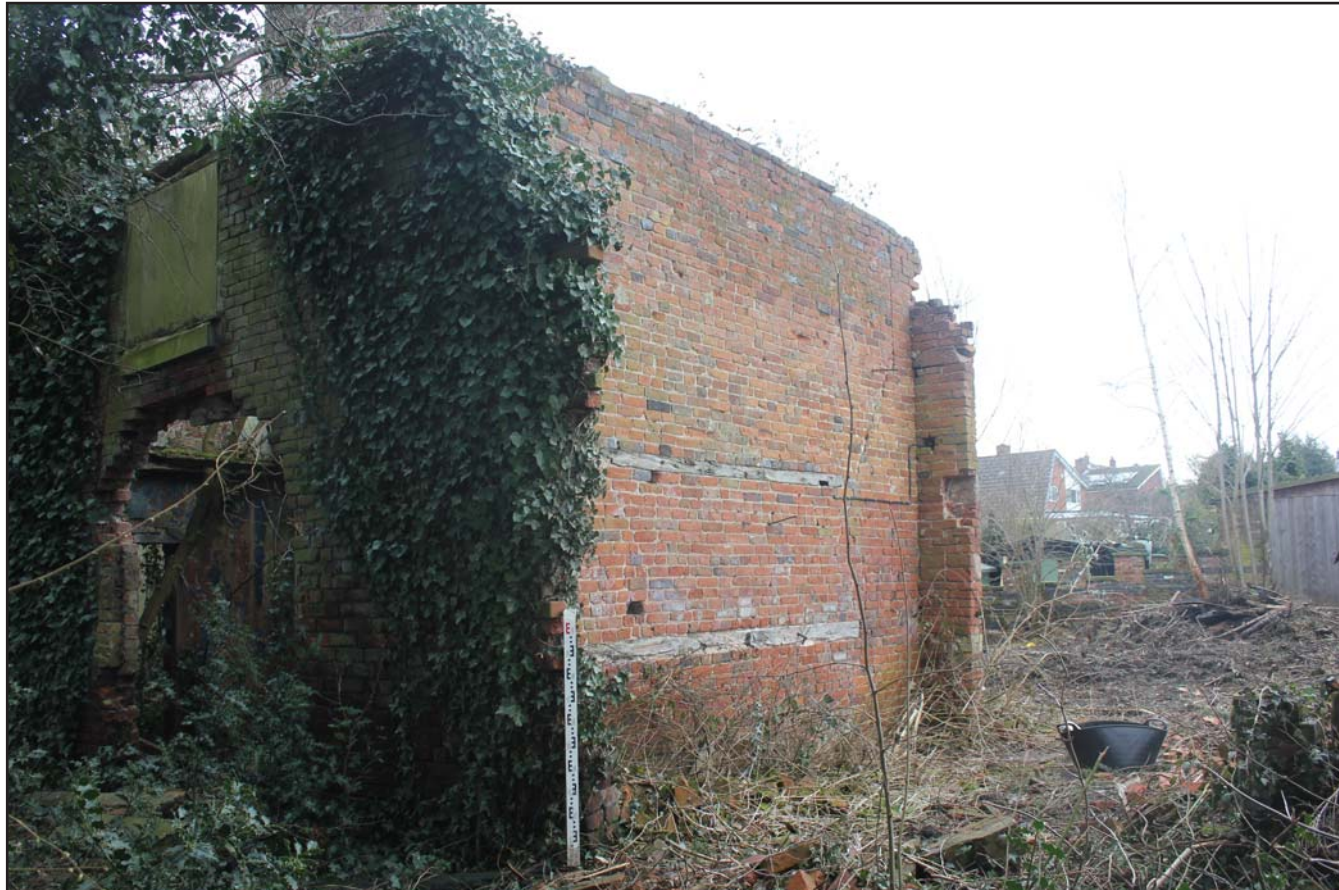
This elevation is the longest surviving elevation still visible of the building and is 13.90m in length. This is also in a very poor state of repair and is probably the most unsafe area on site. From this view the roof is not present. The elevation is comprised of red-brick bonded by mortar once more but this has been obscured by ivy for the most part which has compromised the structure by driving out much of the mortar. The southern end of the elevation is dominated by a large opening which may once have been an archway, possibly with a segmental brick or stone archway, however this is no longer present and the elevation in this area appears structurally unsound. Directly above this large opening there was once a square window with a dressed stone windowsill, but this has since been blocked up with chipboard. In the central portion of the elevation two windows are visible. The upper floor window appears identical to that found to the south above the archway, however the ground floor window is much wider (double the size of the one above). These windows have concrete lintels but have been blocked up with chipboard. To the left of the larger ground floor window there appears to have once been a doorway however this has since been bricked up. To the immediate left of this bricked up doorway there is another small rectangular window; this appears to have been a tertiary phase as part of a larger window which has since been bricked up. Below this window there is a dual course of large square dressed stone blocks; situated just above ground level, below which there is an opening which presumably leads to a cellar below. The cellar is currently full of debris and is located in a very unstable section of wall; however it is reasonable this may once have been a coal chute or access chute for storage in the cellar. To the left of this the elevation continues with a substantial (2/3m) of red brick bonded by mortar wall, however this part of the elevation has collapsed at the northern end. This part of the elevation has been partially rendered and attached to this render are cast iron water troughs presumably used to water animal stock on the farm. Apart from this elevation is featureless.

Plate 09: Little Lowe House, Buglawton, Congleton - Oblique shot Farmhouse - Western and Southern elevations of southern range - From the southwest - 1m scale

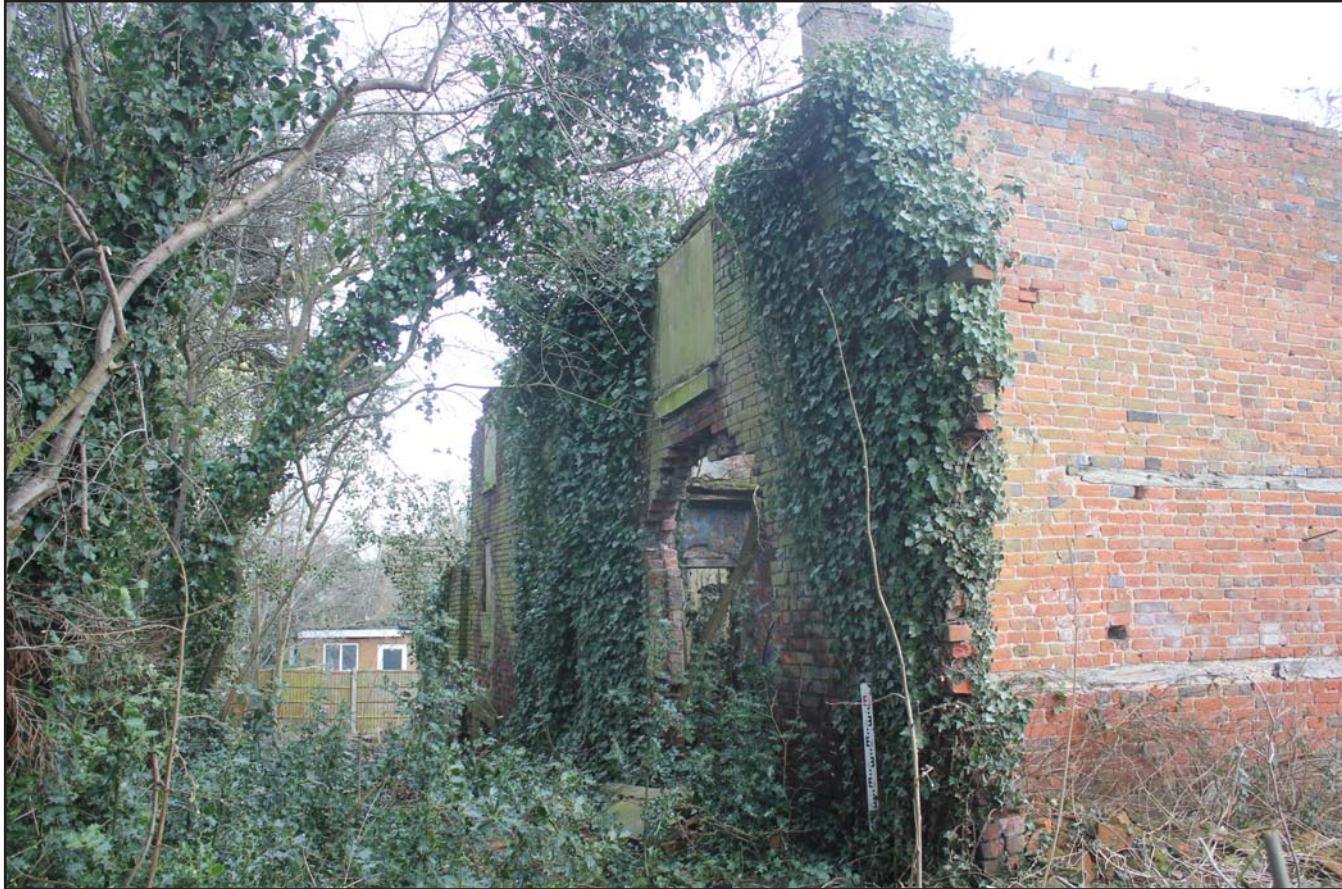
Plate 10: Little Lowe House, Buglawton, Congleton - External shot Farmhouse - Northern elevation of southern range - From the southwest - 1m scale

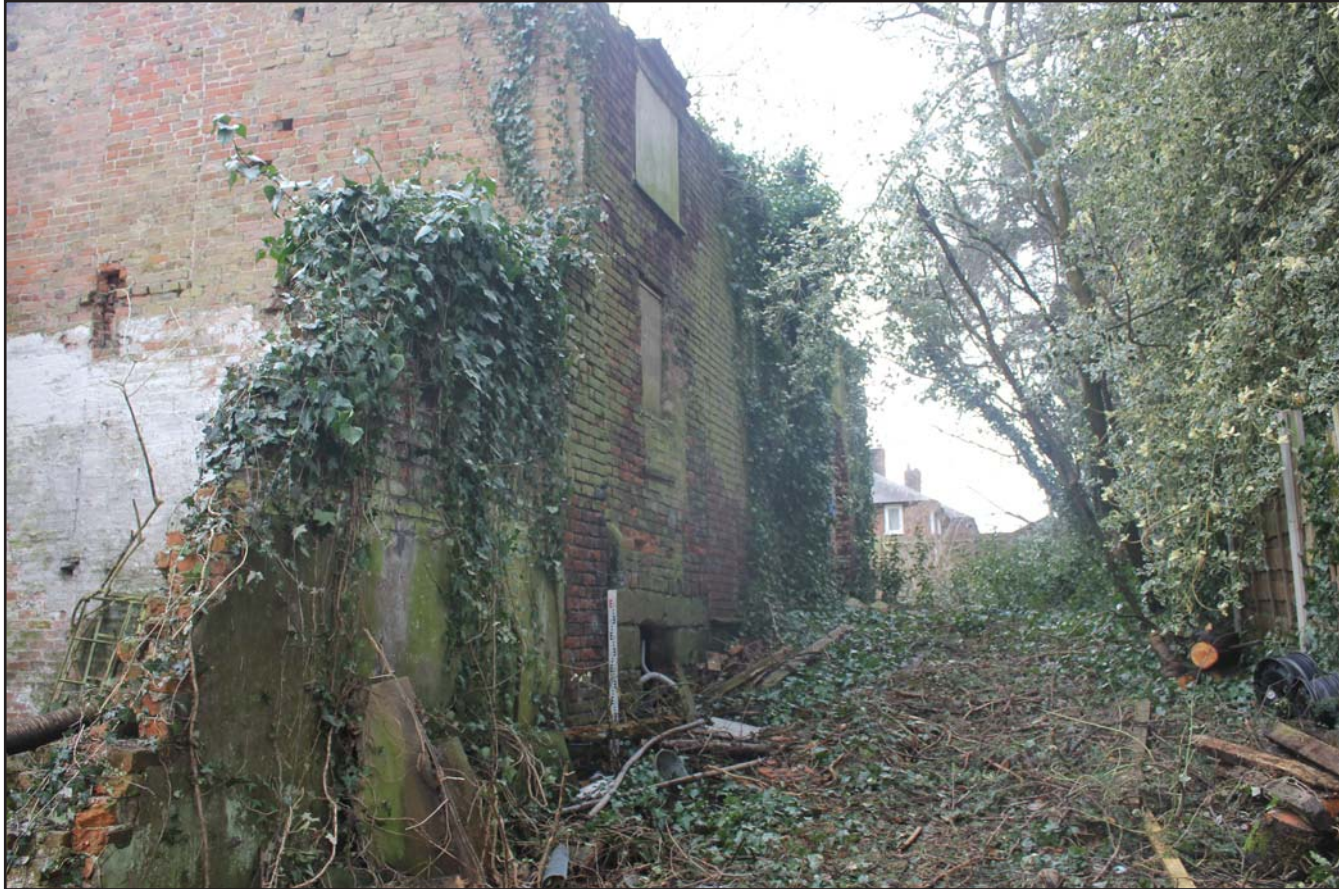
Plate 11: Little Lowe House, Buglawton, Congleton - External shot Farmhouse - Northern elevation of southern range - From the northwest - 1m scale

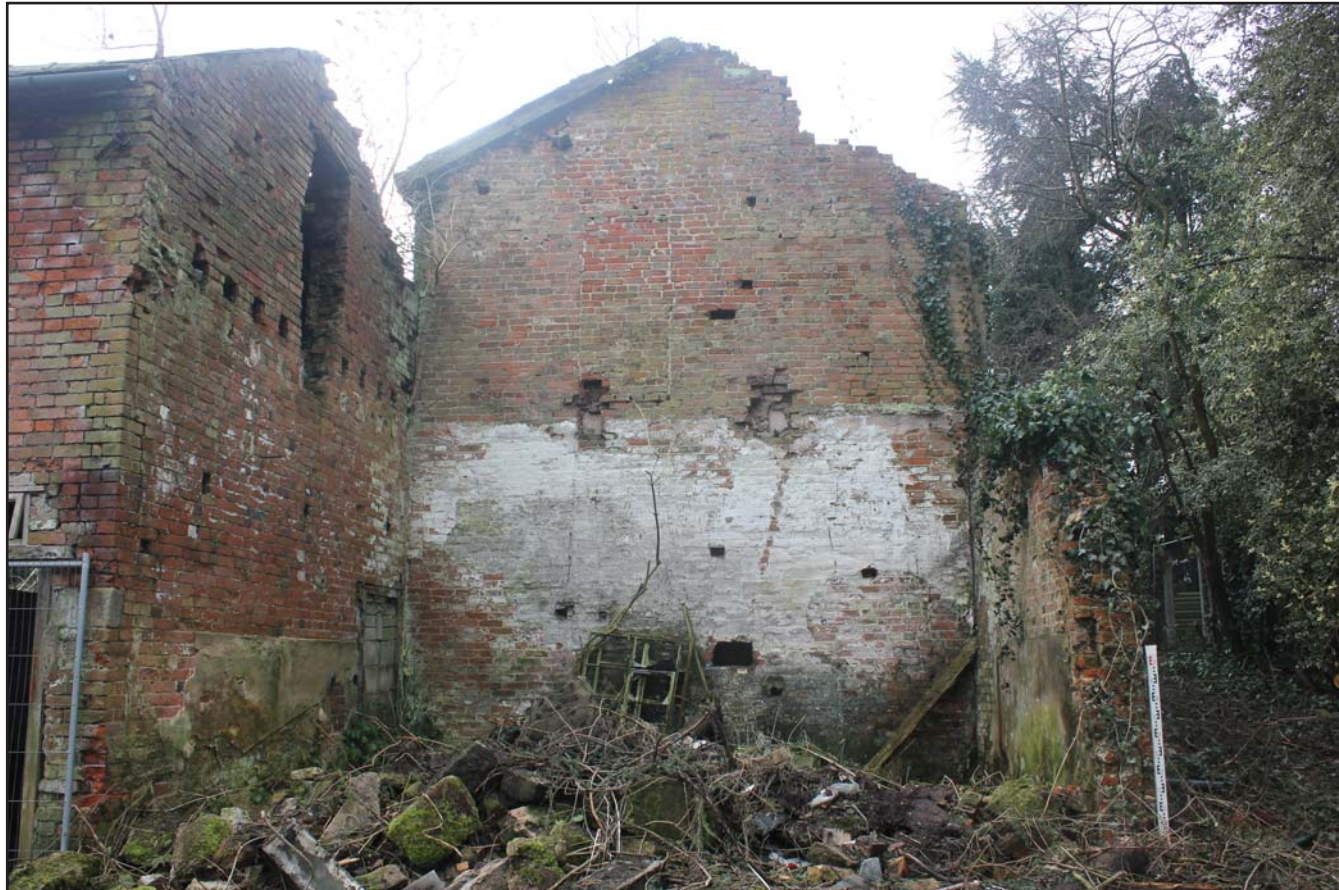
Plate 12: Little Lowe House, Buglawton, Congleton - External (internal wall) shot Farmhouse - Northern elevation of southern range - From the north - 1m scale

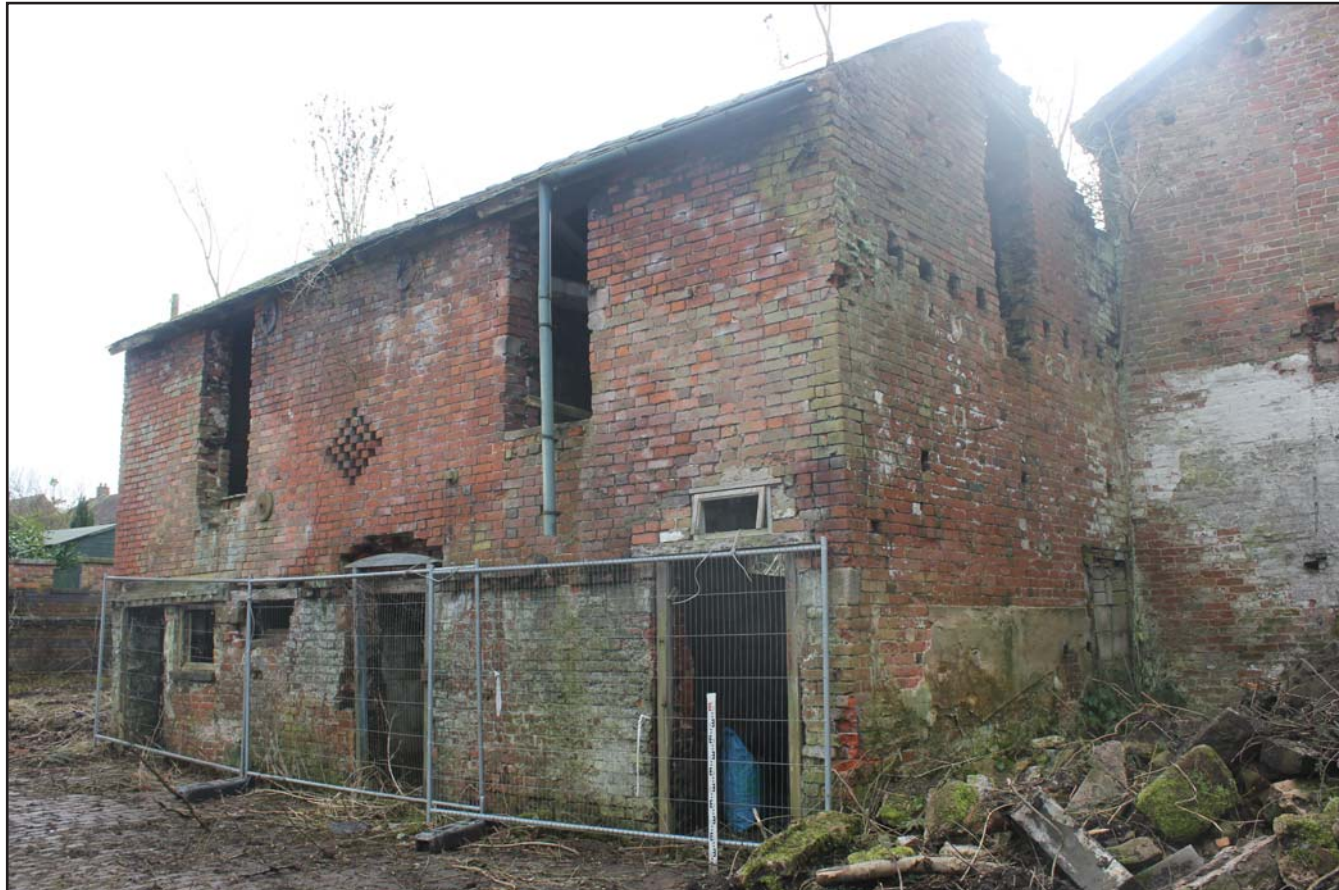
Plate 13: Little Lowe House, Buglawton, Congleton - Oblique shot Farmhouse - Northern and western elevations of northern range - From the northwest - 1m scale

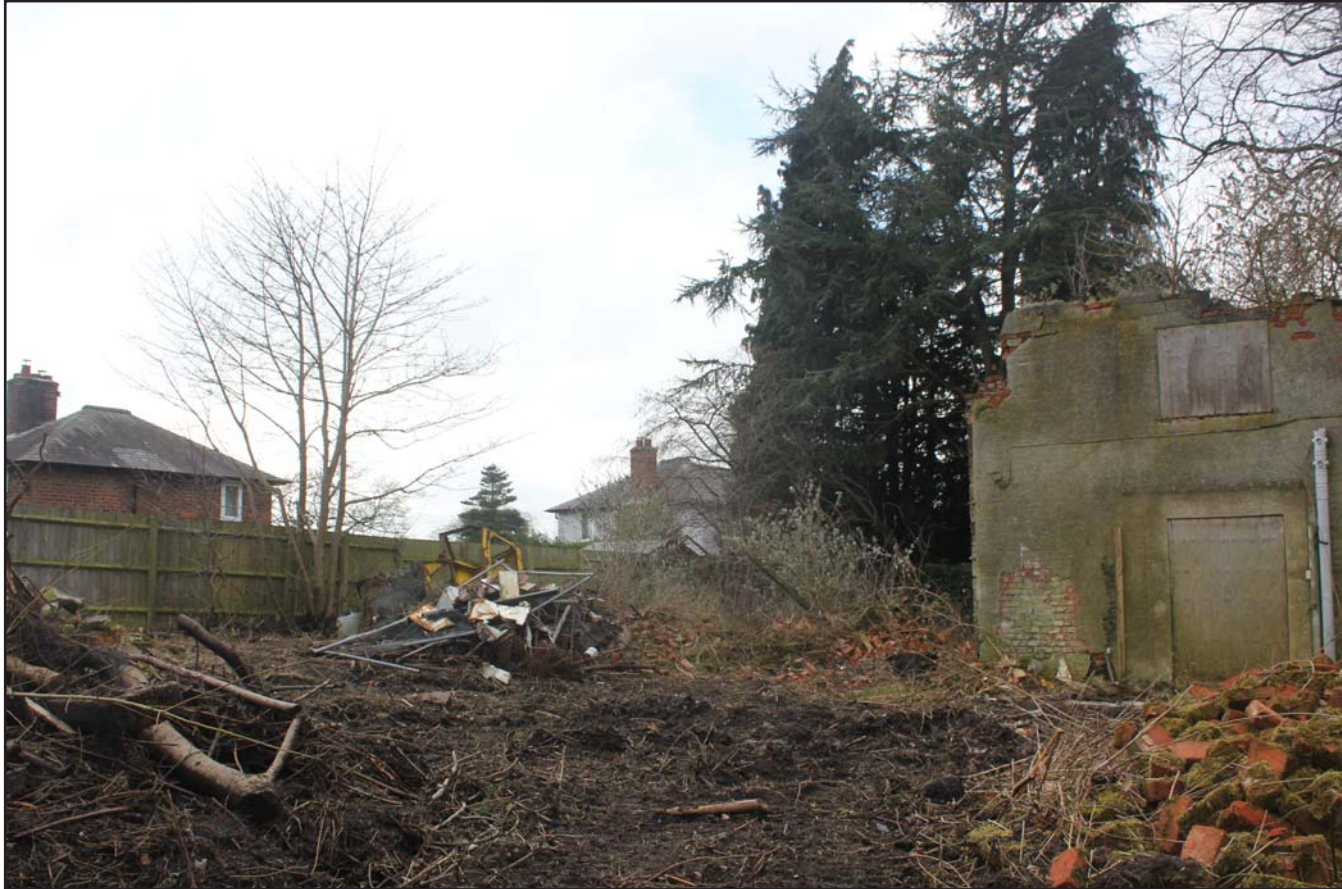
Plate 14: Little Lowe House, Buglawton, Congleton - External shot Farmhouse - Collapsed southern portion of southern range - From the northeast - 1m scale

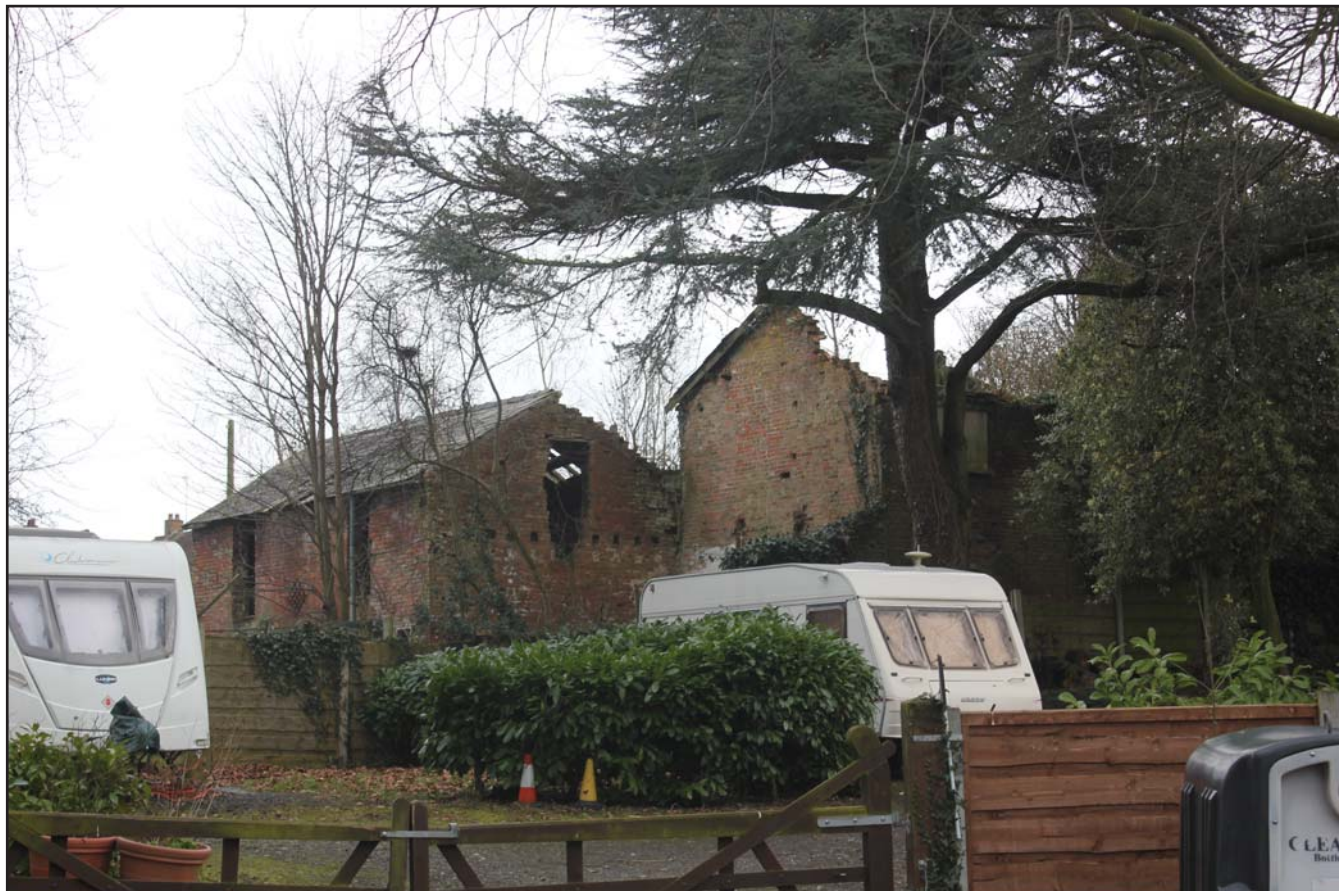
Plate 15b: Little Lowe House, Buglawton, Congleton - External shot Farmhouse - Northern and western elevations of northern range -
From the northwest - no scale

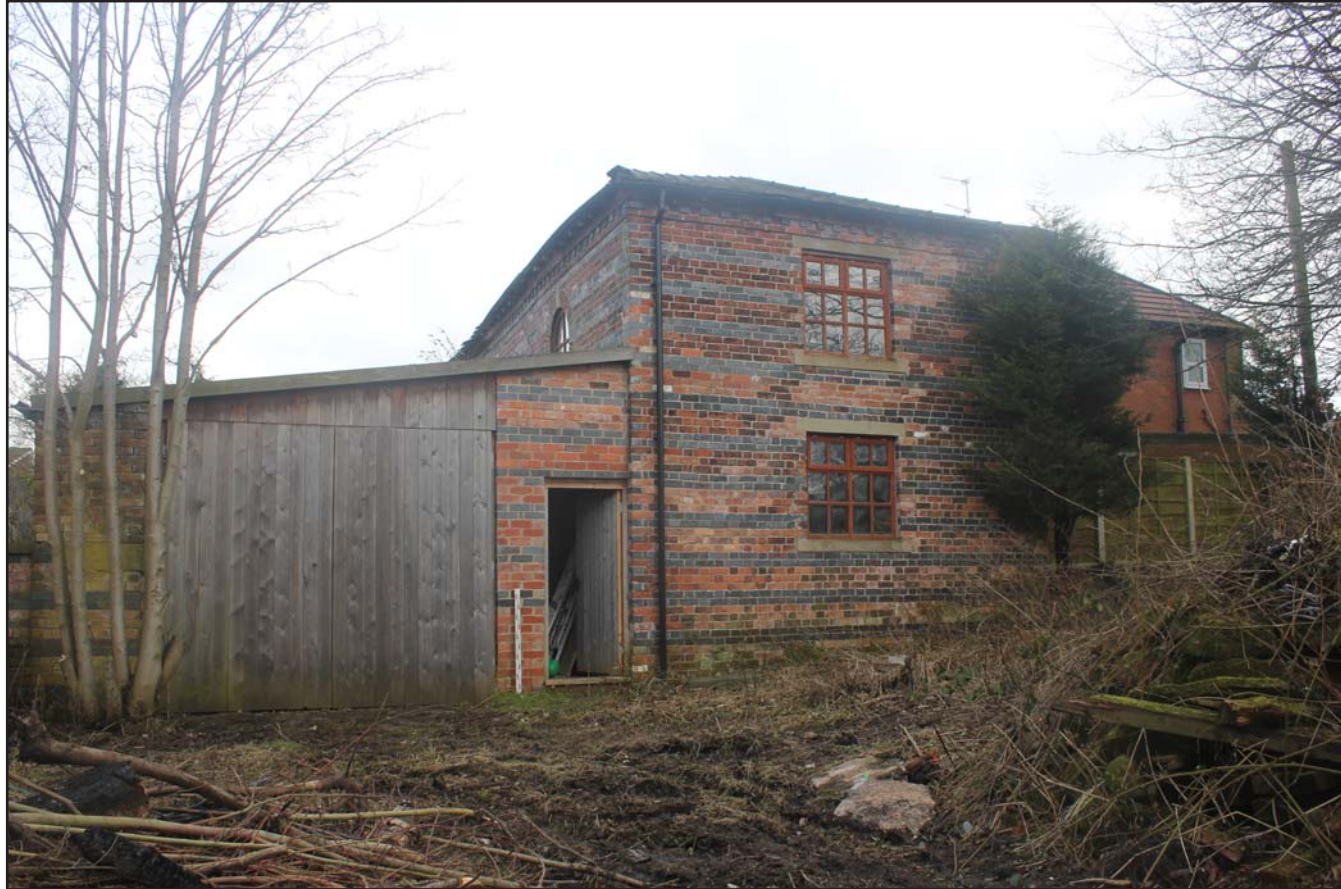
The workshop is rectangular in plan, orientated east to west and measures 14.20m long by 11.20m wide, furthermore all of its elevations (except for the western wall) form the boundary of the site. The western elevation of the workshop is comprised from red and blue brick bonded by mortar. The roof is of a hipped construction forming a quadruple pitch; the pitch visible from this elevation slopes west and is comprised of grey-blue slates and grey-blue ridge tiles. The northern end of the elevation is much lower in profile than the southern end and this is presumably because this was once an exterior yard that was subsequently converted into an interior space by the addition of brick walls and a metal sheet roof. The southern portion of the building is dual-story and appears to be the primary elevation, with the left-hand side representing a secondary brick addition to the original building. The left-hand side of the elevation is dominated by a large timber garage door, to the right of this there is a single doorway which permits access to Room E. The right-hand side of the elevation has two identical timber framed windows on the ground floor and on the upper floor; these are comprised of 12 glass window panes and have concrete lintels and windowsills. There is a pattern within the brickwork which follows a design correlating to two courses of red bricks followed by two courses blue brick, creating a horizontal stripe pattern on this elevation.

Plate 16: Little Lowe House, Buglawton, Congleton - External shot Barn - Western elevation - From the west - 1m scale
