**80, Buxton Road, Congleton,
CW12 2DY.**

Historic Building Record Level 2
Project Code: A0154.1
Report no. 0161

Historic Building Record Level 2

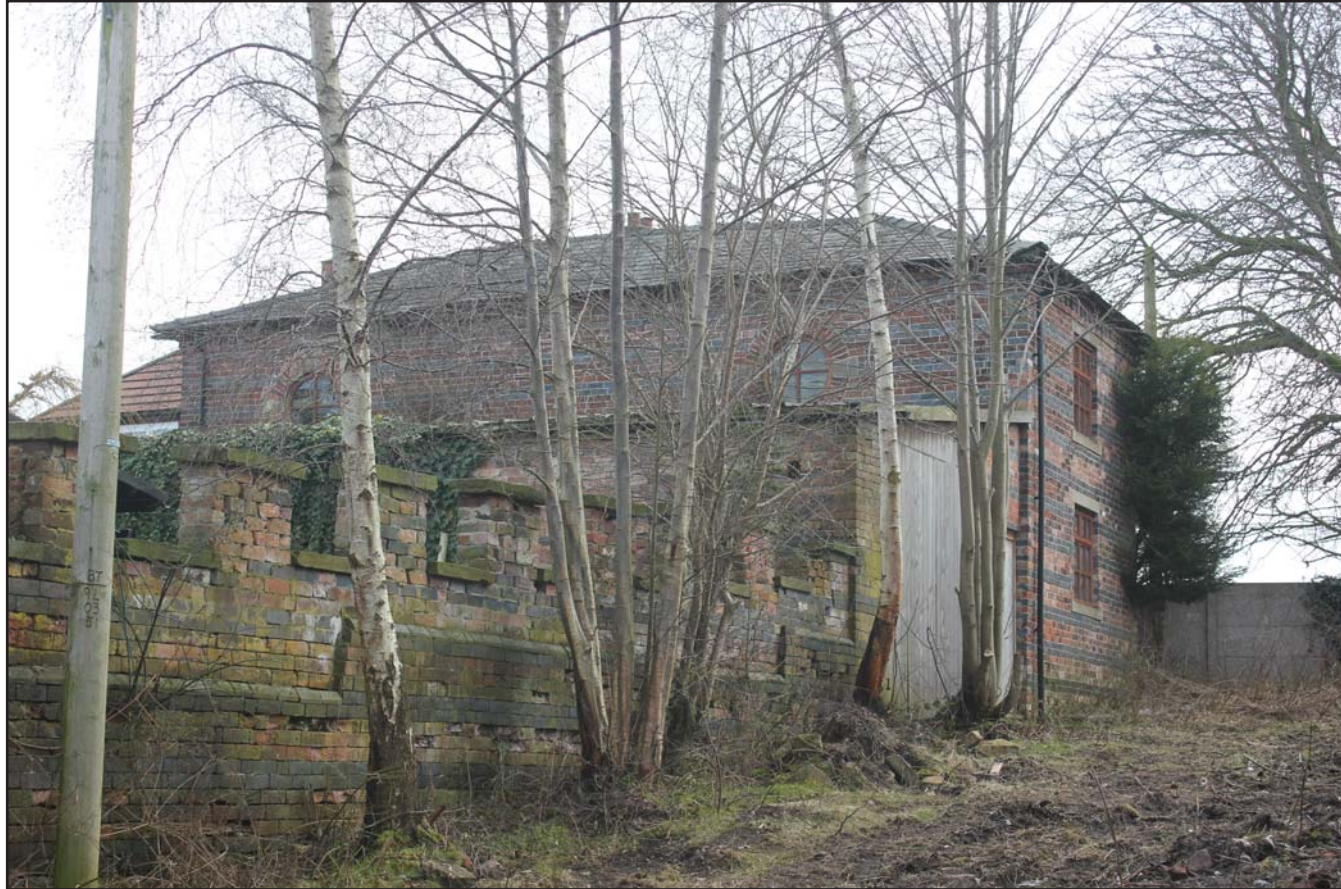
Plate 17: Little Lowe House, Buglawton, Congleton - Oblique shot Barn - Northern and western elevations - From the northwest - 1m scale

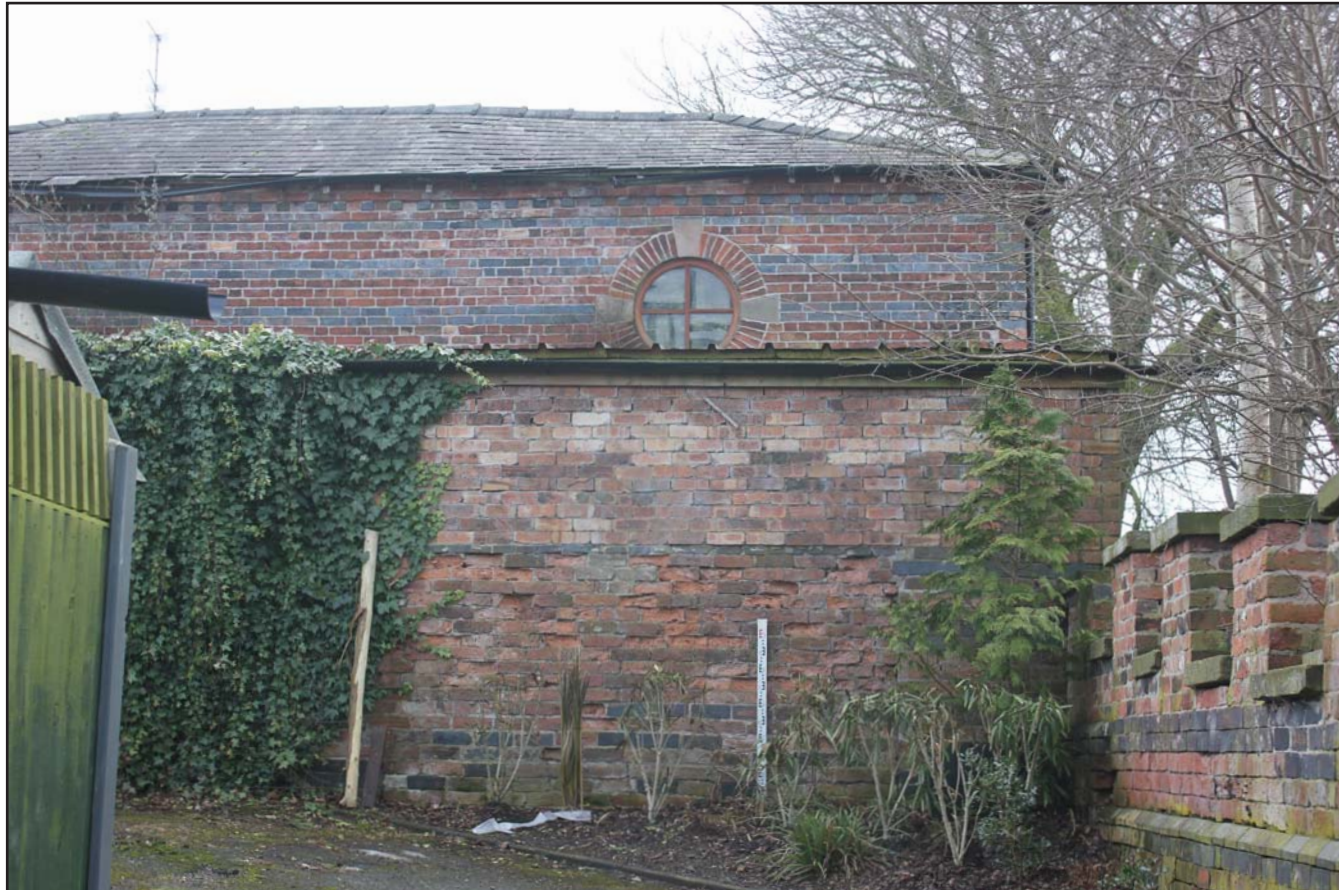
Plate 19: Little Lowe House, Buglawton, Congleton - Oblique shot Barn - Northern and eastern elevations - From the northeast - no scale

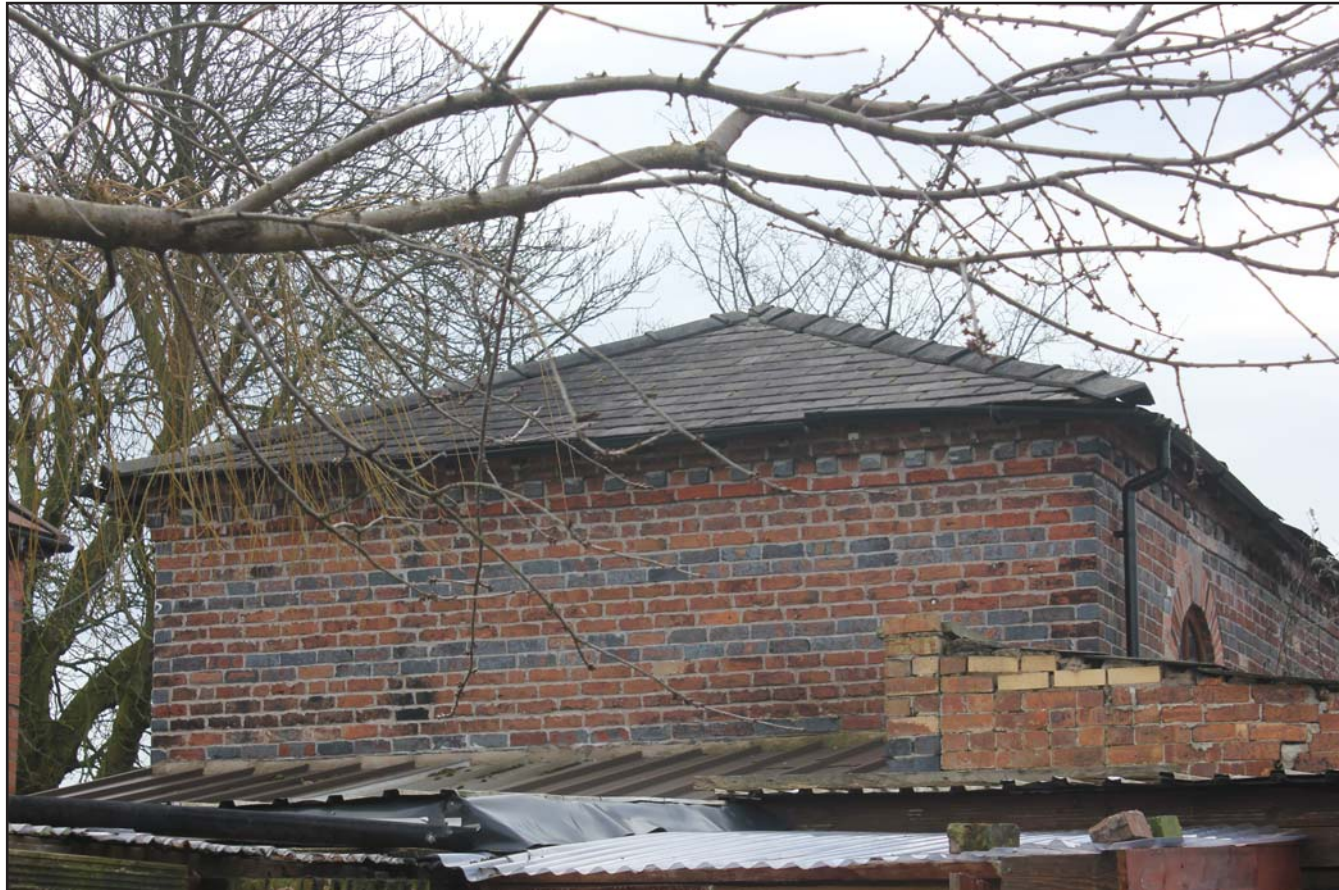
Plate 20: Little Lowe House, Buglawton, Congleton - External shot Barn - Eastern elevation - From the east - no scale

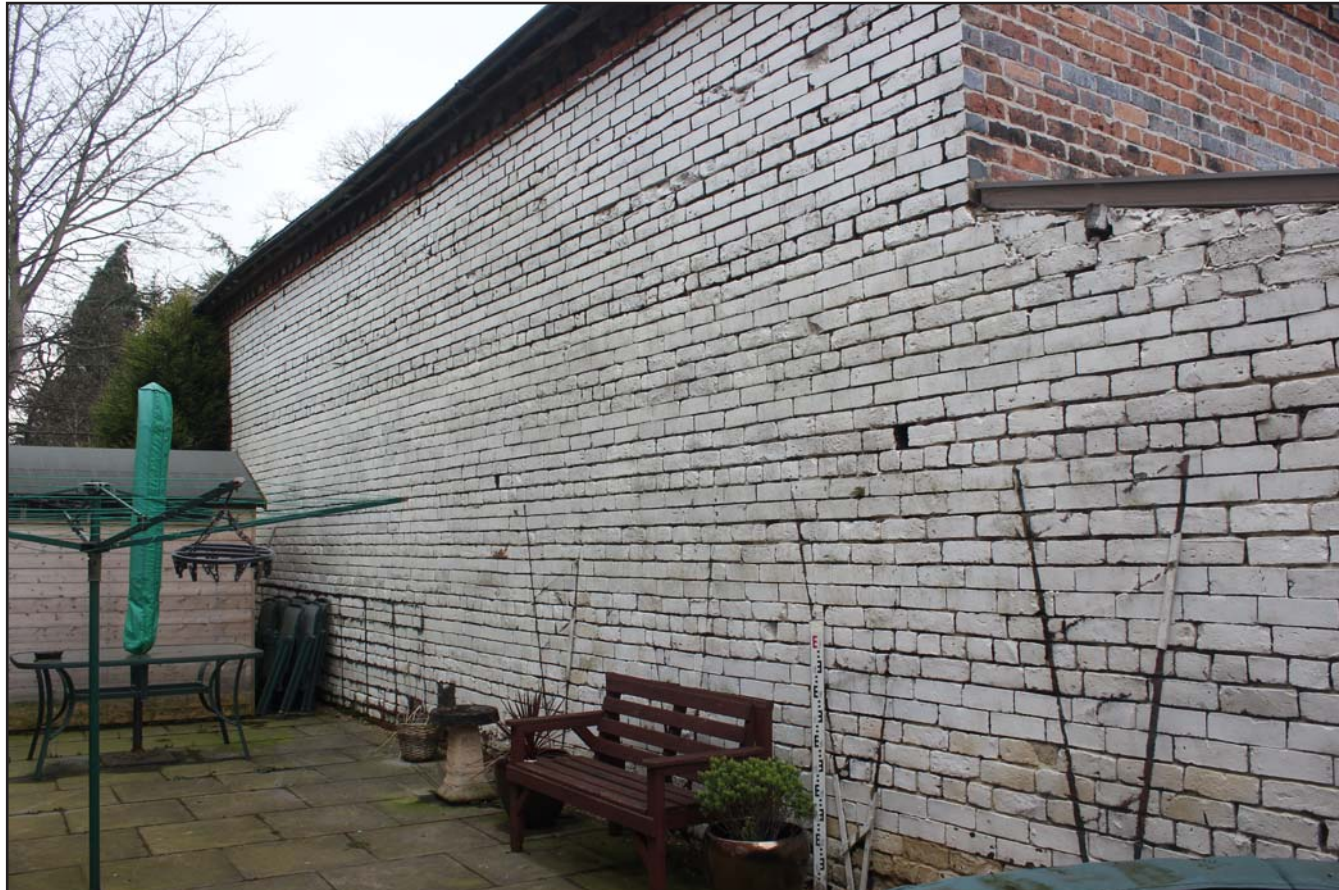
Plate 21: Little Lowe House, Buglawton, Congleton - External shot Barn - southern elevation - From the southeast - 1m scale

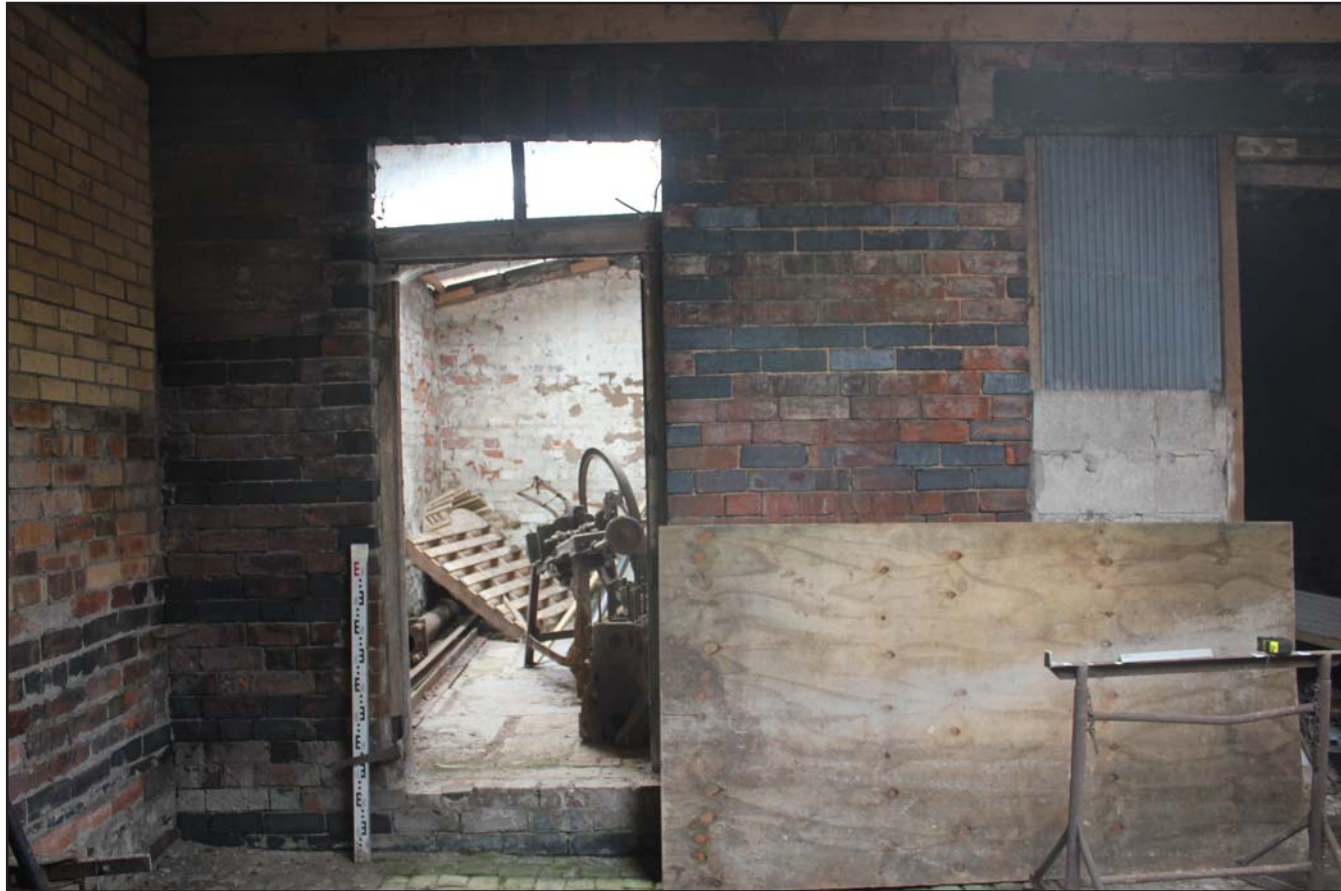
Plate 22: Little Lowe House, Buglawton, Congleton - Internal shot Barn - Door to Room A - From the north - 1m scale

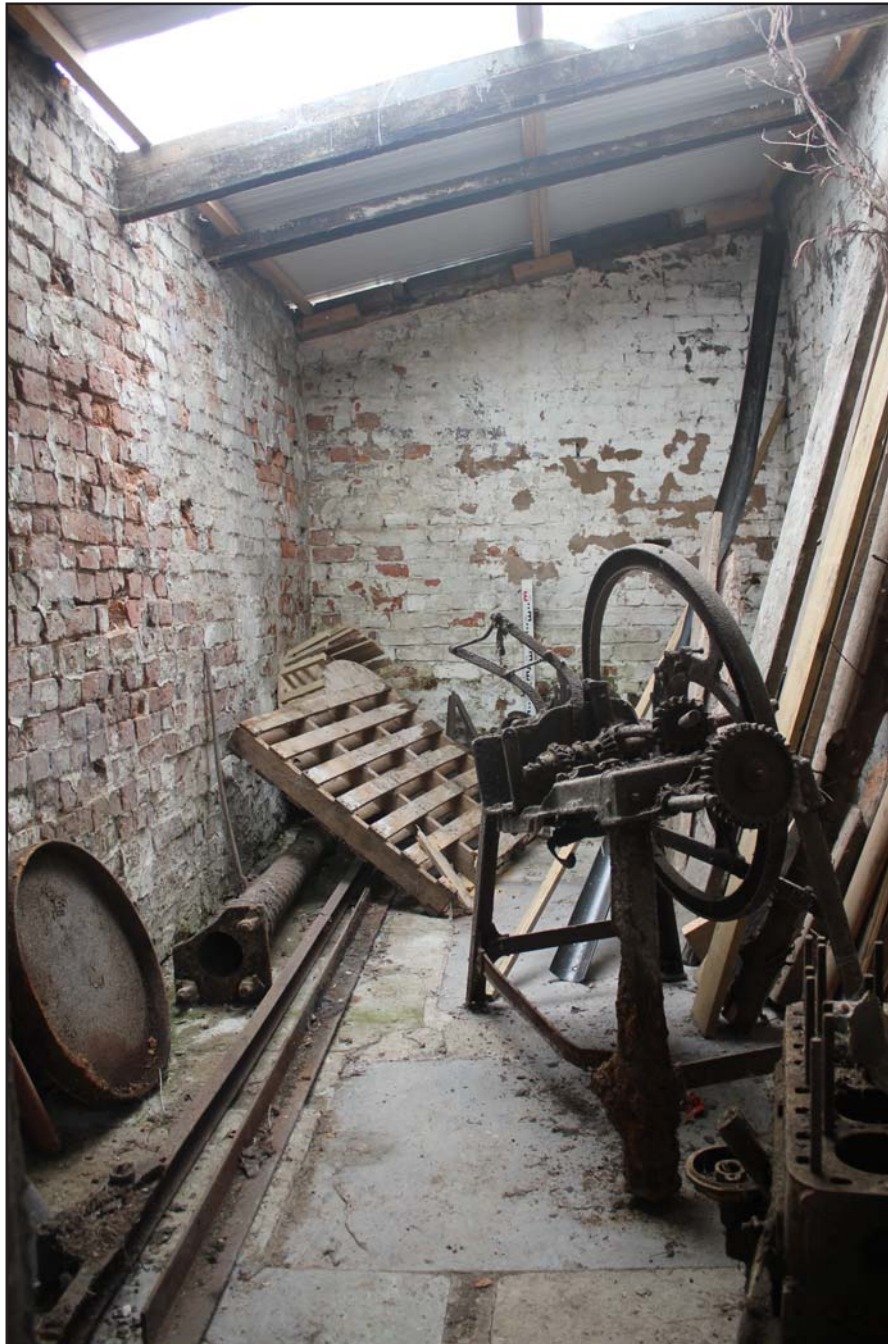
This room is rectangular in plan, orientated north to south and measures 5.10m long by 2.45m wide. The ceiling is comprised of a shallow single pitch roof with wooden rafters supporting modern metal plastic sheeting. All four of room A's elevations are constructed from red-brick bonded by mortar and subsequently painted white, although most of the paint on the eastern elevation has since flaked away. Also on the eastern elevation there was a doorway which has since been blocked off with modern yellow brick and breeze blocks bonded by mortar. The northern elevation has a single doorway with a timber frame which permits access to room E. The floor is comprised from cut stone flags. The room is currently used as a storage area.

Plate 23: Little Lowe House, Buglawton, Congleton - Internal shot Barn - Room A - From the north - 1m scale

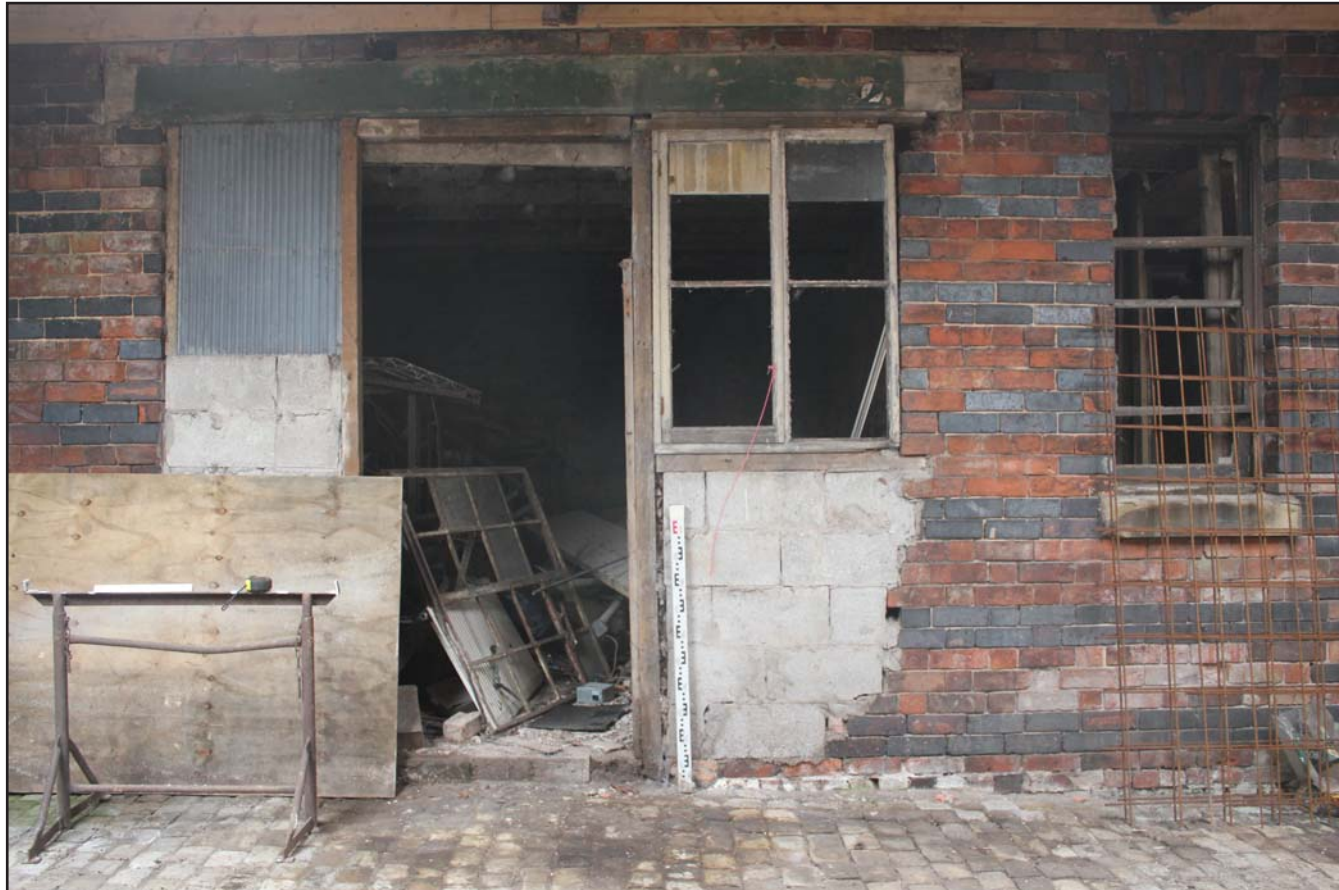
Plate 24: Little Lowe House, Buglawton, Congleton - Internal shot Barn - Room B - From the north - 1m scale

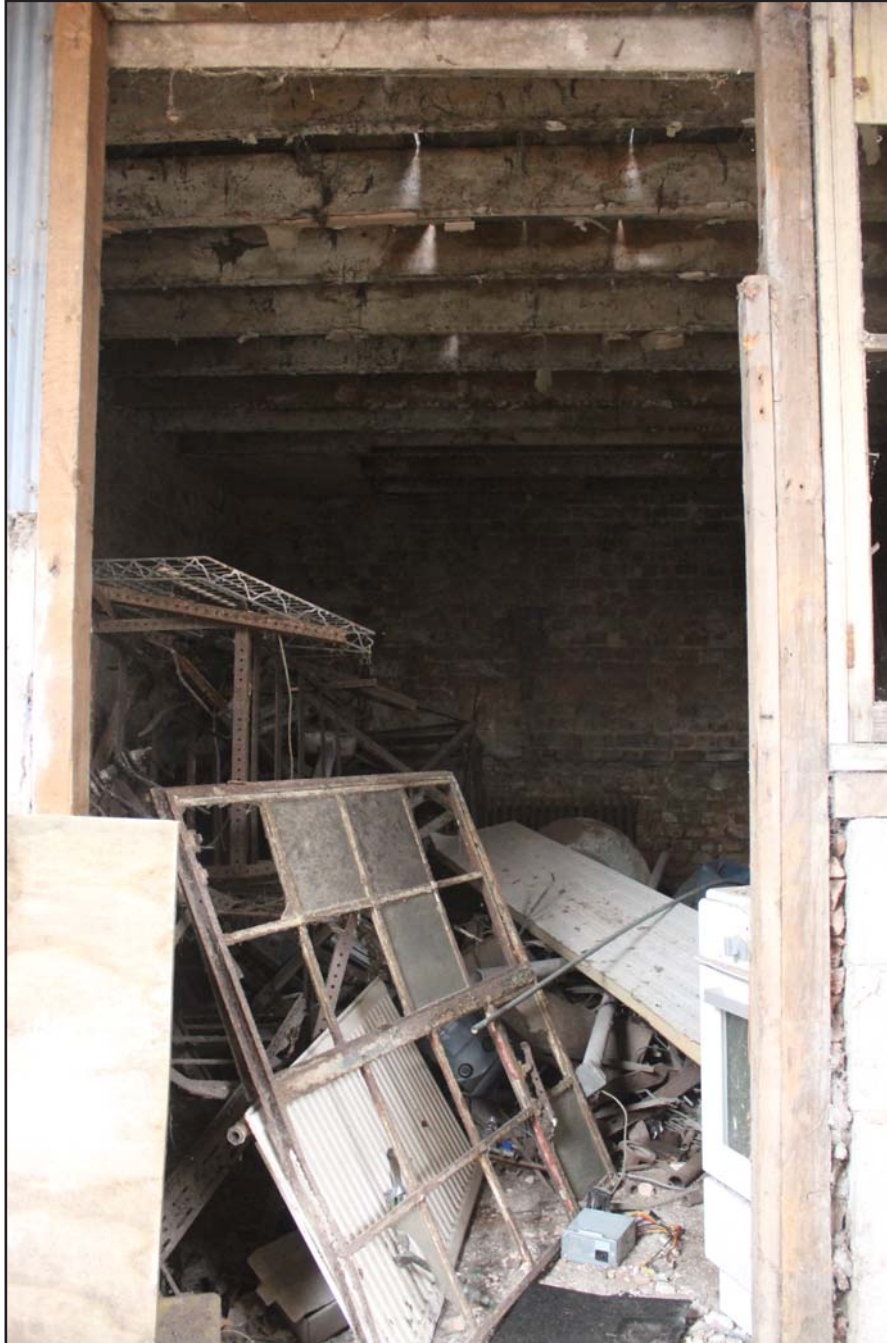
This room is rectangular in plan, orientated north to south and measures 5.10m long by 3.80m wide. The ceiling is of exposed sawn wooden beams and the floorboards from the storey above are visible. This room was entirely full of debris and as such was inaccessible. The walls comprise of red-brick bonded by mortar. The floor was obscured by debris however it may be comprised of stone flags. The room is currently used as a store for refuse.

Plate 25: Little Lowe House, Buglawton, Congleton - Internal shot Barn - Room B - From the north - 1m scale

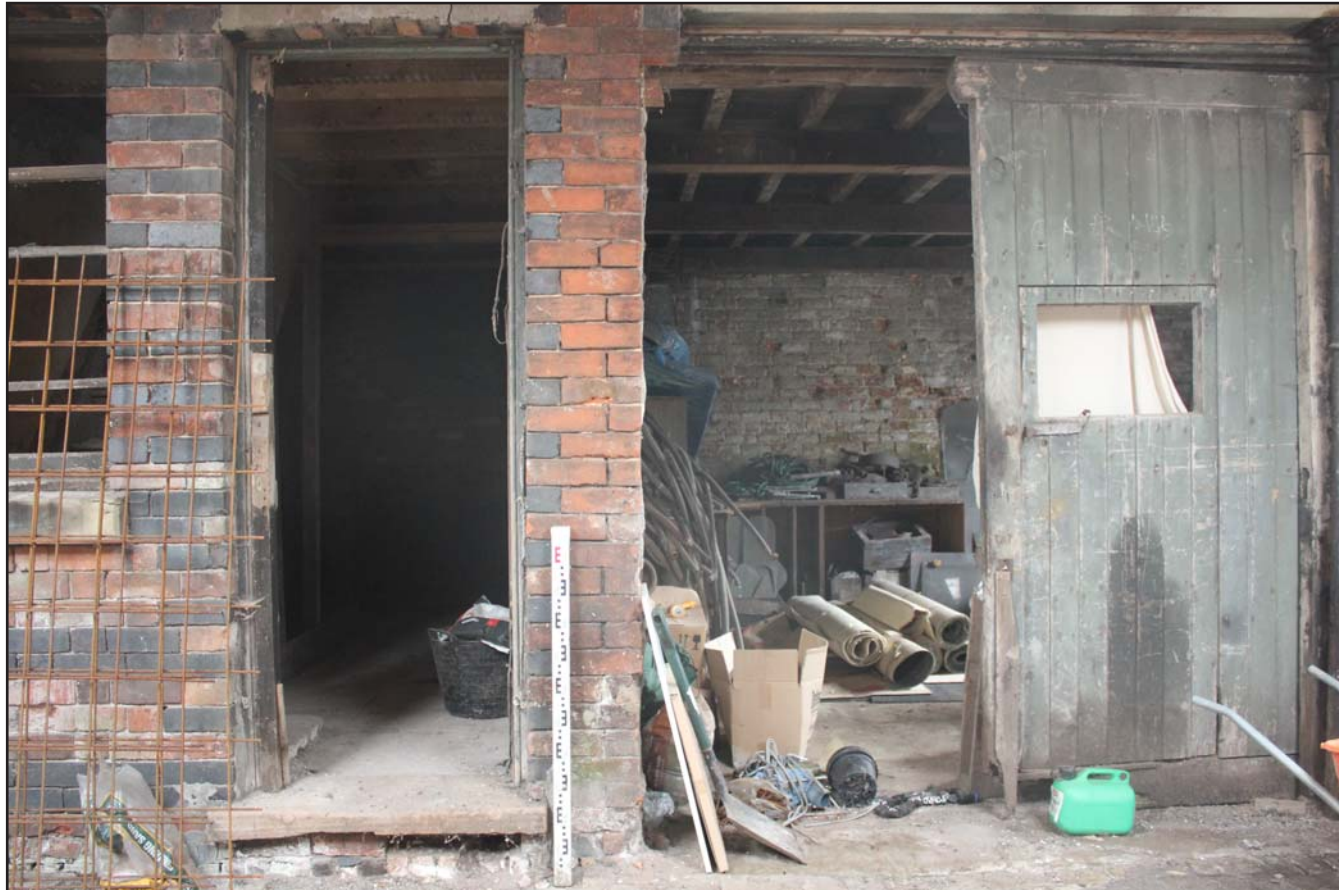
Plate 26: Little Lowe House, Buglawton, Congleton - Internal shot Barn - Door to Rooms C & D - From the north - 1m scale

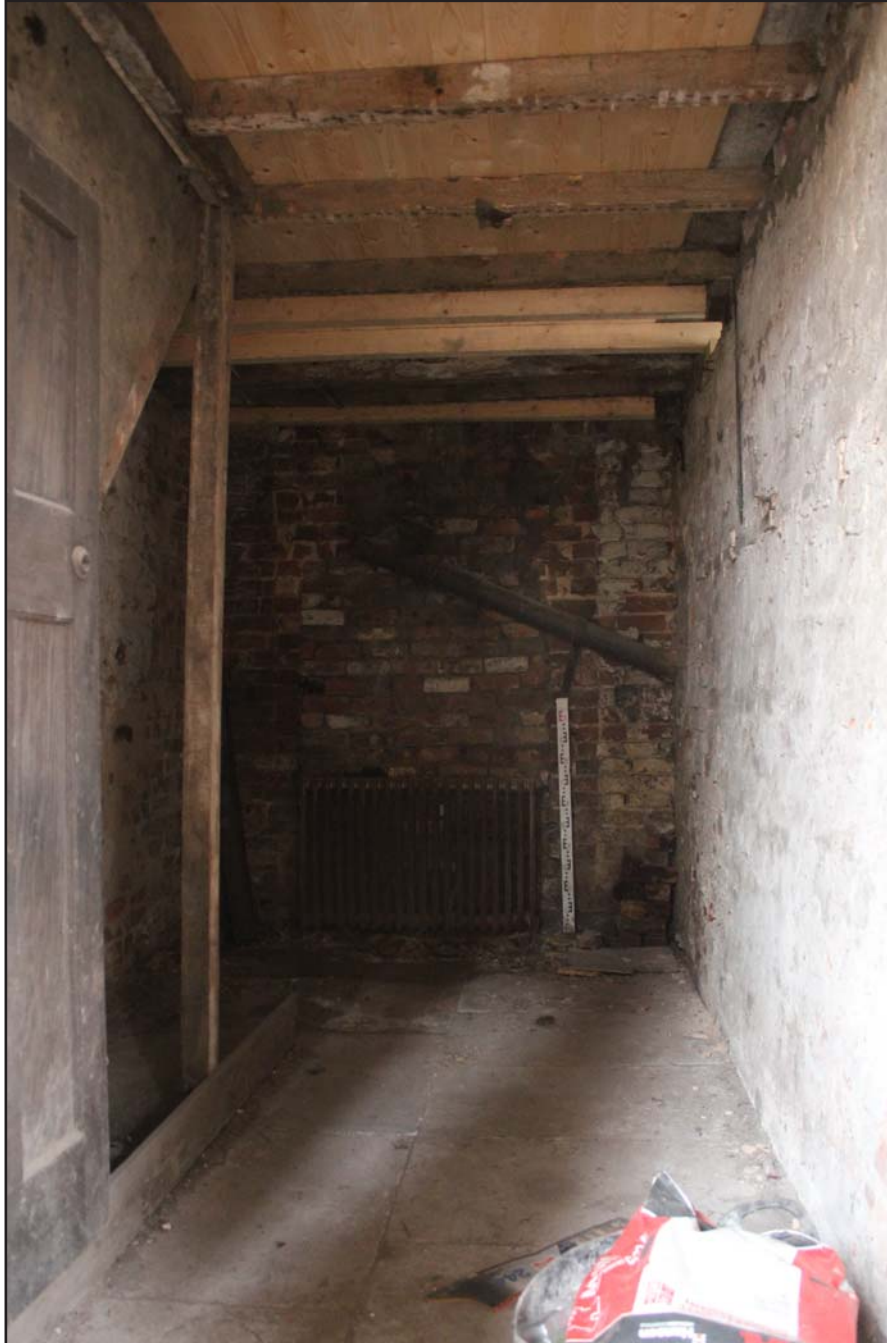
Room C is rectangular, orientated north to south and measures 5.10m long by 2.30m wide. The ceiling is comprised of wooden floor joists which support a wooden floor above. Just inside the door on the left there is a wooden built staircase which leads to the upper floor. The walls are all comprised of red-brick bonded by mortar and have been painted white although most of this painted since flaked away. The southern elevation has a single green-painted cast-iron radiator located on the central portion of the wall. The northern elevation has a single doorway on the left hand side which permits access to room E. The floor is comprised of cut stone flags. The room houses the staircase which permits access to the first floor.

Plate 27: Little Lowe House, Buglawton, Congleton - Internal shot Barn - Room C - From the north - 1m scale

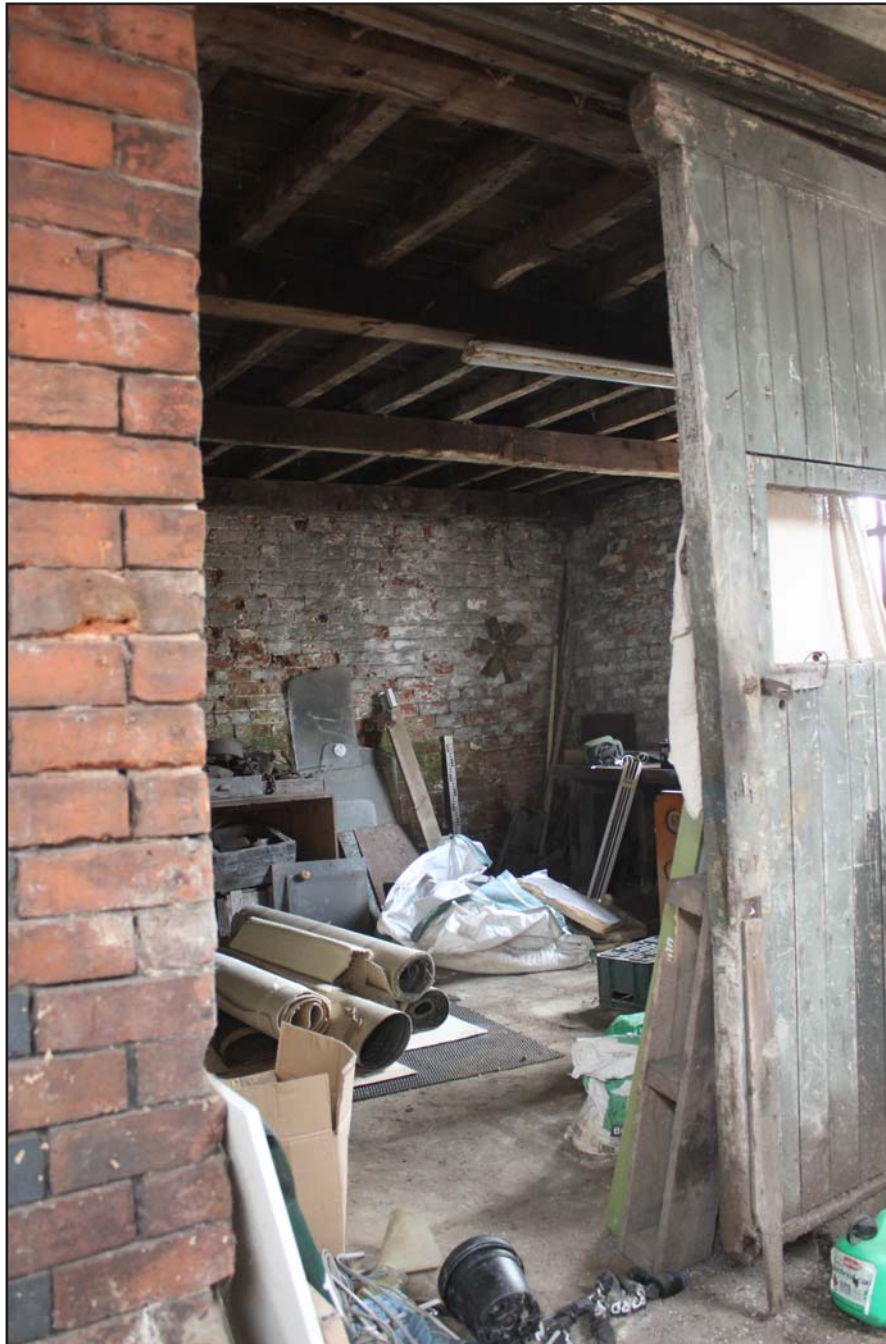
Room D is rectangular, orientated north to south and measures 5.10m long by 4.60m wide. The ceiling is comprised of wooden floor joists, supporting a wooden floor, which are in turn supported by wooden beams. The walls are of red brick bonded by mortar and painted white although most of the paint has flaked away on the southern and western elevations. The western elevation has a timber framed window with 12 glass window panes located just below the upper floor level in the centre of the elevation. The northern elevation is mainly comprised of a large sliding wooden door; this door is substantial and is apparently suspended from metal runners located in a large wooden ceiling joist. The floor is once again of cut stone flags. The room is currently used as a store and workshop area.

Plate 28 Little Lowe House, Buglawton, Congleton - Internal shot Barn - Room D - From the north - 1m scale

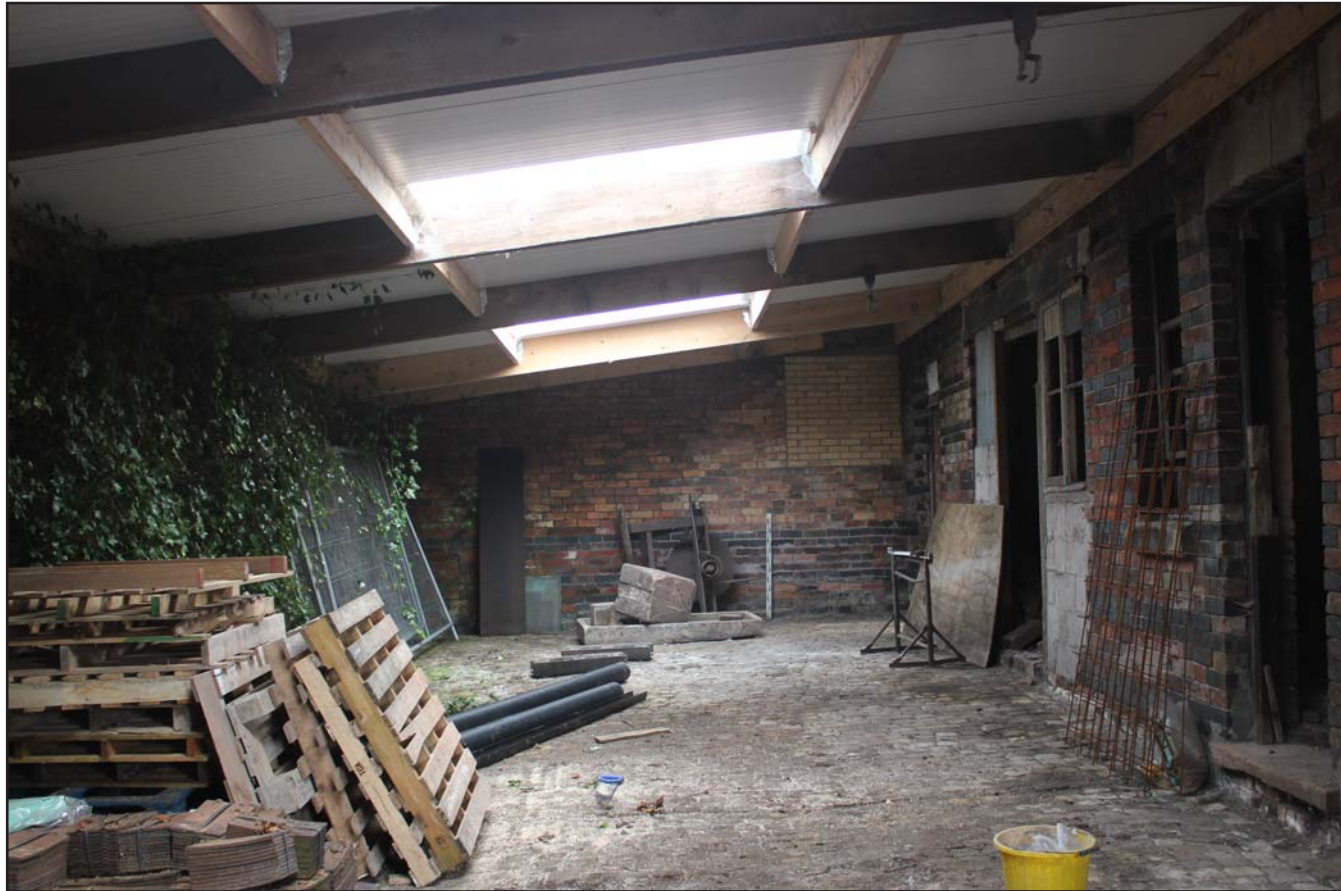
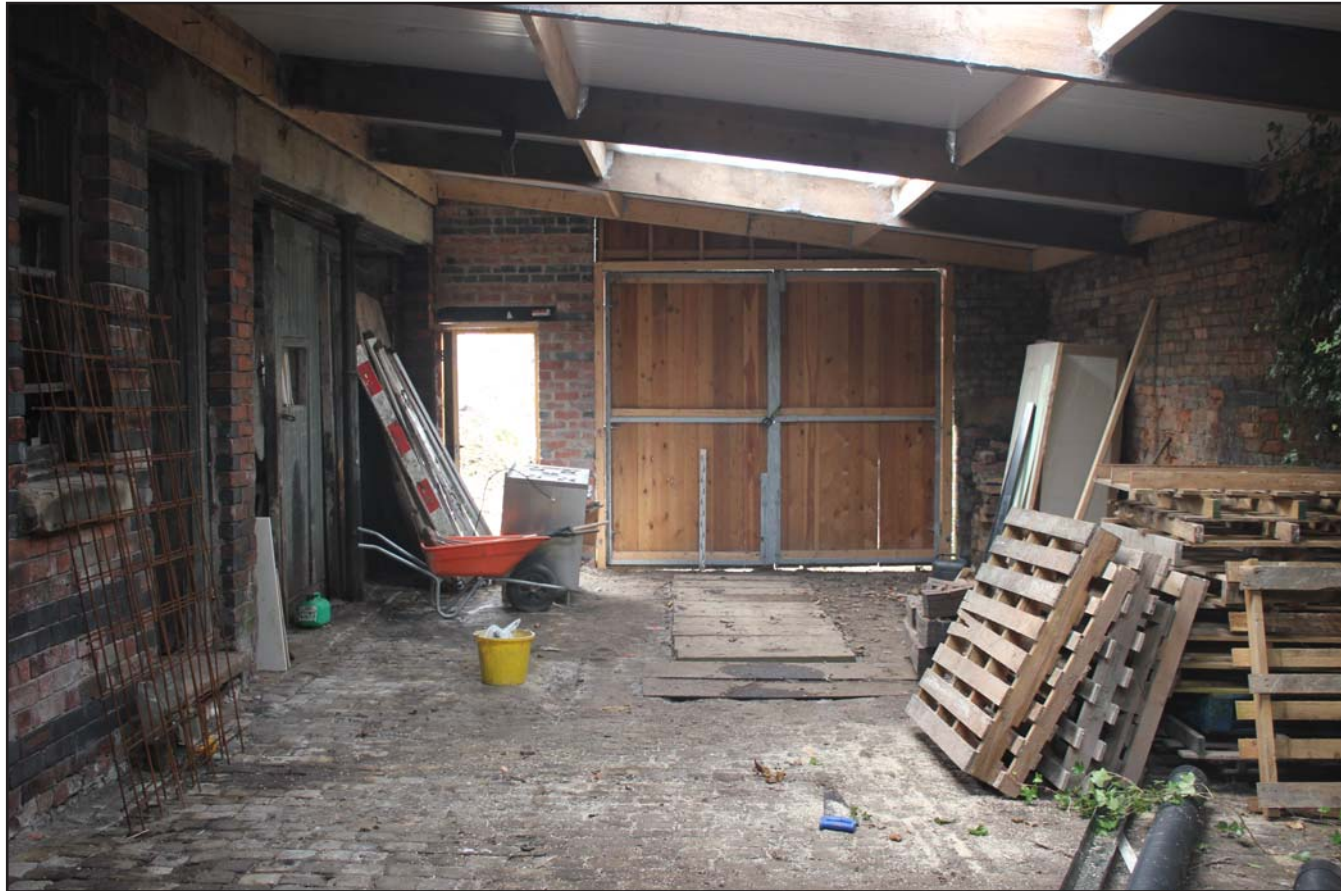
Room E is the largest room in the barn/workshop area and may have once been an exterior area that was roofed over. It is rectangular in plan, orientated east to west and measures 14.20m long by 5.80m wide. The ceiling is comprised of a timber rafter and purlin construction; a single shallow pitched roof has been covered with metal sheets and plastic ceiling lights. The northern elevation is comprised from red-brick and blue-brick bonded by mortar and much of this wall has been obscured by ivy growth, it does however appear featureless. The eastern elevation is also comprised of red-brick and blue-brick bonded by mortar, and apart from a bricked up window in the upper right hand corner it is also featureless. The southern elevation of this room represents the main partition wall; forming the other rooms/bays, it is mainly comprised from red-brick bonded by mortar however there are areas of modern breezeblock and plastic sheeting forming the wall.

At the left-hand end there is a single timber framed doorway which permits access to room A; there is a step into this room of three brick courses in height. To the right of the doorway there is an area of plastic sheeting and breeze block work incorporated into the brickwork. To the right of this there is another timber framed doorway which permits access to room B; to the right of this doorway there is a window set above floor level with wooden frames, these frames have no glass present. To the right of this there is a section of red brick wall bonded by mortar and another narrower vertical window with wooden frames, the glass is also absent from this window, however it does have a substantial dressed stone window sill. To the right of this window there is another timber frame doorway this time with a wooden batten door present, which permits access to room C. To the right of this there is a large opening leading to room D which can be partitioned from room E with a large sliding wooden door. The western elevation is dominated by a large timber double garage door and immediately to the left of this there is a single wooden framed door which permits access to the exterior of the building.

The floor is mainly comprised of laid bricks which have been grouted in. Also at the western end of the building located in the centre of the floor space there is a mechanics pit covered over with wooden boards and reinforced metal plates. At the eastern end of the room there are two objects of interest one is a stone cut water trough sitting unattached to the floor. The other is a table mounted circular saw (also unattached) constructed from steel - now rusted. The room is currently used for storage although at some point it may have been a mechanics garage and/or workshop.

Plate 29: Little Lowe House, Buglawton, Congleton - Internal shot Barn - Room E - From the west - 1m scale

Plate 30: Little Lowe House, Buglawton, Congleton - Internal shot Barn - Room E - From the east - 1m scale

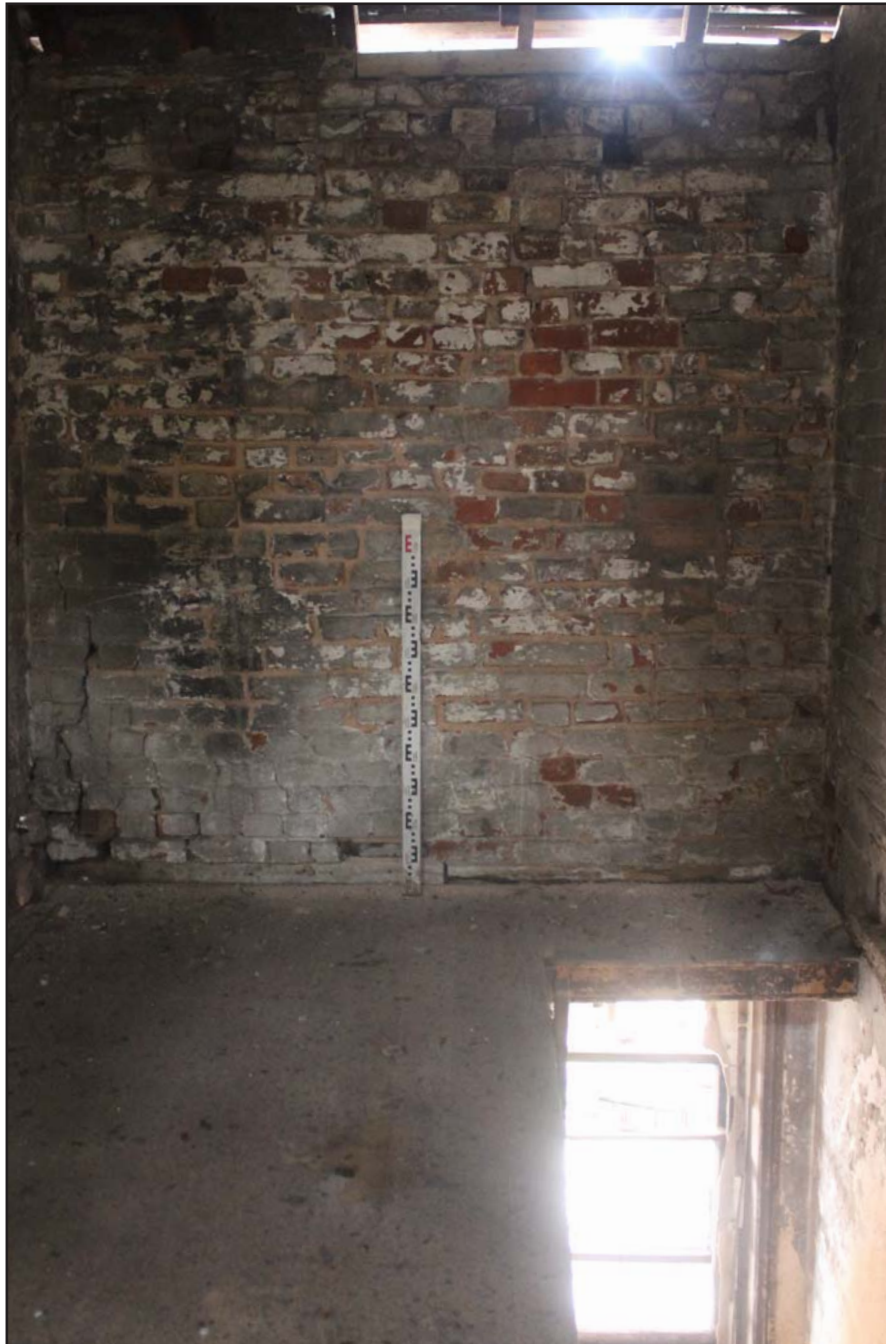
Plate 31: Little Lowe House, Buglawton, Congleton - Internal shot Barn - Room F - From the south - 1m scale

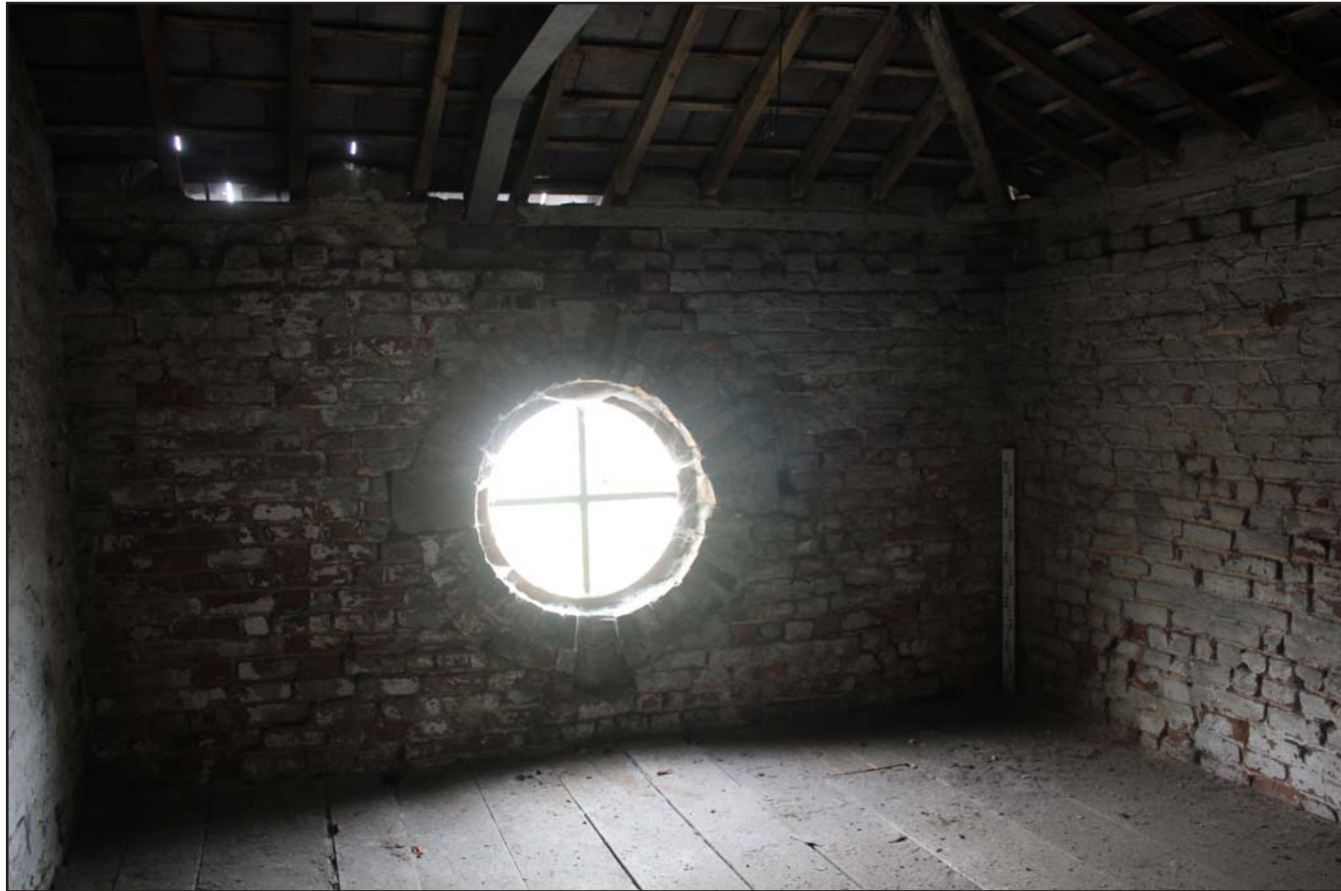
Plate 32: Little Lowe House, Buglawton, Congleton - Internal shot Barn - Room G - From the southwest - 1m scale

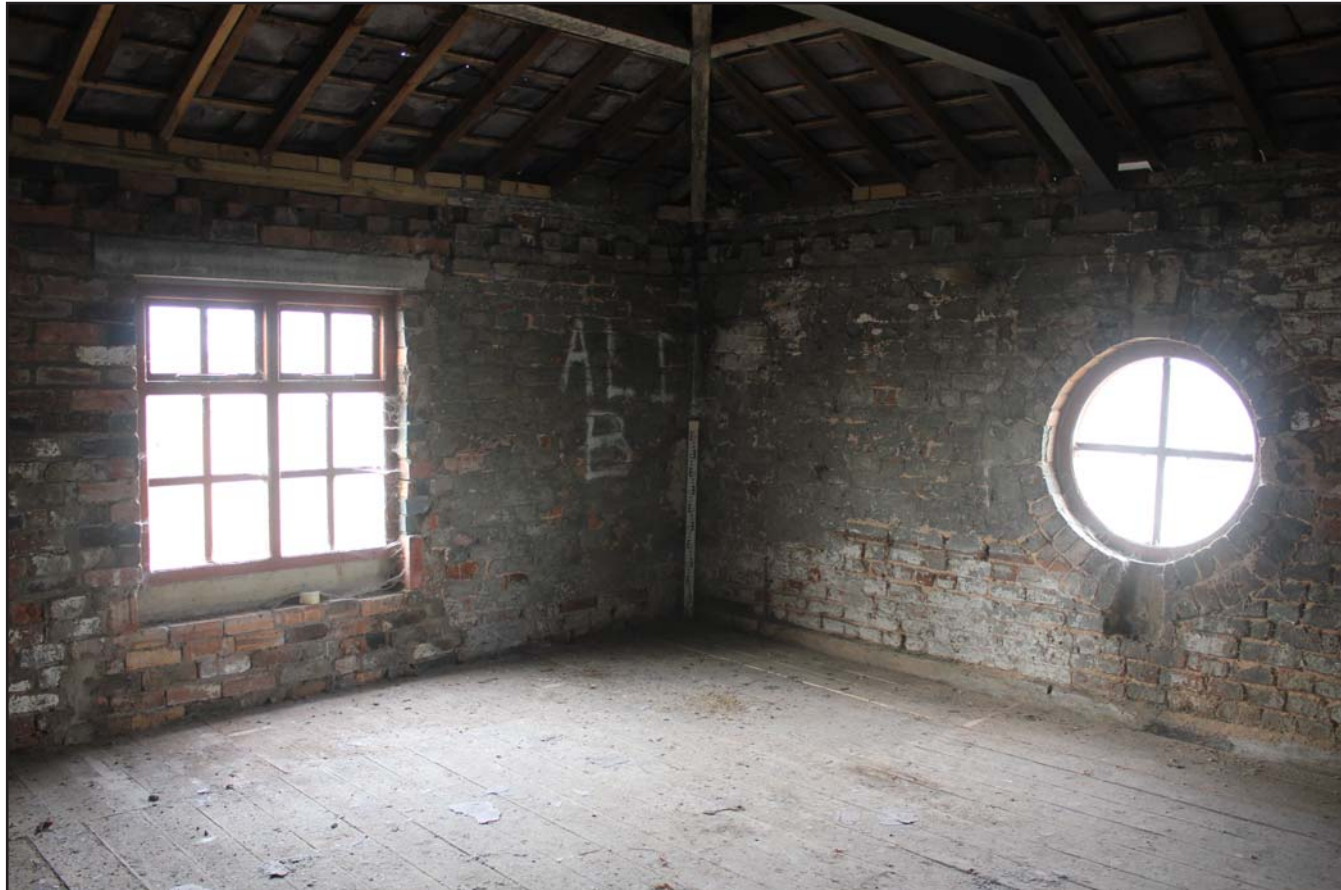
Room H is rectangular, orientated east to west and measures 5.25m long by 5.10m wide. Once again the ceiling is open to the roof space and is of hipped design (see Room G). The walls are comprised of red brick bonded by mortar. On the western elevation there is a square window identical to the one found on the ground floor this has a wooden frame and is comprised of 12 glass panes. The northern elevation has another circular window identical to that found in room G. The floor is comprised of wooden boards.

Plate 33: Little Lowe House, Buglawton, Congleton - Internal shot Barn - Room H - From the southeast - 1m scale
