# Zionist Baptist Chapel, Shifnal, Shropshire, TF11 8AQ.

Archaeological Watching Brief  
Project Code: A0153.1  
Report no. 0178

Archaeological Watching Brief

Client: Shropshire Towns and Rural Housing (STaRH)

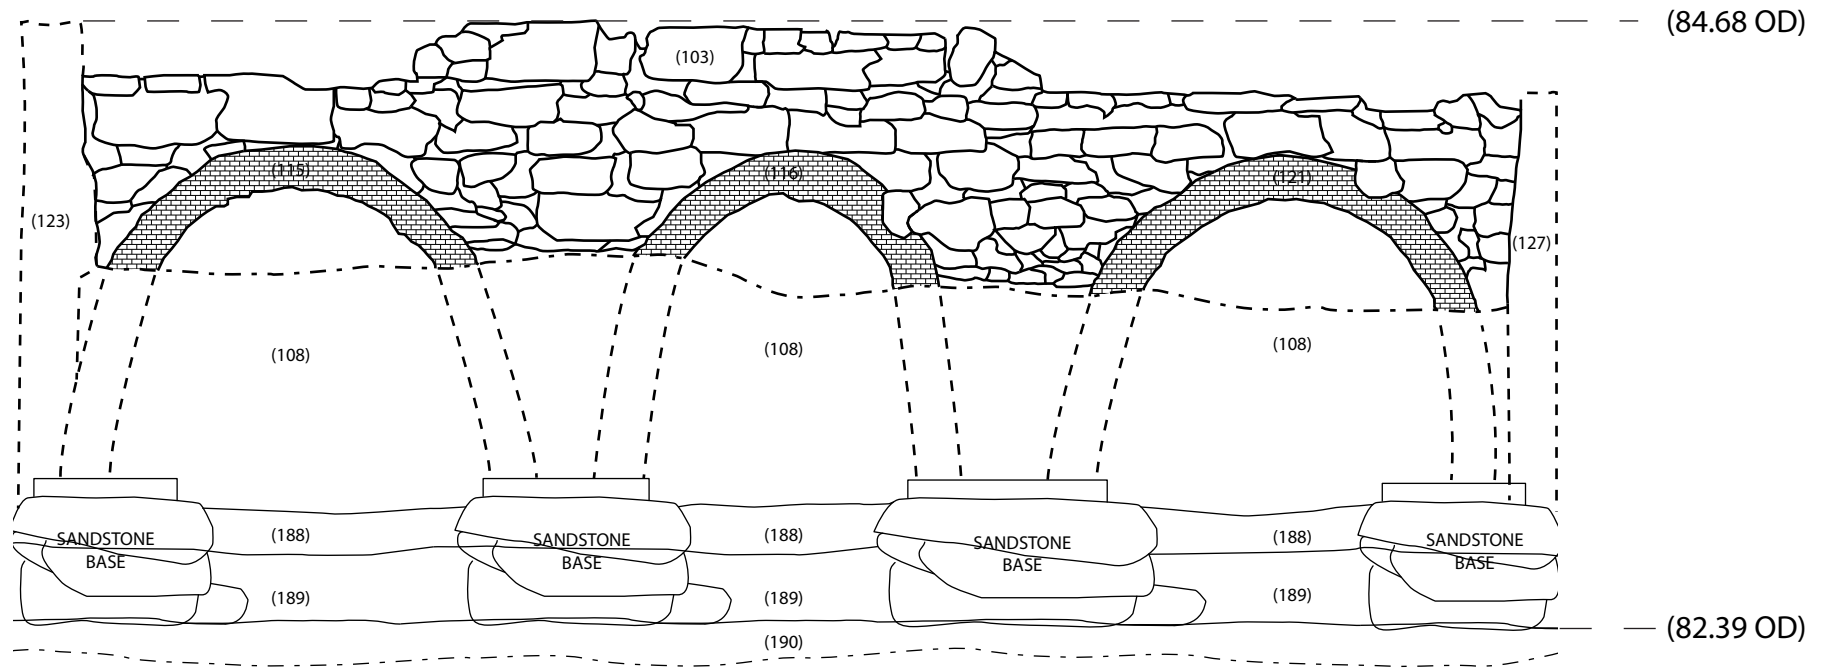
Figure 11. Section of Southern wall (103) showing visible arches (115), (116), (121). Arches are projected below ground onto observed sandstone bases. Scale 1:20 @ A4.

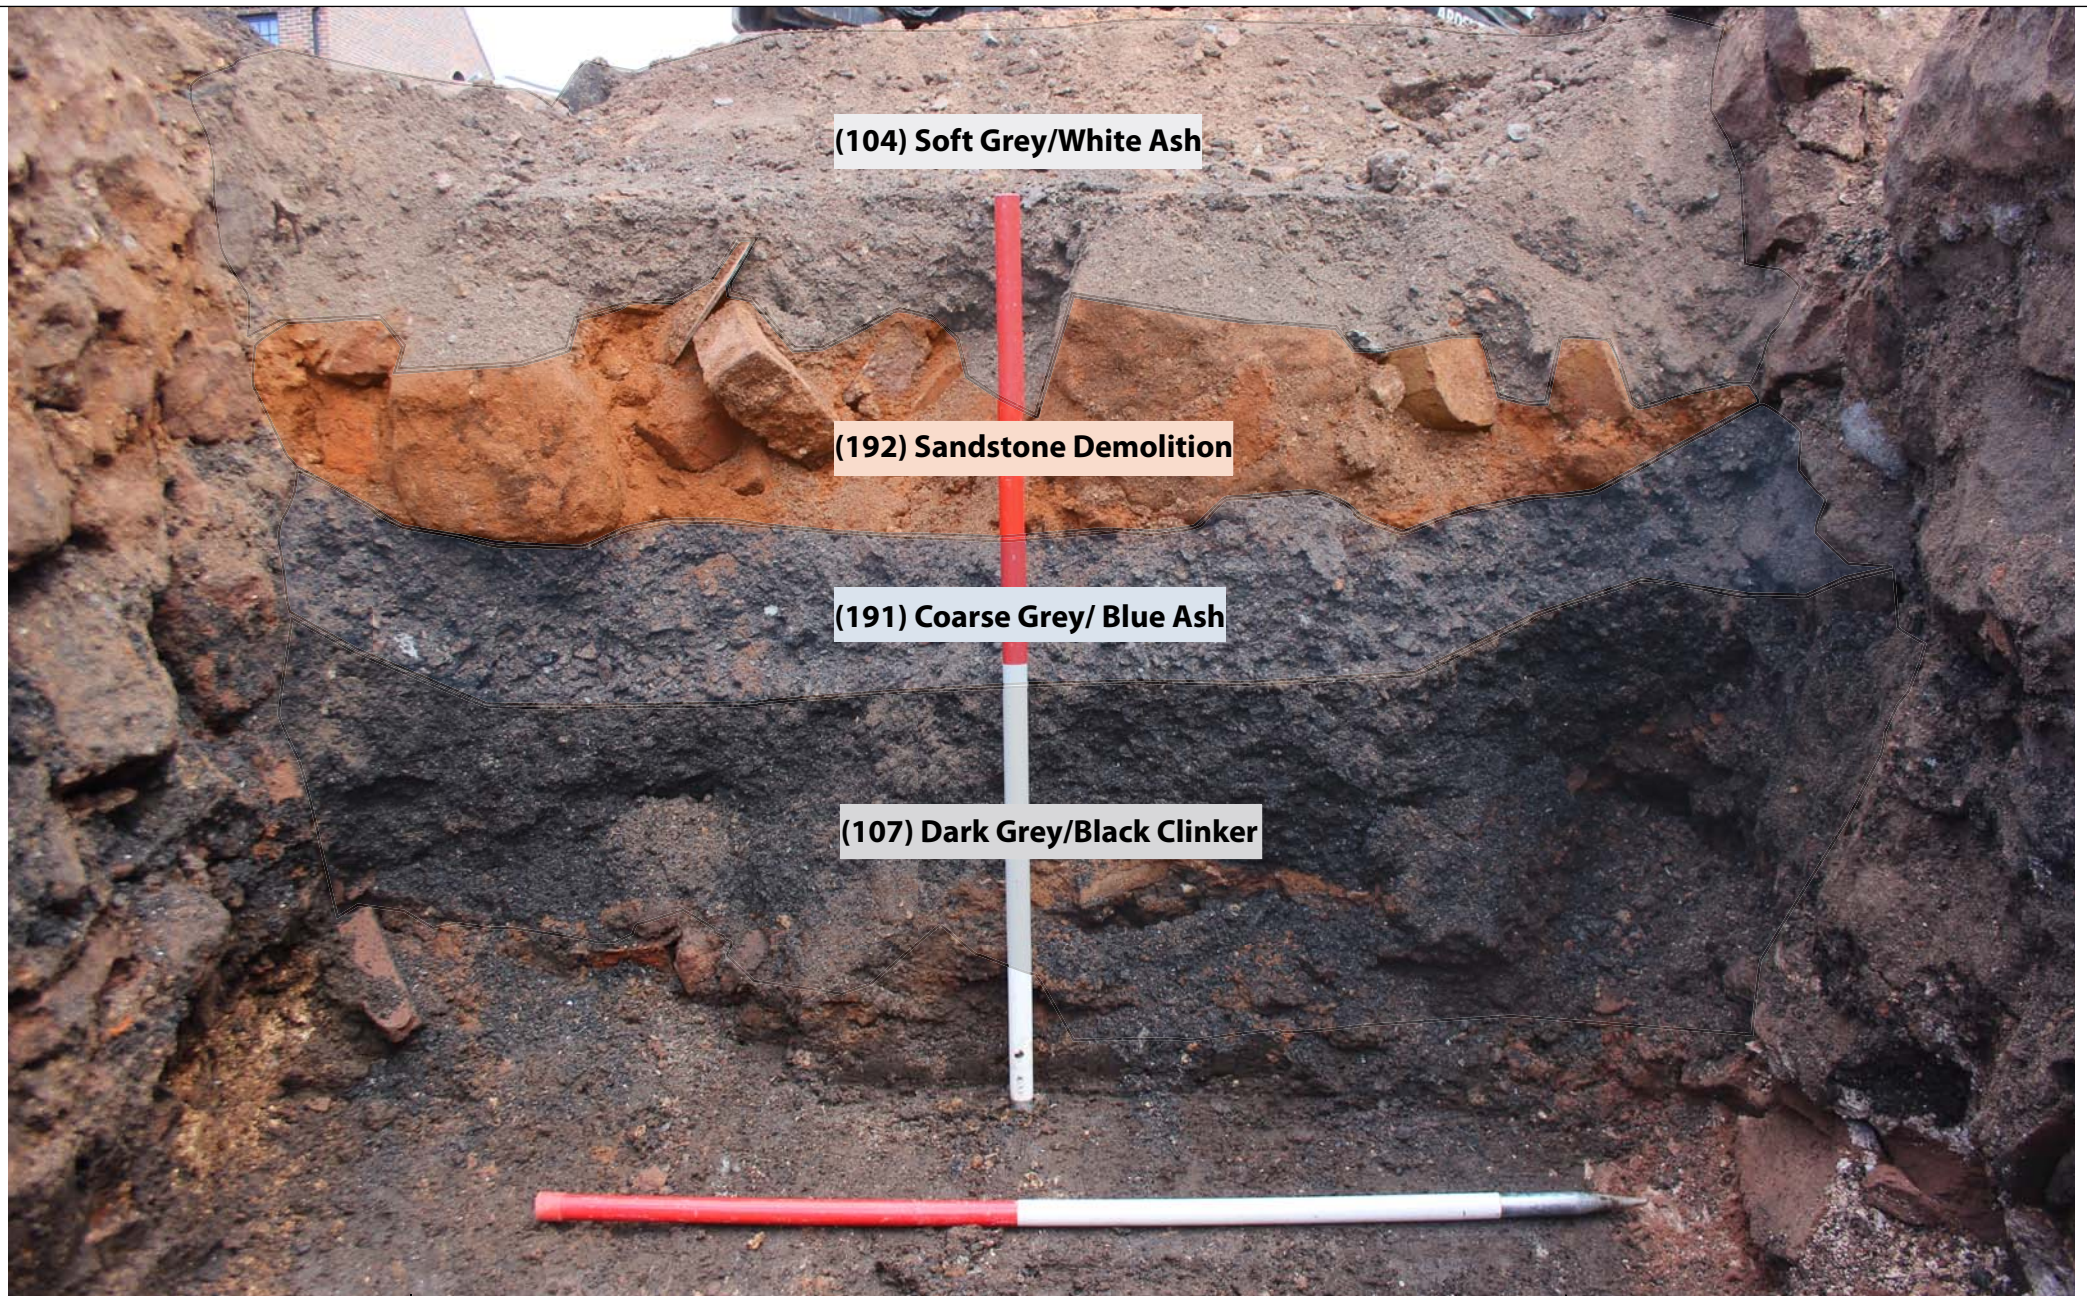
a) Drawn Section of the Parabolic Arch (163).

b) Drawn Section of a Rounded Arch (175).

With regards to the structural composition of the chapel the arches present the most formative question associated with the construction of the building; both with regards to design choice by the architect and how the foundations were excavated given the height/depth of the water table. The arches' pillars were situated upon large sandstone bases which themselves had been laid upon the natural clay (190); these large pads displaced the weight of the building above and anchored the building on a stable building surface. However the depth at which these sandstone pads were located was approximately 2m (82.69 OD) below the ground level and 0.70m below the water table (83.39 OD approx.). The original groundwork for the chapel foundation cut [177] would have been significant with large amounts of material having to be removed in order to accommodate the pads at the depth of 2m. Furthermore the waterlogged nature of the area would have presented additional challenges to construction; for example how to keep water away whilst the pads were located properly, what mortar to use, or how to keep the area dry long enough for mortar to set.

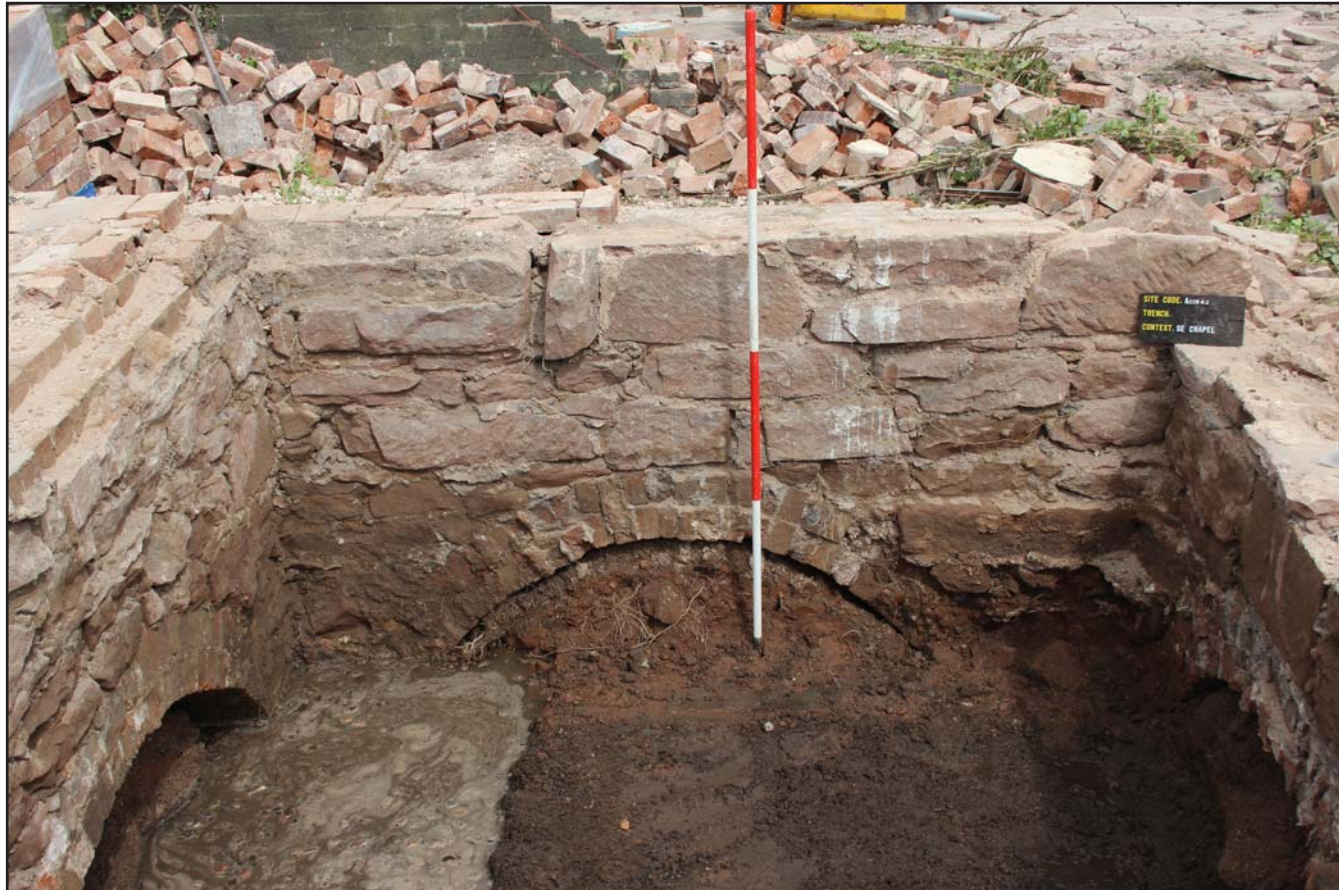
**Plate 13:** Shot showing example of wall and arch construction (southwestern corner of chapel) - from the west - scale 2m

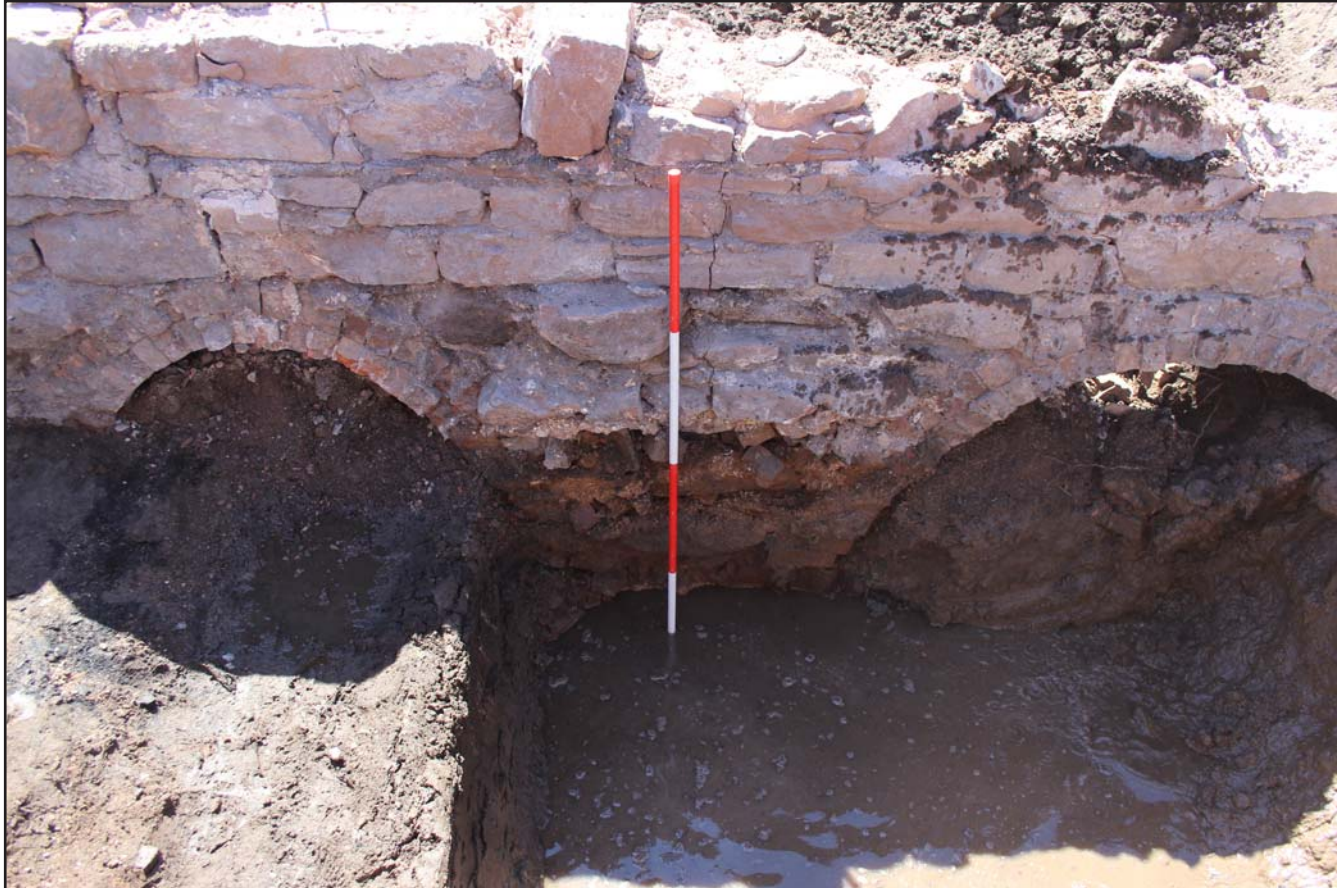
**Plate 14:** Shot showing visible depth of arches (southern wall of chapel) the sandstone base is obscured by water table - from the north - scale 2m

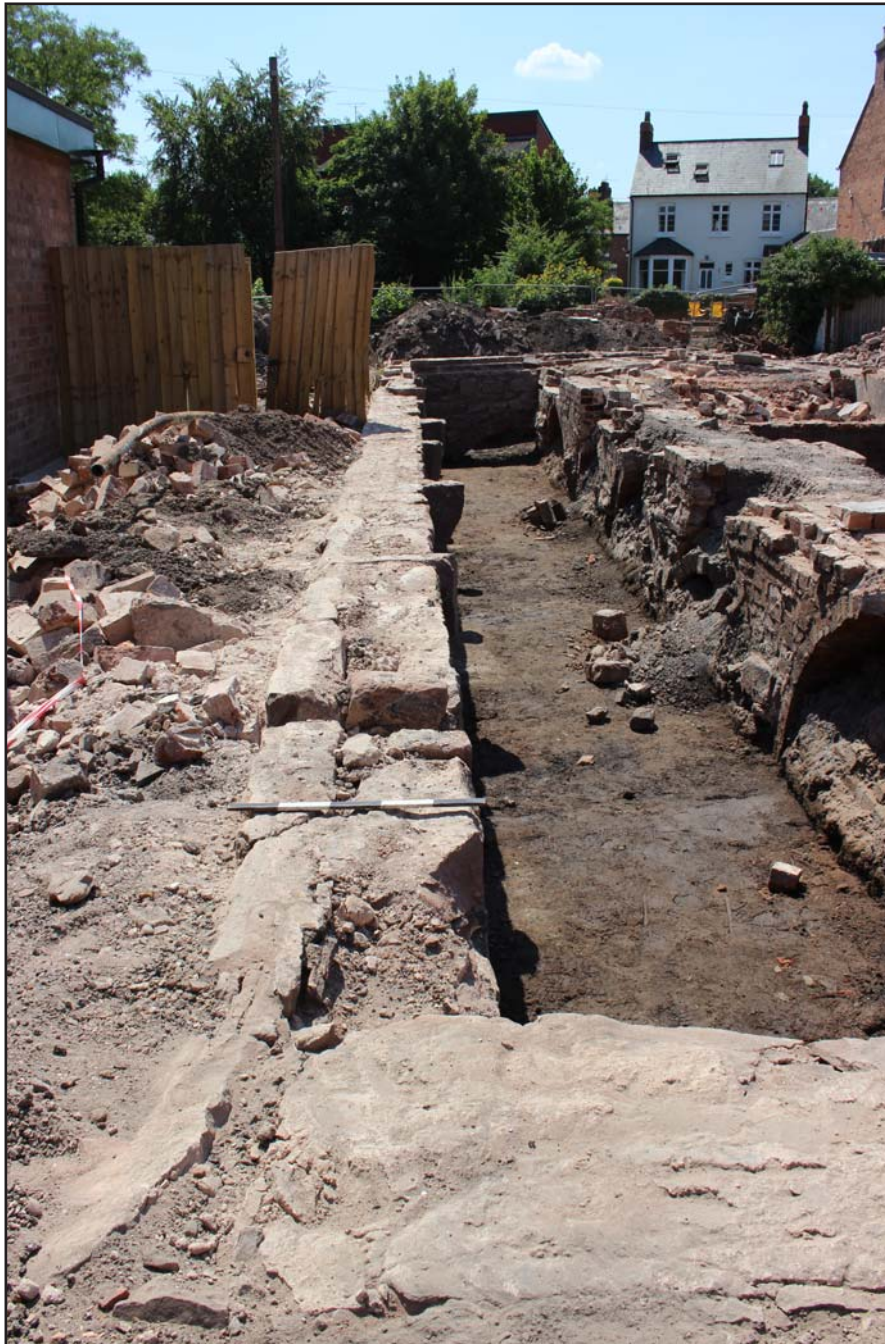
**Plate 15:** Shot of eastern wall (123) showing (on left) the sandstone corbels which may have supported a timber ring beam - from the north - 0.50m

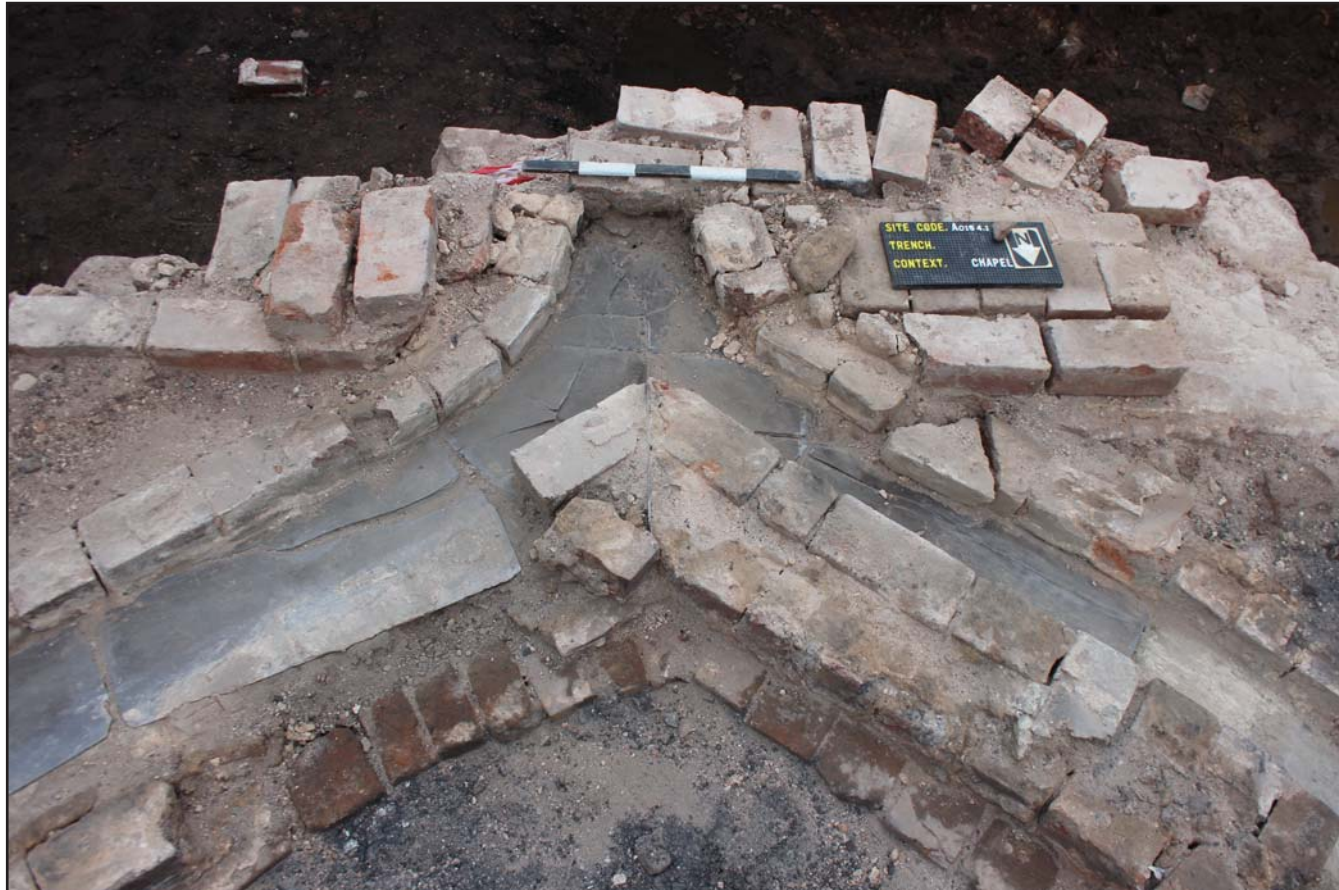
**Plate 21:** Point at which drains (131) & (132) are connected on top of buttress (112 - from the west - scale 0.5m

The drains (131) and (132) also had a built-in gradient; the top of the gradient began for each drain at the point at which they coalesced (on top the central part of the buttress (112) which was incorporated into the fabric of the southern interior wall (110)). The drains then had a direction of fall away to the northeast and northwest respectively; the eastern drain (131) appeared to empty directly into the eastern bay of the chapel (conical clay drain pieces were observed in this area, perhaps aiding drainage in the undercroft), with a fall of 31cm across its length, whereas the western drain (132) discharged into the brick gully (144) with a fall of 25cm across its length. The gully (144) had also been constructed directly onto the brick arch (175) making the arches of the western interior wall roughly contemporary with the western drain (132). The drains were constructed from three courses of bricks respectively which formed a splayed base; the uppermost of the brick courses formed a channel which was lined at the base with pieces of slate and these had had been secured into place with a soft white mortar.

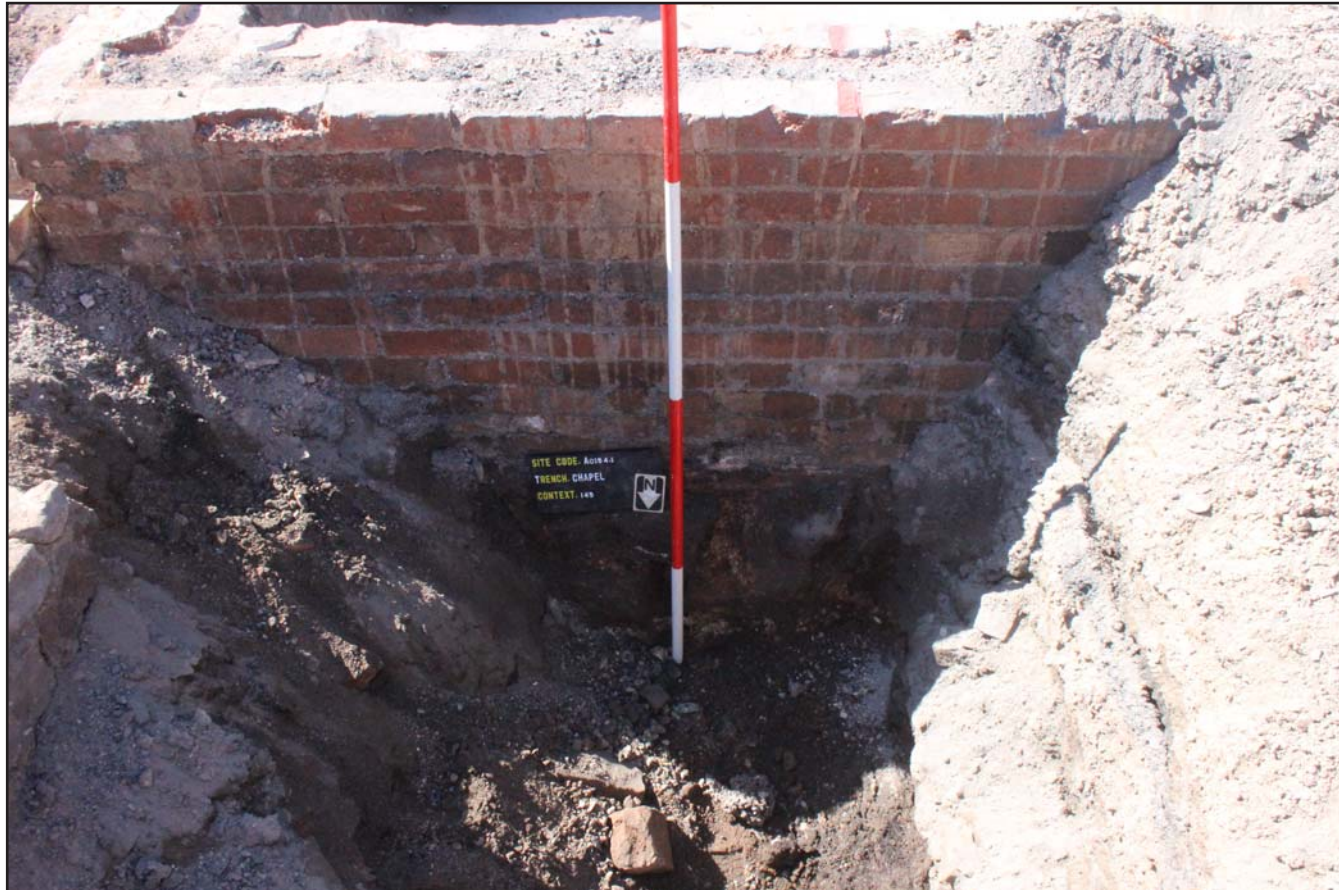
**Plate 28:** Northern wall of baptismal pool (128) showing sandstone foundation below (145) - from the north - scale 2m

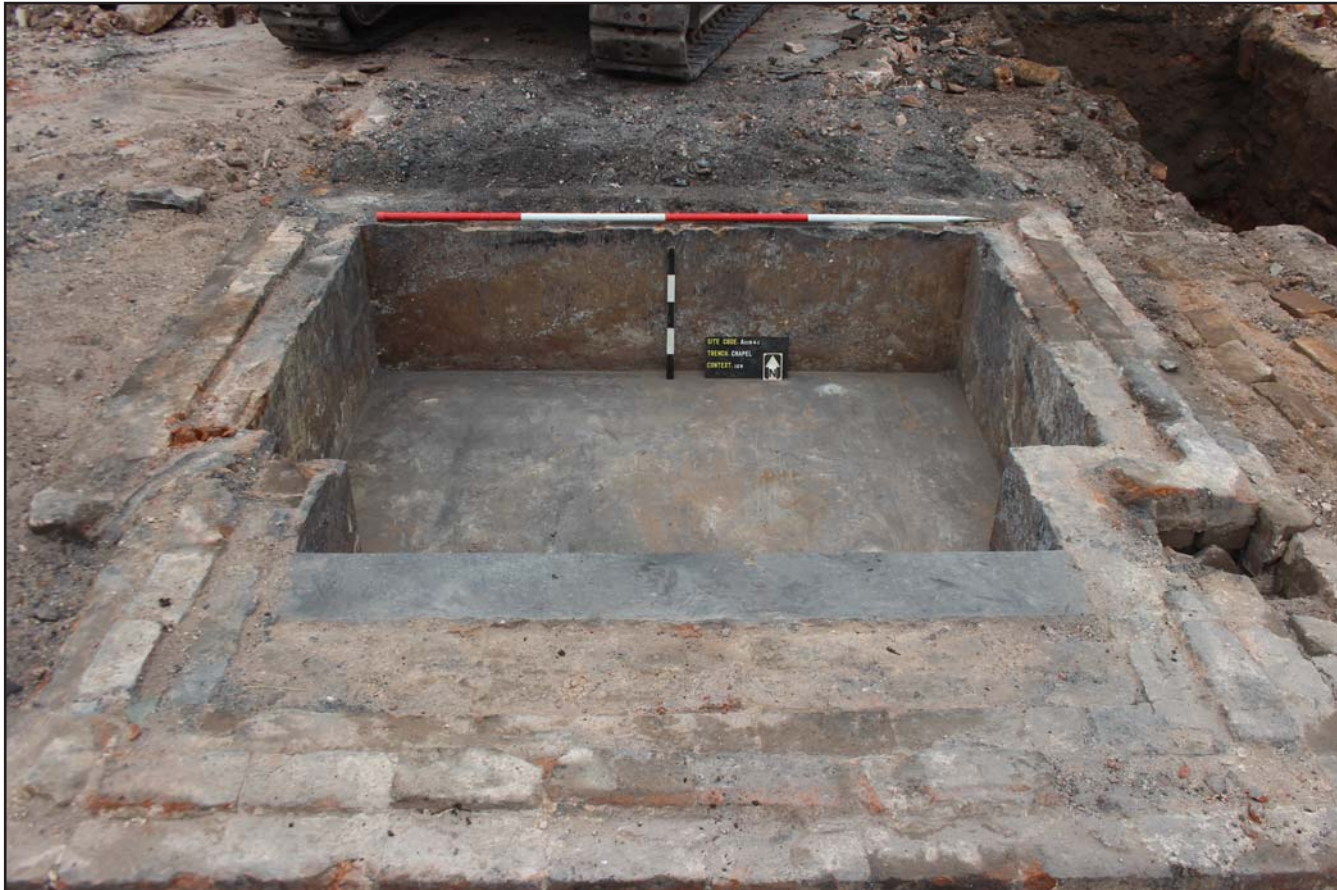
**Plate 29:** Baptismal Pool (128) with polished cement liner (129) - from the south - scale 2m & 0.5m

The walls of the baptismal pool comprised of 11 courses of stretcher bricks, these were unfrosted red bricks bonded by OPC and measured 24cm long by 12cm wide by 6cm deep. When viewed in plan the walls of the pool were three courses wide (0.38m) and formed an opening in the center of the pool; this area was 2.15m long by 1.37m wide by 0.57m in depth and was covered by a polished cement (129). This polished cement was between 18-30mm thick and faced the interior walls of (128) on the south, west and east sides as well as the base. To the north of the pool was a recess into which three steps (130) were constructed, these had also been covered in the same polished cement lining (129) found elsewhere in the baptismal pool. The steps were all uniform in dimensions; 1.65m long by 0.22m wide and 0.19m tall and allowed access to the pool base. In the south-eastern corner of the base of the pool was a small copper pipe drain which would empty the pool; set above this and built into the eastern brick wall of the pool (128) was a brick gully (134) which permitted access to the drain, most likely for cleaning purposes. In the south-western corner of the pool wall (128) was a small over spill channel (plate 34) comprised of the same polished cement (129) that was used to line the pool.

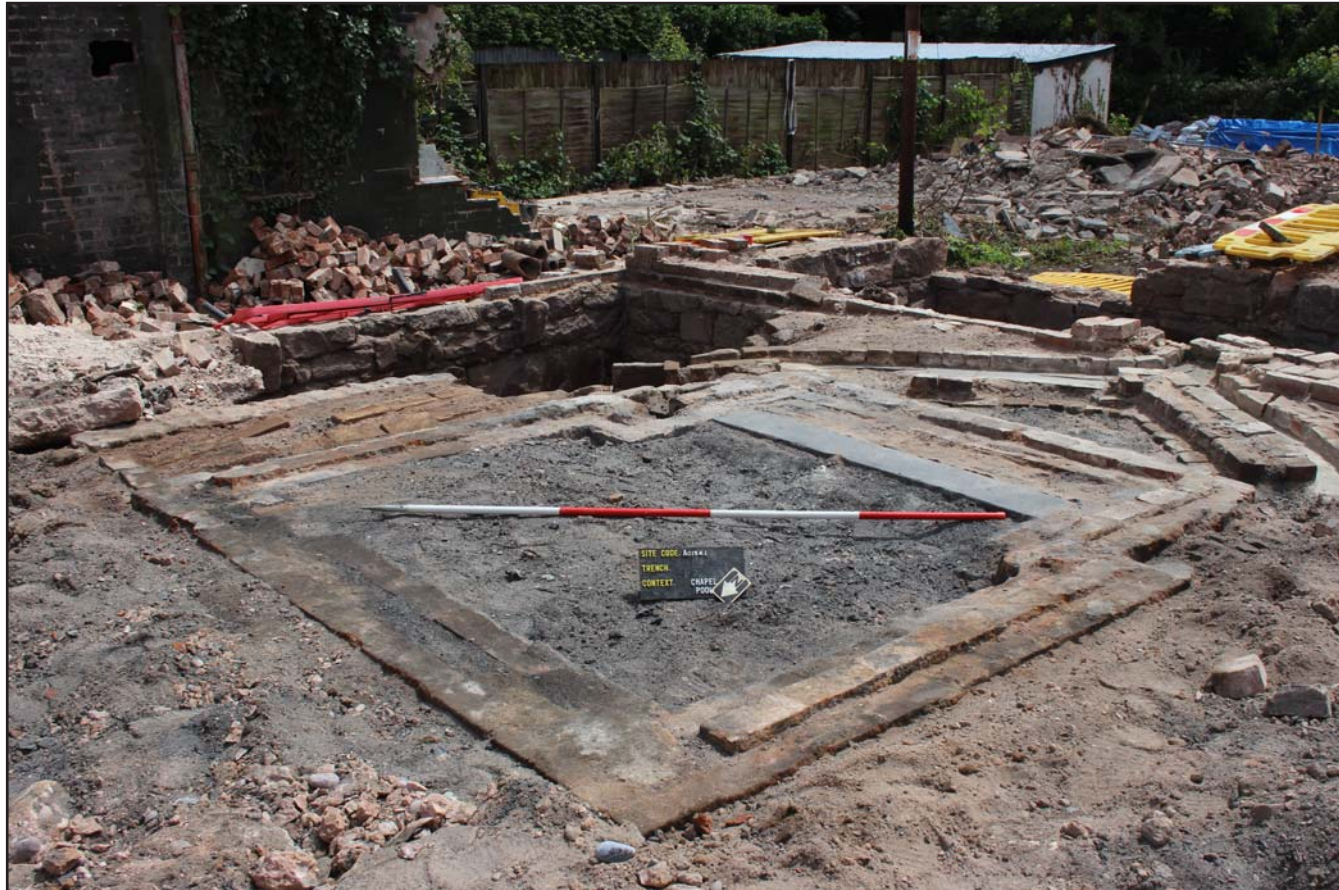
**Plate 40:** Grey brown ash (104) backfill found covering the whole site beneath the concrete floor slab (101) - from the west - scale 1m

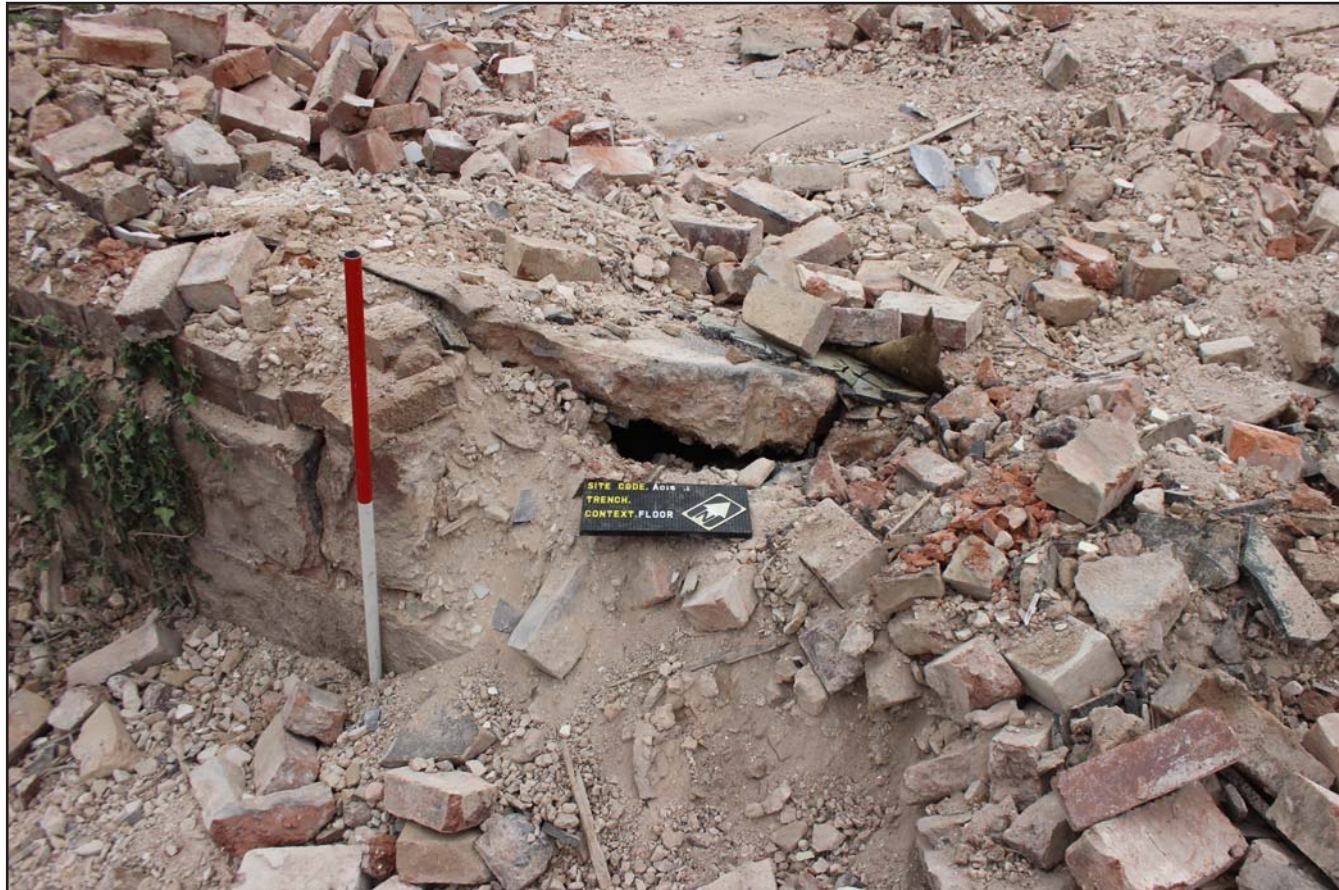
**Plate 41:** Concrete floor slab (101) collapsed into void - from the southeast - scale 1m

When the concrete slab (101) was encountered during this watching brief it was found to be broken in many places especially around the northern and southern bays (plate 41). A property of the soft grey white ash (104) located beneath the slab is that it was heavily absorbent and prone to expansion and contraction over the course of a year; therefore creating a void beneath the concrete over time (plate 42). As a symptom of using this ash as a leveling layer and base for the concrete slab to be cast upon, the foundation of the slab became compromised; causing it to break underneath its own weight and slump into the void that had been created by the contracted ash layer below.

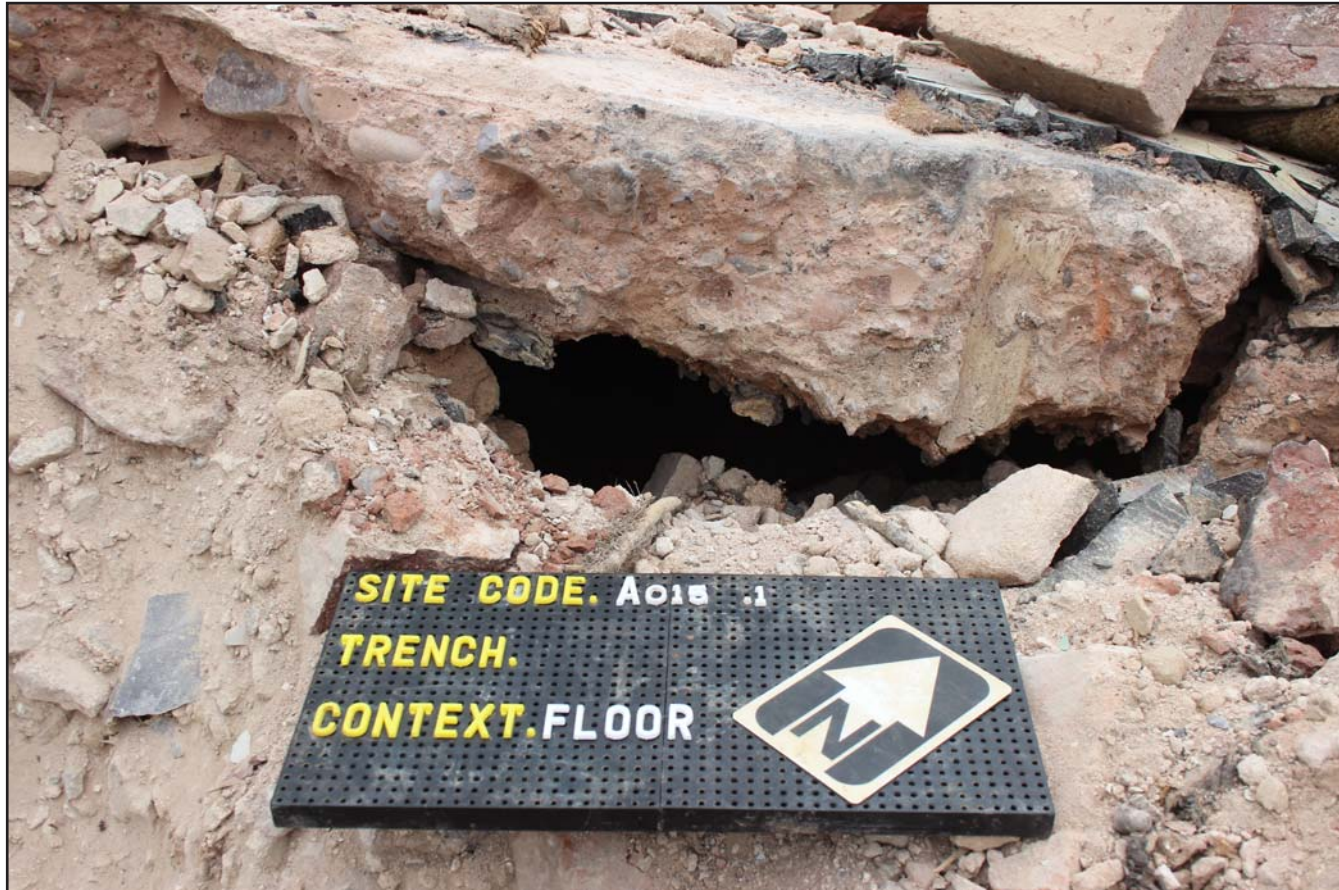
**Plate 42:** Concrete floor slab (101) collapsed into void (close up) - from the southeast - scale n/a

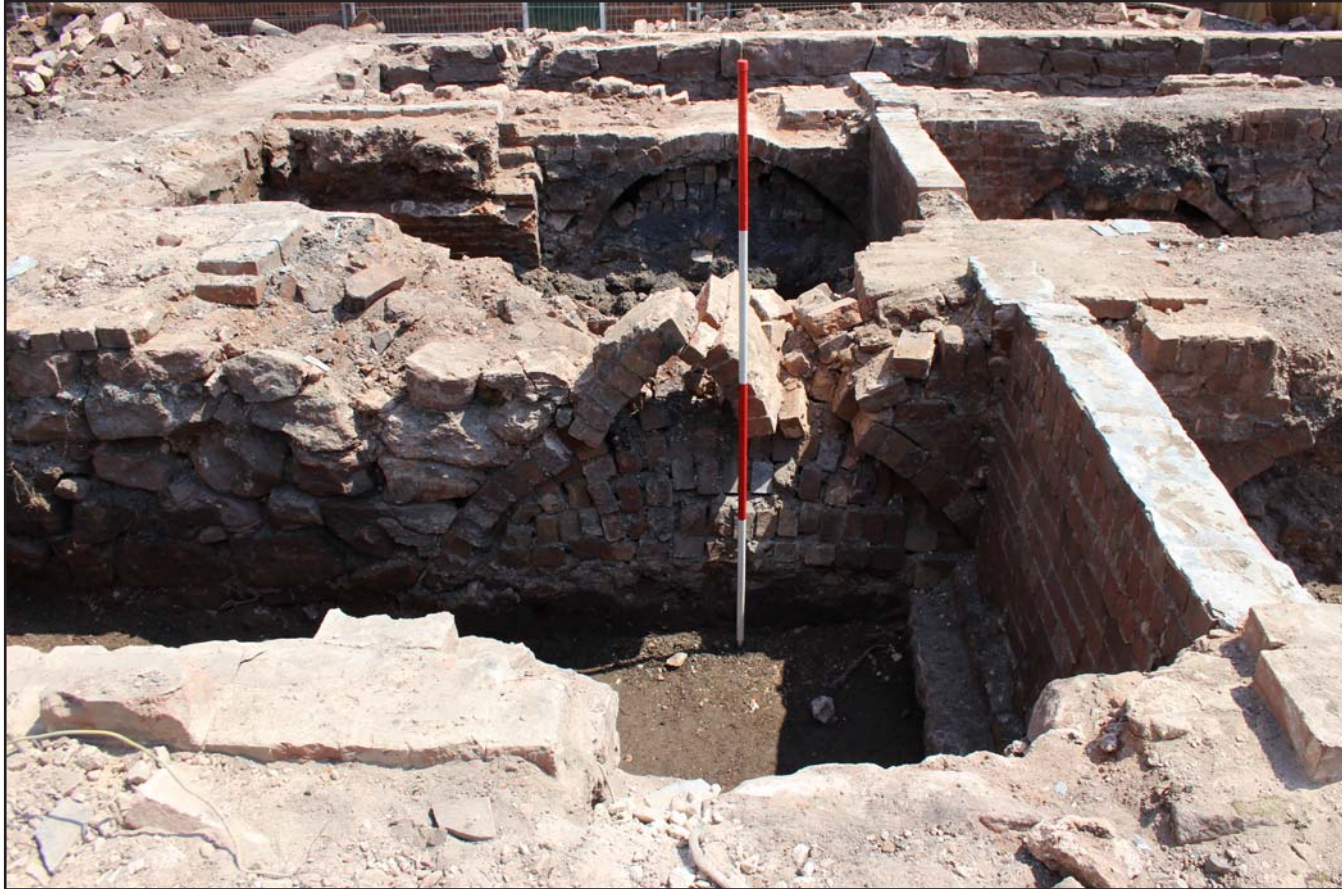
**Plate 48:** Parabolic Archway (163) (foreground) & Rounded arcway (149) (background) - from the west - scale 2m

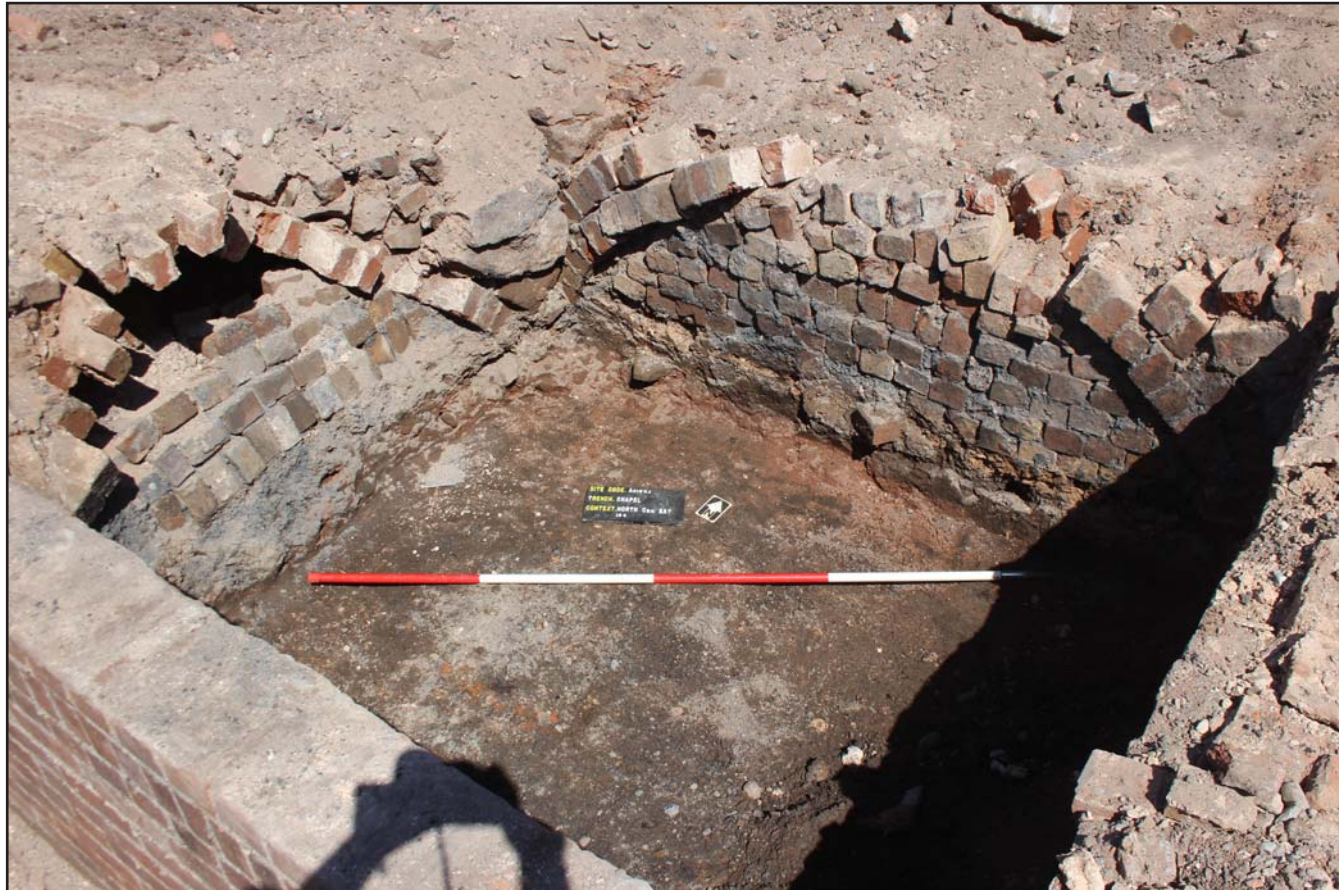
**Plate 51:** Parabolic arch (163) & east-west 'bricked up archway' (164) - from the southeast - scale 2m

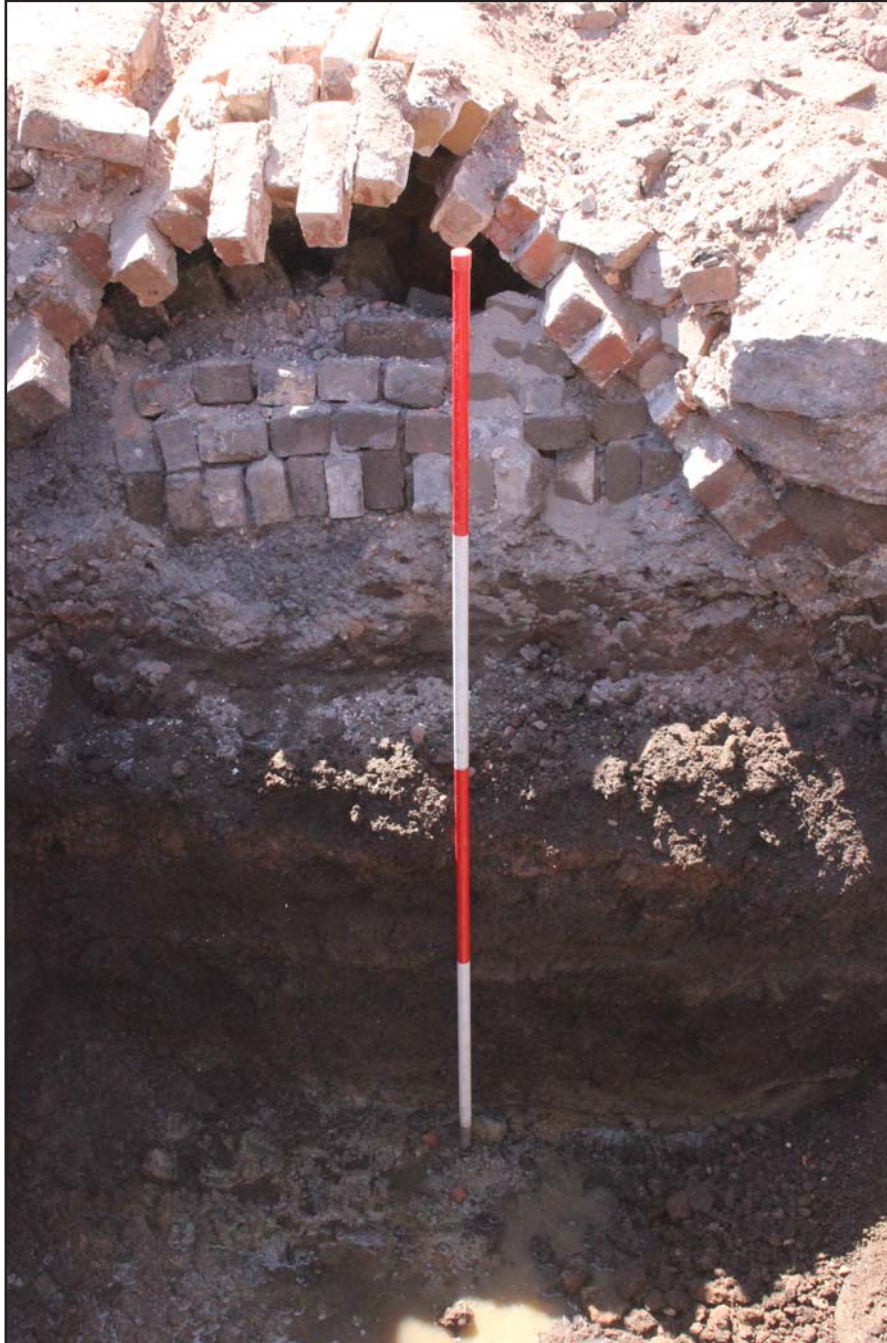
**Plate 52:** Test pit showing stratigraphy onto blue clay (190) - from the east - scale 2m

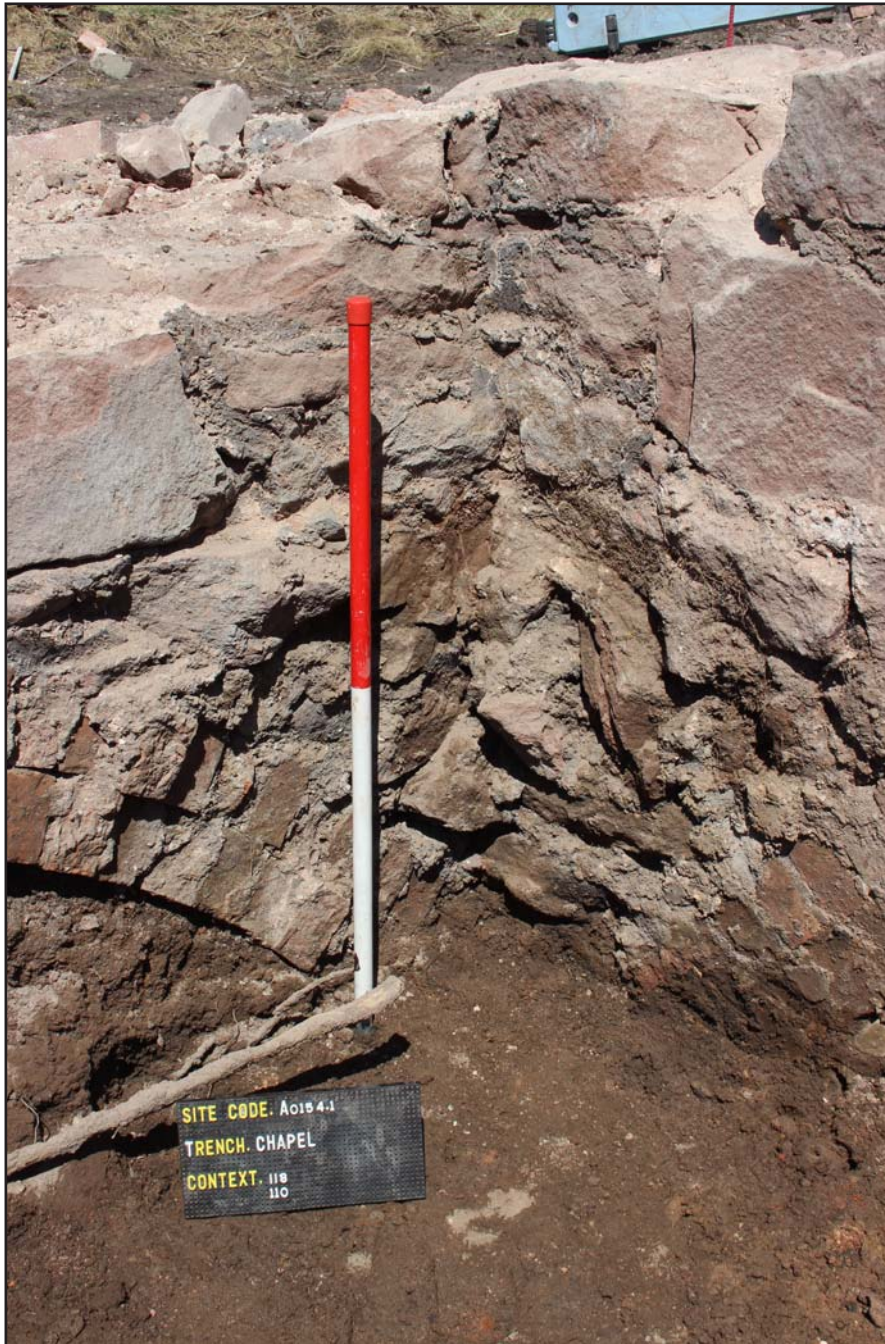
Plate 55: Section showing physical relationship between interior wall (110) and exterior wall (127) - from the southeast - scale 1m

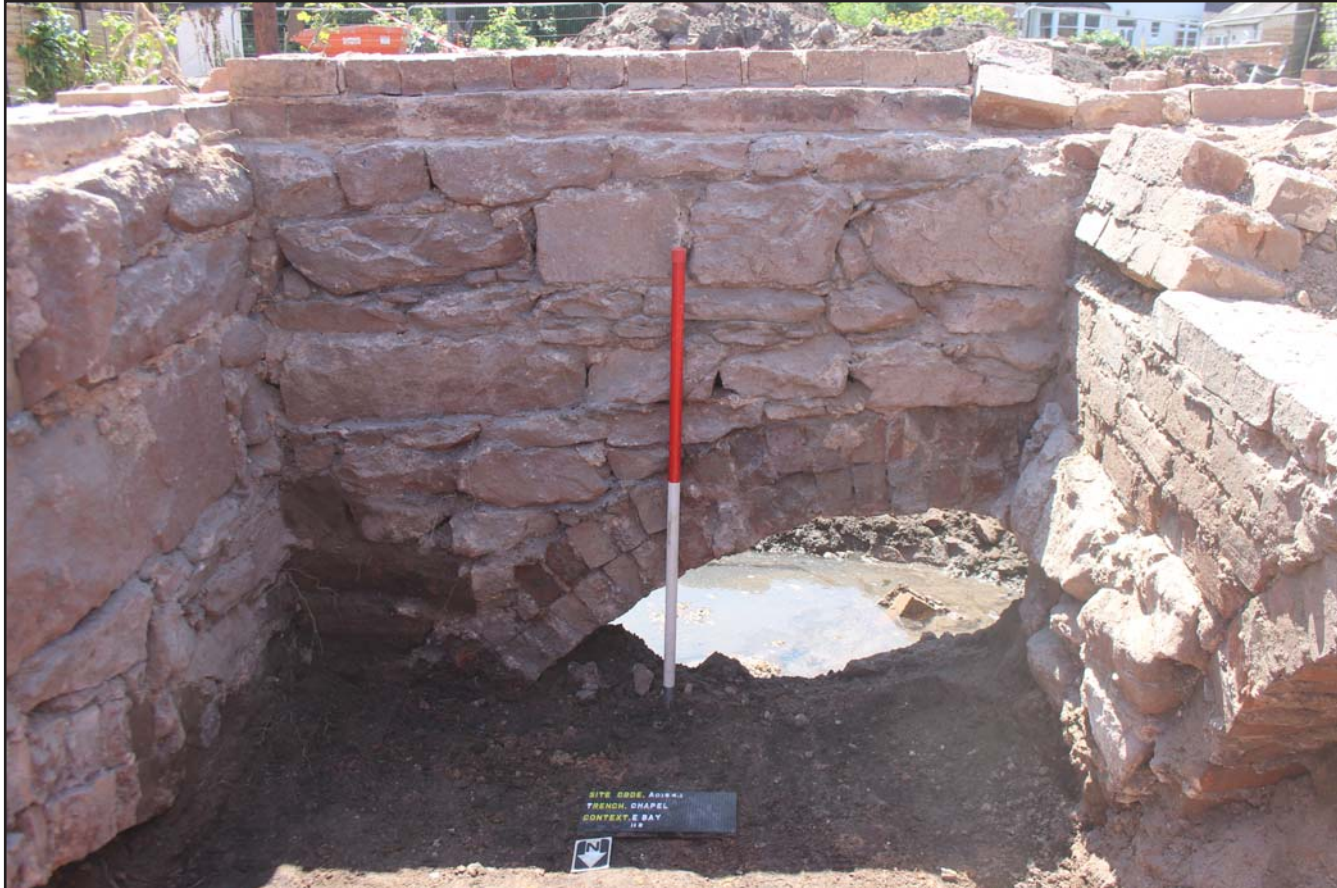
**Plate 57:** Shot showing relationship between exterior wall (123) and southern interior wall (110) and that wall (122) abuts over archway (113) located within wall (110) - from the north - scale 1m
