Creation of Two Additional Car Parks, Telford Crematorium, Woodhouse Lane, Red Hill, Telford, Shropshire, TF2 9NJ.

Archaeological Watching Brief

Report no. 0215

Client: L F Architecture Ltd.

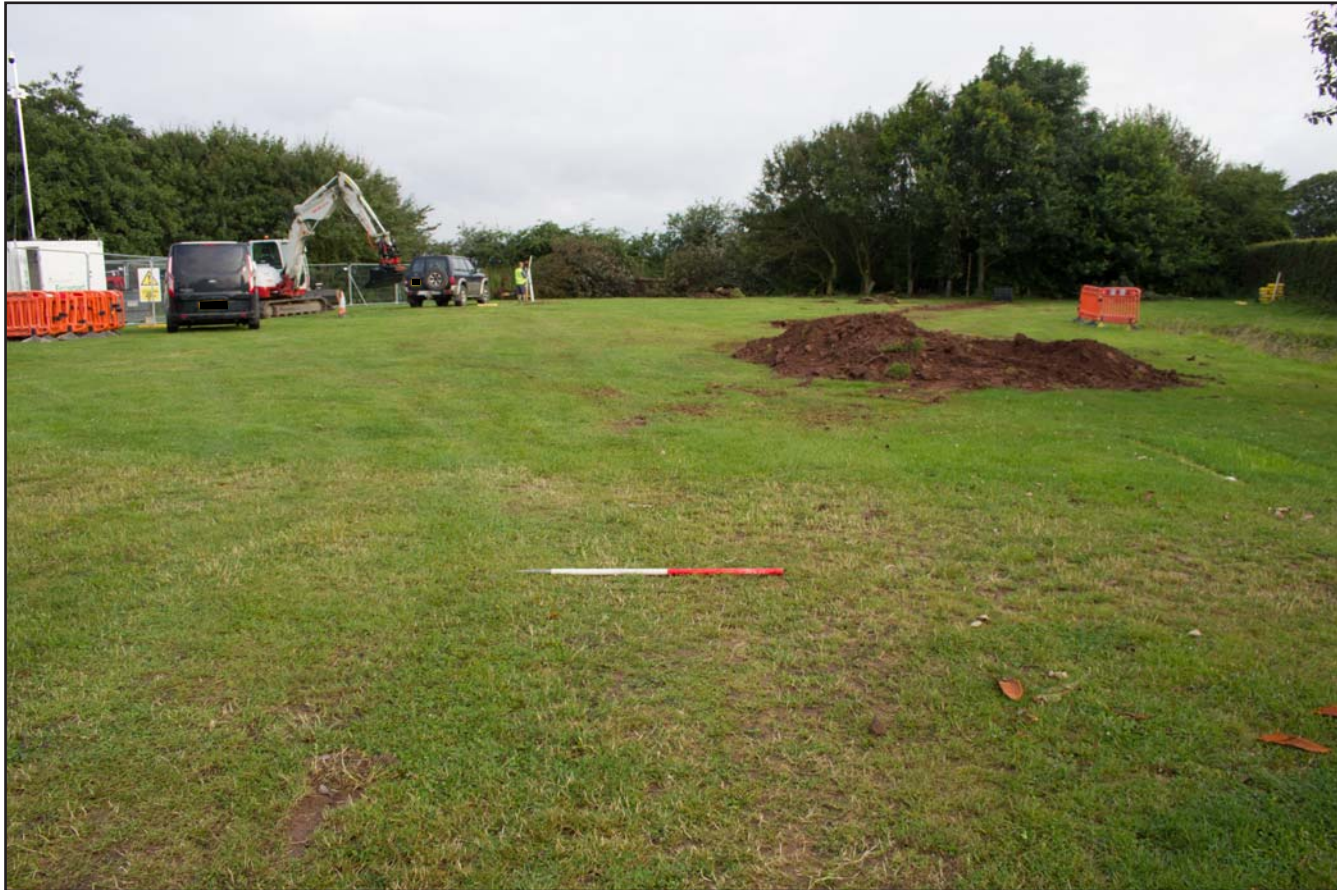
Plate 01: Pre excavation shot of area; Car Park A at Telford Crematorium, Woodhouse Lane, Redhill, Shropshire, TF2 9NJ - from the southeast - scale 1m.

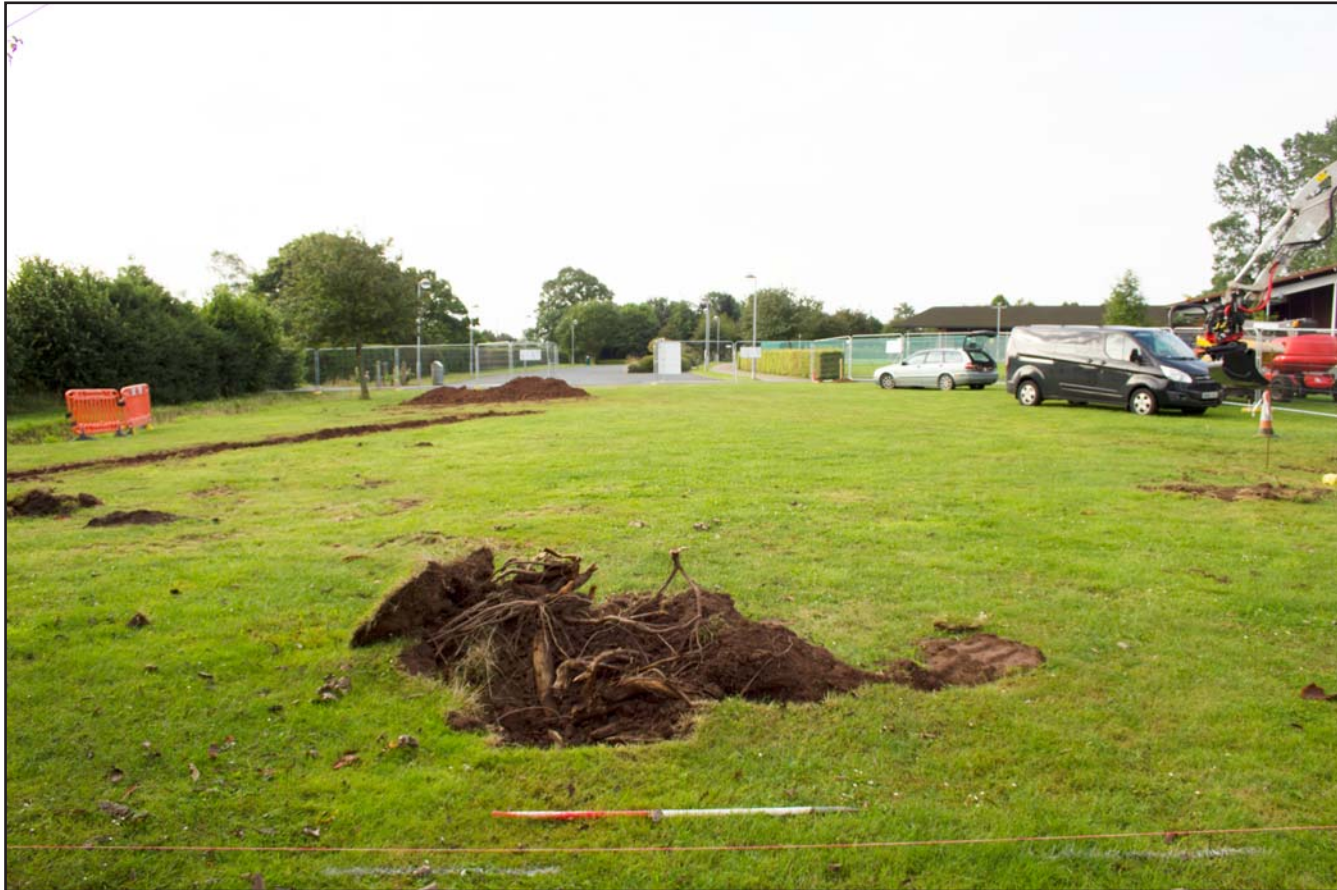
Plate 02: Pre excavation shot of area; Car Park A at Telford Crematorium, Woodhouse Lane, Redhill, Shropshire, TF2 9NJ - from the northwest - scale 1m.

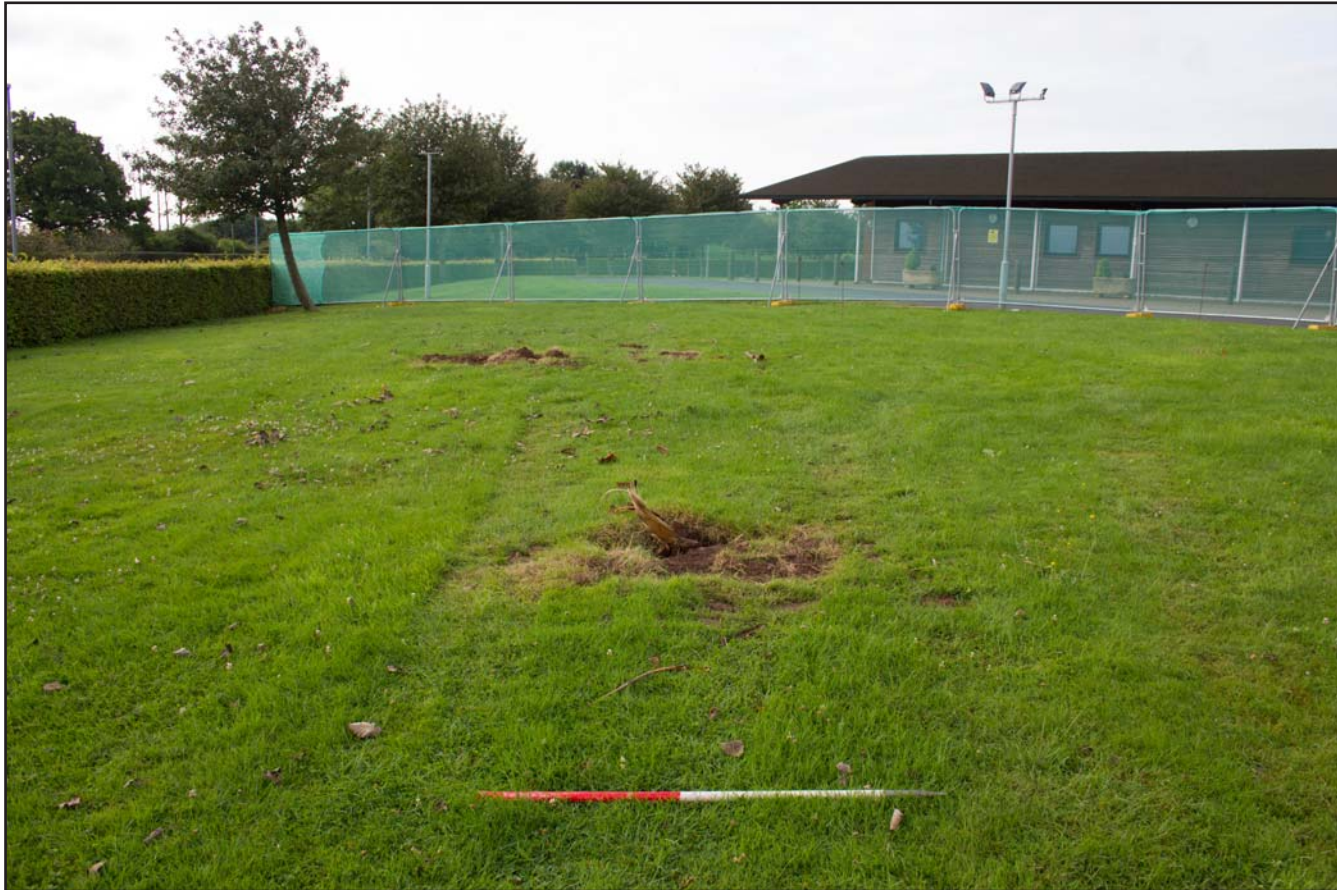
Plate 03: Pre excavation shot of area; Car Park B at Telford Crematorium, Woodhouse Lane, Redhill, Shropshire, TF2 9NJ - from the northwest - scale 1m.

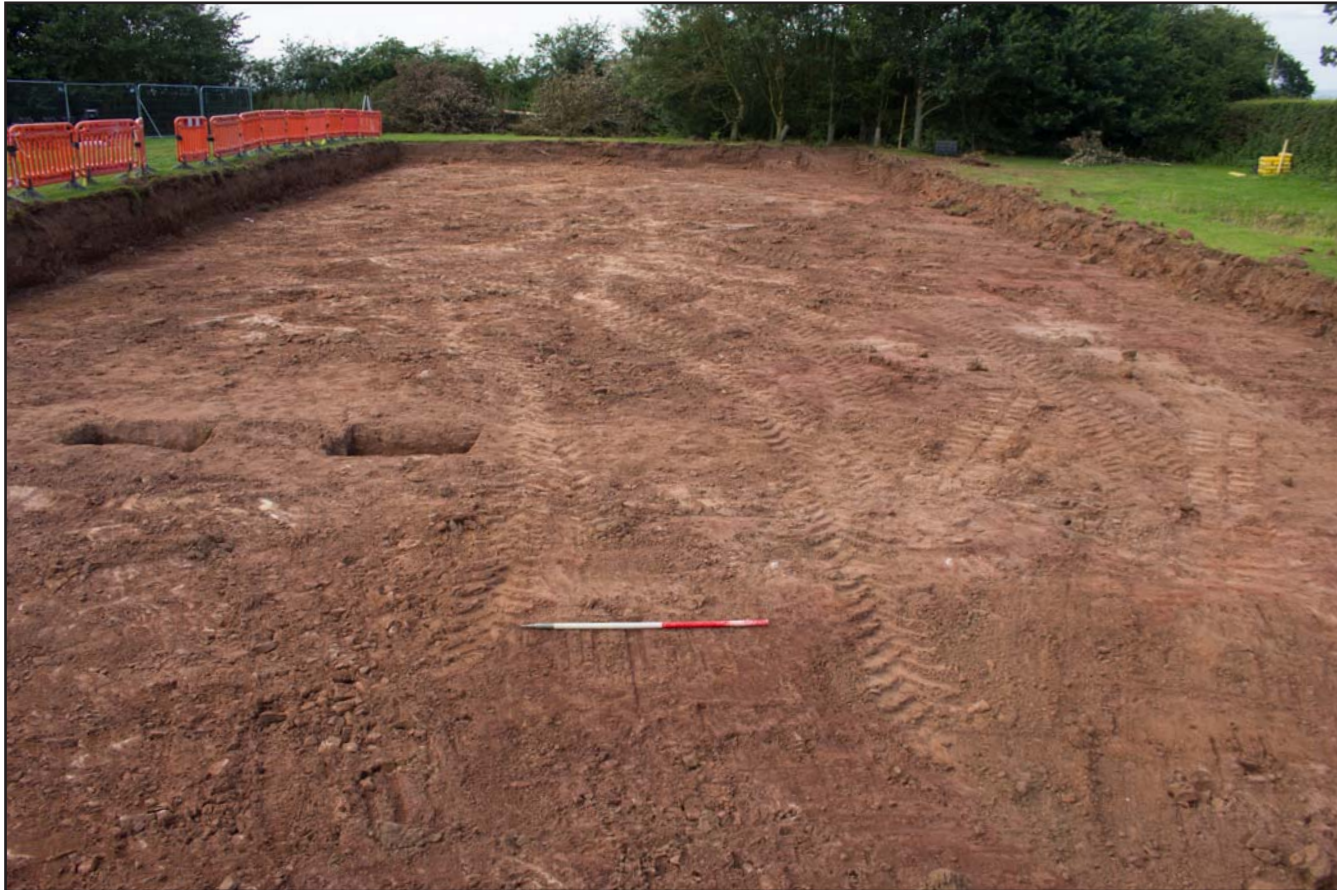
Plate 05: Post excavation shot of area; Car Park A at Telford Crematorium, Woodhouse Lane, Redhill, Shropshire, TF2 9NJ - from the southeast - scale 1m.

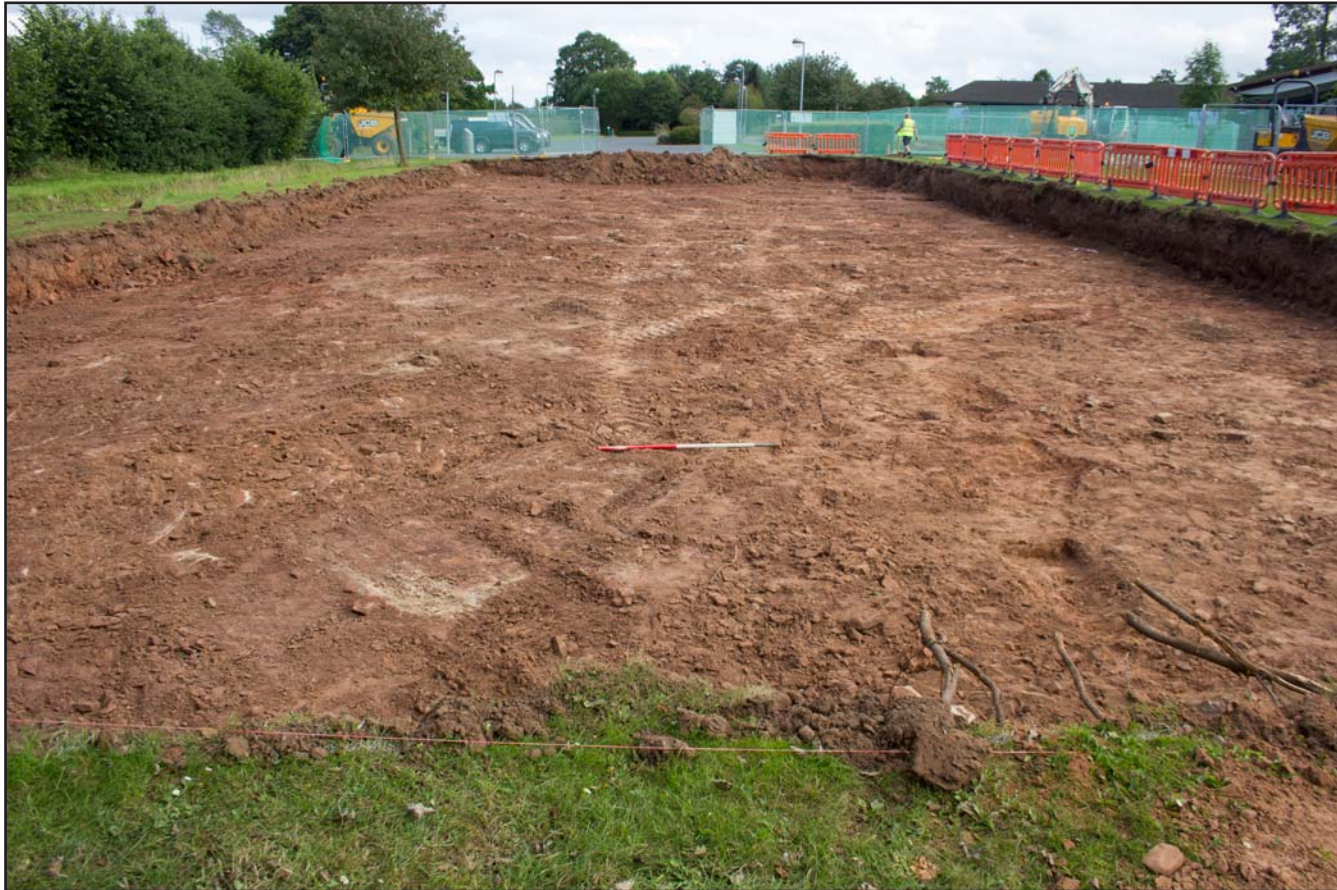
Plate 06: Post excavation shot of area; Car Park A at Telford Crematorium, Woodhouse Lane, Redhill, Shropshire, TF2 9NJ - from the northwest - scale 1m.

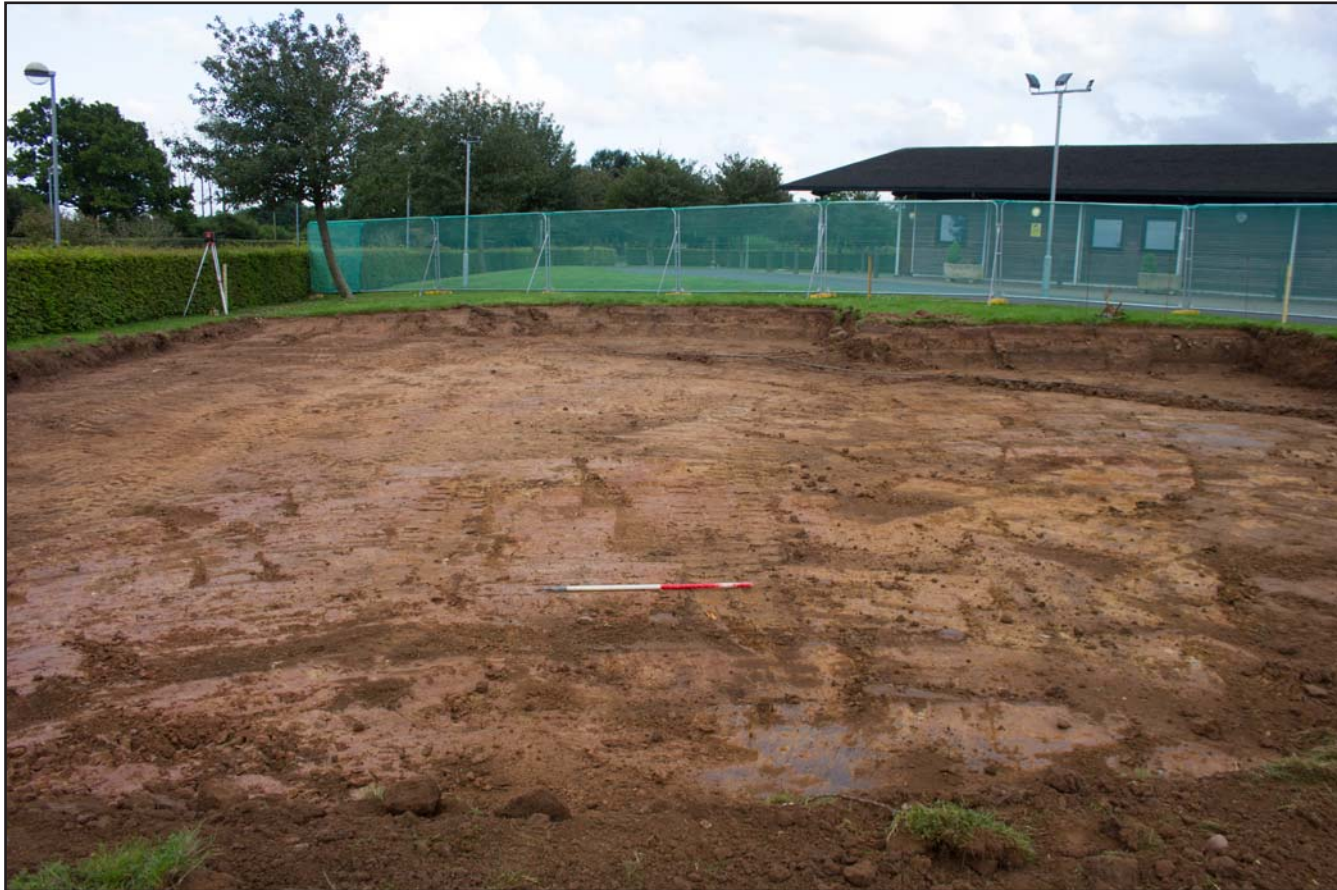
Plate 08: Post excavation shot of area; Car Park B at Telford Crematorium, Woodhouse Lane, Redhill, Shropshire, TF2 9NJ - from the northwest - scale 1m.

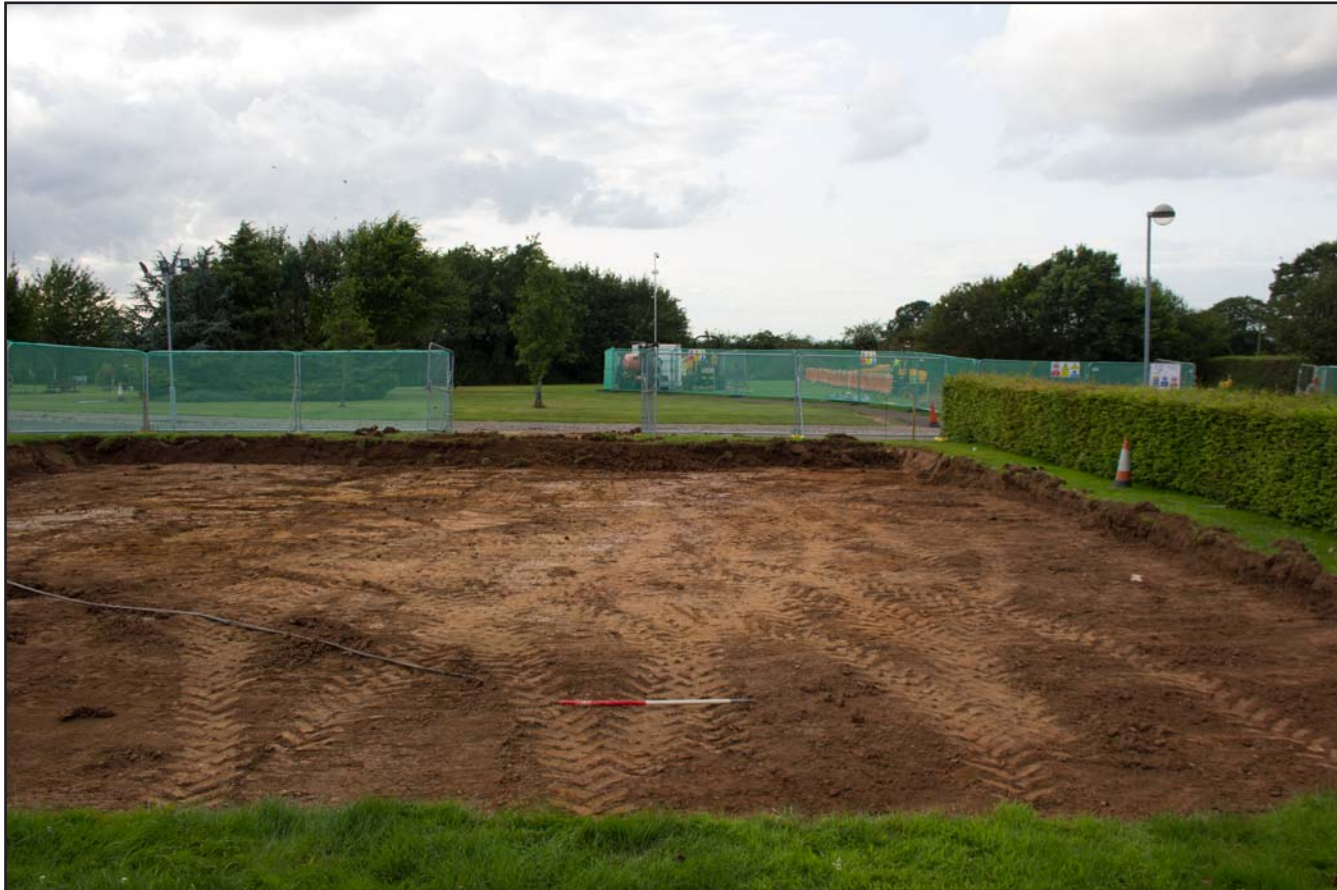
Plate 09: Post excavation shot of area; Car Park B at Telford Crematorium, Woodhouse Lane, Redhill, Shropshire, TF2 9NJ - from the southeast - scale 1m.

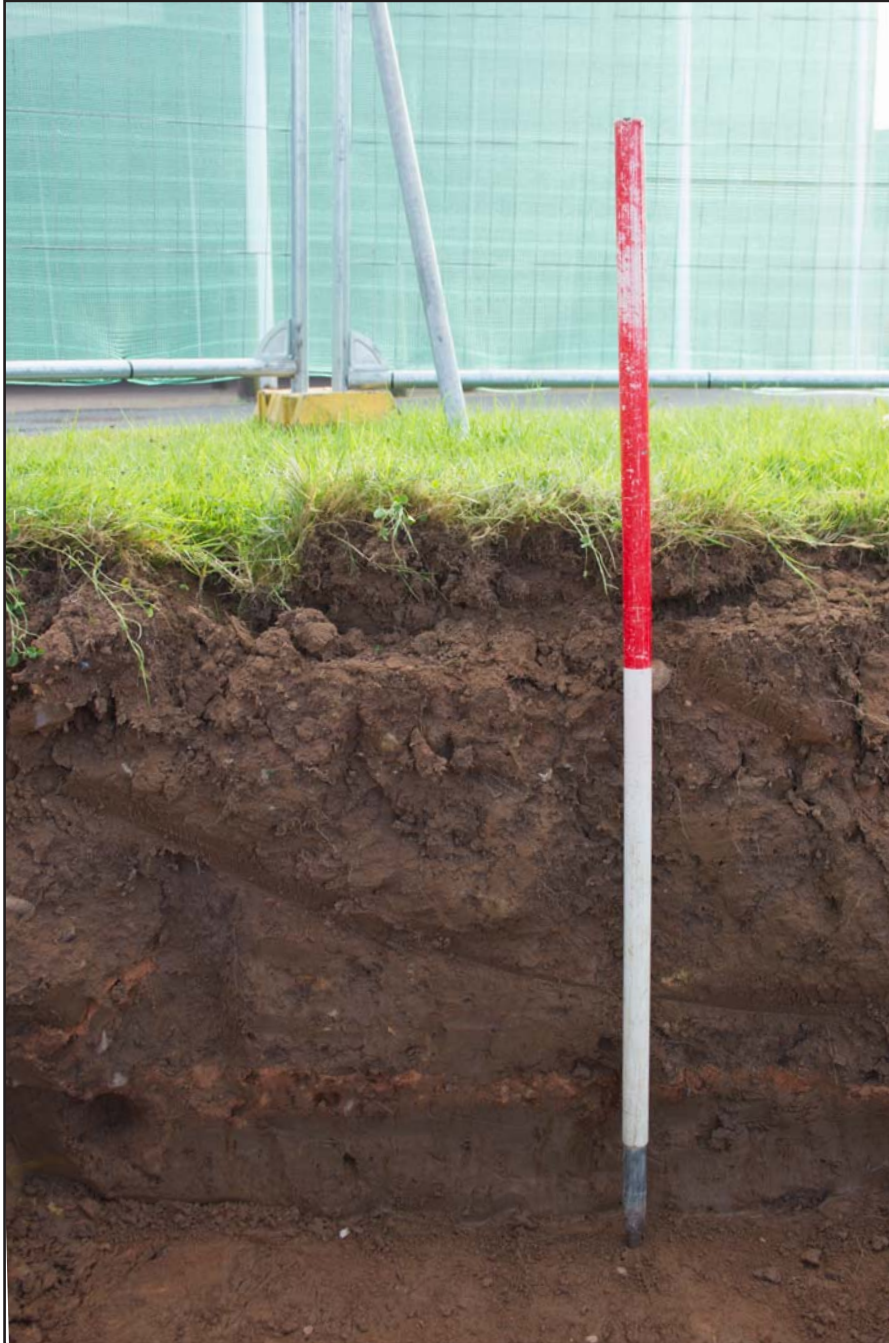
Plate 10: Generic section of excavated area; Car Park B at Telford Crematorium, Woodhouse Lane, Redhill, Shropshire, TF2 9NJ - from the northeast - scale 1m.

The reduced excavation in the area of car park B cut through approximately 0.20m of a soft, mid-red-brown, sand-silt topsoil (103). Below this layer was 0.50m of mid grey-brown, sand-silt-clay subsoil (102) with occasional inclusions of timber posts, barbed wire and plastic. In very isolated areas patches of light orange-brown, sand-clay natural (101) were exposed but generally the area retained subsoil in its base.

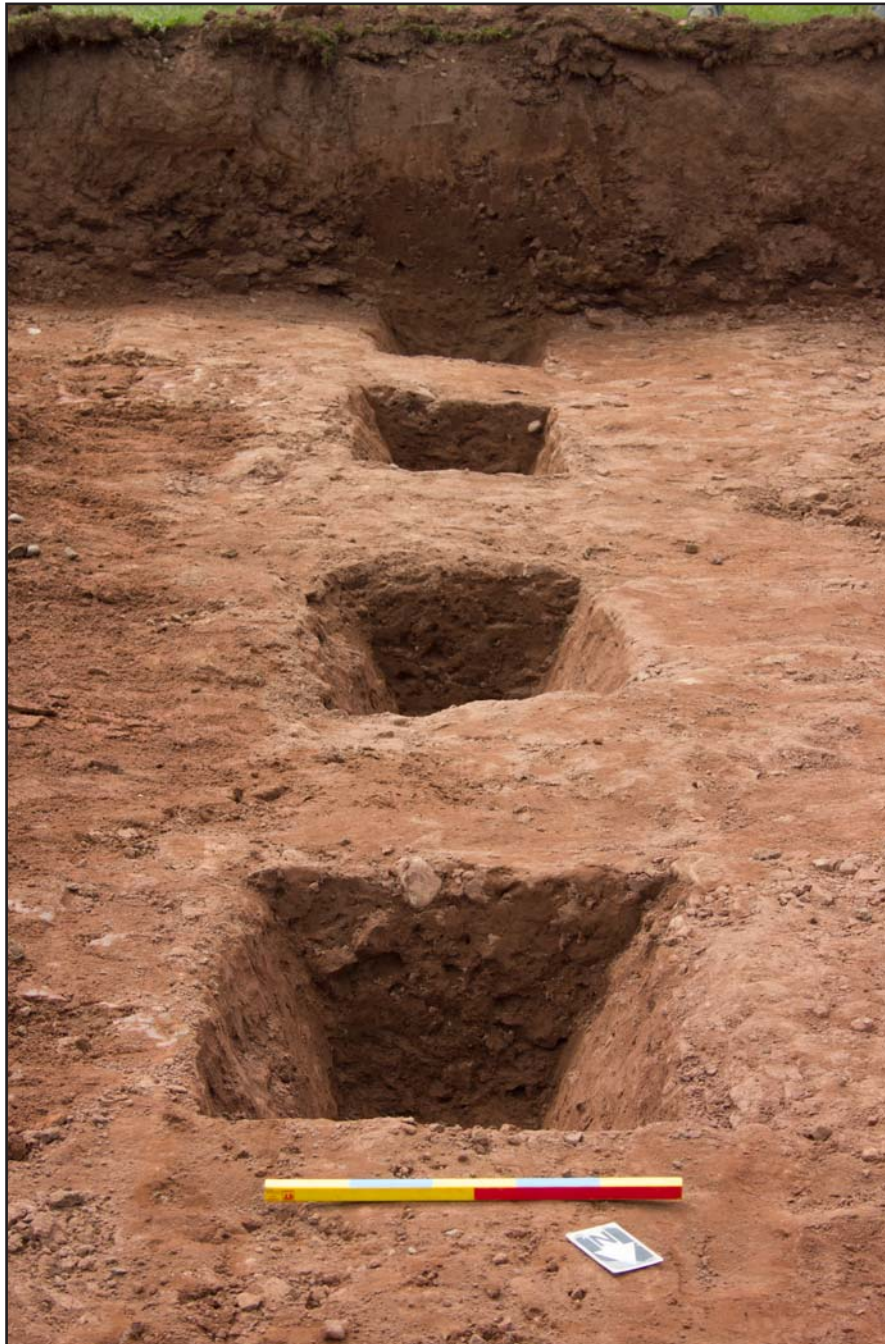
Plate 11: Plan shot showing Linear ditch [104] at Telford Crematorium, Woodhouse Lane, Redhill, Shropshire, TF2 9NJ - from the northeast - scale 1m.

Within the south-western corner of the site and cut into the sand-clay natural (101) was a >7.00m long linear ditch which was orientated southeast to northwest. This ditch had a sharp break of slope near the top of its cut [104] which proceeded sharply to the base; the sides were almost vertical. The base was quite flat although it did undulate slightly along its length. The ditch sloped at its base from southwest (176.01m OD) to northeast (175.67) achieving a fall of 0.34m across its length. The north eastern extent of the ditch [104] was obscured by 8.00m of subsoil (102) which persisted to a greater depth in this area.

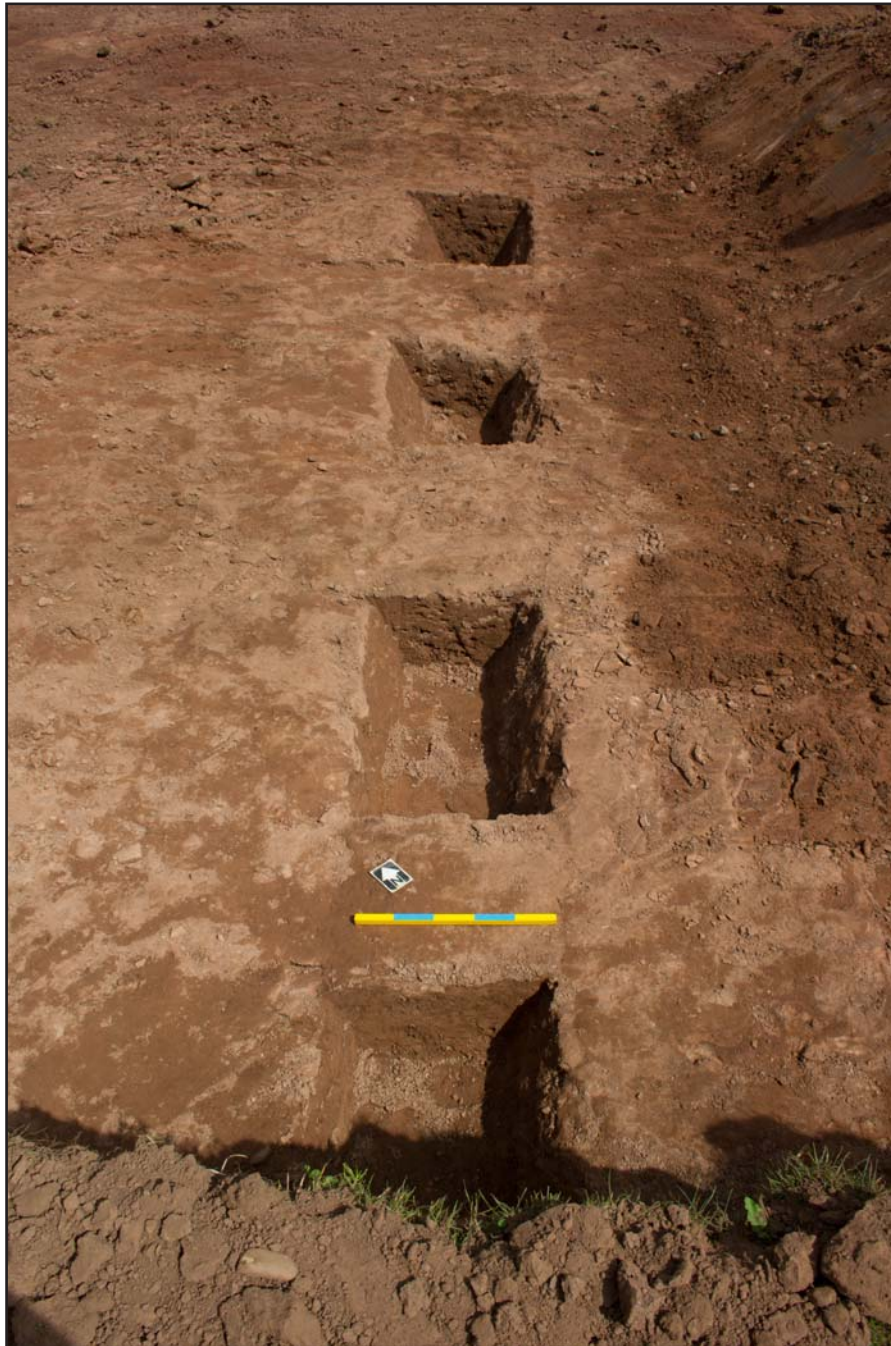
Plate 12: Plan shot showing Linear ditch [104] at Telford Crematorium, Woodhouse Lane, Redhill, Shropshire, TF2 9NJ - from the southwest - scale 1m.

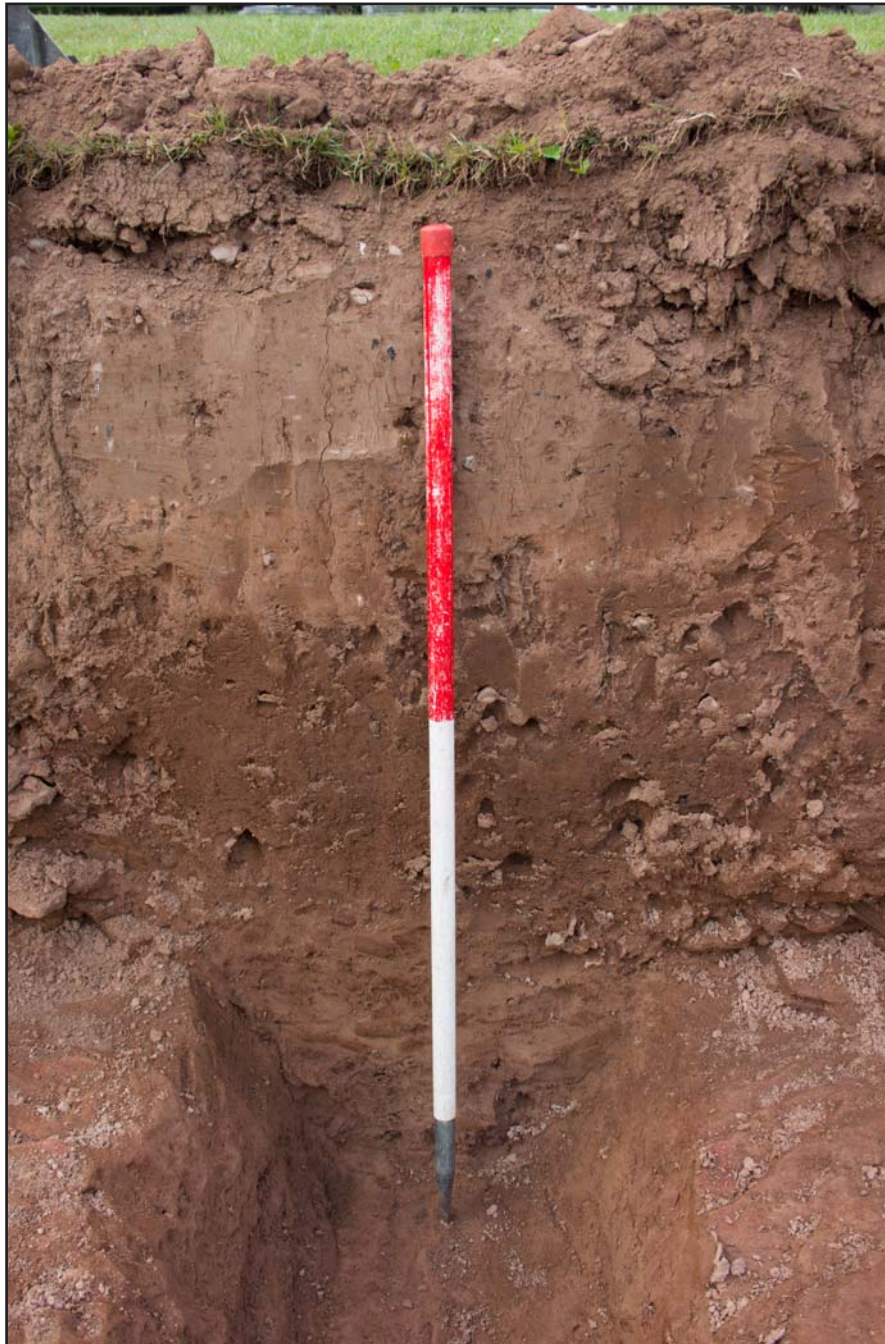
Plate 13: Section A of Linear ditch [104] within area; Car Park A at Telford Crematorium, Woodhouse Lane, Redhill, Shropshire, TF2 9NJ - from the southwest - scale 1m.

The primary fill (105) of the ditch consisted of a mid-grey brown, silt-sand-clay with occasional sub-rounded pebble inclusions and frequent charcoal flecks. It also extended to a maximum depth of 0.44m at the south western end and 0.21m deep at the north eastern end of the feature. The secondary fill (106) of the ditch consisted of a mid-red brown, sand-clay with occasional sub-rounded pebble and cobble inclusions and occasional charcoal flecks. It also extended to a maximum depth of 0.12m at the south western end and 0.31m deep at the north eastern end of the feature.
