Land between Iron Acton Way and North
Road, Engine Common

Desk-Based Heritage Assessment Report

Project Ref: 11/2390

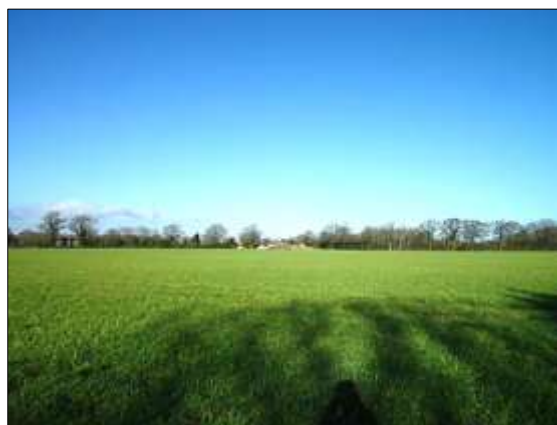
Plate a: View across Area 1, looking northeast.

- 2.2.2 Like most of the study area, Area 1 is generally flat, rising slightly to the north and west. The field had been ploughed but was well weathered. It had been planted with an Autumn/Winter sown cereal crop.

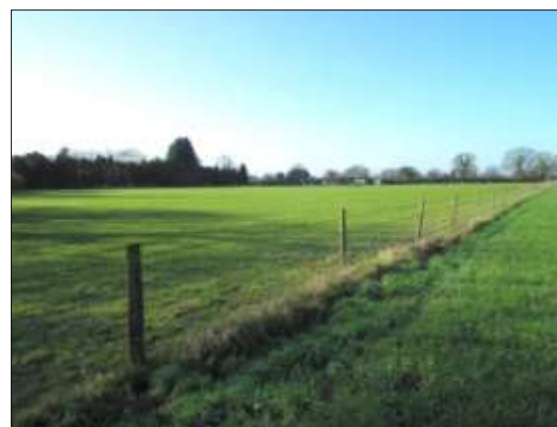
Plate b: View across Area 2, looking southwest from Area 1.

- 2.3.1 Area 2 is in effect a southern extension of Area 1, the only boundary between them is a modern post and wire fence. At the time of this survey this field was pasture for grazing sheep. The western boundary is a continuation of the hedge and ditch along Dyer's Lane. The eastern boundary is a continuation of the hedge line with Area 8, which also forms the boundary with Areas 5 and 6. The southern boundary is a Cypressa

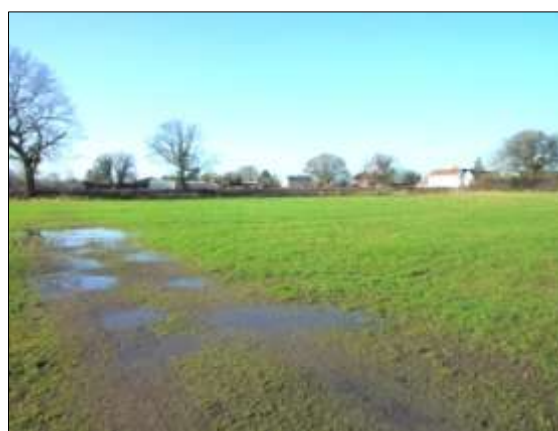
- 2.5.1 Access to this sub-rectangular field was via a gated gap in the eastern hedgerow of Area 3. The remaining field boundaries are all hedgerows. Like Area 3, Area 4 was under grass at the time of this survey. Some slight linear irregularities could be seen on the surface of this field. These were aligned roughly northwest to southeast, i.e. parallel to the long axis of the field. These could reflect former medieval or early post-medieval cultivation strips. To the south of these was a shallow rectilinear area, defined by the presence of standing water. This may represent a former trackway.

Plate c: Possible earthworks in Area 4 partly highlighted by standing water, looking west from the boundary with Area 5.

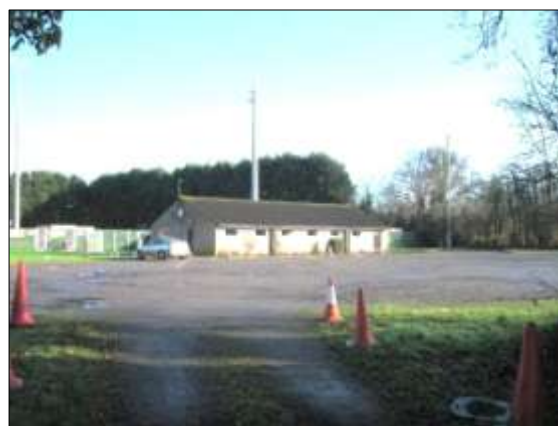
Plate d: Area 6, view of the clubhouse, with hardstanding car park in the foreground and the stadium to the rear.

- 2.7.1 Area 6 is an irregular polygon representing the footprint of the Yate Town Football Club stadium and associated features. Access to the pitch and club buildings was not required as these were considered to be of no heritage potential in themselves and unlikely to yield any surface evidence for buried archaeological remains. The hardcore surfaced car park in the

southern corner of this area was briefly inspected, but as expected yielded no information of note. Access to Area 6 was via a short track leading off Lodge Road through a mature hedgerow forming the south-eastern boundary of the study area at this point. The eastern and northern boundaries of Area 6 are of chain link fences with mature Cypressa hedges.

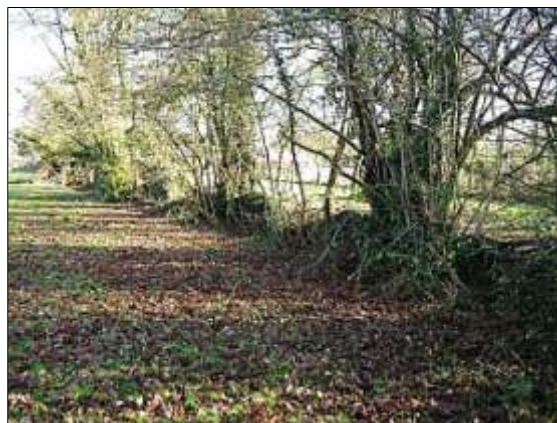
Plate e: Part of the southern boundary of Area 8, showing a dilapidated and overgrown stone wall.

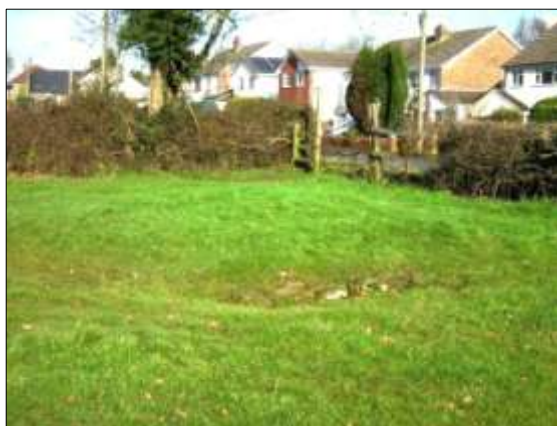
Plate g: A stone-lined hollow in the northeast corner of Area 8.

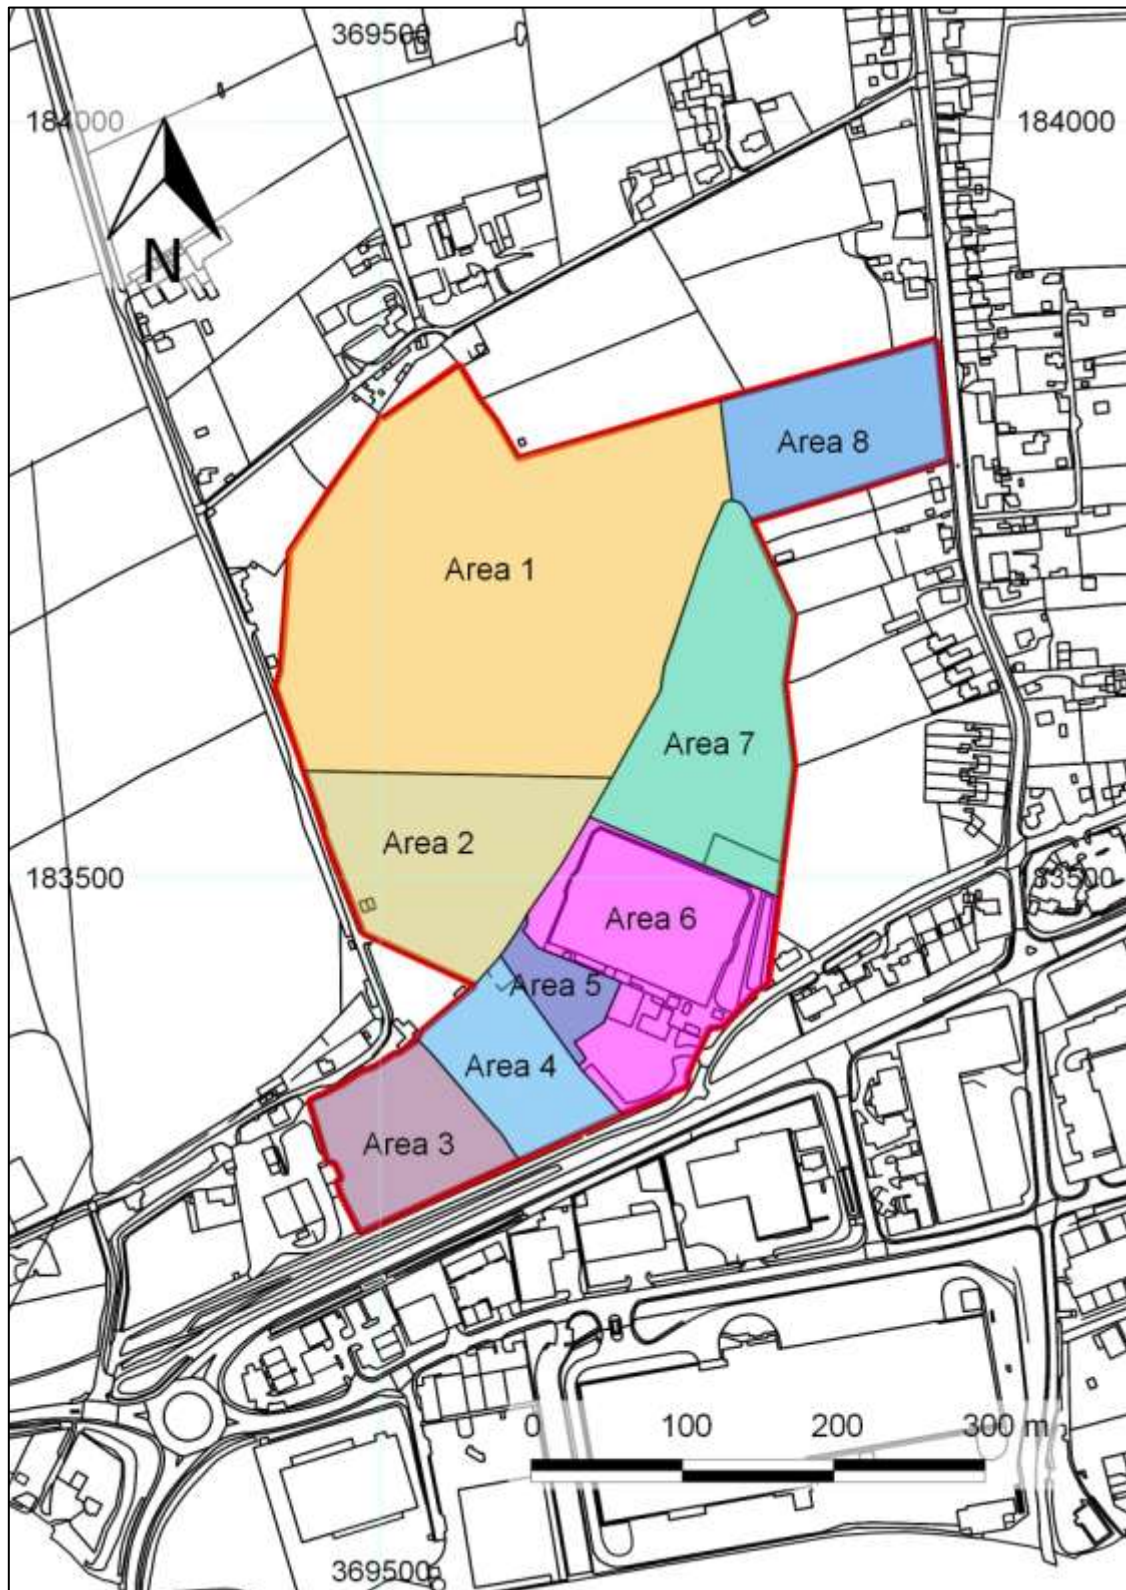
FIGURE 2

Figure 2: subdivisions of the study area for descriptive purposes. Boundary of the study area outlined in red. Approximate scale 1:5,000.

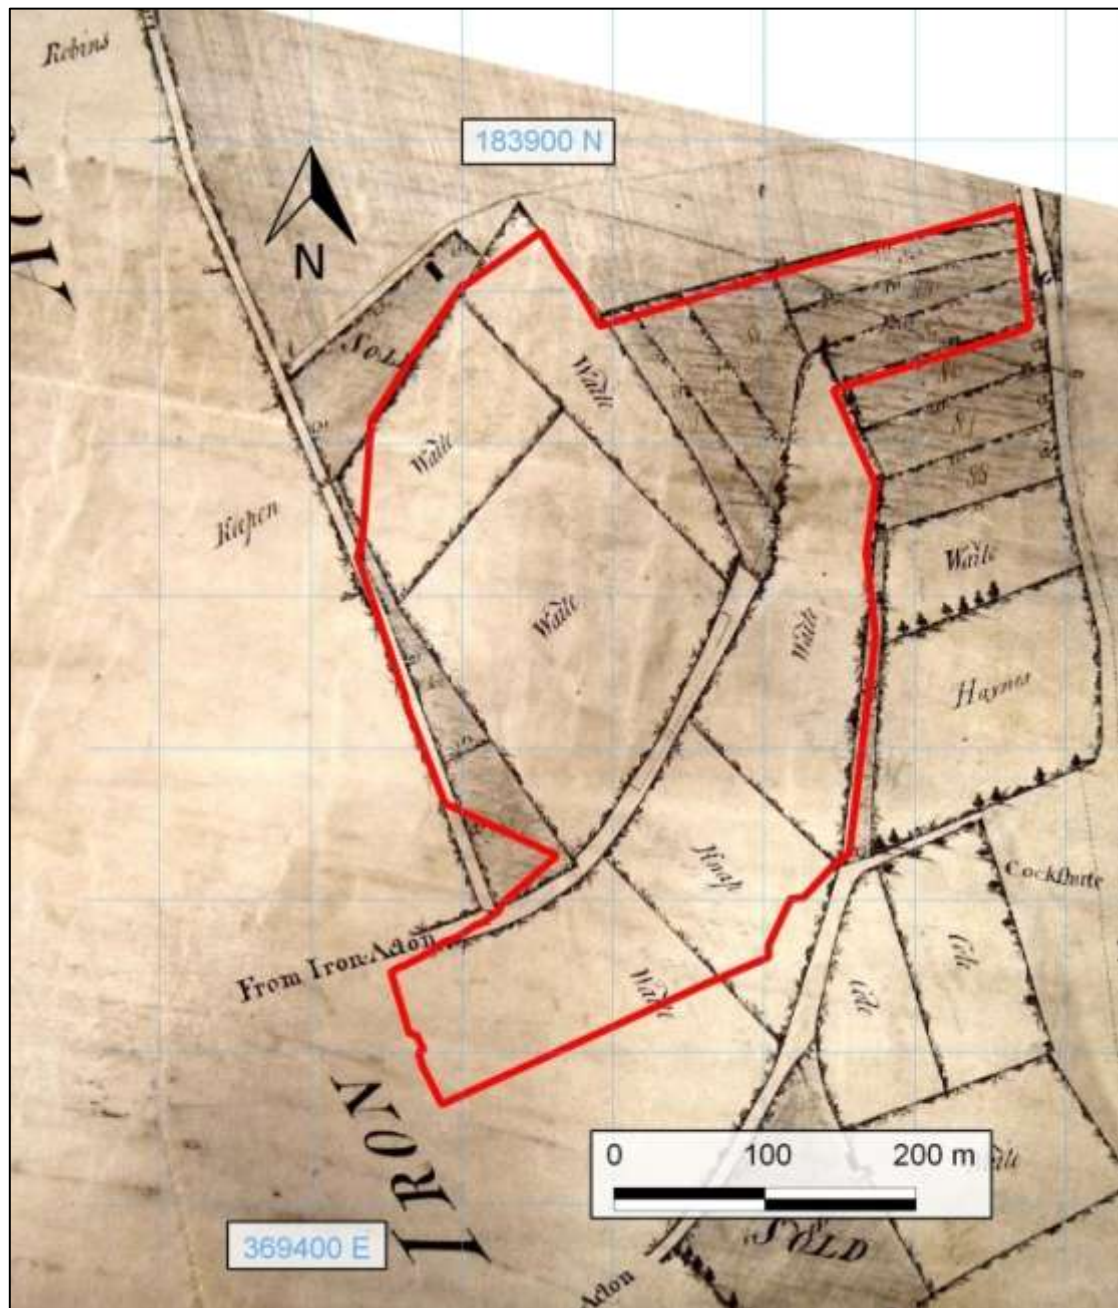
FIGURE 3

Figure 3: An extract from the 1780 Iron Acton enclosure map, BRO/40087, rectified and reproduced at an approximate scale of 1:5,000. The approximate boundary and location of the study area is outlined in red.

- 2.12.7 The course of the Roman Road, as projected on the South Gloucestershire SMR would take the road through the southeast corner of Area 8. However this route is subject to variation as there are no known earthworks associated with the road within the study area, and none were observed during the site inspection. The nearest observed earthworks and cropmarks indicating the road were at NGR ST 69975 84645 (RAF aerial photograph 106G/UK/1721/FP/1197, September 1946). A projected line between this point and the next known point of the road, near Says Court at NGR ST 69366 80941, places the course of the road some 38m west of the South Gloucestershire projection (see **Figure 8**). This would still be within Area 8, but also raises the possibility that parts of the eastern boundaries of Areas 6 and 7 might represent the course of the road, as they are within 17m of the author's projection and were shown as part of an overgrown strip of land on the 1780 Enclosure map (see **Figure 3**).

- 2.14.8 The geophysical results from Area 7 are dominated by the presence of several various linear features, all on an approximate northwest to southeast alignment (Smalley 2012:fig. 8). Seven fairly evenly spaced narrow linear features cross the field in on a roughly west-northwest by east-southeast alignment, encompassing approximately the northern three quarters of Area 7 (ibid.). These features are suggested by Stratascan to represent possible land drains (ibid.). Against this it may be argued that during the site inspection the author noted this field was far from being well drained. Furthermore, the spacing between these features is reminiscent of the narrow pre-enclosure strip field boundaries indicated in adjoining fields on the 1780 enclosure map (see Figure 3).

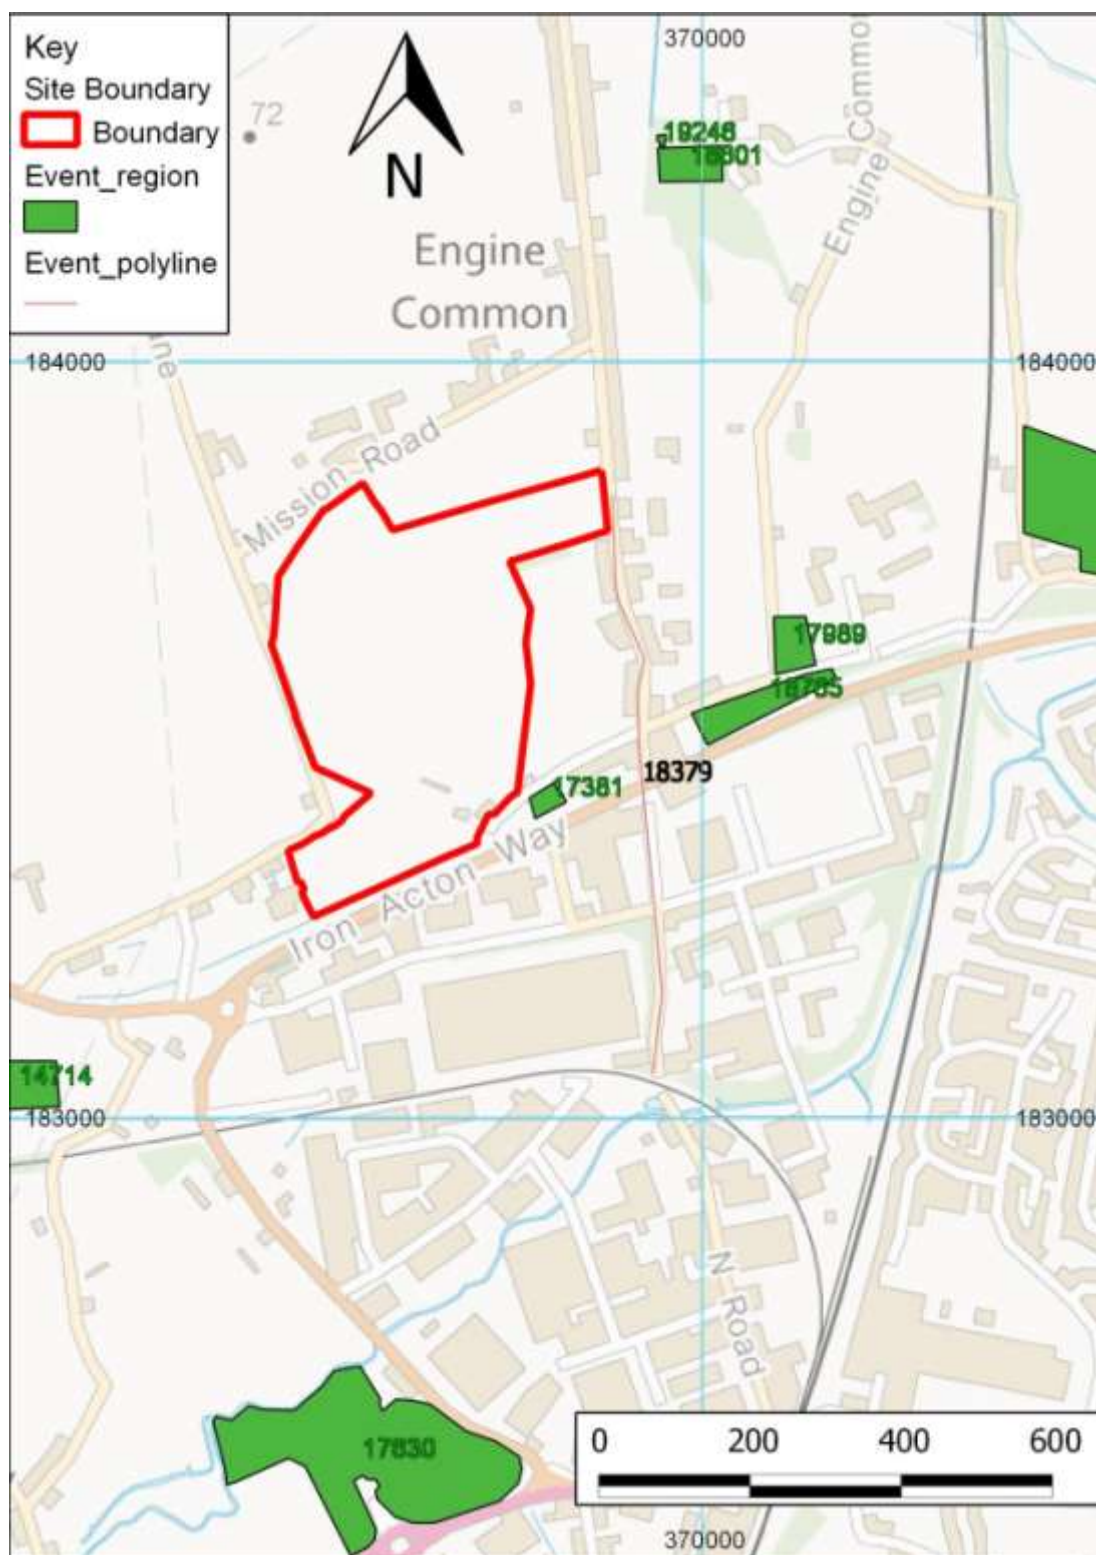
FIGURE 9

Figure 9: Location of core events within a 500m radius of the study area. Based on information supplied by and reproduced by permission of South Gloucestershire Council. Approximate scale 1:10,000. Contains Ordnance Survey data © Crown copyright and database right 2012. HER information © South Gloucestershire Council 2012.

- 2.12.8 However, as there appears to be no good evidence for the course of the Roman road through Yate, it is entirely possible the road passed through another part of the study area or did not pass through the study area at all. Archaeological trial trenching at The Chestnuts (No. 11 Lodge Road, opposite the football stadium), on the line of the road as projected by South Gloucestershire, revealed no evidence for it at that location (SGSMR 17381; see **Figure 9** and Appendix 1, Table 2). An archaeological watching brief held along a water pipeline excavation along North Road revealed no evidence for the Roman road or its possible course (SGSMR 18379; see **Figure 9** and Appendix 1, Table 2). Similarly, an archaeological evaluation and watching brief over the suggested course of the road, during redevelopment of land at Nibley, failed to locate the course of the road, though it was noted that deposits may have been truncated by previous development (SGSMR 17630; see **Figure 9** and Appendix 1, Table 2).

- 2.12.10 Evidence for historic iron working was found some 440m southwest of the study area (SGSMR 14713 and 14714, see **Figure 8**, **Figure 9** and Appendix 1).

Table 2: Events data. HER information © South Gloucestershire Council 2012. See **Figure 9** for distribution plot.

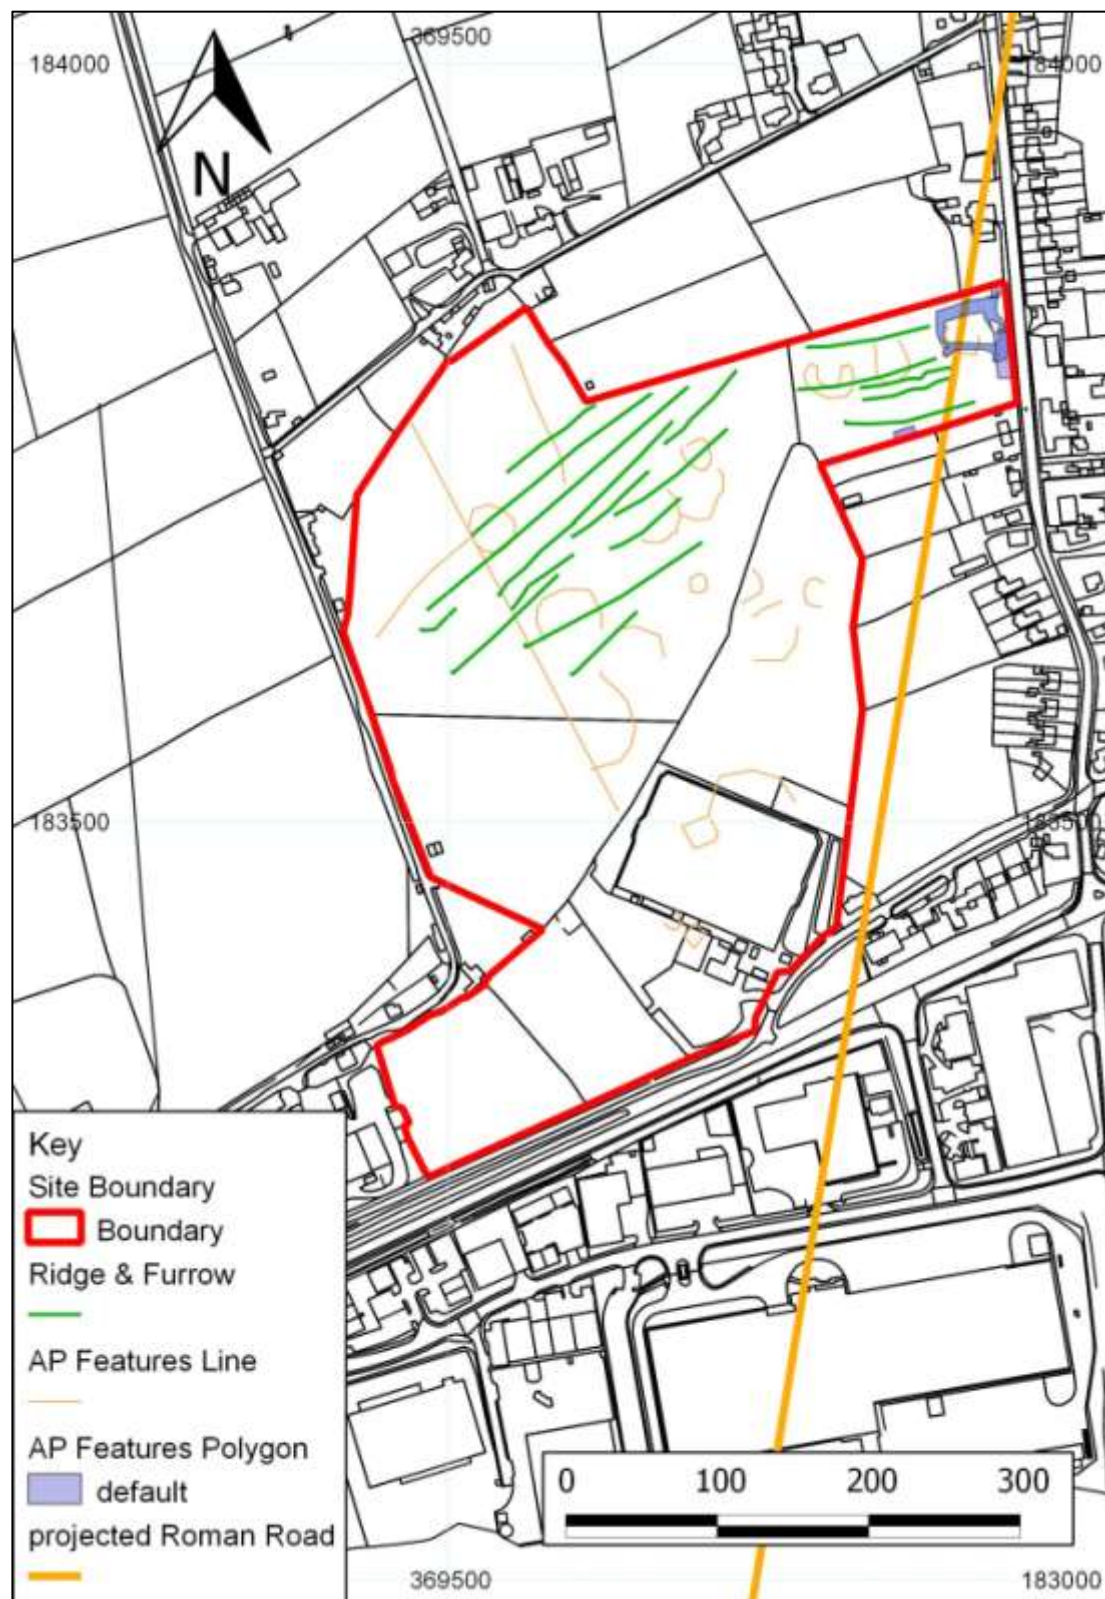
FIGURE 11

- 2.13.2 The principal results have been sketched onto **Figure 11** and are as follows.
- 2.13.3 A series of roughly parallel dark linear cropmarks were observed on several RAF photographs within Areas 1 and 8. These are interpreted as representing the traces of former ridge and furrow cultivation that would have pre-dated the 1780 enclosures but is unlikely to be earlier than the later Middle Ages (c. AD 1100-1540). In Area 1 it is likely that all surface traces have been ploughed out. In Area 8 there are surface irregularities that may relate to former ridge and furrow cultivation. Their presence indicates these parts of the study area were probably part of a medieval 'great field' and were therefore not used for settlement at that time. As archaeological features they are commonplace in lowland England. Unless surviving examples are of exceptional quality they do not usually merit preservation in situ. Within the context of the study area and its environs these examples are not considered to meet this standard.

- 2.13.4 A single linear feature traversing Areas 1 and 2 from northwest to southeast was observed on aerial photographs from the late 1940s. As this was respected by the ploughing of the time it is interpreted as a modern field boundary that was not recorded by the Ordnance Survey. This boundary is no longer extant.

- 2.13.6 A single linear parch mark feature, aligned roughly northwest to southeast, located in the northern corner of Area 1, is interpreted as a footpath, probably of post-medieval or 20th century origin. No trace of this feature was observed on the ground during the site visit.

- 2.13.7 A series of indistinct dark crop marks were observed on aerial photographs from February and April 1955. These were located in Areas 1, 2 and 7. They were generally circular or semi-circular in form. Because of their indistinct nature the interpretation of these features is therefore highly speculative. They could possibly represent traces of settlement or field patterns that pre-date the later Middle Ages, however they could equally be a product of the underlying geology, which at these locations is believed to be relatively shallow.

- 2.13.8 Three small sub-rectangular cropmarks were observed on the same aerial photographs. These were located in Areas 5 and 6. The latter has now been largely covered by the football stadium and associated development.

- 2.13.11 In the northeast corner of the study area, an irregular patch of surface scarring was observed on January 1946 photographs. The cause of this scarring could not be determined but may have been due to contemporary ground disturbance, possibly by livestock. A small rectangular structure, interpreted as a shed, was located in the vicinity. These features, including the shed, were not present when the area was photographed again in September 1946.

- 2.13.12 Aerial photographs from the 1950s indicate some temporary rectangular structures had been erected within Area 8. Two were in a row inside the North Road frontage, while a further two were located against the southern boundary. A strip of darker land inside the North Road frontage may indicate allotment cultivation. An unusual structure was observed in the far north-eastern corner. This appeared to be an upright structure of pyramidal shape, rather like a small obelisk. None of these upstanding features were observed on the 1940s aerial photographs and none were observed on subsequent aerial photographs from 1970 and 1989. The rectangular structures were probably sheds.

Figure 11: Features observed on vertical aerial photographs held in the NMRC, Swindon. Approximate scale 1:5,000.

- 2.13.13 To sum up the results of the aerial photographic interpretation exercise, several features have been observed within the former study area that probably relate to pre-1780 agricultural use of the land. These are not considered significant to warrant further investigation on their own. Some features appear to relate specifically to land use in parts of the study area during the late 1940s and 1950s. Again, these do not appear to warrant further investigation. Some indistinct features have been observed in Areas 1, 2, 7 and 8 that may possibly relate to pre-medieval land use. These features may require further field investigation.
