The Salvation Army Candle Building, Ashley
Road, Bristol

Standing Building Survey Report

Project Ref: 14/2488

30 May 2014

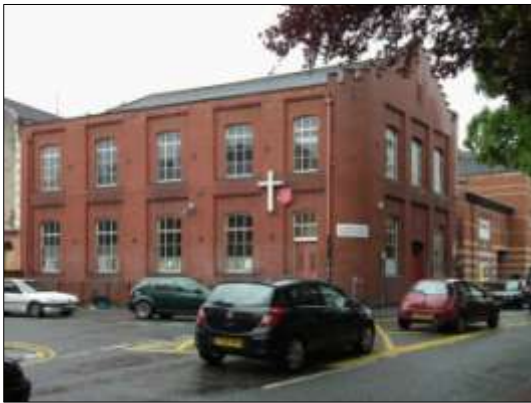
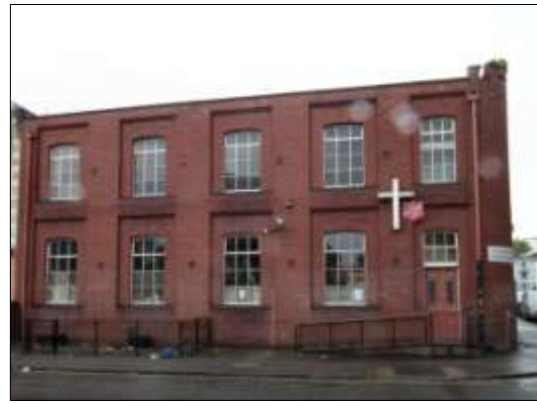
- 2.3.3 The east face is the most visible, since it can be seen at least in part from some distance east along Ashley Road (Plates a & b). The two main levels are divided externally into six recessed bays each, with a wooden framed 12 pane louvre window in all but the northernmost ground floor bay. The latter contains a narrow double door entrance accessible by ramp, surmounted by a six pane wooden frame louvre window. Around the top of this face runs a low level parapet capped with blue ceramic tiles. The external sills of each window bay are picked out in moulded blue coping bricks, while the upper edge of each bay is picked out in moulded red brick. Above the door and each window is a segmental arch in red brick.

Plate a: the Candle Building, looking southwest across Ashley Road. No scale.

Plate b: the east face of the Candle Building, looking west across Brigstocke Road. Scale at distance, 2m.

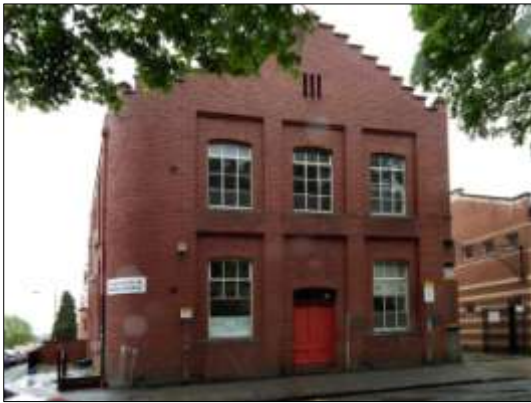
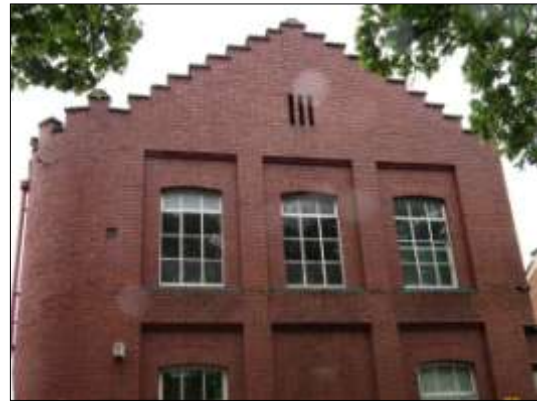
- 2.3.5 The north face of the building (Plates c & d) is possibly the most decorative, but is harder to observe, since Ashley Road is narrower than Brigstocke Road, with mature trees on the north side that obscure views from the houses opposite and from the pavement. The two main storeys are each divided into three rectangular recessed bays of similar form to those described previously. With the exception of the ground floor central bay all contain a wooden framed louvre window surmounted by a segmental arch in brick. The former is a wooden double-door entrance with a single sandstone step up, with wooden framed four pane glass transom over, surmounted by a segmental brick arch.

- 2.3.6 East of the door three rectangular sandstone dedication stones are set into the brickwork at selected locations, but these are worn and largely illegible. Centrally located in the gable end roof space above the upper storey, are three parallel vertical air vents. The parapet to the roof is in equal steps, with flat topped coping in brick or stone. Where the parapet meets the rounded northeast corner it becomes crenelated, giving a turret effect.

Plate c: the north face of the Candle Building, looking south across Ashley Road. Scale 2m.

Plate d: detail of the north face, looking south, no scale.

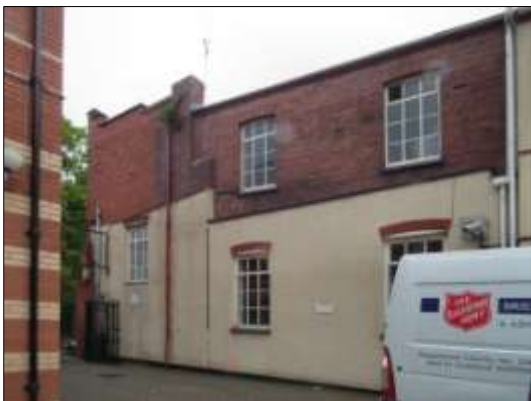
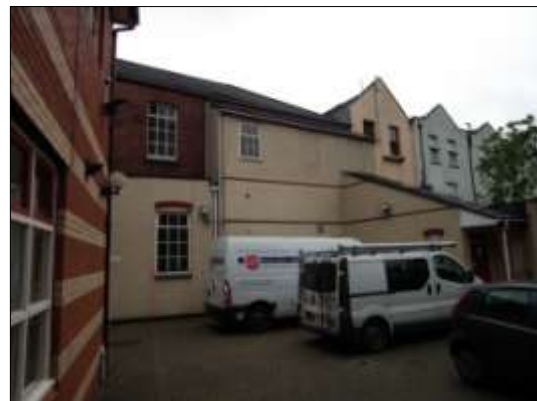
- 2.3.7 The west side of the building (Plates e & f) is the least decorative but the most complex, since it has been heavily modified. Here the differences between ground and first floor are most apparent, since the walls of both are on a different alignment. The first floor is therefore narrower but more rectangular in shape than the ground floor, with a 1.8m difference between the two at the southwest corner. This area is the most obscured, since a later 20th century covered fire escape and extension has been built against the original brickwork, obscuring it. All the modern work has been rendered and painted, as has all the ground floor brickwork of the original building. Therefore only the northern upper half of this face is visible. Here the quality of the brickwork indicates it was not intended for public display. Windows consist of one wooden framed sash with segmental arch over, about mid-way up the northern end of the wall, together with four wooden framed louver windows a little way to the south, two up two down.

Plate e: west face of the Candle Building, looking northeast, scale 2m.

Plate f: west face of the Candle Building, looking southeast, scale 2m.

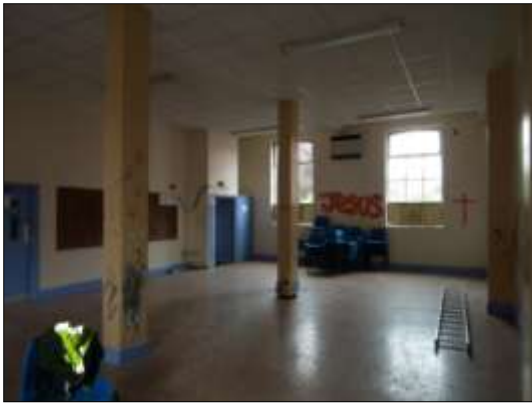
Plate g: Dining Room (G3), looking northeast.

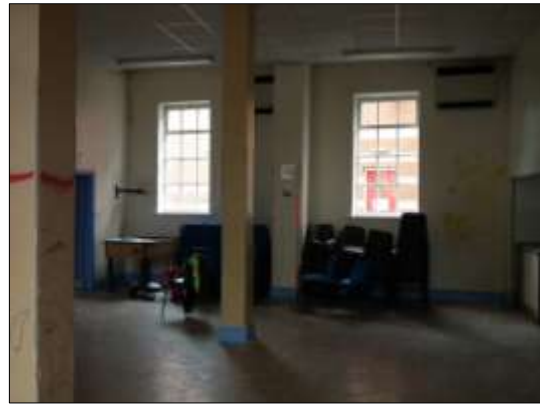
Plate h: Dining Room (G3) looking southwest, scale 2m.

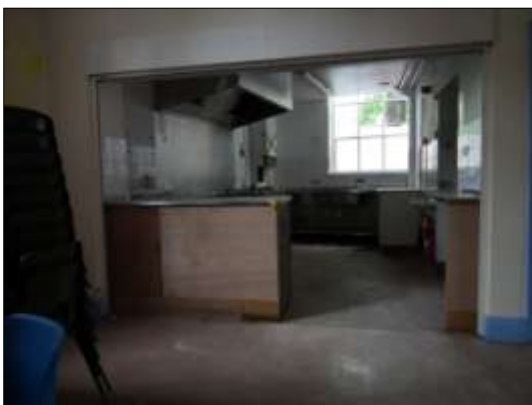
- 2.4.2 In the northwest corner of the ground floor is the open plan kitchen (G4, see Plate i). The lower ceiling here is the result of the mezzanine room above. This obscures the upper portion of the single large 12 pane rectangular window in the north wall.

Plate i: kitchen G4, looking northwest. Scale at distance, 2m.

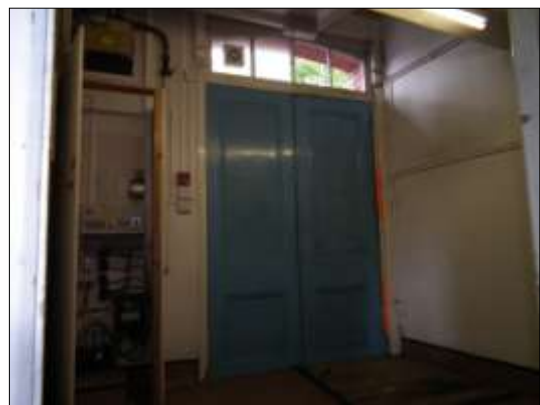
- 2.4.3 The main feature of room G5 (see Plate j) is the solid wooden front double doors, with glass lights above, which open onto Ashley Road. The room itself has been fitted with shelves, indicating the doors have been little used in recent times.

Plate j: entrance lobby and front door, looking north. Scale 2m.

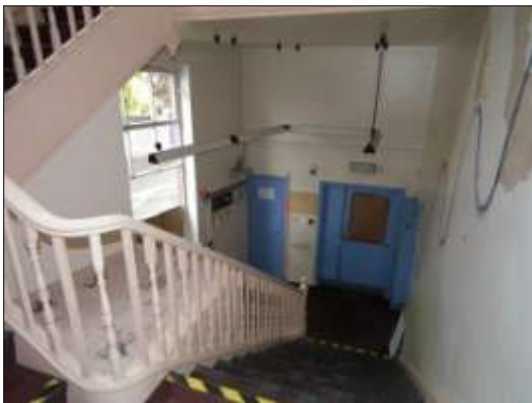
- 2.4.4 Area G6 (Plates k and l) includes the entrance opening onto Brigstocke Road, located in the northeast corner of the building, together with the main staircase to the first floor and mezzanine room above the kitchen. The main entrance consists of a short hallway with two sets of opposing double doors at each end. On the north side of the entrance is a small storage room. The lobby and stairwell are lit by a large wooden framed sash window in the north wall. The entrance faces the main wooden staircase, with turned wooden balustrade and newel post. The posts of the balustrade alternate between turned and rectangular.

Plate k: the main staircase and the Brigstocke road entrance lobby, from the lower landing, looking northeast. Scale 2m.

Plate l: the main staircase, looking southwest.

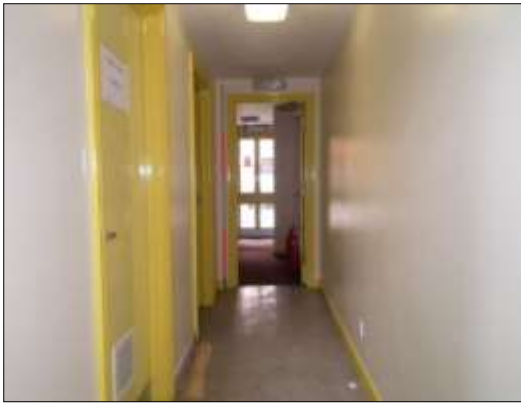
- 2.4.5 The south side of the ground floor has been heavily partitioned into toilets, cloakrooms and cupboards, with the addition of a low false ceiling masking the mezzanine storage area above (for example see Plate m). Although all rooms were inspected, no original fabric could be observed in any except rectangular room G7 (Plates n and o), located in the southeast corner of the building. This area was not affected by the addition of the mezzanine. At the time of inspection the false ceiling had largely been removed, though nothing remarkable was observed above it. In the west wall were two large rectangular wooden framed louver windows of 12 panes each, though the lower frames had been boarded over, presumably for security reasons.

Plate m: corridor G7 looking southwest, scale 2m.

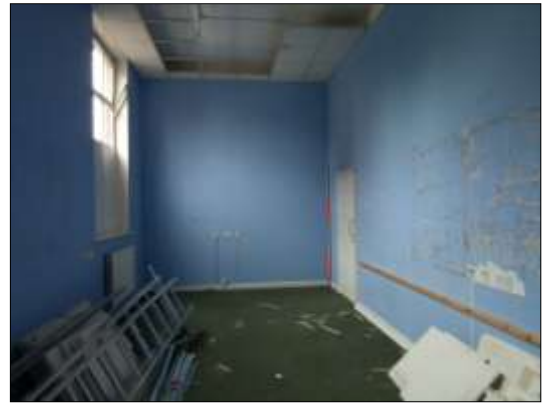
Plate n: room G8 looking south southeast. Scale 2m.

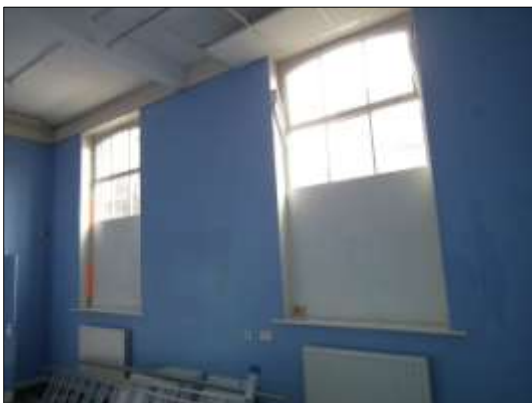
Plate o: the windows in the east wall of room G8, looking north. Scale 2m.

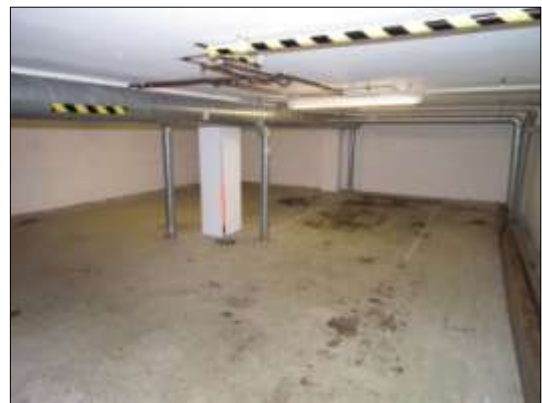
- 2.5.1 Two mezzanine areas were observed (Figure 4). Although these are both later 20th century additions, they each preserve elements of the core building. Area M1 (Plate p) is a low (1.68m) rectangular room in the southern end of the building, formerly used as a storage space. Area M1 is accessed from a landing at the foot of the first floor external stairway (see Figure 5 and Plate l), also added in the later 20th century. An opening in the west wall of M1 provides access to the under stairs area, where part of the earlier west face, including a blocked window, could be observed (Plate q).

Plate p: room M1 looking northeast, scale 1m.

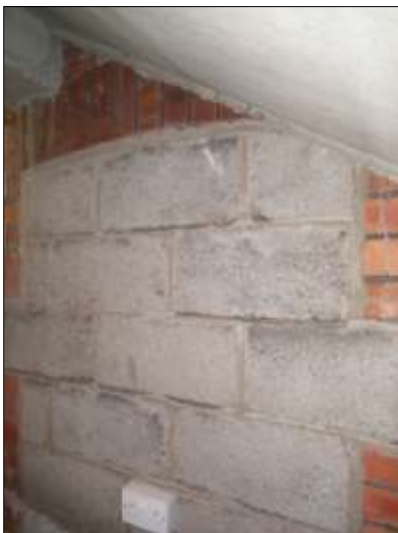
Plate q: blocked window in former frontage (M2), looking north. No scale.

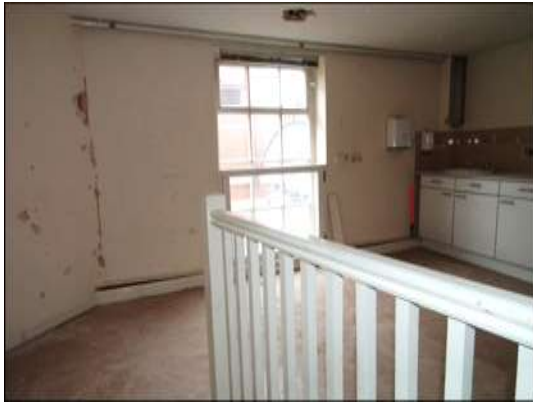
- 2.5.2 The second mezzanine area (M2) is accessed through a door on the west side of the main staircase lower landing. A short flight of two steps leads up to the main floor of this room (Plate r), which is fitted out as a domestic kitchen area. The main feature of interest here is the sash window located in the west wall (Plate s).

Plate s: room M3 looking northwest, scale 1m.

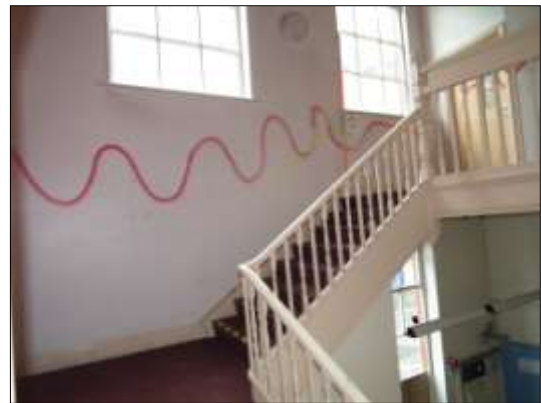
- 2.6.1 Access to the first floor is via the main staircase in the central northern part of the building. The staircase is U-shaped, with two landings on the west side separated by a short flight (Plates k, l & t). The southern landing is the lower and provides access to the mezzanine room (M2). The stairwell is lit by two 12 pane louvre windows in the north wall at first floor level (Plate u). Room F2 is accessed from the first floor landing F1. Room F2 occupies the northeast corner of the building, but exhibits no unusual features other than the 12 paned louvre window in the east wall, the upper portion of which is obscured by the false ceiling.

Plate t: the main staircase from the lower landing, looking north. Scale 2m.

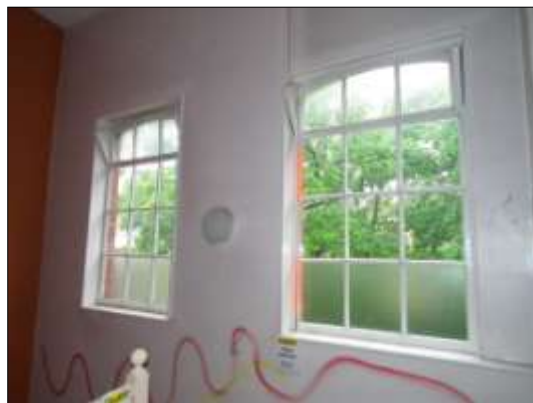
Plate u: the staircase windows in the north wall, looking northwest. Scale 2m.

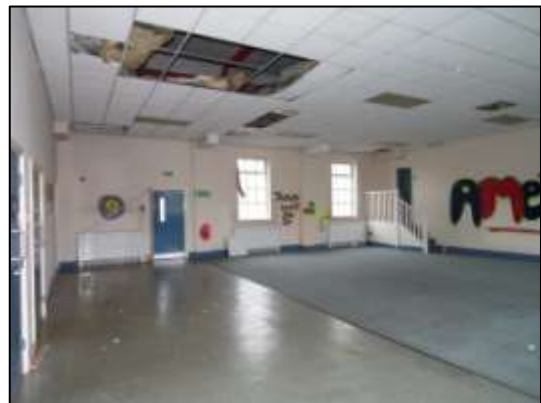
- 2.6.2 The majority of this floor is occupied by area F3, a large open plan space formerly used for children's play. This is lit by two 12 pane wooden framed louvre windows on the west side (Plate v) and three on the east (Plate w). The ceiling is false, but in the southern central area enough tiles had been removed to reveal a shaped and painted wooden ceiling above (Plates x & y).

Plate v: Area F3, looking west. Scale at distance 2m.

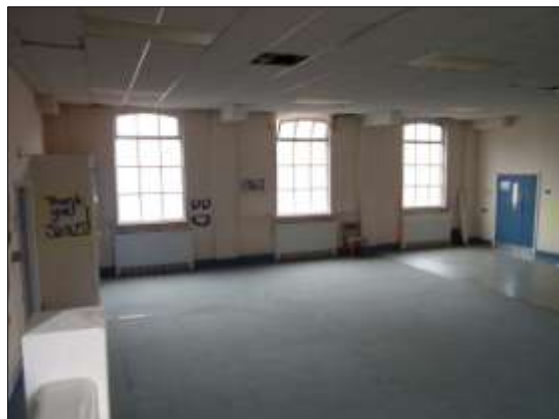
Plate w: the east wall of Area F3, looking east. Scale at distance 2m.

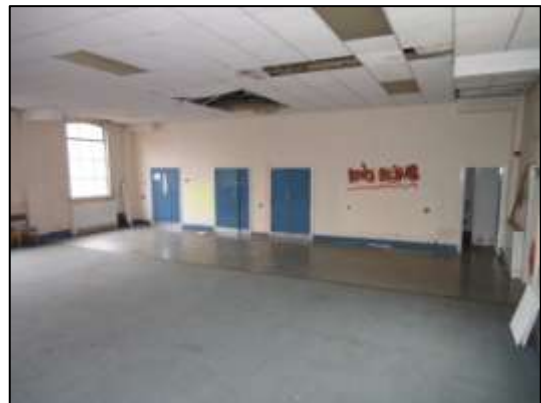
Plate x: area F3 looking southeast. Scale at distance 2m.

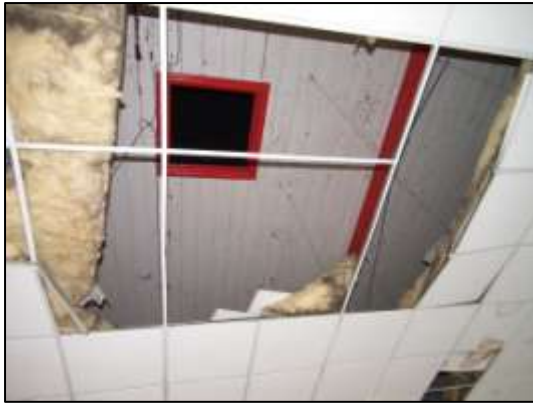
Plate y: area F3, exposed portion of original ceiling.

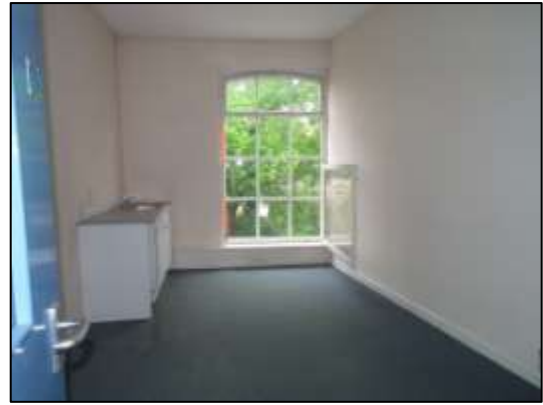
- 2.6.3 In the northwest corner of F3 is a short flight of wooden steps leading to room F4, formerly a clinic room. This room exhibits a single 12 pane wooden framed louvre window in the north wall; it also has a false ceiling.

Plate z: room F4, former clinic, looking north. Scale 2m.

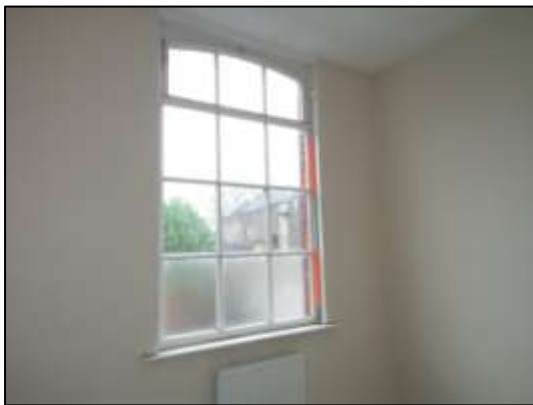
- 2.6.4 Room F5 in the southeast corner is accessed directly from F3. Formerly a community storage room, the only visible feature of note is the window (Plate aa).

Plate aa: room F5, looking east. Scale 2m.

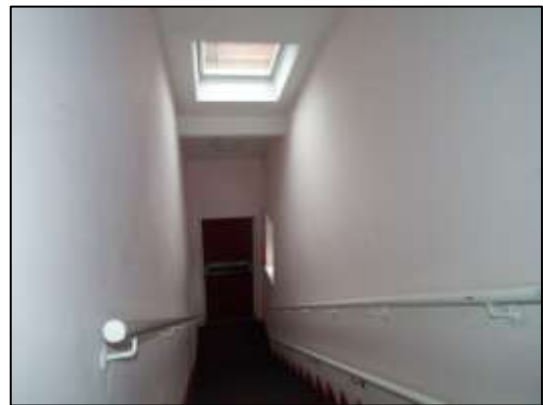
- 2.6.6 The covered L-shaped fire escape F8 (Plate bb), located on the southwest face of the building, is accessed by a door on the south side of the west wall of F3. The mid-stage landing provides access to Mezzanine area M1.

Plate bb: fire escape from mezzanine landing, looking southwest. Scale 2m.
