BRISTOL & WEST ARCHAEOLOGY

University of Bath Arts Barn,
Claverton Down Campus, Bath

Standing Building Recording Report

28 May 2014

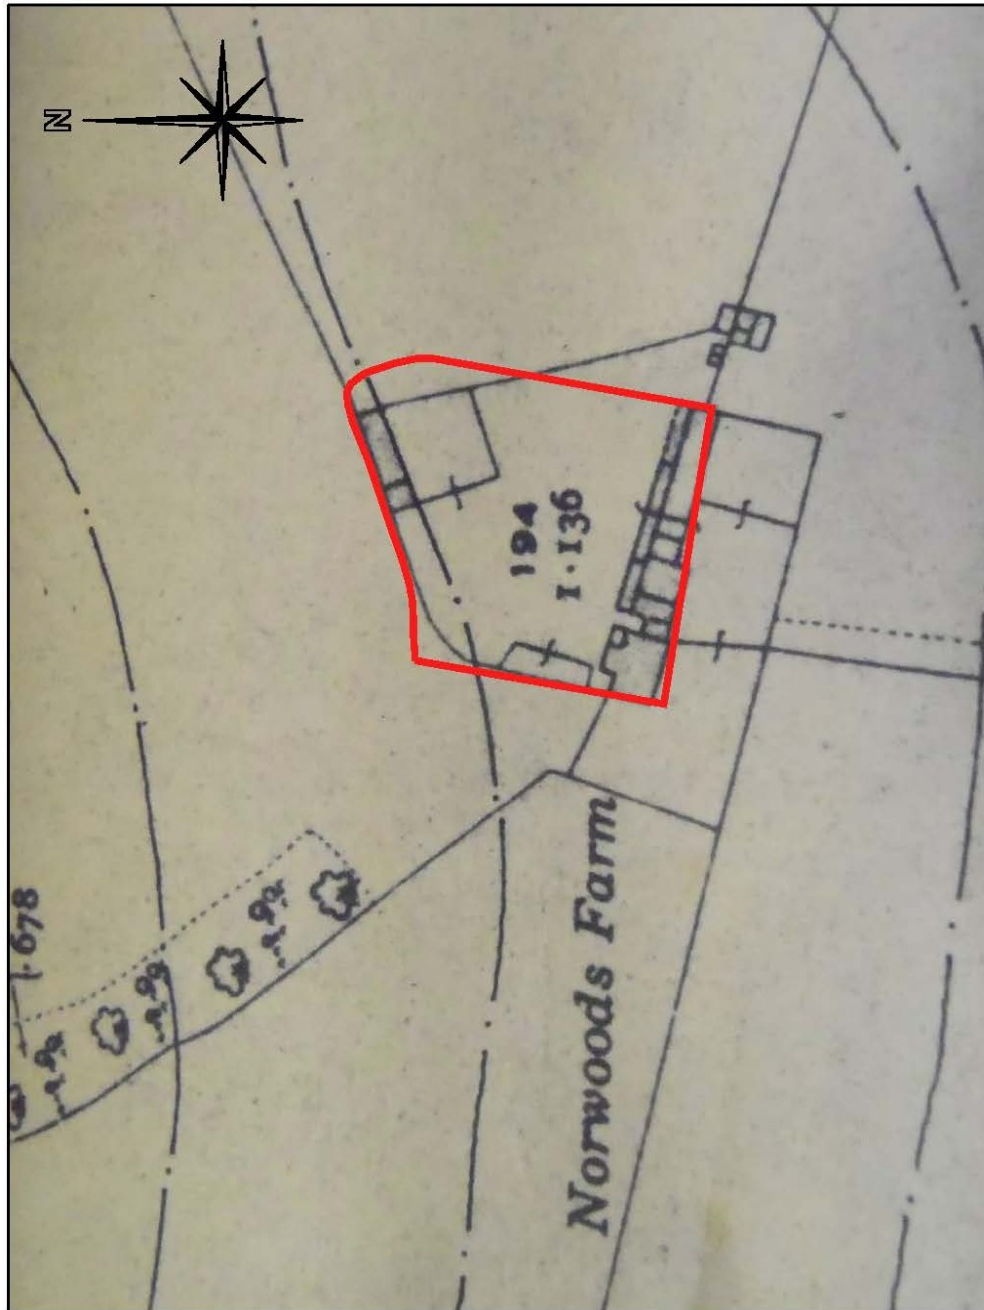
Figure 4. Extract from 1964 (1:1250) OS. Reproduced courtesy Bath Record Office.

- 3.10 The building later called the 'Arts Barn' is first depicted on the 1887 First Edition Ordnance Survey on the north side of a small enclosure where it formed part of "Norwoods Farm" (Fig. 3). The building is also shown on the 1964 Ordnance Survey by which time it is no longer named (Fig.4).

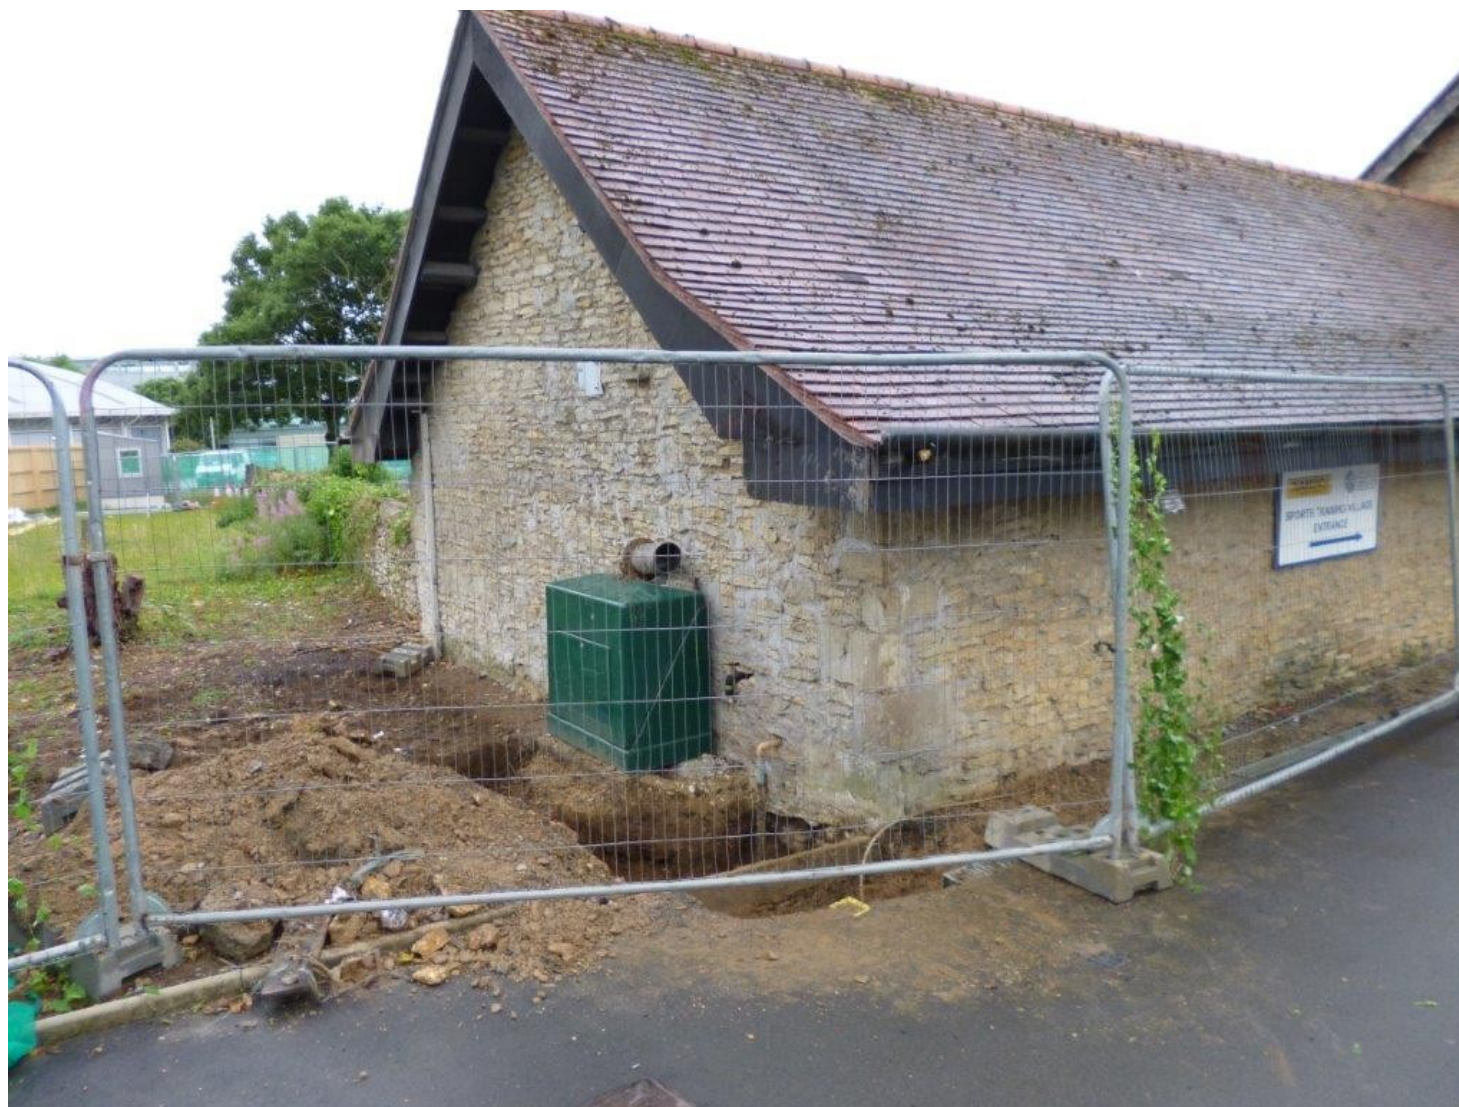
Plate 3. East elevation of single-storey barn showing recently raised gable wall and roof.

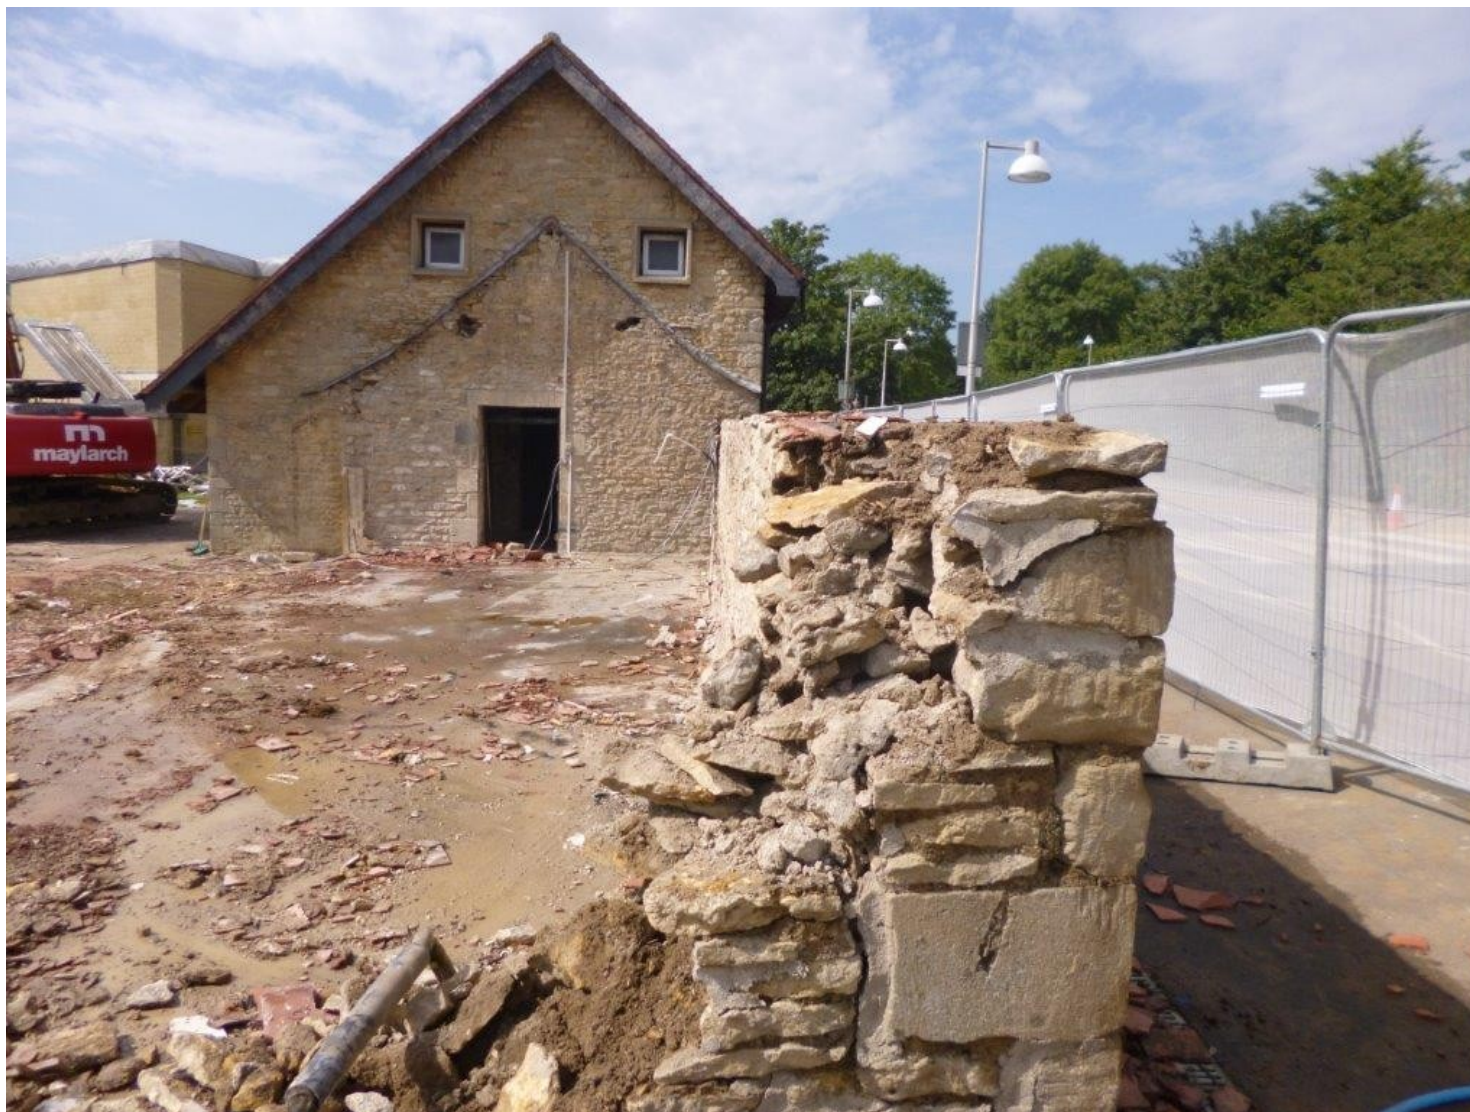
Plate 4. Detail showing the long-and-short quins following demolition of most of the single-storey barn, looking west.

- 4.3 Walls were all of random limestone rubble bonded in a dirty-cream coloured lime mortar which contained abundant small pieces of charcoal and limelight but which had in places been heavily repointed using grey coloured cement-based mortar. The northern wall, 508mm (20 inches) thick, had been significantly rebuilt at its western end where it met the 1972 extension, evidenced as there was no obvious join between the old and the new walls. The northeast corner of the building was finished in long-and-short dressed limestone quoins, as was the southeast corner.

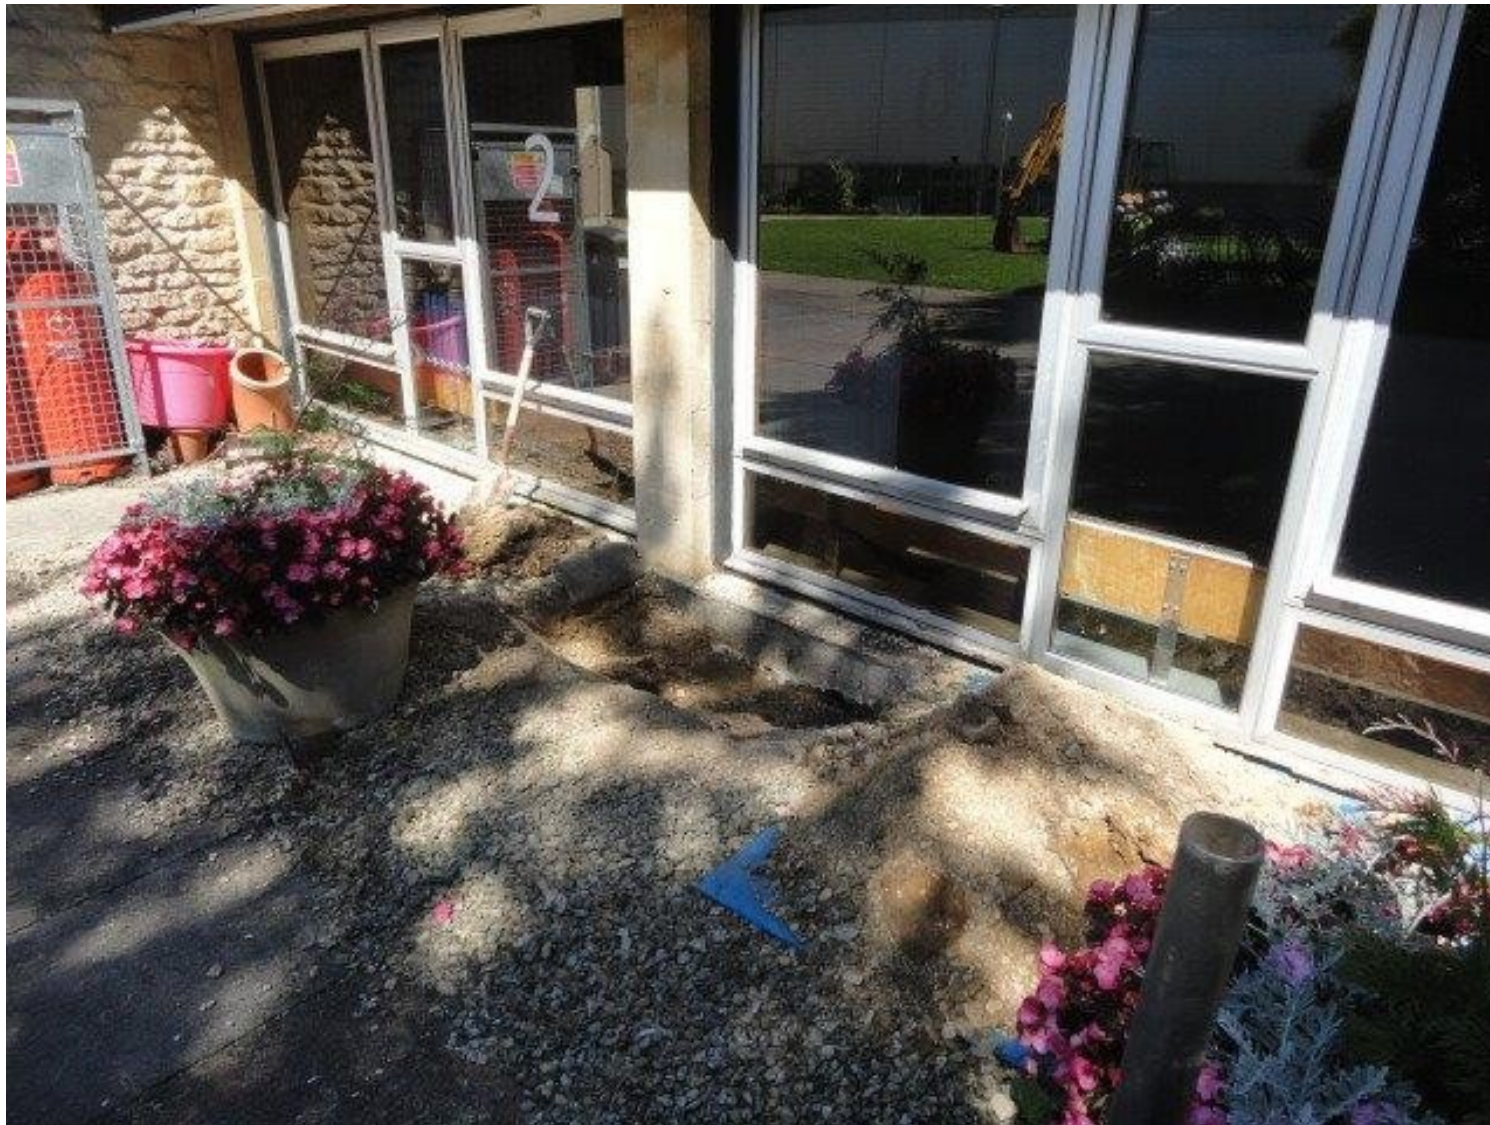
Plate 5. South external elevation of single-storey barn.

- 4.4 The south facing elevation was three-quarters glazed using aluminium frames, separated with two masonry pillars. East of this the south main wall abutted the eastern gable wall and was clearly a later addition as there was a straight join between the two.
- 4.5 The height of the east gable wall to the apex of the roof was 5.2m and to the eaves, 1.98m, but there were clear signs that the pitch of the roof was originally steeper and that the gable wall had been raised in 1972 to create a kick-up above a wide soffit. The roof itself was covered in red rustic brown 'Rosemary' plain clay tiles with half-round ridge tiles.

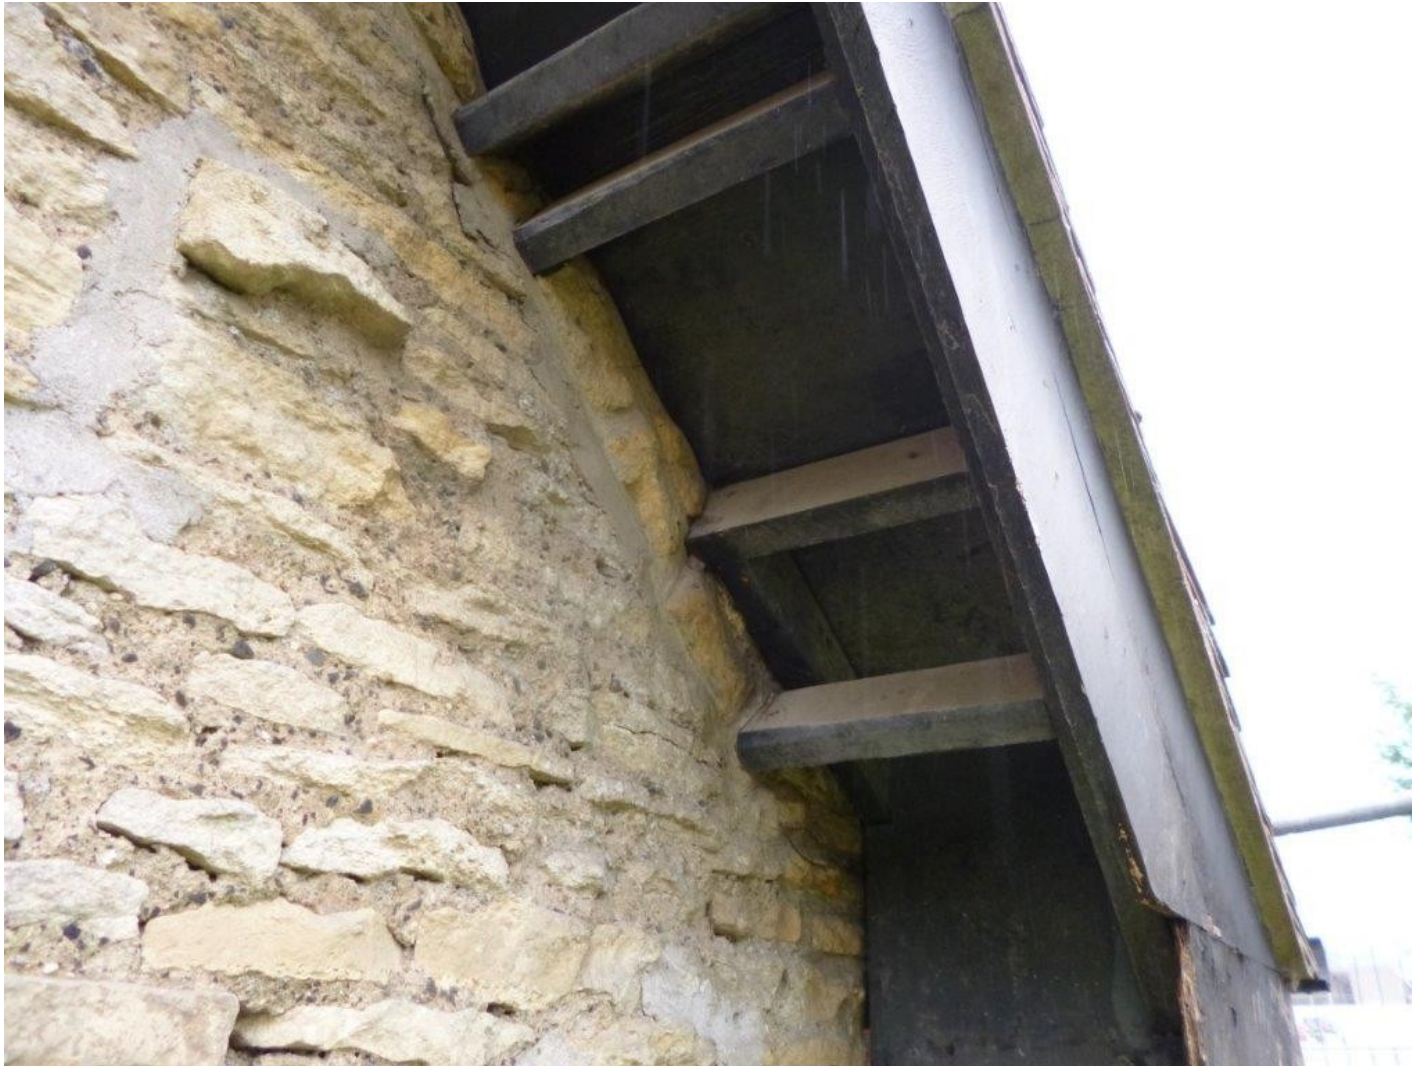
Plate 6. East elevation of single-storey barn showing raised gable wall and roof.

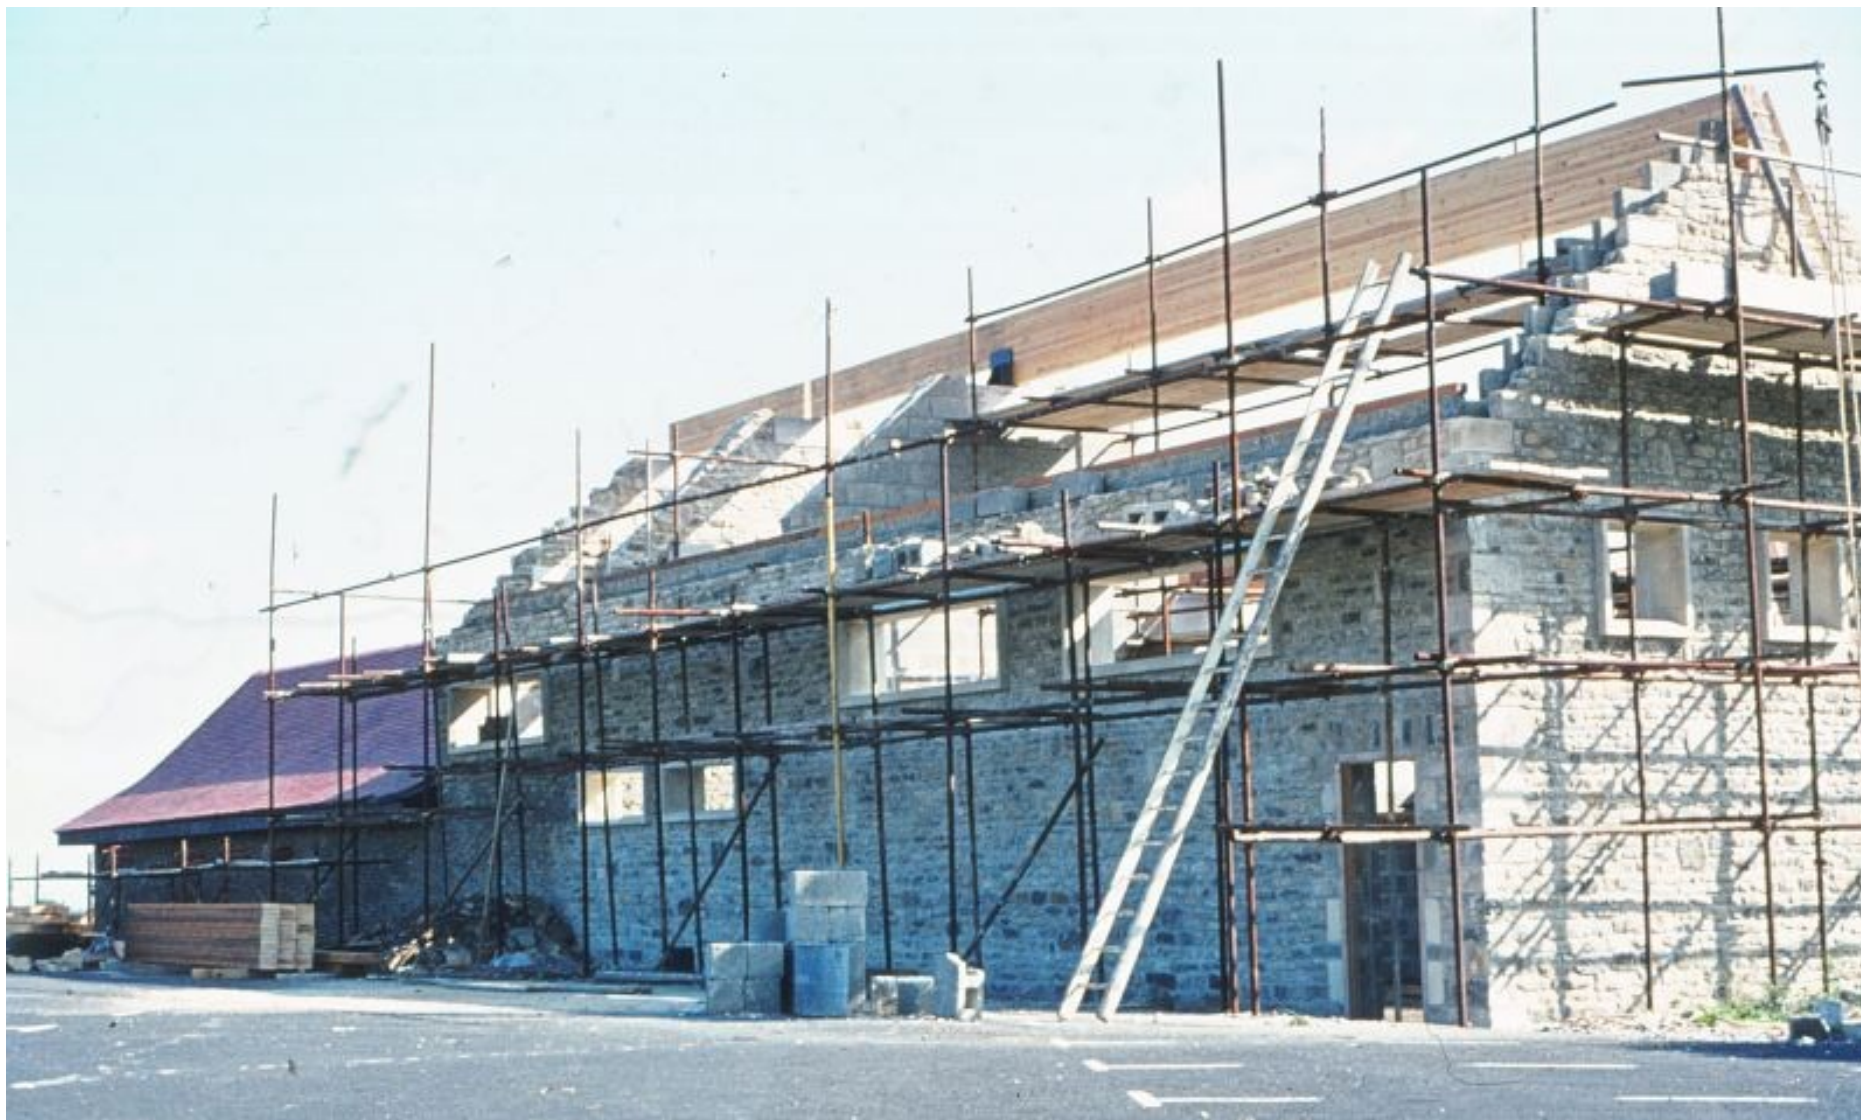
Plate 7. View during construction of the 1972 extension to the single-storey agricultural building looking southeast. Photo courtesy University of Bath.

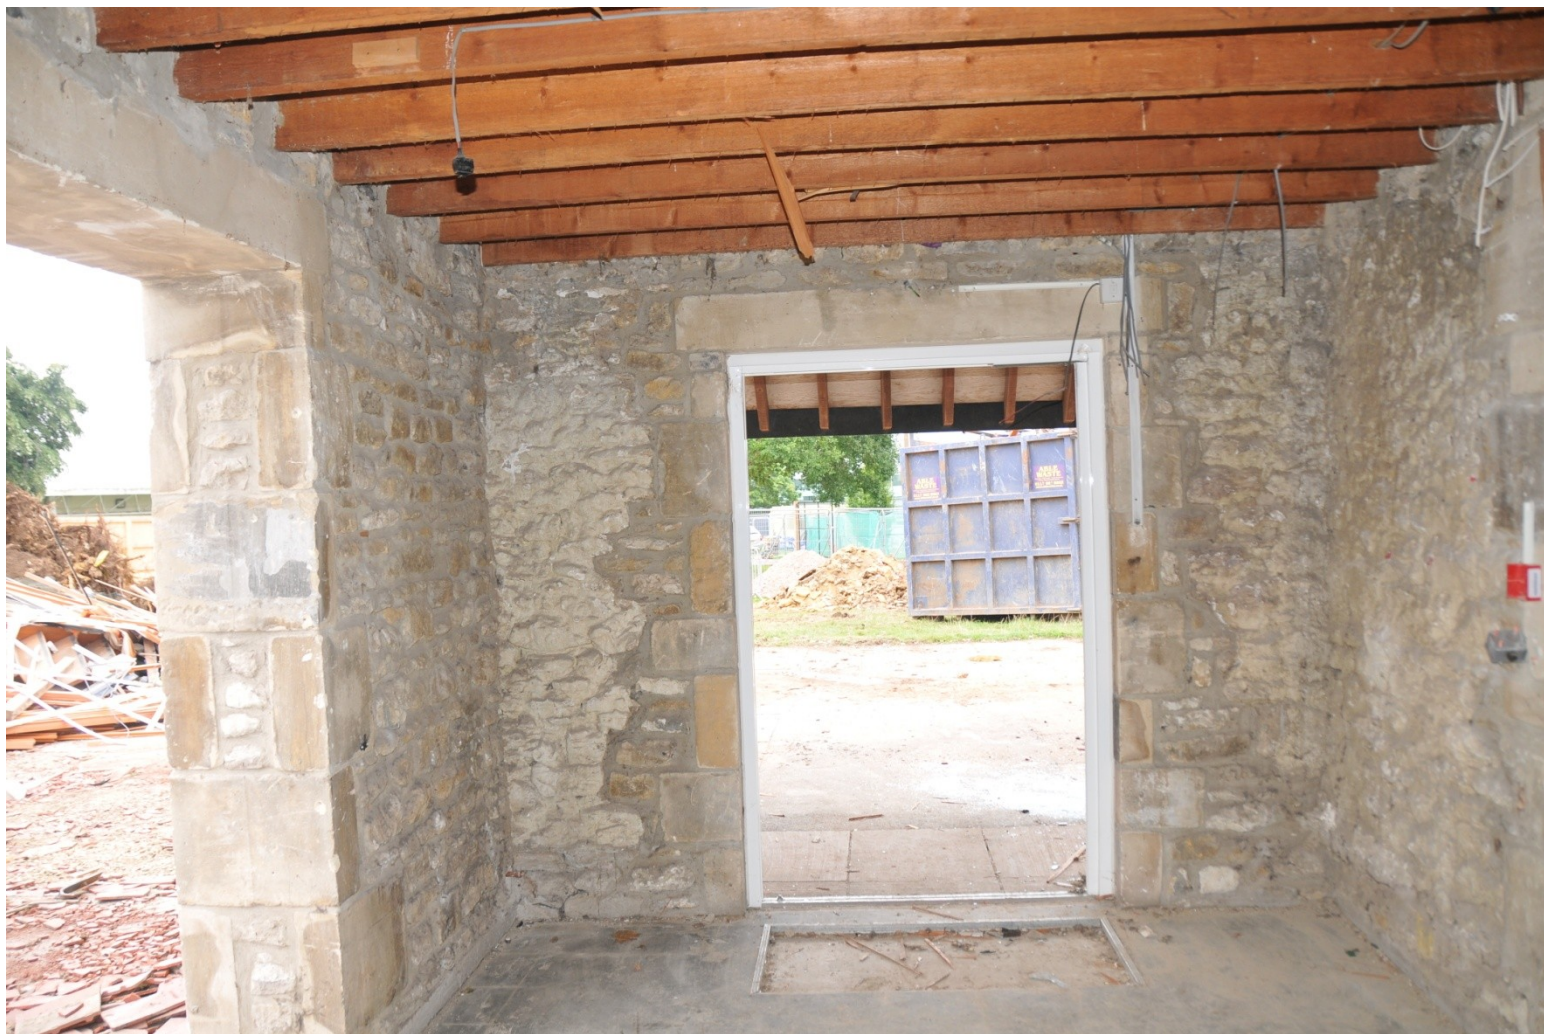
Plate 8. View south from inside small room at west end of barn showing 1970's door openings.

- 4.9 This room was almost entirely rebuilt and a second floor added during the 1972 works to create the 'Arts Barn'. Walls were of random rubble as elsewhere in the building and door openings appeared to be modern. Nothing of architectural note was noticed.

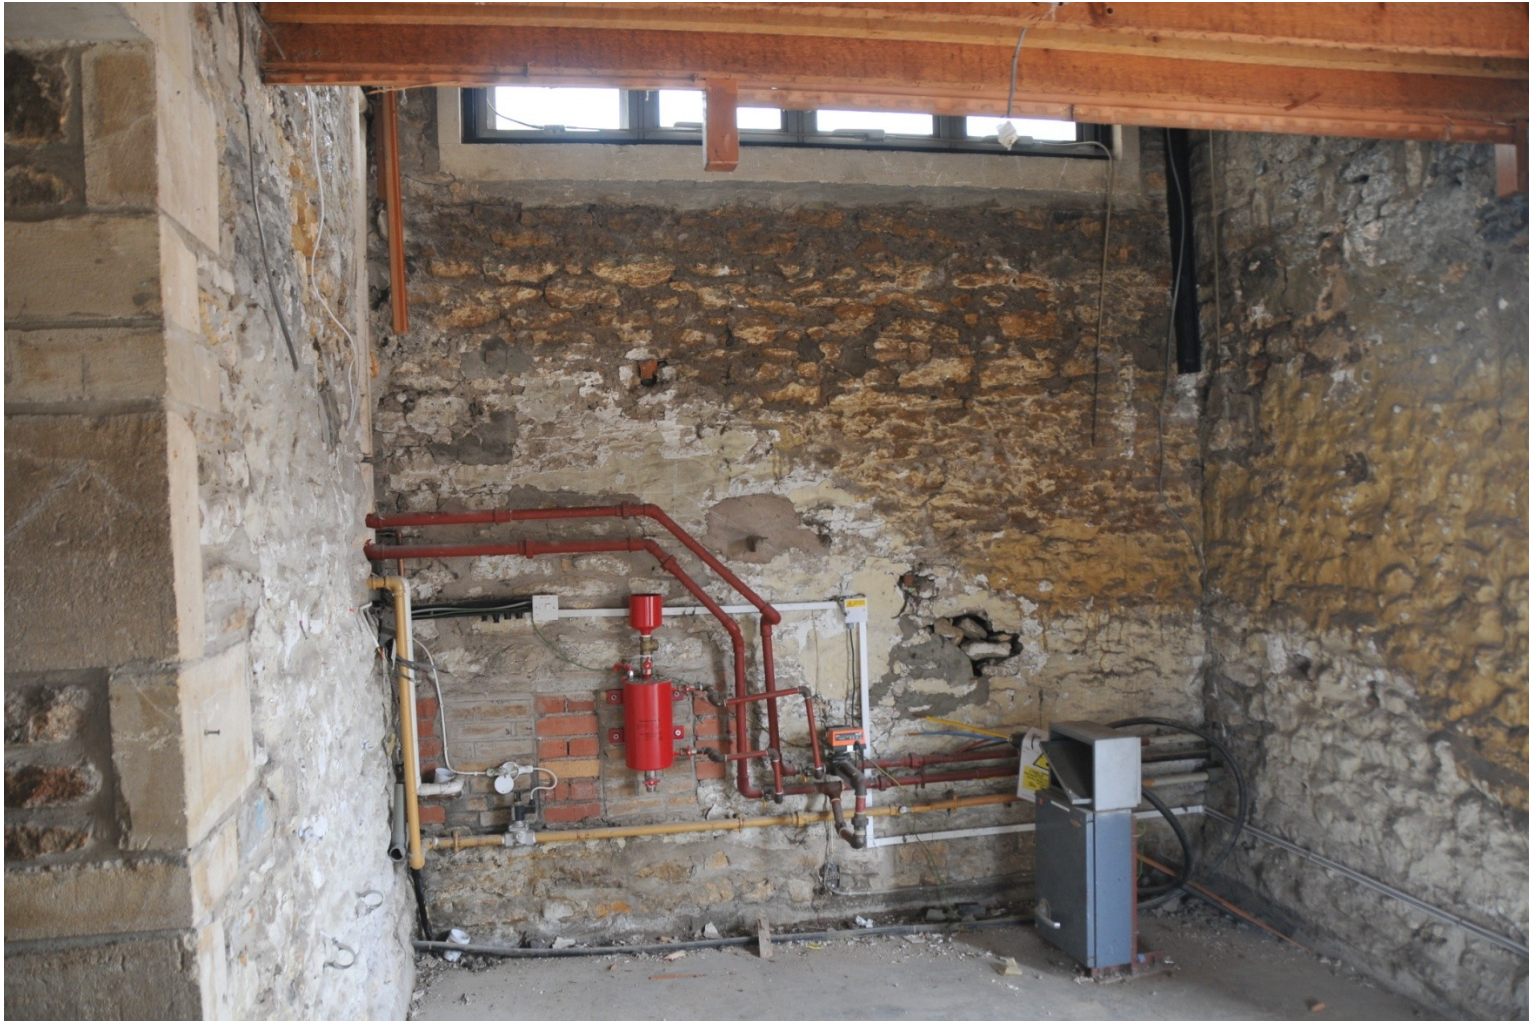
Plate 9. View north inside small room at west end of barn showing shadow of stairs on wall.

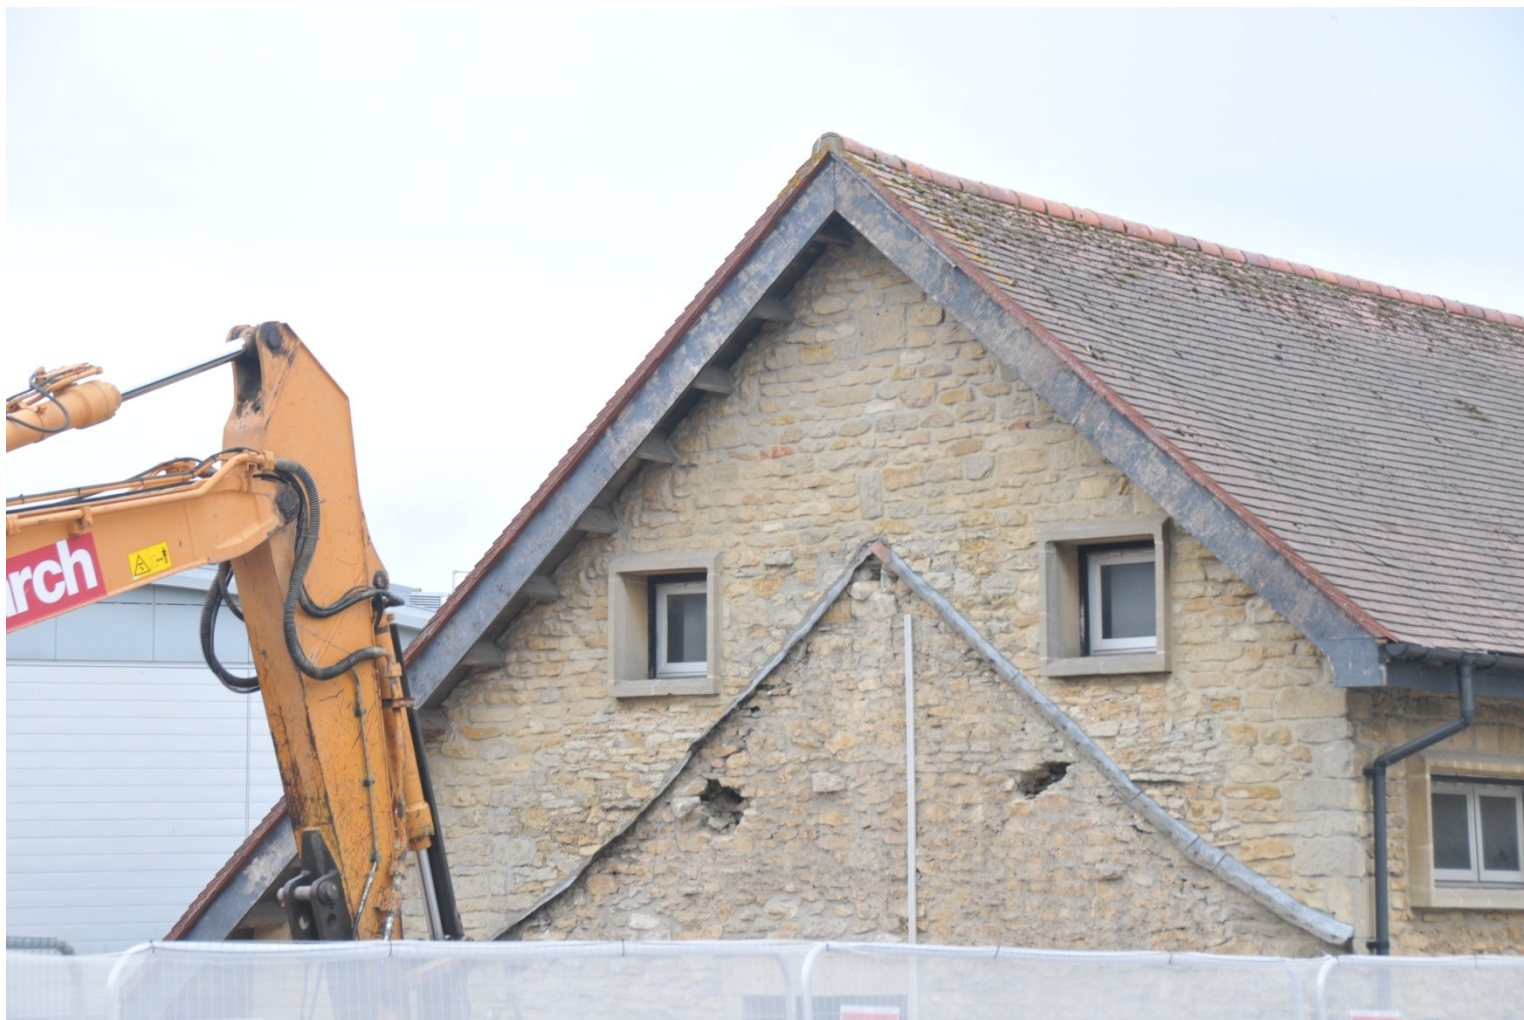
Plate 10. West gable wall of single-storey barn showing flashings and holes for purlins.

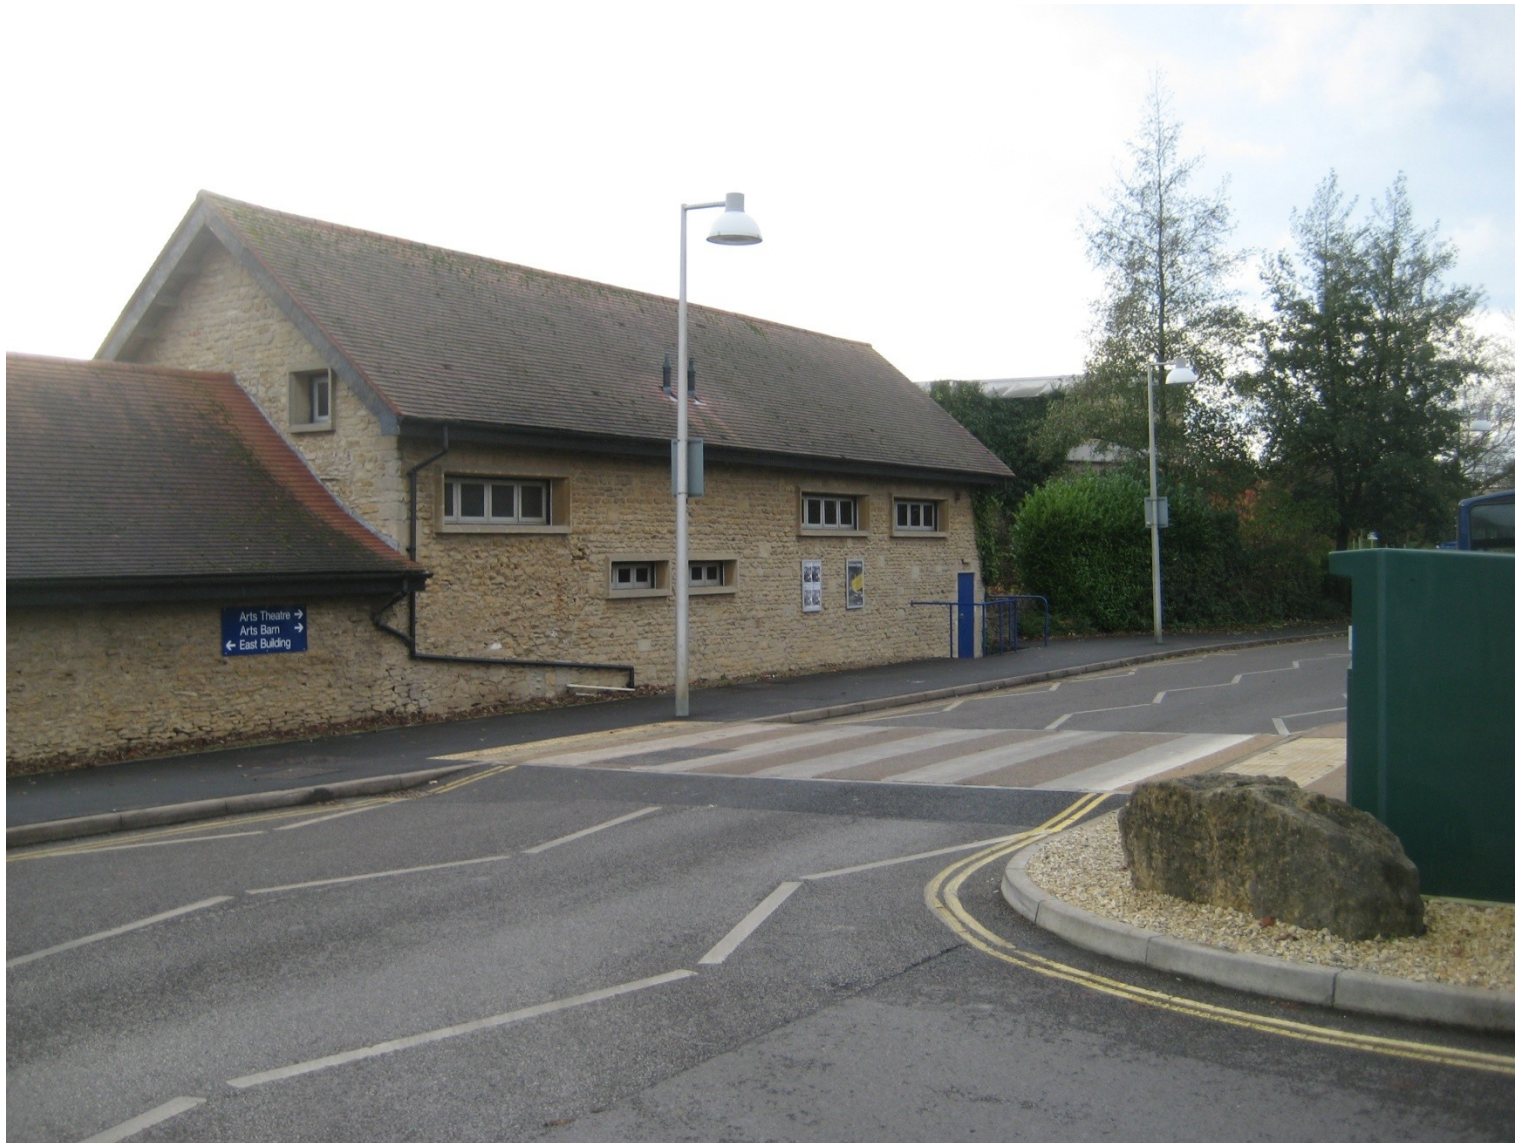
Plate 11. North elevation viewed southeast.

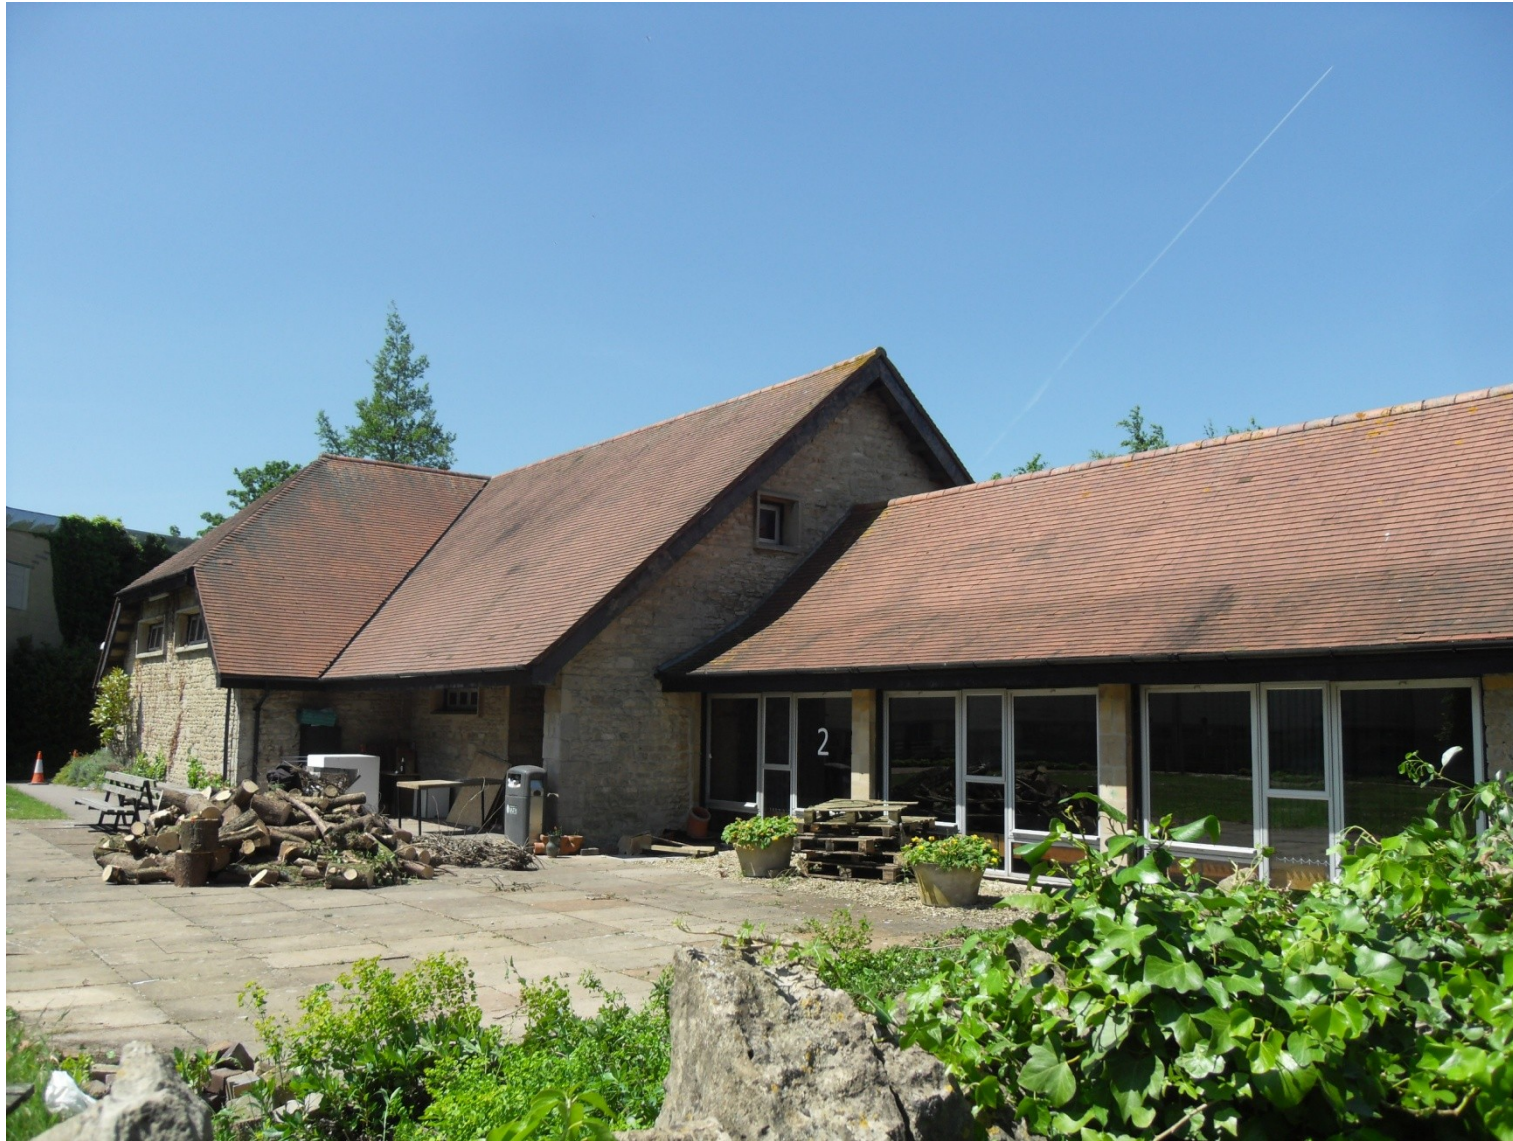
Plate 12. South elevation viewed northwest during soft strip.

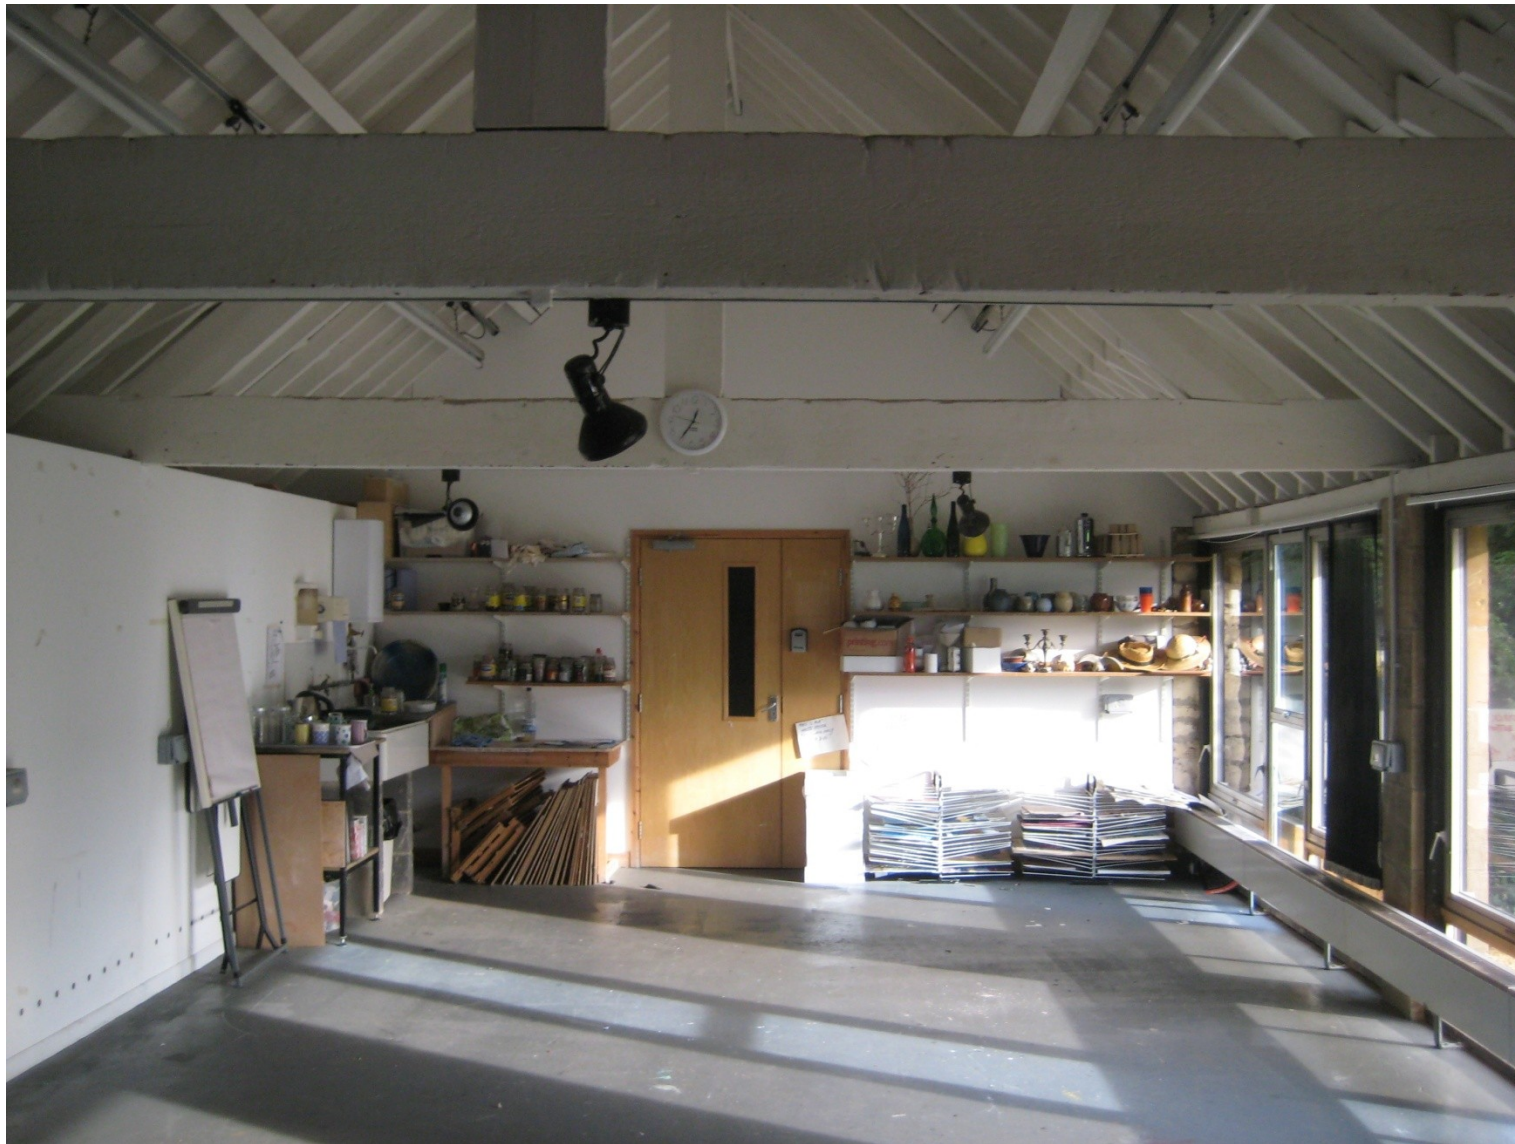
Plate 13. Single-storey barn looking east showing stud partition and door at east end.

- 4.6 The floor throughout was reinforced concrete above a ring beam which extended around the perimeter of the building, overlying a layer of plastic dpc. The northern wall was lined with stud-framing and sealed with sheets of fibrous board, painted white, for pinning artwork to and to reflect light back into the room. Behind this, the random stonework wall had been pointed using grey coloured cement-based mortar.
- 4.7 The eastern quarter of this room was divided with a modern stud partition wall and door to provide a storage room with sink for cleaning paint brushes etc.
- 4.8 No ceiling existed. The roof was supported on three wooden trusses, each having a king post. It is not known whether the trusses were pegged, nailed or bolted. One purlin supported the common rafters on each pitch of the roof, the whole underside of which was close-boarded.

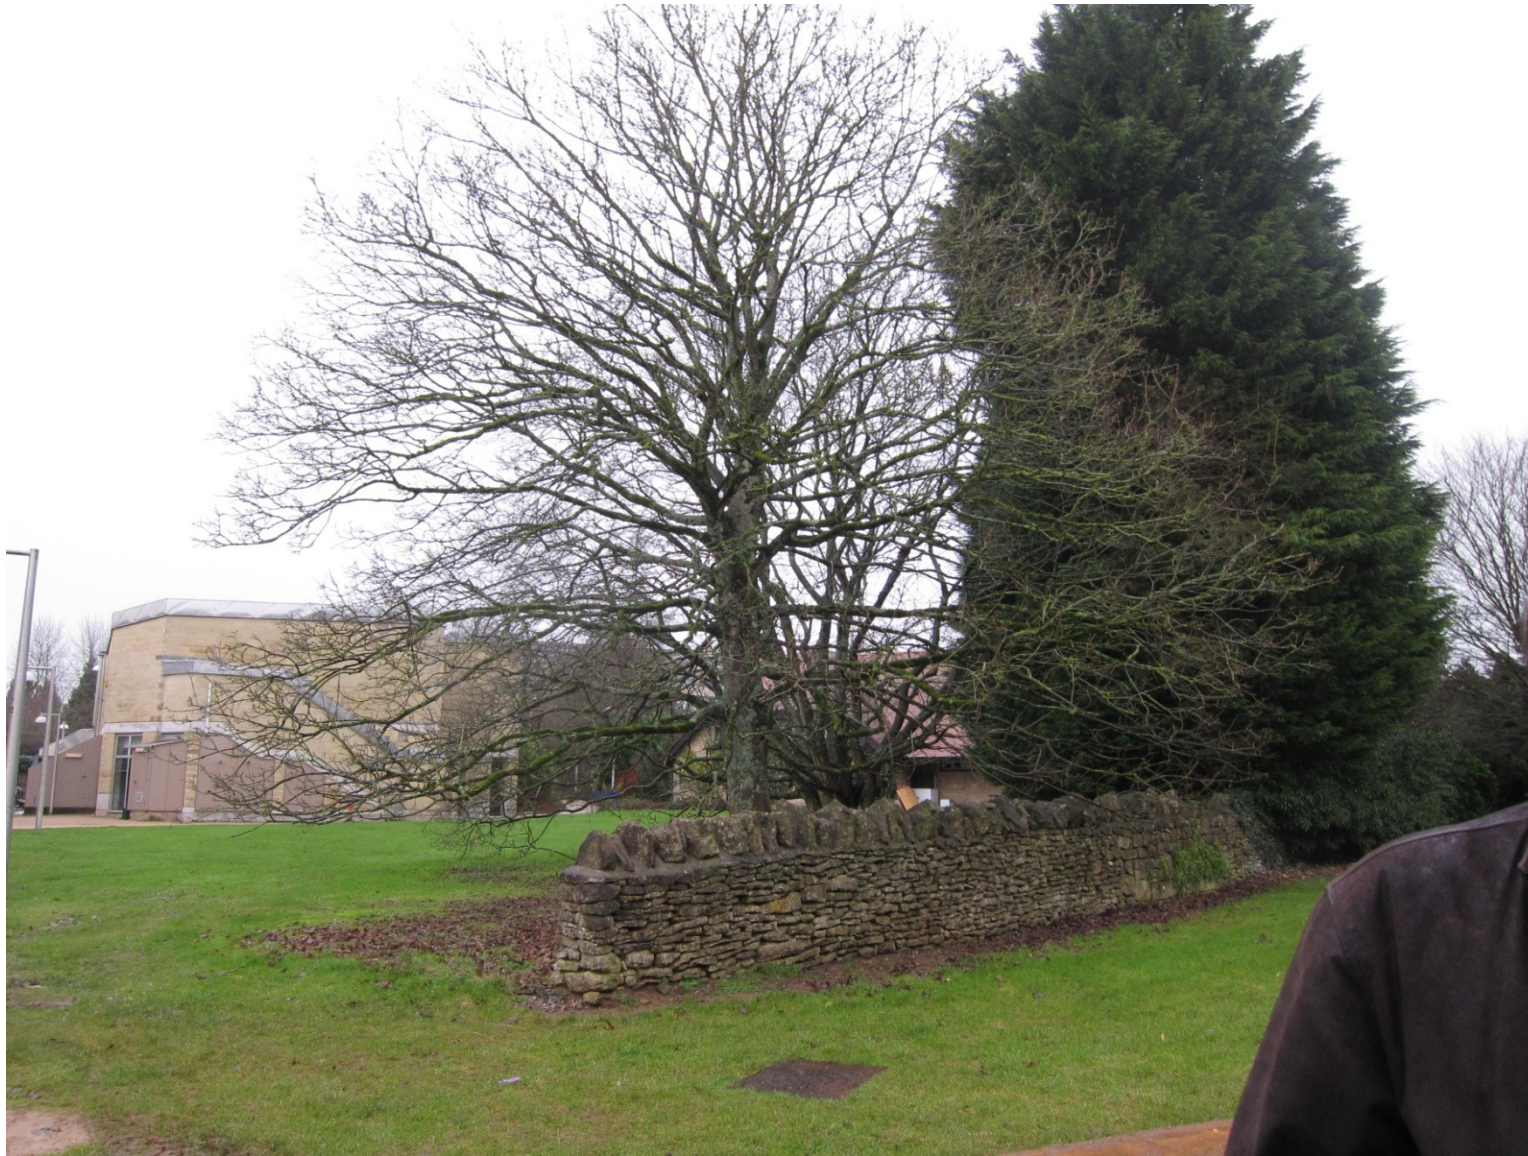
Plate 15. Boundary wall southeast of Arts Barn.

- 4.1 The 'Arts Barn' was a single-storey agricultural outbuilding constructed of local limestone rubble. It occupied an area on the north side of a small enclosure which was partially delineated on its north and east sides by limestone rubble boundary walls having vertical coping stones that probably formed part of the Norwoods Farm enclosure depicted on the First Edition OS and later plans. However, the building clearly underwent significant alterations and rebuilding when it was extended in 1972 and converted for arts use and no architectural features of note are visible in the photographic archive.
