BRISTOL & WEST ARCHAEOLOGY

University of Bath Arts Barn,
Claverton Down Campus, Bath

Standing Building Recording Report

28 May 2014

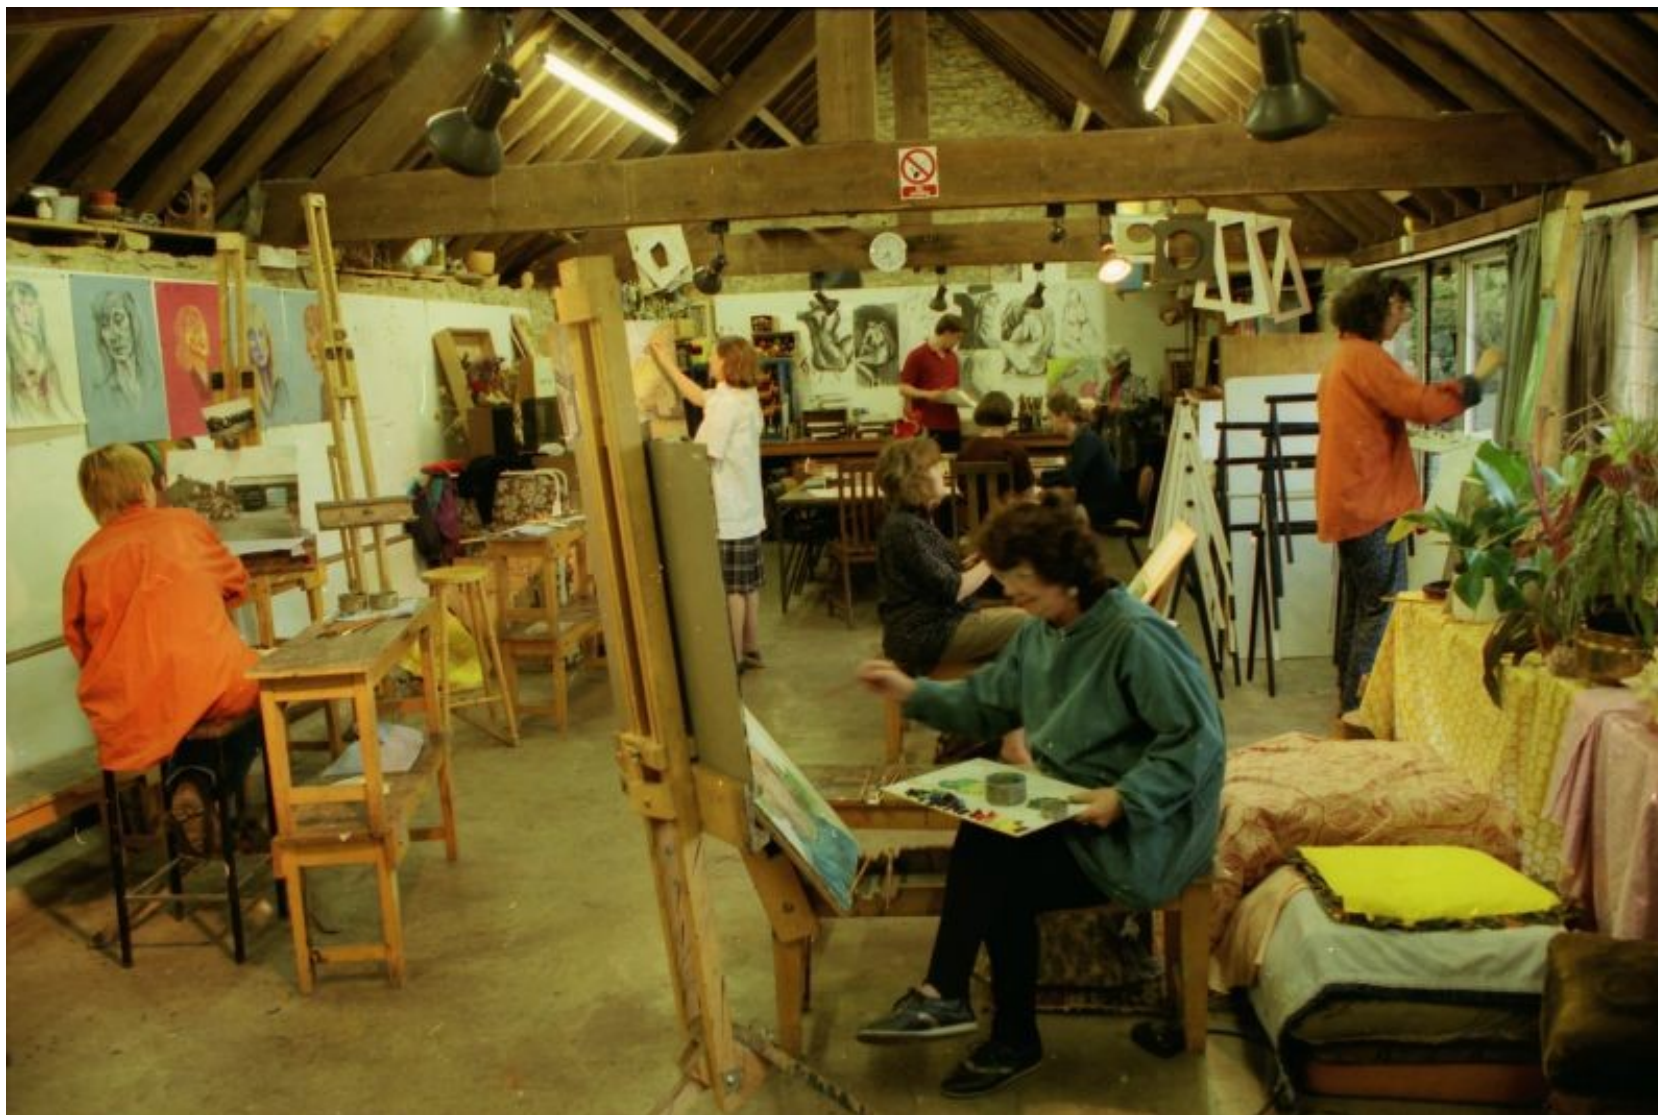
Plate 19. View inside single-story barn looking east, undated but before partition with door was added at east end of building. Courtesy University of Bath.
