Proposed site for Dolphin School,  
Land off Bath Buildings, Montpelier,  
Bristol

## Archaeological Watching Brief Report

Client: BAM Construction

23 September 2016

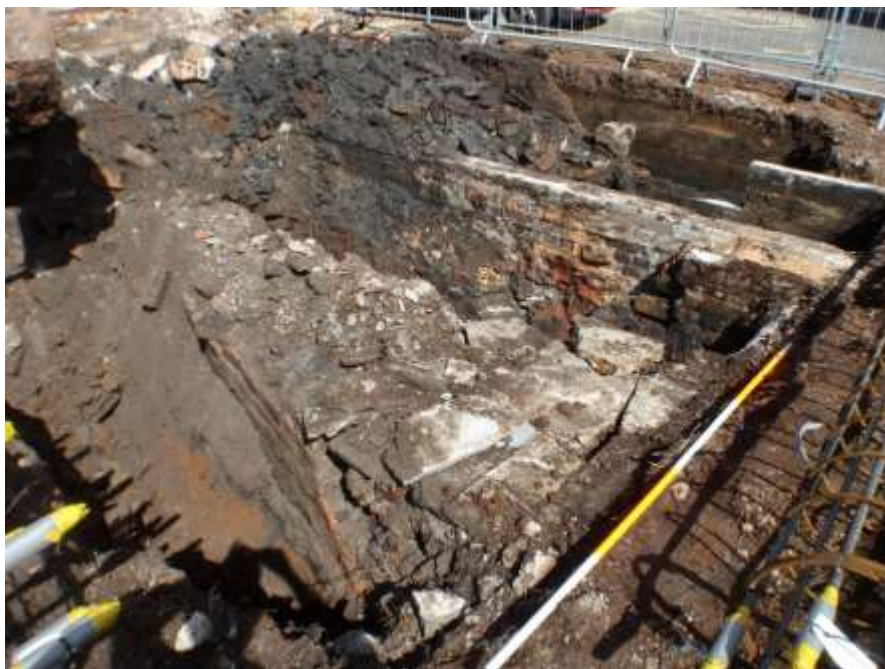
- 5.3 Immediately south of the culvert lay a rectangular, concrete chamber (102) divided in two by a brick wall, truncated by a brick culvert (103) and with a barrel-vaulted roof. Nearby lay a brick-built cistern (115).

Plate 1. Culvert (103) foreground and Structure (102) background, looking NW. Scale 2m.

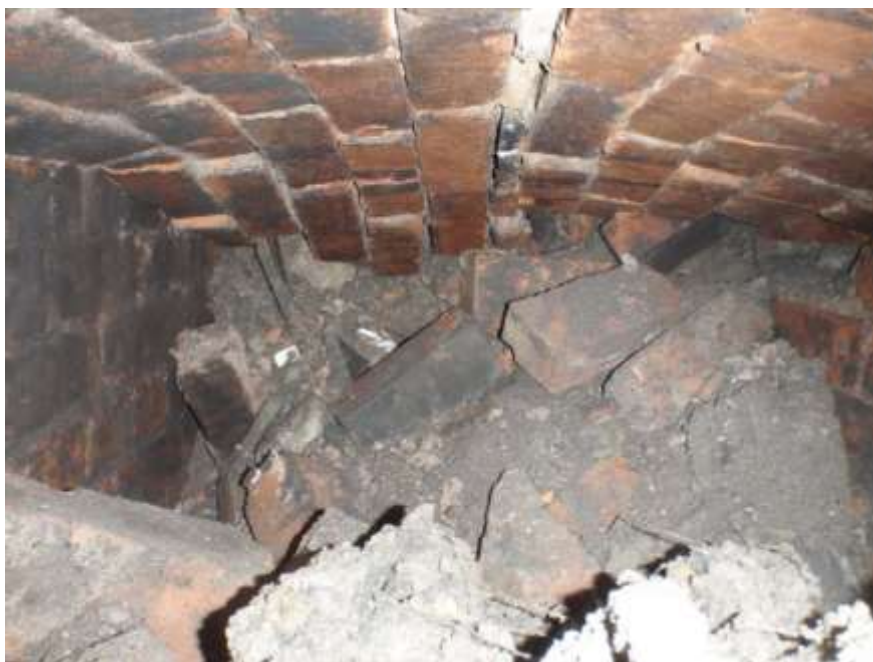
Plate 2. Interior of Culvert (103) looking N. No scale.

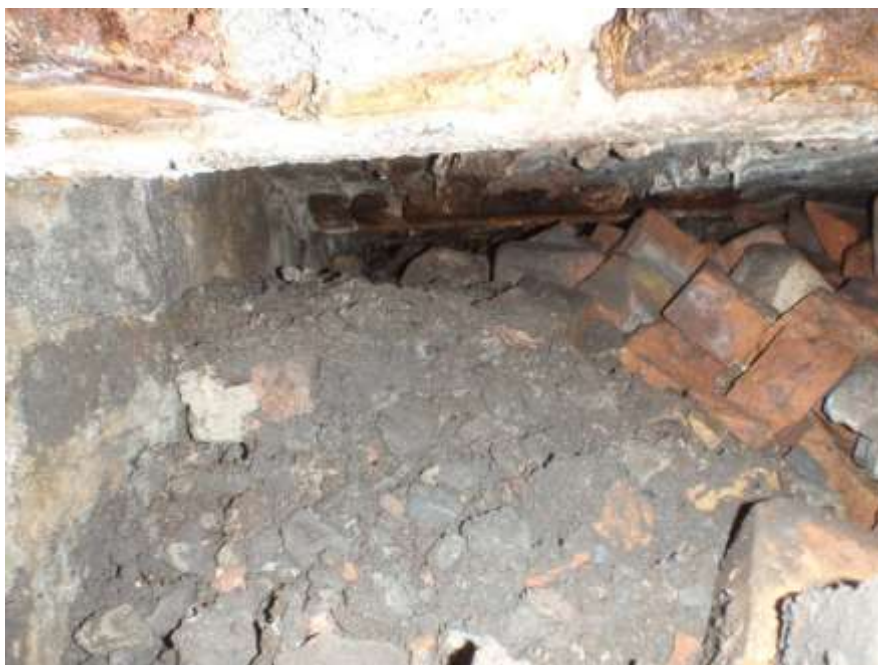
- 5.2 Pile-caps 16-18 for Sprinkler Tank - excavated into the north side of the culvert for Cutler's Mill Brook. The culvert (Structure 106) had vertical walls of mixed brick and sandstone rubble, up to 0.8m thick, while the roof was flat, of heavily mortared brick supported over iron rafters. Internal dimensions of the culvert were 3.1m. across and 2.1m. high and although partially filled with rubble, there were no signs of a flowing brook within the chamber. Built above the walls of the culvert were two masonry walls (107) and (108).

Plate 3. Interior of Culvert, (Structure 106) looking N. No scale

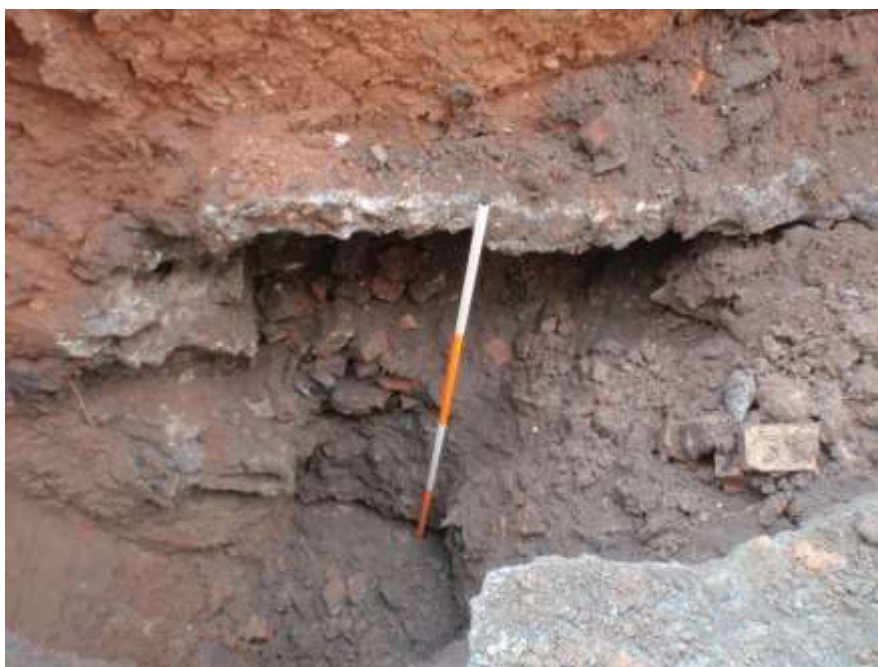
106	Structure	Two parallel side walls and a roof of bricks (230 x 110 x 70mm) and dark grey lime mortar, supported by iron girders. No visible base. Largely backfilled with bricks. Culverted Cutlers Mill Brook. Sidewalls are random coursed, limestone rubble (average 200 x 150 x 80mm) bonded with a strong dark grey lime mortar.	Interior chamber is 3.1m wide. Structure is 2m from bottom of walls to inside of roof.			C18
107	Wall	Built over the southwest side of culverted Cutlers Mill Brook. Unworked, random coursed limestone rubble (average size 180 x 100 x 80mm) bonded with a weak brownish grey lime mortar.	In section only 450mm wide		0.8m	C19
108	Wall	Built over the northeast side of culverted Cutlers Mill Brook. Unworked, random coursed limestone rubble (average size 180 x 100 x 80mm) bonded with a weak, brownish/grey lime mortar.	In section only 300mm wide. 3.1m wide cavity between (107) and (108) filled with bricks		1m	C19

Plate 4. Cross-section of the culvert (Structure 106) as exposed during excavation for pile-cap, looking S. Scale 2m.

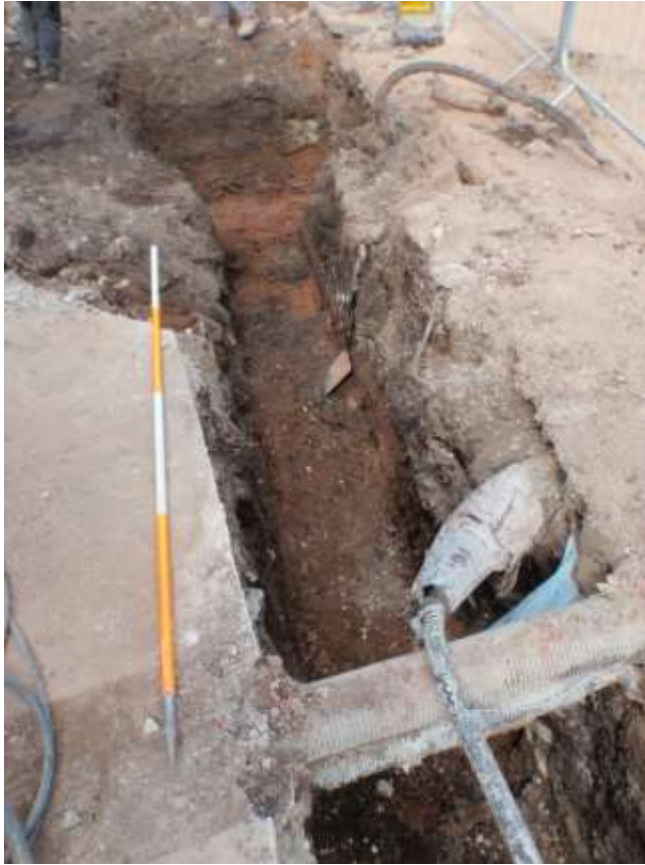
- 5.6 Trenches were excavated across the site for a variety of services. Service Trench 1 reached a maximum depth of 2m, revealing below a modern road surface, made-ground layer (109) above garden soil deposit (110). The northeast side of the trench was the face of a masonry wall (104) which continued above ground level beyond the trench where it became the garden boundary to No 27 Bath Buildings.
- 5.7 Service Trench 2 - dug to a depth of 1.1m and revealed a rectangular brick built pit over a concrete base.
- 5.8 Service Trench 3 - excavated to a maximum depth of 1m through made-ground (101) averaging 200mm thick and archaeologically sterile clay (111). The culvert for Cutlers Mill Brook was breached at the northeast end of the trench for manhole MH C02.

Plate 5. Service Trench 1 as excavated, looking N. Scale 2m.

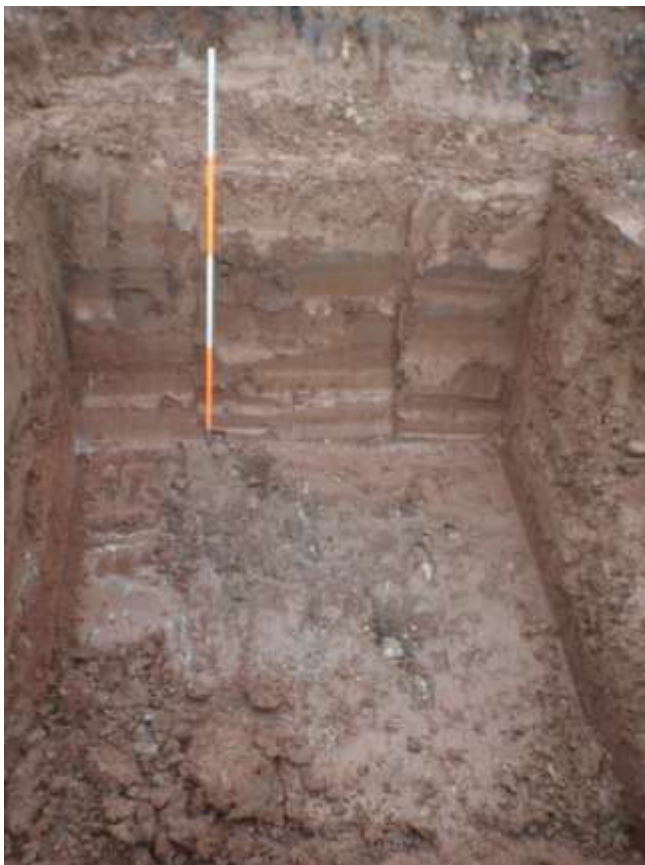
- 5.9 Service Trench 4 – excavation revealed a shallow layer of made-ground (101) over the natural clay (111) which was cut by an un-dated, silty clay-filled, pit-like feature (113,114).

113	Cut	Sub-oval pit feature in base of MHF 05b. Top 500mm removed but not fully excavated.	1.7m x 1.1m	>500mm	-
114	Deposit	Firm, mid brown/strong brown silty clay with rare, small medium limestone fragment inclusions. Fills cut (113).	1.7m x 1.1m	>500mm	-
115	Structure	4 walls of brick with cement bonding and a base of Pennant sandstone slabs. Probable cistern.	1.5m x 4m	1.2m	C19

Plate 6. Cut 113, Fill 114 in base of Trench 4, looking S. Scale 2m.

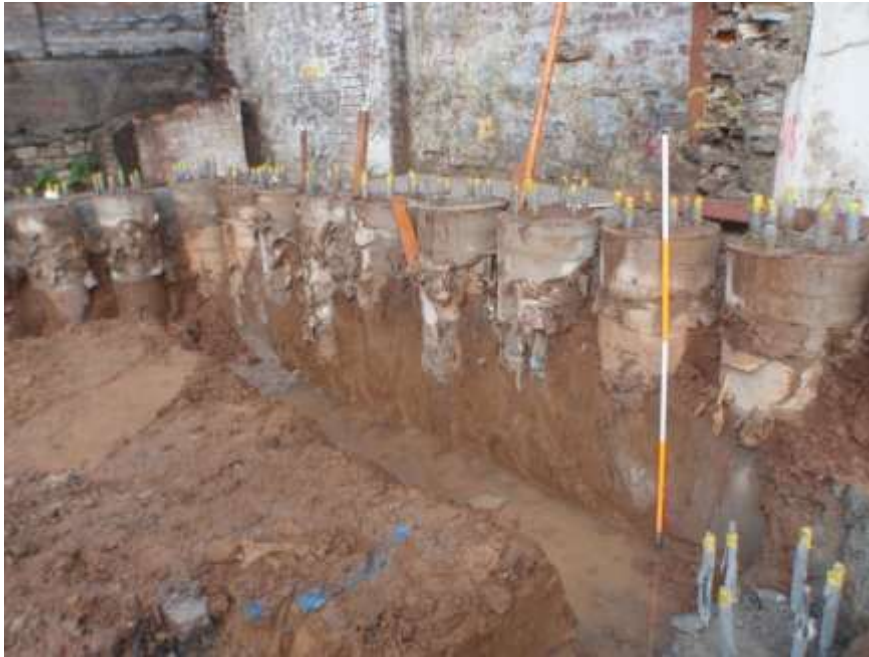
Plate 7. Excavation for Groundbeam in west corner of the site, looking NW. Scale 2m.

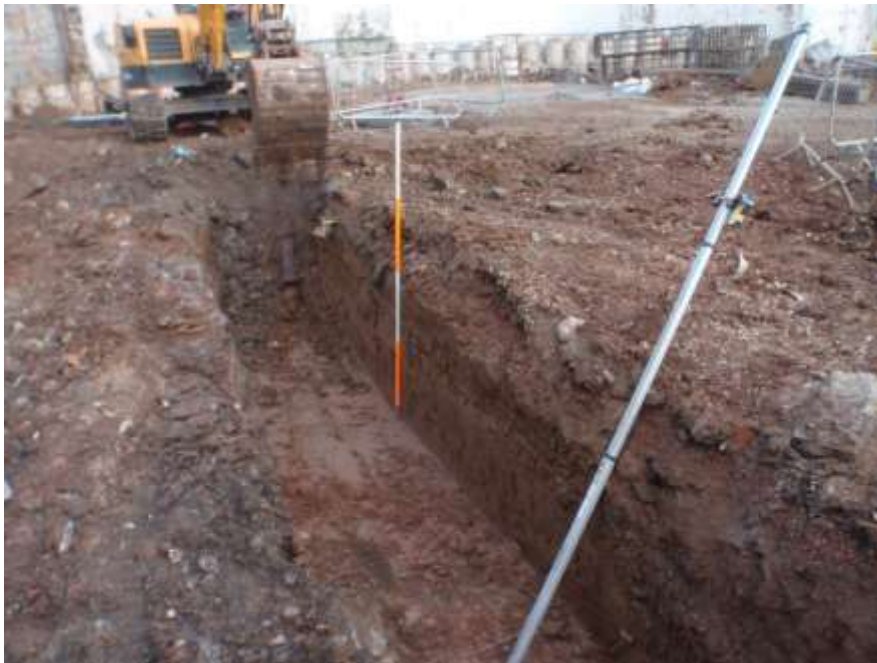
- 5.5 Extensive ground-beams were excavated between pile-caps and approximately eighty-percent of these were monitored. Dug to depths of between 0.5m - 1.5m, generally the excavations revealed deposits of made-up ground (101), averaging 200mm deep underlying concrete surfaces and overlying brownish/red natural geological deposits (111). The exception to this sequence was in an excavation in the south of the site which revealed 0.8m of made ground (109) overlying a 0.5m deep layer of topsoil (110) above the natural clay.

Plate 8. Typical trench for Groundbeam, looking S. Scale 2m.

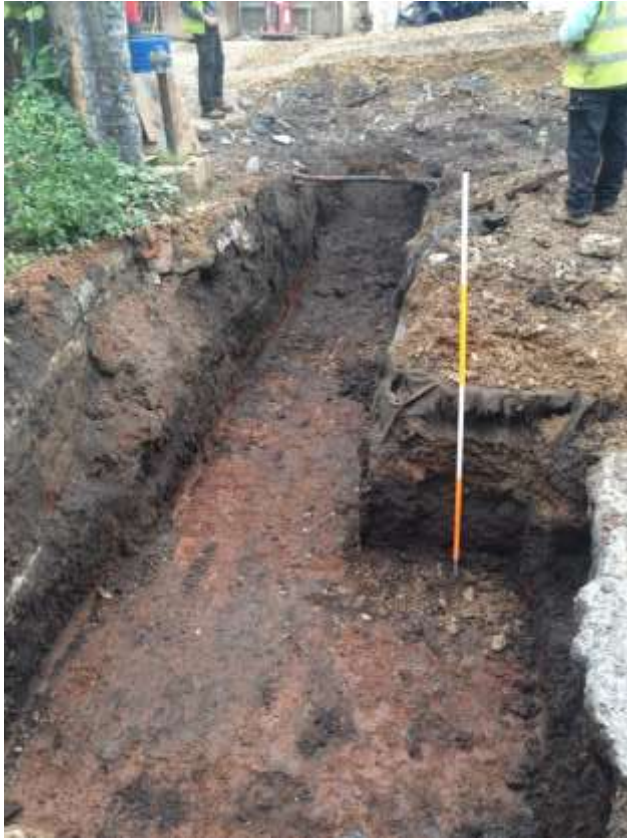
Plate 9. Groundbeam excavation showing Layer (110), looking SW. Scale 2m.

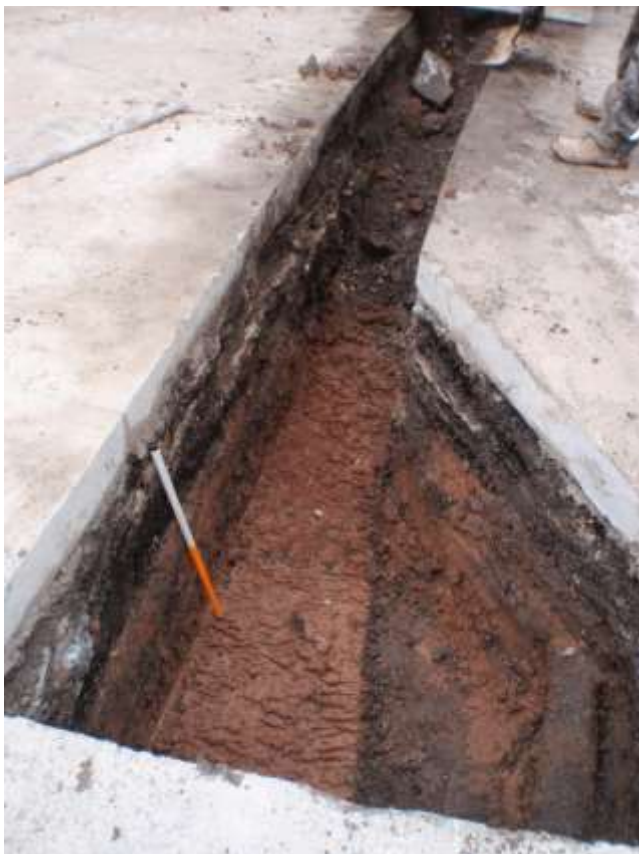
Plate 10. Service Trench 1 as completed, looking N. Scale 1m.
