Former Central Ambulance Station,
Marybush Lane, Bristol

Archaeological Evaluation Report

BWA Ref: 15/2547

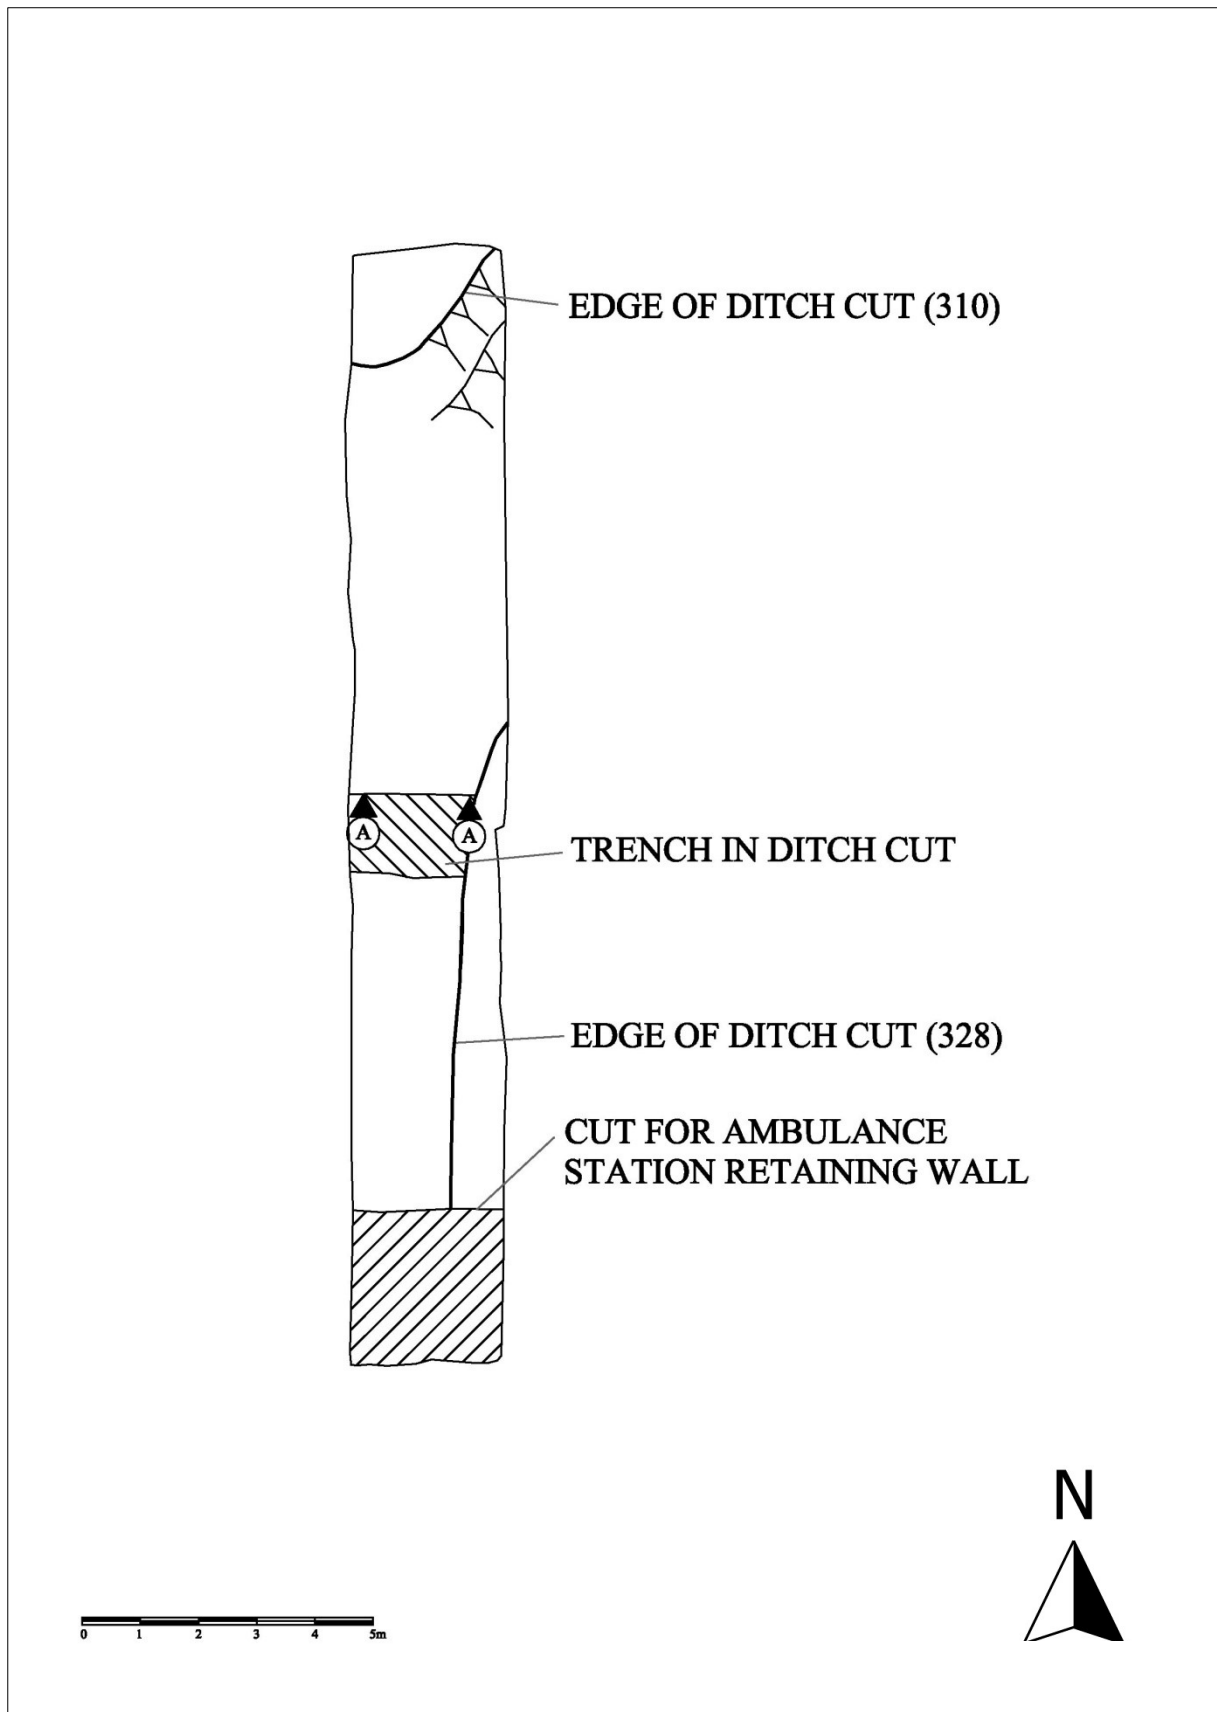
Figure 3. Trench 3 showing edge of ditch and location of section AA. Scale as shown.

- 5.4 **Trench 3** (18.25m long x 2.5m wide). Excavated onto the natural clay substrate (319) at depths between 0.3m and 1.9m, with the upper surface lying at between 11.31m and 12.71m aOD. The natural sandstone was cut by a large feature, probably a ditch which had two edges partially exposed within the trench, and appeared to be aligned roughly on a northeast – southwest axis. The base of the ditch was not reached. Two box sections were hand dug through the ditch deposits, recorded here as Cuts [310] and [328]. This revealed a sequence of at least 25 separate deposits. The width of the ditch was difficult to assess but it was in excess of 2.5m wide, over 1.7m deep, extending beyond the limits of excavation, except in the south where it was cut by the north wall of the Ambulance Station. The lowest levels recorded within Cuts [310] and [328] were 11.59 and 10.72m aOD.

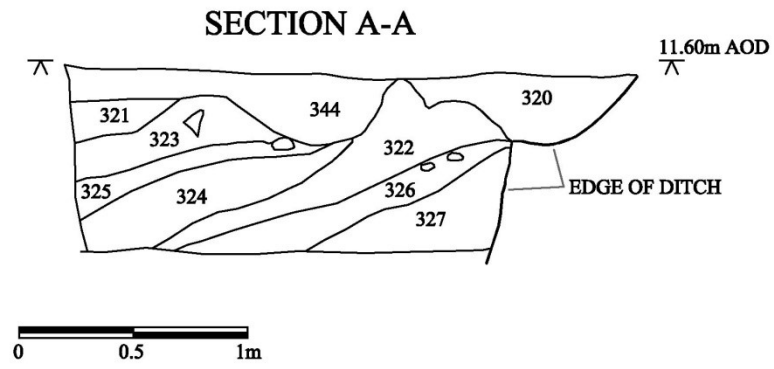
Figure 4. Section AA in Trench 3. Scale as shown.

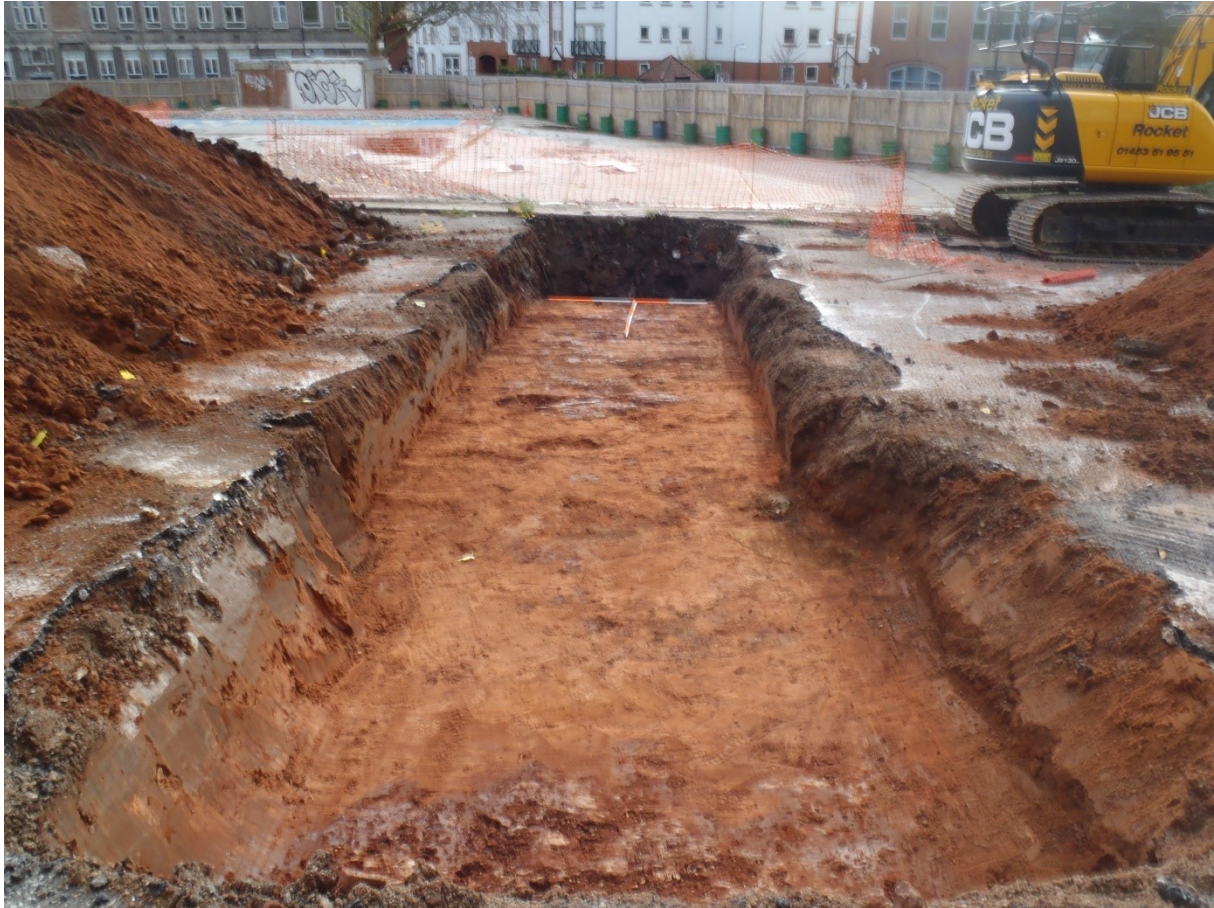
Plate2. Trench 2 viewed south. Scale 2m x 2m.

- 5.2 **Trench 2** (13.60m long x 2.5m wide). Excavated onto the natural sand and sandstone substrate (208) at an average depth of 0.60m and reached a maximum depth of 1.5m at the south end within Cut [202]. The upper surface of the sandstone (208) lay at between 11.51aOD and 12.44m aOD. Overlying the sandstone were two thin fairly compact lenses of silty clay (206) and (207), with laid sandstone slabs within the upper surface of (207). Deposit (206) was only recorded in section. These deposits were similar to Layers (313) and (355) in Trench 3A and are possible of medieval date. Both deposits were sealed beneath (205) which may have been subsoil. This had been cut [202] for construction of a split level retaining wall (203) for the 1960s Ambulance Station and backfilled (204). The uppermost deposit in the trench was the modern car park surface

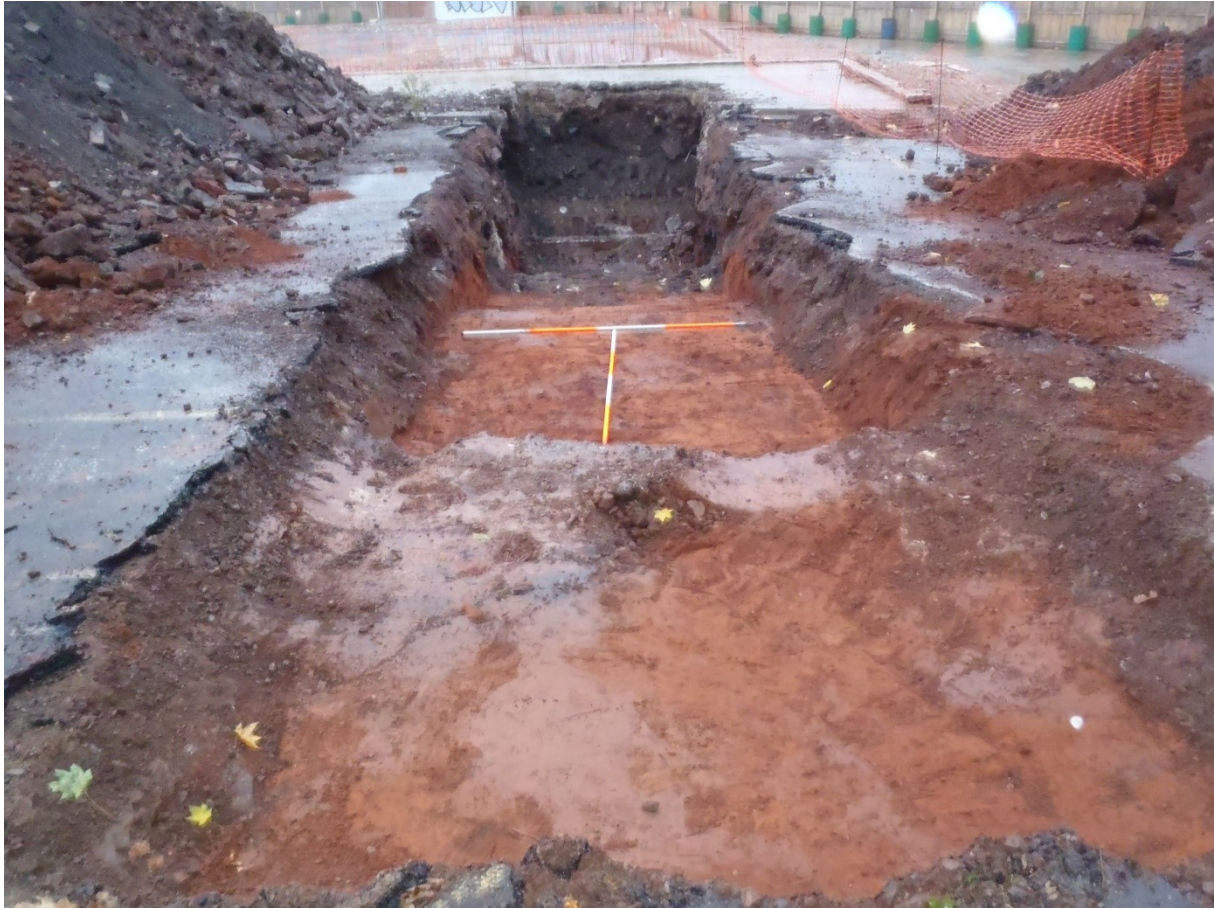
Plate3. Trench 2A viewed looking south. Scale 2m x 2m.

- 5.3 **Trench 2A** (17.50m long x 2.5m wide). Excavated onto the natural sand and sandstone substrate (309) at a depth between 0.47m and 1m, and reached a maximum of 2m within cuts [302] and [342] at the south end of the trench. The upper surface of the substrate (309) lay at between 10.10m aOD and 12.90m aOD. The natural sand and sandstone were sealed by mid-brown silty clay subsoil (363), up to 0.45m thick. Context 363 was cut features and structures. At the north end of the trench was a cut [340] backfilled with subsoil 341 containing a pier of hard mortar and masonry (308) of unknown function, but late post-medieval in date. To the south of this lay a linear cut [342] and fill (343) for cellar wall (306), with an associated brick floor to the south (305). At the south end of the trench was the modern cut [302] and fill (303) for the split level retaining wall of the 1960s Ambulance Station. No significant archaeological features, deposits or finds were present within the trench.

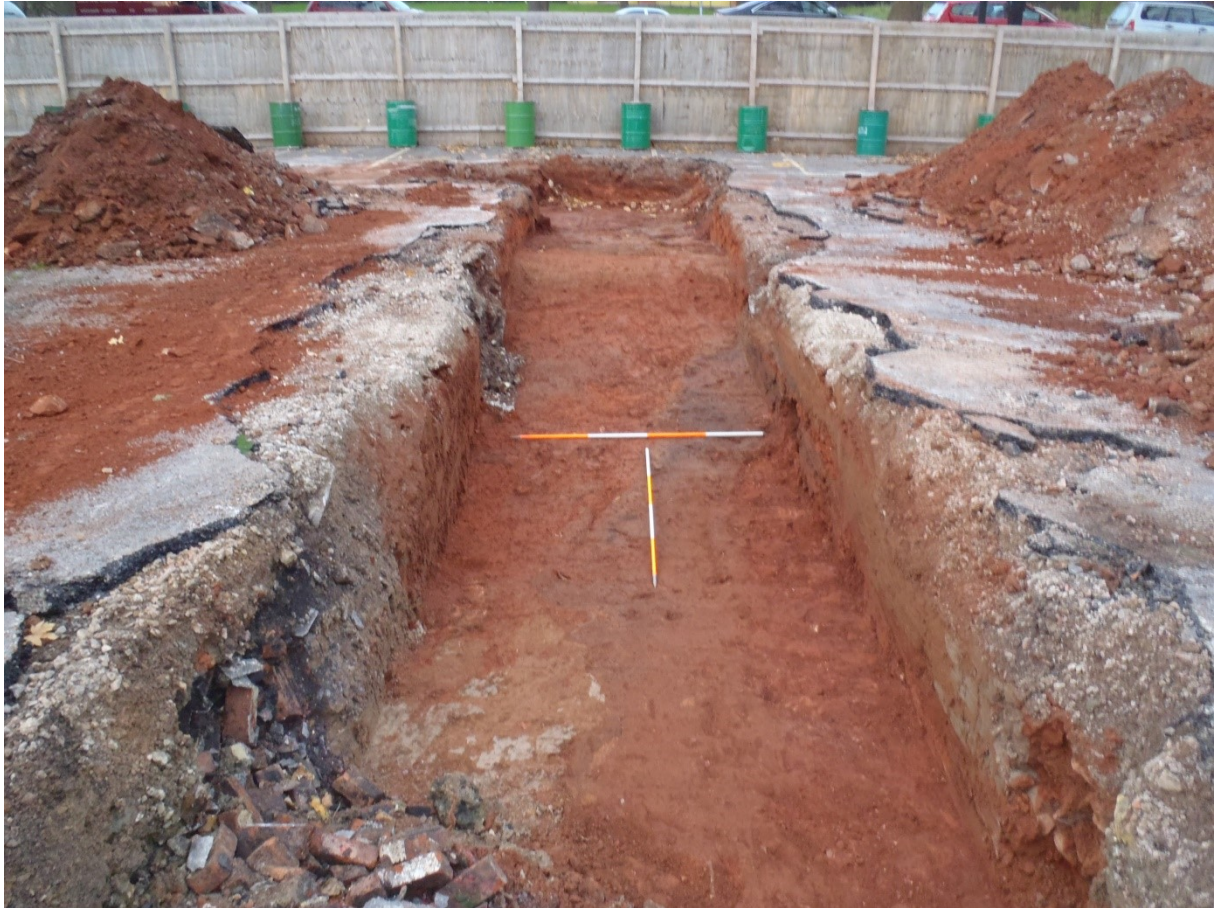
Plate4. Trench 3 looking north. Scale 2m x 1m.

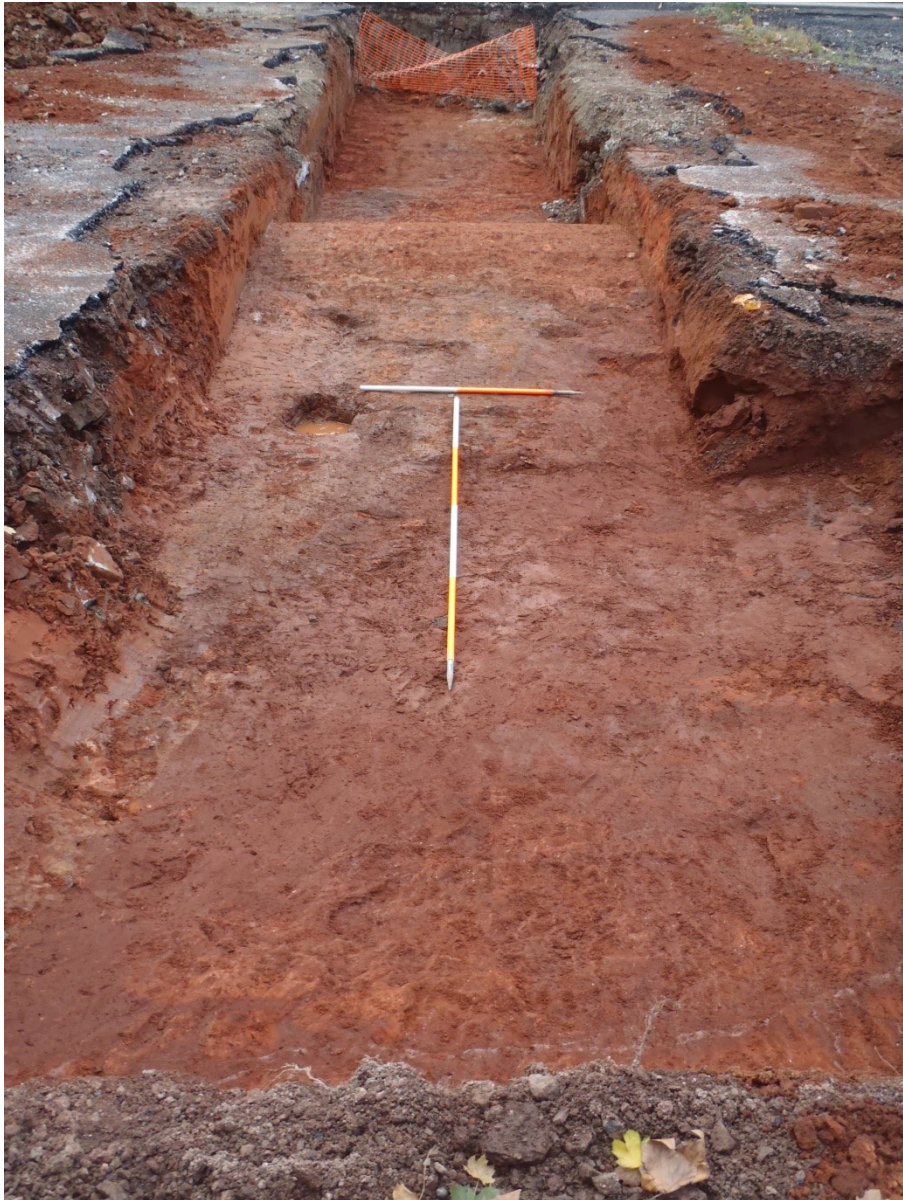
Plate5. Trench 3 looking south. Scale 2m x 1m.

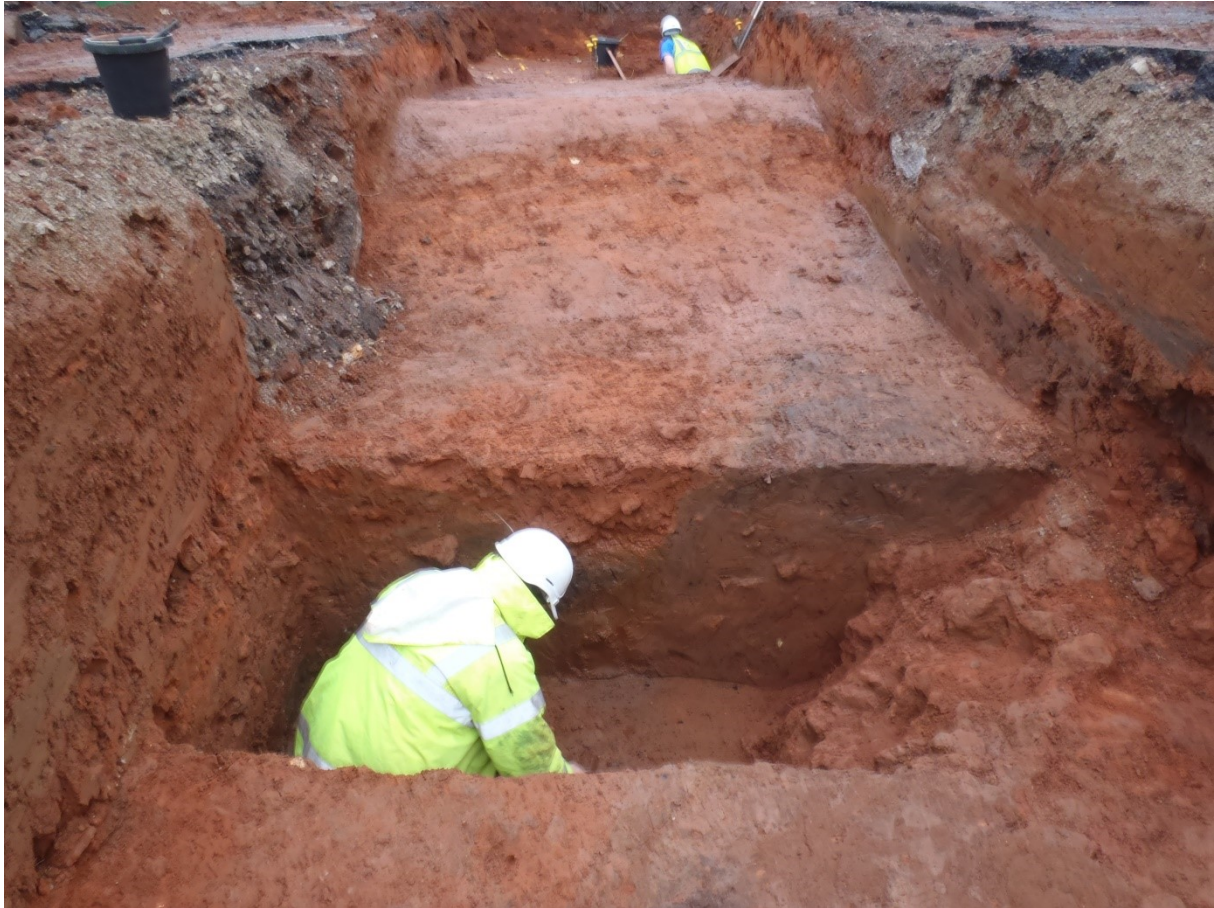
Plate 6 Trench 3. Ditch during excavation of box section, viewed north.

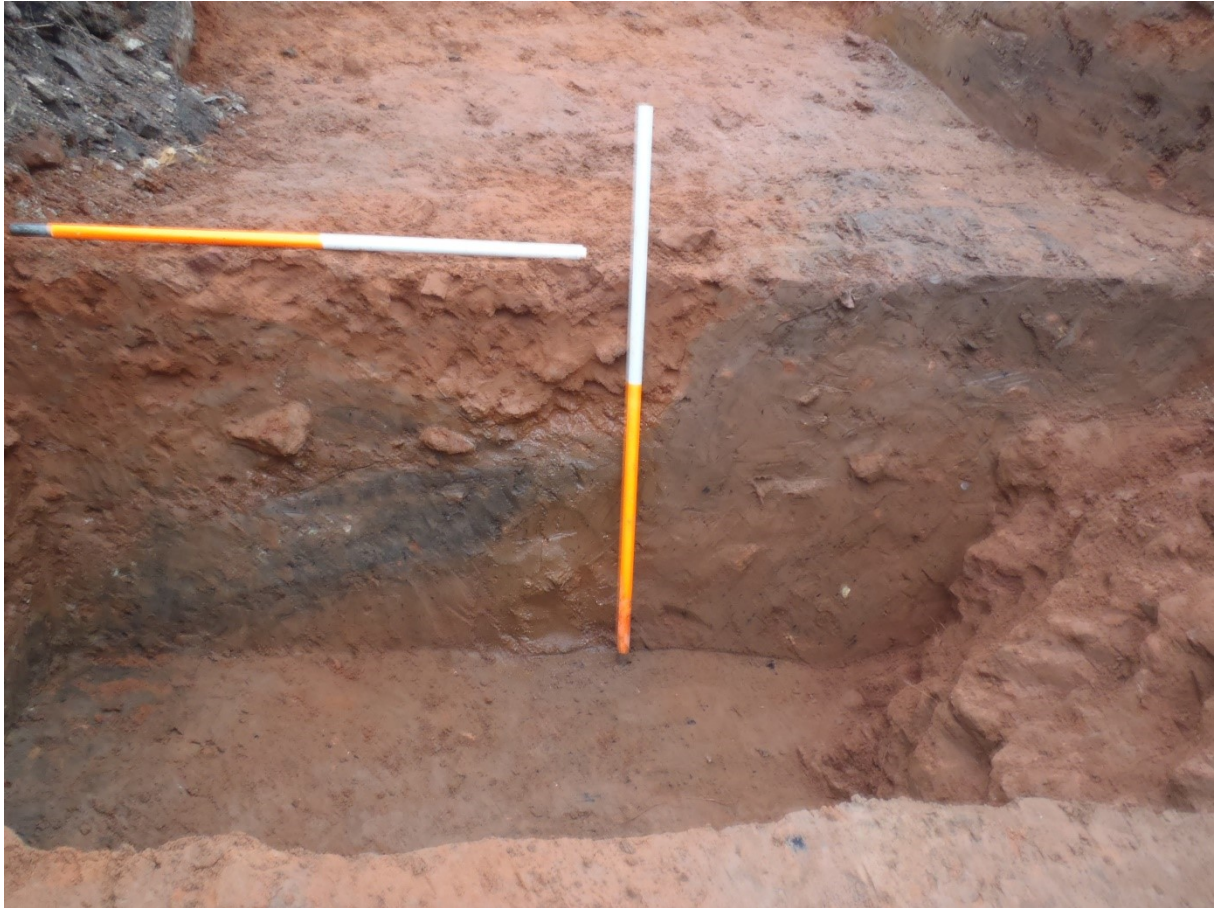
Plate 7. Trench 3. Box section through ditch deposits, viewed north. Scale 1m x 1m.

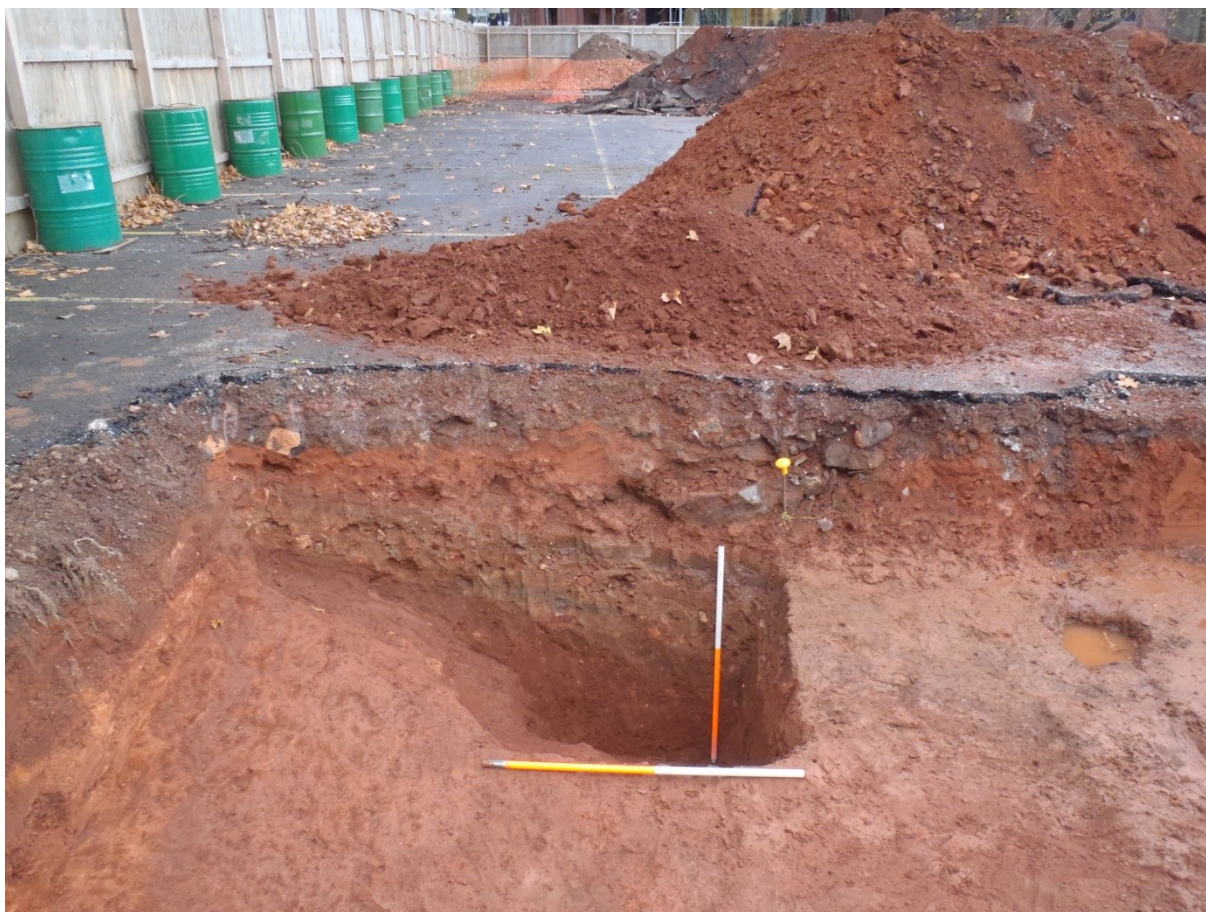
Plate 8. Trench 3. Box section through ditch north end of trench, viewed east. Scale 1m x 1m.

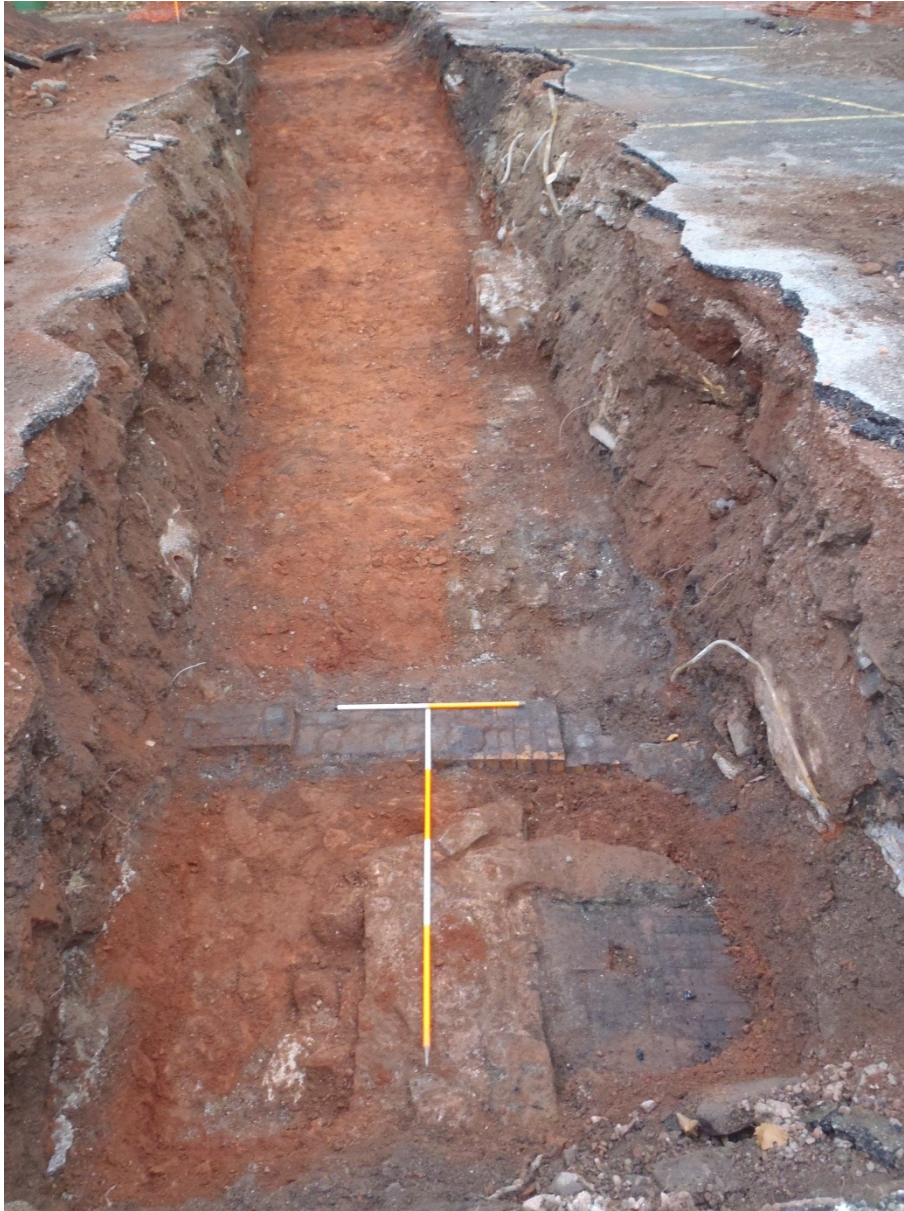
Plate 9. Trench 4 viewed north. Scale 2m. x 1m.

- 5.5 **Trench 4** (18.50m long x 3.10m wide). Excavated onto the natural substrate (403) at an average height of between 10.56 and 12.26m aOD. Two sandstone walls were exposed,

possible dating from the 17th century (404) and (407). A surface of sandstone slabs and brick (405) abutted wall (404) and was likely to be of similar date. These three structures had been cut by the insertion of a later brick wall (406) on a concrete footing. No significant archaeological features, deposits or finds were present within the trench.

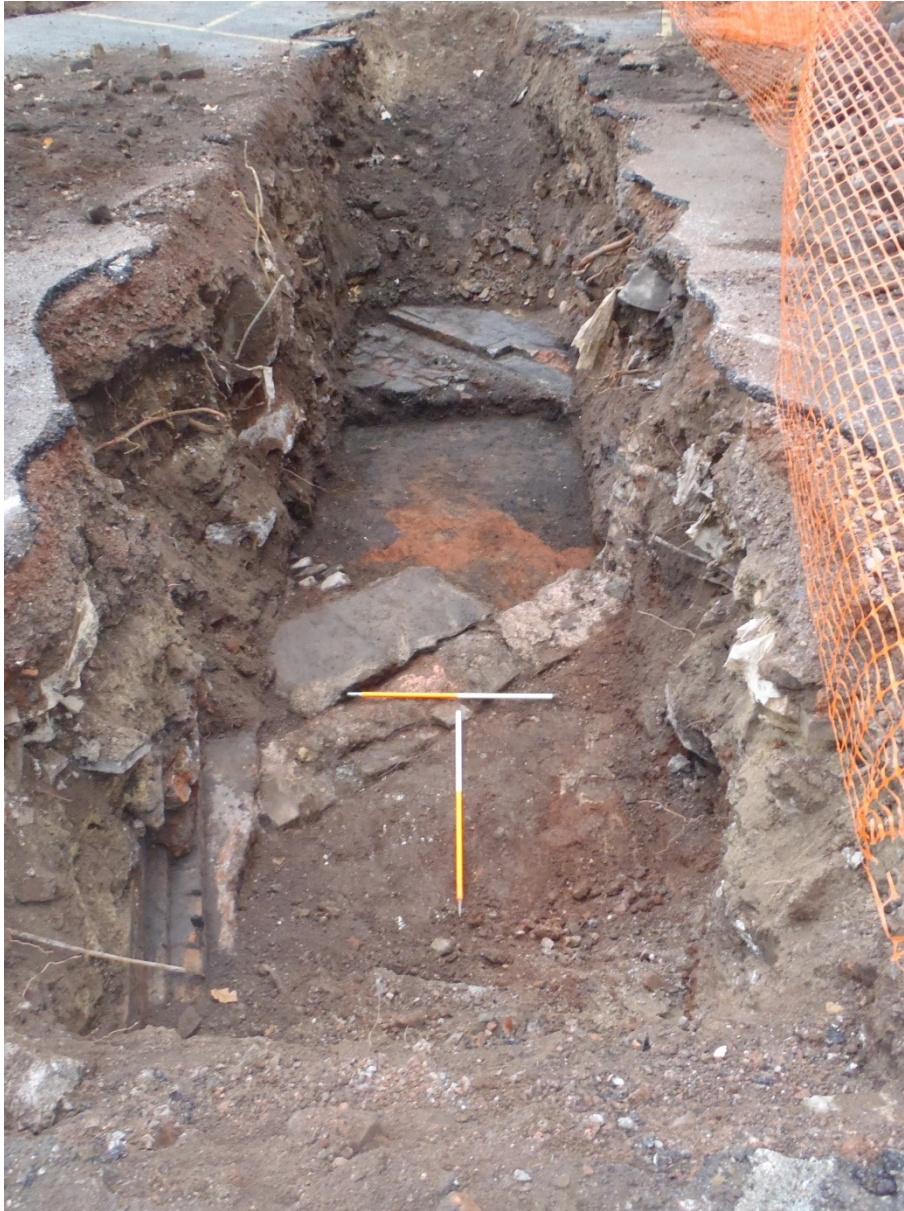
Plate10. Trench 5 viewed north. Scales 1m. x 1m.

- 5.6 Trench 5** (12.90m long x 2.0m wide). Excavated to a maximum depth of 2.3m. In the trench base, the upper surface of the natural sand and weathered sandstone substrate (302) may have been exposed, but owing to reasons of health and safety, this could not safely be ascertained. This deposit was situated at an average height of 10.16m aOD. Cutting across the trench from N – S, was a linear structure (Wall 509) which may have been associated with the adjacent, fragmentary remains of a cobble floor (506 & 507). These structures were of possible 17th century date but had been truncated by later walls on concrete foundations (504) and (505), as well as a small concrete pad (505). The uppermost deposit comprised tarmac and bedding gravel (501). No significant archaeological features, deposits or finds were present within the trench.

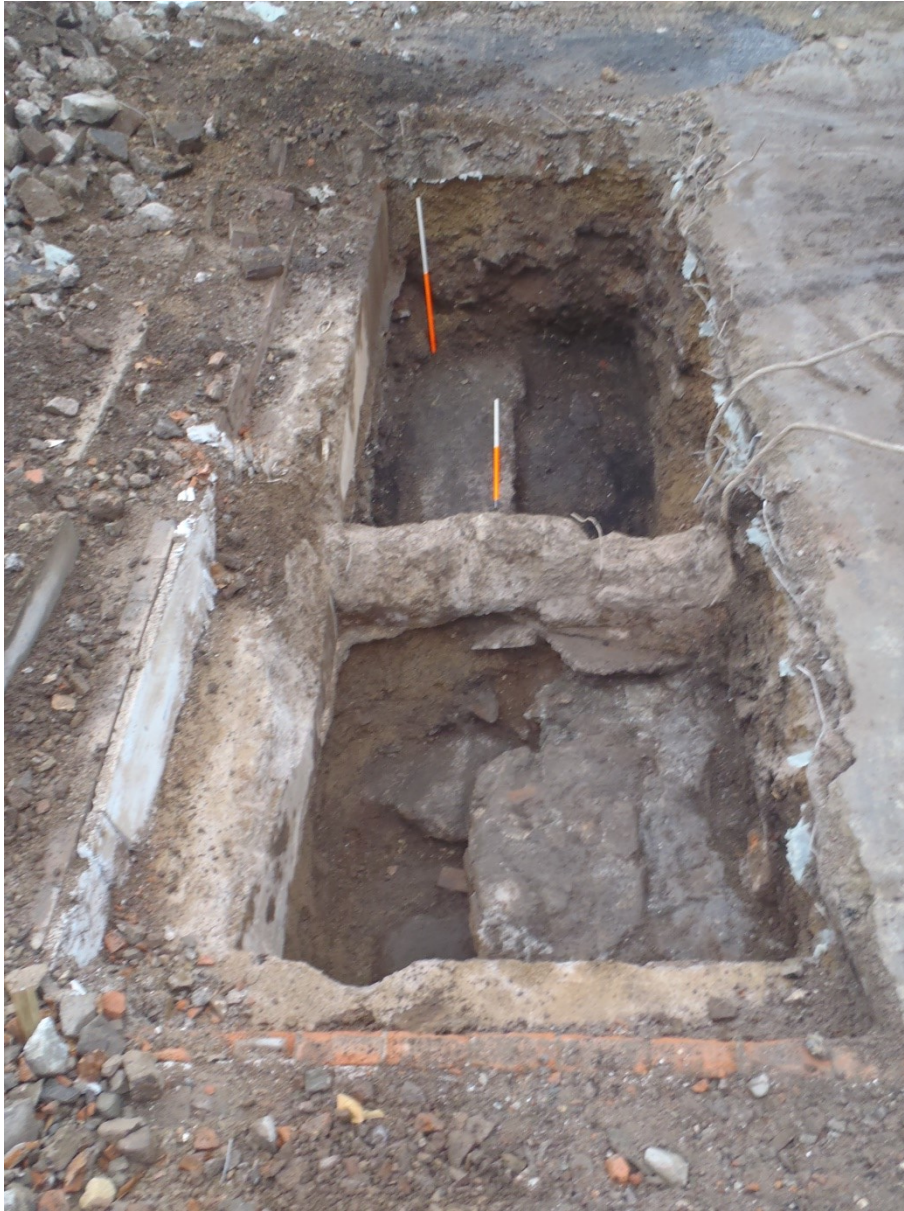
Plate11. Trench 6 viewed west. Scale 1m. x 1m.

- 5.7 Trench 6** (5m long x 2m wide). Excavated to a maximum depth of 2m wholly within deposits of made-ground (605), with no natural clay substrate visible. Below the modern concrete floor (601) was a concrete ring-beam (604) and deposits of gravel and scalplings (602) which also filled a large service pipe trench. Further modern services (606) lay below this and these cut two parallel walls (608) and (609) that predated the Ambulance Station. Separated from these by the ring-beam (604) was a further wall (607) on a concrete footing. All these features were butted by an extensive made-ground layer, Deposit (605). No archaeological features, deposits or finds were present within the trench.
