Ferrybridge BESS, West Yorkshire

Archaeological Evaluation Report

One Planet Developments

May 2023

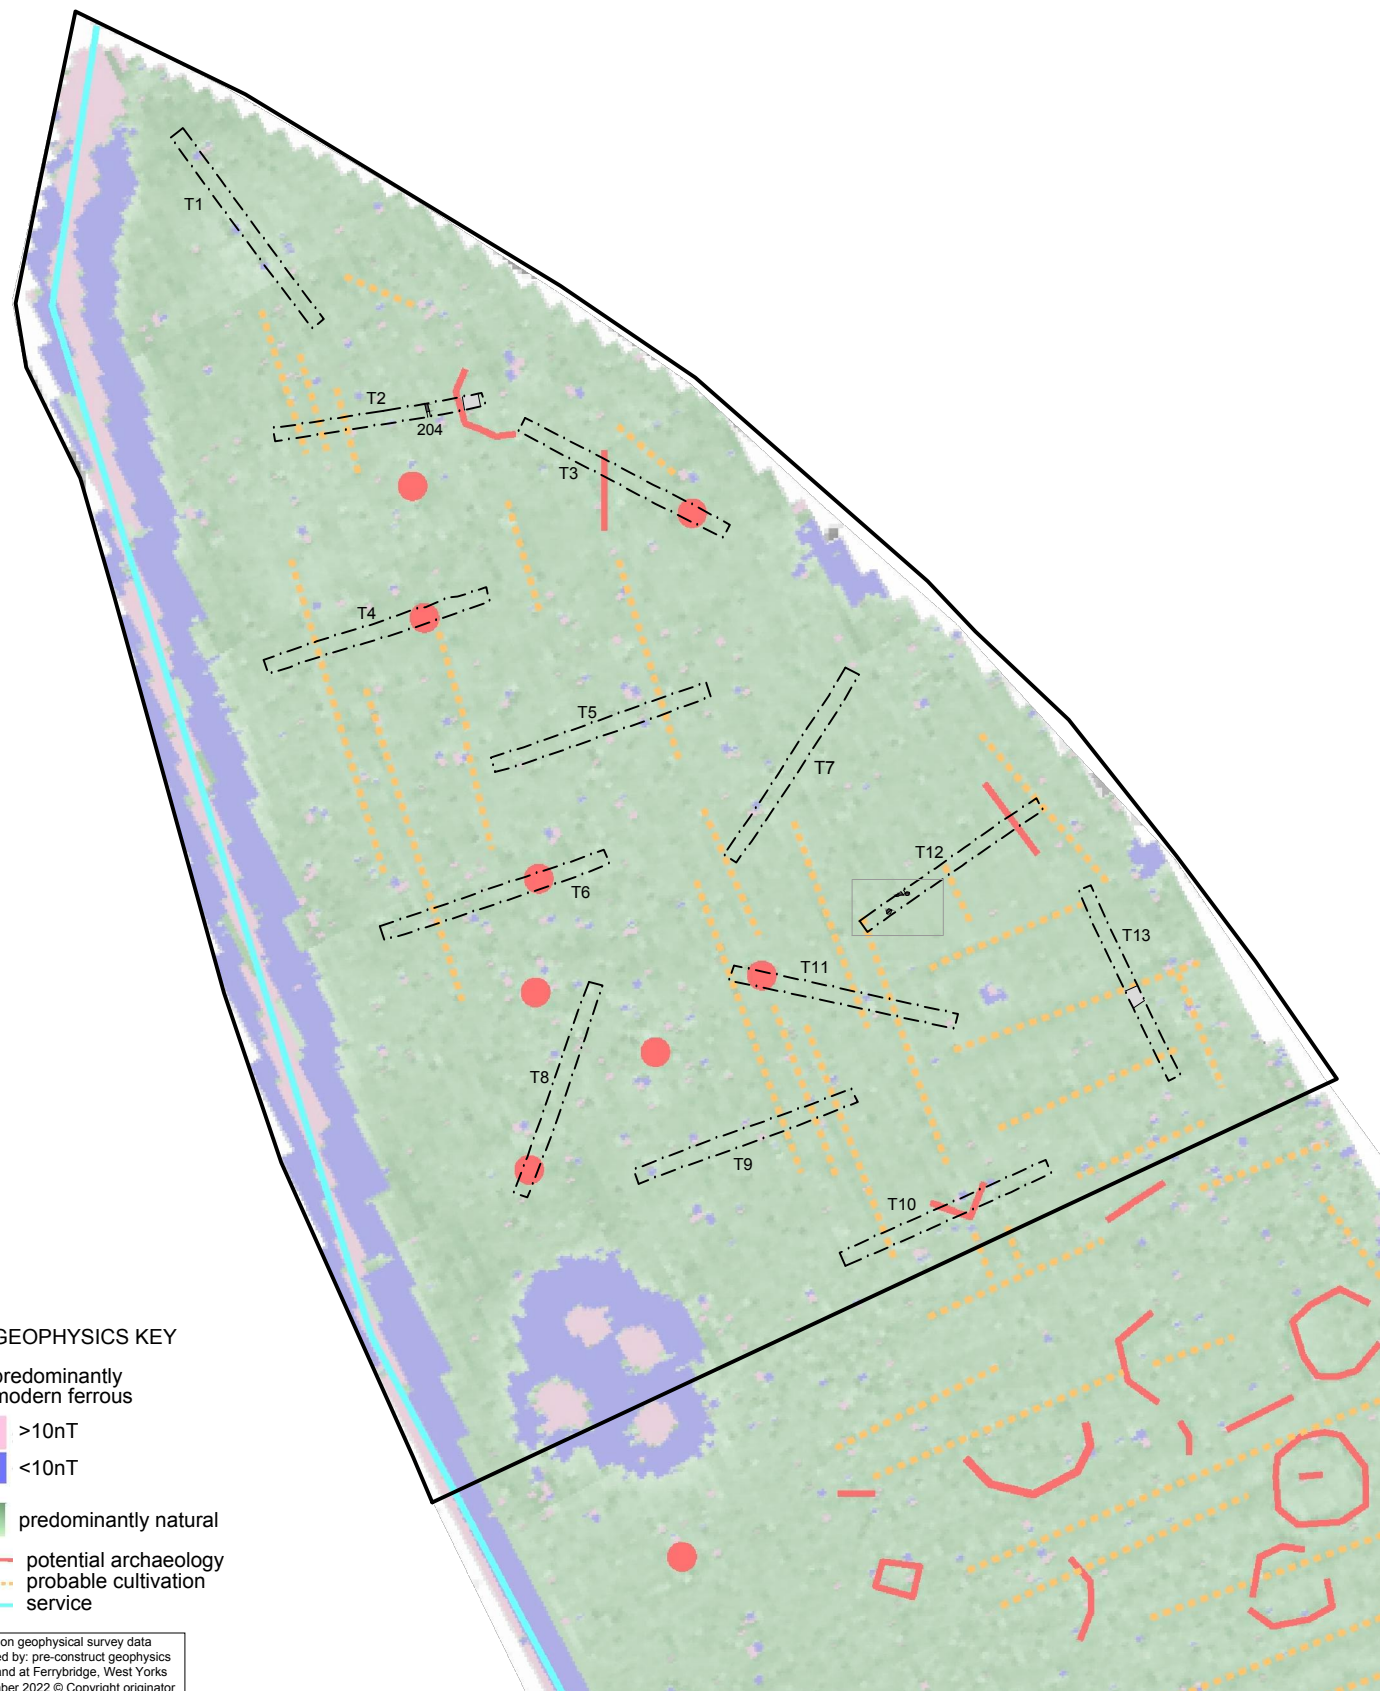
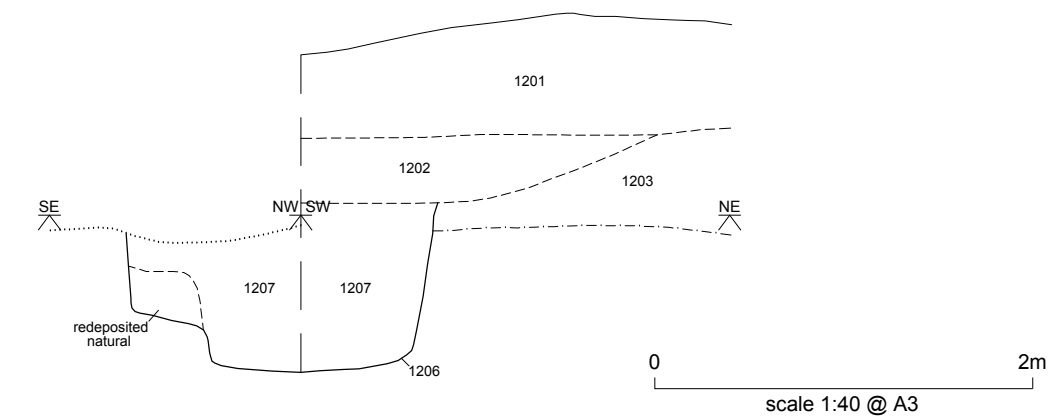
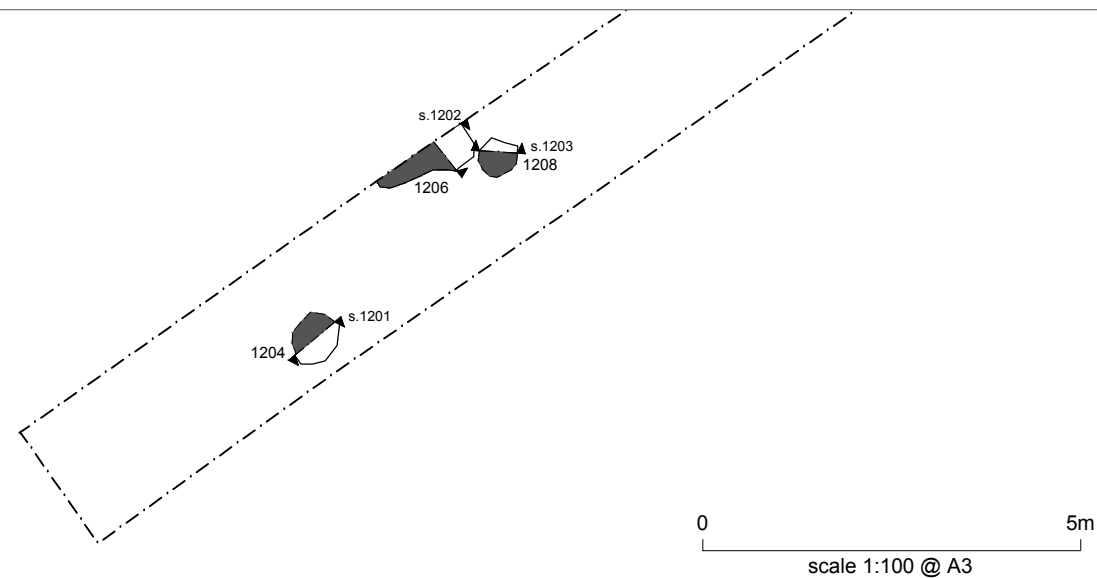
Trench 1, sample section

Trench 4, sample section

Trench 12, section 1202

Trench 12

- 4.2.1 Typical representative sections of these trenches are shown in Figure 2.
- 4.2.2 No archaeological features were identified in these trenches.

- 4.3.1 Trenches 7 and 8 were located in the south west of the Site. Representative sections of these trenches are illustrated in Figure 2.
- 4.3.2 Topsoil in these trenches ranged from 0.28 to 0.30 m deep.
- 4.3.3 Underlying the topsoil throughout both trenches were two layers of made-ground (702 and 703, 802 and 803). The upper layer (702, 802) consisted of dark orange-brown sandy silt 0.18–0.70 m deep. The lower layer (703, 803) consisted of blackish brown sandy silt 0.15–0.40 m deep. These deposits included modern fabric and plastic and are likely to have derived from large scale construction work in the area.
- 4.3.4 The made-ground deposits immediately overlay natural geological deposits, indicating that the area may have been machine stripped to this level prior to construction activity.
- 4.3.5 No further archaeological features were identified in these trenches.

- 4.4.1 Trench 12 was located towards the south east of the Site. A representative section of the trench is included in Figure 2. Topsoil in Trench 12 ranged from 0.22 to 0.33 m deep. Subsoil was not consistent throughout the trench but, where present, it measured up to 0.20 m deep.

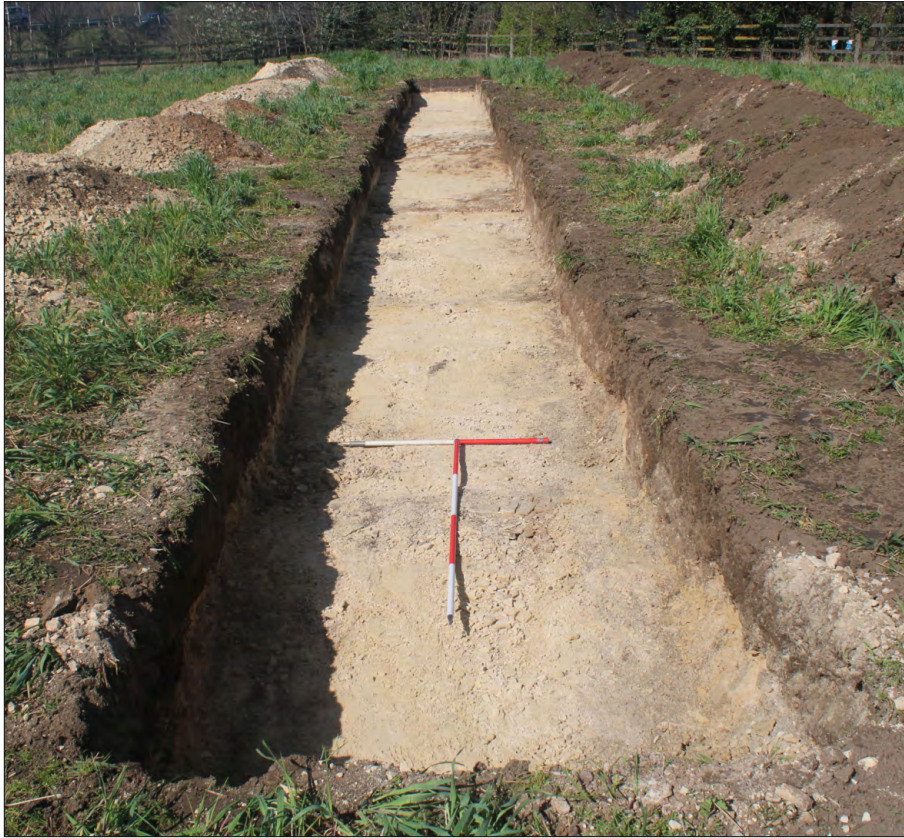
Plate 1

Trench 1, facing north west

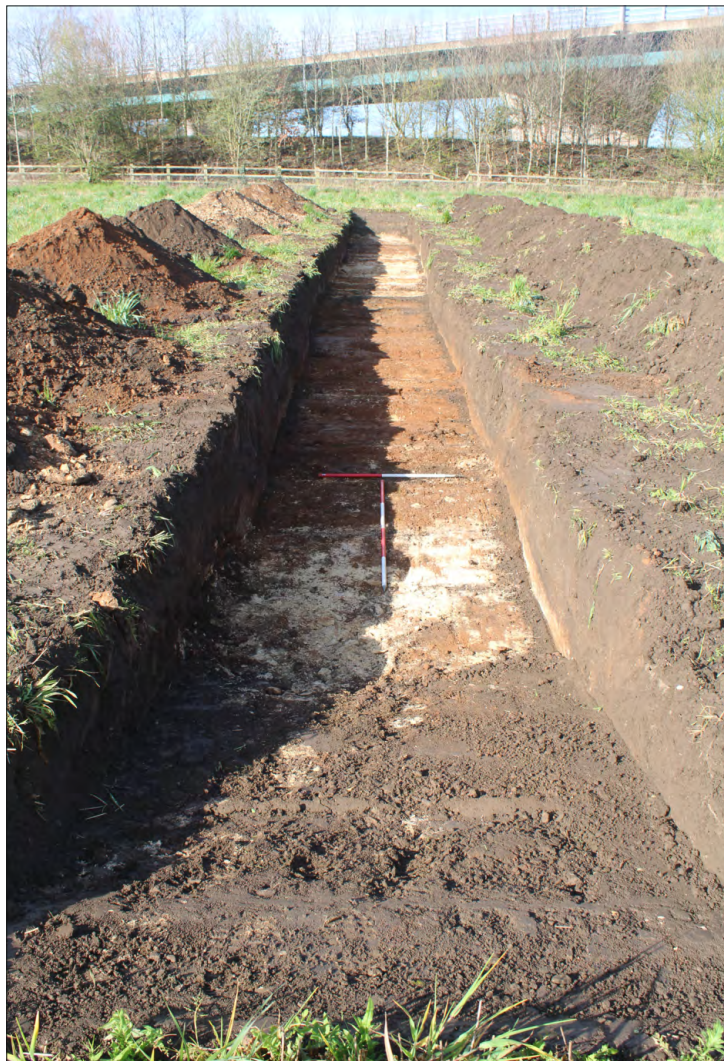
Plate 2

Trench 4, facing west

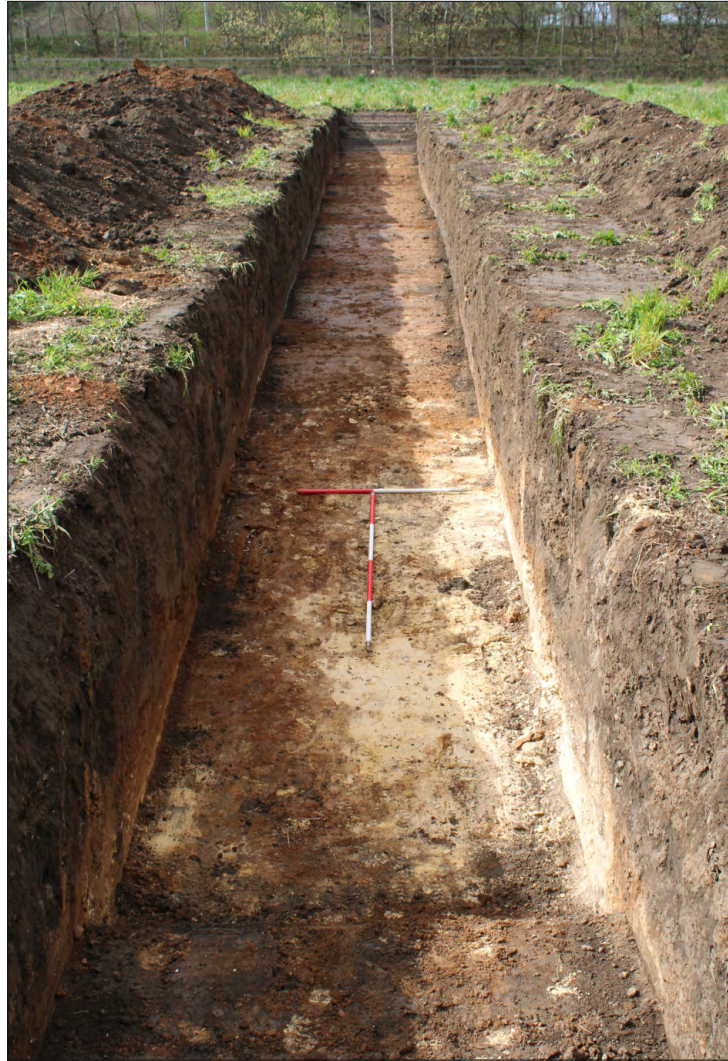
Plate 3

Trench 7, facing west

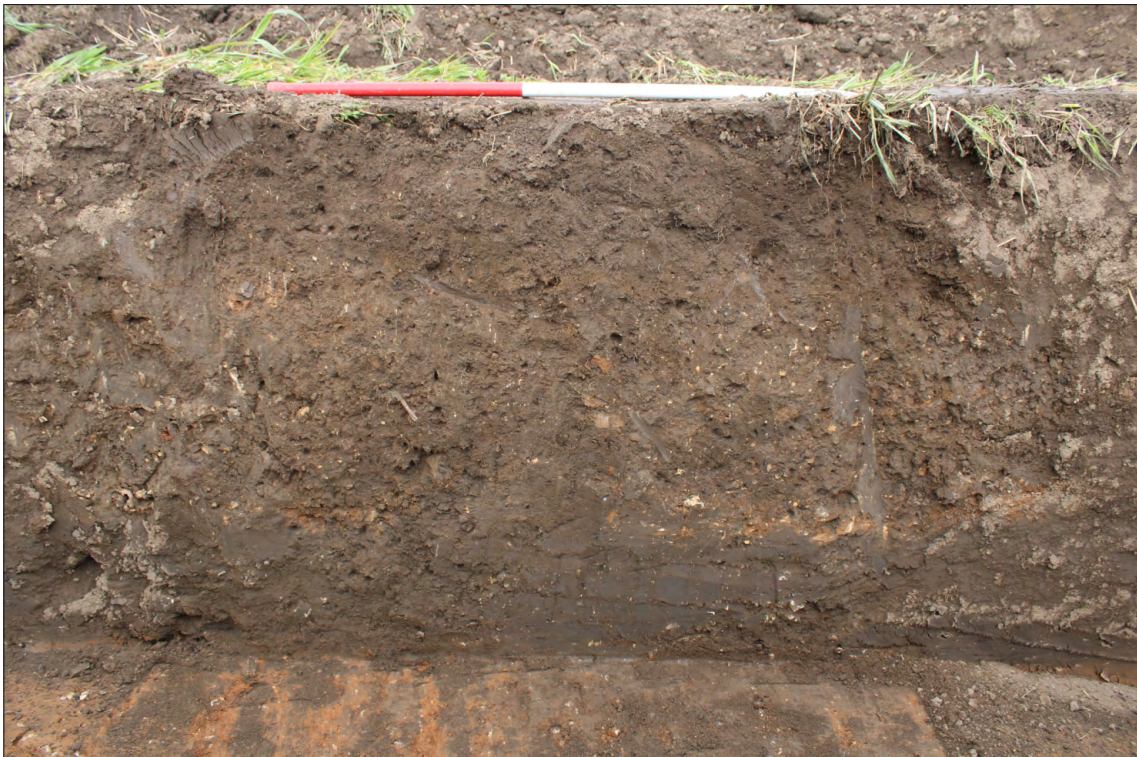
Plate 4

Trench 7, made ground 702, south facing section

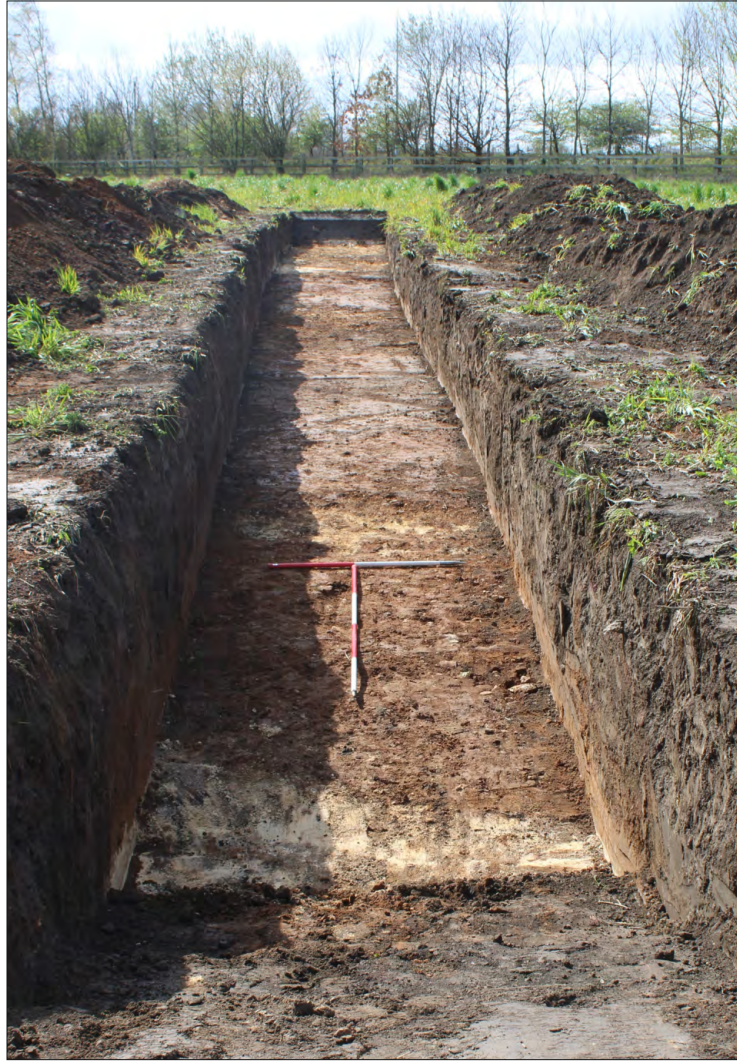
Plate 5

Trench 8, facing south west

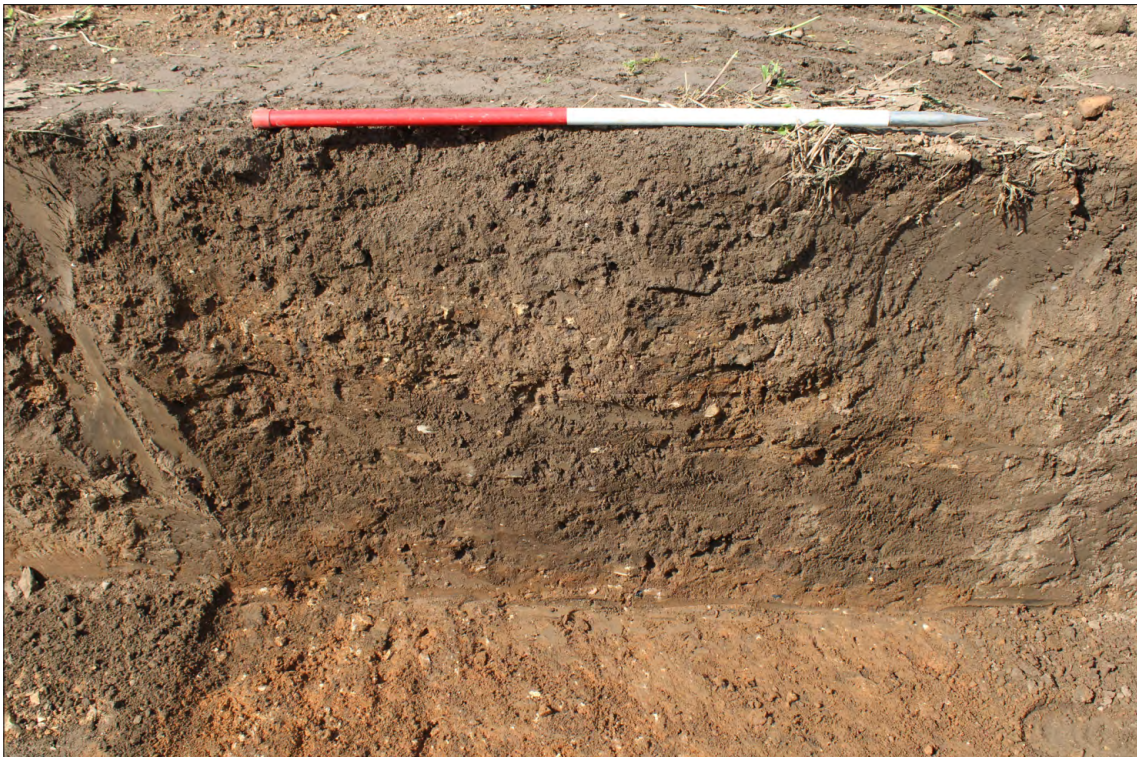
Plate 6

Trench 8, made ground 802, south east facing section

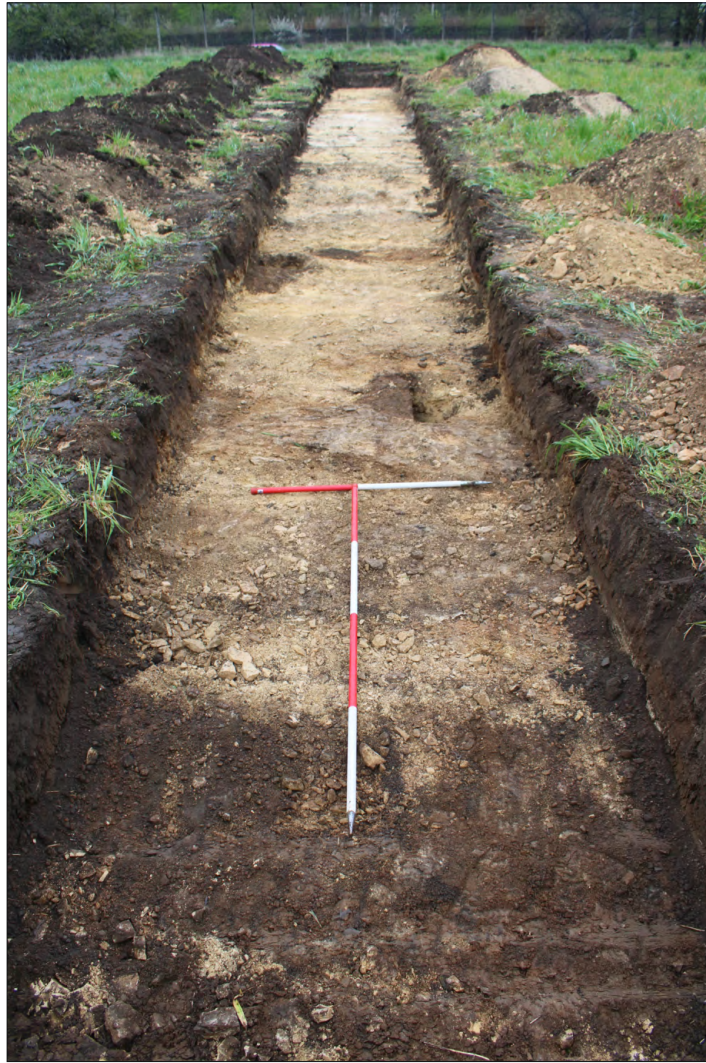
Plate 7

Trench 12, facing north east

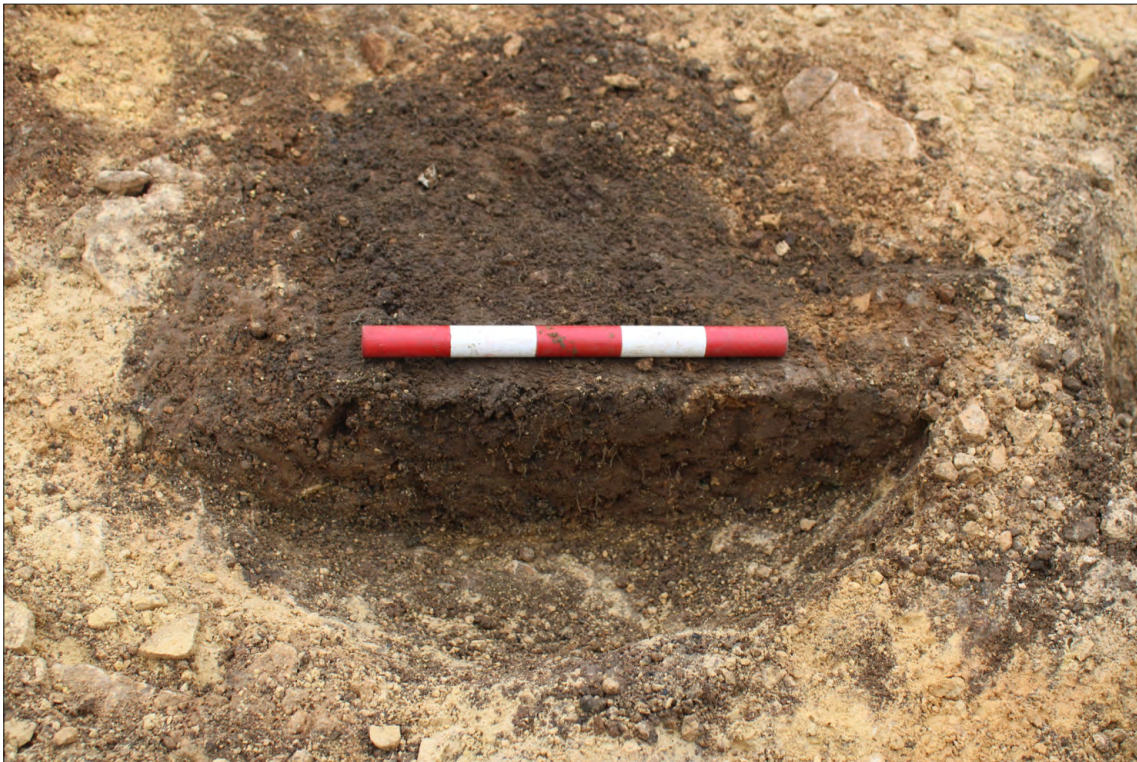
Plate 8

Trench 12, Pit 1208, south facing section

- 4.4.2 Three pits (1204, 1206, 1208) were identified after removal of subsoil, cut into the natural bedrock. Pit 1208 measured 0.47 by 0.58 m , and 0.12 m in depth, and contained modern ceramic and ironwork. Pit 1204 measured 0.70 by 0.64 m , and 0.33 m in depth. It contained a fill (1205) of mid-orange brown sandy silt. No artefacts were recovered from the fill. Pit 1206 was exposed over an area of 1.03 by 0.49 m, continuing beyond the limit of excavation, and was 0.37 m deep. It contained a fill (1207) of dark brown silt. No artefacts were recovered from the fill.

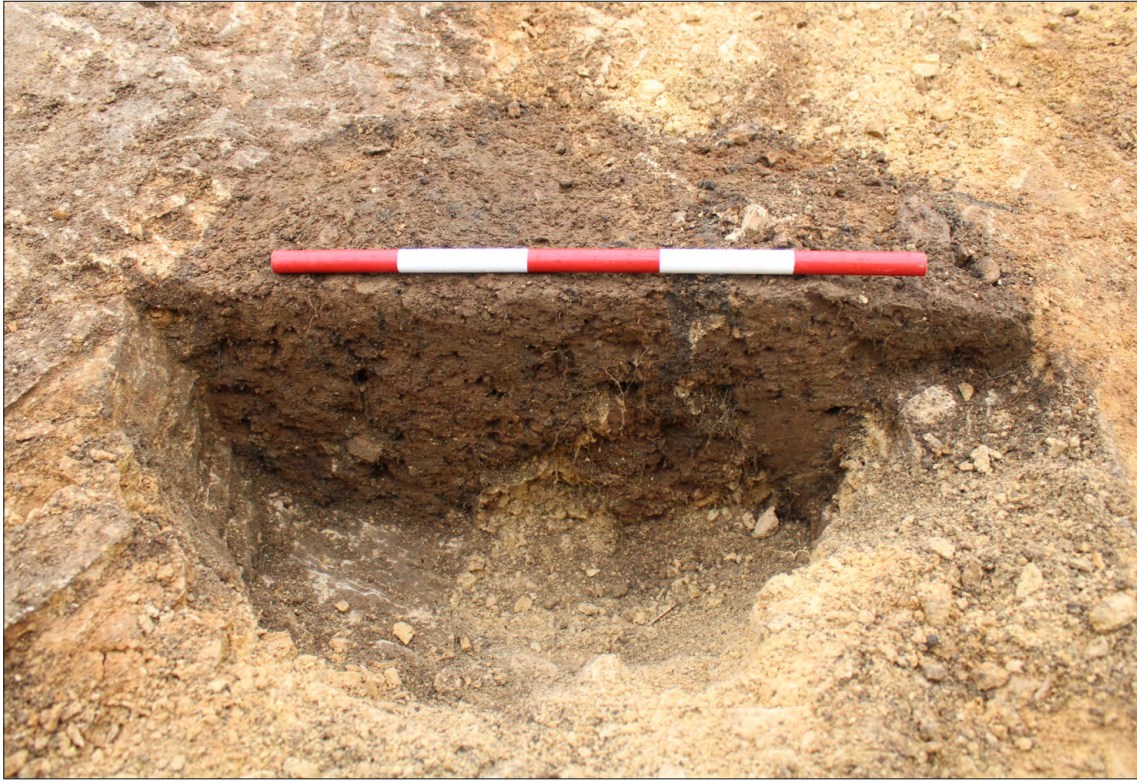
Plate 9

Trench 12, Pit 1204, north west facing section

- 4.4.3 Without dating evidence, a date cannot be assigned to either pit 1204 or pit 1206, although considering their association with pit 1208 it is likely that they are of modern origin.

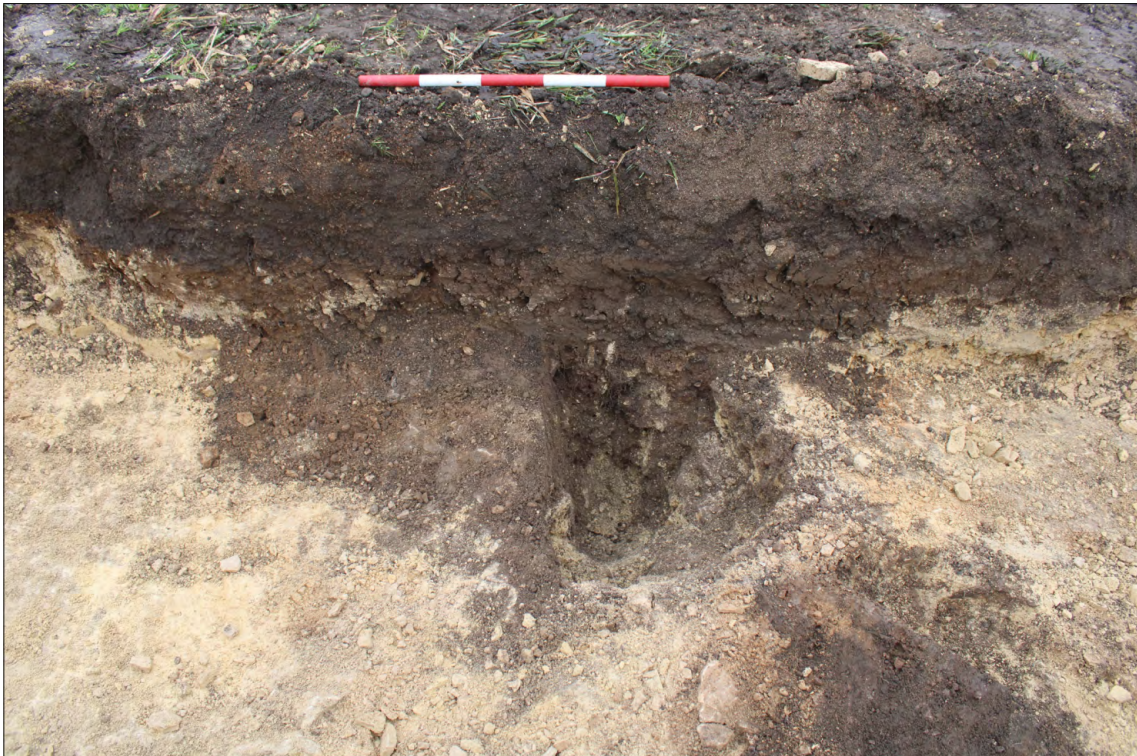
Trench 12, Pit 1206, south east facing section

- 6.1.1 A bulk environmental soil sample was recovered from the fill of pit 1206. Due to the lack of dating evidence from the fill and the pit's association with the modern pit 1208, it has not been considered necessary to process the sample. The sample has been temporarily retained at Ecus' Barnard Castle office in the event that processing is considered necessary in the future but will be discarded if no further archaeological work is required at the Site.
