**Hopewell House, Calverley Road, Oulton -  
Archaeological building recording and  
Heritage Assessment  
IGS Developments Ltd**

Planning application 10/03430/FU

Report Title: **Hopewell House, Calverley Road, Oulton, Yorkshire**

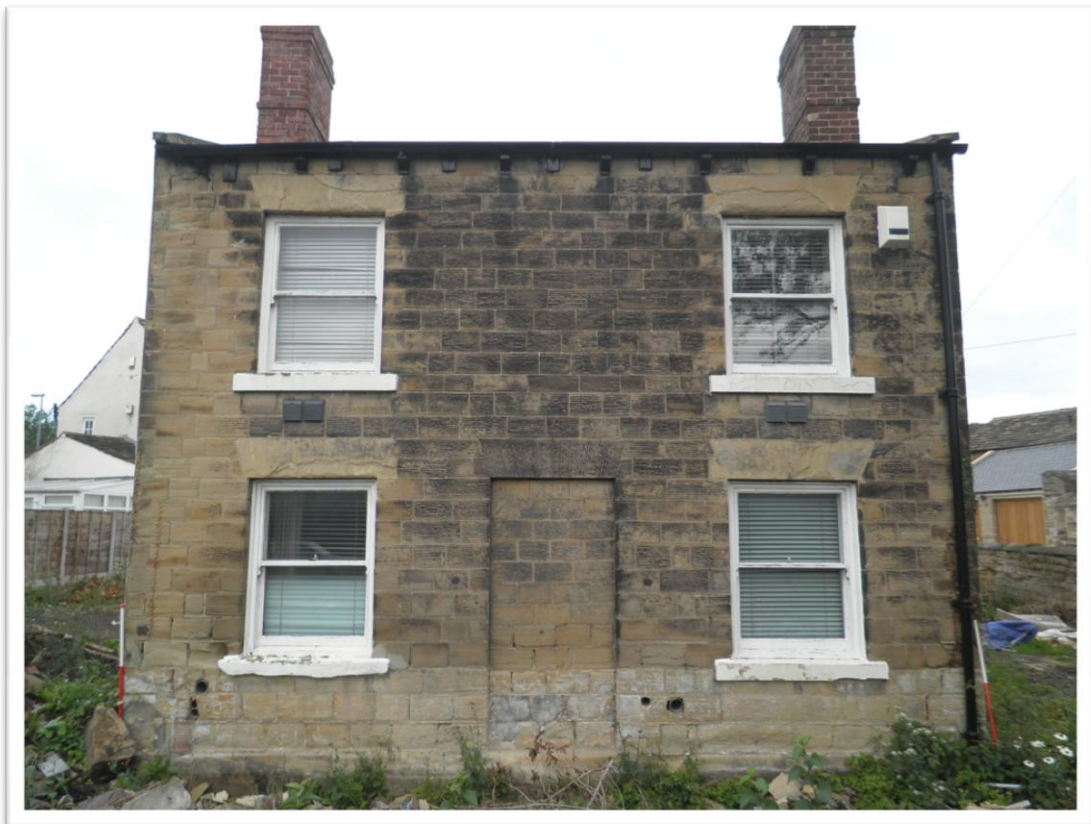
- 7.2 The construction of the house is mostly of squared blocks of York stone ashlar with rendering on the east and west sides of the property.
- 7.3 The south elevation is made of neat ashlared yolk blocks with a stone dentil course at the eaves and large stone lintels above the four windows (two on each floor). The windows themselves are simple horned timber sashes with large plate glazing. In the centre of this simple elevation is a shallow niche, which appears to be a blocked doorway. In reality the ashlar blocking appears to be primary and the internal arrangement of the property also demonstrates that this was never a functioning doorway but was created to give the façade symmetry, or perhaps because it was created using an existing design.

**Plate 1: South frontage of Hopewell house**

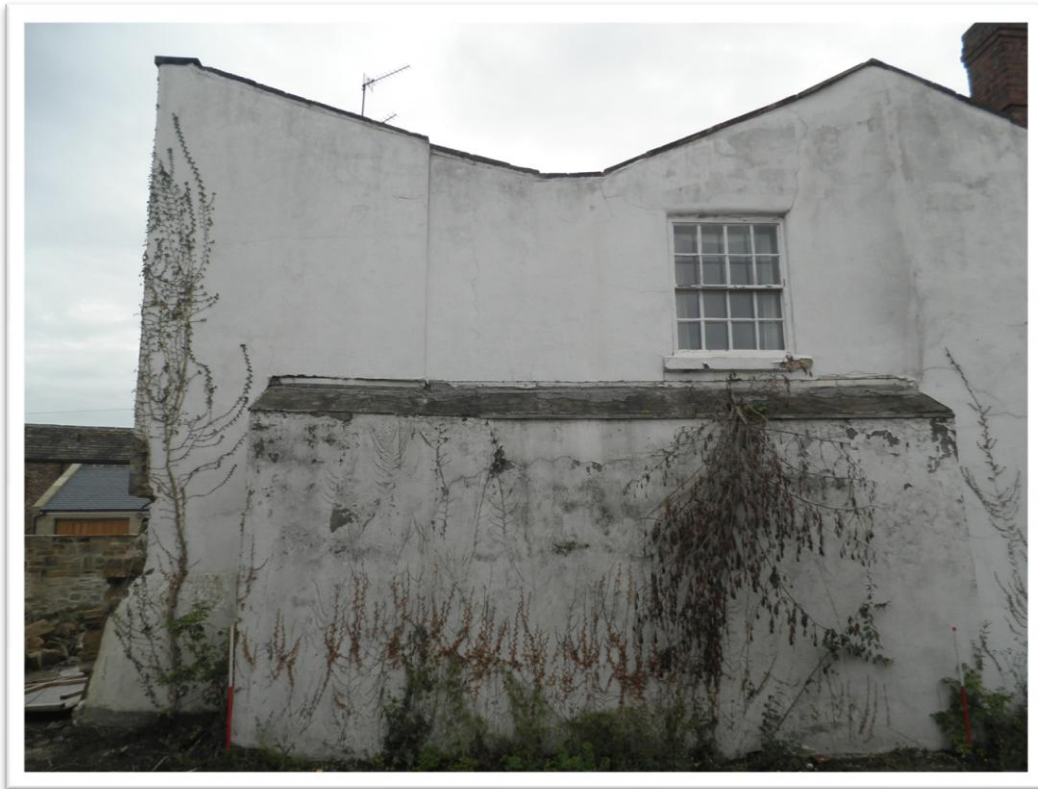
- 7.4 The western elevation is covered in a heavy cementitious render which presumably hides stone walling beneath. The elevation has a gable to the south and a half gable to the north. It is rather plain but is pierced by a single window unlike the sashes on the south elevation this has many panes and is without horns. An unusual feature on this elevation is the solid masonry buttress-like feature which has no internal access within the property. This is probably the remnants of a chimney which served the former outbuildings, (now lost but visible on the west side of the house on the Ordnance Survey mapping).

**Plate 2: Western elevation of Hopewell House**

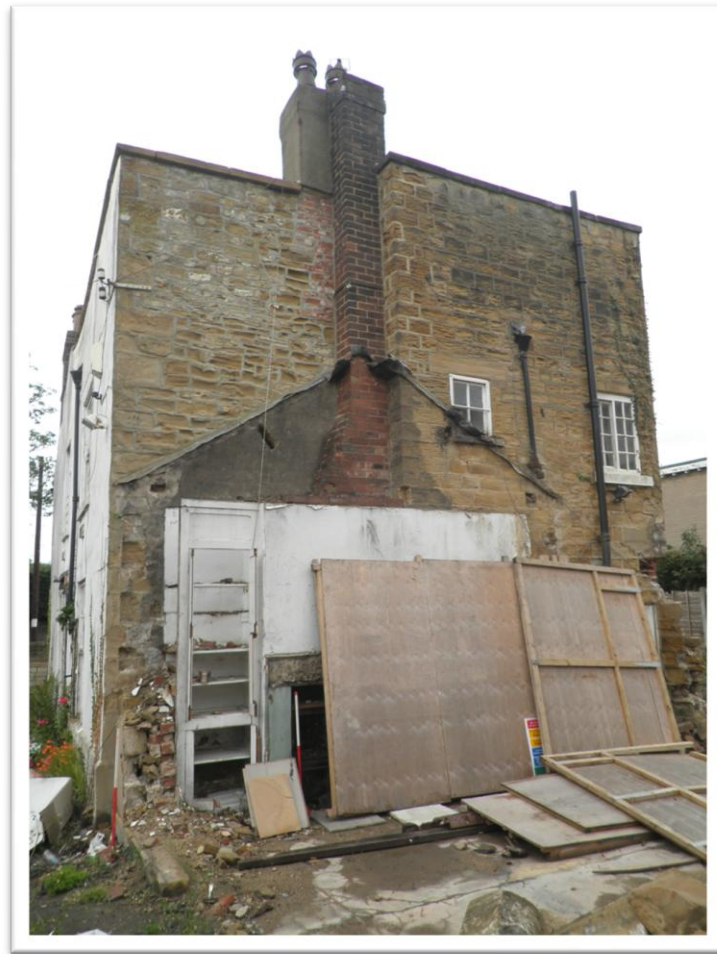
- 7.5 The north elevation is made up of well coursed York stone blocks, which unlike the south front are not ashlar. The half gable makes this elevation appear flat roofed and rather devoid of features. At the foot of the elevation one may see signs of the demolished extension at the rear of the property which was constructed in the 1870s - 1880s between the plan held in the Leeds archives and the 1<sup>st</sup> Edition OS map. This survives as a roof scar, a truncated wall, some internal plaster and a range. The range is served by an external brick chimney flue which is attached to the side of the earlier stone wall. There are only two windows on this elevation, a simple casement at the eastern end and almost in the centre a small sash, the frame of which is partially cut by the addition of the later extension.

**Plate 3: Northern elevation showing demolition of 1870s extension**

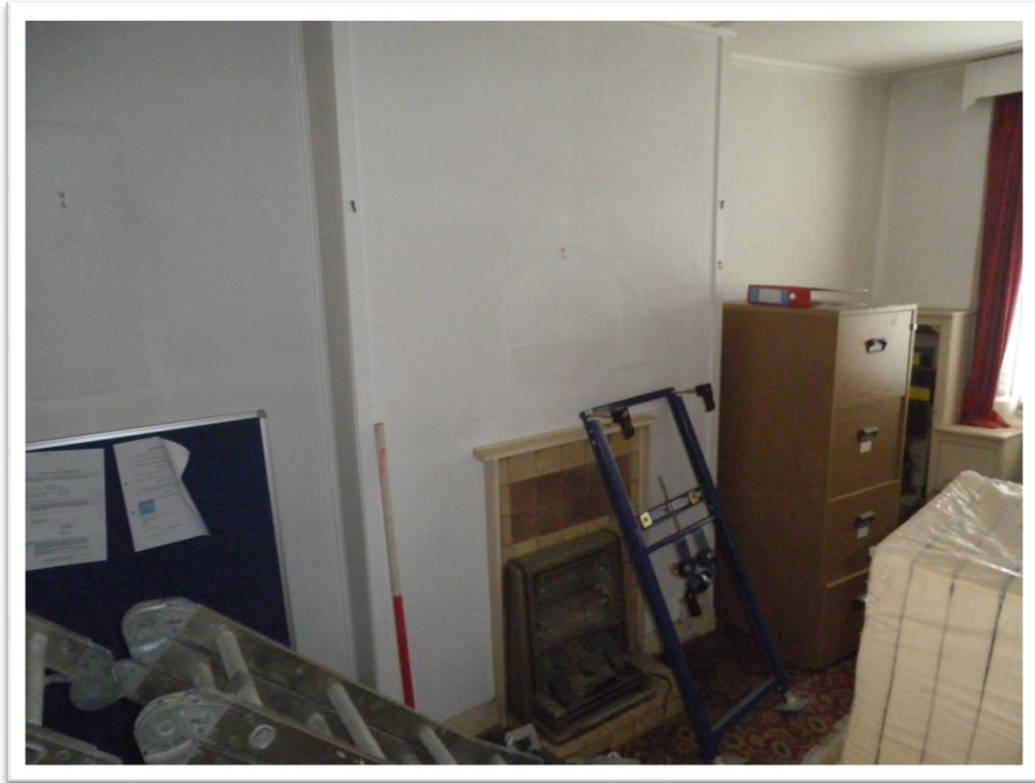
Room 1 is located in the south east corner of the property and is a small reception room with a blocked fireplace, and integrated early 20<sup>th</sup> century cupboard. The original floorboards are in situ under the current carpet and are made of machine cut 19<sup>th</sup> century softwood timber. As throughout the ground floor many fixtures and fittings appear to date from the mid 20<sup>th</sup> century, although some of the integrated cupboards within room 1 may be older.

**Plate4: Interior of Room 1**

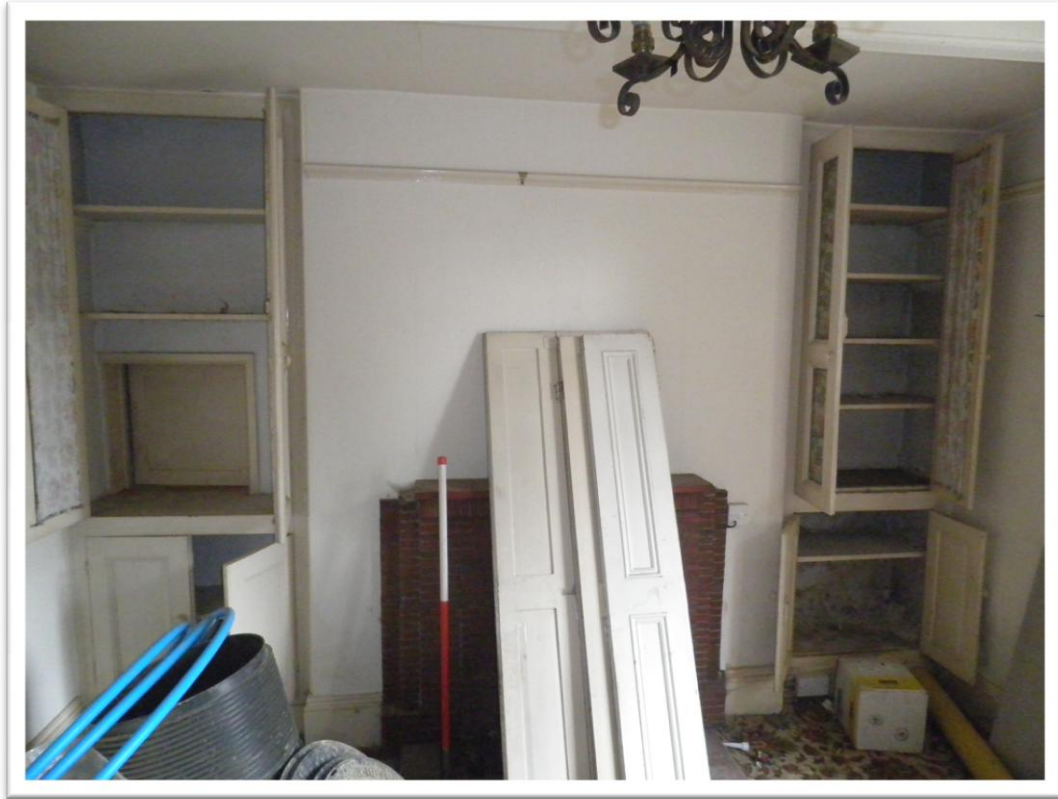
Room 3 is the largest downstairs room and contains a 20<sup>th</sup> century fireplace at the north end with integrated cupboards and a serving hatch surrounding it. These are either original features or relate to a later refurbishment. This would appear to have been intended as a dining room. There is a large 19<sup>th</sup> century window on the east side of the building. This room is accessed from a long corridor which ends in a door which would have entered the demolished extension. On the east side of this corridor are a small cupboard under the stairs, a larger pantry cupboard and a wash room (Room 4). These are the most noteworthy original features surviving on the ground floor and are of low significance.

**Plate 5: Interior of Room 3**

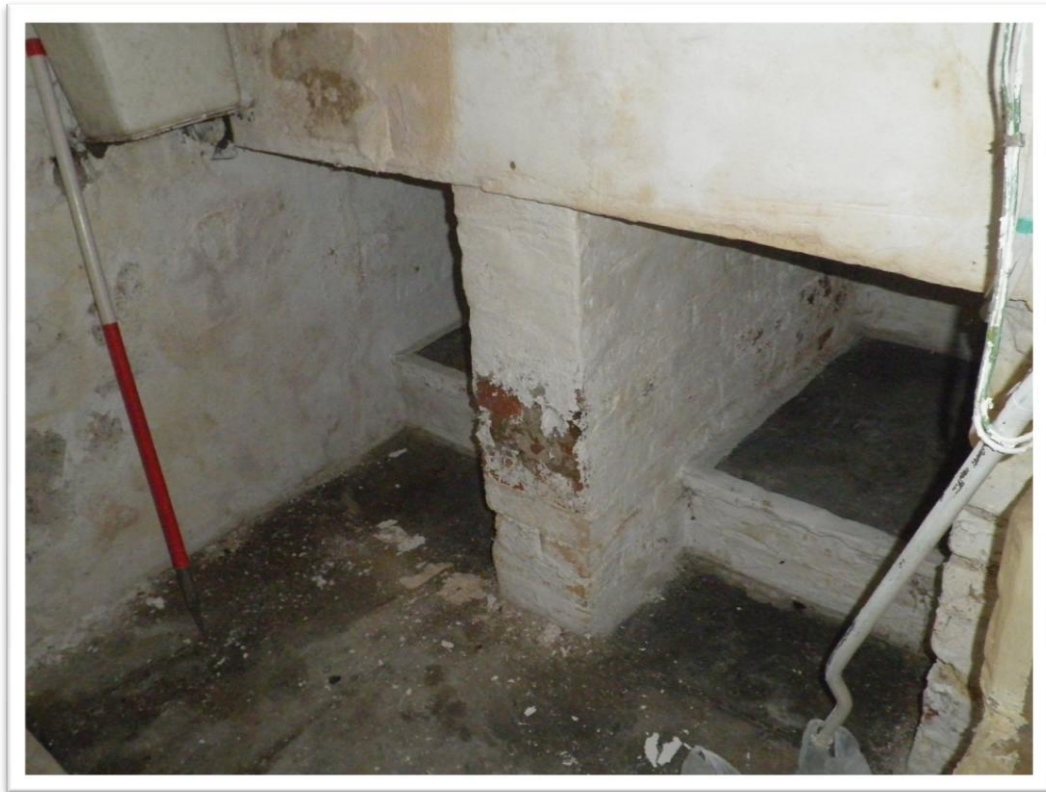
Room 4 is accessed down a small flight of stone steps and retains some features indicative of it having been scullery or bottle store. The visible foundations are constructed of machine made brick and stone and this supports the dating of the cottage to mid 19<sup>th</sup> century. This is an original room and in good condition however the features within are only of low significance.

**Plate 6: 19<sup>th</sup> century brick storage bins (Room 4)**

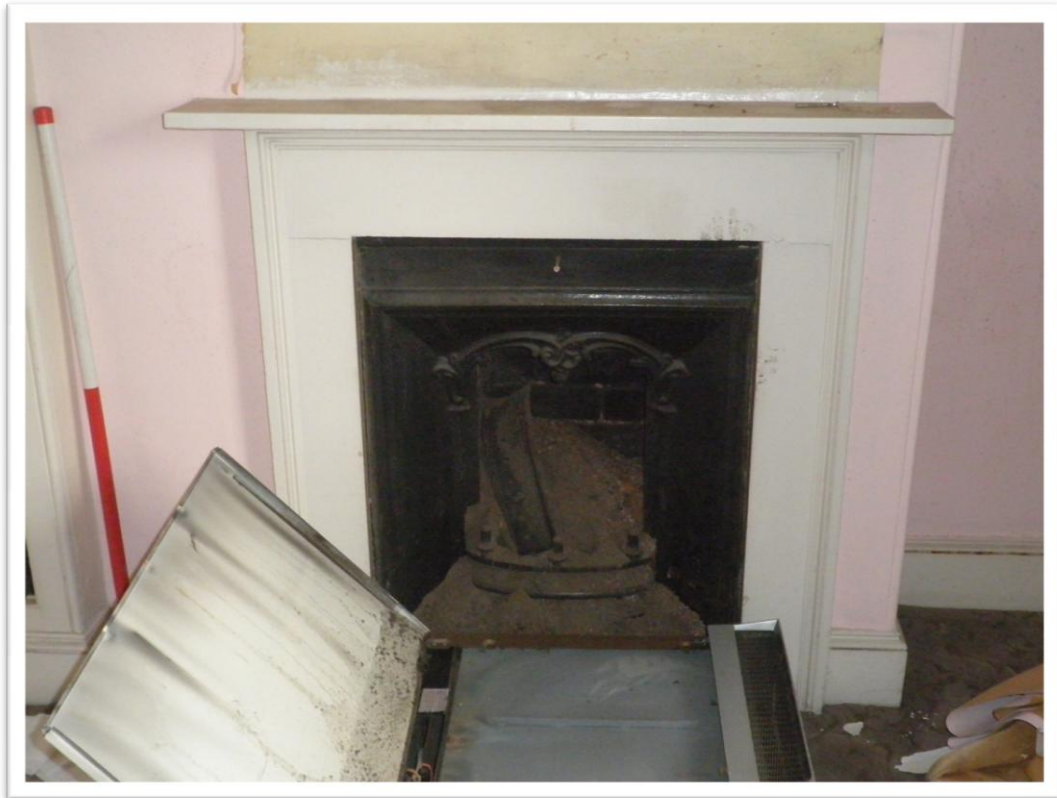
Room 8 was most likely the master bedroom of Hopewell house and retains several original features including a cast iron fireplace and cupboard space

**Plate 7 Cast iron fireplace in room 8**

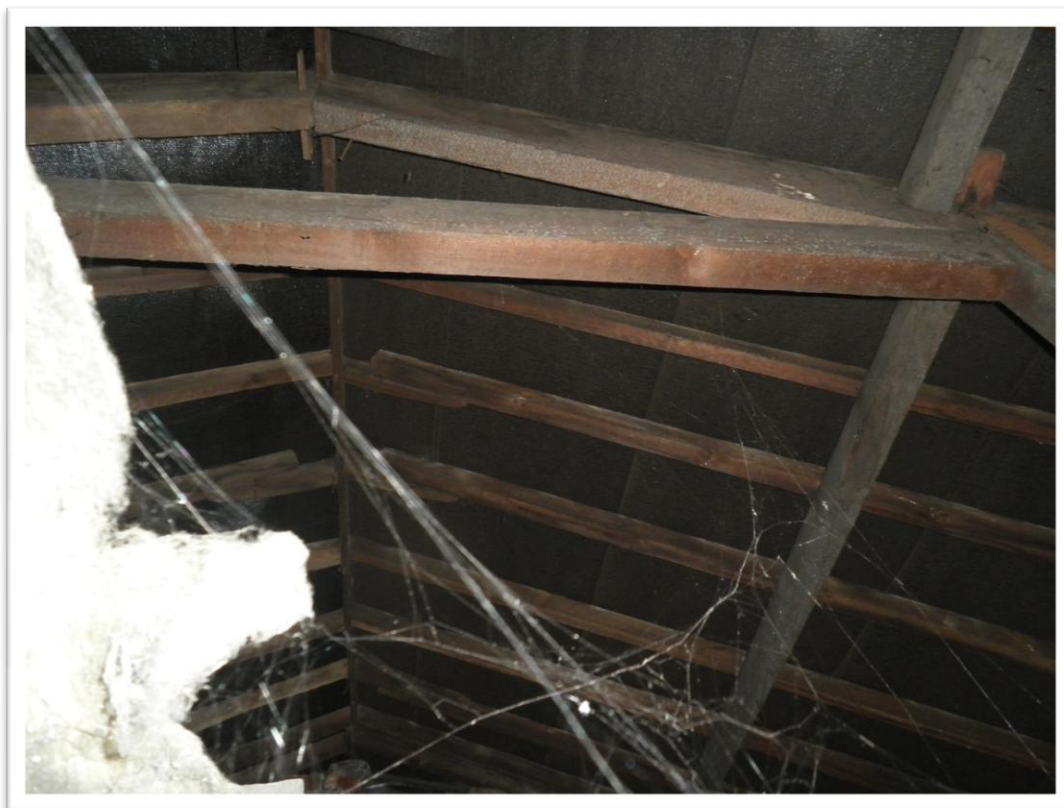
The roof structure of the property was not accessed but was examined through two loft hatches although these were too small to access fully. The roof structure is constructed of machine made timber, and brick with simple open trusses supporting softwood rafters. There was no older timber or structural elements visible where access was possible. The timber structure supports a slate roof which may also be original.

**Plate 10: Roof structure**

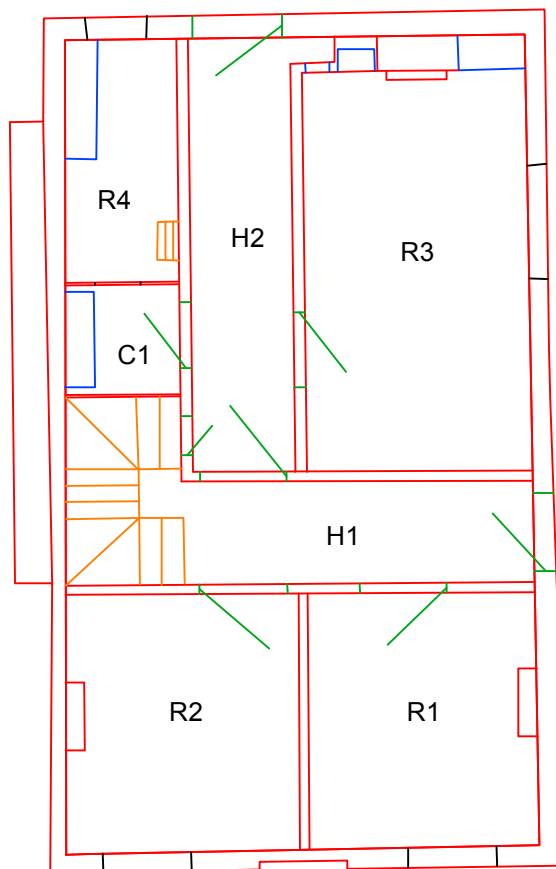
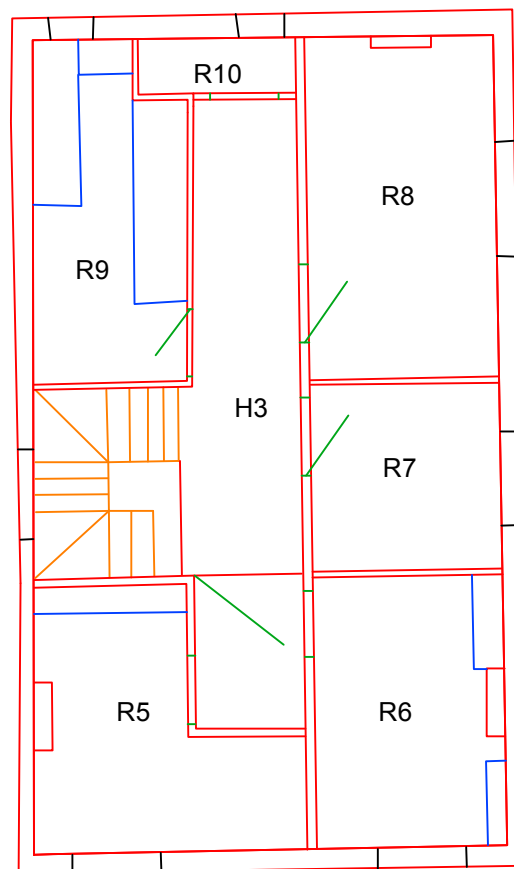
- 7.11 The house is entered from the east through a large door into an hallway (H1) which runs the full width of the house and faces the stairwell. To the south side of this corridor are two rooms (R1 and R2) and to the north a second corridor which runs the remaining north south length of the house. The hallway is lit by a single large window over the stairwell. Light fittings and general décor appear to be mid 20<sup>th</sup> century while the doors on the lower floor appear to be original mid – late 19<sup>th</sup> century. There are no apparent features of significance with the exception of room 3.

The first floor is accessed up a y large stairwell lit by a large window. On the upper floor 4 bedrooms (Rooms 5, 6, 7 and 8) are accessed along a central landing (H3) which runs north south. This also accesses the bathroom and lavatory (R9 and R10).

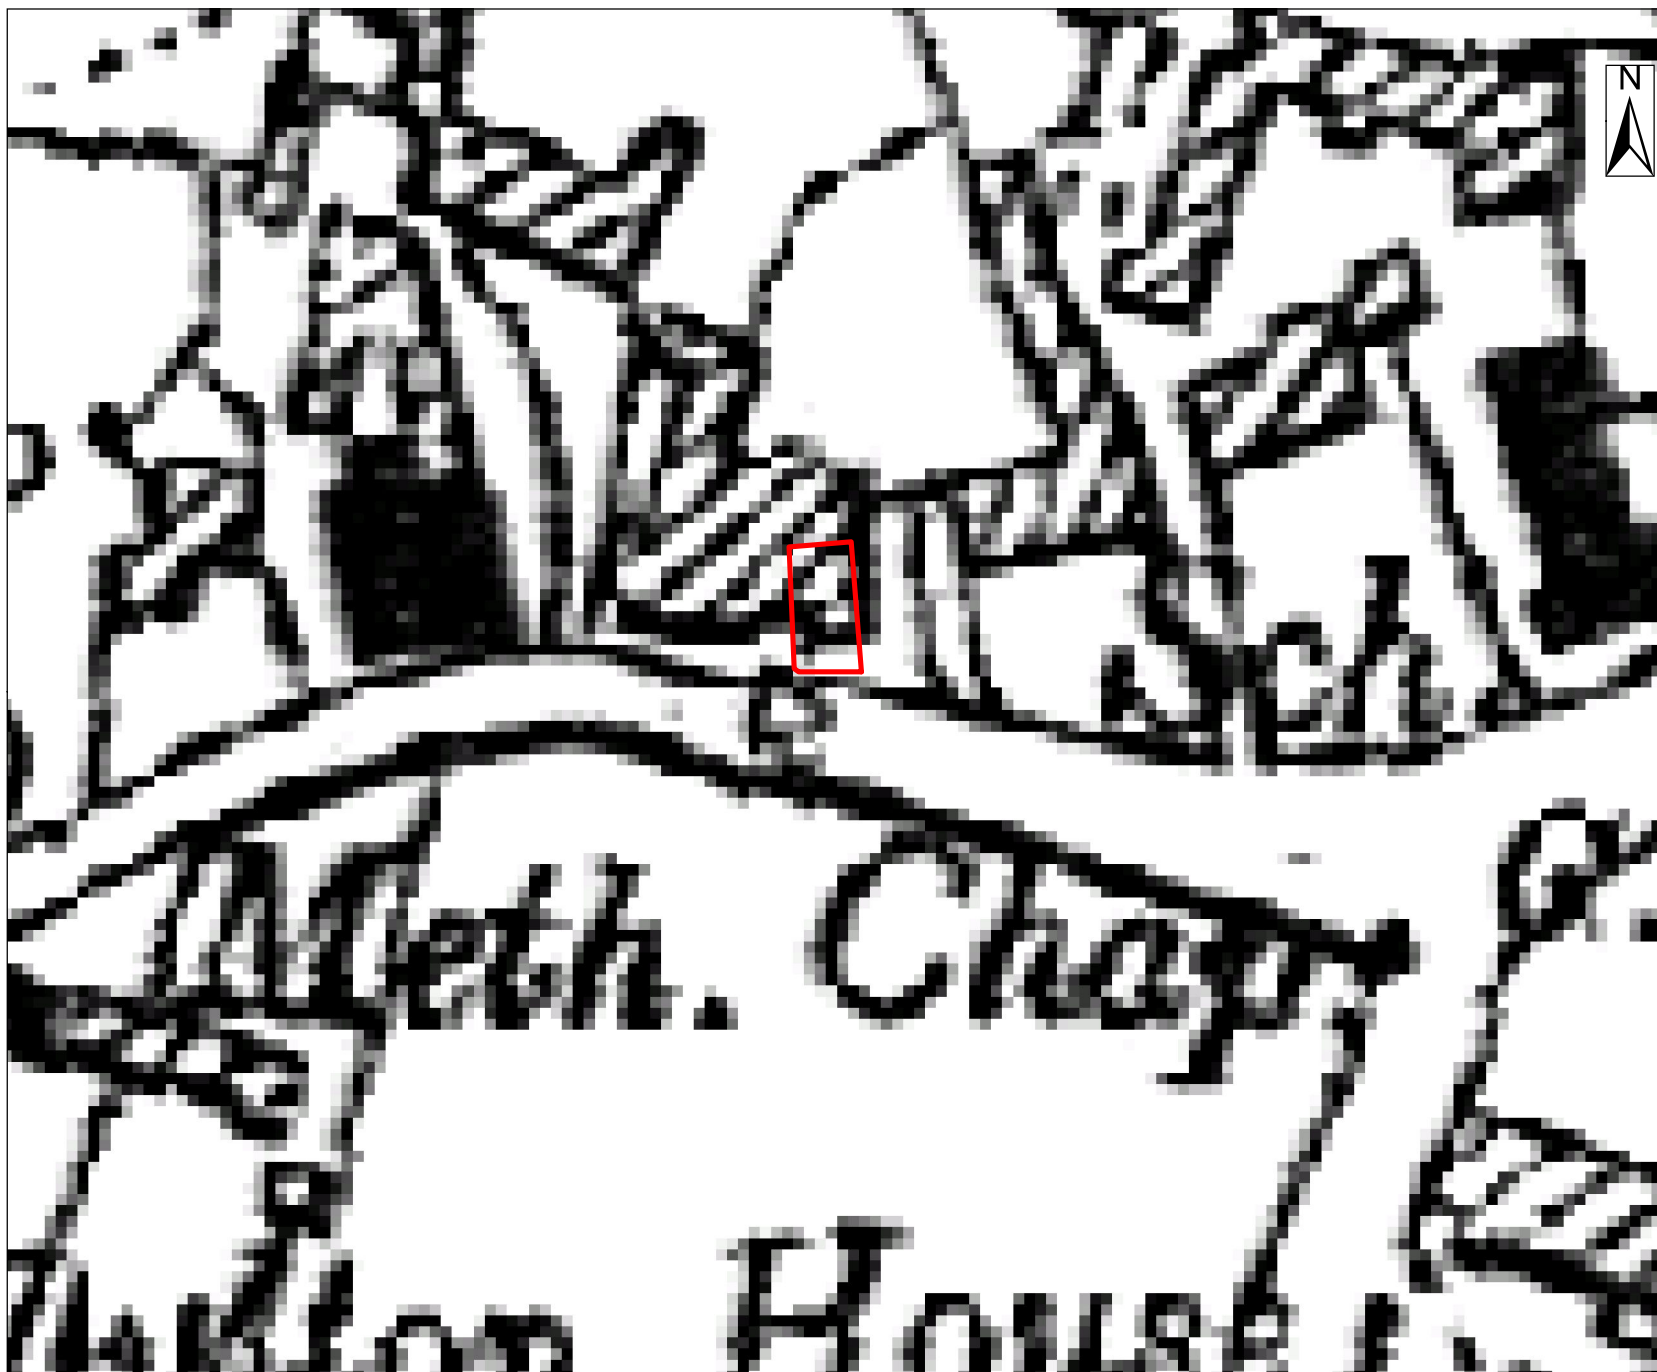
**Figure 10: OS 1:10560  
1st Edition**

- 5.2 The 1:10560 OS mapping shows less detail than the first edition dating to the 1860s and shows Hopewell house connected to the buildings to the west but without an extension to the north. This extension can be dated from documentary evidence to the 1870s and so the map chronology backs this up.
