Tattershall Castle Curzon Earth Closet, Lincolnshire – Historic Building Recording and Archaeological Supervision and Recording

Prepared for the National Trust

Report Title: Tattershall Castle Curzon Earth Closet Historic Building Recording and Archaeological Supervision and Recording

Revision: V1.0
Issue Date: 01/08/2016
Report Ref: 7032

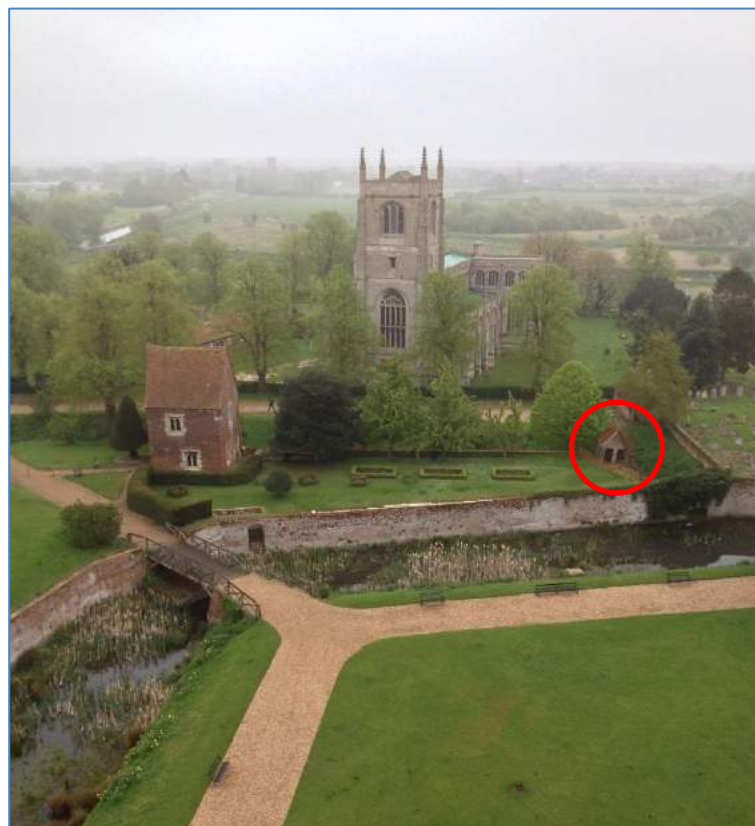
Plate 1: View towards Curzon Earth Closet (circled in red) from Tattershall Castle, positioned between the inner and outer moat.

- 1.2.1 The Curzon Earth Closet is located within the grounds of Tattershall Castle, Lincolnshire. Although the building is not listed it is located within the Tattershall Castle and College Scheduled Monument (NHLE: 1018394). The building is situated immediately adjacent to the outer moat (**Plate 1**) and abuts a retaining wall which is believed to date to the fifteenth century.
- 1.2.2 The programme of recording was focussed upon the standing remains of the Curzon Earth Closet and part of the earlier retaining wall.

- 4.1.1 The Curzon Earth Closet is a single storey, red brick building, with a pitched pan-tile roof, possessing a footprint measuring approximately 2.52 m by 2.71 m. The building is situated in the grounds of Tattershall Castle (**Plate 1**). To the east of the building is a red brick retaining wall which abuts the eastern elevation of the building beyond this is the outer moat of the castle. South of the building the outer moat cuts back in towards the inner moat, which is located approximately 5 m west of the building. The former Tattershall Guard House sits approximately 34 m north of the building.

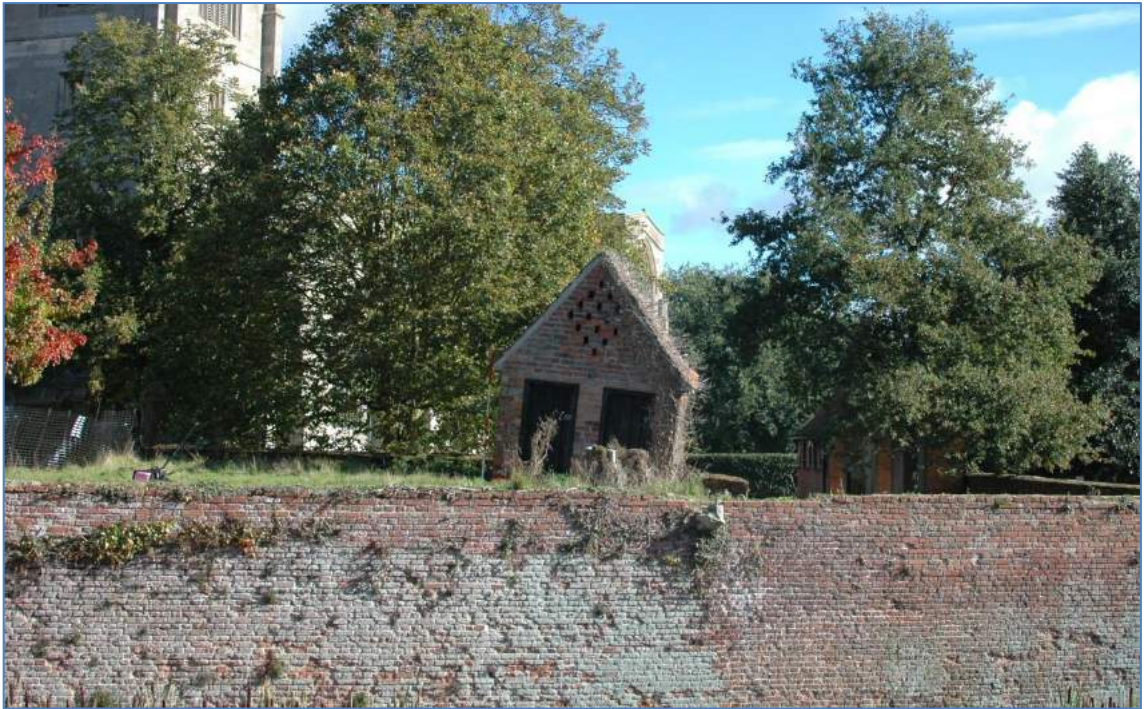
Plate 2: General view of west facing elevation from opposite side of moat.

- 4.2.2 The west facing elevation (**Plate 2, Figure 2**) is the principal elevation of the building. It contains two timber batten doors within plain timber door frames (**Plate 3**). Above the doors are three rows of horizontal red clay tiles, which form a decorative band across the front of the building. The gable is decorated with a series of ventilation holes set into a diamond pattern. The verges of the gable are sealed with mortar at its junction with the pan-tile roof. These rafters rest on a timber rafter plate.

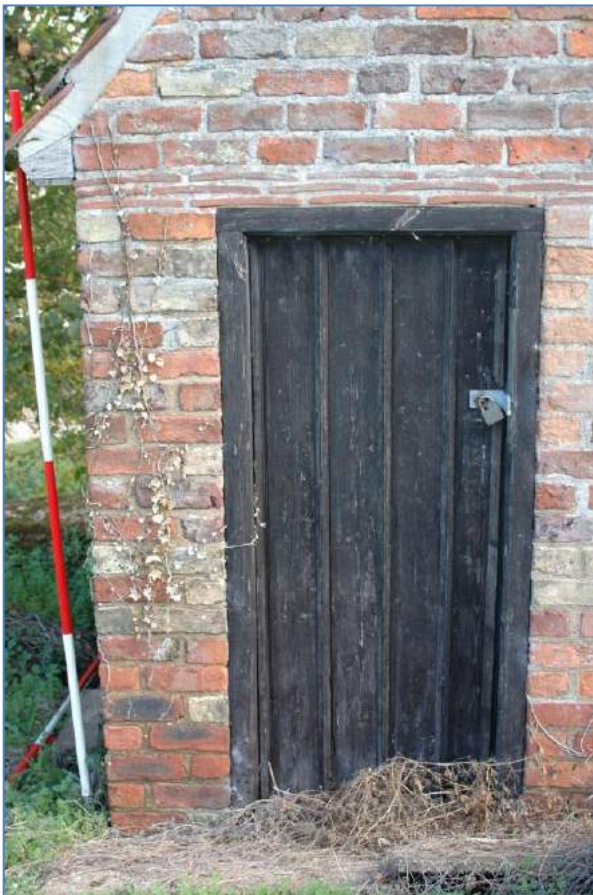
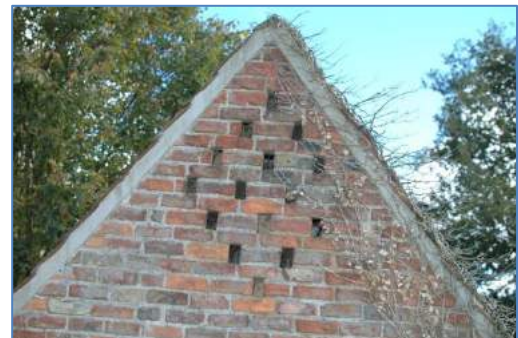
Plates 3 & 4: Detail of timber batten door and detail of ventilation in gable of west elevation

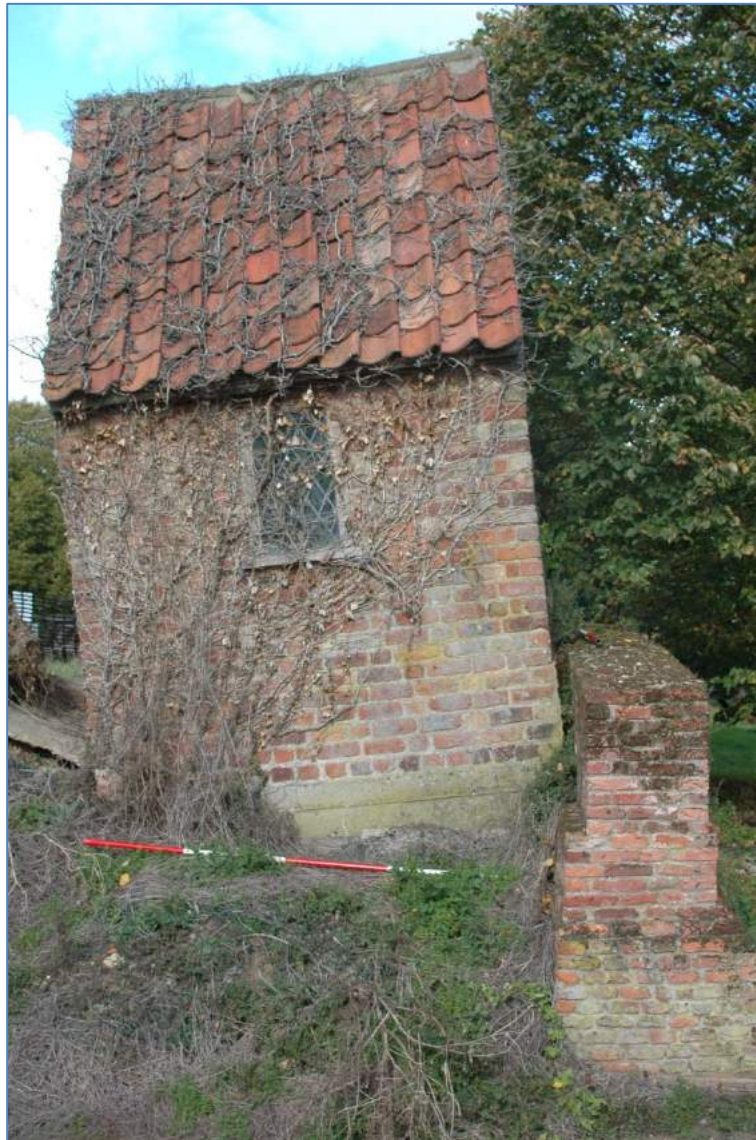
Plate 5: General view of the south elevation

- 4.2.3 The south elevation (**Plate 5, Figure 2**) comprises a plain red brick wall, with a centrally placed timber framed, leaded window. The window has a projecting timber sill. A timber lintel runs across the top of the wall, under the roof line. As a result of subsidence the concrete slab foundation of the building is exposed.

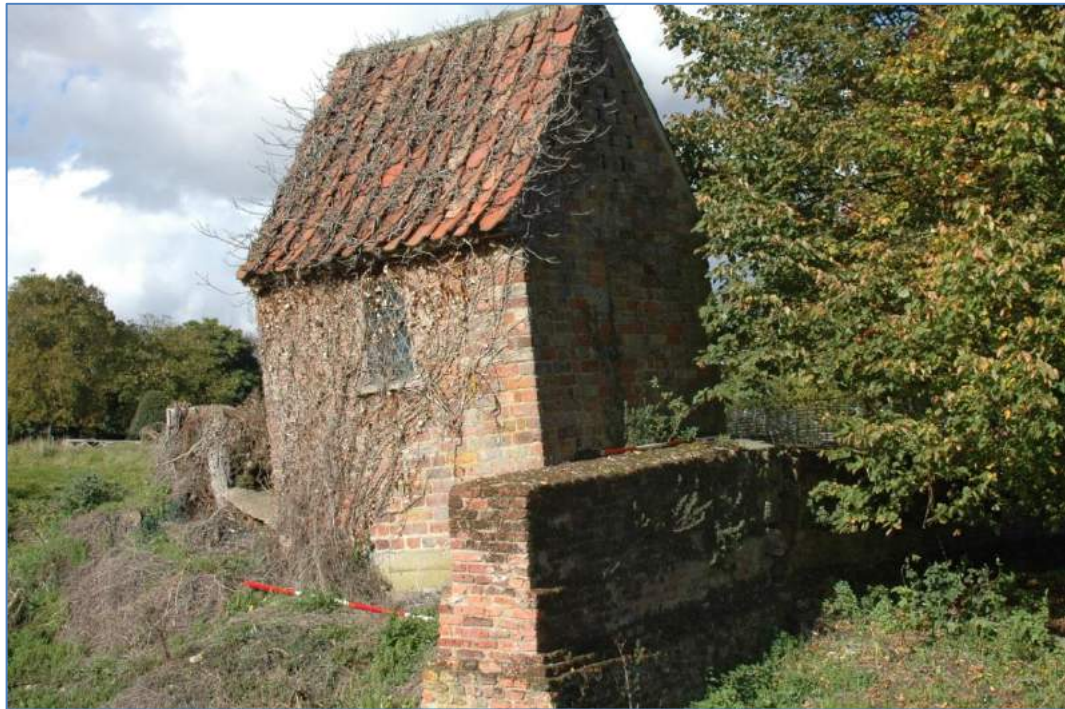
Plate 6: General view of south and east elevations and retaining wall.

- 4.2.4 The eastern elevation (**Plate 6**) abuts the 15th century retaining wall of the castle moat. The gable is decorated with a series of ventilation holes set into a diamond pattern, which matches that of the west elevation. There are no additional architectural details.

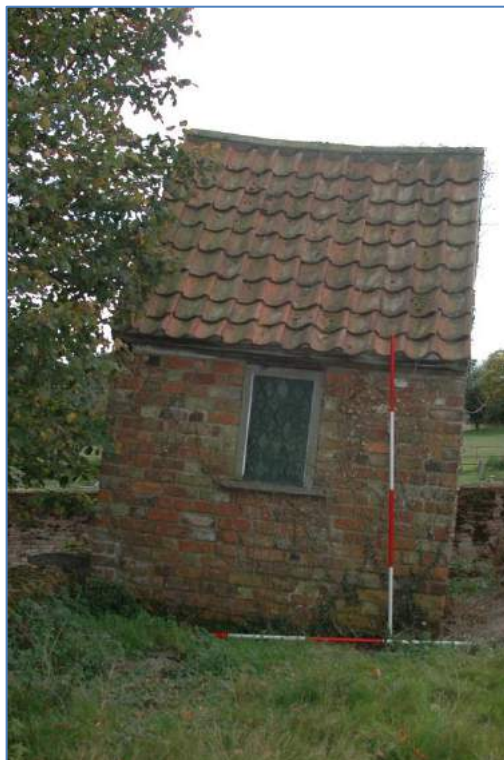
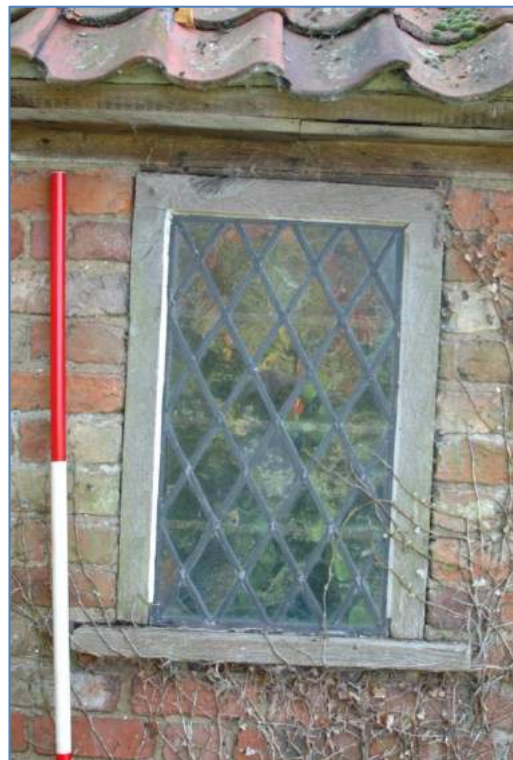
Plate 7 & 8: General view of north elevation and detail of timber framed, leaded window.

- 4.2.5 The north elevation (**Plate 7**) comprises a plain red brick wall, with a centrally placed timber framed, leaded window (**Plate 8**) which matches the window of the southern elevation. A timber lintel runs across the top of the wall, under the roof line.

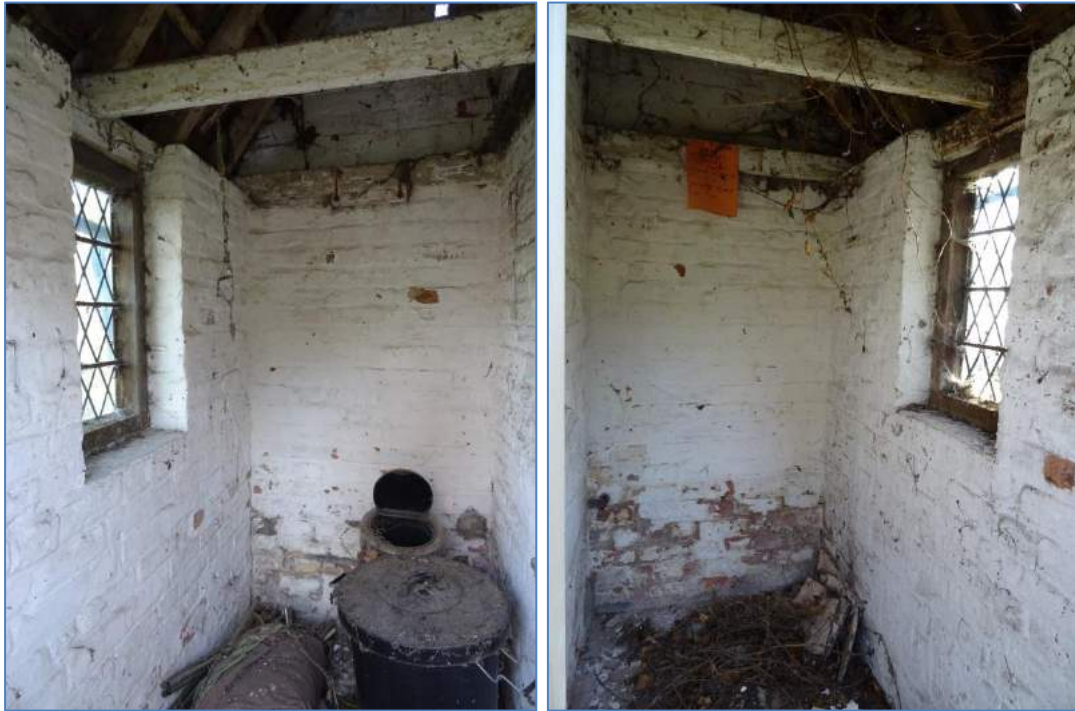
Plate 9 & 10: General views of the interior of the Earth Closets

- 4.2.6 The building comprises two Earth Closet cubicles separated by a brick wall. Access could not be gained to the interior of the building for further inspection, due to structural instability, however observations were made from the doorways.
- 4.2.7 The interior of both rooms was more or less identical (**Plates 9 and 10**), comprising white painted brickwork walls, and red tile floor (**Plate 12**). Scars were visible, as well as truncated sections of pipework, preserving the location of plumbing although all fixtures had been removed. The scars from brackets for above head cisterns were also evident. A short section of lathe and plaster work was evident below ridge level, but otherwise the ceiling was open to the rafters (**Plate 11**). A single narrow tie beam bisects both rooms.

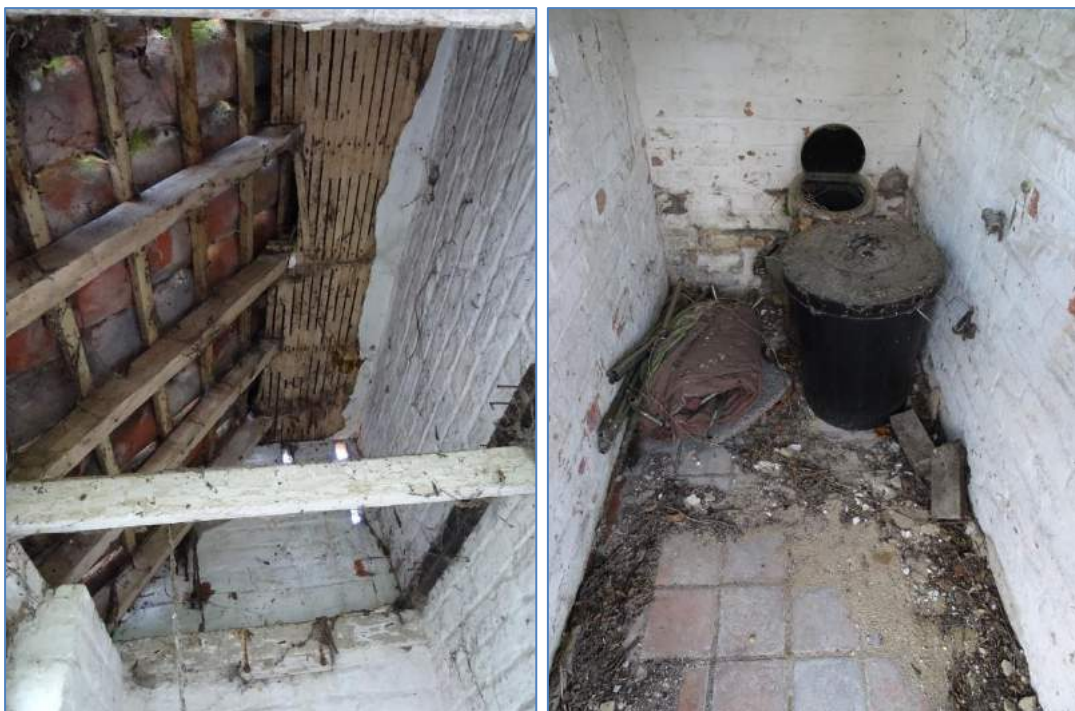
Plate 11 & 12: Detail of the ceiling and floor of the northern room of the Earth Closets.

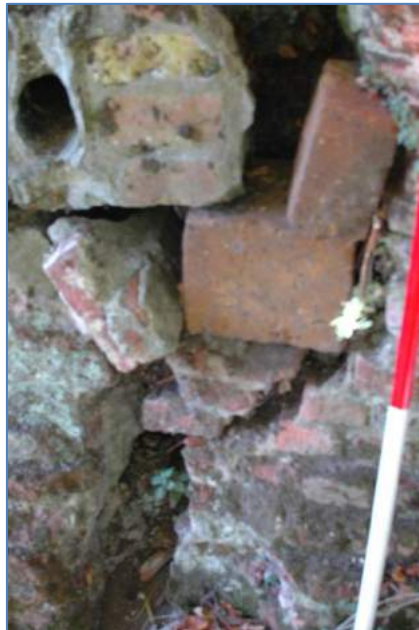
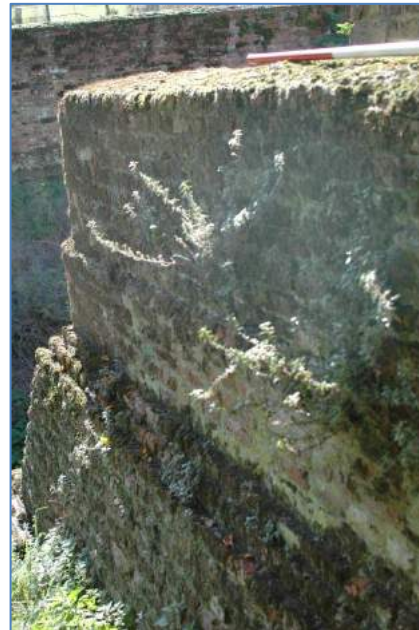
Plate 13 & 14: Detail of inserted plumbing, damage and later repairs to the retaining wall

- 4.3.1 The retaining wall to the east of the Curzon Earth Closet comprises a red brick, wall measuring approximately 1.5 m at its southern end. The main body of the wall is three courses thick measuring 48 cm. At the southern end the wall steps out to a metre wide.
- 4.3.2 The retaining wall runs between the Curzon Earth Closet and the Castle gatehouse. The Earth Closet building does not incorporate the 15th century wall into its fabric. The wall has had to be altered in order to accommodate plumbing. The insertion of the later plumbing and the undermining of the wall and the Earth Closet building by burrowing animals have created a structural weakness in the wall (**Plate 13**) which has caused the damage to the southern end. Attempts to strengthen the wall appear to have been made using later brick and heavy concrete pointing (**Plate 14**).

- 6.1.3 A number of repairs have been undertaken at the southern end of the wall and although the Earth Closet does not make use of the historic fabric of the wall, the plumbing for the Earth Closet has been inserted through the wall. This, coupled with the undermining of the structures by burrowing animals has caused some structural damage to the wall, which, it is hoped, has been stabilised as a part of these works. Earlier repairs have been undertaken and these can easily be identified through the heavy concrete pointing and the use of later brick. The southern end of the wall in particular appears to have been consolidated, and may not represent a terminus in its original form, although excavation did not reveal evidence of the wall having turned.

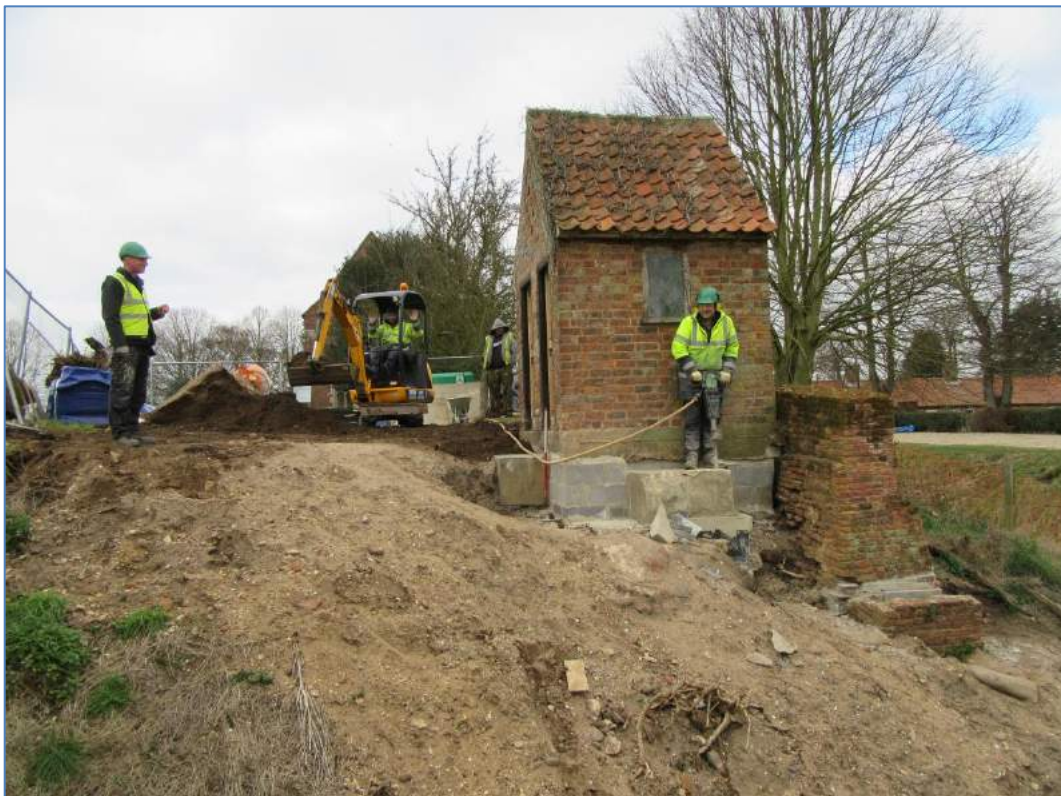
Plate 15: Working shot during final stages of archaeological supervision and recording following righting of the Earth Closet.

- 5.1.1 Monitoring was undertaken during the excavation of trenches around the edge of the Curzon Earth Closet (**Figure 3**), a trench beneath the southern end of the retaining wall, and during re-grading following the works (**Plate 15**).

- 5.1.2 The excavation around the Earth Closet totalled an area of approximately 3.5 m by 4.9 m. This was excavated in several phases, comprising initially of several trial pits around the perimeter of the building (TP 1 and 2 to the north, TP 2 to the west and TP 3 to the south). These were subsequently enlarged and joined to form a continuous trench. The depth required was around 0.5 m below the level of the buildings foundation slab, resulting in a trench which was 1.3 m deep at the northwest corner and 0.6 m deep in the southwest corner. Once temporary piles were in place to support the Earth Closet, the ground beneath the foundation slab was excavated out. Further piles were formed and ground beams constructed upon which the Earth Closet were carefully jacked up back to vertical.

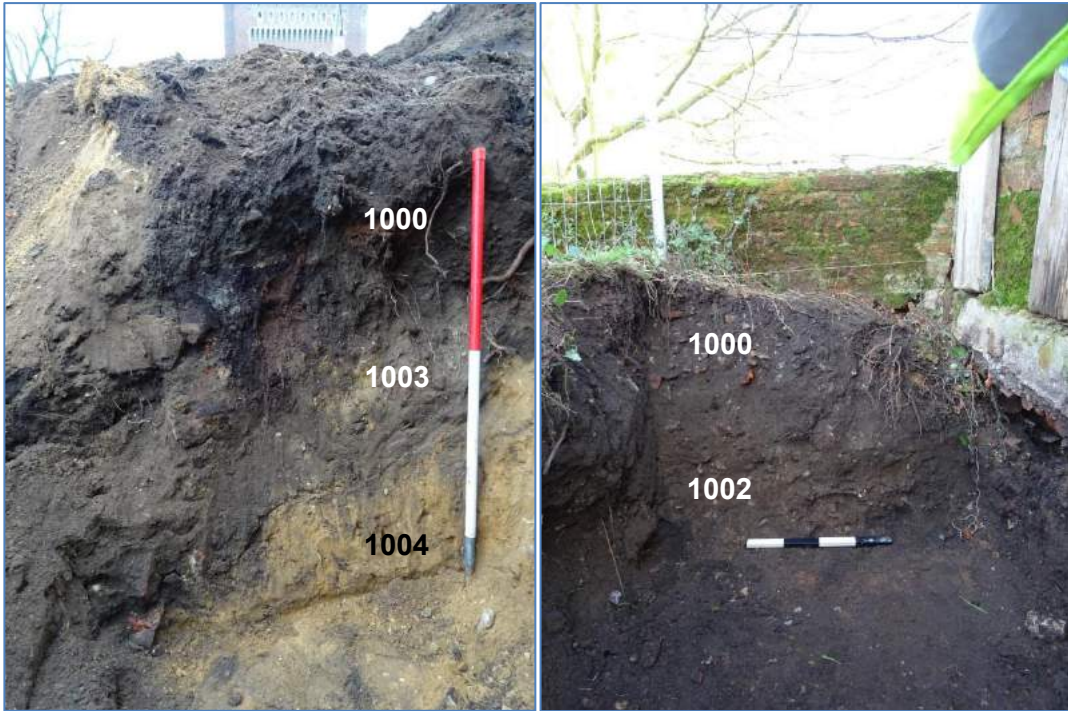
Plate 16 & 17: West facing section to southwest of Earth Closets (left), and east facing section to north of Earth Closets (right)

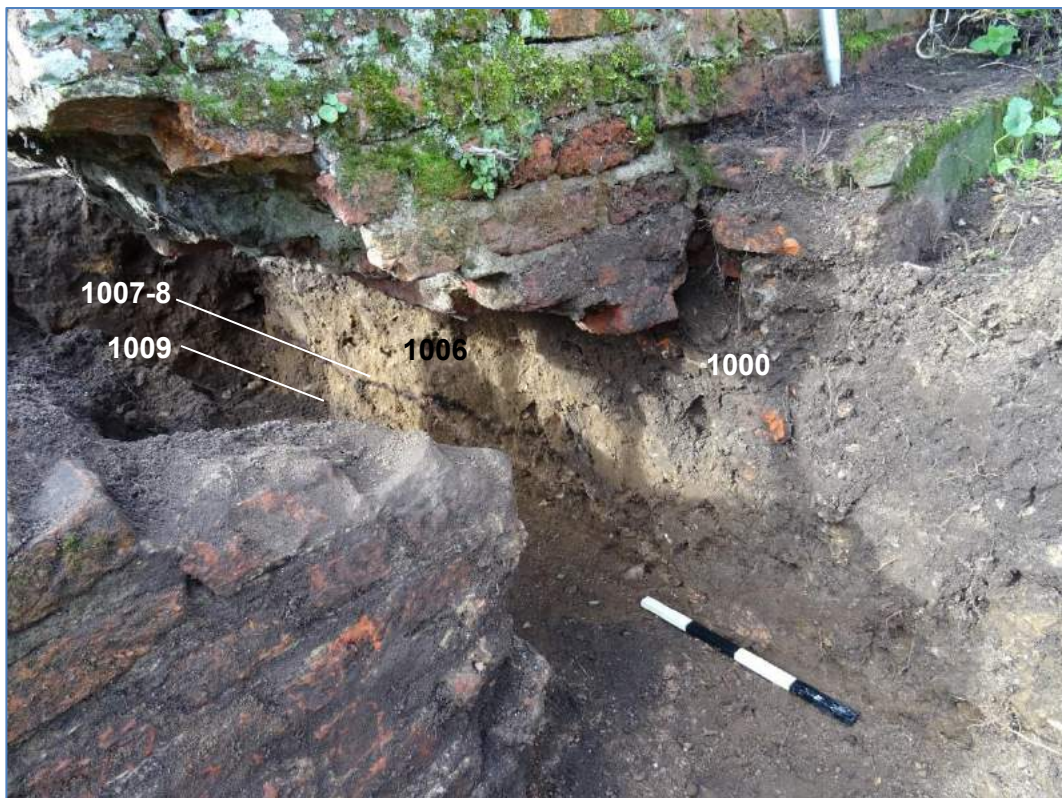
Plate 18: South facing section beneath retaining wall

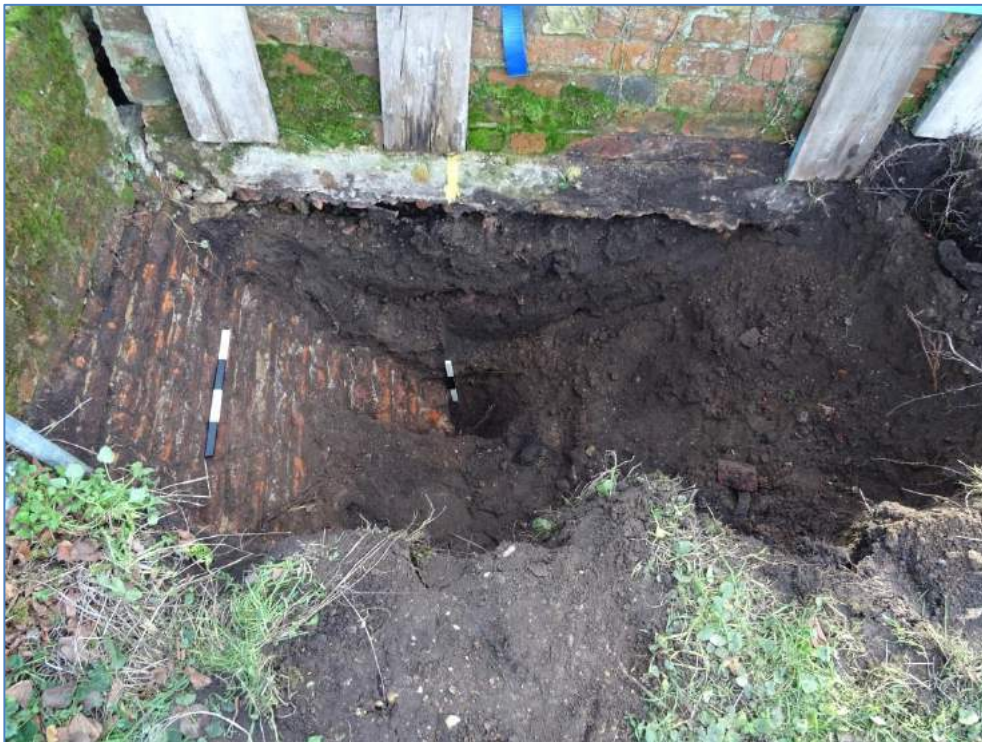
Plate 19: Trench north of Earth Closets, looking south, showing footings of retaining wall (Structure **1011**)

- 5.3.1 The footings of retaining wall Structure **1011** were exposed within the trench to the north of the Earth Closet (**Figure 4.1**). In total, 18 courses of brick work were exposed beneath ground level, stepping out by 0.8 m from the above ground elevation of the wall before descending vertically from a depth of 1 m below ground level (6.42 mAOD). The full depth of footings was not observed. This profile was observed to continue beneath the Earth Closet, but had been truncated beneath the southern half of the building in order to apparently accommodate a waste pipe from the Earth Closet. No cut was identified for the wall within the trench, indicating that it predated the formation of the bank behind.

- 5.3.3 It is interpreted that the footing profile observed to the north of the Earth Closet potentially reflects the function of the wall as retaining a substantial bank, with the change at the southern end comprising an area of reconstruction associated with the Curzon restorations.

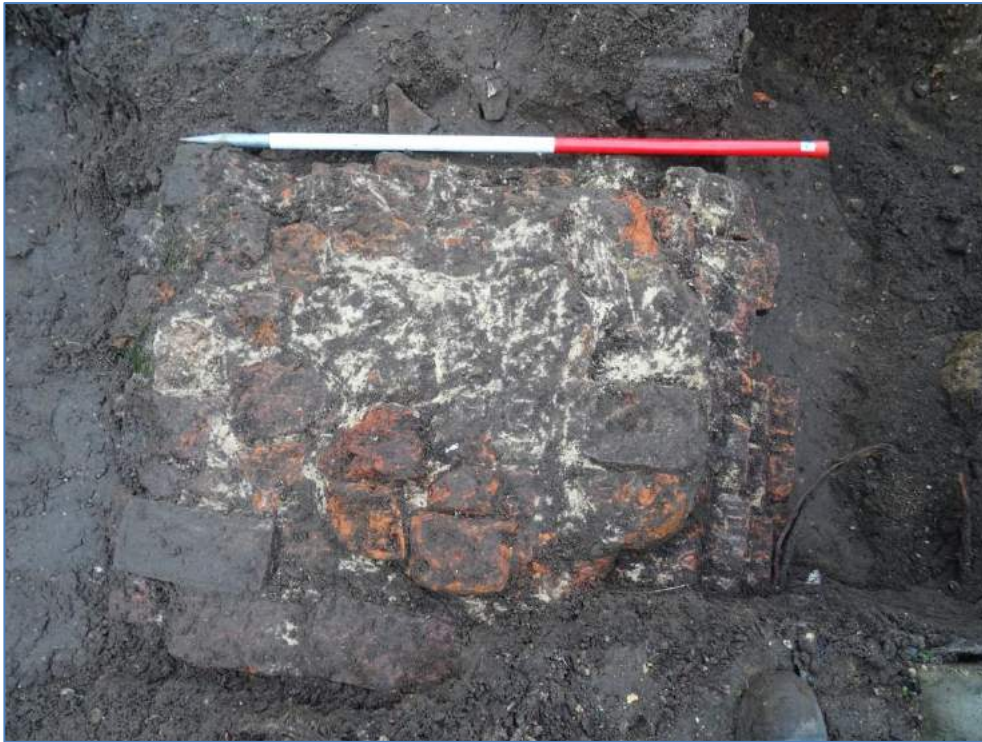
Plate 20: Structure **1001** looking from above (north is to the right of the frame)

- 5.3.4 Excavation to the south of the Earth Closet exposed Structure **1001** (**Figure 3**). The structure was constructed of red hand made brick, set in a lime mortar, four courses deep, square in plan, and pitched in line with the slope of the bank. The structure was situated within context **1000**, and whilst excavation did not allow full inspection of deposits beneath, it appeared to be sat on the same context. It is therefore interpreted to form a detached structure, which has moved down the bank as a result of ground disturbance. The original position or function of the structure is unknown.

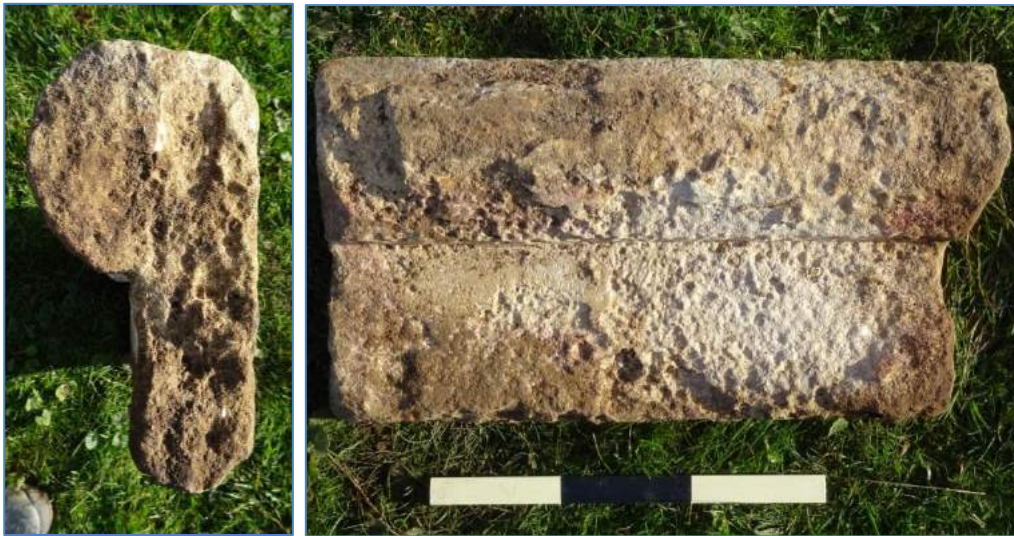
Plate 21: Masonry recovered from beneath the Earth Closets

- 5.4.13 A single masonry block was identified beneath the southern edge of the Earth Closets' foundation. This was nominally from context **1000**, although the extent of disturbance from animal burrowing was such that it is considered unstratified. The block was rectangular, measuring 26 by 48.5 cm, of limestone with a projecting chamfered moulding along one half. No scars were evident for fittings or other features consistent with use as a door or window jamb, although the surfaces were pitted with erosion. The block has been retained by Tattershall Castle.

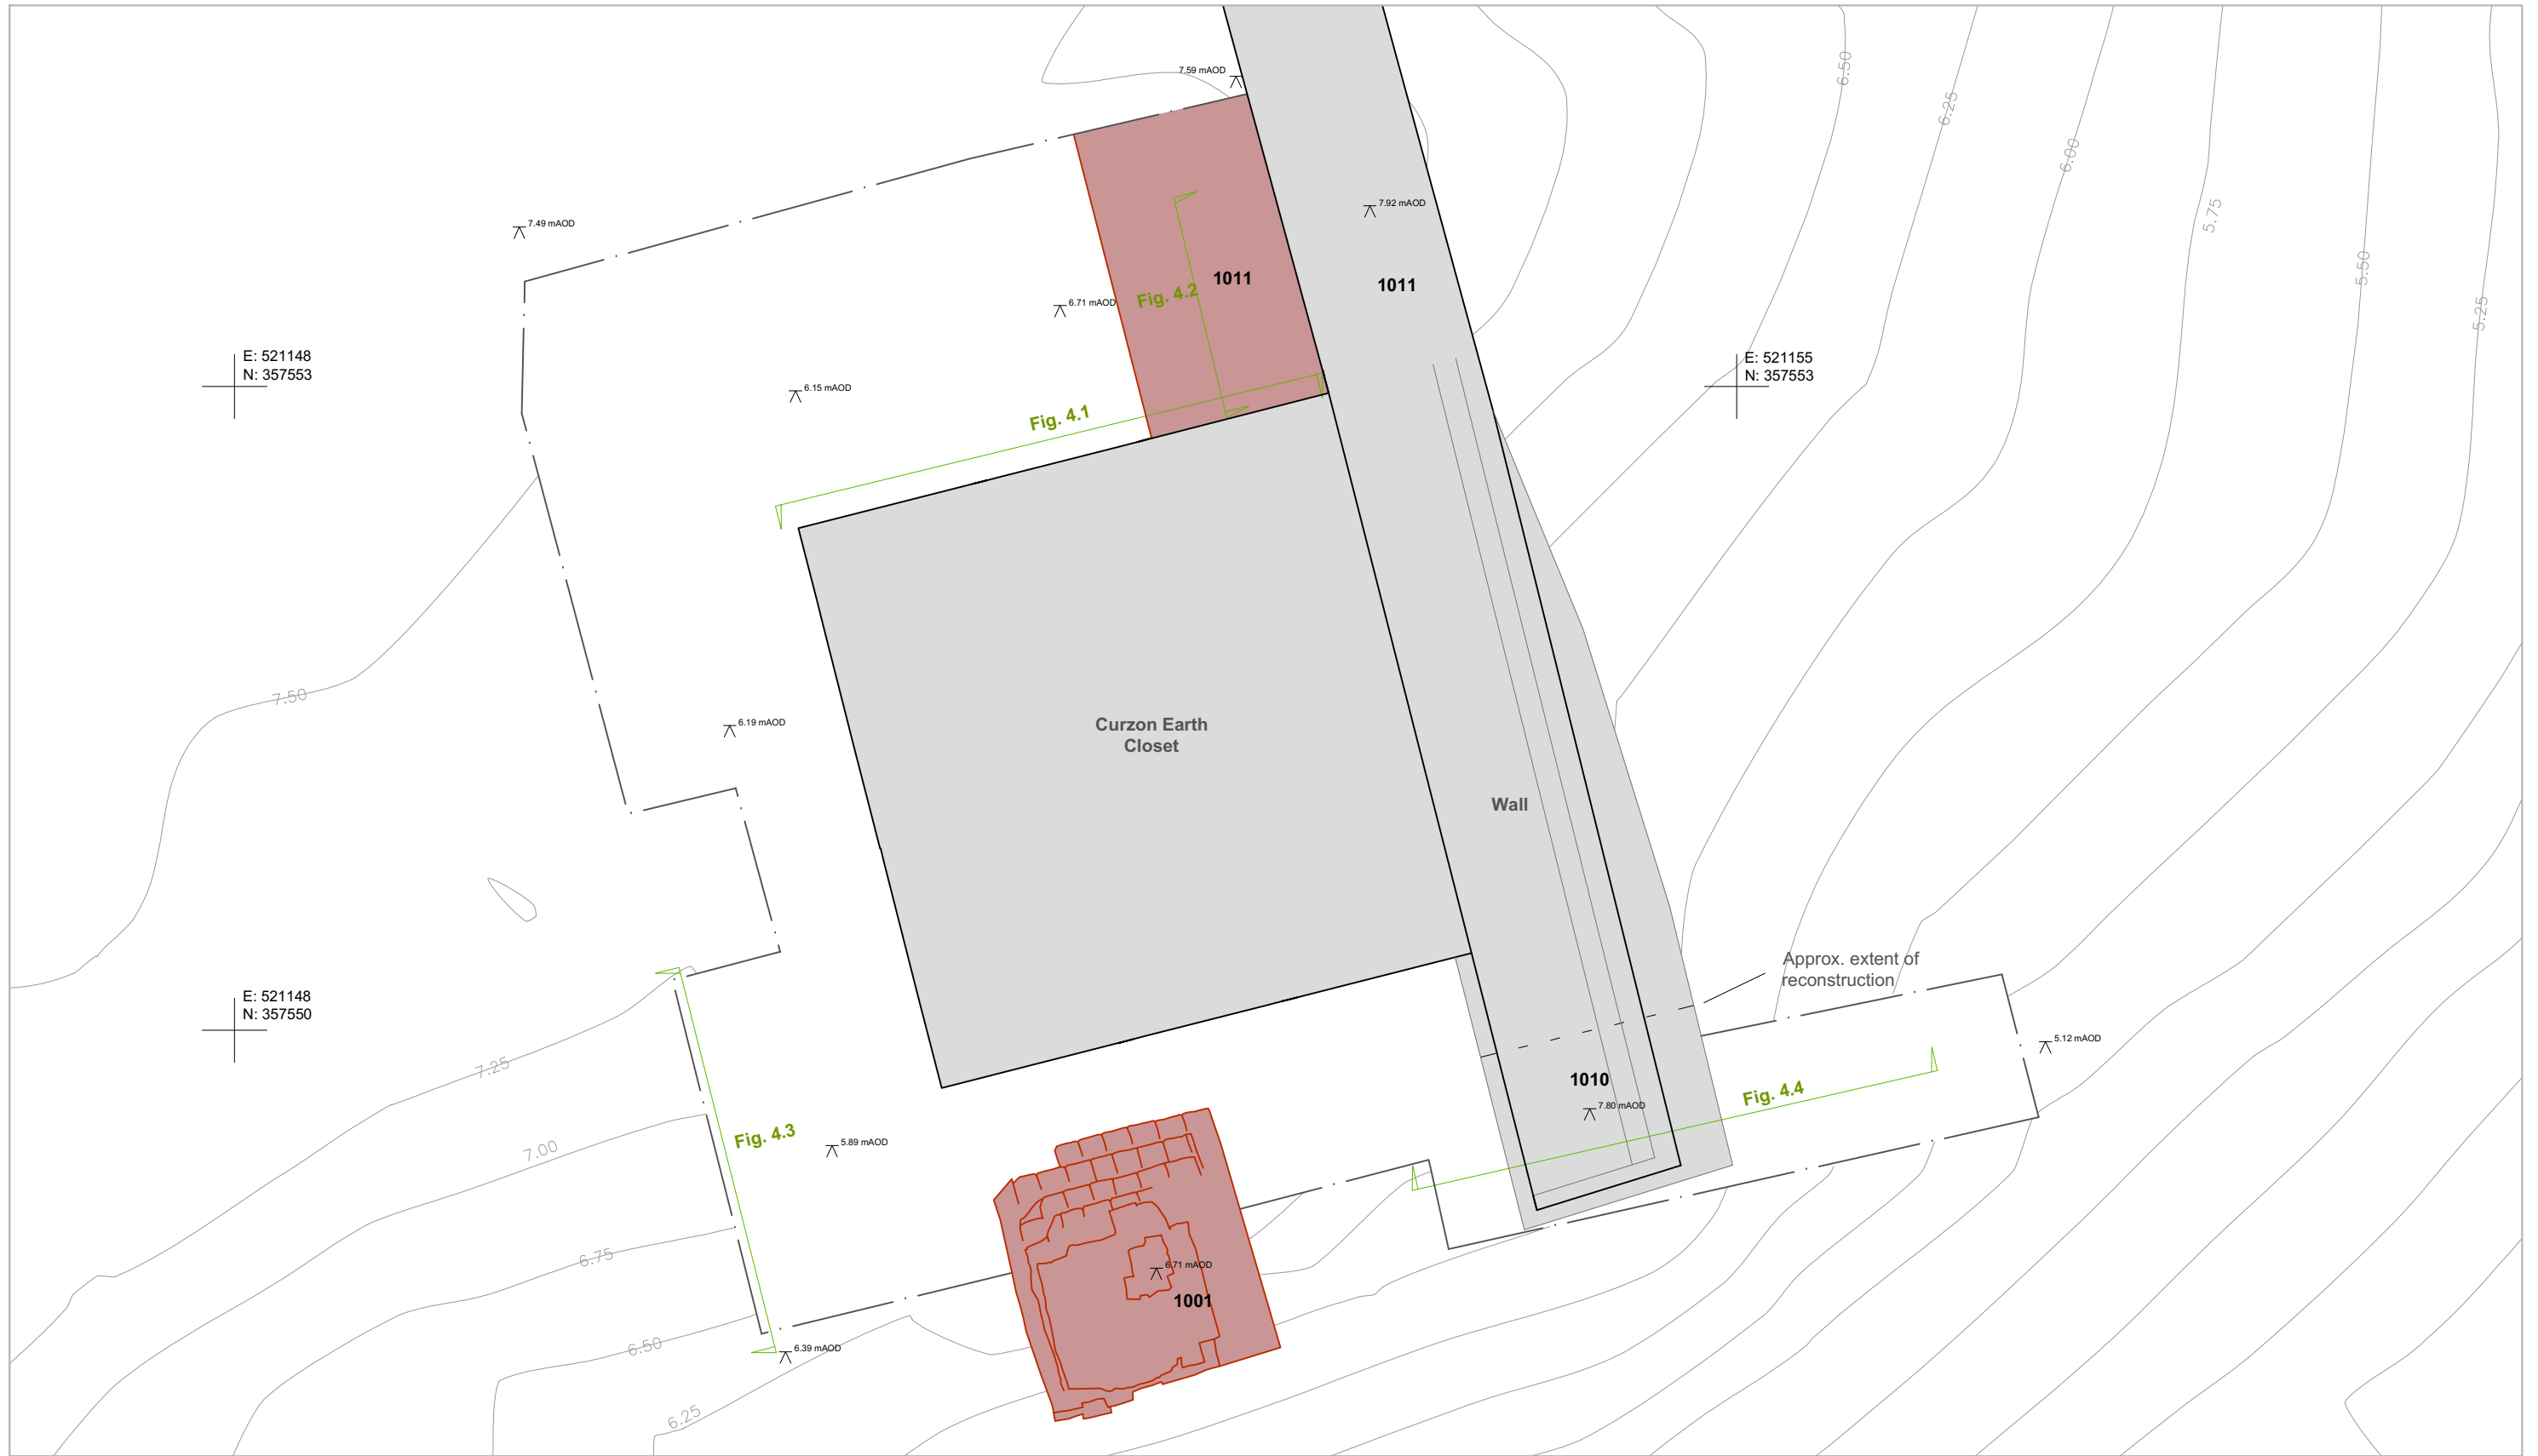
Figure 4.1:
North facing section along northern elevation of Curzon Earth Closet

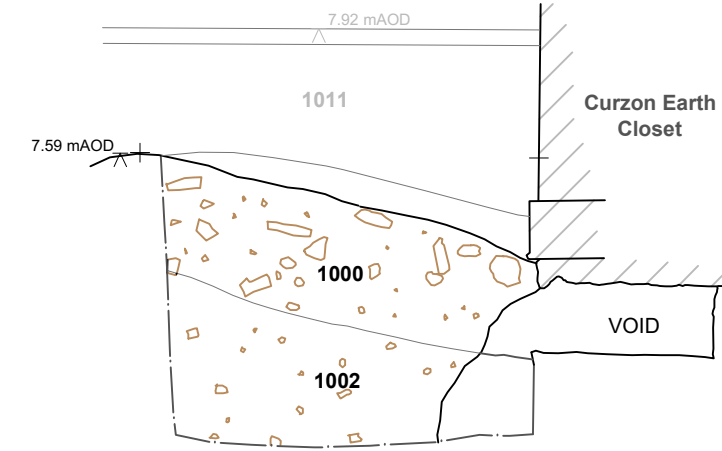
Figure 4.3:
East facing section to southwest of Curzon Earth Closet

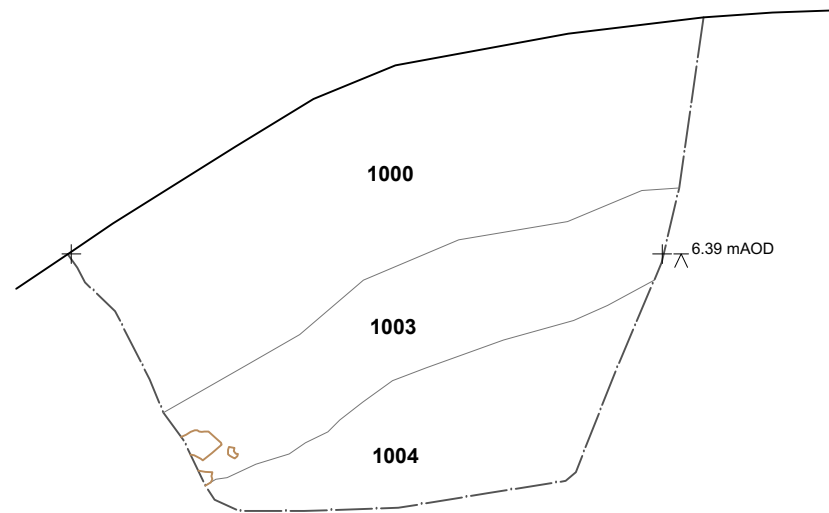
Figure 4.4:
South facing section beneath projection of wall to south of Curzon Earth Closet
