# **Longshaw Estate, Peak District – Archaeological Watching Brief Report**

**National Trust**

**November 2017**

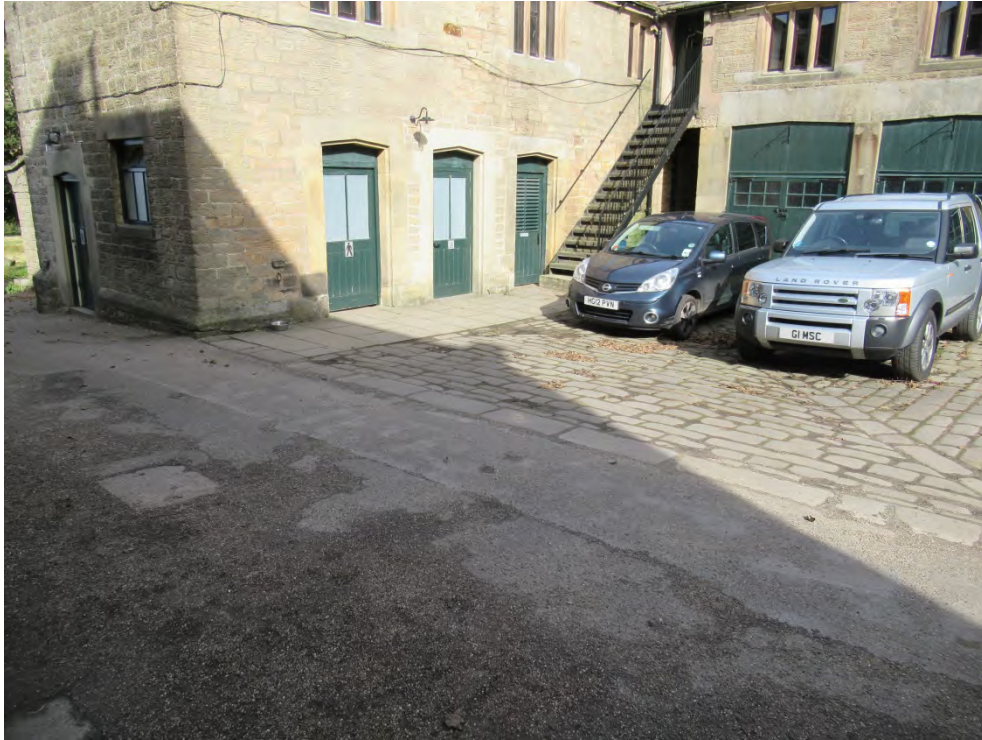
**Plate 1: View of north of the courtyard with former stable block and carriage house**

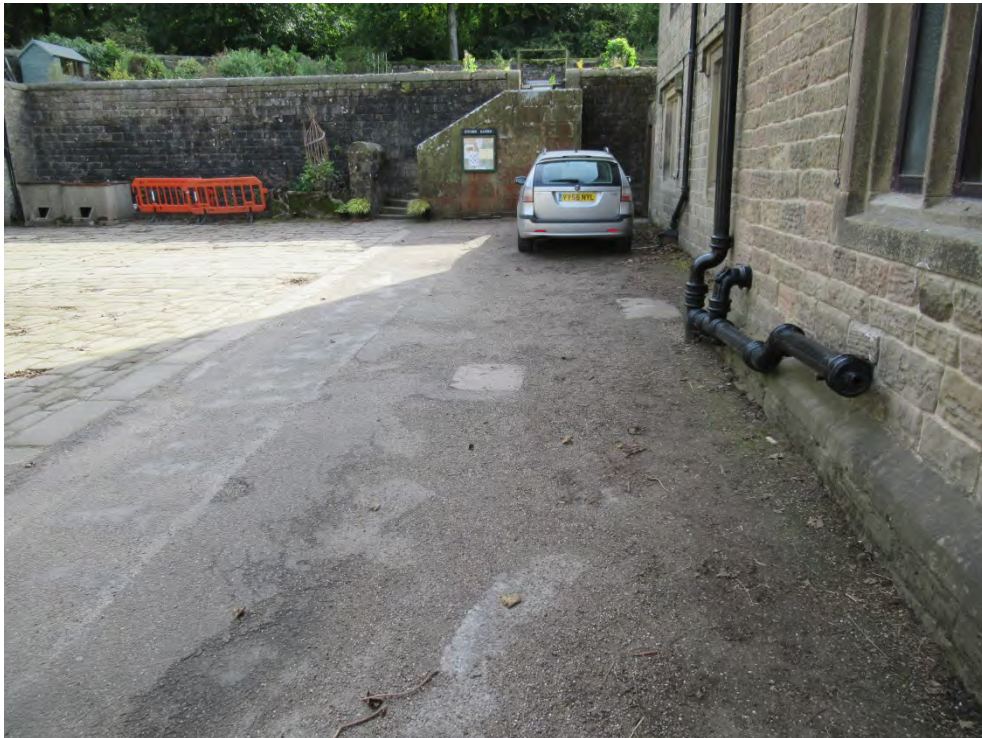
**Plate 2: View across south of courtyard with Longshaw Lodge and retaining wall for kitchen garden beyond**

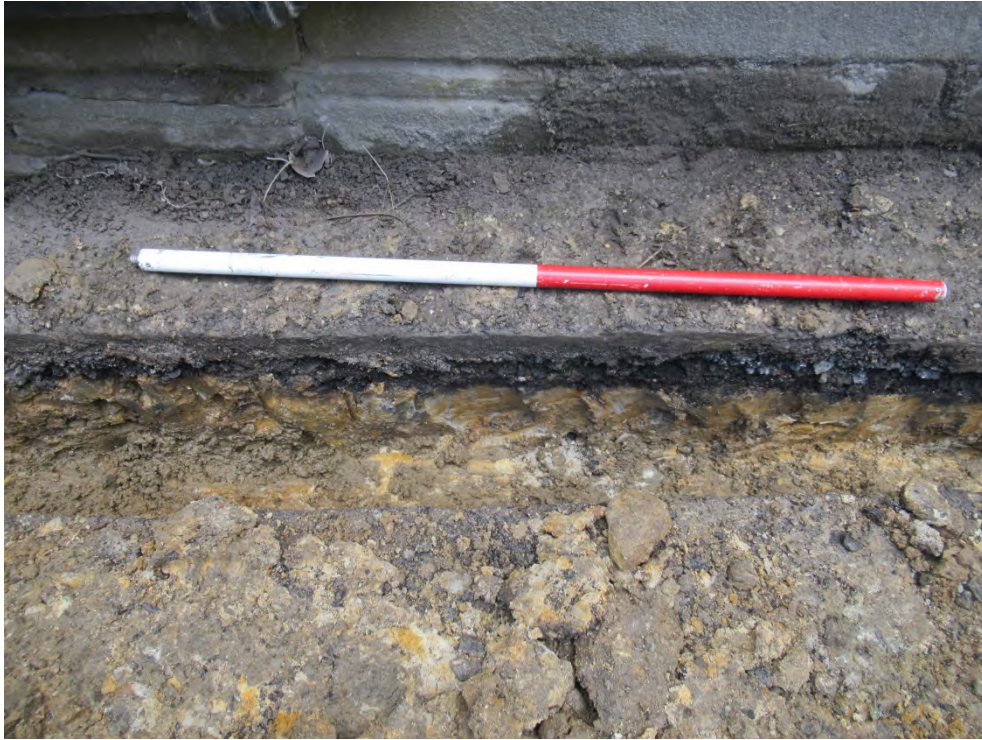
3.2.2 The underlying natural substrate (**102**) comprised a mid-yellowish brown sandy clay and was encountered at 0.10 m below ground level (bgl). The tarmac surface was laid directly onto the natural (**Plate 3**). The paving slabs overlaid a thin levelling layer of light yellowish brown sand (**104**) identified at 0.05 m bgl and 0.07 m thick. This layer in turn overlaid a dark brownish grey clay sand (**105**; **Plate 4**).

**Plate 3: Representative section of the southern portion of the groundworks**

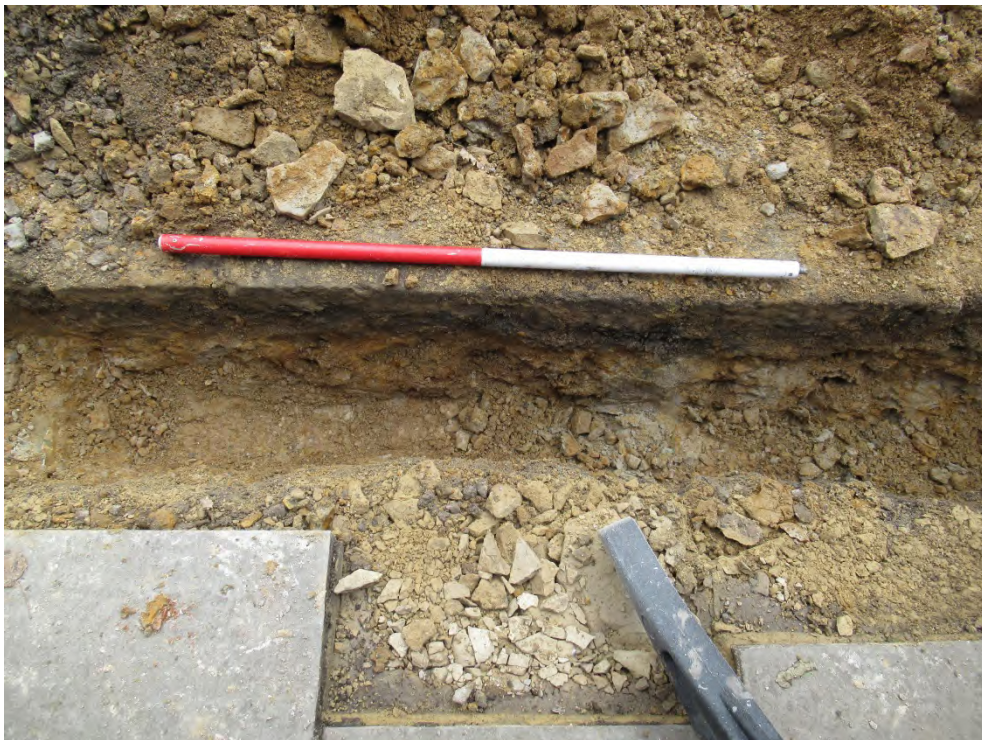
**Plate 4: Representative section of the northern section of the groundworks**

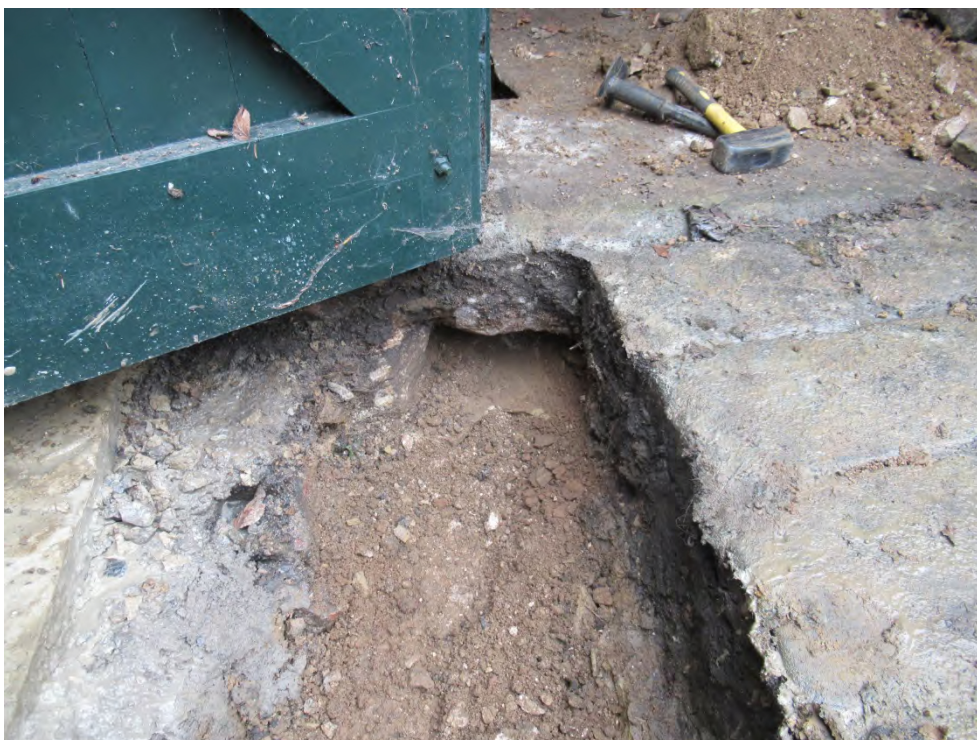
3.3.1 The northeast end of the trench extended into the southwest corner of the former carriage house. The floor of the carriage house was paved with sandstone slabs (**108**). The carriage house foundations (**109**) were also revealed during the excavations and were found to be of millstone grit and extended beyond 0.25 m bgl (**Plate 5**).

**Plate 5: Detail of foundations (109) for carriage house from the southwest**

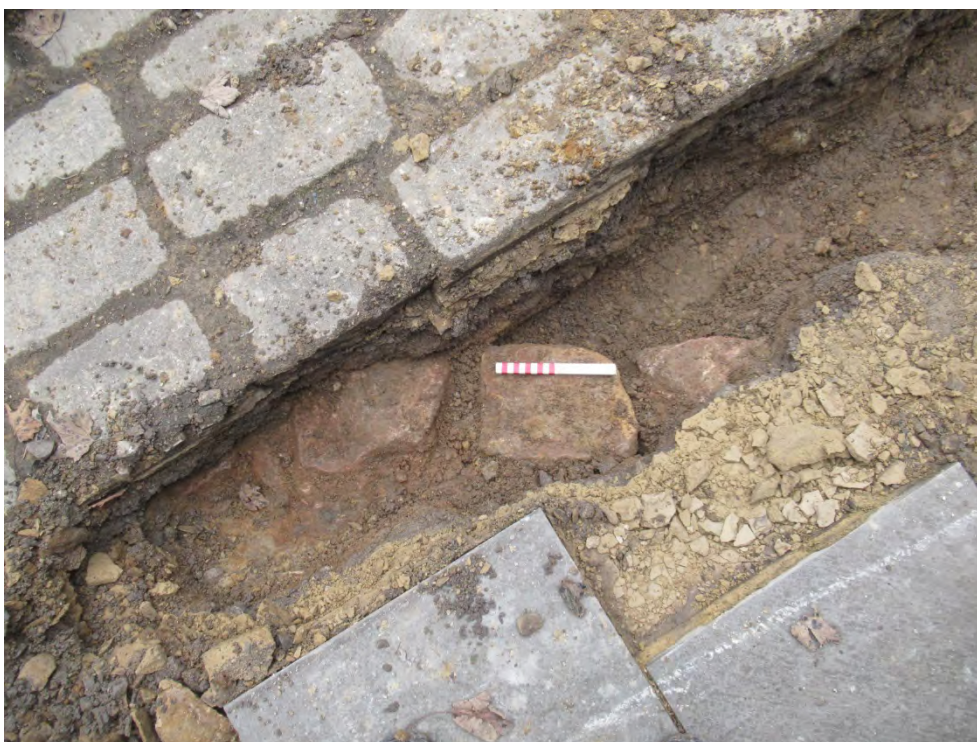
3.3.2 The only other archaeological feature encountered during the archaeological monitoring was a sandstone structure (**106**) aligned east-west. The structure was one course, single skinned and constructed from roughly squared sandstone blocks (**Plate 6**).

**Plate 6: Probable drainage structure (106) from the west**

- 4.1.1 The archaeological monitoring resulted in the identification of the foundations of the nineteenth-century carriage house and a sandstone structure of uncertain function. The sandstone structure is likely to be a drainage feature and may predate the buildings within the courtyard as it was aligned on a differing orientation to the courtyard itself. However, the narrow dimensions of the service trench excavated during the groundworks means that a more thorough investigation of this feature was not possible.

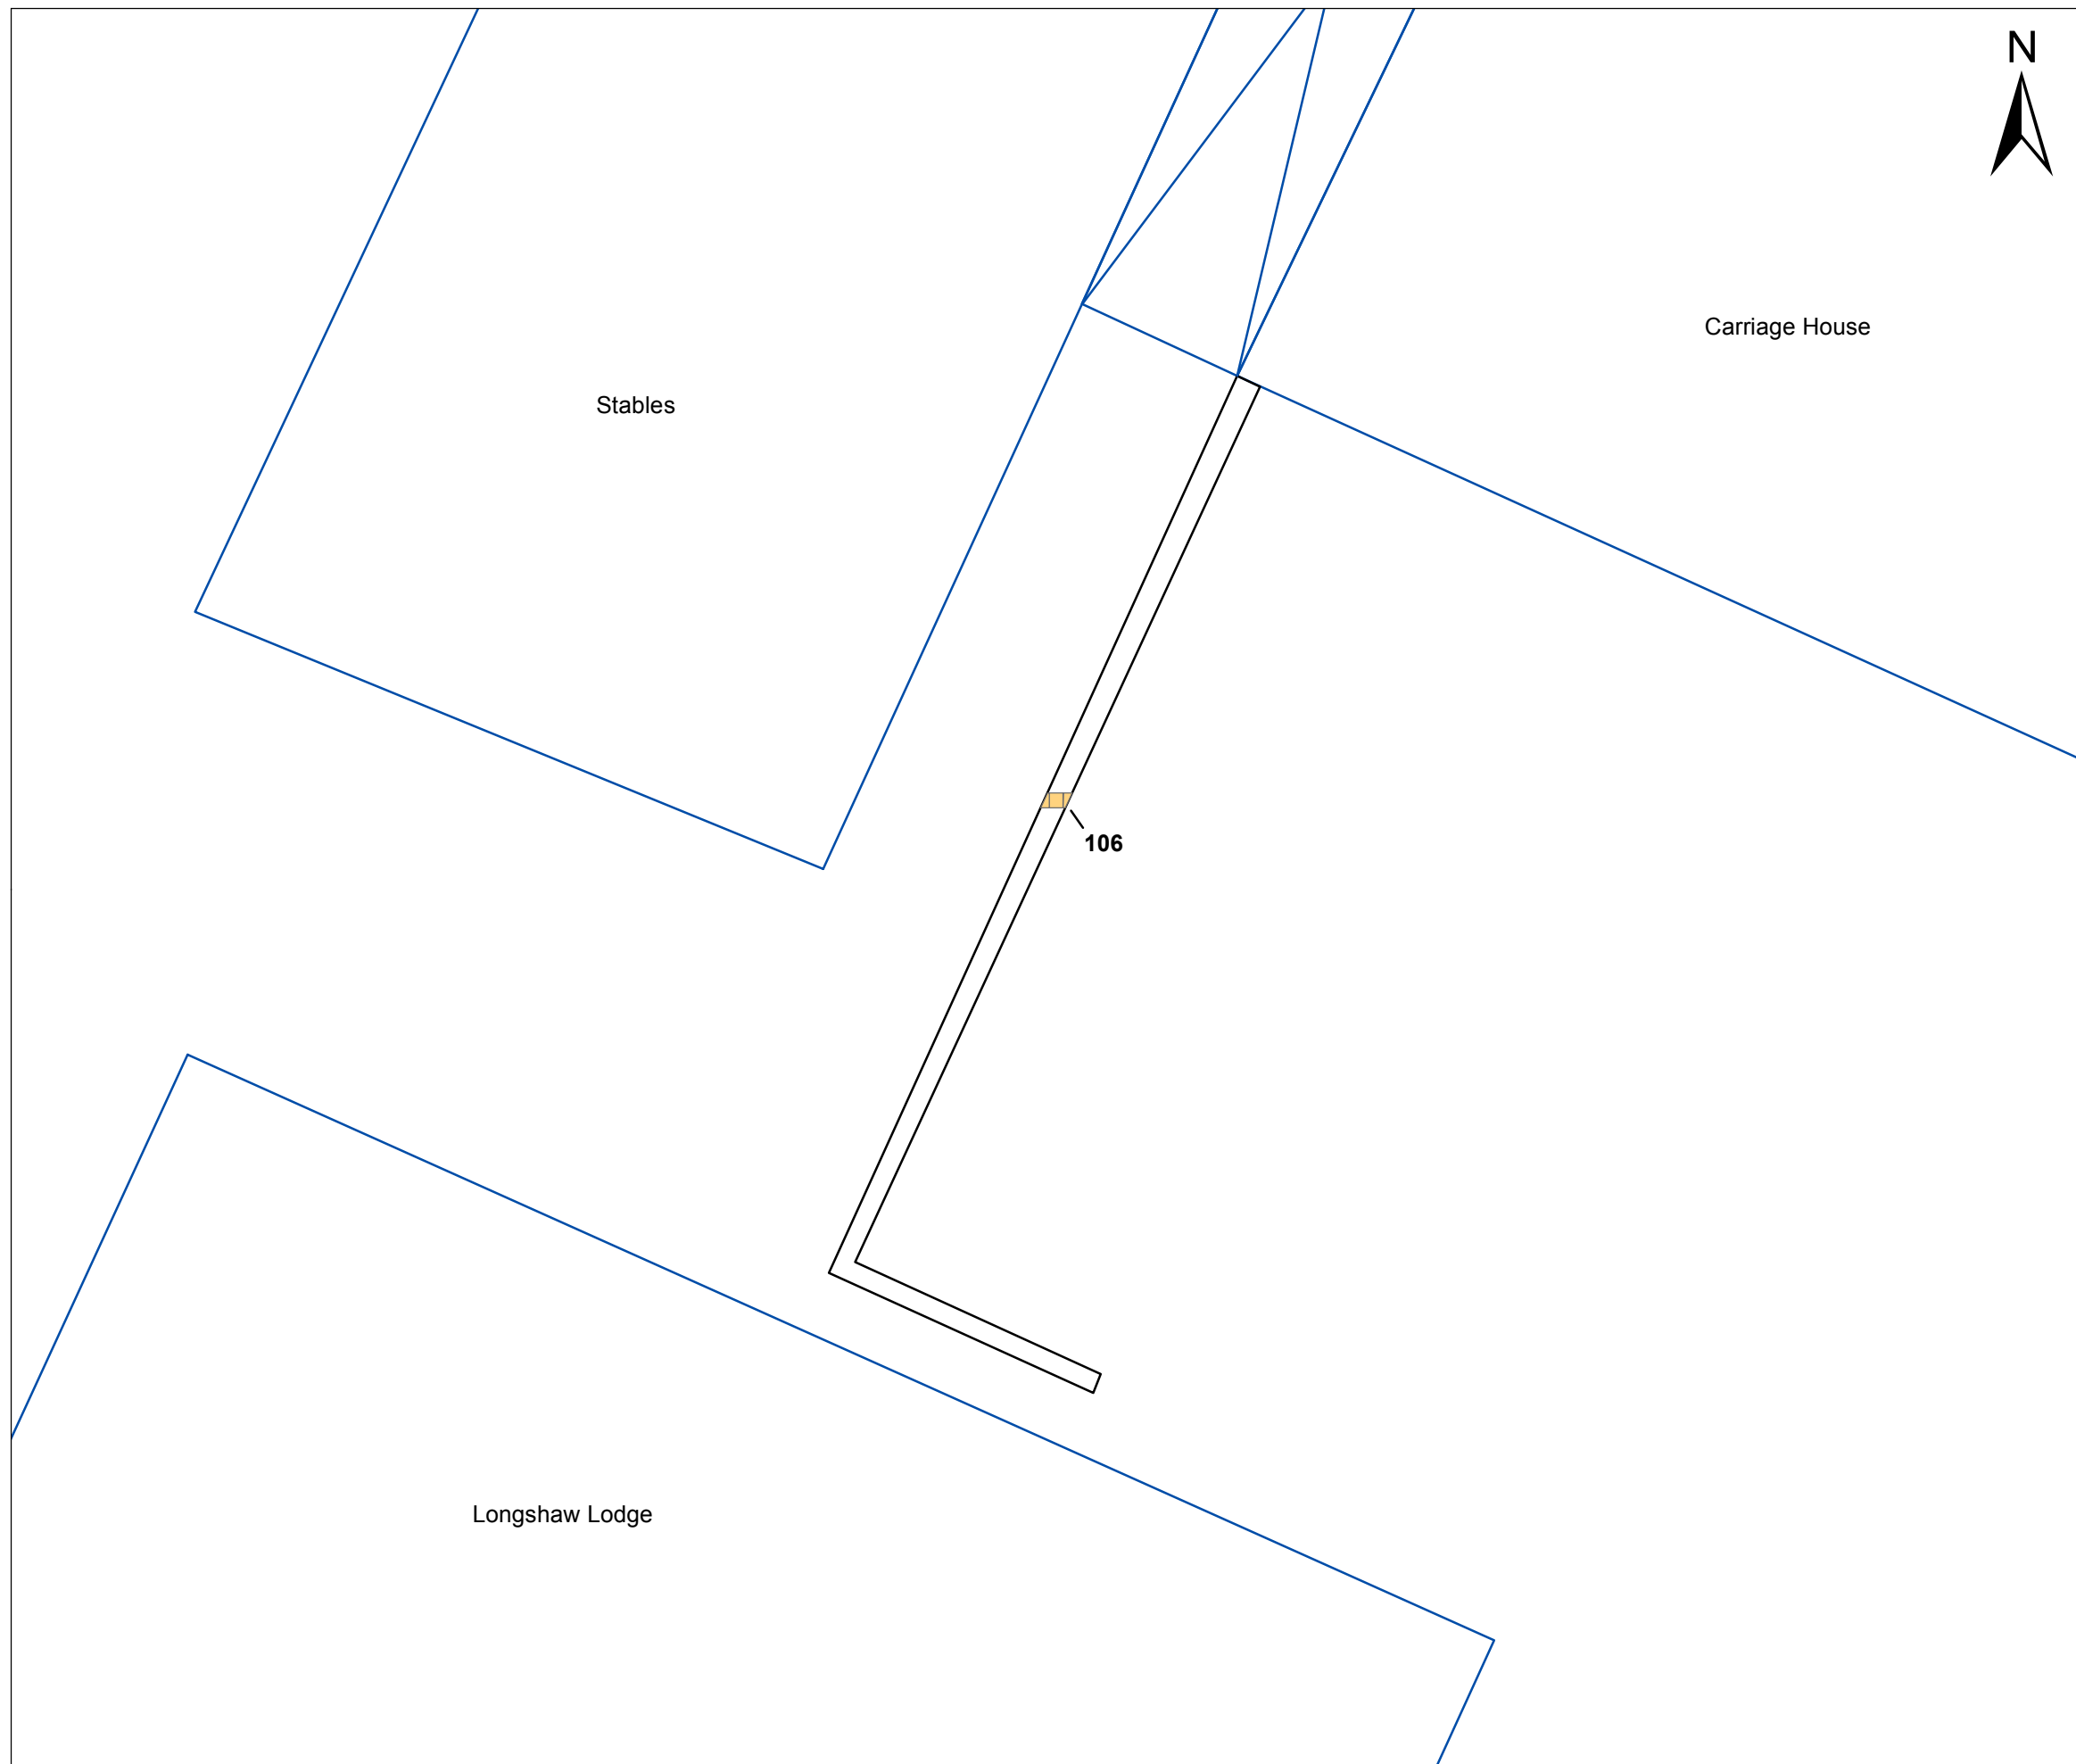
**Figure 2: Trench Plan**

3.1.1 The following section presents the results of the archaeological monitoring. The context descriptions for recorded archaeological deposits are reproduced in **Appendix 1**. Where referenced within the text, context numbers are indicated in bold text. The groundworks comprised the excavation of a single trench measuring 18.3 m in length, 0.3 m wide and 0.4 m deep. The extent of the trench excavated during the archaeological monitoring is depicted on **Figure 2**.
