**Former Flowserve Pump Division Site,
Hawton Lane, Balderton, Newark On Trent,
Nottinghamshire**

Historic Building Recording

April 2019

Report Title: **Former Flowserve Pump Division, Hawton Lane, Balderton,
Newark-on-Trent – Historic Building Recording**

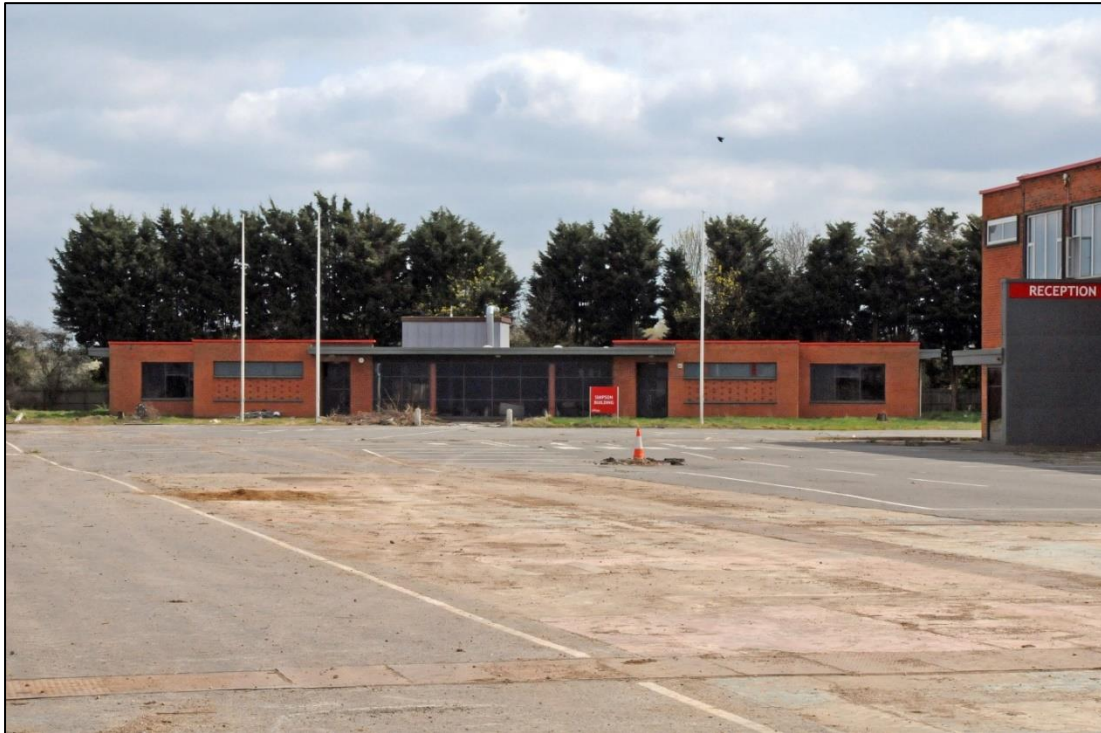
Plate 1: General view of west facing elevation of **Building 1**, from across the yard (image 0036).

4.2.2 The entrances are located either side of three floor-to-ceiling height windows which form the central bay (**Plate 1**). The windows are separated by brick piers. All have aluminium frames, windows one and three comprising six panes of glass (2 x 3), whilst the central window comprises 12 panes (4 x 3). Either side of the central windows and entranceways, bays 1, 2, 4 & 5 contain a single aluminium frame window with a blue-brick sill. The north facing elevation (**Plate 2**) comprises three bays.

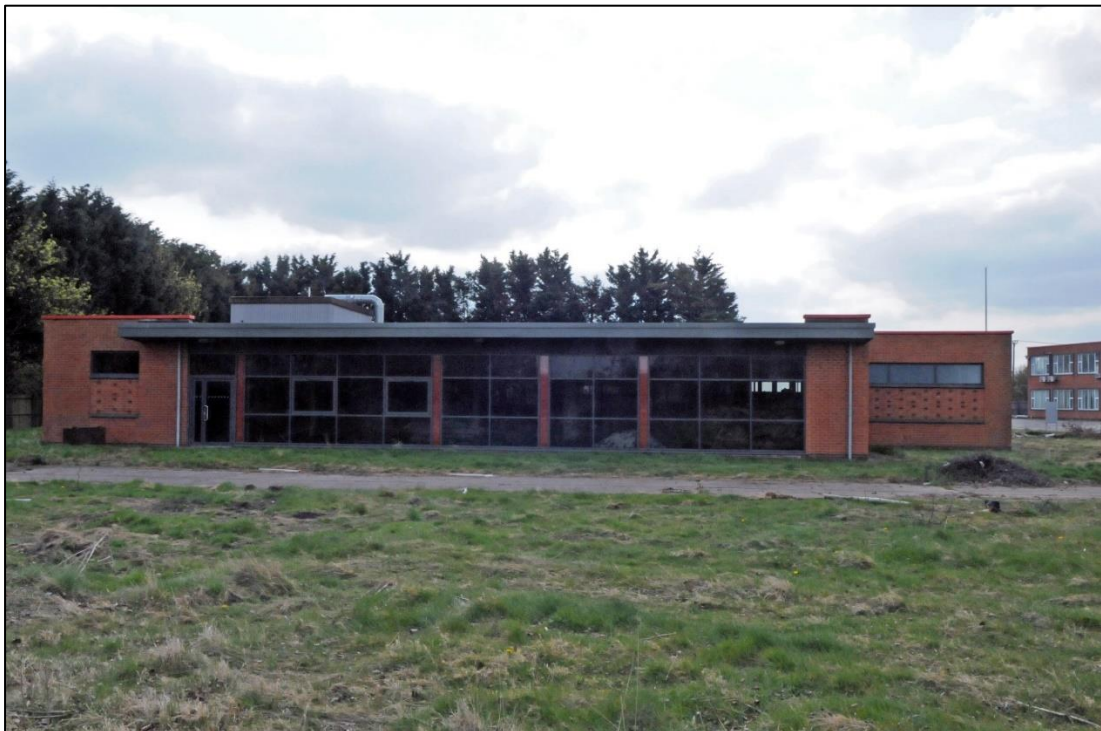
Plate 2: General view of north facing elevation of **Building 1** (image0060).

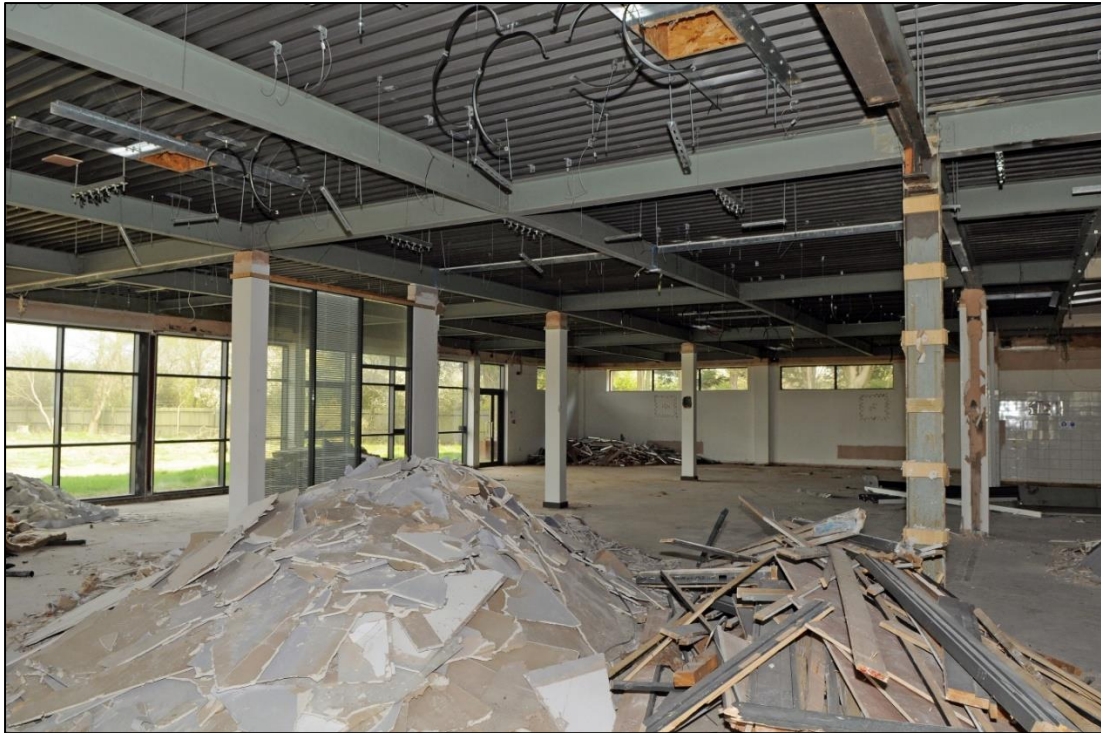
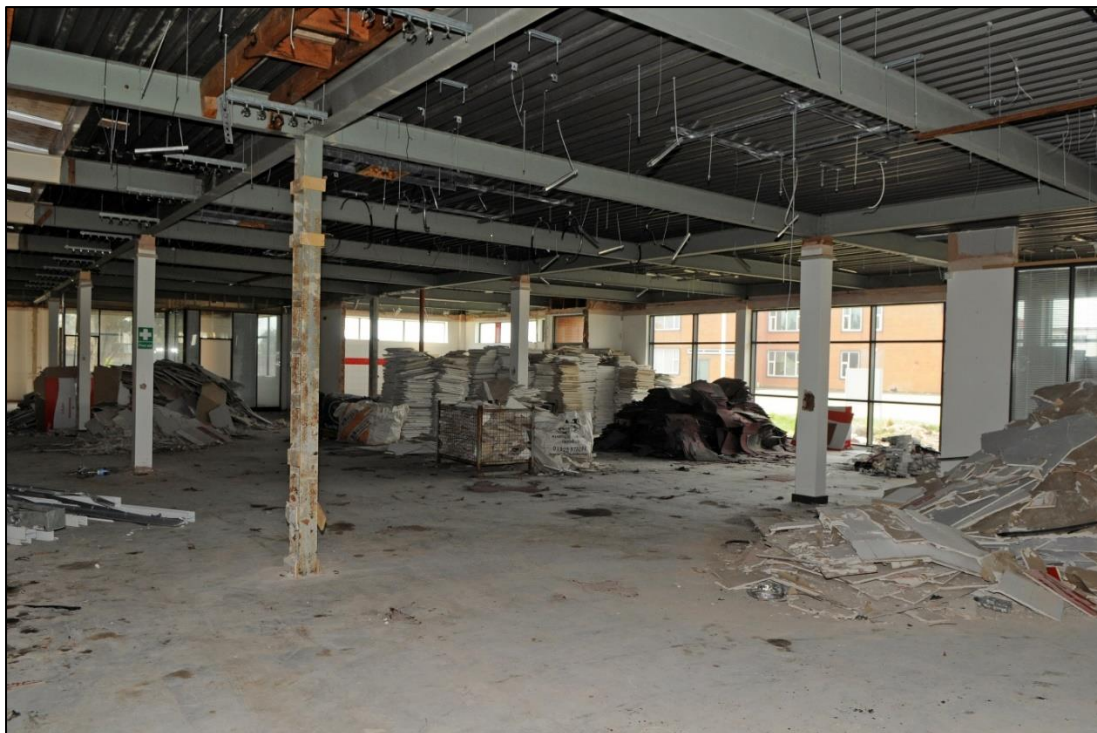
Plate 5: General view of the interior of **Building 1** facing north west (image 0071).

Plate 6: General view of the interior of **Building 1** (image 0072).

Plate 7: General view of the interior of **Building 1**, facing south west (image 0073).

4.2.4 All interior partitions have been removed (**Plates 5-7**). The roof is supported by a number of steel columns spaced at regular intervals. The remains of the toilet unit can be seen in the north-eastern corner of the building (**Plate 8**).

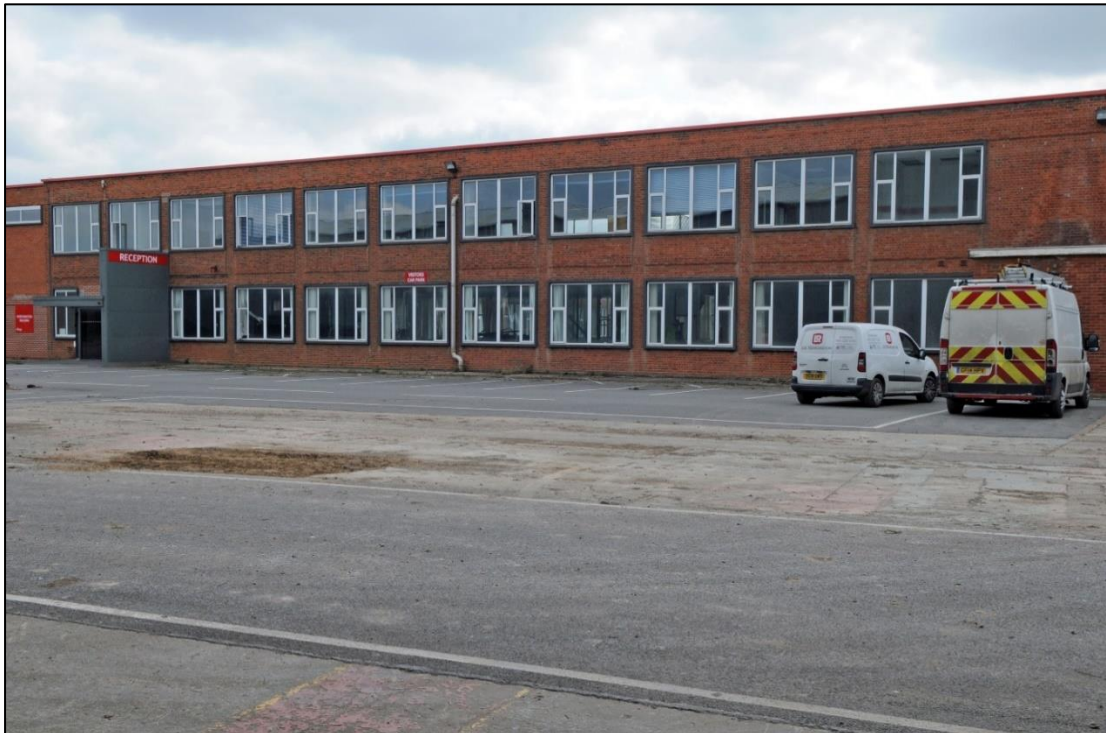
Plate 14: General view of the northern elevation of **Building 2** (image 0083).

is potential that it is a later rebuild. Formerly this block was connected to the workshops to the north (which have since been demolished). A steel-framed, glazed corridor connects this block to a two-storey, L-shaped building, constructed in red-brick (**Plates 11-14**). This part of the building first appears on the 1970-1971 OS map. The building has numerous rectangular windows, the majority of which have been fitted with UPVC frames. A number of steel-framed and timber-framed windows do survive within the earlier block (**Plate 9**). An entrance door is located in the northern elevation of the western block, with a modern porch, which signposts the reception (**Plate 14**).

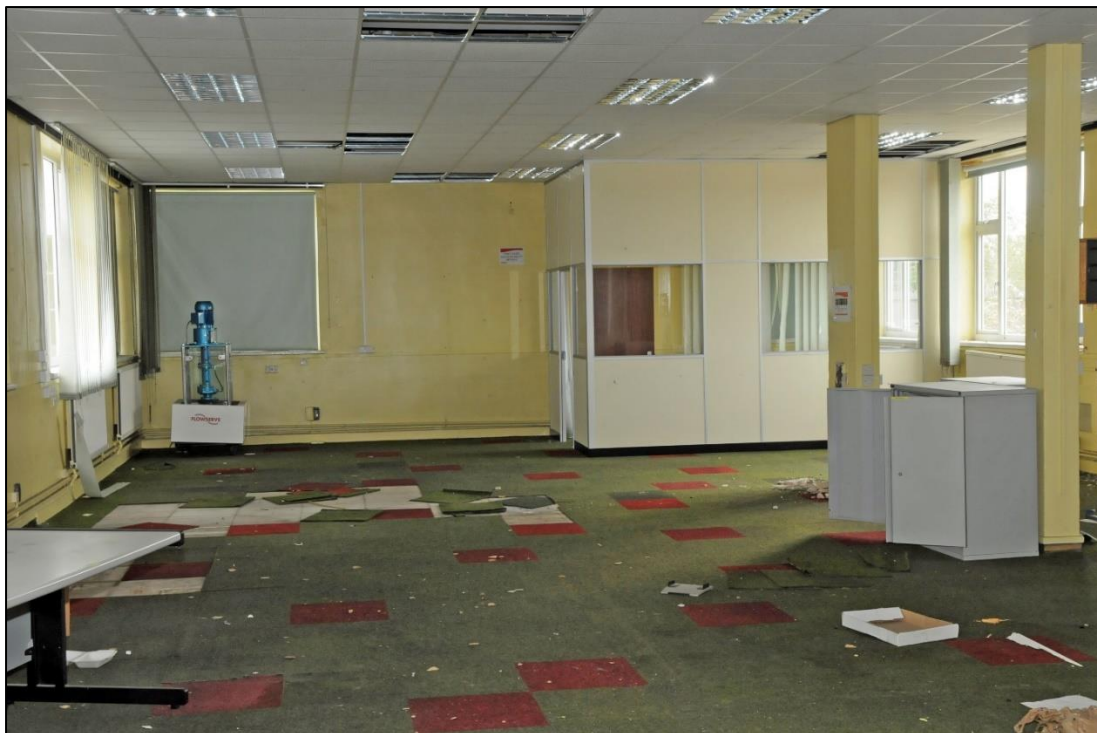
Plate 15: General view of partitioned office space in **Building 2** (image 0096)

Plate 16: General view of office space in **Building 2** (image 0109).

4.3.2 Internally, the building comprises a series of partitioned offices (**Plates 15-16**). The original staircase and a number of timber doors survive in the western block (**Plates 17**). The removal of the suspended ceiling reveals a corrugated flat roof, supported by a series of rolled-steel joists (RSJs, **Plate 18**).

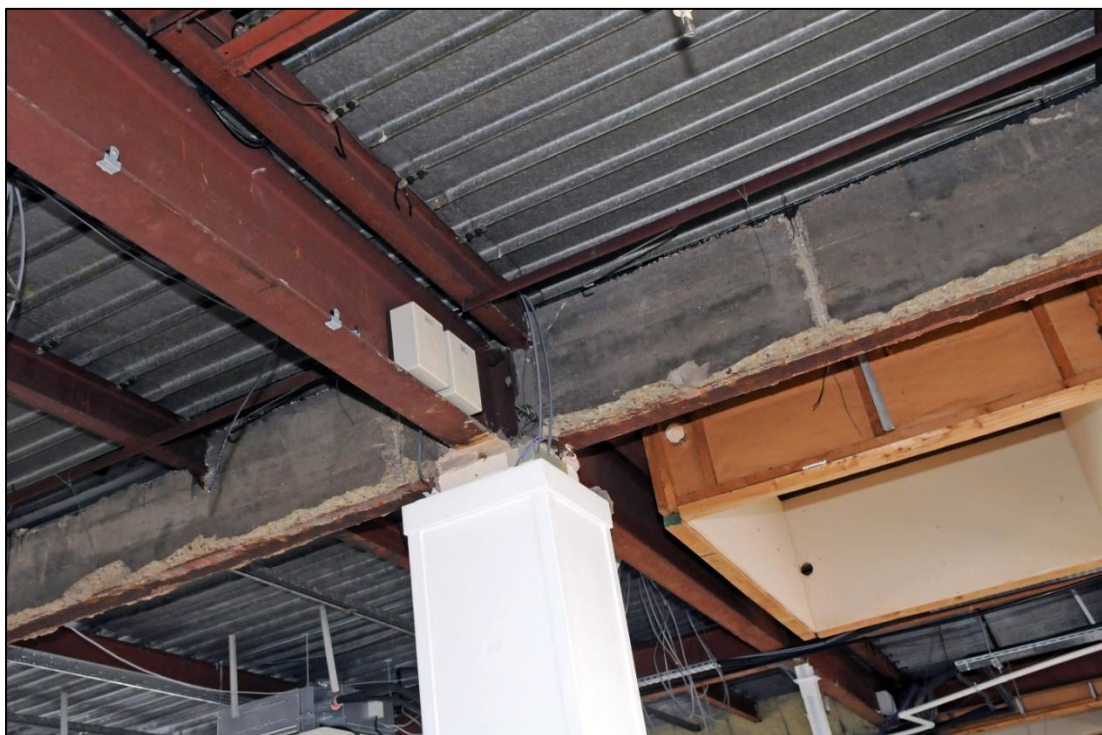
Plate 18: Detail of roof structure eastern block of **Building 2** (image 0110).

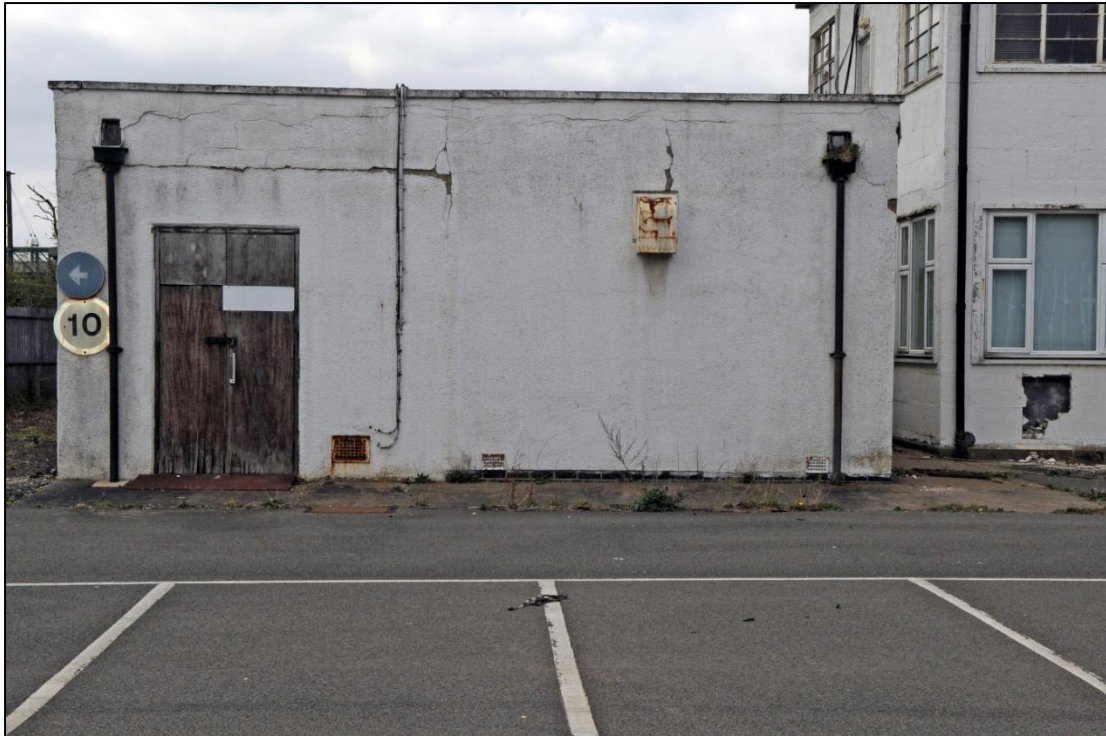
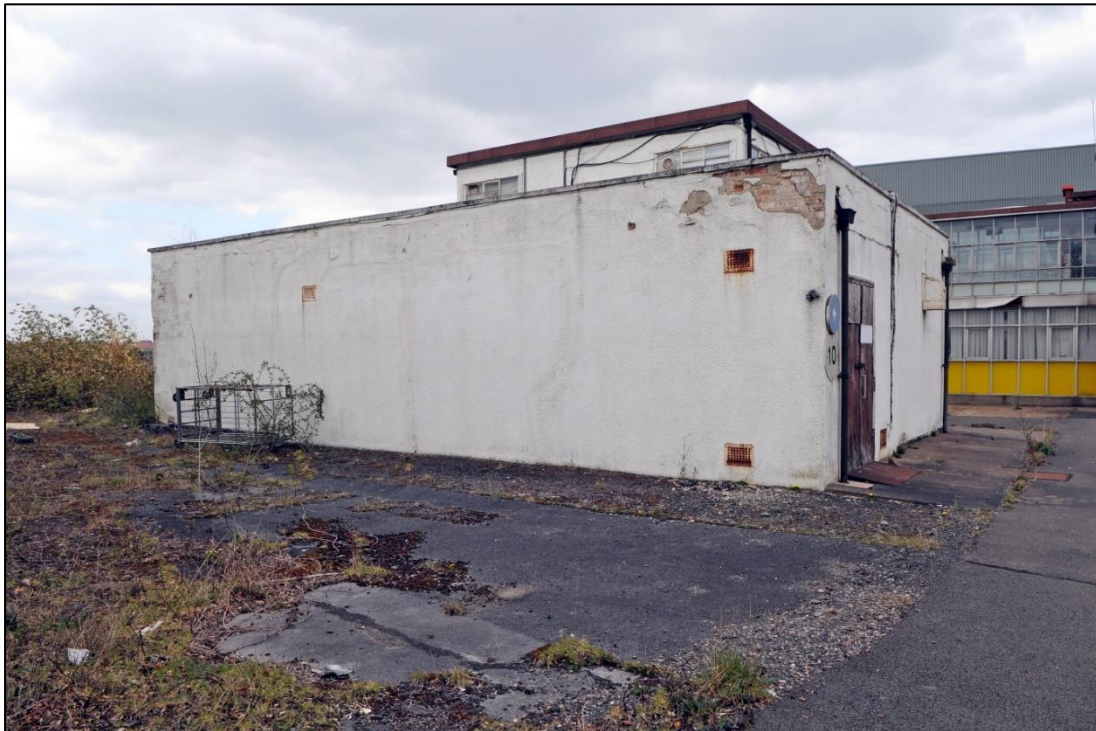
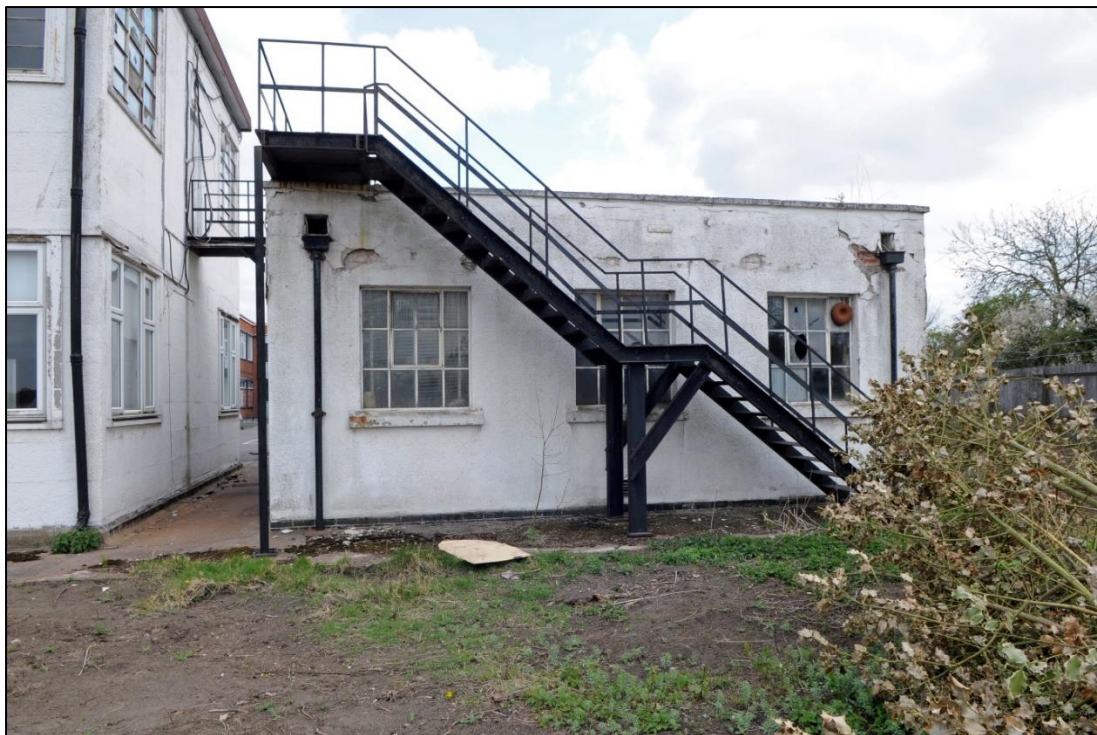
Plate 19: General view of the east facing elevation of **Building 3** (image 0074).

Plate 20: General view of the south facing elevation of **Building 3** (image 0075).

Plate 21: General view of the west facing elevation of **Building 3** (image 0076).

4.4.1 **Building 3** is a single storey, rectangular plan, transformer unit (**Plates 19-21**). It is constructed in rendered brick. A steel-frame fire-escape, serving **Building 2** cuts across the top of the building and down across the southern elevation of the building (**Plate 21**). Access to the interior could not be gained at the time of survey.

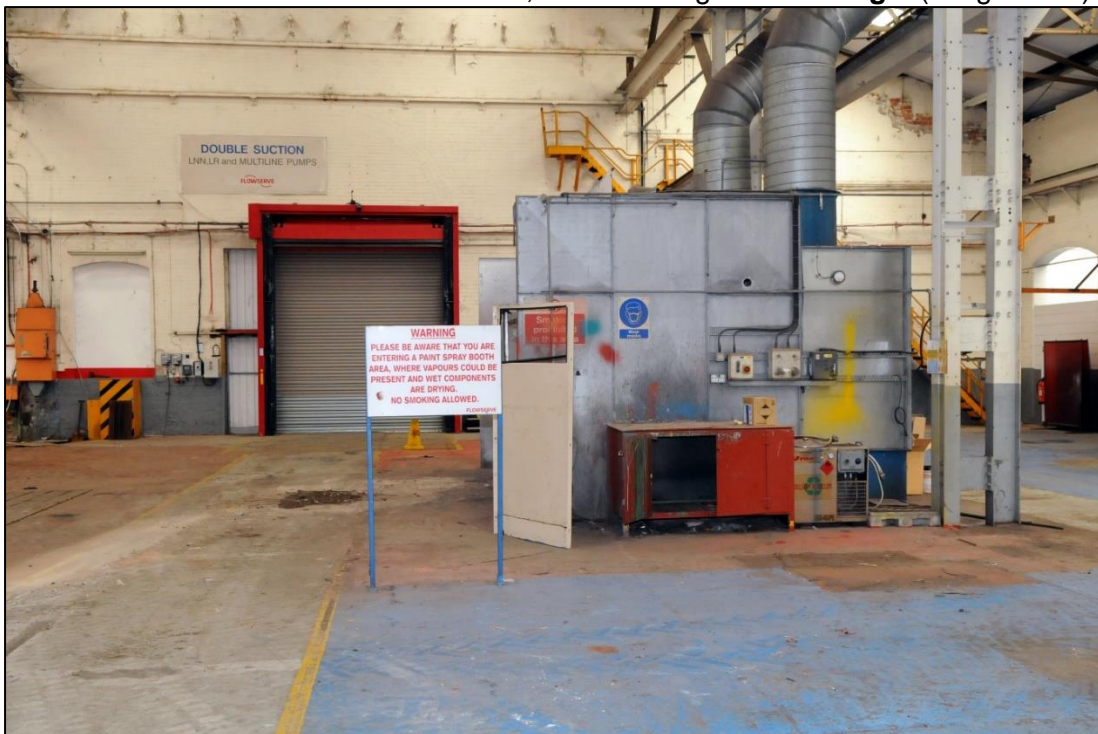
Plate 30: Detail of paint spraying station, Western range of **Building 4** (image 0030).

4.5.2 Internally the building is subdivided into five areas. The first is a large range extending down the western side of the building (**Plate 23**). This range has a pitched roof with steel, double fink trusses. At the northern end of this range there are larger doors above which is a relieving arch constructed from three rows of brick headers (**Plate 24**). Along the eastern wall are a series of blocked arched windows (**Plate 25**). All surviving windows of this section were modern UPVC replacements (**Plate 26**) with the exception of those within the 'MOD' (**Figure 4**). At the southern end of this range a number of machine parts and bases remain (**Plates 27 – 29**). This range also includes a paint spraying station (**Plate 30**) and a handwashing station (**Plate 31**).

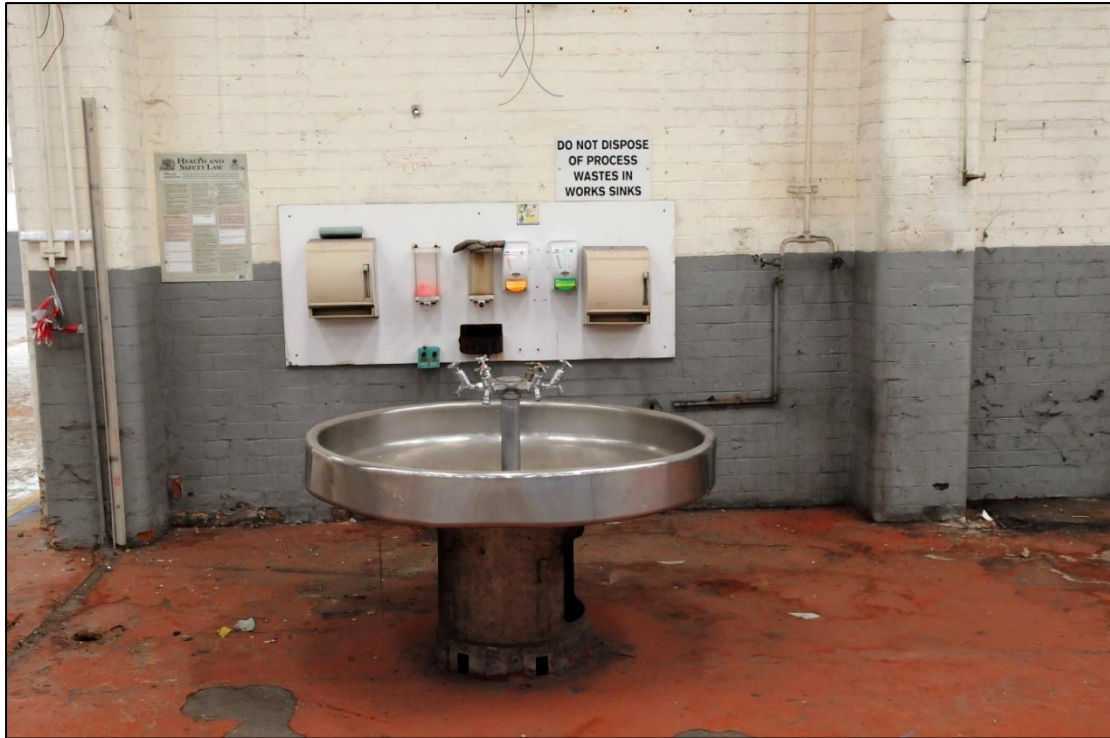
Plate 31: Detail of handwashing station, Western range of **Building 4** (image 0028).

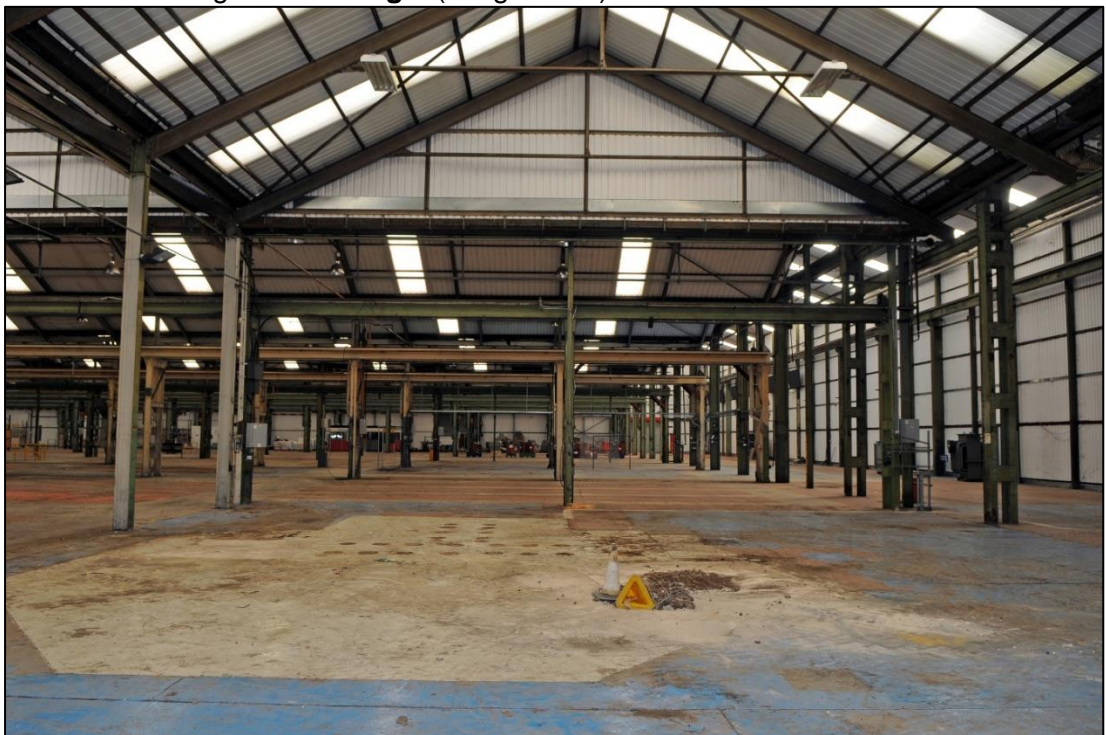
Plate 34: General view of one range of double pitched roof leading into the eastern range of **Building 4** (image 16).

- 4.5.4 To the south of this block was a double-pitched section (**Plate 34**) which connects the western range with the eastern range. This section is supported by steel-framed, king post trusts.

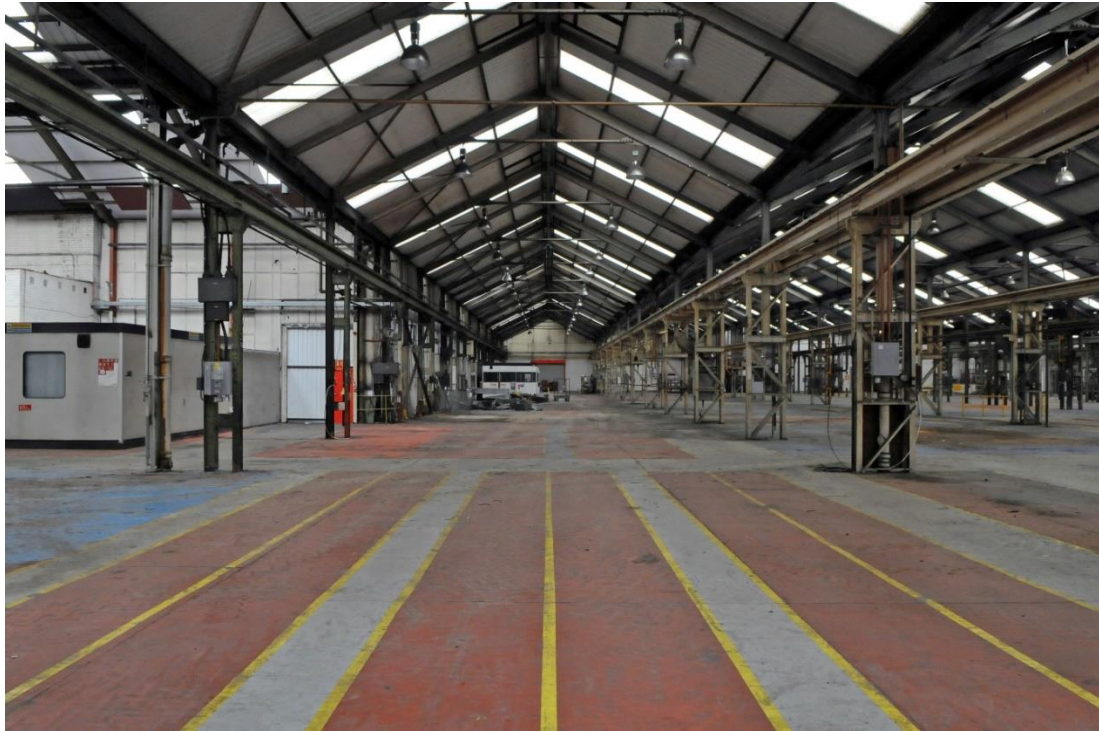
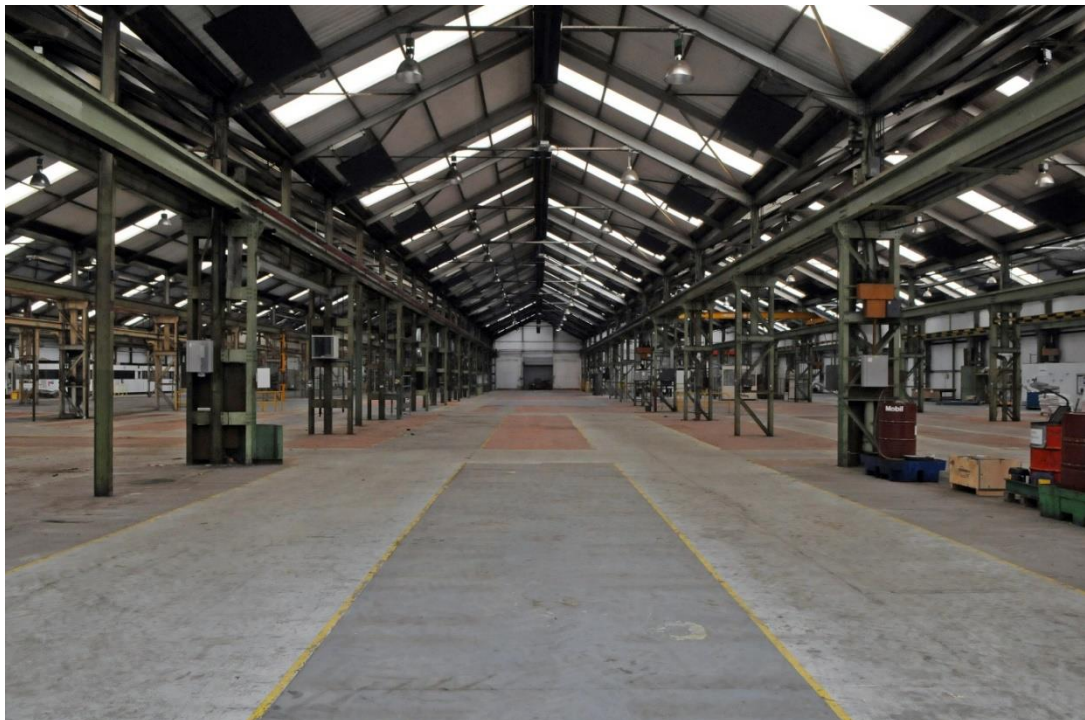
Plate 35: General view of eastern range, facing north (image 0017)

Plate 36: General view of eastern range, facing north (image 0020)

- 4.5.5 The eastern range comprises six bays. This range is constructed as a steel frame with corrugated aluminium cladding (**Plates 35 – 36**). There is little surviving evidence for specific activities in this range, with the exception of a quality control area located at its northern end.
