**Haweswater Aqueduct Resilience
Programme (HARP).
Haslingden Road Compound,
Rossendale.**

**Archaeological Trial Trenching
Report**

For United Utilities Water

December 2023

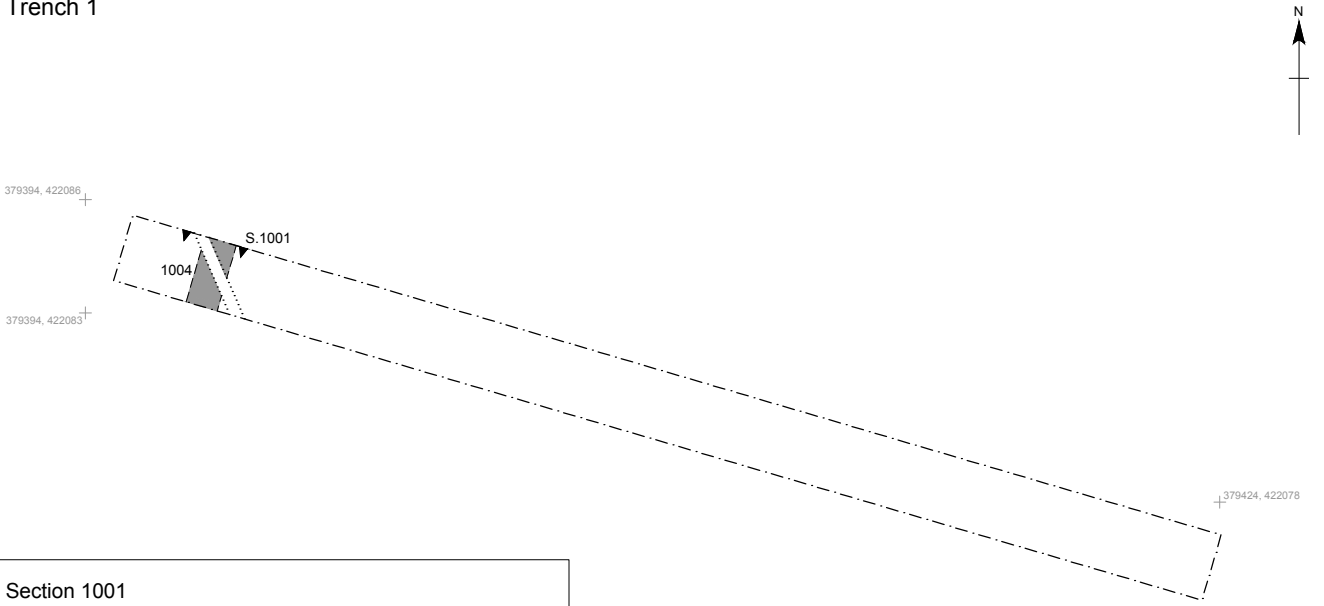
Trench 1

3.2.2 The natural orange clay (**1003**) was encountered at a depth of 0.5m across the trench. A single linear ditch (**1004**) was recorded cutting through the natural clay, approximately 2m from the north western end of the trench and running along a north to south alignment (Plate 2, Figure 2). Ditch **1004** was 0.9m wide and 0.11m deep and was filled by a sterile deposit of mid brownish-grey sandy clay (**1005**). Wet weather conditions and contamination by a modern land drain, cutting across ditch **1004** on a north-west to south-east alignment, meant that retrieving secure environmental samples from fill **1005** was unviable and no diagnostic material was recovered.

Section 1001

- 4.1.1 The geophysical survey showed a rectilinear anomaly crossing the centre of the trench from east to west, before returning to the south to again cross the trench at its south eastern end (Magnitude Surveys 2020; Fig. 2). This anomaly was not identified at either location within the trench. Instead, the evaluation identified a single ditch **1004** crossing the north west end of the trench running from north east to south west. Unfortunately, due to weather conditions and truncation of ditch **1004** by a modern land drain, no diagnostic material was recovered to enable dating or further interpretation of the feature.

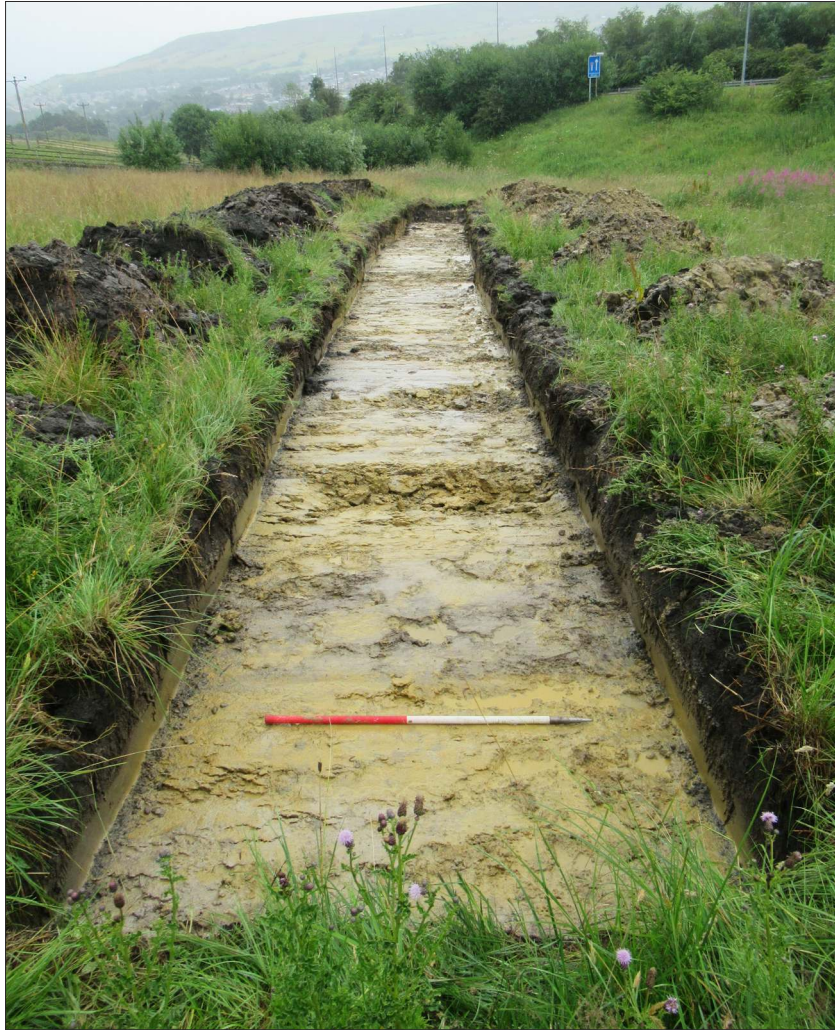
Plate 1

3.2.1 Trench 1 measured 30m x 1.8m and was orientated north-west-west to south-east-east. The trench was located between the A681 Haslingden Road to the north and the A56 Haslingden Bypass to the south in a field set to pasture. The ground sloped downwards to the east (Plate 1).

Trench 1: overview of trench,
facing south east

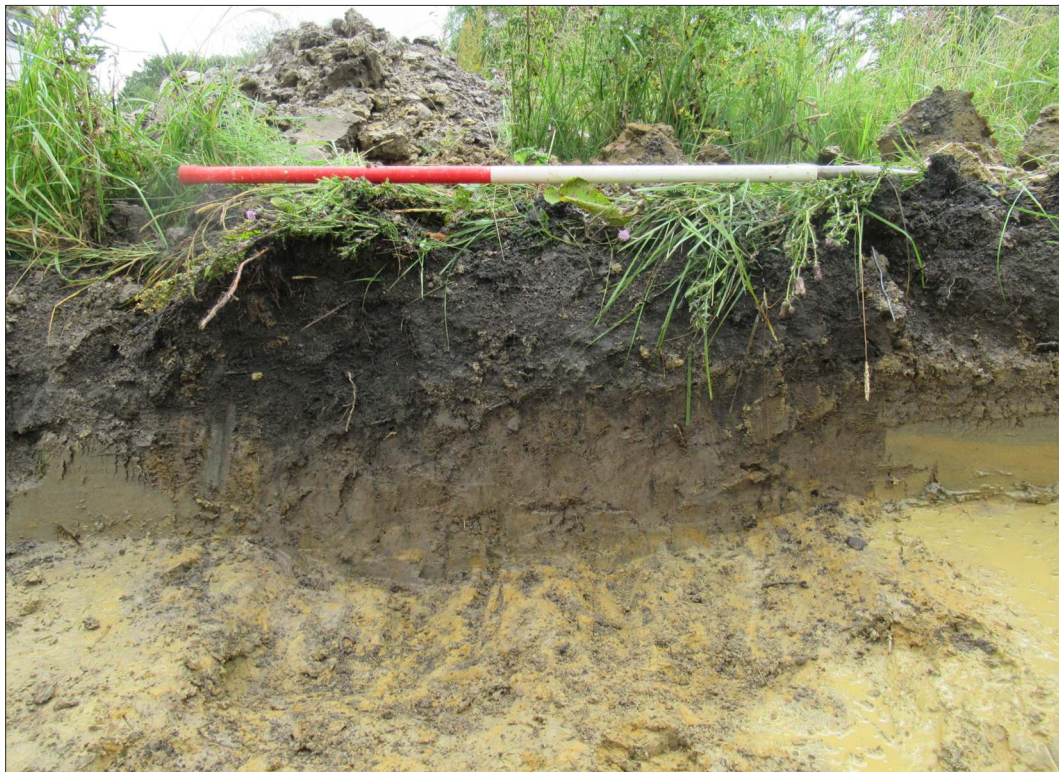
Plate 2

Trench 1: south west facing section of ditch 1004

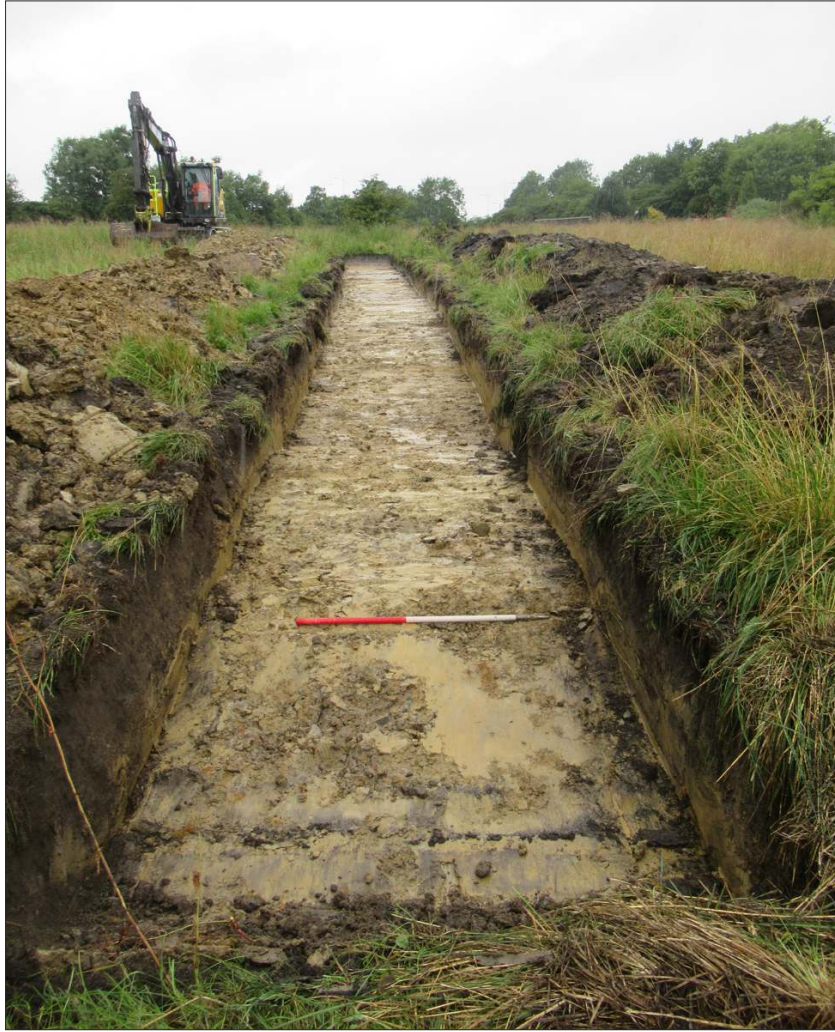
Plate 3

3.2.4 The anomaly recorded by the geophysical survey crossing the centre and south eastern end of the trench could not be identified (Plate 3).

Trench 1: overview of trench,
facing north west
