**Haweswater Aqueduct
Resilience Programme (HARP).
Woodgate Hill, Bury, Greater
Manchester.**

**Archaeological Trial Trenching
Report**

For United Utilities Water

December 2023

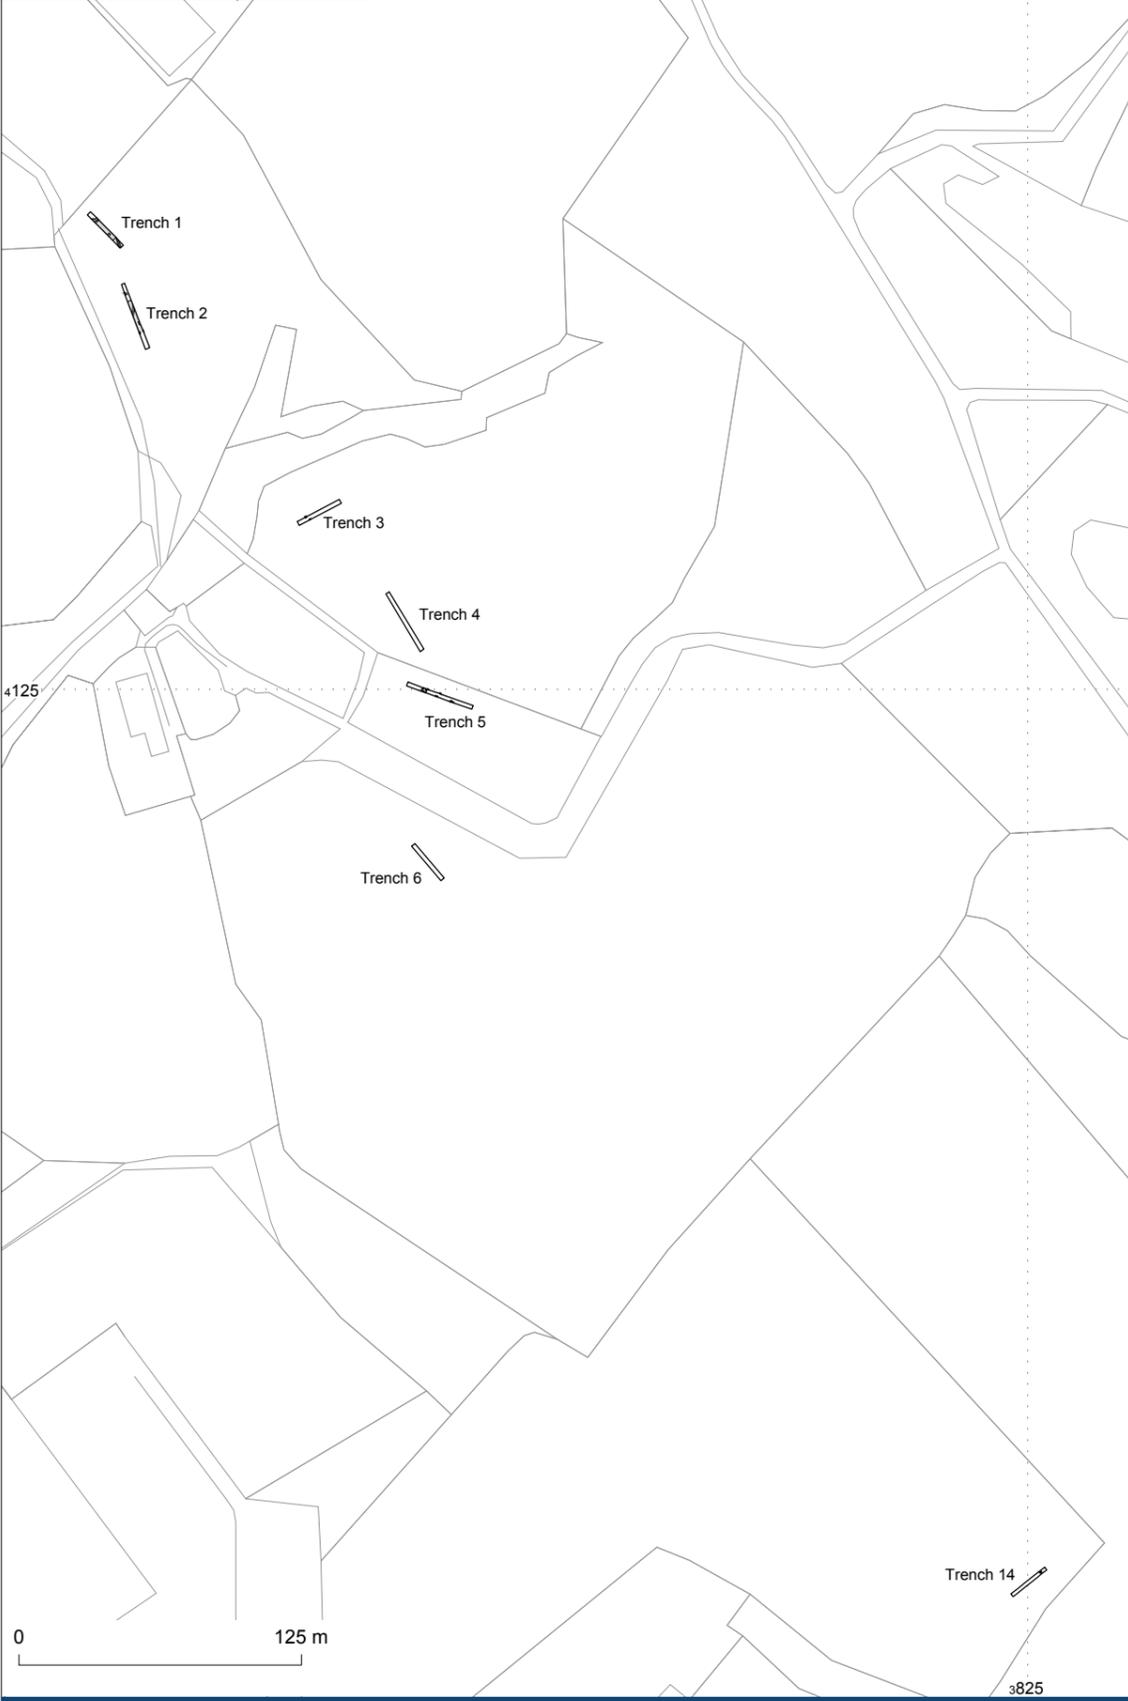
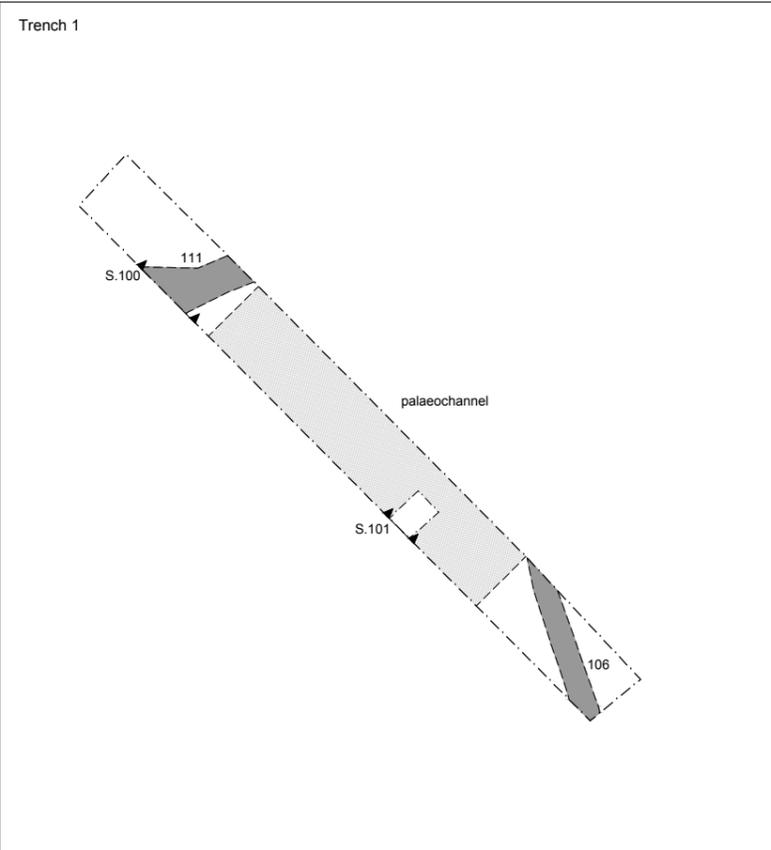
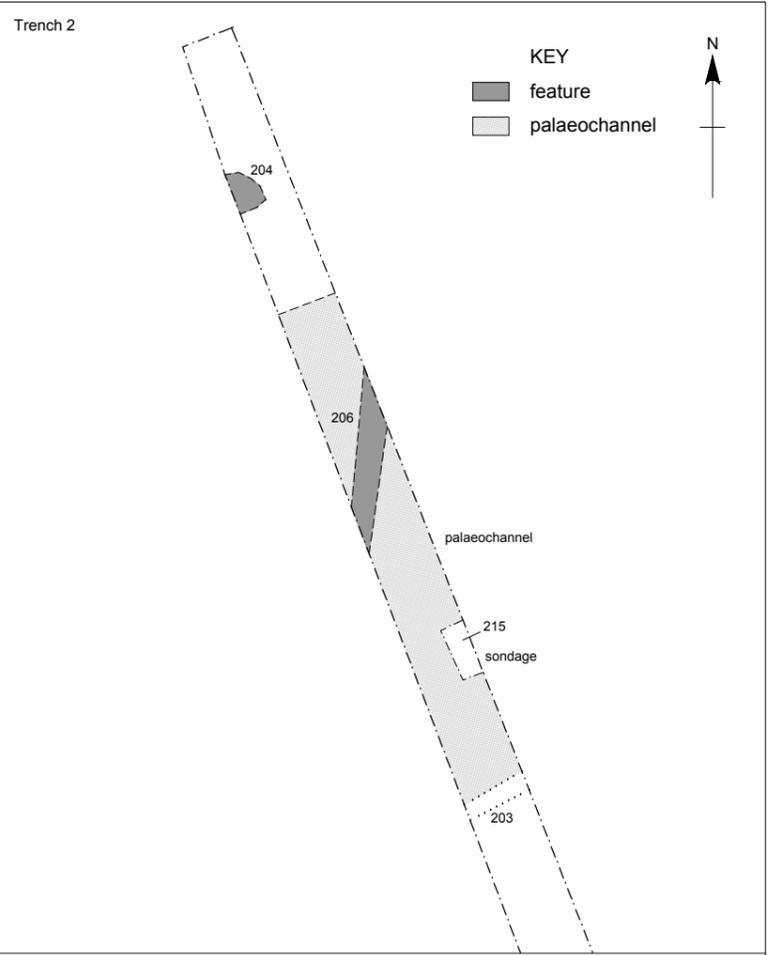
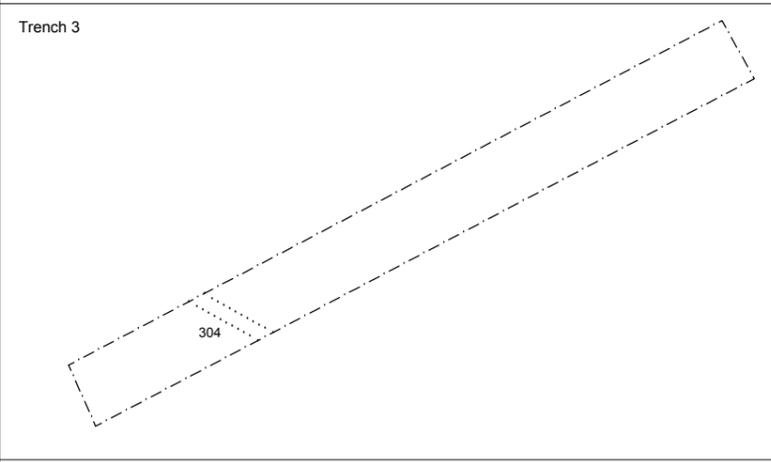
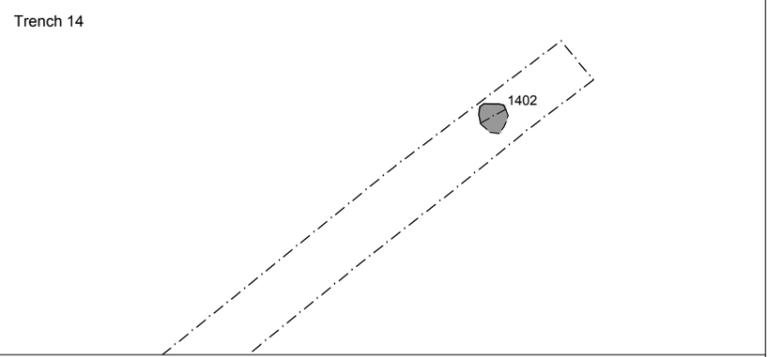
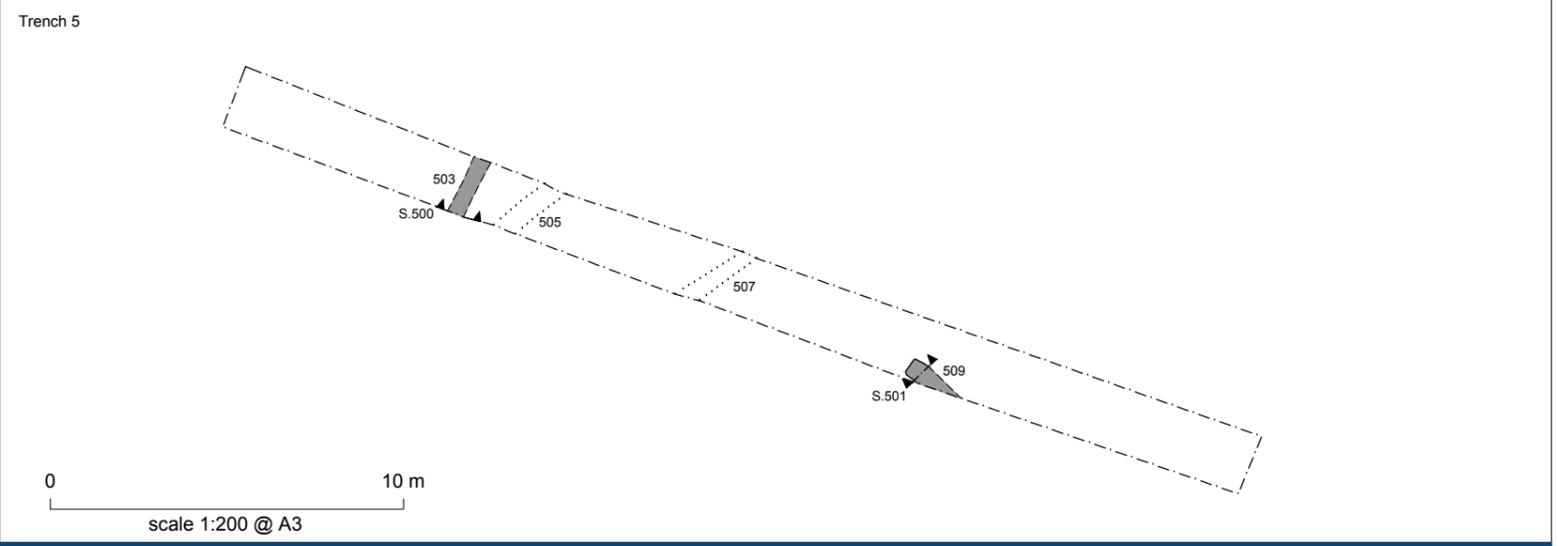
Figure 2

Haweswater Aqueduct Resilience Programme Woodgate Hill, Greater Manchester: trench plans and sections

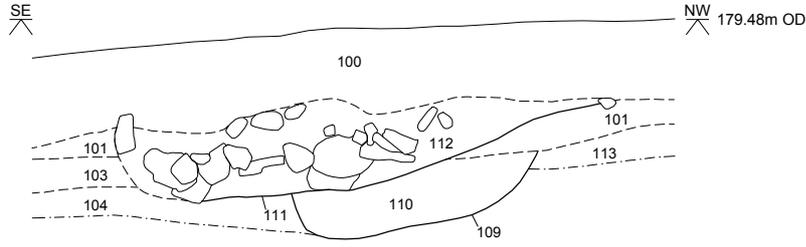
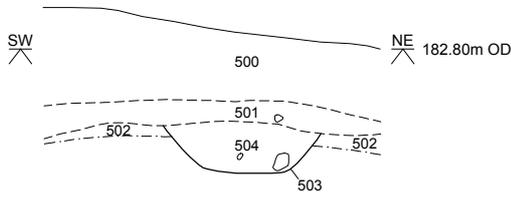
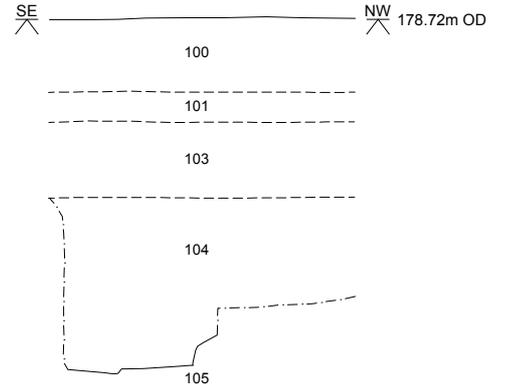
Haweswater Aqueduct Resilience Programme Woodgate Hill, Greater Manchester: sections Figure 3

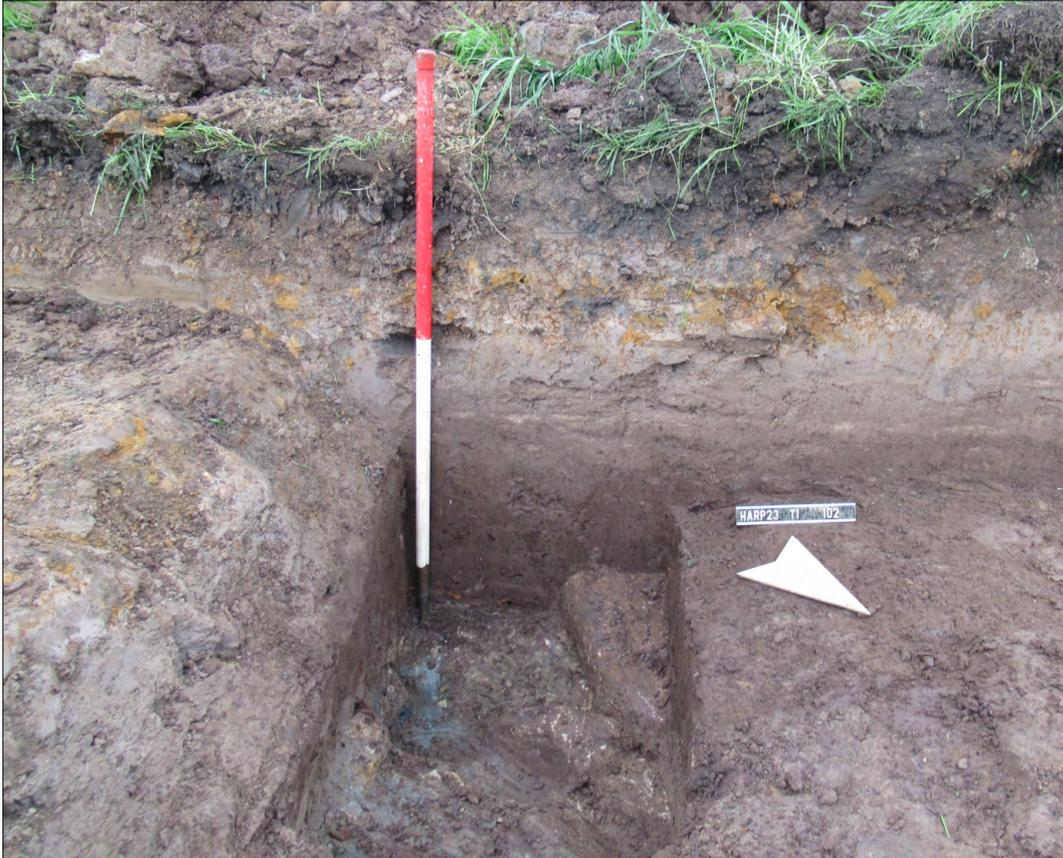
Plate 1

Trench 1: north east facing section of sondage through
palaeochannel 102

- 3.2.3 A palaeochannel (**102**), measuring approximately 10m in width, cut through the natural clay on a roughly east to west trajectory and was likely a relict channel of the Gypsy Brook. A sondage excavated at its centre encountered its base at a depth of 1.1m below ground level (bgl), eroded into the natural bedrock and bluish-grey boulder clay (Plate 1). It was filled by an initial deposit of dark greyish-brown silt (**104**), 0.5m thick, that contained moderate amounts of natural organic material, notably twigs. Deposit **104** was superseded by a 0.3m thick layer of light grey plastic clay (**103**) which appeared to seal the palaeochannel.

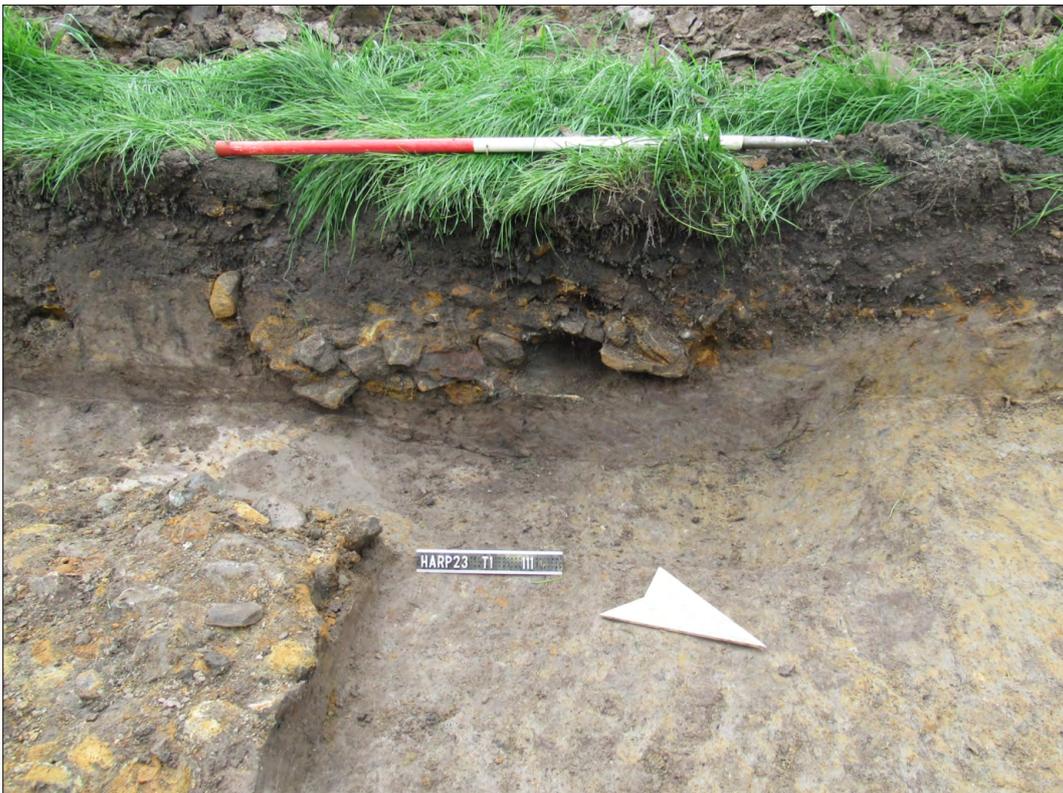
Plate 2

Trench 1: north east facing section of gully 109 and
potential trackway 111

- 3.2.4 A 0.8m wide shallow gully (**109**) cut through deposit **103**, apparently following the northern edge of palaeochannel **102**. It was filled by a sterile, light brownish-grey clayey-silt that contained no diagnostic material attaining to a potential date or usage. A later stone-filled feature was excavated above gully **109** along the same alignment and potentially represents a later phase (Plate 2, Fig.3). This will be discussed in more detail below.

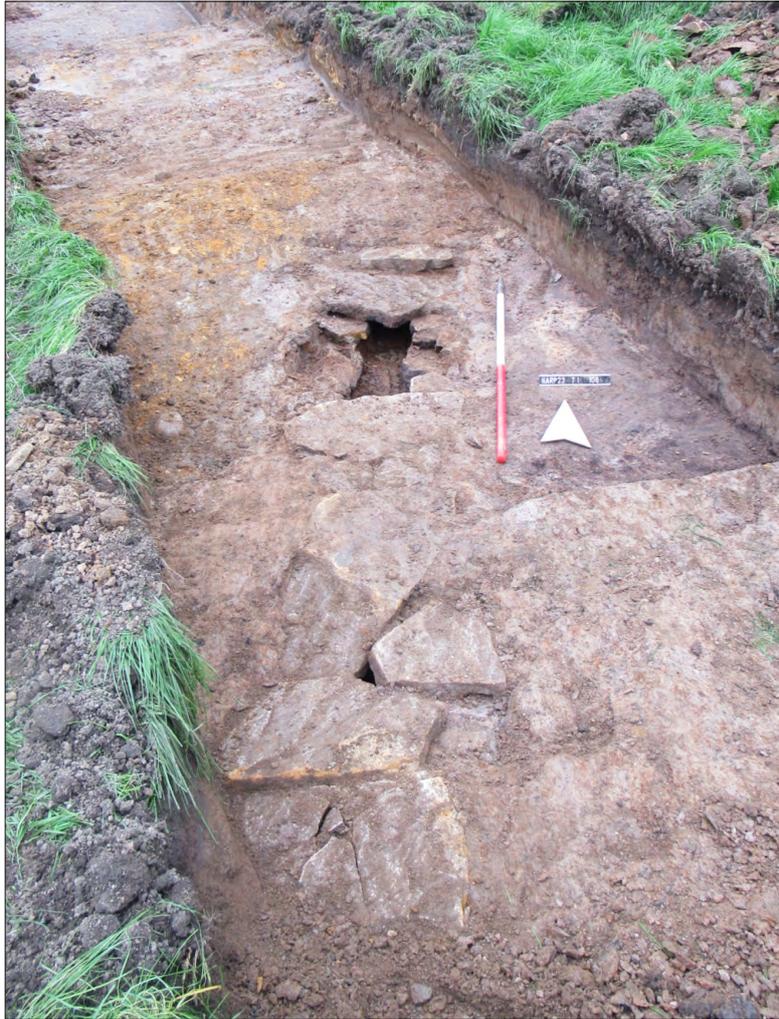
Plate 3

Trench 1: culvert 106, looking north

running along a north to south alignment (Plate 3). The drain sat within a vertical-sided cut (**106**), 0.6m wide and 0.25m deep, and was constructed of flat sandstone slabs along the base and top with 3 rough courses forming the walls (**107**). The central aperture was approximately 0.15m square and contained a light grey sandy-silt fill (**108**) which had accumulated along the base. The culvert was also encountered at the north-western end of Trench 2 to the south (**206**).

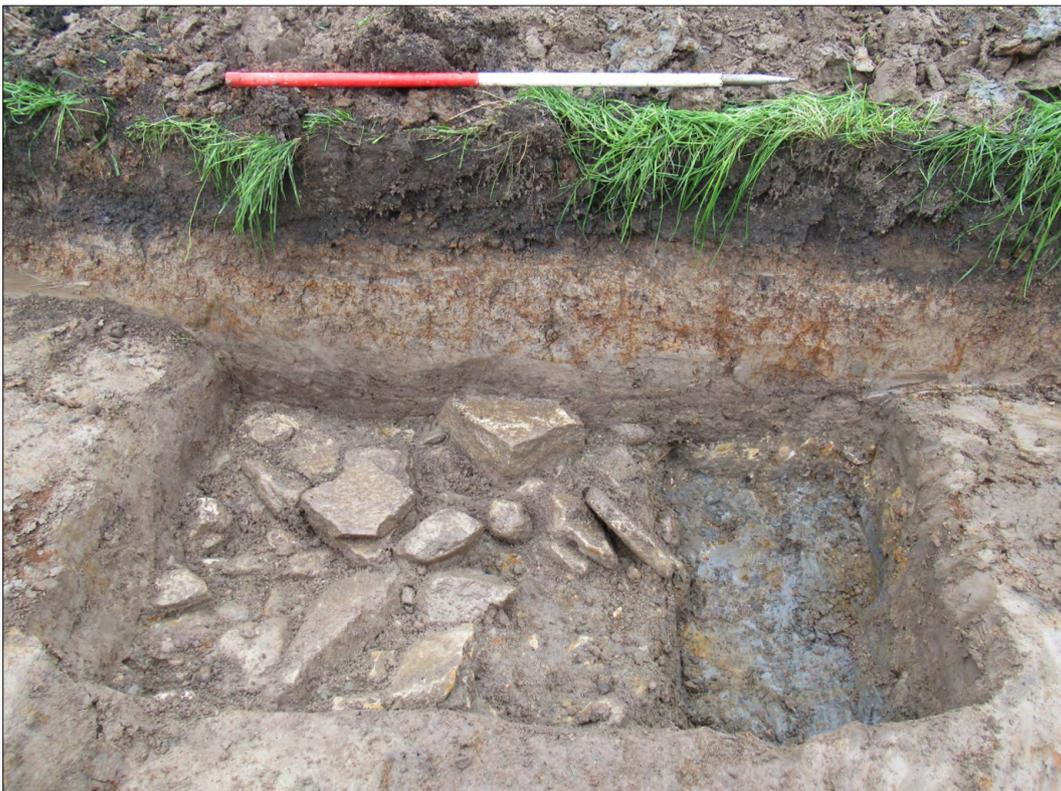
Plate 4

Trench 2: south west facing section of sondage through
palaeochannel 209

3.3.2 The orange natural clay was observed at the south-eastern end of the trench, at a depth of approximately 0.5m. A second palaeochannel (**209**) cut through the upper natural clay along a north to south alignment, and likely converges with channel **102** within the field to the north-east. A sondage was excavated through the centre of **209** and encountered its base at a depth of 1m bgl, eroded into the natural bedrock and bluish-grey boulder clay (**215**, Plate 4). A mixed deposit of eroded bedrock fragments within a grey sandy-silty matrix had accumulated along the base (**214**), which was superseded by a dark greyish-brown silt (**213**) and a light grey plastic clay (**212**), comparable to fills **104** and **103** of palaeochannel **102** in Trench 1.

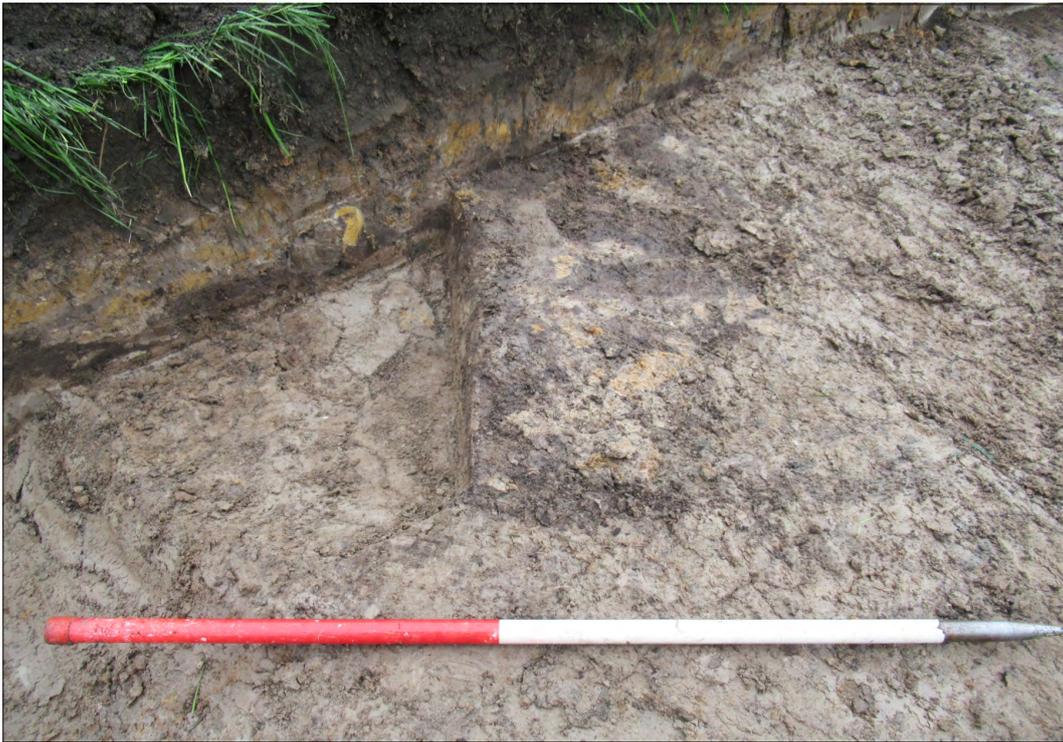
Plate 5

Trench 2: overview of circular feature 204

3.3.4 At the north-western end of the trench was a shallow, circular feature (**204**), which measured 1.1m in diameter and 0.25m deep and extended into the south-western edge of the trench (Plate 5). It was filled by a mixed deposit of redeposited orange clay and dark greyish-brown silty clay (**205**) but contained no diagnostic finds.

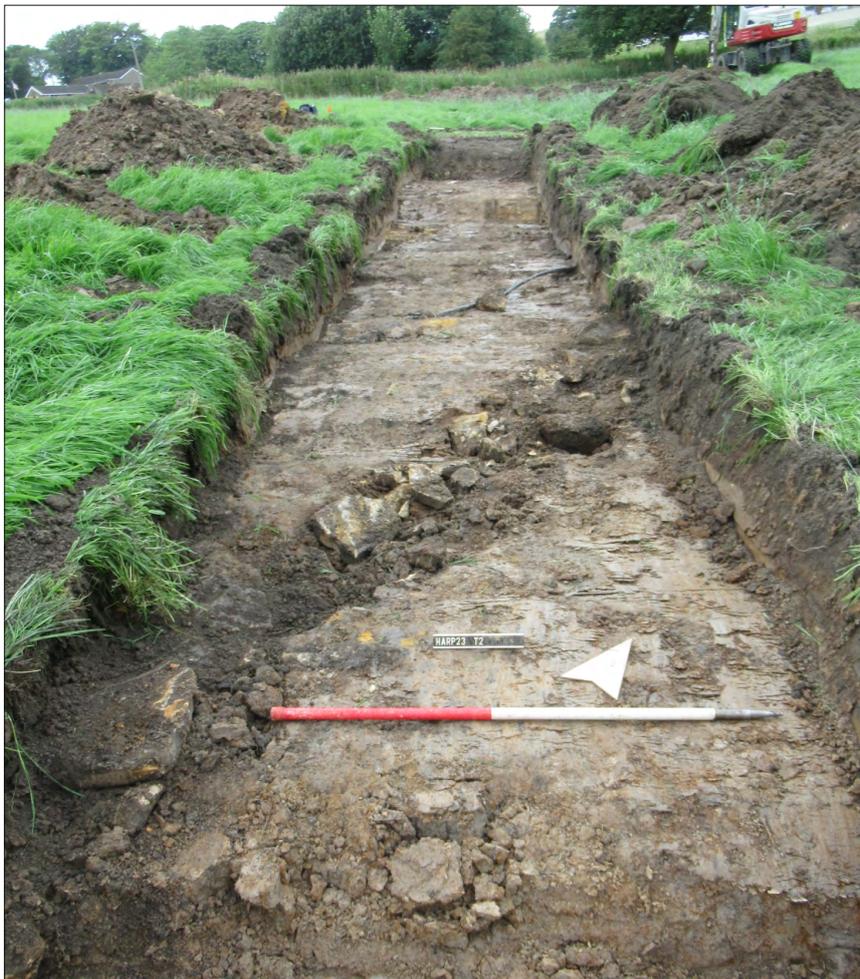
Plate 6

Trench 2: overview of culvert 206/106, looking north west

3.3.5 The southwards course of stone drain **106** was encountered again to the south of **204** and recorded in Trench 2 as **206**. Its structure was consistent with that recorded in Trench 1, however its upper slabs had been heavily disturbed and the cut infilled with topsoil, presumably as a result of modern farming (Plate 6).

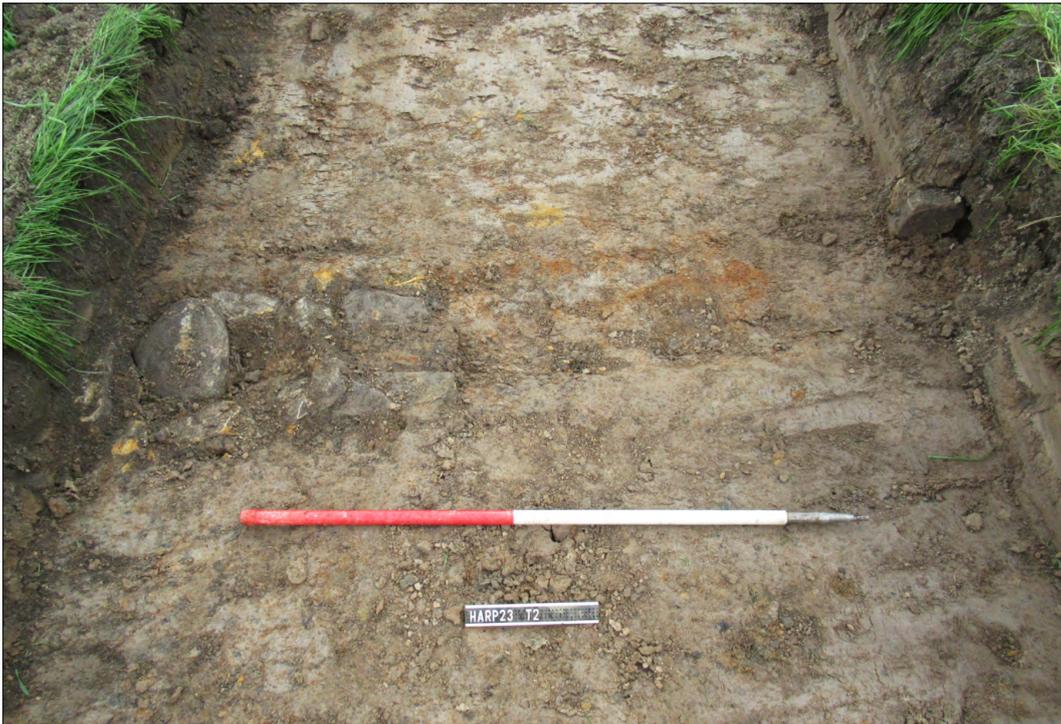
Plate 7

Trench 2: overview of drain 203

3.3.6 A shallow stone-lined drain (**203**), 0.5m wide, ran along a north-east to south-west alignment, towards the western edge of underlying palaeochannel **209**. This too had been heavily truncated, with only a single course of fragmentary stone surviving along its base (Plate 7).

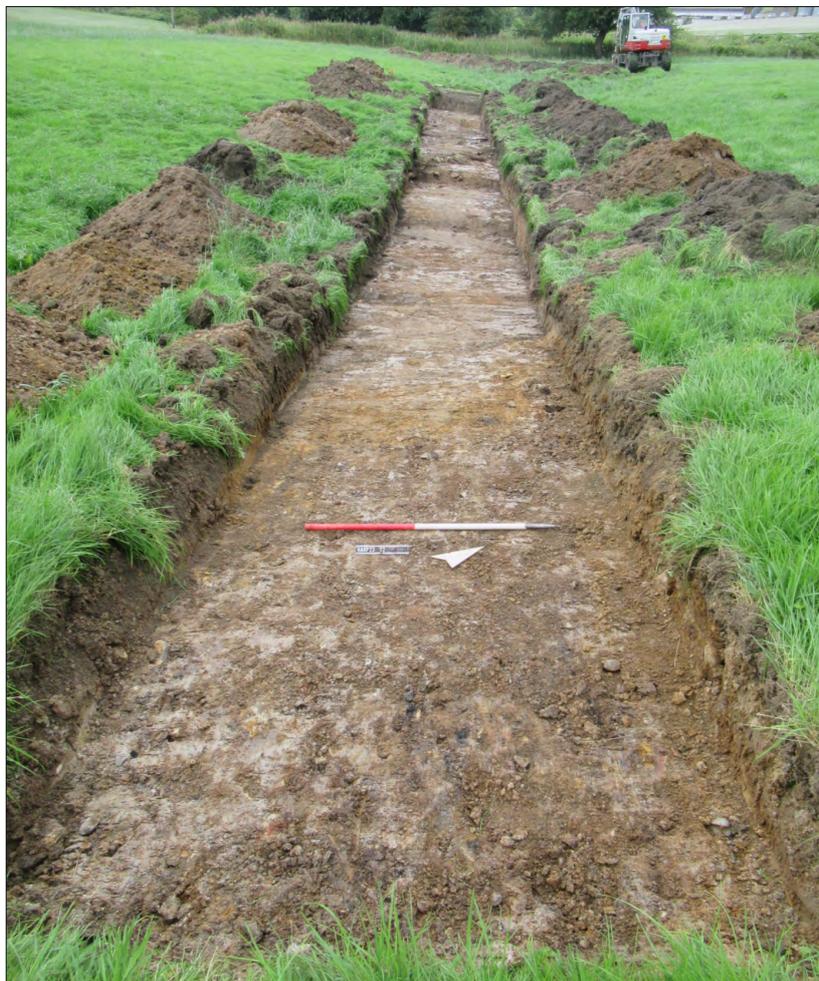
Plate 8

Trench 2: trench shot, looking north west, showing
deposit 201 in the foreground

3.3.7 At the south-eastern end of the trench, a 0.15m thick layer of redeposited orange clay (**201**) sat above the subsoil and potentially resulted from upcast of material from the excavation of quarry

pits, although no nearby examples are indicated on the geophysical survey (Plate 8).

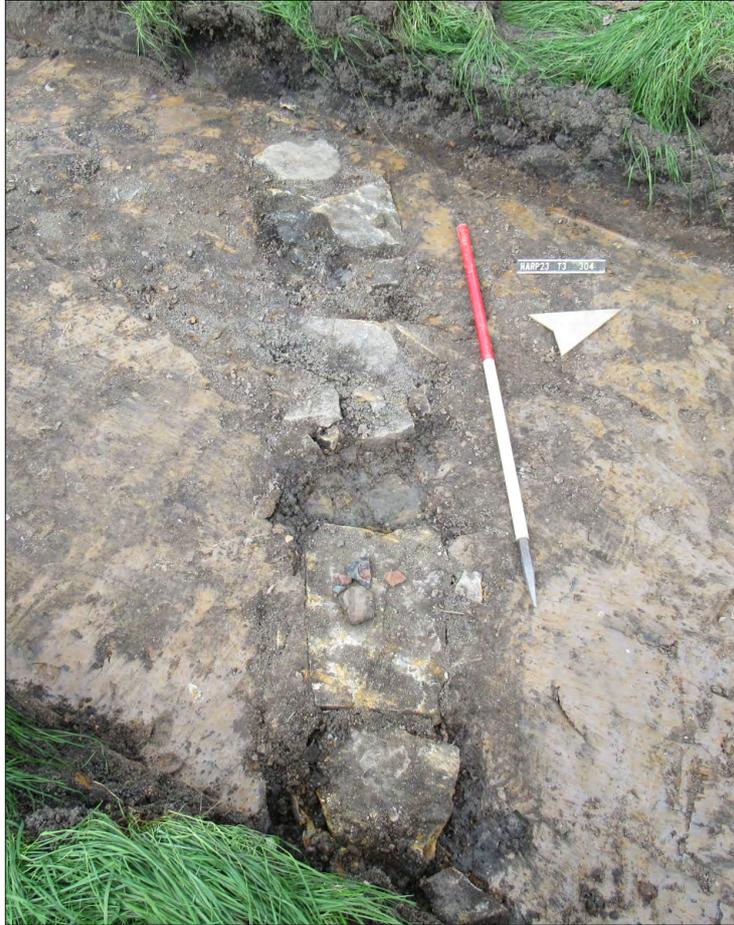
Plate 9

Trench 3: overview of stone-lined drain 304

3.4.3 The only feature encountered in the trench was a stone-lined drain (**304**), 0.5m wide and orientated east to west, which was constructed of a basal course of sandstone fragments topped with rough sandstone slabs (Plate 9). Fragments of nineteenth century pottery were recovered from drain **304**. The drain potentially corresponds to a weak linear anomaly identified in Area 5 of the geophysical survey (Magnitude 2020)

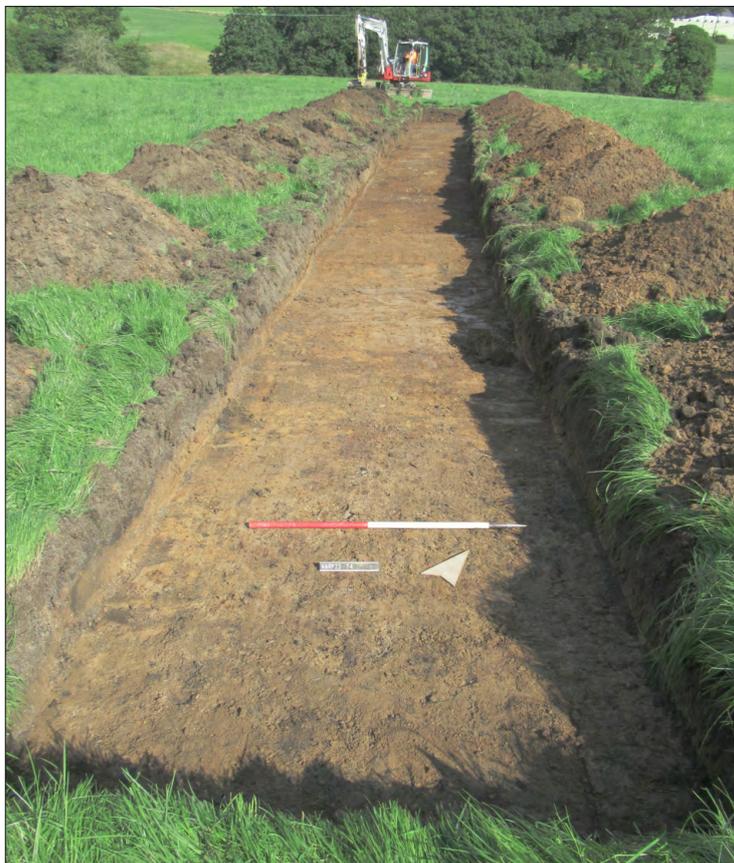
Plate 10

Trench 4: trench shot, looking north west

3.5.2 No archaeological features were identified in Trench 4. The natural geology (**402**) was an orange-brown shaley clay with patches of degraded coal (Plate 10). This was superseded by a 0.1m thick mottled orange and grey subsoil horizon (**301**) and 0.25m topsoil (**300**).

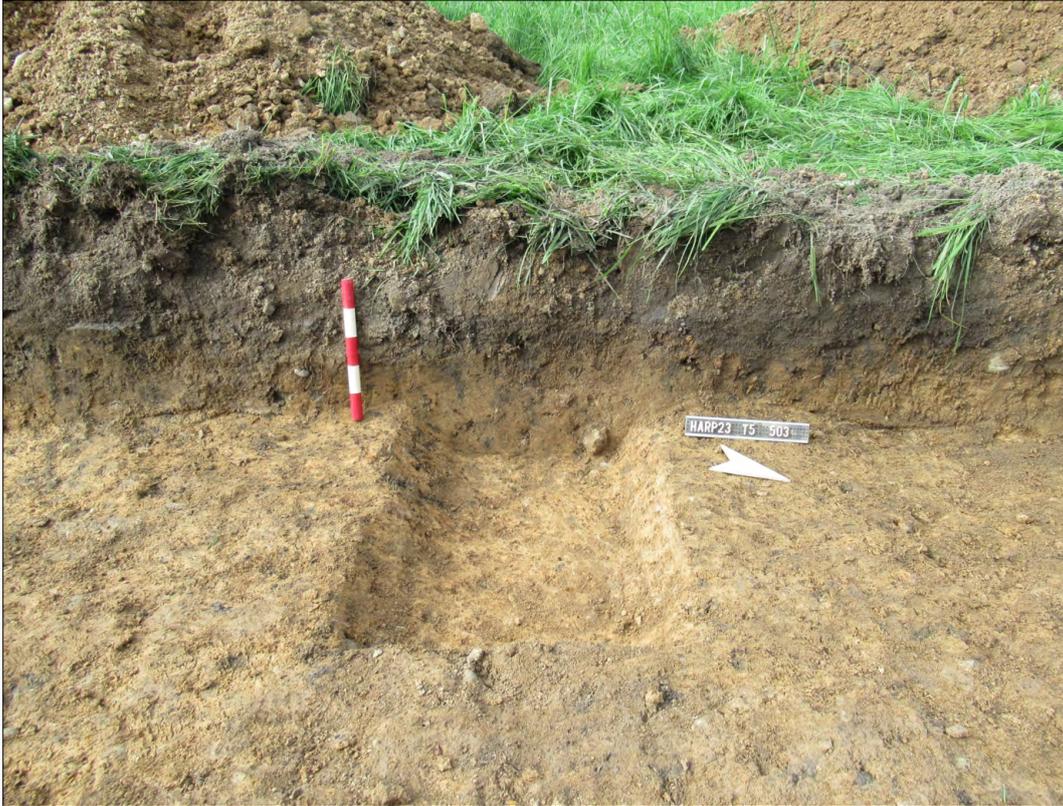
Plate 11

Trench 5: north facing section of gully 503

- 3.6.3 Seven metres from the western end of the trench was a 0.6m wide gully (**503**), running along a roughly north to south alignment (Plate 11). Gully **503** was 0.17m deep and had moderately steep sides and a flat base. It was filled by mid greyish-brown silty clay (**504**) with occasional small sub-rounded stones, but which contained no finds or environmental evidence.

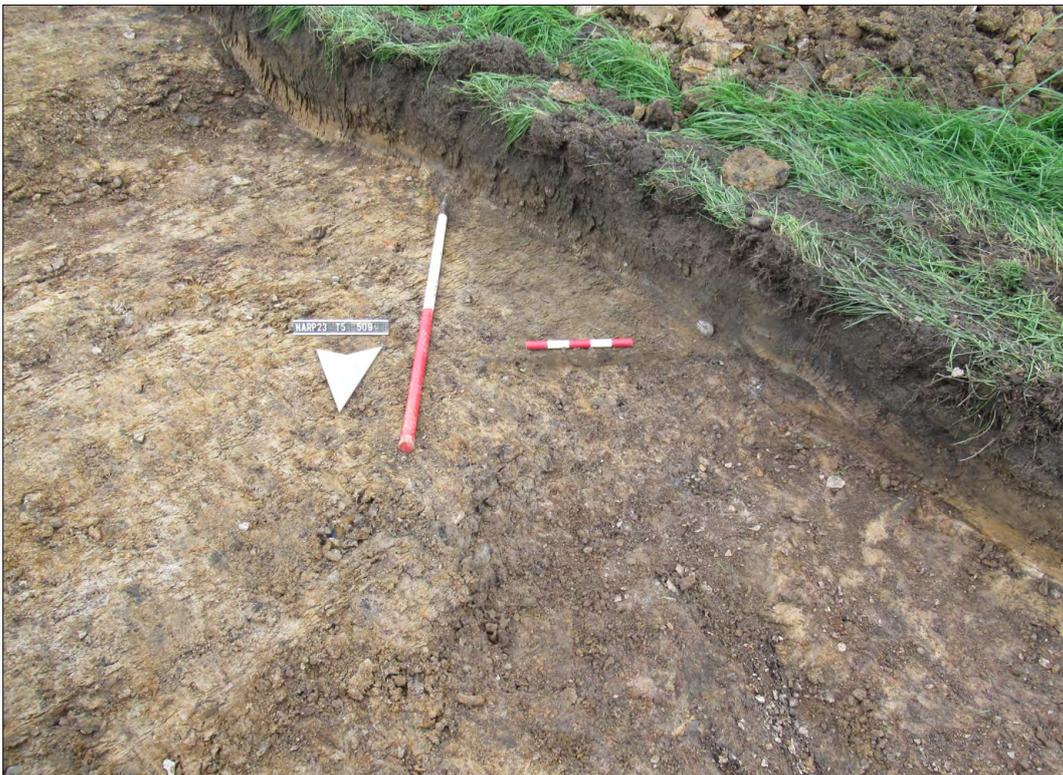
Plate 12

Trench 5: truncated gully terminus 509

- 3.6.4 The terminus of a second gully (**509**) was recorded c.9m from the eastern end of the trench (Plate 12). It was orientated north-west to south-east and measured 0.5m wide but only 0.05m deep due to substantial truncation by modern farming. It was filled by a mid greyish-brown silty clay deposit that contained charcoal and occasional flecks of CBM (**510**). Due to the truncated nature of the feature, this deposit was unable to be sampled due to potential contamination.

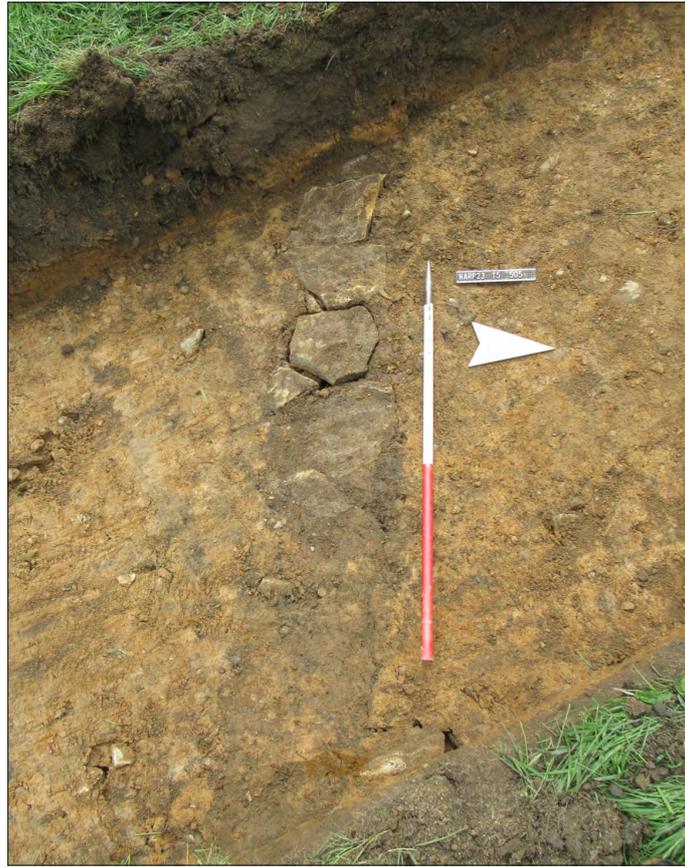
Plate 13

Trench 5: Overview of stone drain 505

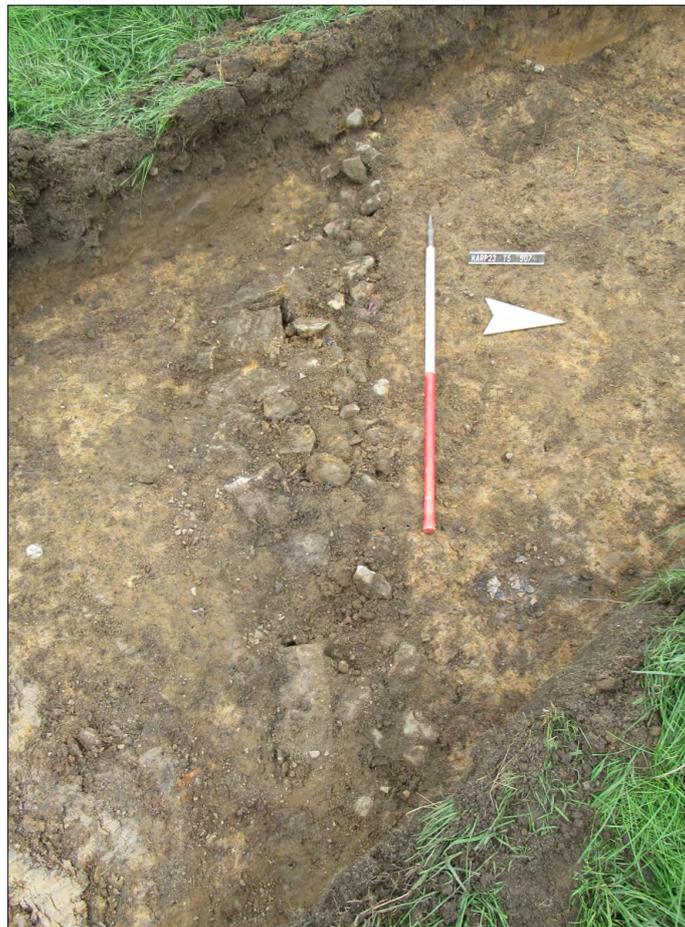
Plate 14

Trench 5: Overview of stone drain 507

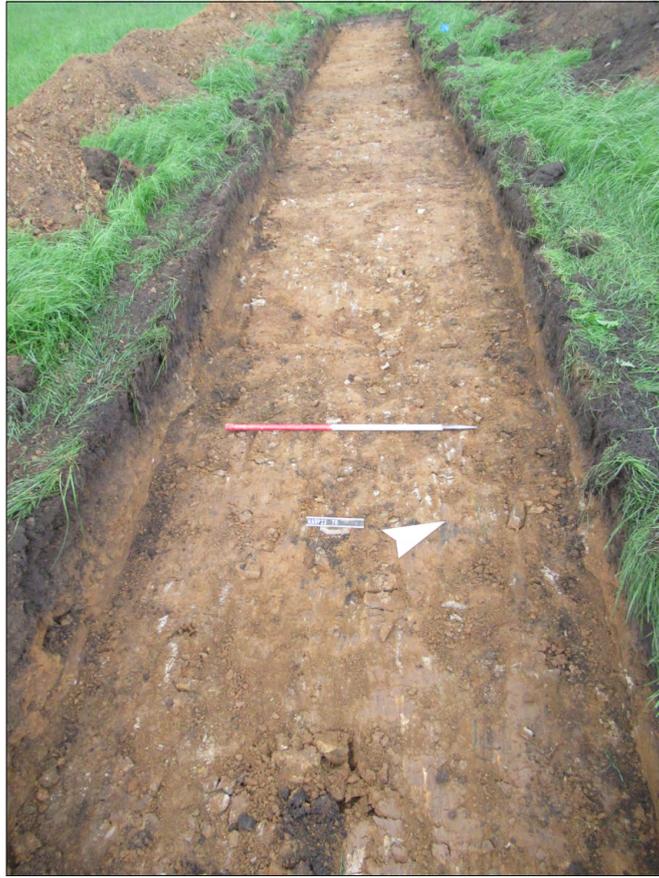
Plate 15

Trench 6: Trench shot, looking north west, showing furrows 604

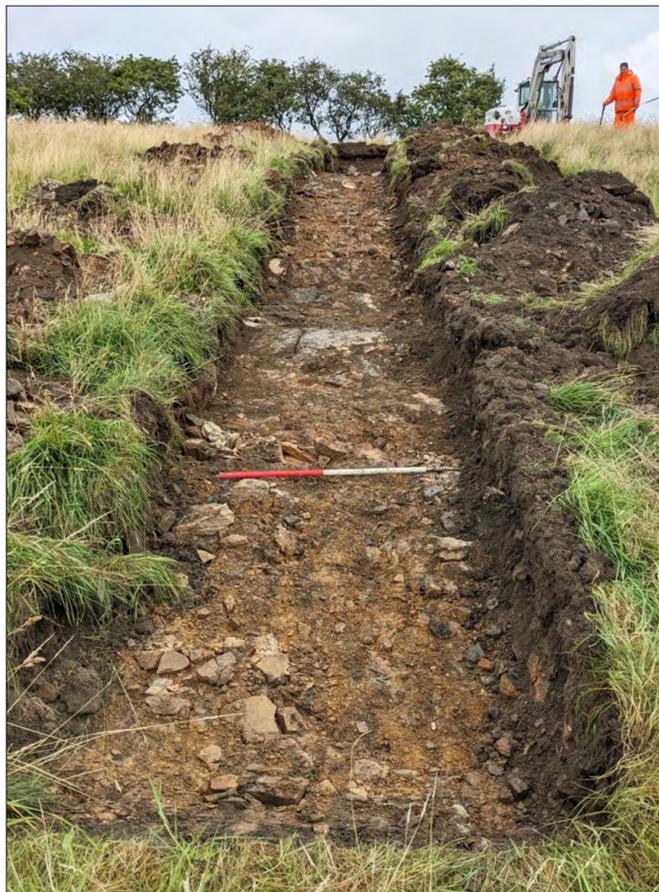
Plate 16

Trench 14: Trench shot, looking north east

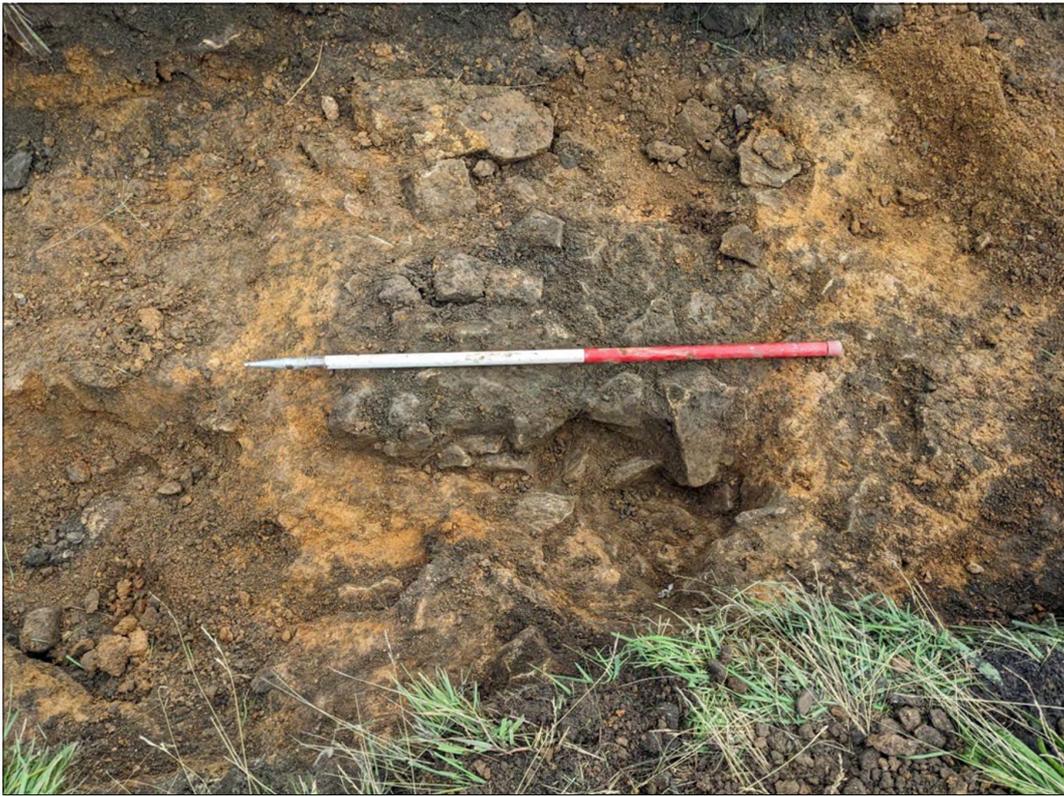
Trench 14: South east facing section of pit 1402
