# **The Minster Church of All Saints, Rotherham - Archaeological Test Pitting Report**

**Report Title:** The Minster Church of All Saints, Rotherham - Archaeological Test  
Pitting

**Version:** V1.0  
**Issue Date:** December 2023  
**Report Ref:** 21584

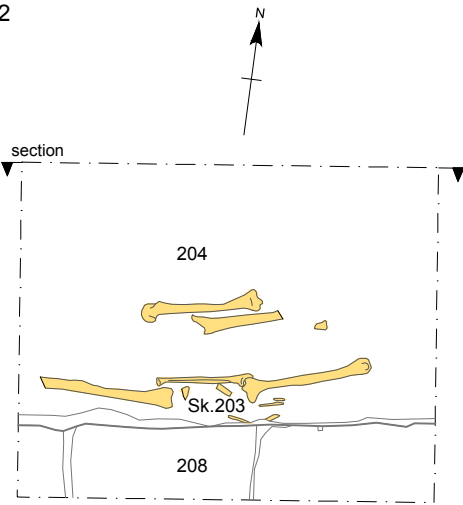
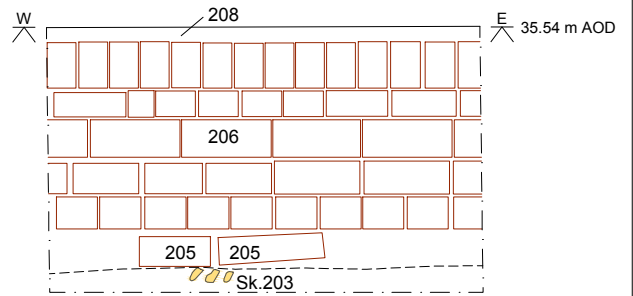
Figure 2

South facing section, Test Pit 2

Rotherham Minster: Test Pit 2 plan and section

4.2.1 Test pit 2 was located to the south of an area of pews in the Nave (Figure 2; Plates 1 and 2). An area of 20th century flagstones was removed (208) and 19th-century levelling deposits (201) associated with the raising of the existing floor excavated to a depth of c. 0.55 m below floor level (34.99 m aOD).

4.2.2 A grave cut (202) was revealed at the base of the southern section and was filled with a mixed sandy soil (204) containing disarticulated human remains, which was excavated to a depth of 34.66 m aOD. The ribs, right femur, and right humerus and ulna of an east west aligned inhumation (203) were exposed and overlain by an assumed ledger stone or stone flooring (205) of the pre-19th century Minster floor. There was no evidence of coffin fittings.

4.2.3 A brick wall (206) of the 19th-century heating system was constructed over the assumed ledger stone. Disarticulated human bones were revealed to the north of the grave and it is assumed that at least one additional inhumation lies at a deeper level.

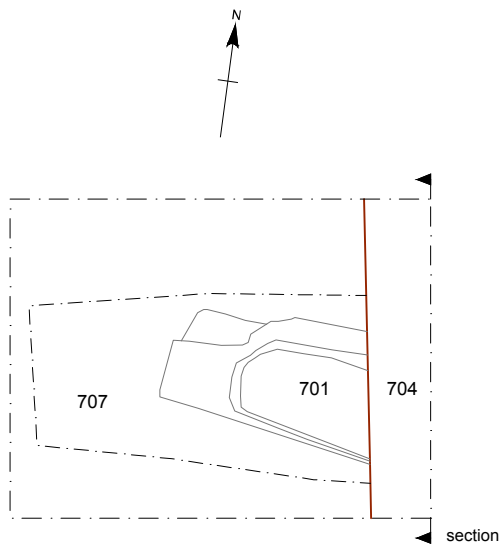
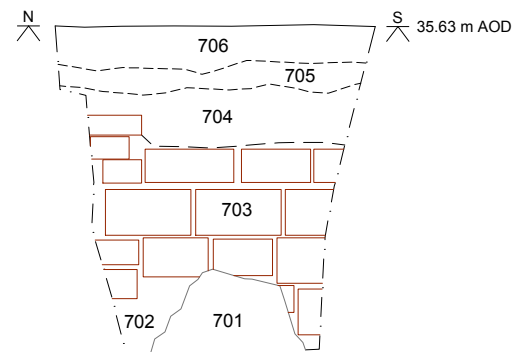
Figure 3

West facing section, Test Pit 7

Rotherham Minster: Test Pit 7 plan and section

4.3.1 Test pit 7 was located in a changing room in the North Transept and measured 1.1 m by 0.8 m (Figure 3; Plate 3). A ledger stone (706) formed the existing flooring and, once removed, the test pit was excavated through rubble levelling deposit (704) to a depth of 0.85 m (34.78 m aOD). Excavation ceased when possible sandstone bedrock was reached (707). A sandstone wall foundation (701) was constructed on 707, the upper part of which lay at 54.3 m aOD. A section of 19th century brick wall and voids limited excavation to the east and west.

4.3.2 The assumed bedrock was overlain by wall 701, which was east west aligned, two courses high and bonded with a lime mortar. No joins or bonding could be seen in stone 707 but if not bedrock, feasibly the stone represented the lower part of wall 701.

4.3.3 Wall 701 was at least c. 0.5 m wide and over 0.7 m long, with the upper stone being c. 0.3 m high.

The wall was heavily truncated and assumed rubble in the southern section of the test pit could have represented continuation to the south and considerably wider wall. The wall may have formed part of the northern wall of the North Transept of the Norman Church or an internal division.

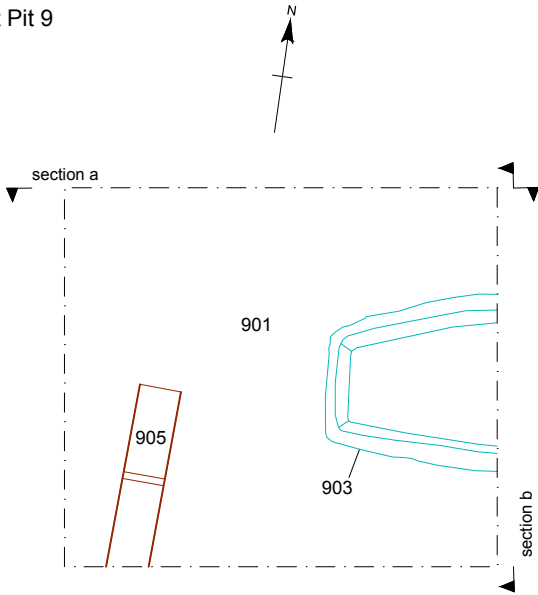
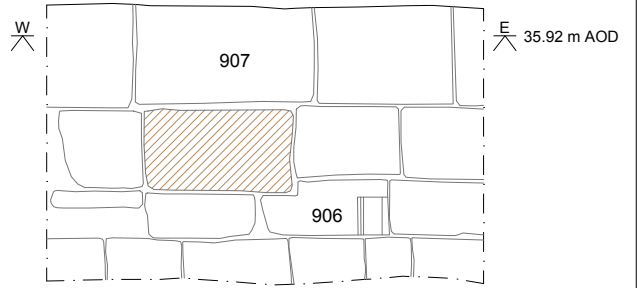
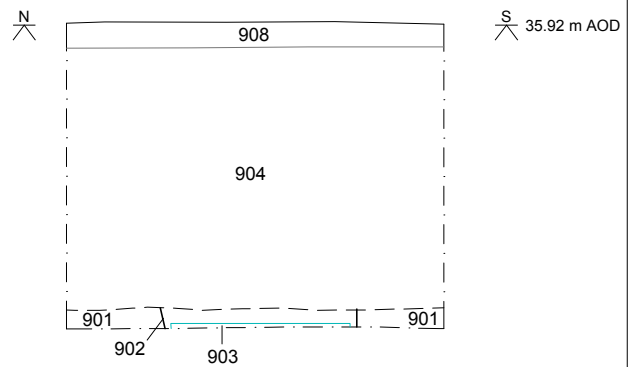
Figure 4

a. South facing section

b. West facing section

Rotherham Minster: Test Pit 9 plan and sections

- 4.4.1 Test pit 9 was located in the north chapel to the south of the northern wall (Figure 4; Plates 4). The test pit measured 1.28 m by 1 m and was excavated through rubbly levelling deposits (904) to a depth of 35.19 aOD (0.73 m below floor level).

- 4.4.2 The levelling deposits overlay a mixed assumed grave soil cut by grave cut (902) containing the western end of a lead coffin (903). The coffin was aligned east to west and at least 0.8 m wide. Its full extent could not be determined.

- 4.4.3 The lower levels of the north chapel wall were revealed (906) with painted plaster evident (Plate 5). The wall contained irregular sized stones with the upper section of wall (907) being more regular; wall 906 and was most likely the foundations for 907 and was partly constructed from reclaimed masonry, although an earlier phase of wall must be considered.

- 4.4.4 A 19th-century brick footing (905) was revealed to the west of the grave and was of an uncertain function. The wall was a single skin and two courses high.

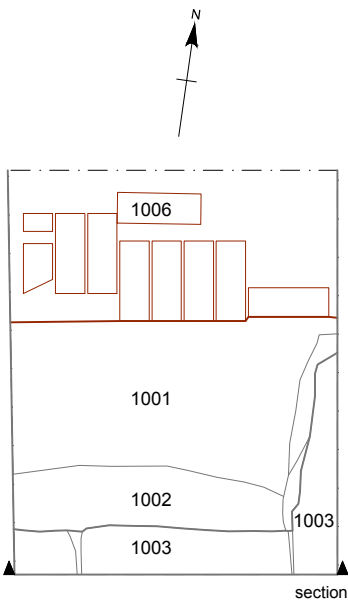
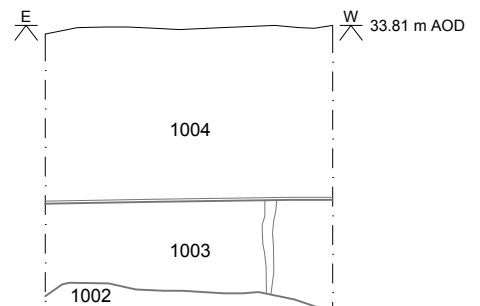
Figure 5

North facing section

Rotherham Minster: Test Pit 10 plan and section

- 4.5.1 Test pit 10 was excavated against the external north chapel wall and measured 0.84 m by 0.8 m (Figure 5; Plate 6). Following the removal of a section of concrete path, excavation was carried out to a depth of c. 0.75 m below ground level (33.06 m aOD).
- 4.5.2 The foundations of the Minster's northern wall were seen to step out at c. 33.36 m aOD (1003) and again at the base of the test pit (1002). The foundations were trench built through natural reddy sandy clay (1001) and their full depth could not be ascertained. The north wall of the Minster (1004) was of a similar construction.

- 
- 4.5.3 A brick wall (1006) was revealed on the northern edge of the test pit and may be associated with a structure pre-dating the adjacent toilet block. The bricks were laid on a crude concrete foundation and were two courses high in a header bond.
- 4.5.4 The north wall and later structure were abutted and overlain by a mixed graveyard soil (1005) containing 19th century pottery, animal bone, clay pipe stems and disarticulated human remains. An MNI of two individuals was calculated.

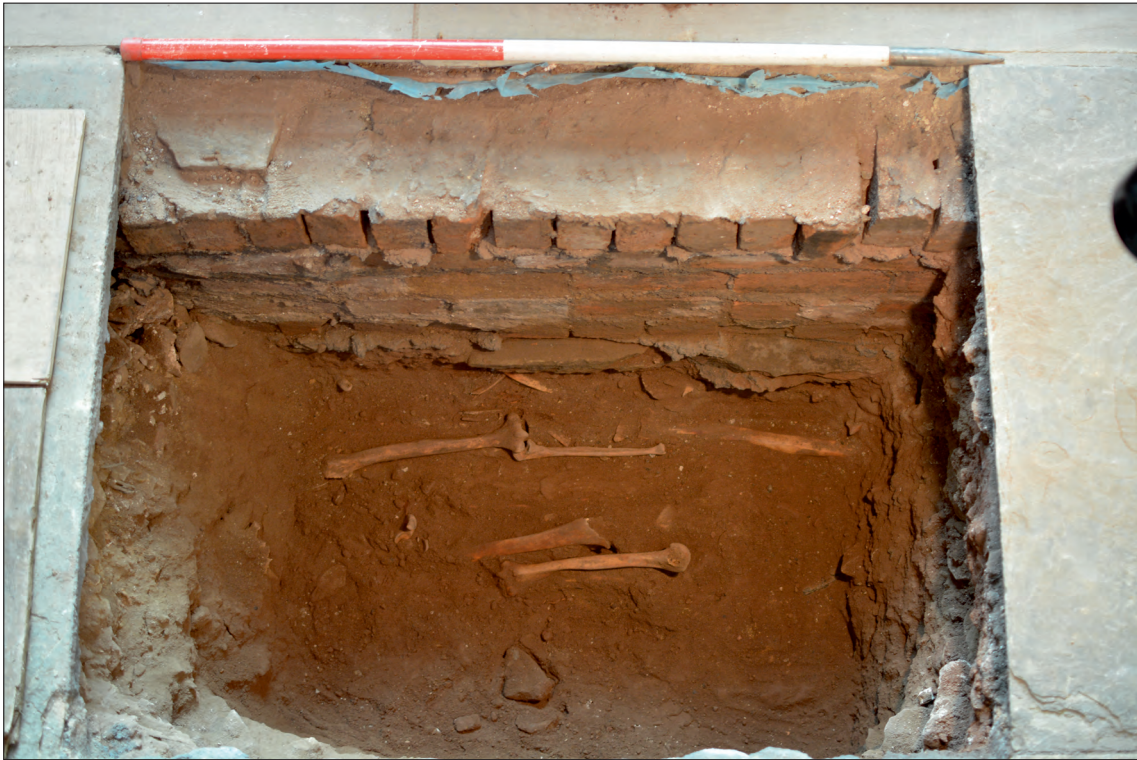
Plate 1

Test Pit 2 looking south

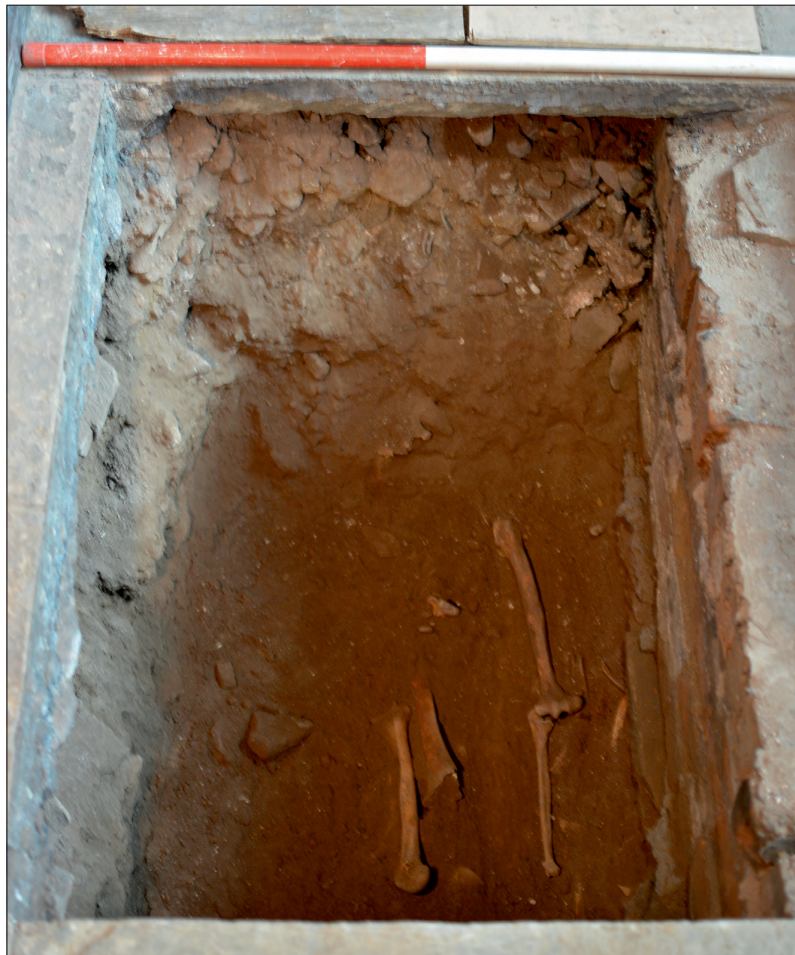
Plate 2

Test Pit 2 looking east

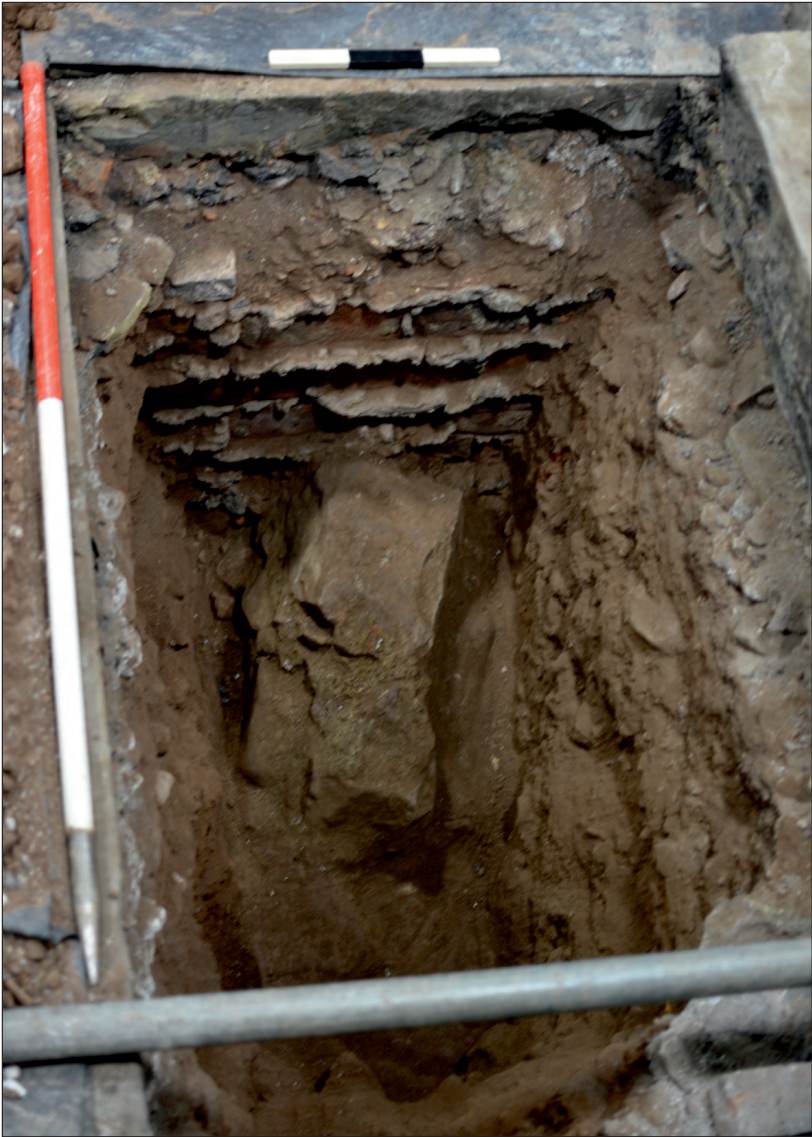
Plate 3

Test Pit 7 looking east

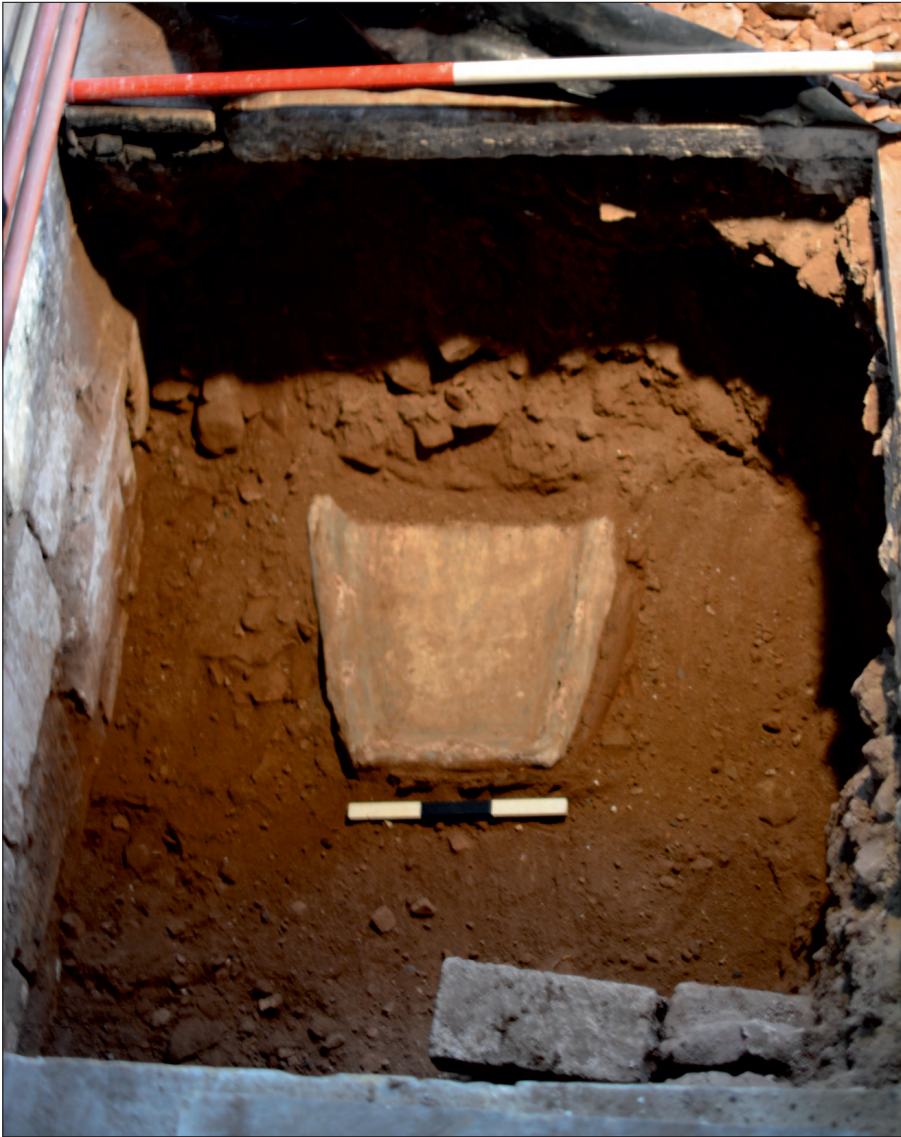
Plate 4

Test Pit 9 looking east

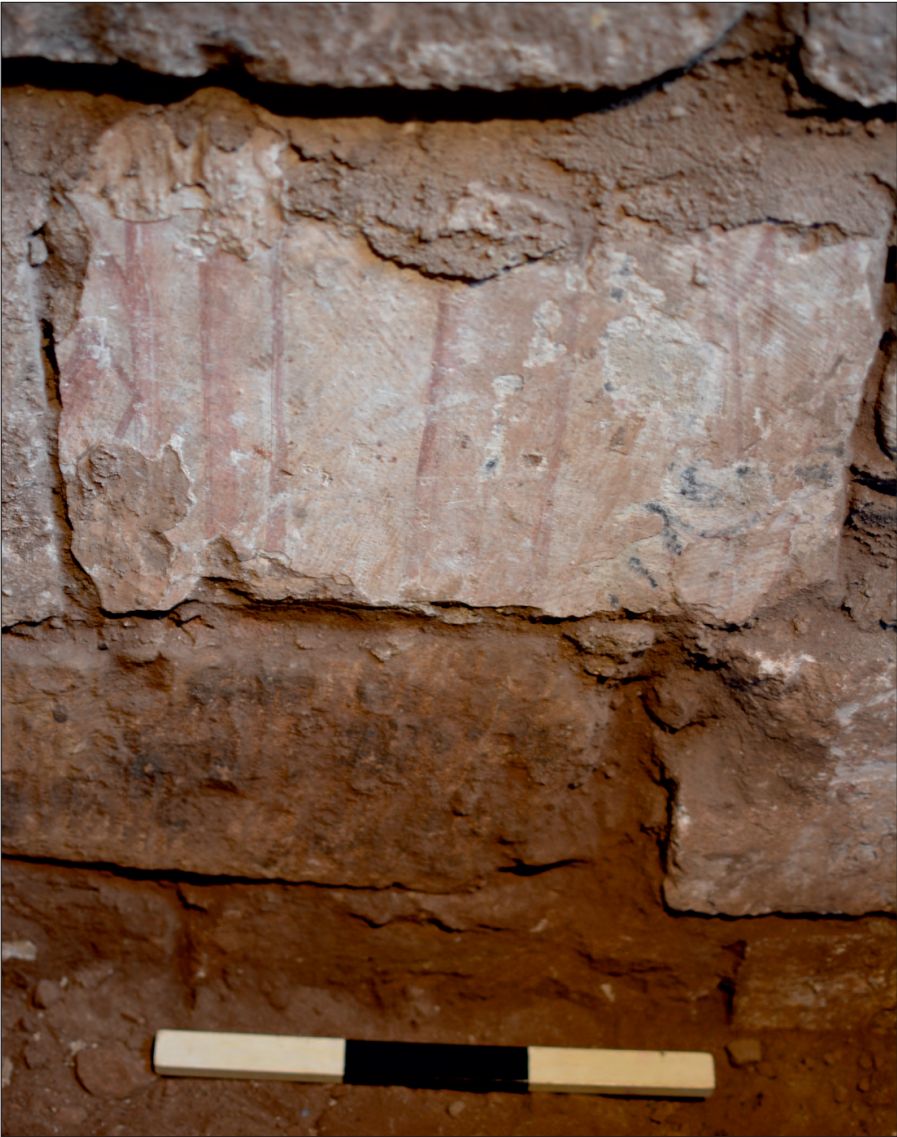
Plate 5

Test Pit 9 looking north

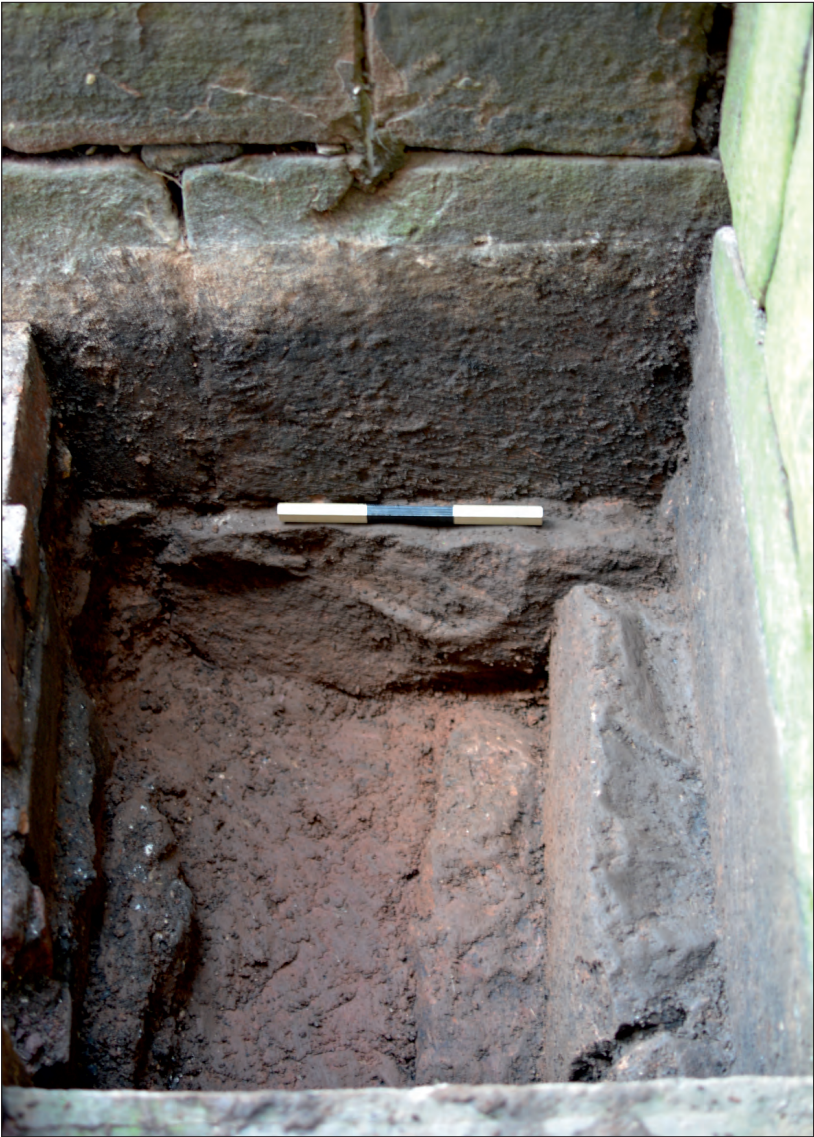
Plate 6

Test Pit 10 looking east

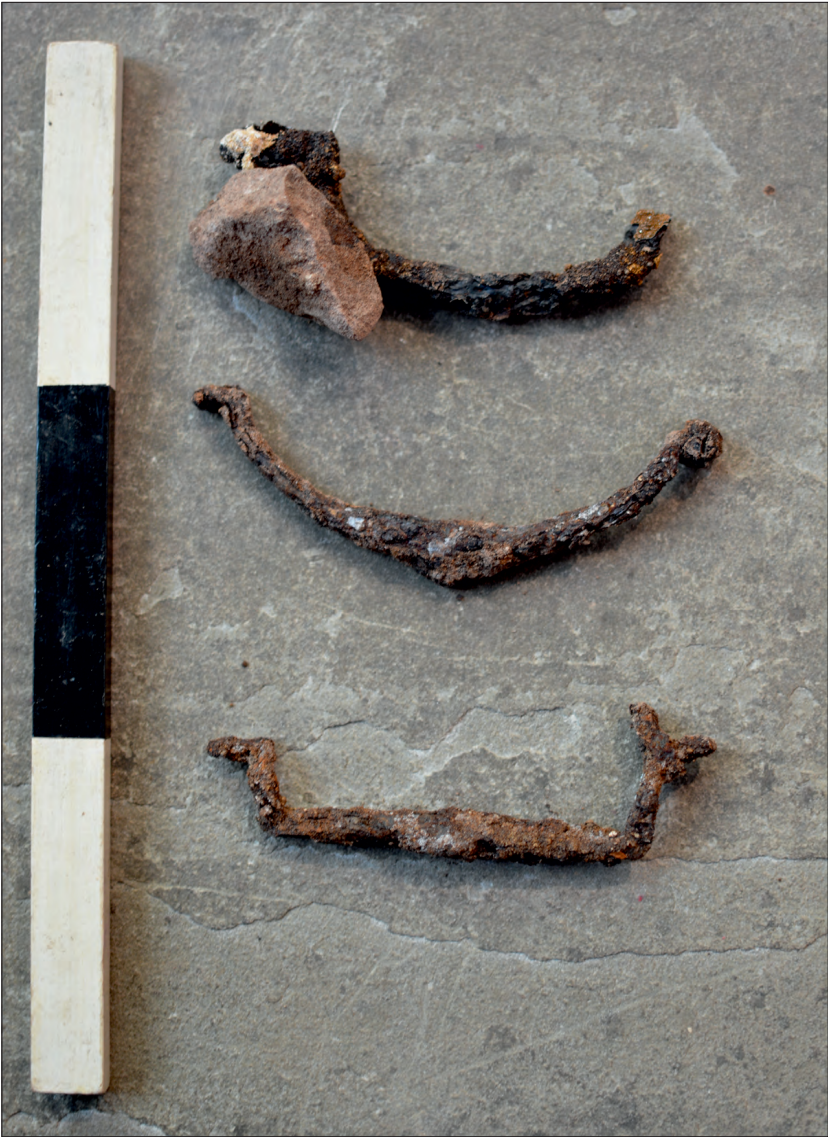
Plate 7

Coffin furniture

- 4.3.4 The levelling deposit (702) contained three iron coffin handles, fragments of iron decorative coffin furniture, iron nails, a clay pipe stem, and 19th century pottery. Redeposited human remains were also recovered including undiagnostic fragmented long bone shafts. A MNI of six individuals was calculated from two right adult femurs and four distinct sub-adult humerii.
- 4.3.5 Deposit 702 and wall 701 were truncated by a 19<sup>th</sup> century wall 703, that formed the western limits of a shaft containing electrical ducting.

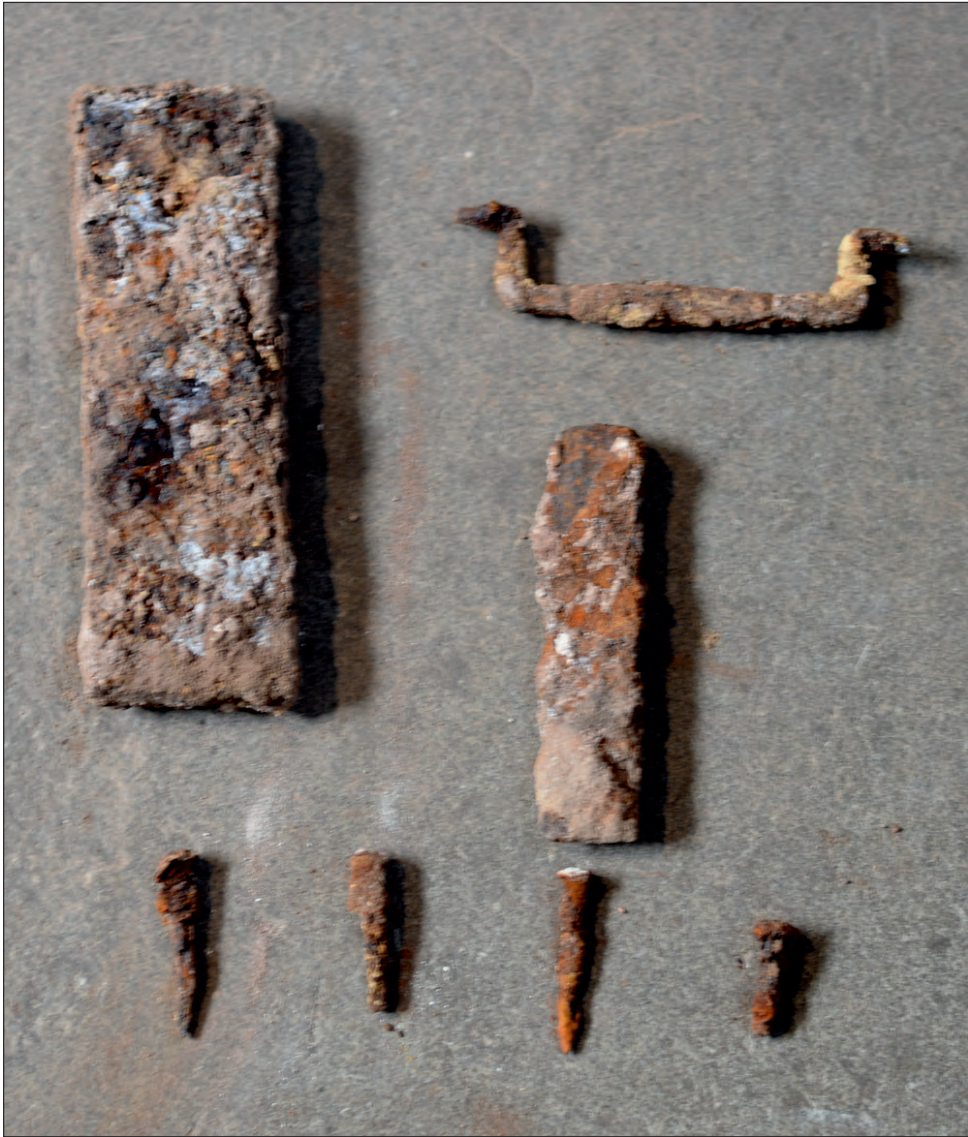
Plate 8

Coffin furniture

4.2.4 All deposits were overlain by the 19th rubble filled levelling deposit (201), which also contained wood fragments, nails and decorative iron fragments of coffin furniture, sherds of glass, 19th century pottery and a large number of disarticulated human remains, representing an MNI of two.
