HISTORIC SCOTLAND PROPERTIES IN CARE
MINOR ARCHAEOLOGICAL WORKS 2011

Burleigh Castle: Watching Brief, September 2011.

SITE: Burleigh Castle, Milnathort.

DESCRIPTION: Watching brief during the excavation of a single trench to take the footings of a new interpretation board.

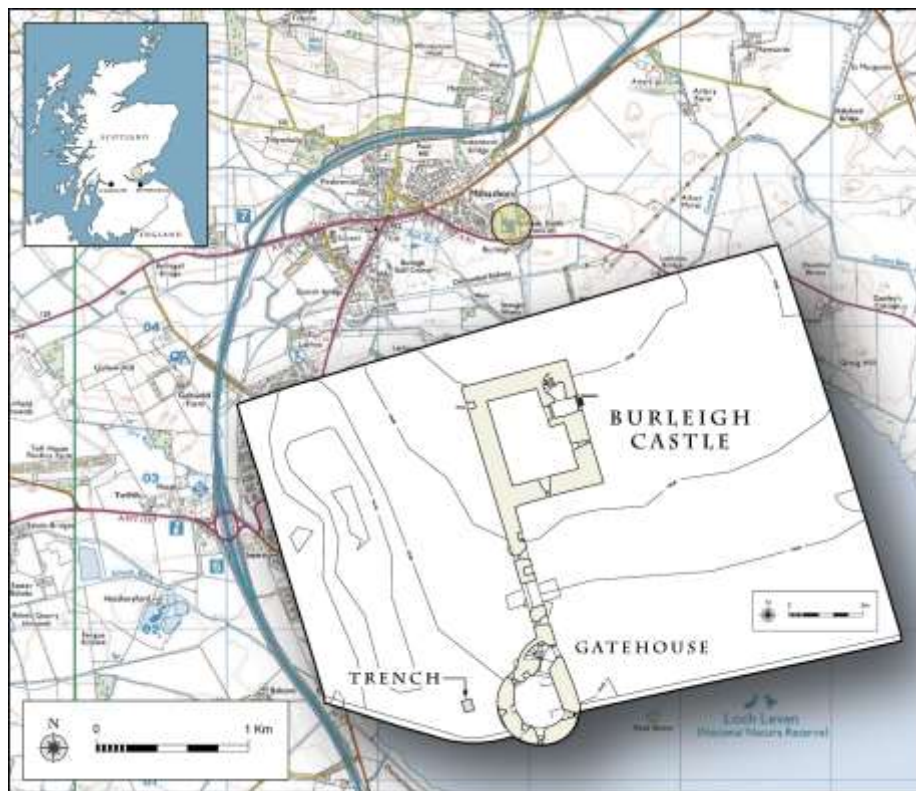
Figure 1: Plan showing the location of Burleigh Castle along with the area of the present works.
© Crown copyright. All rights reserved 2011. Licence number 100036933.

A trench measuring 1m (NW/ SE) x 0.6m (NE/SW) was excavated in an area W of the S end of the outer façade of the castle (Fig.1) and E of the assumed line of a possible ditch, which follows a roughly curving alignment W of the main façade, ultimately running off towards the S end of the S Tower.
