HISTORIC SCOTLAND PROPERTIES IN CARE
MINOR ARCHAEOLOGICAL WORKS 2011

Kelso Abbey: Excavation, June 2011.

SITE: Kelso Abbey, Kelso.

DESCRIPTION: Small-scale excavation ahead of the installation of new signage.

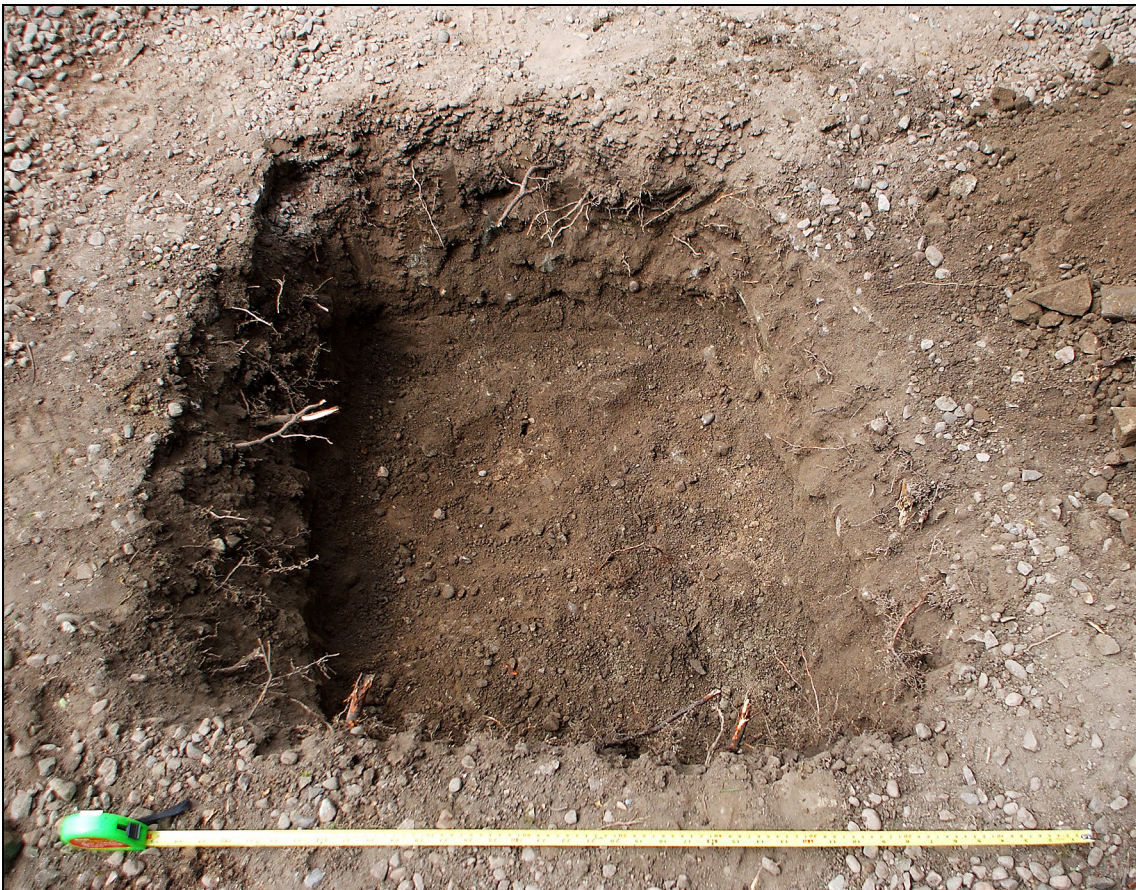
Figure 2: Post-excavation photograph of the trench (No.4, detail).

The trench was located 3.4m W of the S face of the W door, between two existing interpretation panels. The two existing panels were removed, and a new trench excavated, measuring 0.8m x 0.8m x 0.5m (LxWxD). The contents of the trench comprised **001**, elements of the modern concrete pad associated with the existing signage (0.1m thick), which lay over **002**, a dark silt and gravel layer containing early 20th century bottle glass (0.1m thick), which in turn lay over a compacted rubble deposit (**003**) that extended across the trench (0.15m thick), and which contained two fragments of worked stone (**SF001** and **SF002**). Context **003** sealed **004**, a heavily compacted silt deposit containing lots of mortar fragments. This was excavated to a thickness of 0.15m throughout the trench, before the required depth of the trench was reached (c.0.5m), and excavation ceased.

No.	Description	From	Date
01	Preparation and general location of Trench 1.	W	07/06/11
02	Site pre-excitation.	SW	07/06/11
03	General location showing West Door.	W	07/06/11
04	Trench 1 fully excavated.	W	07/06/11
05	Trench 1 fully excavated.	N	07/06/11
06	Trench 1 fully excavated.	S	07/06/11
07	Trench 1 fully excavated.	W	07/06/11
08	Interpretation board in place prior to backfilling.	E	07/06/11

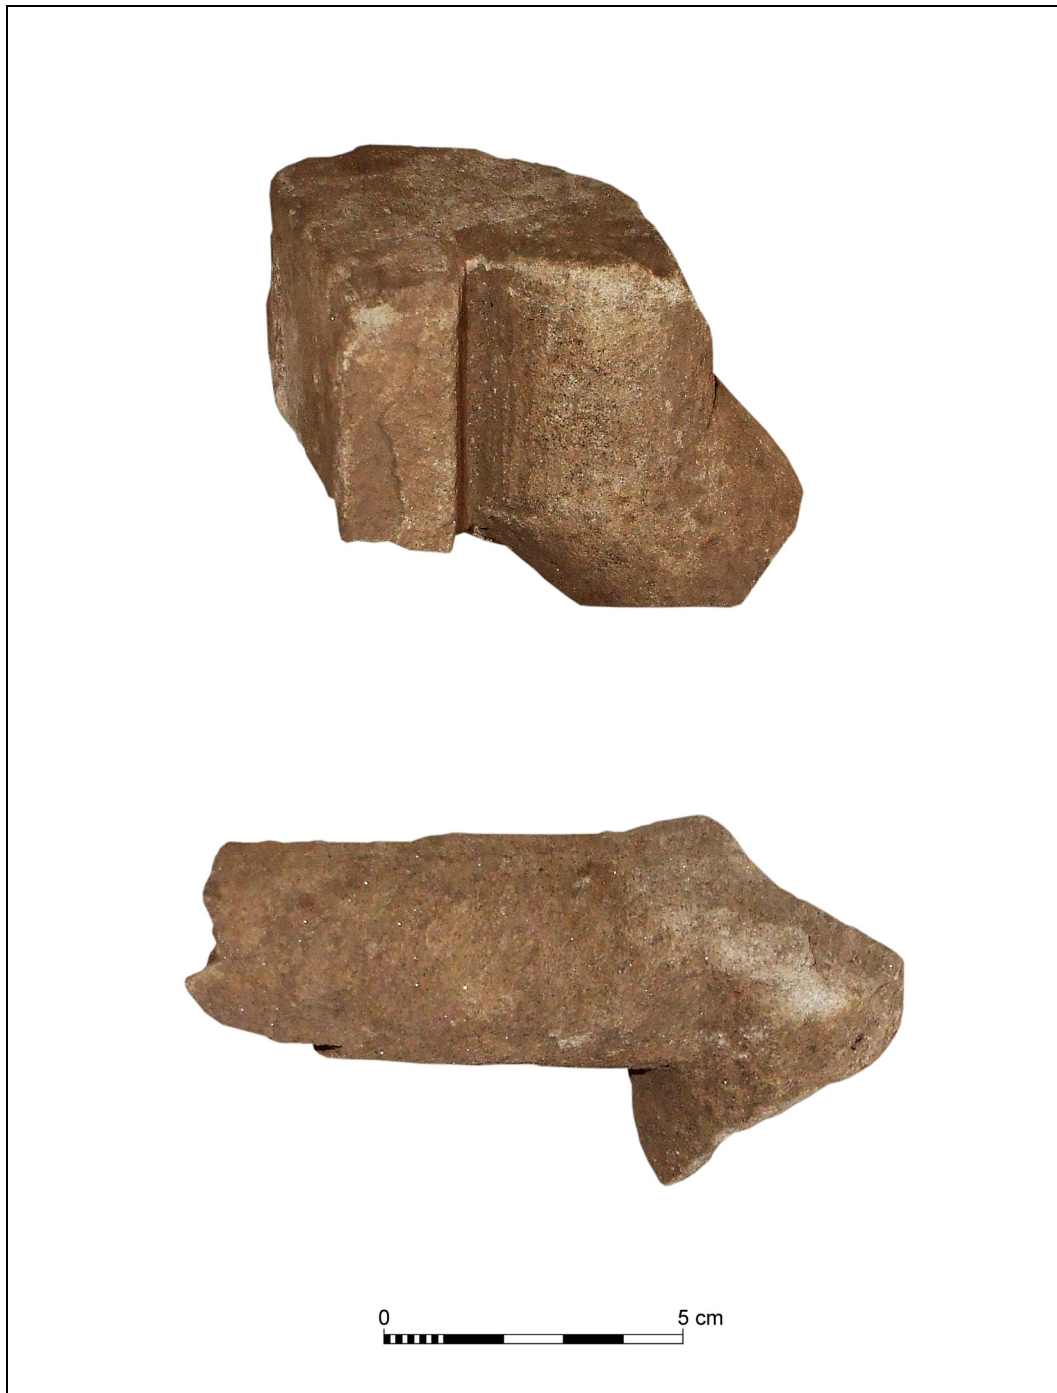
Figure 3: Small finds 001 (top) and 002, retrieved from context 003.

No.	Context	Description
001	003	Fragment of moulded stone measuring a maximum of 70mm (long) x 60mm (wide) x 60mm (thick). Small fragment of roll moulding – finely cut with slight evidence of diagonal tooling. A fine grey sandstone. Possible fragment of W doorway decoration.
002	003	Fragment of moulded stone measuring a maximum of 110mm (long) x 38mm (wide) x 40mm (thick). Detached fragment of roll moulding – almost complete circular section of possible mullion type decoration or 'projecting' design. Finely tooled and cut from a fine grey sandstone. Possible fragment of W doorway decoration.
