**Antonine Wall:
Rough Castle
Test Trenching
February 2011**

**HS PIC Index Number:
Project Code: HSCO-90013-2011-01**

**16th - 18th February 2011
Kirkdale Archaeology**

Site: Rough Castle, The Antonine Wall, near Bonnybridge.
N.G.R.: Centred c. NS 8431 7991
Project Description: Test trenching to characterise the nature of the Roman period ditch, prior to remedial drainage works.
Project Code: HSCO-90013-2011-01

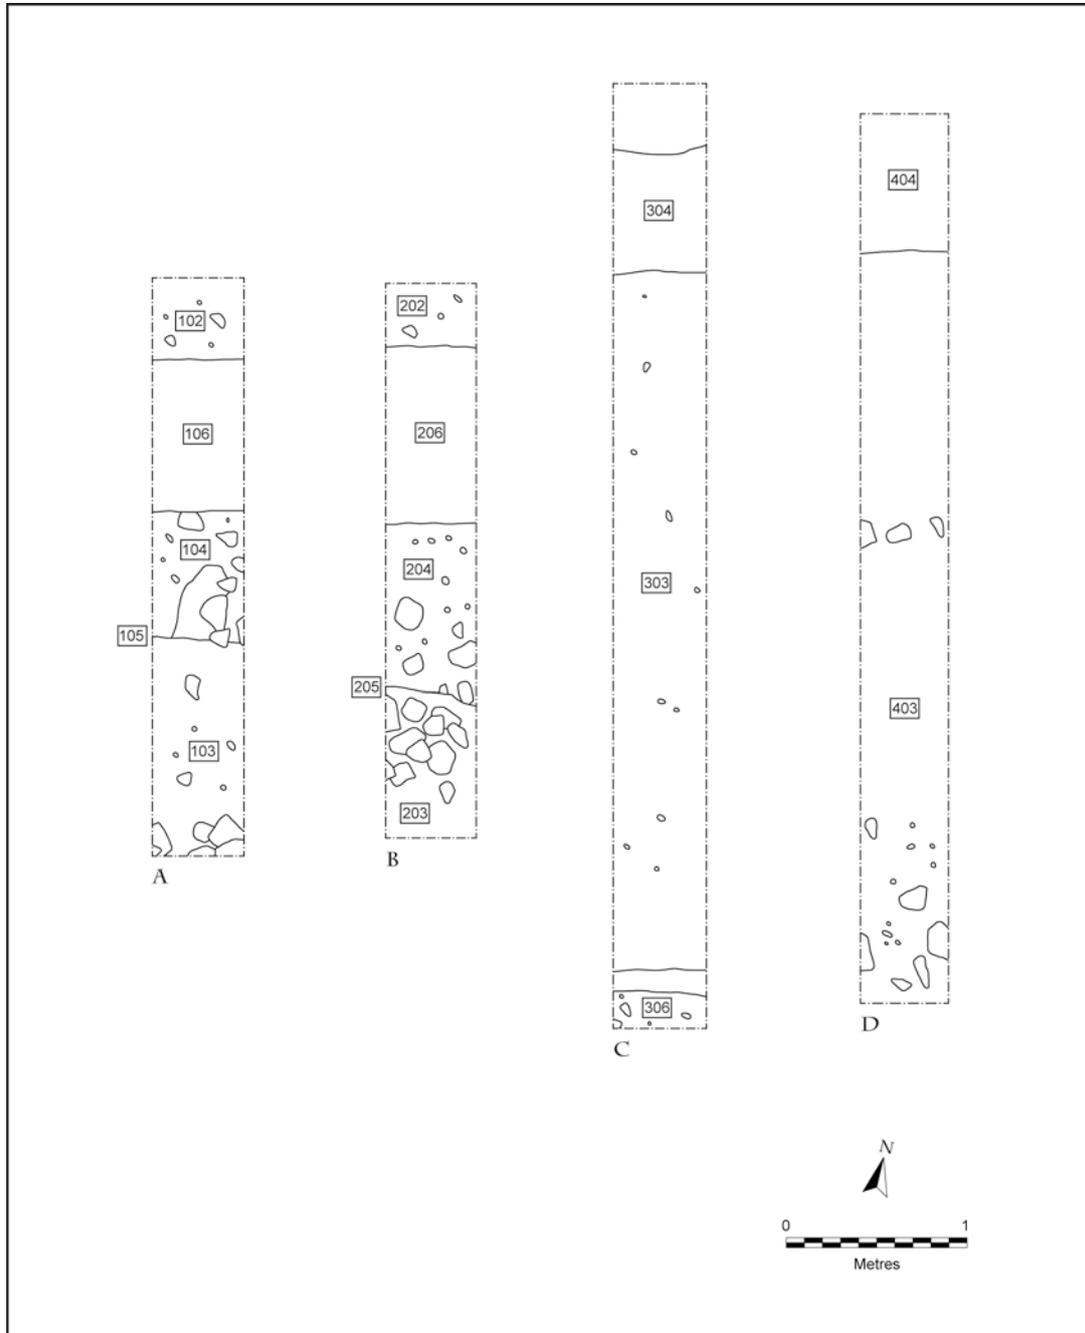
Figure 3: Post-excavation plans of Trench 1 (A), Trench 2 (B), Trench 3 (C) and Trench 4 (D).

Trench 1 (see Figures 3 and 4) was located in the central part of the W side of the ditch. In plan, the trench measured 3.24m N/S x 0.5m wide E/W. The maximum depth achieved was 0.4m due to persistent water inundation. The trench ran from the centre of the ditch up its sloping S bank. The fills consisted of a c. 80mm thick turf (101) flattening towards the ditch base, overlying a stoney mid-brown introduced topsoil (102), up to 200mm thick. In the S portion of the trench, below (102), the S ditch bank was exposed. This was a steeply sloping bank of compact yellow clay (103), the face of the original Roman ditch cut. This had been truncated to the N by (105), the original cut to install the drainage. The extent and shape of the cut were not exposed as it had been backfilled to the S by a re-deposited mixture of yellow clay, brown peat and sub-angular sandstone fragments (104). This layer constituted the material that was truncated during the 1960s works. The waterlogged nature of the

Trench 2 (see Figures 3 and 4) was located in the E portion of the W side of the ditch. In plan, the trench measured 3.10m N/S x 0.5m E/W. The maximum depth achieved was 350mm due to persistent water inundation. The trench ran from the centre of the ditch up its sloping S bank. The fills consisted of a c. 80mm thick layer of turf (201), flattening towards the ditch base, overlying a stony mid-brown introduced topsoil (202), up to 150mm thick. In the S portion of the trench, below (202), the S ditch bank was exposed. This was a steeply sloping bank of compact yellow clay (203), the face of the original Roman ditch cut. This had been truncated to the N by (205), the original cut to install the drainage. The extent and shape of the cut were again not exposed as it had been backfilled to the S by a re-deposited mixture of yellow clay, brown peat and sub-angular sandstone fragments (204). This layer, as in (104), constituted the material that was truncated and re-deposited during the 1960s drain installation. To the N of (204) was the S end of the fill covering the central drainage channel. This fill, (206), consisted of medium sized sub-rounded pebbles, generally less than 50mm in size, and was excavated (again accompanied by rapid bailing out

Trench 3 (see Figures 3 and 5) was located at the W end of the E side of the ditch. In plan, the trench measured 5.30m N/S x 0.5m E/W. This was the only trench where it remained dry enough to allow the exposure of the geo-textile membrane overlying the drainage channel. The trench ran from the centre of the ditch up the sloping S bank of the ditch. The fills consisted of a *c.* 60mm thick layer of turf (301) flattening towards the ditch base, overlying a stony mid-brown introduced topsoil (302), up to 200mm thick. In the S portion of the trench, below (302), the S ditch bank was exposed. This was a steeply sloping bank of compact yellow clay (306), the face of the original Roman ditch cut. This had been truncated to the N by (305), the original cut to install the drainage. The extent and shape of the cut were again not exposed as it had been backfilled to the S by a re-deposited mixture of yellow clay, brown peat and sub-angular sandstone fragments (303). This layer, as in (104), constituted the material that was truncated and re-deposited during the 1960s drain installation. It overlay a layer of medium sized sub-rounded pebbles (308), generally less than 50mm in size, although this layer was not exposed to its full depth. This was again part of the 1960s drainage works, probably a layer carrying water from the S bank to the central drainage channel. To the N of (303) was the S end of the fill covering the central drainage channel. This fill (304) consisted of medium sized sub-rounded pebbles, generally less than 50mm in size and was excavated until the geo-textile membrane (307) over the drainage channel was exposed, at a depth of 400mm from the ground surface.

Trench 4 (see Figures 3 and 5) was located in the central portion of the W end of the E side of the ditch. In plan, the trench measured 4.90m N/S x 0.5m E/W. The trench ran from the centre of the ditch up the sloping S bank of the ditch. The fills consisted of a layer of *c.* 70 mm thick turf (401) flattening towards the ditch base, overlying a stony mid-brown introduced topsoil (402), up to 350 mm thick. In the S portion of the trench, below (402) was a re-deposited mixture of yellow clay, brown peat and sub-

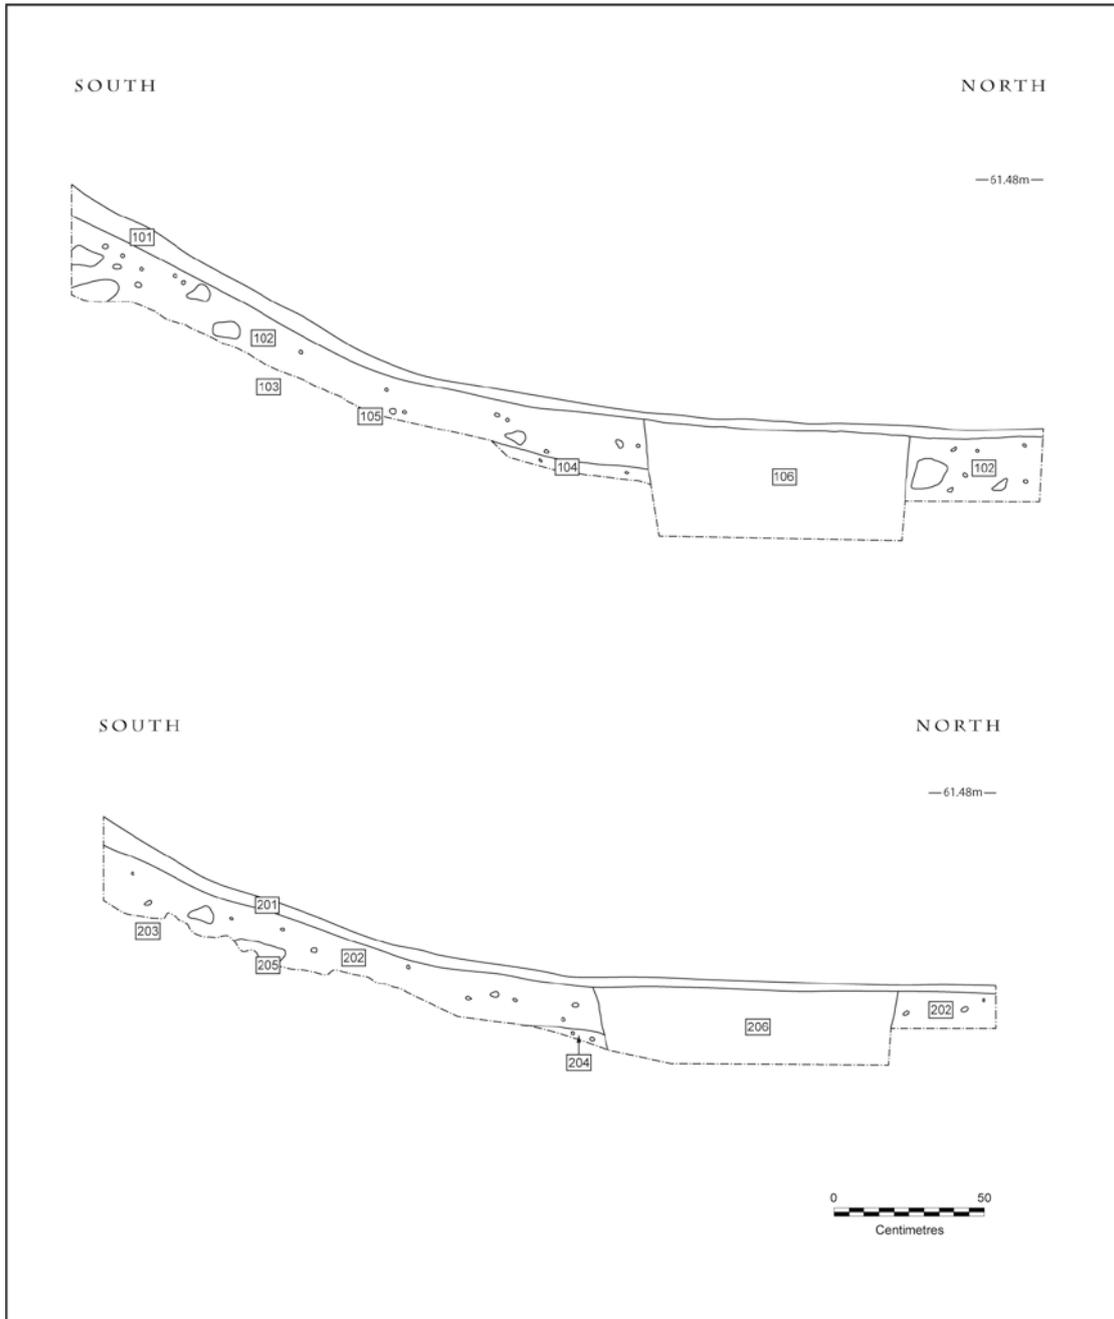
Figure 4: East-facing sections in Trench 1 (top), and Trench 2.

ditch base meant that over a long period of time peaty deposits would have formed and accrued over the V-shaped yellow clay base. The drainage infrastructure and flattening of the base meant the truncation of the S and N margins of the N and S ditch banks (respectively), as well as the excavation of the accumulated siltation deposits of the ditch base. It is this material (104) that was re-deposited as part of the ditch fill, possibly because its impervious nature would direct water to the central drainage channel. Within (104) was SF001 (see Figure 6), a rim sherd from a Samian Ware bowl. To the N of (104) was the S end of the fill covering the central drainage channel. This fill (106) consisted of medium sized sub-rounded pebbles, generally less than 50mm in size, and was excavated (accompanied by rapid bailing out of the trench) to a depth of 400mm without sign of the geo-textile membrane over the drainage channel. The trench had to be stopped at this level due to water inundation.

of the trench) to a depth of 350mm without sign of the geo-textile membrane over the drainage channel. The trench had to be stopped at this level due to water inundation.

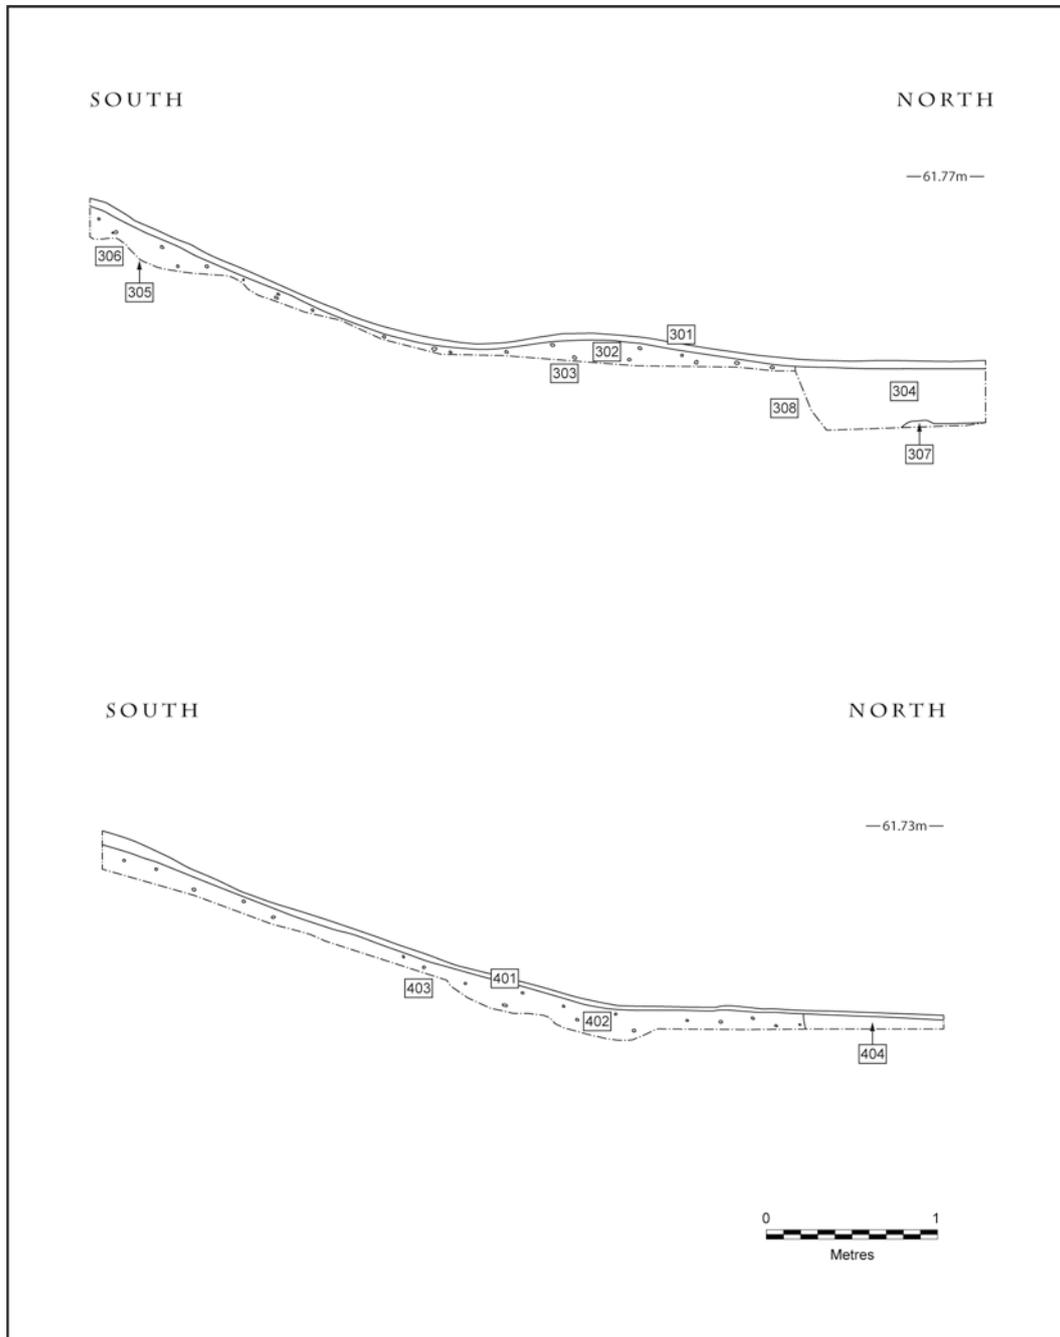
Figure 5: East-facing sections in Trench 3 (top) and Trench 4.

angular sandstone fragments (403). This layer, as in (104), constituted the material that was truncated and re-deposited during the 1960s drain installation. To the N was a layer of sub-rounded pebbles (404), generally less than 50mm in size, although this layer was not exposed to more than 100mm depth due to rapid and persistent

water inundation. Context (404) represented the central fill over the drainage channel.

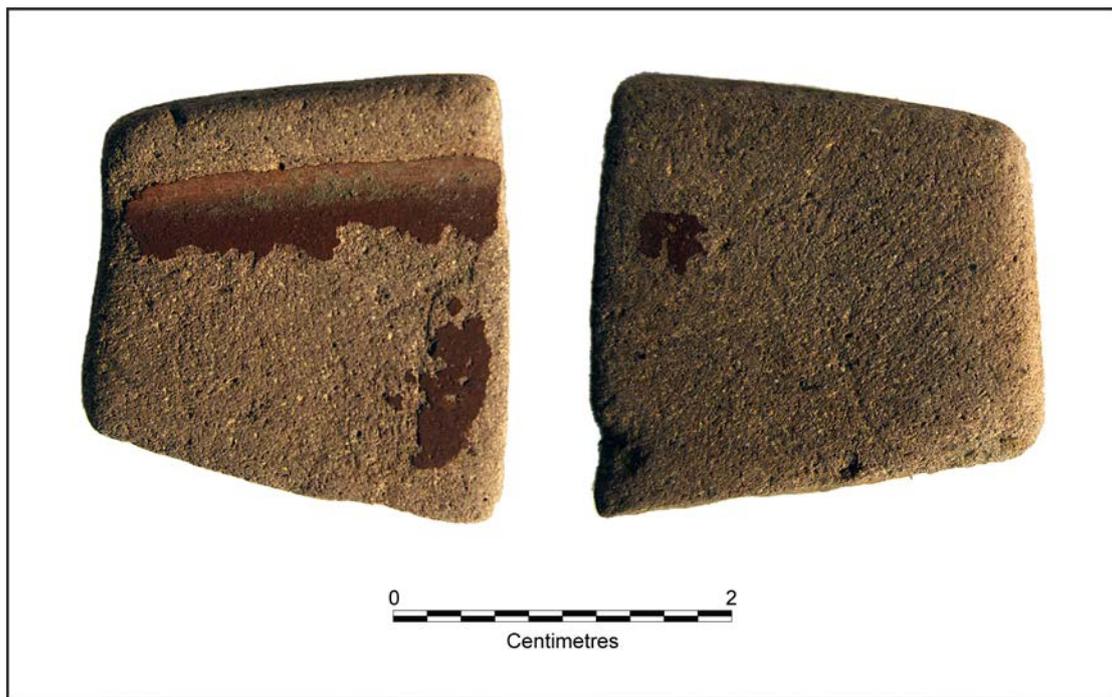
Figure 6: The piece of Samian Ware recovered from Trench 1.

No.	Description	Type
SF001	Rim sherd from a Samian Ware bowl.	Pottery
