**HISTORIC SCOTLAND PROPERTIES IN CARE  
MINOR ARCHAEOLOGICAL WORKS 2014/2015**

**Balvenie Castle • Monitoring • March 2014**

**SITE:** Balvenie Castle, Banffshire

**DESCRIPTION:** Watching Brief during the relocation of an existing information panel.

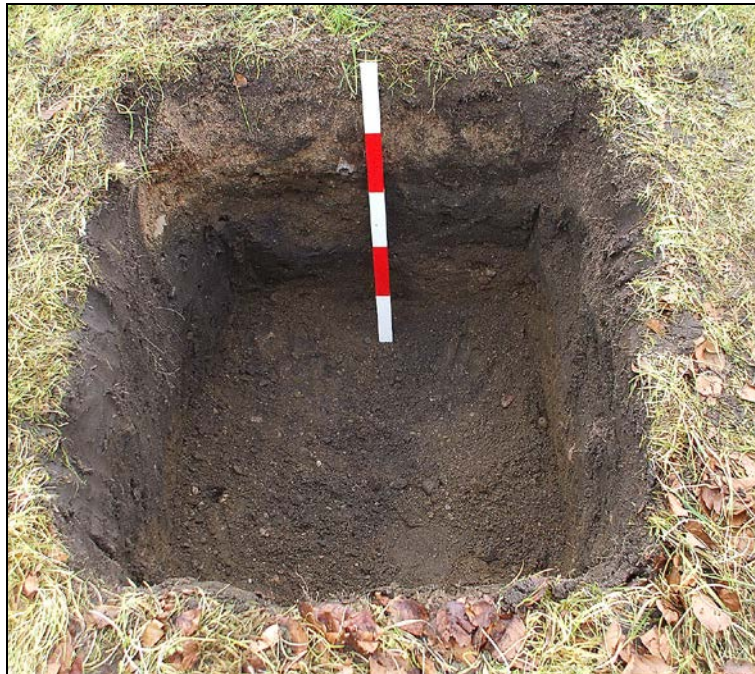
**Plate 1:** Post-excavation shot of the relocated trench.

The trench was marked out 90cm NW of the granite kerb on the NW side of the car park. The trench measured 60cm SW/NE x 60cm NW/SE and required a depth of 60cm in order to bed the base and legs of the sign. The turf **001** was 10cm thick and overlay two banded layers of modern landscaping.
