Historic Scotland
Properties in Care
Minor Archaeological Works 2007

Threave Castle: Archaeological Monitoring, May 2007

HS PIC Index number: 90301
Project code: HSCO-90301-2007-02

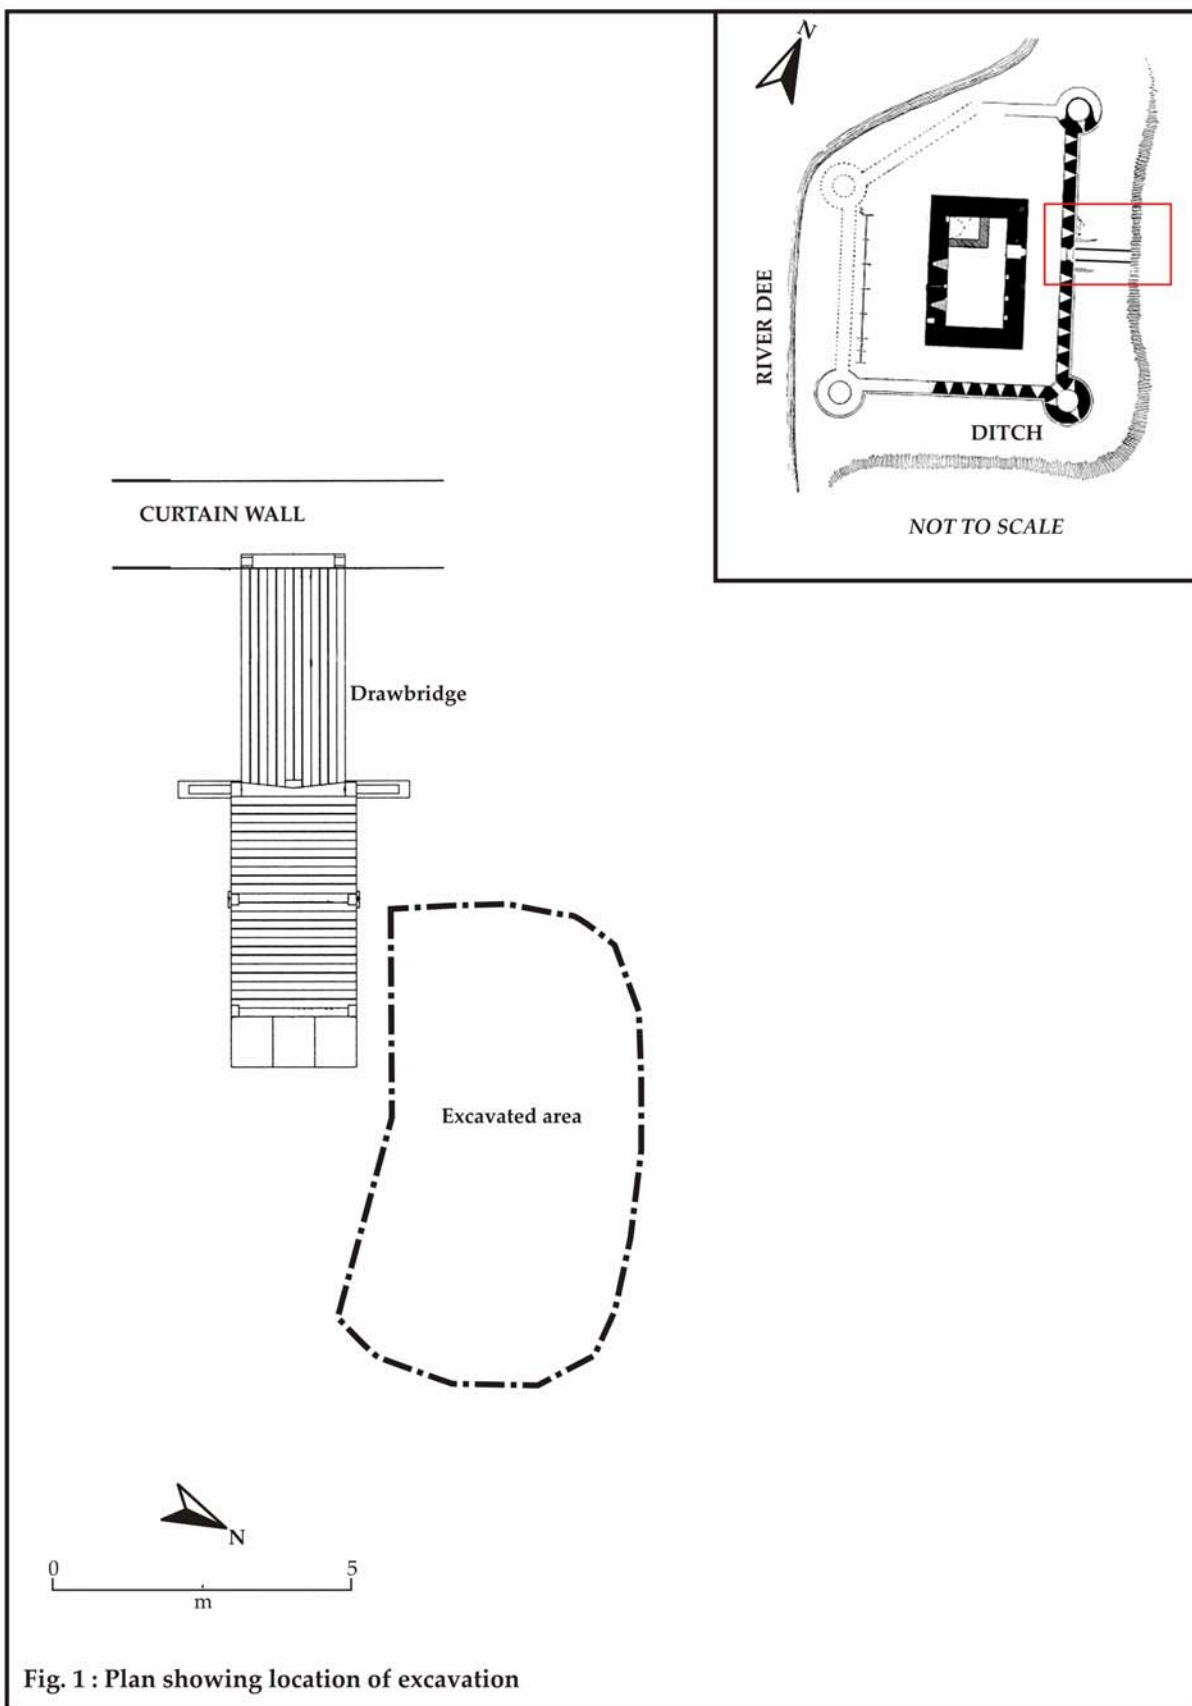
Fig. 1 : Plan showing location of excavation

The area of turf removed measured a maximum of 4.75 m N-S by 8.10 m E-W. A strip was dug by hand around the perimeter of the affected area, with the rest removed by mechanical turf cutter. The effect of this was that the hand dug strip tended to be dug deeper, generally 100 mm, but up to 150 mm, while the turf cutter rarely went below 50 mm deep.

Topsoil **F001** was mid brown fine silt containing occasional small stones. The only other deposit seen was to the NE, at the foot of the earthwork bank, where some larger stones, **F002**, were noted sloping down to the S. These were angular chunks of schist, up to 200 by 150 mm long. No artefacts were recovered.

Across almost the entire trench nothing below topsoil was seen. The only exception was in the NE corner, where the hand dug strip exposed the top of stones **F002**. These may represent tumble from the outer defensive earthwork.
