**Seton Collegiate Church:
Archaeological Monitoring,
February 2007**

HS PIC Index number: 90275
Project code: HSCO-90275-2007-01

<u>Site</u>	Seton Collegiate Church
<u>N.G.R</u>	NT 418 751
<u>Project Description</u>	Archaeological monitoring
<u>Project code</u>	HSCO-90275-2007-01

SUMMARY: A watching brief was maintained during the excavation of drains running from the north end of the west elevation of Seton Collegiate Church. These were needed to connect new guttering and drainpipes to an existing surface water drain. One of the two trenches partially uncovered the burial remains of two adults and one child. The date of these remains was uncertain and they were left in situ.

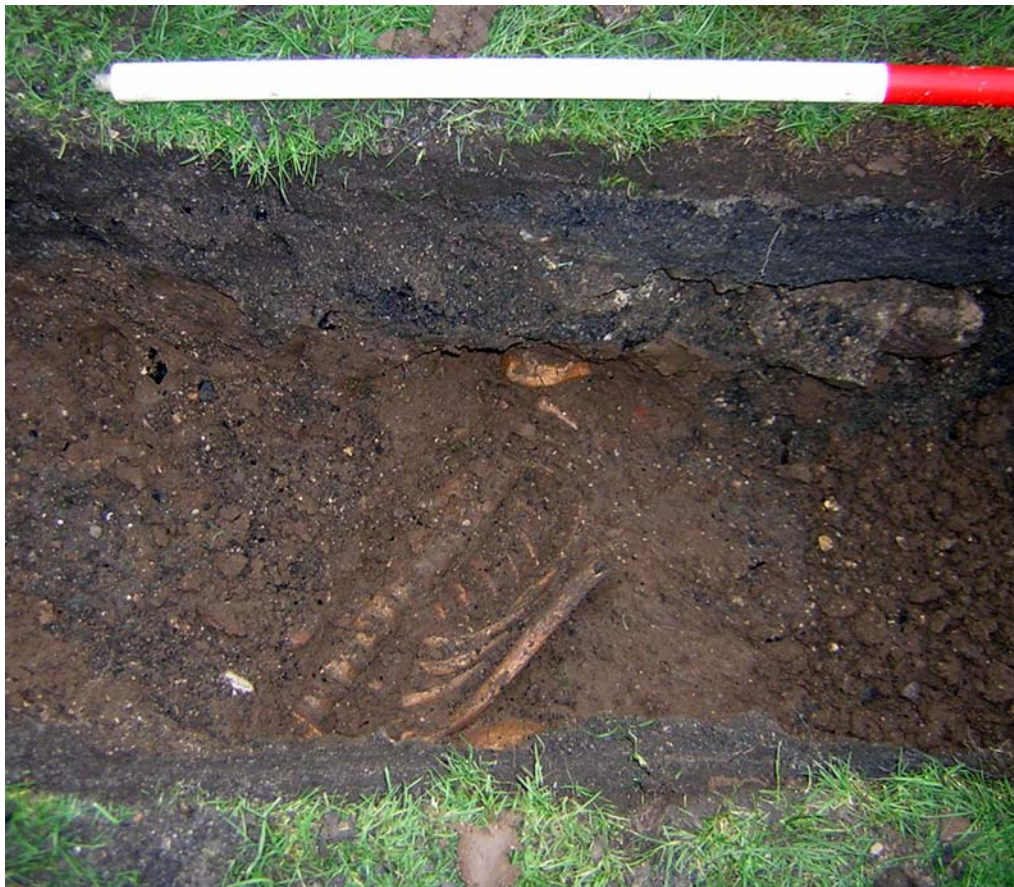
The first burial revealed in the trench was indicated by the top of adult skull (109) in the N section of the trench at a depth of between 400 - 500 mm. Although not excavated fully, this burial appears to be cut into burial (112). This second burial spanned the width of the trench with the spine, ribcage and left arm of an adult visible with the jaw revealed in the S section of the trench. Both burials (109) and (112) are aligned roughly SW-NE with the head at the SW as opposed to the conventional E-W with the head at the W.

Plate 1 : Trench 1 - showing uncovered human remains (109) / (112), taken from N

At this stage, a discussion took place with the MCU staff to ascertain whether the drain could be positioned slightly higher in order to avoid disturbing the burials and to try to avoid burials along the remaining section of trench. This was agreed and excavation continued at a depth of 400 mm rather than 500 mm. However this depth revealed one more burial (115), that of a child. Only the slightly crushed skull of the child was revealed at a depth of 400 mm, aligned roughly WSW-ENE. The depth of the trench was then reduced once more to roughly 300 mm and no further burials were encountered. All the burials were left *in situ* and covered with a layer of pea gravel to protect them from the drain.
