Discovery and Excavation in Scotland

Burghead Well: Archaeological Monitoring, January 2007

HS PIC Index number: 90044
Project code: HSCO-90044-2007-01

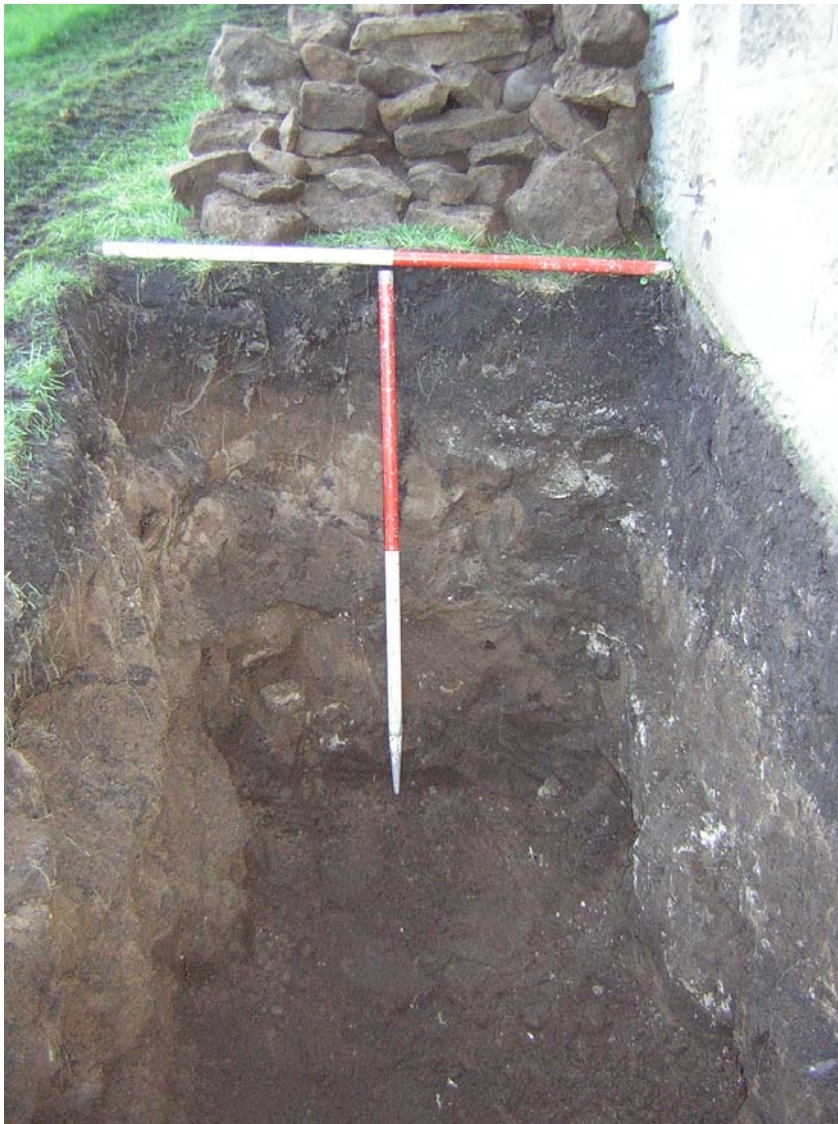
Plate 1 : W end of trench showing E facing section, taken from E

Sandy deposit **(104)** was the earliest deposit identified within the trench. It did not contain any finds but was not a natural deposit as it contained a mixture of sandstone rubble and water-eroded stones. This most likely represents late 19th-century landscaping or may have resulted from excavation and rebuilding carried out at the time of discovery of the Pictish well during the 19th-century. All the deposits above **(104)** relate to the construction and use of the jailhouse, subsequently a residential property in the 20th century.
