LOCAL AUTHORITY:	West Dunbartonshire
PROJECT TITLE/SITE NAME:	Dumbarton Castle: French Prison
PROJECT CODE:	HSCO-90107-2007-01 & HSCO-90107-2007-02
PARISH:	Dumbarton
NAME OF CONTRIBUTOR:	Alan Radley
NAME OF ORGANISATION:	Kirkdale Archaeology
TYPE(S) OF PROJECT:	Watching brief
NMRS NO(S):	NS47SW 5.00
SITE/MONUMENT TYPE(S):	Defence/ Castle
SIGNIFICANT FINDS:	None
NGR (2 letters, 8 or 10 figures)	NS 3996 7453
START DATE (this season)	6 November 2006
END DATE (this season)	9 March 2007
PREVIOUS WORK (incl. <i>DES</i> ref.)	Stewart, D (2005 k) 'Dumbarton Castle, West Dunbartonshire (Dumbarton parish), evaluation; watching brief', Discovery Excav Scot, 6, 2005, 141-142,
MAIN (NARRATIVE) DESCRIPTION: (May include information from other fields)	<p>A small excavation and assessment took place over four days at Dumbarton Castle during November 2006. The French Prison had been deteriorating badly and this was particularly evident in the badly cracked west wall of the east ground floor room and east wall of the small room at the base of the stairs. To investigate these problems two trenches were opened - one to investigate the wall foundations in the east room, and the other to examine the bas

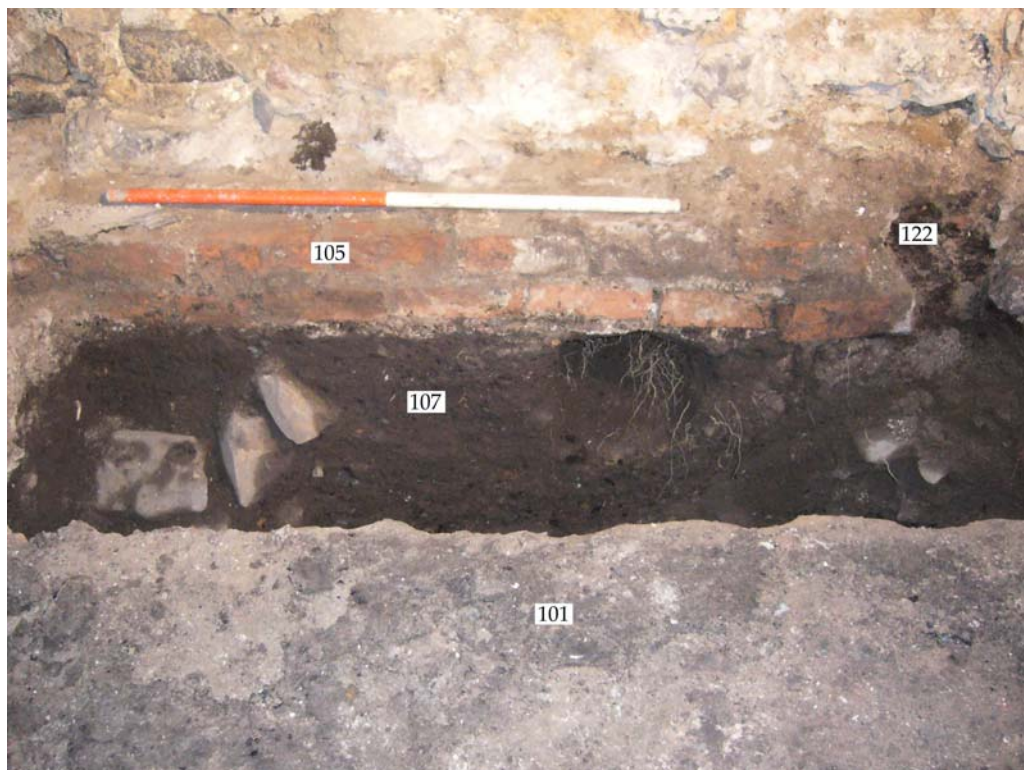
Plate 1 : Trench 1 - showing deposits below W wall, taken from E

The upper deposit, **(101)**, was loose, light-mid brown, gritty sand with 5-10%, 20-60 mm diameter, stones. Below **(101)** was **(102)**, loose, yellow/brown mortar and stones (30% stones measuring 60 mm by 40 mm on average) with some brick fragments.

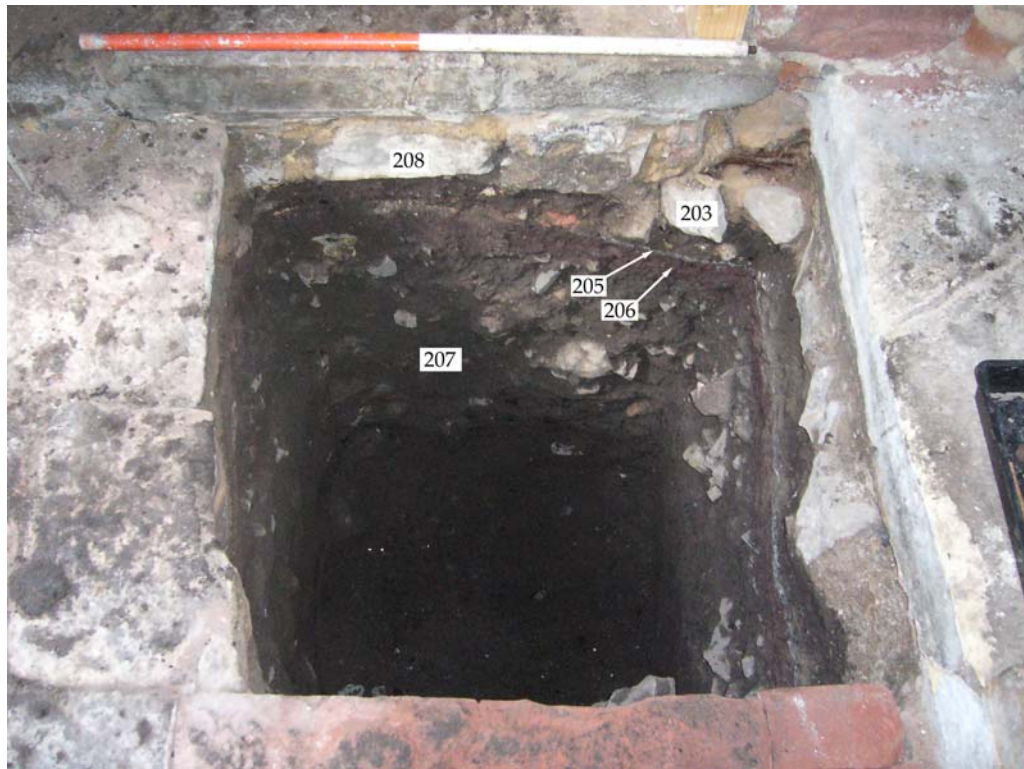
Plate 2 : Trench 2 - showing E facing section, taken from E

At the W edge of the trench there were two courses of stone (208), measuring 500 mm high, bonded with yellow/brown mortar. The upper course in (208) comprised neatly cut slabs measuring 800 mm N-S and 200 mm thick on average and the lower ones were roughly rectangular and up to 600 mm by 400 mm thick. Below (208) and (202), there was a compact, dark brown/black, silty clay (203) with abundant coal dust and lumps as well as fragments of brick, plaster and flecks of mortar, and beneath this in the N half of the trench was a 10 mm thick deposit of orange-brown mortar (204). (204) was directly over (205) in the N half of the trench. (205) was a very compact deposit of ash, coal, brick fragments and charcoal measuring 25 mm

thick. Below (205) and also in the N part of the trench, was an 80 mm thick deposit of very compact, red-brown, gravelly silt (206) with flecks of charcoal, coal and mortar. The primary fill of the trench was loose, dark brown, clayey silt 207 with many (approximately 30%) sub-angular stones, up to 200 mm by 150 mm and 100 mm thick. This deposit measured 670 mm in thickness, and was not bottomed, and the majority of the stones were in its upper half.

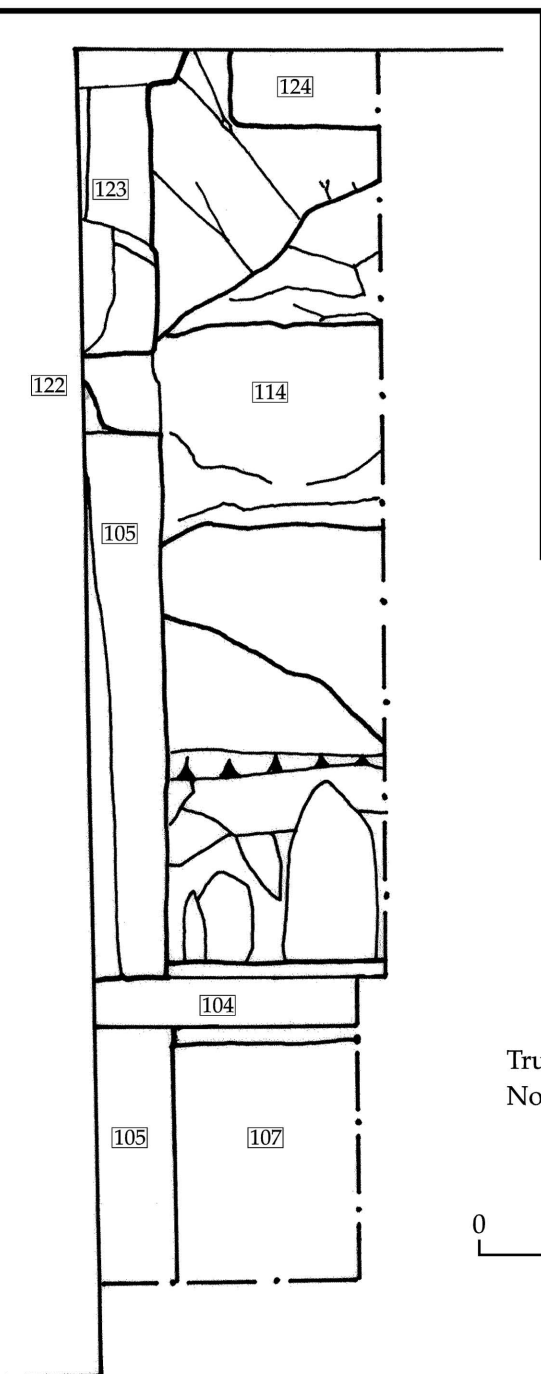
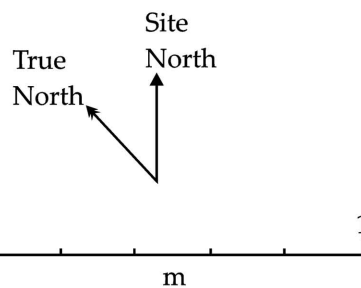
Fig. 4 : Plan of Trench 1

In Trench 1, all of the earliest deposits were seen in the deeper part of the trench that extended 1.50 m S from the N wall which was excavated to a depth of 1.50 m. Bedrock was reached in all but the southernmost 300 mm of the deeper part of the trench. Below (106) and (123), (107) was a deposit of loose, dark grey, sandy silt with many stone grits, some small stones and occasional flecks of mortar and charcoal. (107) was up to 350 mm thick and sealed (115). Deposit (115) was a 200 mm thick, loose mix of orange-brown clay and mid-dark brown, slightly silty clay. Sealed by (115), loose, grey-brown, clayey silt (121) included 15-20% small stones and some lumps of coal. (121) measured up to 250 mm in thickness and sealed (117). (117)

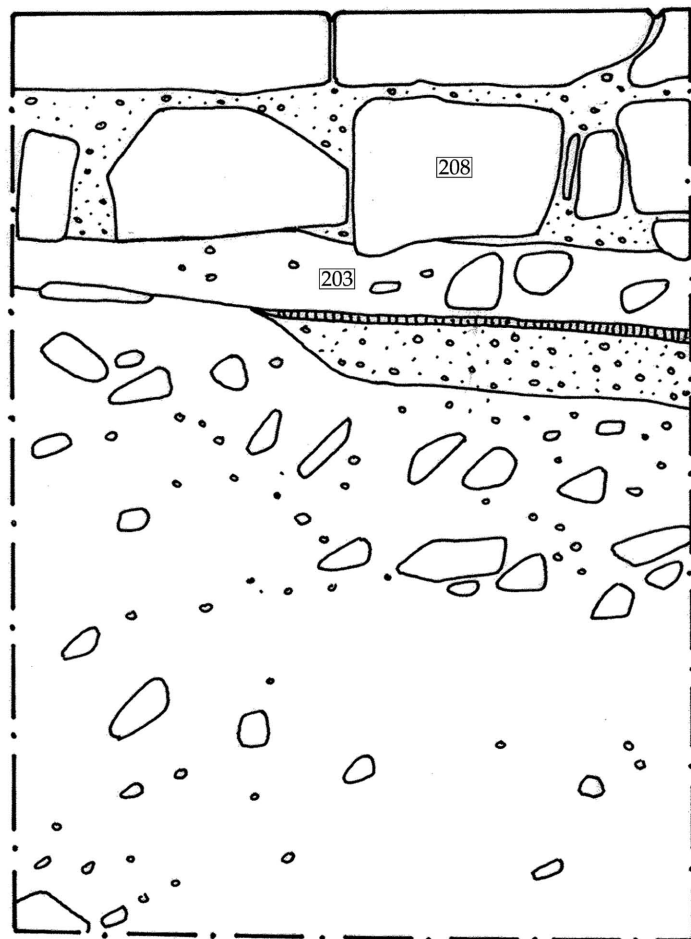
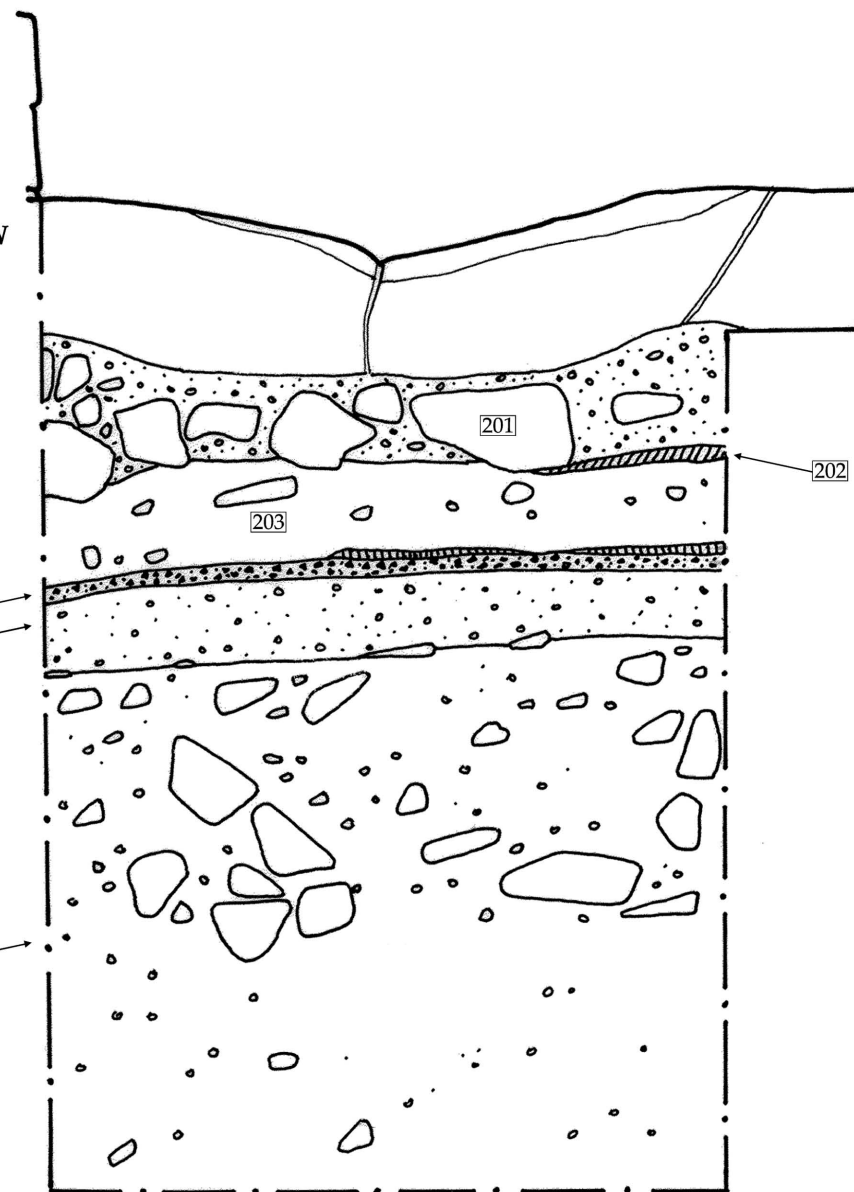
Fig. 5 : Trench 2 sections

The bottom step of the stairway (209) measured 900 mm E-W and was 200 mm thick, formed with a single stone that had cracked toward the E end and was very worn in the middle, dipping down up to 80 mm from the sides. The uppermost deposit excavated, immediately under (209), was a deposit of stones and very loose, dark brown, clayey silt (201) (60% sub-rectangular stones 80 mm by 60 mm on average) up to 100 mm thick. At the base of (201) was a patchy deposit of yellow/brown mortar (202) with small fragments of brick and occasional coal and charcoal flecks.

W section (E facing)

N section (S facing)

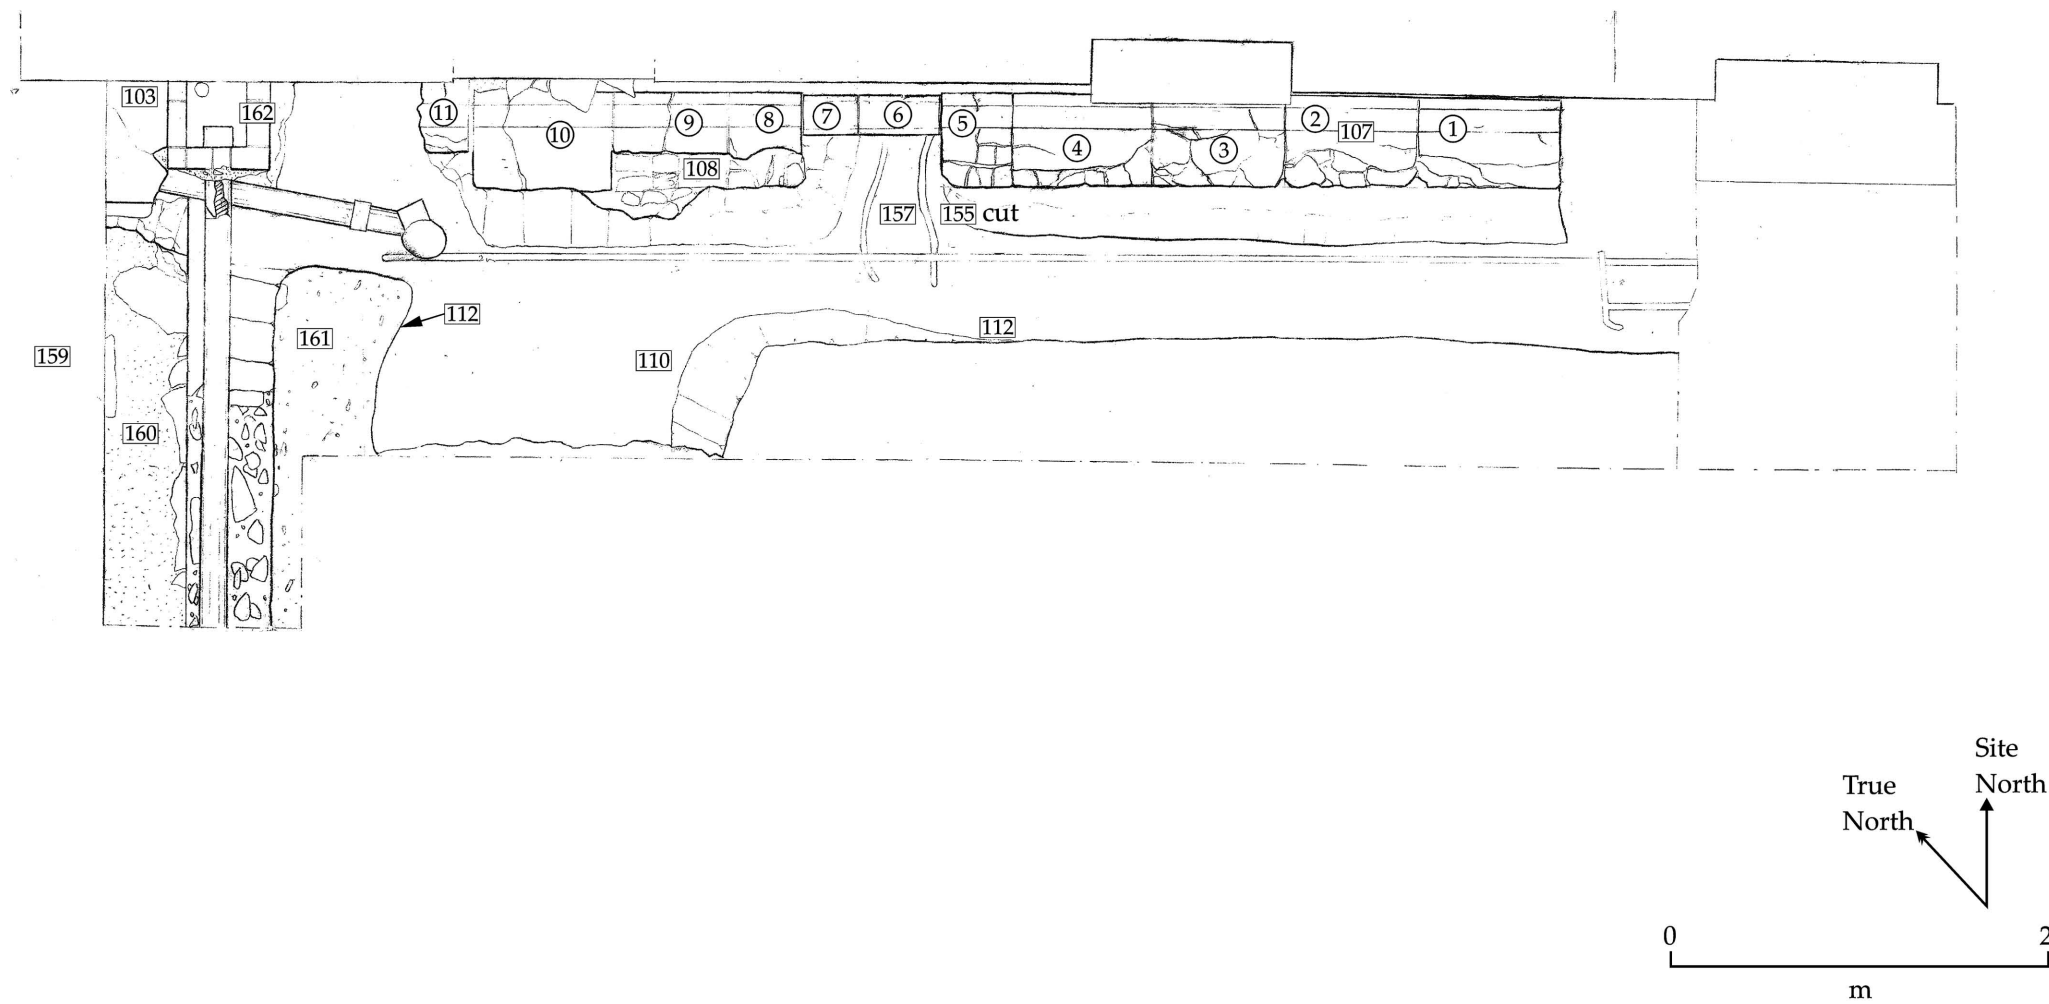
Fig. 5 : Trench 1, W end

Located immediately E of **103 (phase 7)**, **104** is an area of broken sandstone slabs. Immediately under **104** there was a brick built box, **162**. **162** was built against the S wall of the French Prison and formed with single lines of bricks, two courses high, at the E, S and W sides. **162** measured roughly 300 mm square internally and 240 mm in depth. 120 mm diameter cast iron pipe, **122**, ran S from **162**. The steep sided cut for **122, 123**, measured 500 mm E-W and 350 mm deep.

At the W end of the trench, **104** is an area of broken sandstone slabs. Immediately under **104** was a service box, **162** and **104** the capping for it. Cast iron pipe, **122**, took waste away from the base of **162**. **104** takes water from a down pipe in the SW corner of the roof with **122** taking the water S.

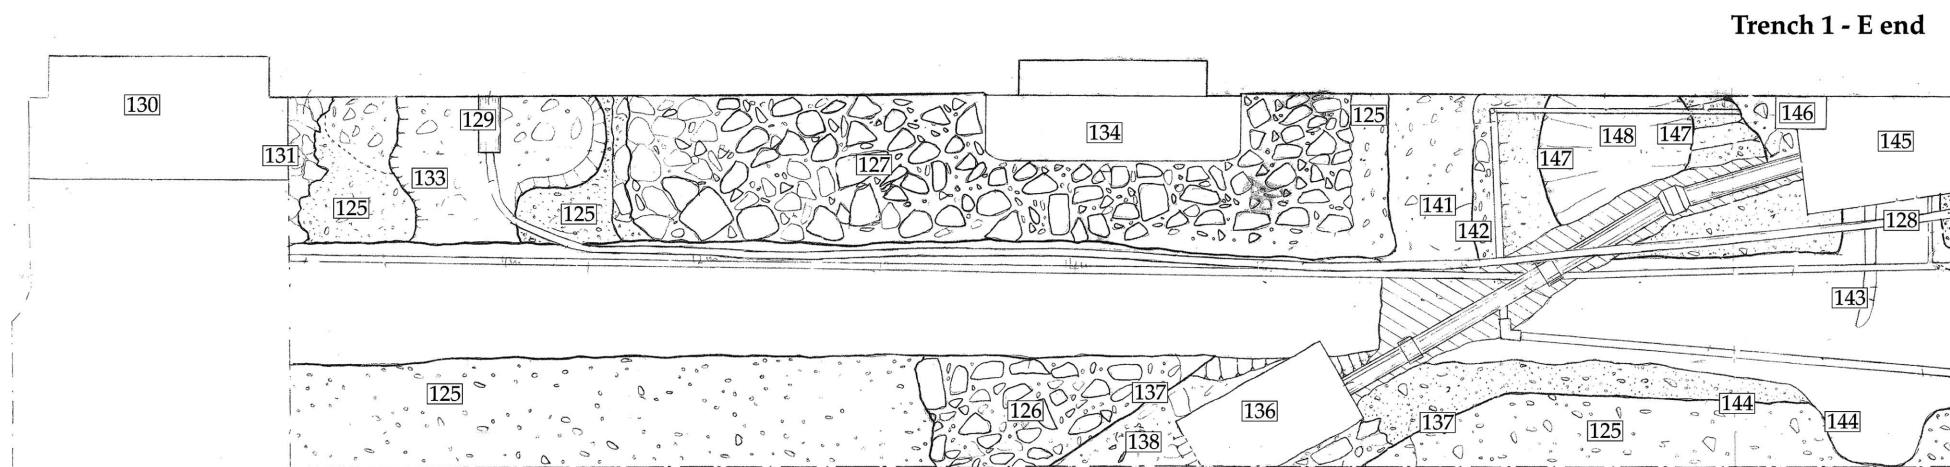
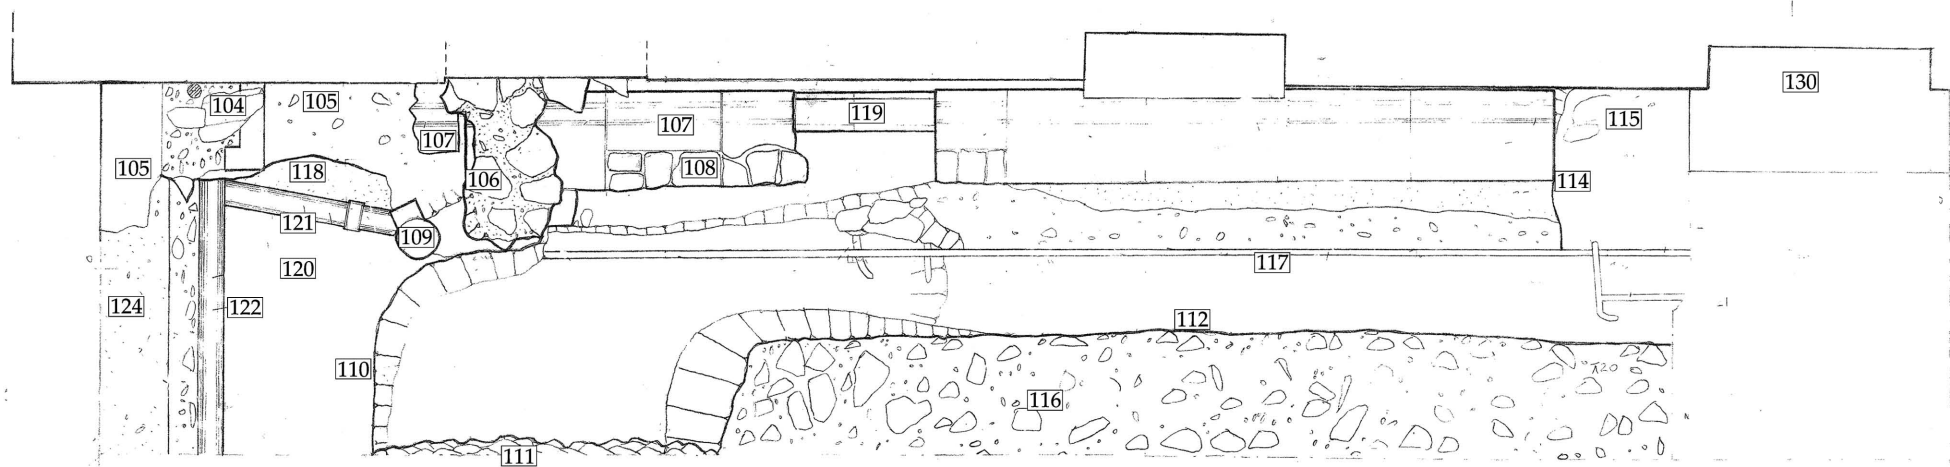
Fig. 6 : Trench 1- most recent features

Trench 1 - W end
